## Theoretical &amp; Applied Mechanics Letters

## Letter

## Progress on the ultrasonic testing and laser thermography techniques for NDT of tokamak plasma-facing components

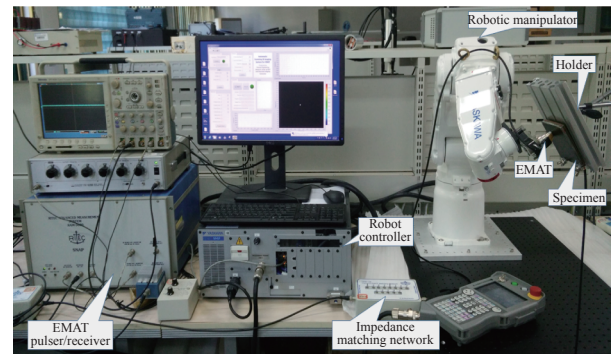
Fig. 2. Setup of the flexible robotic EMAT-scanning experiment system for FW inspection

The robot-based flexible EMAT inspection system is shown in Fig. 2. The details of the experimental system and the basic principle of the testing method have been given in Ref. [11]. The EMAT is excited by a long burst current to generate a series of ultrasonic waves with a specific central frequency. When there is a delamination defect under the EMAT, an ultrasonic resonance would occur [11, 21]. A signal processing method based on power spectrum density (PSD) analysis of the resonant ultrasonic signals is introduced for the delamination defects identification and imaging.

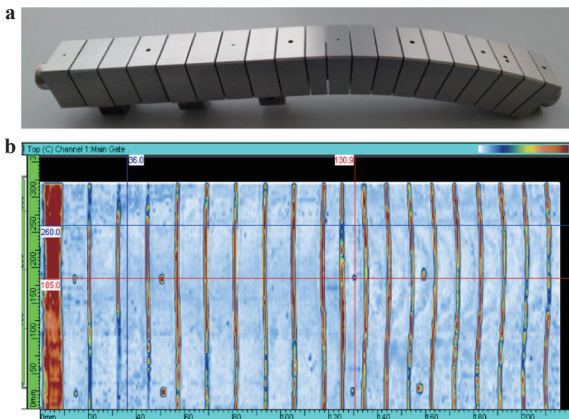
Fig. 1. a Monoblock W/Cu mock-up with flat-bottom holes and b UT C-scan image at the interface of Cu-CuCrZr.

To fit with the curved shape of the monoblock, a special scanning scheme was designed. The focus UT probe was driven by a flexible tube in the longitudinal direction. The scanning process was stepped in the circumferential direction. Based on this scheme, a spiral UT system was set up to detect the bonding quality of the monoblocks. The testing frequency was chosen to be 15 MHz. For the evaluation of detection effect of the UT, a standard test-piece was fabricated using HIP shown in Fig. 1(a). A series of flat-bottom holes of 1 mm size were fabricated in the

sample but other conditions kept the same as the actual product manufacture. A C-scan image of the standard test-piece is shown in Fig. 1(b). It can be seen that though there is normal response caused by the interface effect of different materials, the signal of the flat-bottom holes is clear. For the judgement of the defect, the calibration was conducted. In detail, the amplitude due to the hole whose size is larger than 2 mm was selected as the critical value and set to be 80% of the screen high. The signal exceeding this value will be recognized as a defect signal. The monoblock qualified by the spiral ultrasonic system was then tested through the HHF testing. It is found that the qualified monoblocks can withstand 1000 cycles of heat load at 10 MW/m<sup>2</sup>. It is also clarified that the bonding quality of W/Cu monoblock PFCs can be properly tested by the proposed UT system [5].

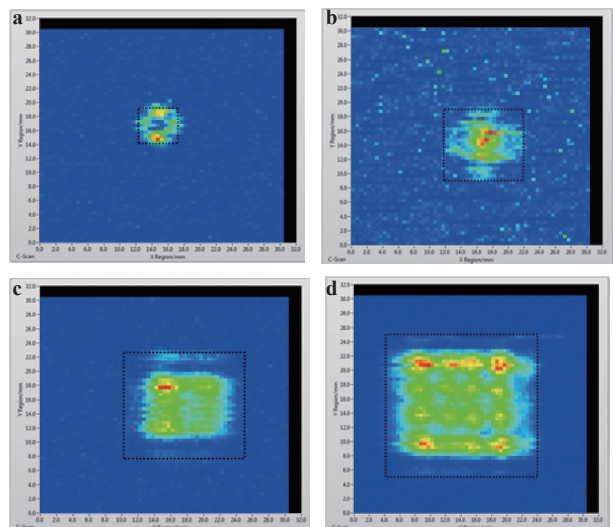
Fig. 3. C-scan images of the different delamination defects: a 5 mm×5 mm, b 10 mm×10 mm, c 15 mm×15 mm, and d 20 mm×20 mm delamination

Figure 3 shows examples of the ultrasonic C-scan images of a specimen with four artificial delamination defects by using the flexible EMAT system. The images are obtained by measuring

the peak values of the PSD curves of the ultrasonic resonance signals at each scanning points. The specimen is made with an aluminum plate and a copper plate bonded together by using diffusion welding. It can be seen that the four delamination defects with size from 5 mm×5 mm to 20 mm×20 mm are clearly identified. The size of the delamination defect can also be directly evaluated from the image with a relative small error.

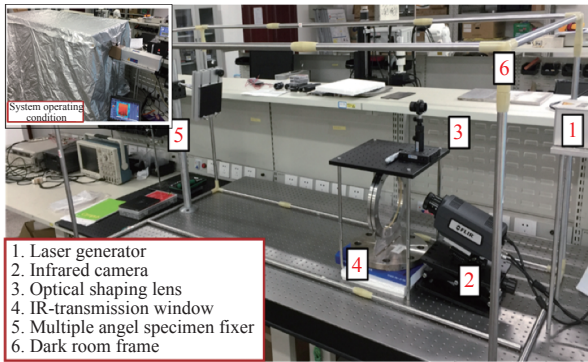
Fig. 4. Setup of LIRT experiment system to simulate the online inspection of FW in VV

Considering the special structure and environment in the VV, carrying out the inspection through the VV window is one of the prefer approaches. To evaluate the feasibility to inspect FW by using LIRT system set outside the VV, the influences of the distance and angles between target FW plates and the inspection system are necessary to be considered. Figure 4 shows the setup of LIRT experimental setup to simulate the online inspection of FW in VV. The exciting laser was generated by the laser driver. A function generator is adopted to provide a square pulse wave to the laser generator module and to modulate the laser duration and power. As the initial laser is in a round shape with Gauss distribution, a set of optical lens is adopted to shape the laser into a relative homogenous round laser spot. In addition, a

95% infrared (IR)-transmittance glass window was fabricated and set in front of the IR camera to take into account the influence of the practical VV window. A multiple angle specimen fixture was fabricated to adjust the distances and angles of FW specimen. Excepting the laser generator and controlling unit, the other sub-systems are set into a dark room cover. A mid-wave infrared camera is adopted to capture the thermal images and to transfer them to computer. During a heating and cooling period, the thermal images were acquired from the end of the laser pulse with 60 Hz frame rate. After 20 s totally 1200 images were recorded to ensure enough transient decay temperature signals [19, 22].

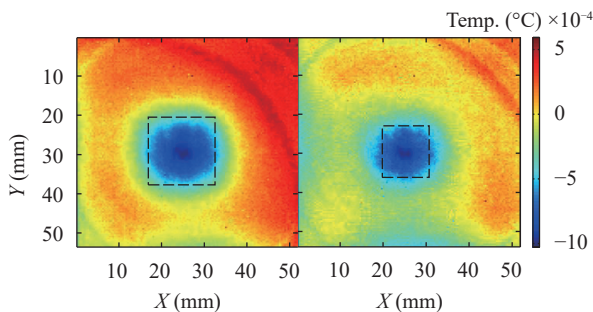
Fig. 5. Processed thermal images of calibration cases

At first, the direct facing mode inspection is implemented. A calibration experiment is then carried out based on the measured results. The sound reference experiments are carried out with the Al-Cu double-layered specimen. The specimen used here is the same with that mentioned before. After recording the raw thermal images, a Thermographic Signal Reconstruction method (TSR) is applied to reduce noise interference and enhance the quality of the inspection image of laser thermography for a higher defect contrast. As illustrated in Fig. 5, the defects contrast was significantly enhanced by taking difference between calibration and sound reference images. The two defects (with size of 20 mm×20 mm and 15 mm×15 mm, respectively) become clearly visible in this case. However, the size of the defects image seems smaller than their actual size.

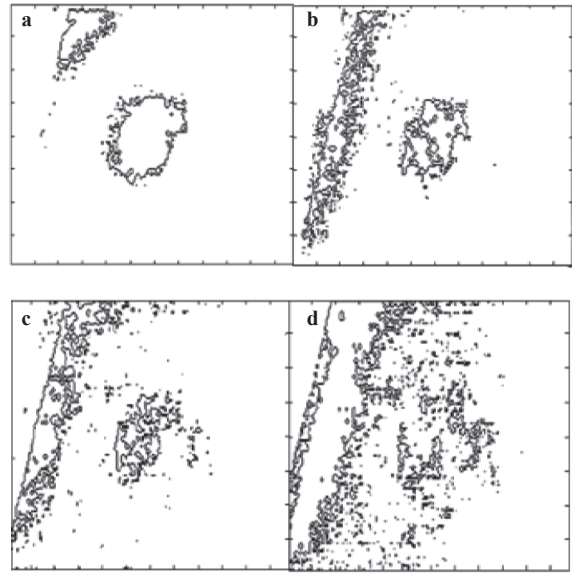
Fig. 6. Defect boundary results of the Al-Cu specimen in 2.2 m/60°-44° angle inspection mode, the size of the four delamination defects are a 20 mm×20 mm, b 15 mm×15 mm, c 10 mm×10 mm, and d 5 mm×5 mm, respectively

ing algorithm was applied to identify the boundary of the defects by using the actual calibration data fork. Figures 6 and 7 show the results of the Al-Cu specimen in the 2.2 m/60°-44° and 2.2 m/35°-44° inspection modes. From these figures it can be noted that the identified defect shapes were transformed and the defect boundary become indistinct with the increasing of inspection angle. The reason is supposed that the IR camera ac-

quired less infrared emissivity in angle modes than in direct facing mode. The 5 mm×5 mm square delamination in the Al-Cu specimen become invisible in these angle modes, which means the detectability in two angle inspection modes are limited at 2.0 depth to width ratio [19].

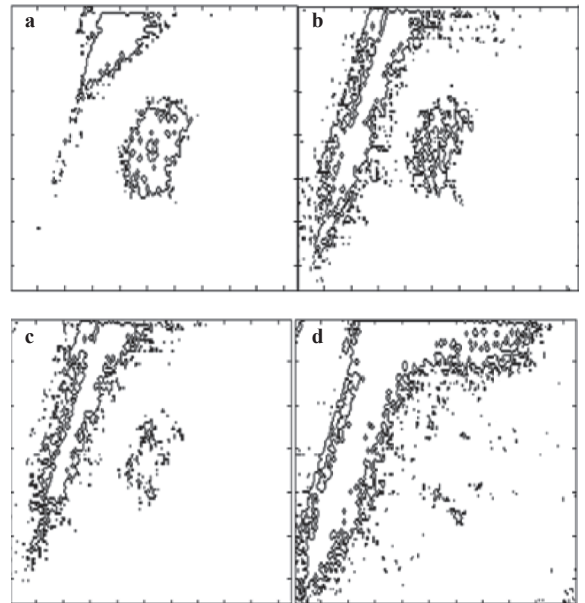
Fig. 7. Defect boundary results of the Al-Cu specimen in 2.5 m/35°-44° angle inspection mode, the size of the four delamination defects are a 20 mm×20 mm, b 15 mm×15 mm, c 10 mm×10 mm, and d 5 mm×5 mm, respectively

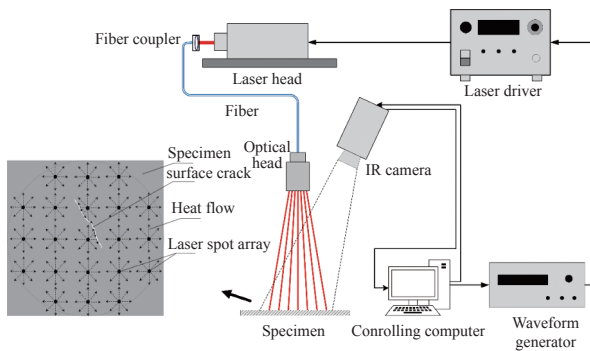
**Fig. 8.** Schematic diagram of the fiber-guided LAST system and the basic principle for crack inspection.

As shown in Fig. 8, the proposed fiber-guided LAST system is composed of excitation, sensing, data processing and control units. Similar to the LST system established before, a function generator is used to modulate the laser duration and power. The modulated laser is firstly coupled into a fiber with a core diameter of 0.4 mm, and then split into 9 × 9 laser spots array by using an optical head. The designed optical head connected with the fiber is composed of two plano-convex lenses and a diffractive

optical element. The sensing units contain an IR camera with the resolution of 640 × 512 pixels, the sampling rate of 60 Hz, and the measurement accuracy of 50 mK. The data processing and control units comprise a personal computer (including data acquisition and processing software).

The principle for crack inspection by LAST is shown at the left side of the Fig. 8. The heat flow generated from the laser spots will be perturbed by the crack and form a sharp temperature difference across the two sides of crack. After recording the whole heating and cooling procedure, an image processing procedure is applied. In this way, the cracks in a large area can be inspected in one testing. Therefore, it can provide a fast and intuitive measurement.

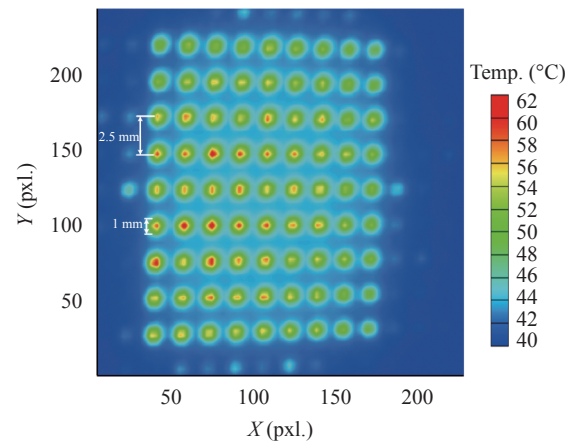
**Fig. 9.** Measured thermal image with 9 × 9 laser array spots (1 pixel sees 0.1 mm).

To verify the performance of the developed LAST system, a measurement on a steel specimen without crack was firstly carried out. The specimen is coated with black lacquer at first to increase the absorption rate and surface emissivity. Figure 9 shows the experimental results. From measured thermal image, the  $9 \times 9$  laser array spots can be clearly observed and the laser size and spacing meet well with the inspection requirement.

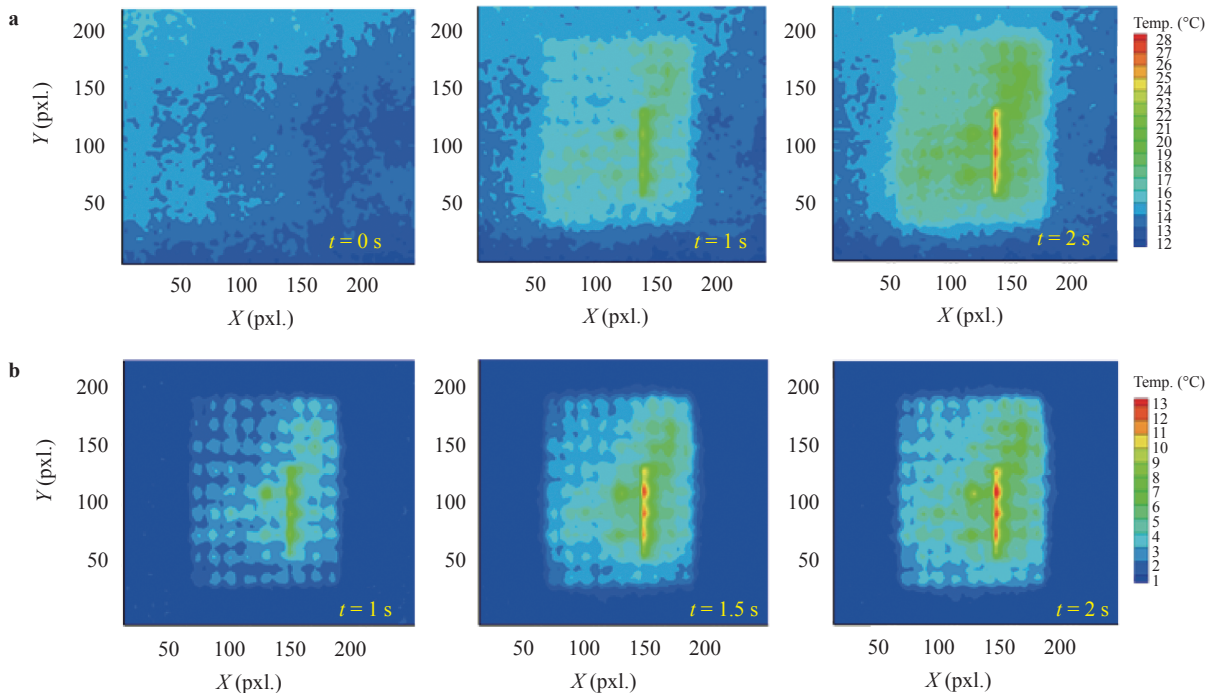
**Fig. 10.** Thermal images at different record time measured on the stainless steel plate with a crack. **a** Raw thermal images, **b** computed background free images

The inspection experiment is also conducted on an uncoated stainless steel specimen with an electric discharge machining (EDM) crack. In experiment, a  $9 \times 9$  laser spot array with the duration of 2 s was generated as heating source. The 2 s heating period and 8 s cooling period were recorded by the IR camera. Figure 10(a) shows the raw thermal images at different recording times. Although the crack heat pattern can be recognized in the raw thermal images, the laser spots is not so clear as that shown in Fig. 9. This is because the emissivity of the uncoated specimen is low and the surface is uneven. In order to reduce the background noise, the cold image subtraction was applied and the obtained background free images are shown in Fig. 10(b). It can be seen that the background noise is mainly removed, and both the laser array spots pattern and crack heat pattern become clearer. However there is still some noise in these images but the noise is randomly distributed while the crack heat pattern in each thermal image is almost the same.

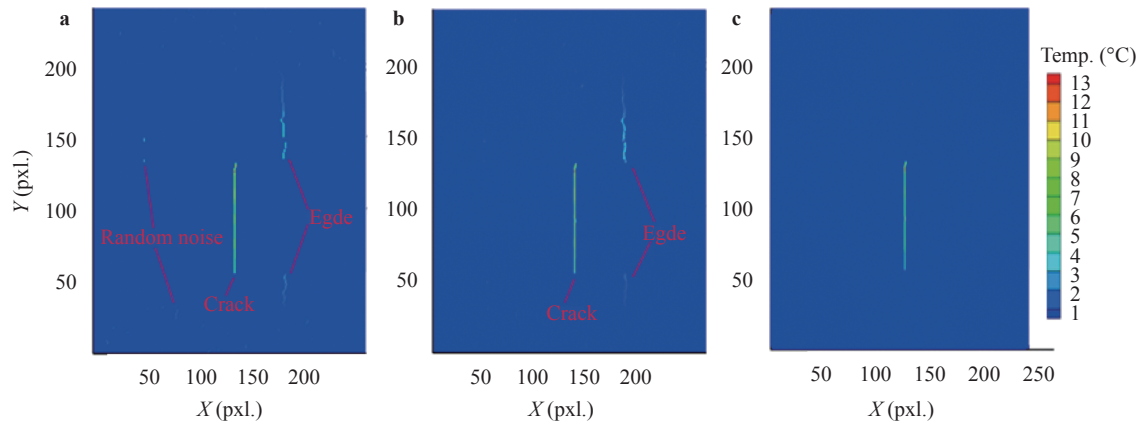
**Fig. 11.** Noise elimination procedure for extreme value image. **a** Crack extraction with a single background free image, **b** crack extraction with multiple background free images, **c** final image without edges

After calculating the background free image sequence, the surface pattern can be greatly eliminated. Then the holder exponent analysis method is adopted to isolate the crack from heat source pattern in the background free sequence. However, in this method the crack is extracted from a single image at a certain frame but not from the whole image sequence, which may cause the loss of information and increment of noise level. To solve this problem, an improved crack extraction method is proposed. Instead of applying the holder exponent analysis to a single background free image for crack imaging in the previous method, the superposition of several images are applied to further reduce the random noise that may cause false indication of cracks. The details of the improved crack extraction method are given in Ref. [20]. Figure 11(a) shows the extracted crack image with a single background free image. The crack can be clearly recognized though there is still some random noise. Figure 11(b) shows the crack extraction results by using the improved method. A significant reduction of noise can be witnessed by super-

imposing multiple crack isolated images from  $t = 1$  s to  $t = 2.5$  s (a total of 13 frames from frame 9 to 21). At last, the edges are removed by comparing with the heating area in original thermal image, as shown in Fig. 11(c).

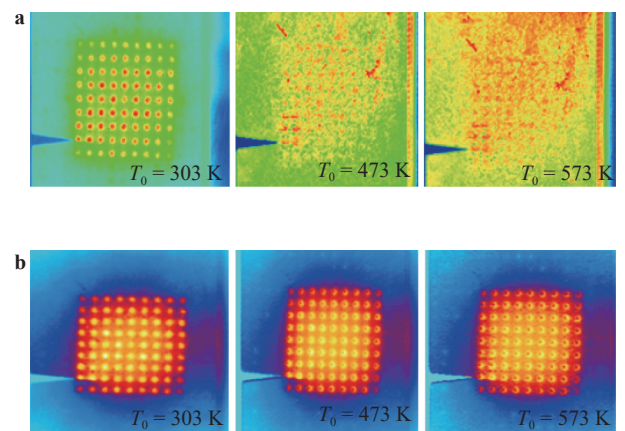
**Fig. 12.** Thermal images measured on a specimen with different initial temperatures. **a** Raw thermal images, **b** computed background free images

Online inspection of surface cracks at elevated temperature is more challenging for the health monitoring of the Tokamak structures. An experimental investigation has been also conducted to investigate the feasibility of LAST method for surface crack inspection at elevated temperature. In the experiment, a steel plate with a fatigue crack was heated to different temperature. When the temperature of the specimen reached to 373 K, 473 K, and 573 K, corresponding LAST measurements were conducted respectively. Figure 12(a) shows the raw thermal images measured on the specimen at different initial temperatures with a 2 s laser heating pulse. At room temperature, the laser spot array can be clearly observed and the crack can be identified without particular image processing. However, with the rising of initial temperature, the thermal contrast of thermal images becomes much lower and the crack indication is also masked by the background noises. Figure 12(b) shows the corresponding background free images for the raw thermal images. After the image processing, as the background noise is stationary, only the laser

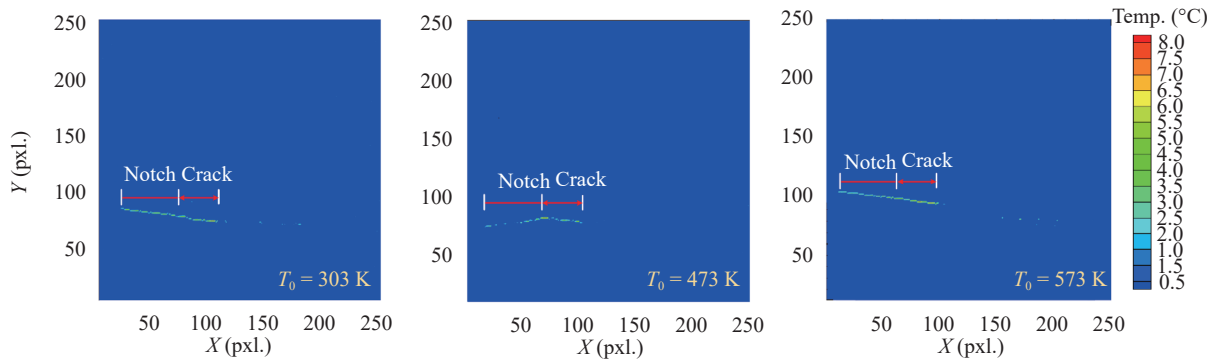
**Fig. 13.** Final crack extraction results for thermal images of different initial temperatures.

induced temperature variation is retained. Figure 13 shows the final crack extraction results for the thermal images of different initial temperatures. The results reveal that the good detection capabilities of LAST can be maintained for surface cracks even at elevated temperature.
