Citation: Miah, S., Kaparias, I., Ayub, N., Milonidis, E. and Holmes, W. (2019). Measuring cycle riding comfort in Southampton using an instrumented bicycle. In: 6th International Conference on Models and Technologies for Intelligent Transportation Systems (MT-ITS). . IEEE. ISBN 9781538694848

Measuring cycle riding comfort in Southampton using an instrumented bicycle

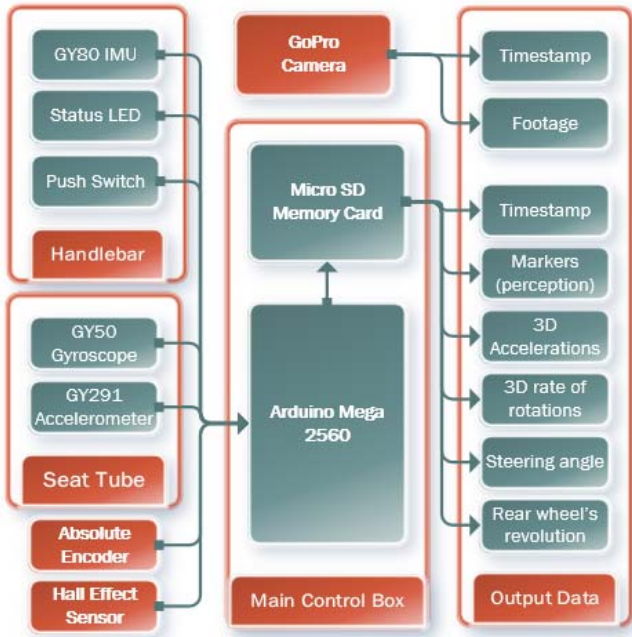
The seat tube enclosure houses another set of accelerometer and gyroscope configuration, and these are used to monitor the rear frame acceleration and angular rate respectively. The Hall Effect and the absolute encoder sensors are used to measure the revolutions of the rear wheel and the steering angle respectively, while the main control box incorporates an Arduino Mega 2560 board along with various electronic components and micro SD memory card. In addition, a GoPro camera is installed on the bicycle for the purpose of visual validation of the journeys. The iBike’s full system architecture is shown in Fig. 2.

Fig. 2. iBike measurement system architecture and output data

In order to establish riding comfort and demonstrate the iBike’s capability in this respect, only the timestamp, markers and vertical acceleration data are analyzed in this study. The authors believe that cycle riding comfort is very likely also influenced by the rider’s behavior, and this could include a variation of speeds and steering angles in order to avoid a pothole or surface defect. However, this is beyond the scope of the present study and the authors envisage analyzing these other parameters in a subsequent publication.

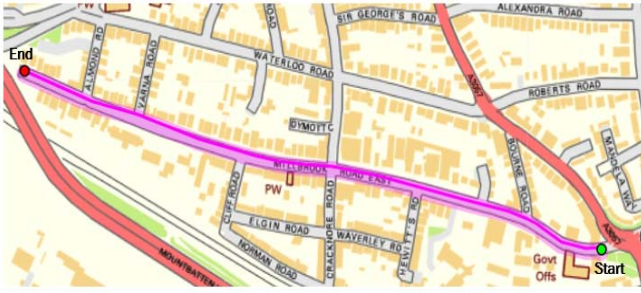
or vice-versa, such that a completed round trip along MRE, highlighted in pink in Fig. 5, is considered as two runs.

Fig. 5. Survey route: MRE, Southampton, UK

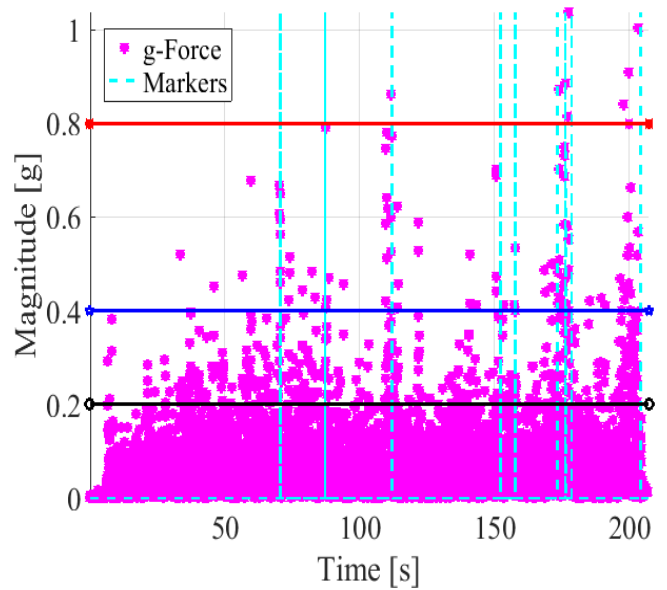
magnitude values. Fig. 7 presents the vertical acceleration data from a single run conducted at the survey location and after taking the absolute value and removing the normal $1g$ from them. Each pink solid dot represents a vibration hit and it is also associated with a magnitude value, which is used to categorize it into either “low”, “moderate” or “high” severity. In the present study, the threshold ranges shown in Table I are adopted based on a fine-tuning exercise carried out by analyzing the GoPro camera’s footage, the data from the accelerometer and the markers denoting cyclist perceptions. A more elaborate study seeking to establish the threshold values for these categories in a systematic way is currently under way; however, this is beyond the scope of this paper.

Fig. 7. Pre-resurfacing accelerometer data with markers and thresholds

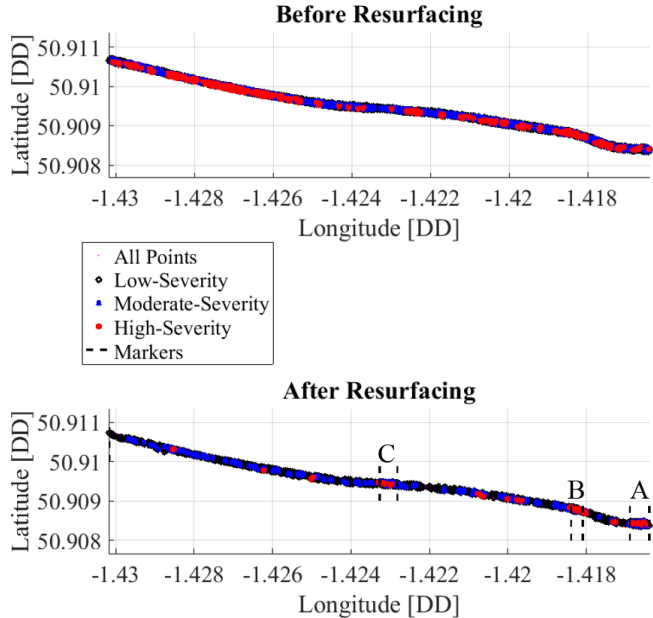
Subsequently, the vibration hit data with their magnitude and position values found through the analysis of the accelerometer data for all runs of the before- and after-resurfacing cases are depicted in Fig. 10, grouped by severity category. The locations of Markers A and C in the figure have not been resurfaced, whereas the location of Marker B represents a speed hump. It is apparent that the number of high severity hits has considerably decreased in the after case, and visual examination of the data shows that it matches cyclist's perception depicted in Fig. 8 and Fig. 9.

Fig. 10. Hit severity pre- and post-resurfacing along MRE

defects have been repaired through the resurfacing of MRE. However, instances of finishing "snags" in some parts of the surface appear to introduce new minor defects (g, h and i) that are not visible to the naked eye, and these still have some negative effect on the riding experience, as demonstrated both by the rider themselves and the analysis of the sensor data presented in Fig. 9 and Fig. 10 (after case).

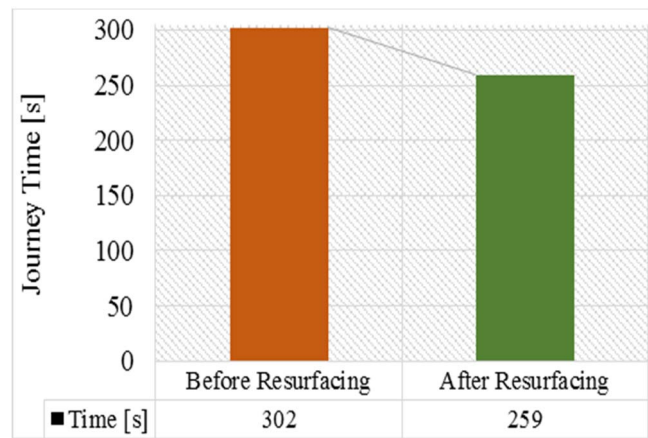
Furthermore, it is also clear from Fig. 12 that on average the journey time for the after-case has reduced by 9 seconds along the 1 km surveyed route. This suggests that in the after-case the cyclist has been able to ride faster along the route because of the reduction of the discomfort caused by surface defects.

Fig. 12. Average journey time along MRE pre-and-post-resurfacing

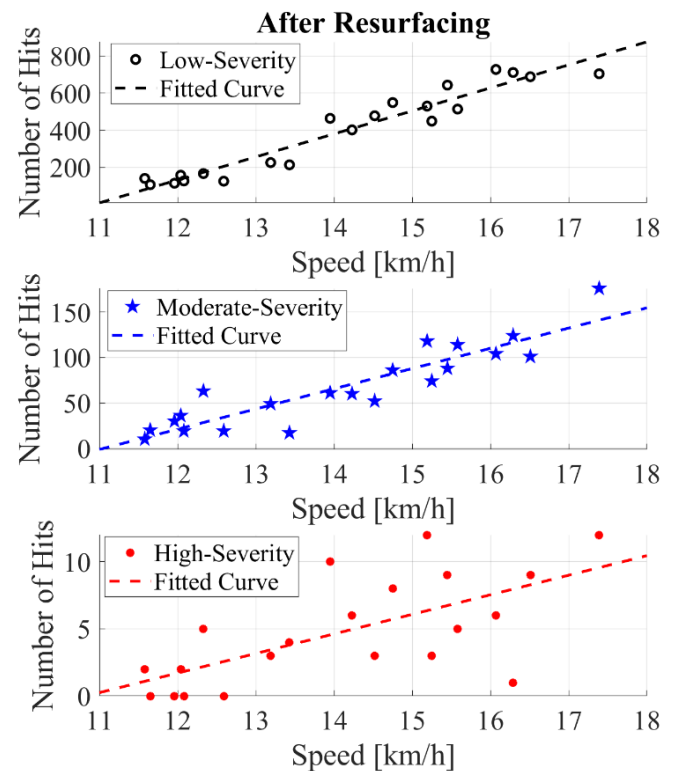
Considering the post-resurfacing case of MRE, the relation between speed and number of hits is depicted in Fig. 17. As can be observed, there appears to be an opposite relation between the two parameters compared to the before-case, as higher travel speed is associated with a higher number of hits across all three severity categories. This can be attributed to the fact that most pre-resurfacing defects on MRE have been repaired/removed, and the selected few ones

remaining are avoidable by swerving. As such, when riding slowly, it is possible to swerve around the defects, which results in lower numbers of hits, but when riding faster, it is more difficult to avoid the defects, so a higher number of hits occurs. Thus, post-resurfacing cycling comfort appears to be more strongly dependent on cycling speed than in the before-case, where speed plays a less important part.

Fig. 17. Post-resurfacing: cycling speed and number of hits

After resurfacing, however, a strong positive correlation can be identified between the number of hits and the speed for all three severity levels. This pattern is more in line with what would be anticipated from a “typical” road (with few defects), i.e. that slower cyclists (typically less experienced and on leisure trips, e.g. children) experience a more comfortable ride than faster ones (typically more proficient, e.g. commuters). It also highlights the overall finding of this analysis, which is that in the absence of widespread pavement defects, riding comfort is higher, with slower cyclists benefitting most. On the other hand, the presence of widespread pavement defects/damage results in a deterioration of riding comfort for fast and slow cyclists alike.
