Evaluation of wetland health of prairie potholes at the Bandy Ranch Ovando Montana

**Evaluation of Wetland Health of Prairie Potholes at the
Bandy Ranch
Ovando, Montana**

APPENDIX C
PHOTOGRAPHIC LOG

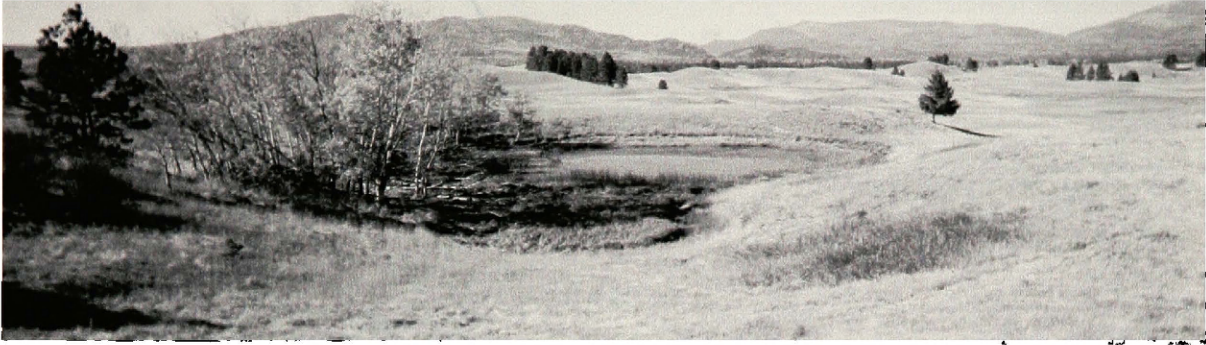
Pothole 1 - Viewing west.

During the second week of September 1997, six cattle were accidentally allowed access to the south pasture. On that date the cattle were observed in and around Pothole 1. On other occasions, Potholes 40, 41, and 42 were observed to have cattle in the pothole. Based on conversations with Bandy Ranch managers, these cattle were owned by an adjacent landowner that accessed the property through an unmended fence.

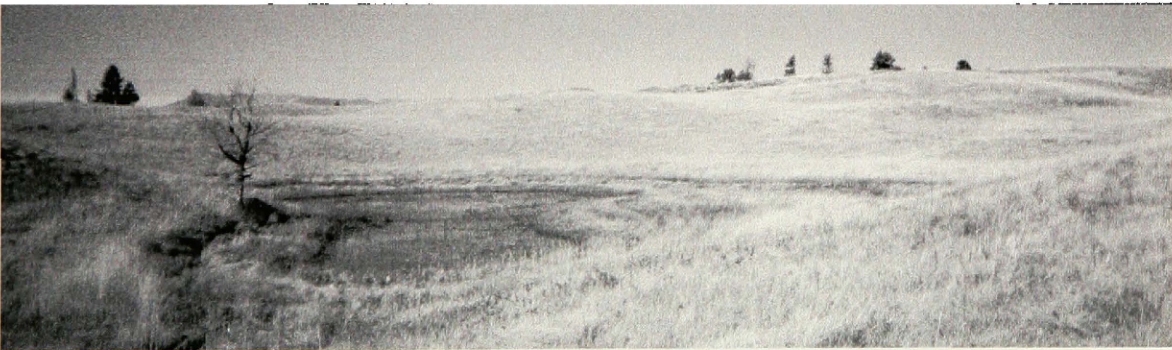
Pothole 3 - Viewing northwest.

Much of the bare ground that was observed around Potholes 3, 15, 17, 18, 31, 41, 43, and 44 exhibited both hummocking and pugging. While it is likely that the hummocking and pugging was caused by cattle grazing (all of these potholes are located areas with grazing), some of the hummocking and pugging can be the result of large game animals such as elk or deer.

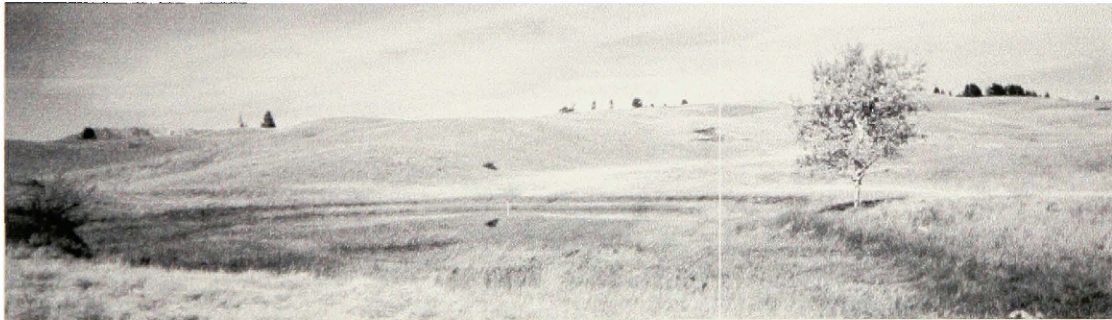
Pothole 15 - Viewing northwest.

Several potholes (Potholes 1, 15, 17, 18, 30, 40, 41, 42, 43, and 44) that scored below 80 percent overall health were affected by this inventory item. As previously stated, these potholes were noted as having between 3 and 20 percent of their total area occupied by bare ground. In addition, a large percentage of the potholes lacked the presence of trees and shrubs, which are excellent shoreline stabilizers. Large percentages of moderate stabilizers, such as spikesedge (*Eleocharis palustris*) and Baltic rush (*Juncus Balticus*) was observed in many of the shoreline areas. A perfect score (actual 6 out of a possible 6) was given to potholes that had greater than 85 percent of the shoreline exhibiting this type of vegetation. Pothole 43 had between 0 and 35 percent of the shoreline occupied by vegetation with deep, binding root mass; Pothole 42 had between 36 and 65 percent; and the remainder of the above-listed potholes had between 66 and 85 percent.

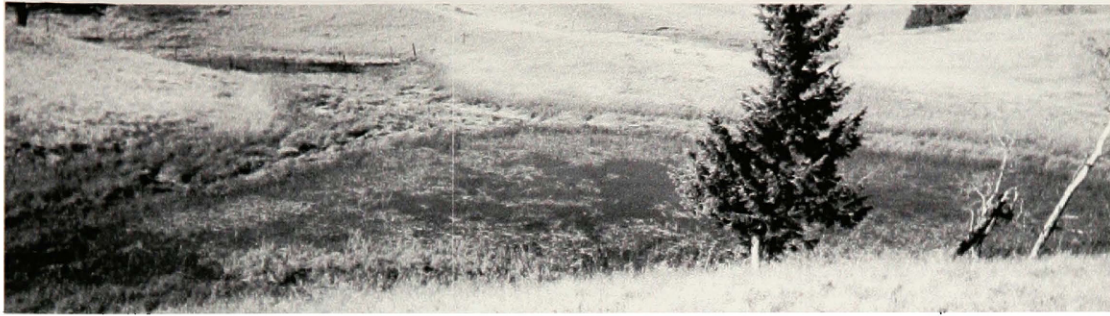
Pothole 29 - Viewing west.

As with tree regeneration discussed above, the inventory of Potholes 29 and 30 identified one shrub species (*Salix geyeriana* [geyer willow]) that was mature at both potholes. No seedling or sapling willows were identified during the inventories. This species does not appear to be perpetuating itself in this location. Very few geyer willows were noted
