Revegetation for riverbank stabilization on the upper Clark Fork River, Montana

REVEGETATION FOR RIVERBANK STABILIZATION
ON THE UPPER CLARK FORK RIVER, MONTANA

by
Brendan James Moynahan
B.A. Bates College, 1994
presented in partial fulfillment of the requirements
for the degree of
Master of Science
The University of Montana
January 1999

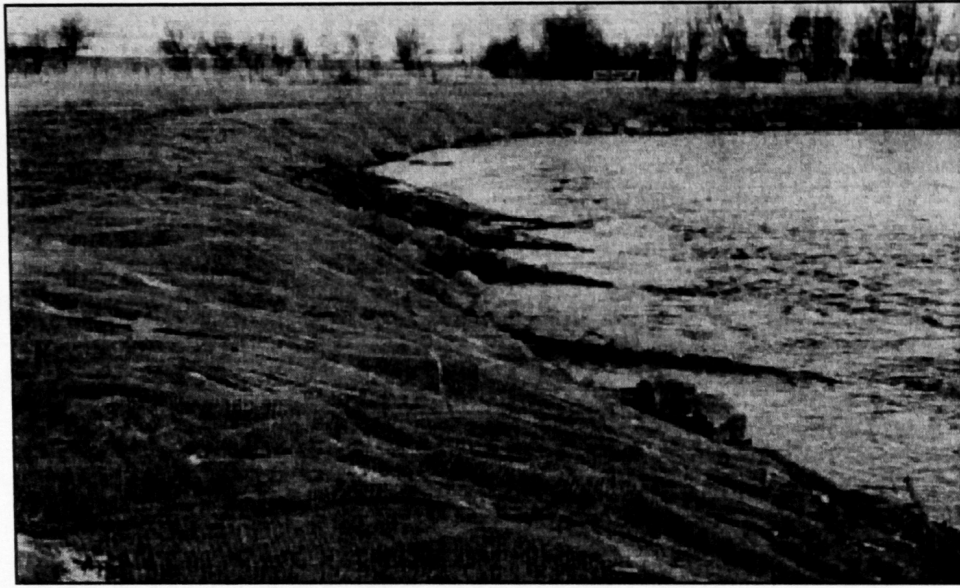
Figure 2. Placement of log bars to deflect the erosive force of the current away from the bank and toward the center of the channel.

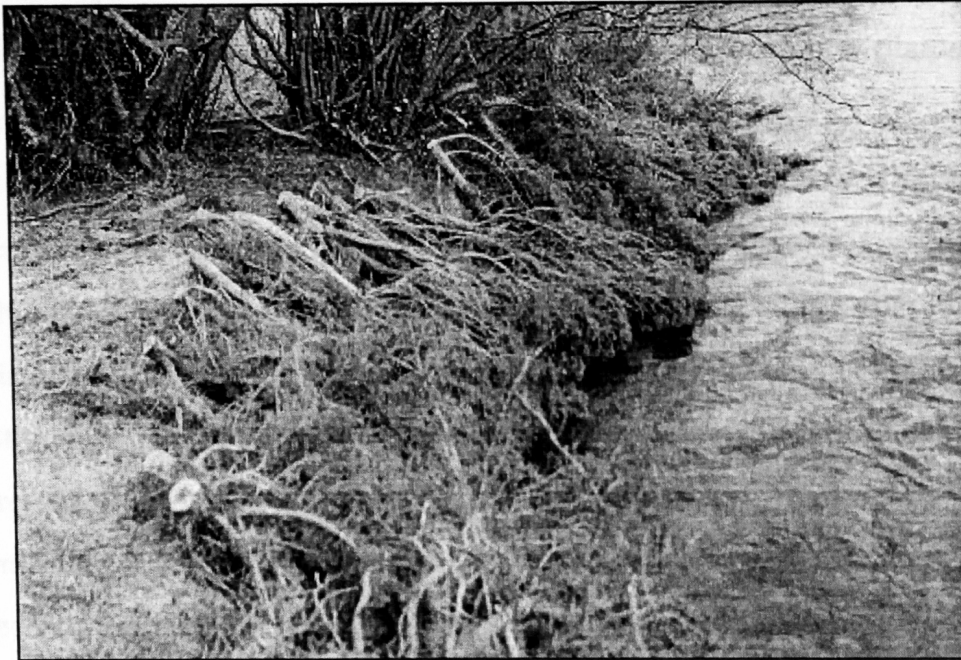
Figure 4. Placement of *Juniperus scopulorum* (Rocky Mountain juniper) revetments along the outer edge of a vertical bank. The revetments are designed to reduce the erosive force of the current and to minimize the impact of winter ice floes.

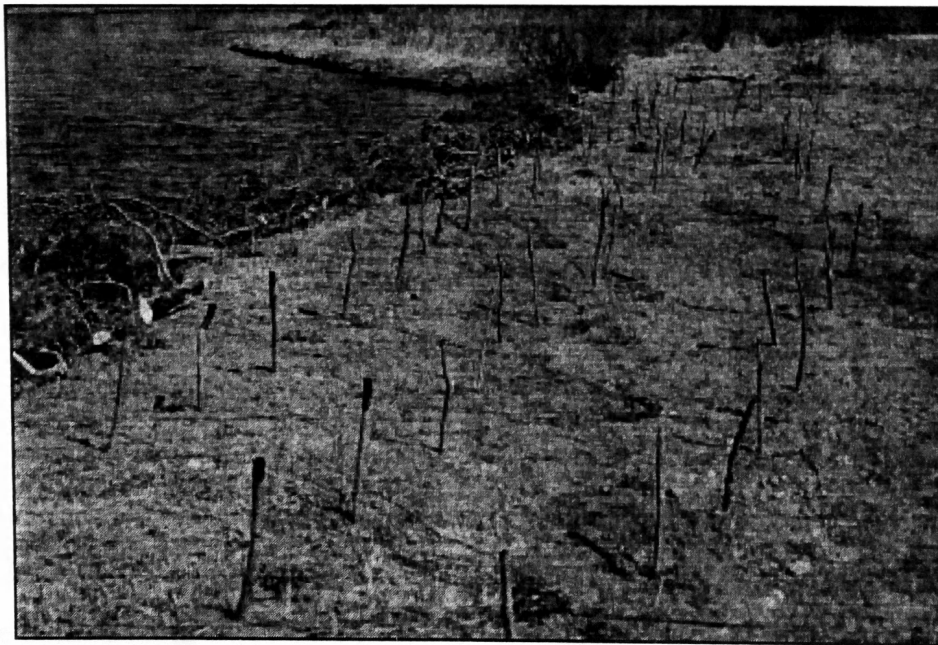
Figure 5. The vertical *Salix* spp. cutting planting method. Cuttings extend approximately 30 cm (1 ft) above the bank surface.

At sites with vertical cuttings, random individual cuttings totaling 20 percent of the total number of planted cuttings at that site were sampled. Every cutting at each site was assigned a number corresponding to its location on the bank. A random number generator was used to determine the individual sample cuttings. A representative photograph of this planting method is presented in Figure 5.

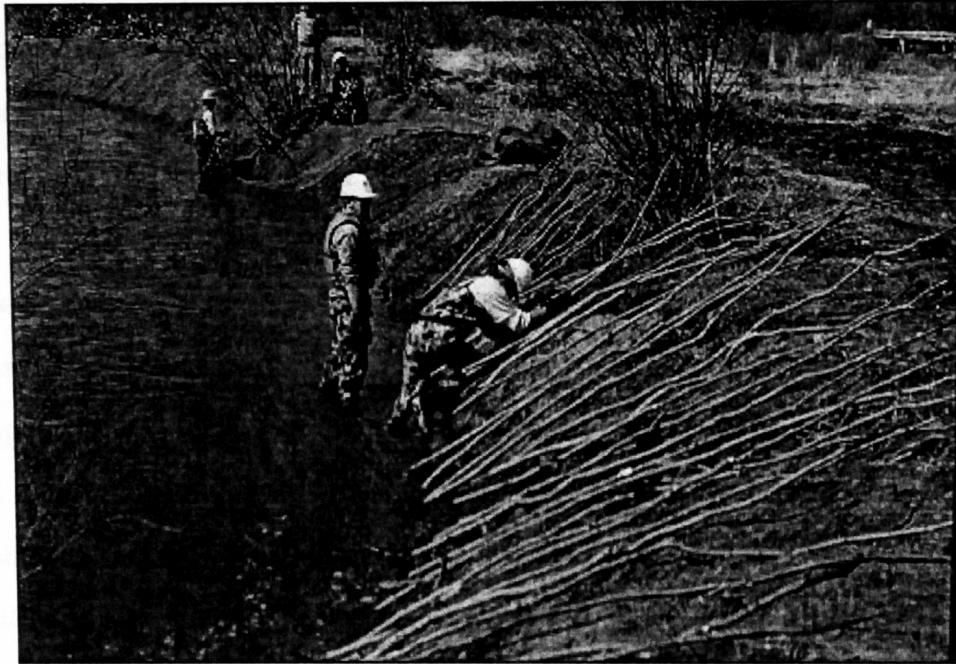
Figure 6. Placement of angled *Salix* spp. cuttings along a re-sloped bank. Cuttings are approximately 3 m (10 ft) long and spaced at 30 cm (1 ft).

Angled cuttings. Three sites were planted with angled cuttings: FW02, PRA1, and PRB4. Treatment areas with angled cuttings consisted of vertical banks that were sloped back to a 2:1 or 3:1 slope with the bucket of a track-mounted excavator. Cuttings, approximately 2 to 3 m (6 to 10 ft) in length and 2 to 4 cm (1 to 1.5 in) in diameter, were placed against the bank every 0.3 m (1 ft) with the butt end in the channel to the depth of the expected base-flow water level. Base-flow water level was determined by researching U.S. Geological Survey historic flow data. Cuttings were covered with approximately 2.5 to 5 cm (1 to 2 in) of site soil along their entire length. The bank was then covered with coconut fiber erosion control fabric, which was secured to the slope with rebar staples. The fabric is designed to help maintain bank integrity for 5-8 years so plantings have time to establish. This planting method is depicted in Figures 6 and 7.

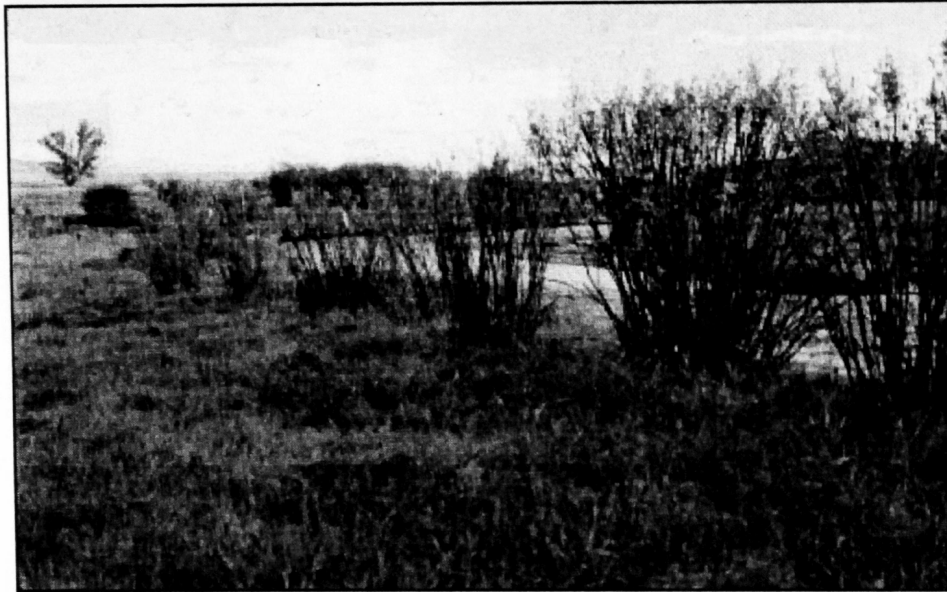
Figure 8. Placement of mature *Salix* spp. transplants. Transplants are approximately 2 to 2.5 m (6 to 8 ft) tall.

Mature transplants—Mature transplants were planted into the upper bank at two sites (PRB2 and DT). All shrubs were obtained from areas as close to the planting site as possible, and none were obtained further than 0.4 km (0.25 mi) away. Preference was given for shrubs that appeared to be healthy (i.e. vigorous leaf and shoot growth and no apparent diseases). Shrubs were collected when dormant during the late fall and early spring and were planted the same day. A track-mounted excavator (Komatsu PC200LC) with a thumb attachment was used at one site (DT) to collect and transplant shrubs in the fall of 1996, and a four-blade tree spade (Vermeer 50M) mounted on an articulated front-end loader (Cat 950) was used on a second site (PRB2) in the spring of 1997. Shrubs were watered after transplant. A survival count was conducted in early June 1998 to determine overwintering and post-runoff survival. A representative photograph of this planting method is presented in Figure 8.

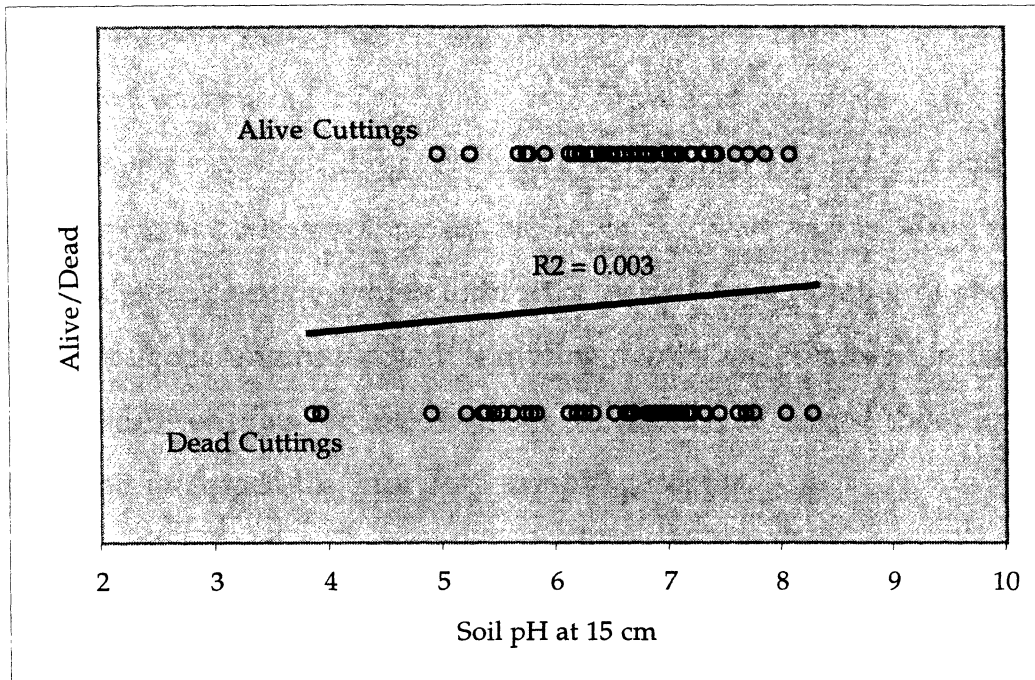
Figure 12. Logistic regression plot of *Salix* cutting survival versus soil pH at the 15 cm sampling depth.

The logistic regression of soil pH at 15 cm (6 in) and 45 cm (18 in) versus *Salix* spp. cutting survival yielded R² values of 0.003 and 0.007, respectively (Figures 12 and 13). Because the logistic regression yielded R² values below the critical rejection value of 0.70, I fail to reject H₀1 and conclude that there is no evidence of a correlation between soil pH and *Salix* spp. cutting survival within the range of pH values measured at these sites.

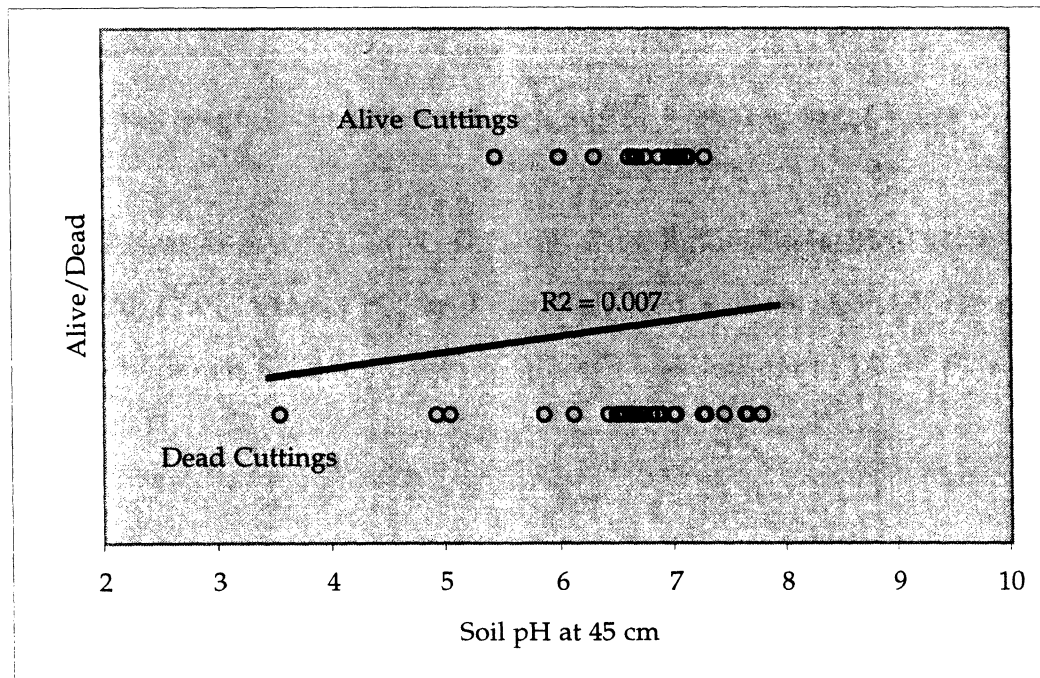
Figure 13. Logistic regression plot of *Salix* cutting survival versus soil pH at the 45 cm sampling depth.

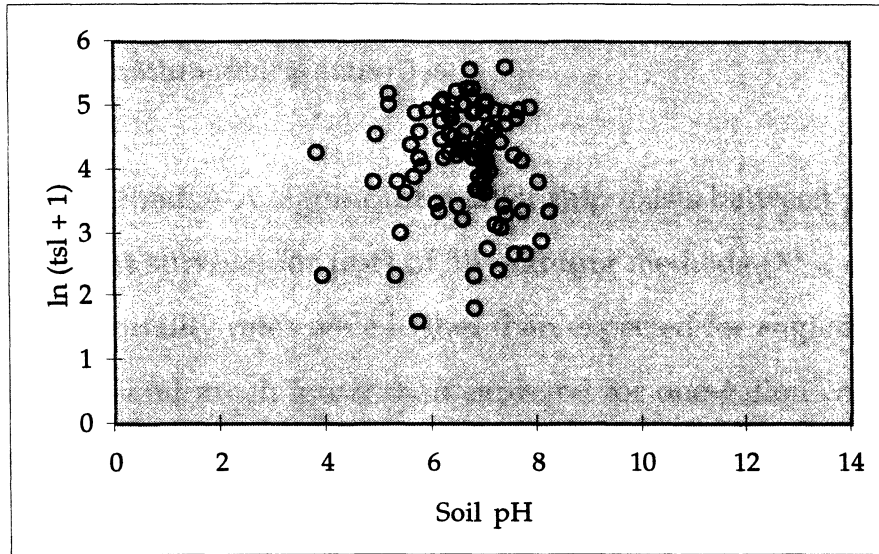
Figure 14. Scatter plot of soil pH at 15 cm (6 in) versus *Salix* cutting growth as measured by total shoot length (n=104).

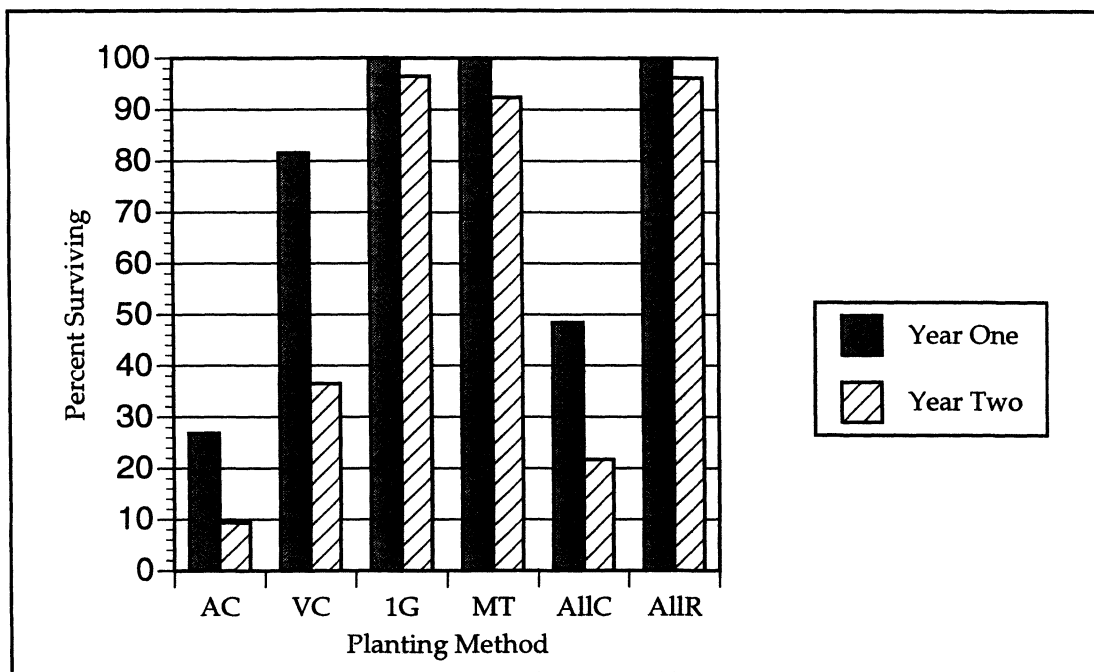
Figure 17. Survival percentages of all planting methods. Planting method codes: AC = angled cuttings, VC = vertical cuttings; 1G = one-gallon containers; MT = mature transplants; AllC = all cuttings (sum of all angled and vertical cuttings); AllR = all rooted stock (sum of all one-gallon containers and mature transplants).

Available literature on *Salix* spp. cutting survival reports extremely high first year survival (Chosa and Shetron 1976, Stewart and Berglund 1983, Hoag 1991, Svejcar and others 1991). Most do not report survival after the first year. Differences in survival between the first year and second year for vertical and angled cuttings observed in this study (Figure 17) underscore the importance

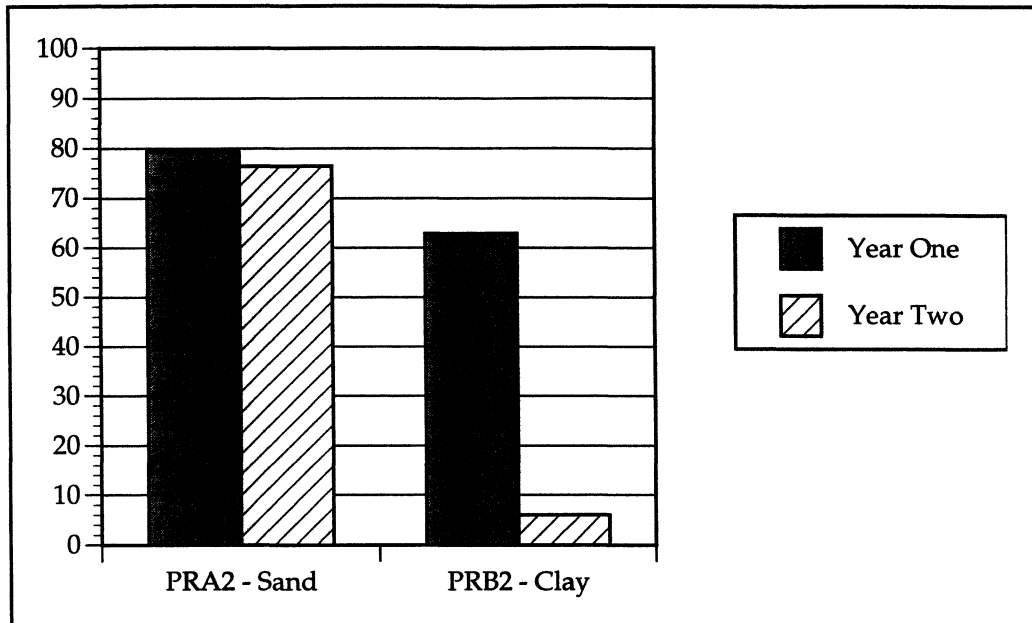
Figure 18. Survival percentages of vertical *Salix* spp. cuttings planted in a sandy floodplain (PRA2, n=34) and in a clay bank backfilled with sand (PRB2, n=35).

Soil texture may influence *Salix* spp. cutting survival, but was not quantified in this study due to a lack of replicates in each soil type for each planting method. The planting holes of all vertical cuttings were backfilled with coarse sand. One site (PRA2) had vertical cuttings planted into a sandy floodplain, and another (PRB2) had vertical cuttings planted into a dense, black clay, then backfilled with sand. Though survival differences between these two planting sites cannot be statistically analyzed, raw survival percentages varied greatly between these two soil types (Figure 18).

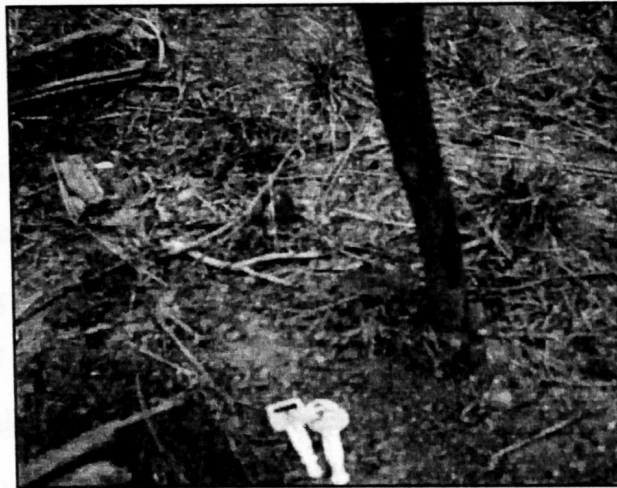
Figure 19. Example of cutting damage as a result of utilization by white-tailed deer.

As discussed above, soil texture and insect utilization may have a pronounced effect on cutting survival. Some sites received greater degrees of ungulate browsing on shoots than others. Cuttings that were browsed often had pieces of bark stripped from the cutting (Figure 19). All these factors vary between sites and may affect survival and growth.
