### Upstream Geomorphic Response to Dam Removal: The Blackfoot River, Montana

UPSTREAM GEOMORPHIC RESPONSE TO DAM REMOVAL:  
THE BLACKFOOT RIVER, MONTANA

Thesis

Master of Science  
in Environmental Studies

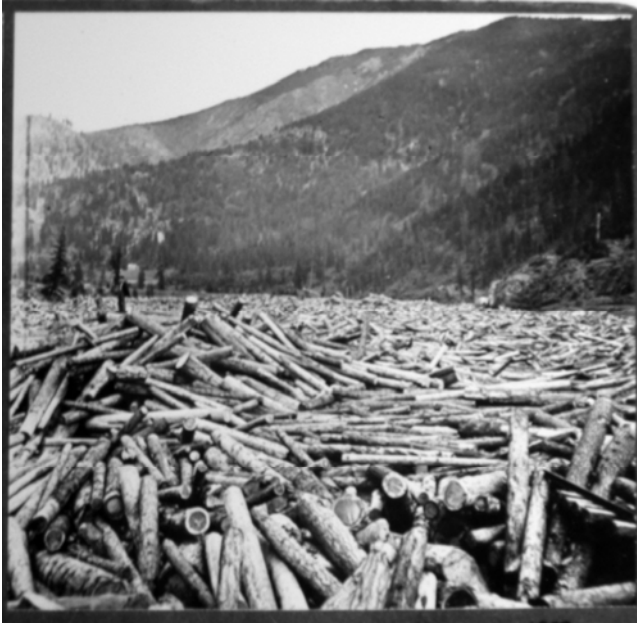
Figure 6. River of wood: cut timber fully covering the Blackfoot River in Bonner adjacent to the Stimson Mill following the 1908 flood (The Montana Collection, Mansfield Library, The University of Montana).

typically associated with dam construction (e.g., Dynesius and Nilsson 1994, Graf 1999, Ward and Stanford 1995). Furthermore, the human-induced recruitment of large woody debris to the channel from logging operations upstream left a legacy of > 10,000 individual logs in the lower 3 km of the BFR (Figure 6). At the time of the dam removal, the large woody debris was located on the bed and buried in the coarse reservoir sediment deposit in the upper reservoir.

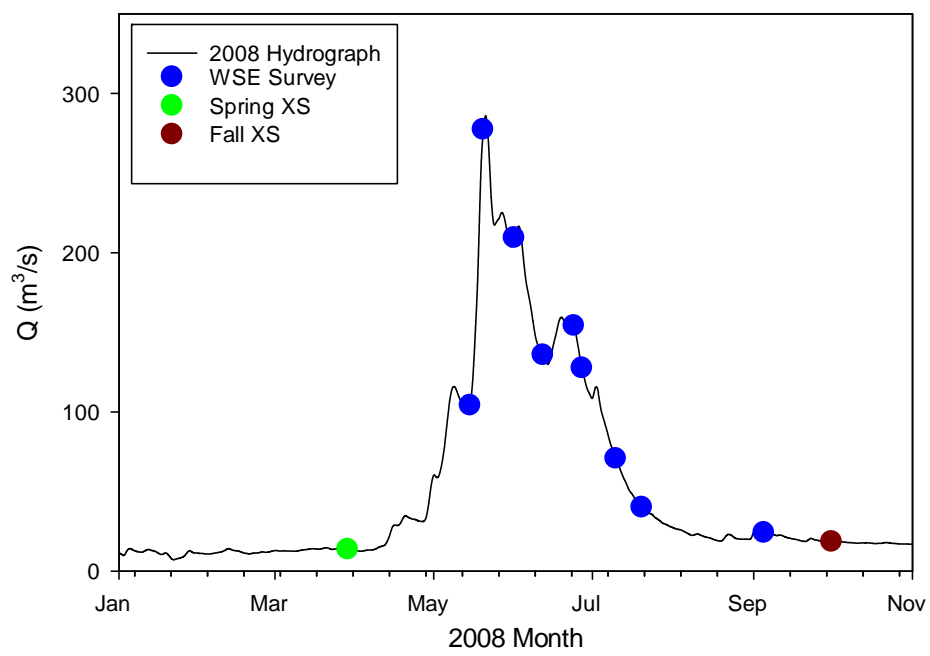
Figure 10. 2008 hydrograph for the Blackfoot River. Closed points show water surface elevation (WSE) survey dates, and open dots show repeat cross section survey dates at base flow.

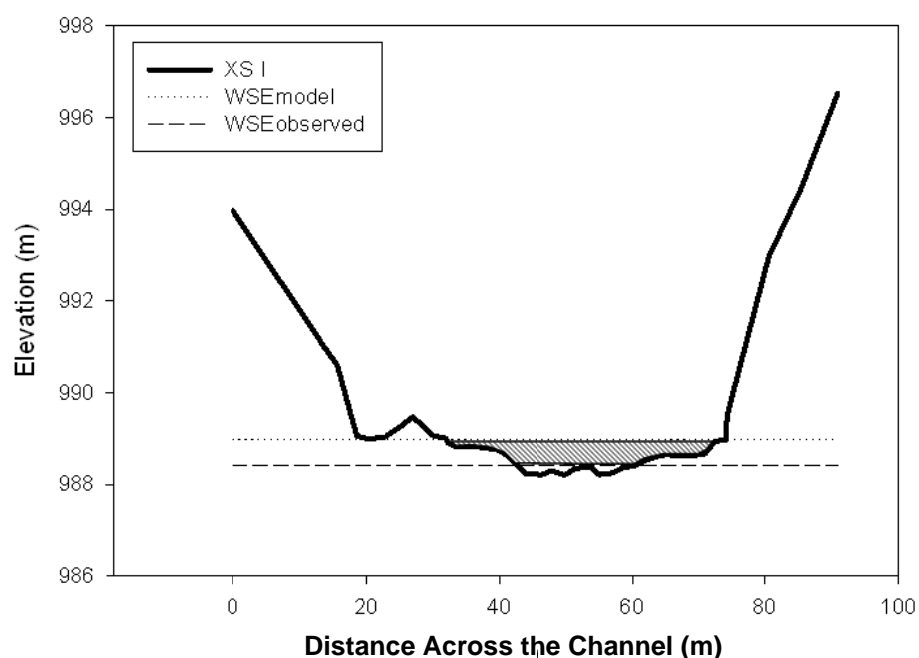
Figure 11. Pre-erosion cross sectional topography for Cross Section I. Dotted line is  $WSE_{model}$ , dashed line is  $WSE_{obs}$ . Erosion of the shaded cross sectional area between the two lines is the hypothesized mechanism causing a deviation between the observed and modeled water surface elevations.

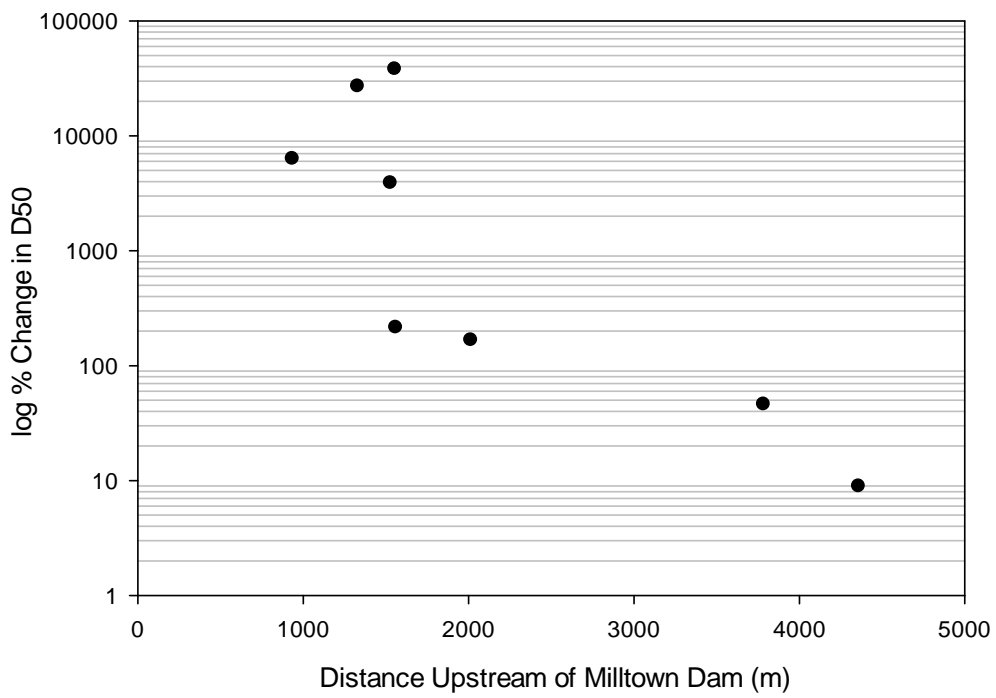
Figure 16. Percent change in the median grain size illustrating the coarsening of the bed in the lower reservoir. Fining (negative values) not depicted in this log-scale figure.

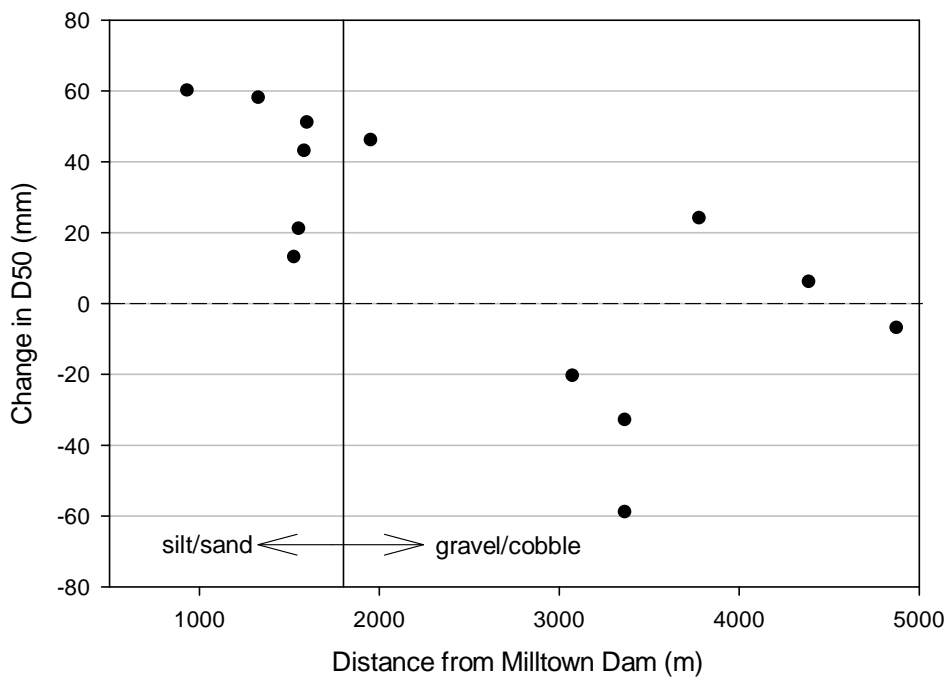
Figure 17. Change in bed surface texture ( $D_{50}$ ) from Spring to Fall 2008. Vertical line at 1800m denotes gravel-silt/sand transition before the 2008 spring runoff. As of Fall 2008, entire study reach is gravel-cobble.

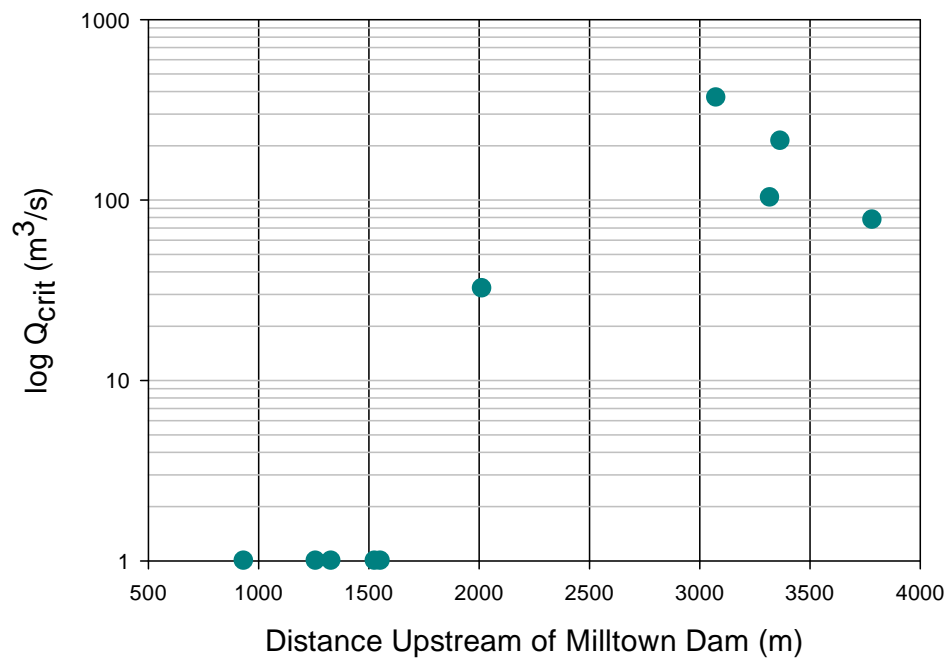
Figure 18.  $Q_{crit}$ , or discharge necessary to mobilize the Spring 2008 bed sediment shown by their distance from the Milltown Dam site. Fine sediment in the lower reservoir is mobile at all discharges, while higher discharges are needed upstream, where the bed consists of coarse material (gravel and cobble).

The grain mobility analysis performed in BAGS shows that the silt-sand deposit was mobile at virtually all discharges. The fine deposit was likely scoured out of the study reach well before the peak discharge on May 20. Upstream, the coarse bed was mobilized at discharges ranging from 32 - 369  $m^3/s$  (Figure 18).

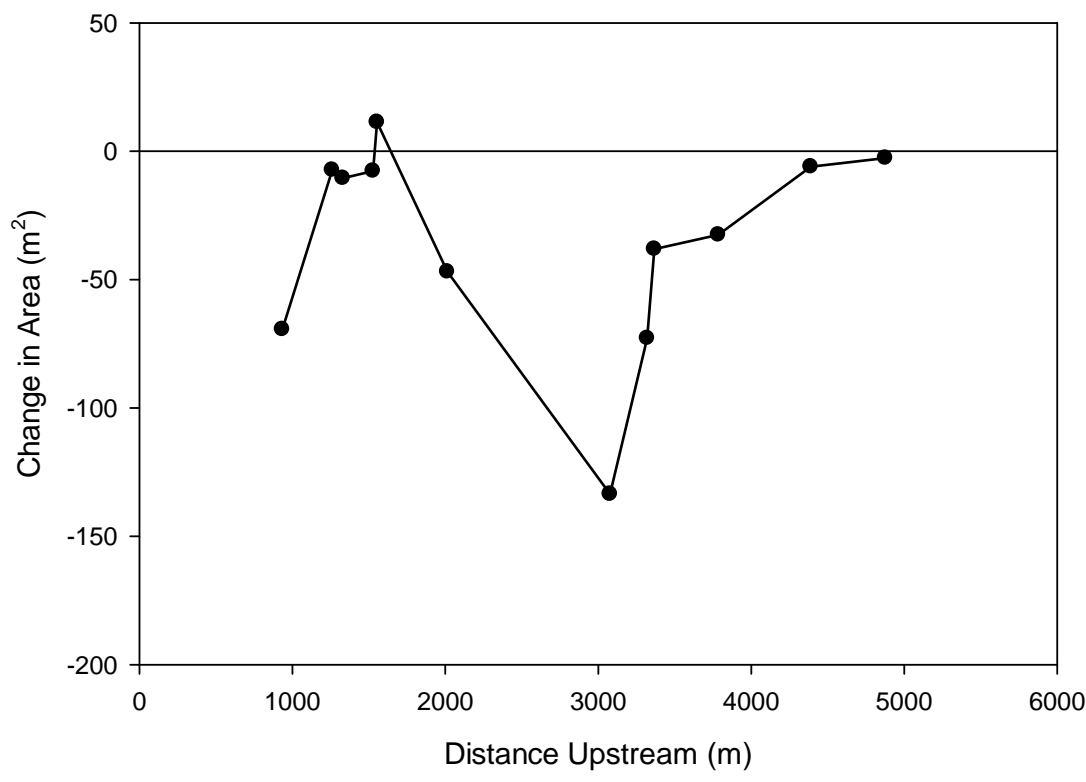
Figure 19. Spring-Fall 2008 change in cross sectional area (based on repeat cross section surveys) shown versus distance upstream of Milltown Dam (x). Negative and positive changes in cross sectional area show local scour (-) and deposition (+). The geomorphic response extended 5 km upstream of the dam, and 2 km beyond the upstream limit to the reservoir.

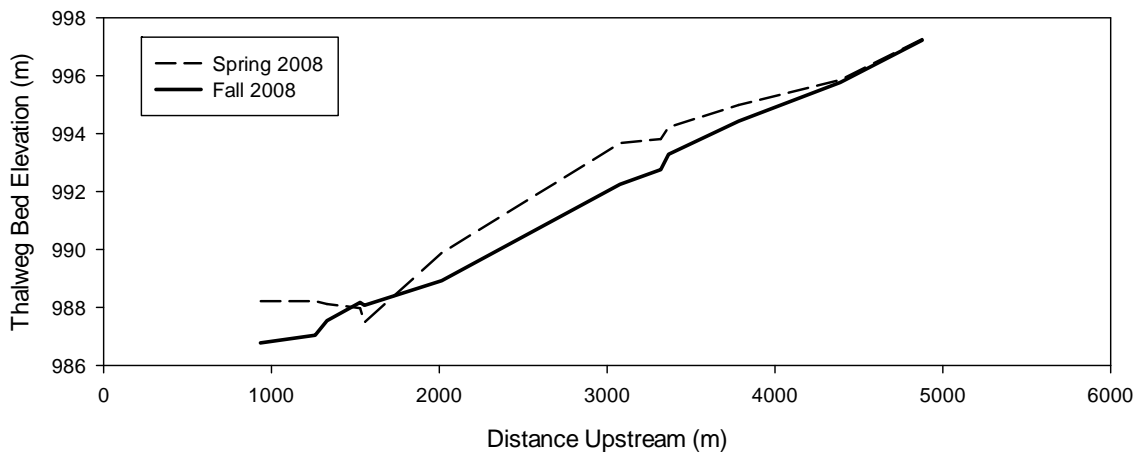
Figure 20. Longitudinal profile showing Spring and Fall 2008 bed elevations based on repeat cross section surveys. Headward erosion extended 4.5 km upstream.

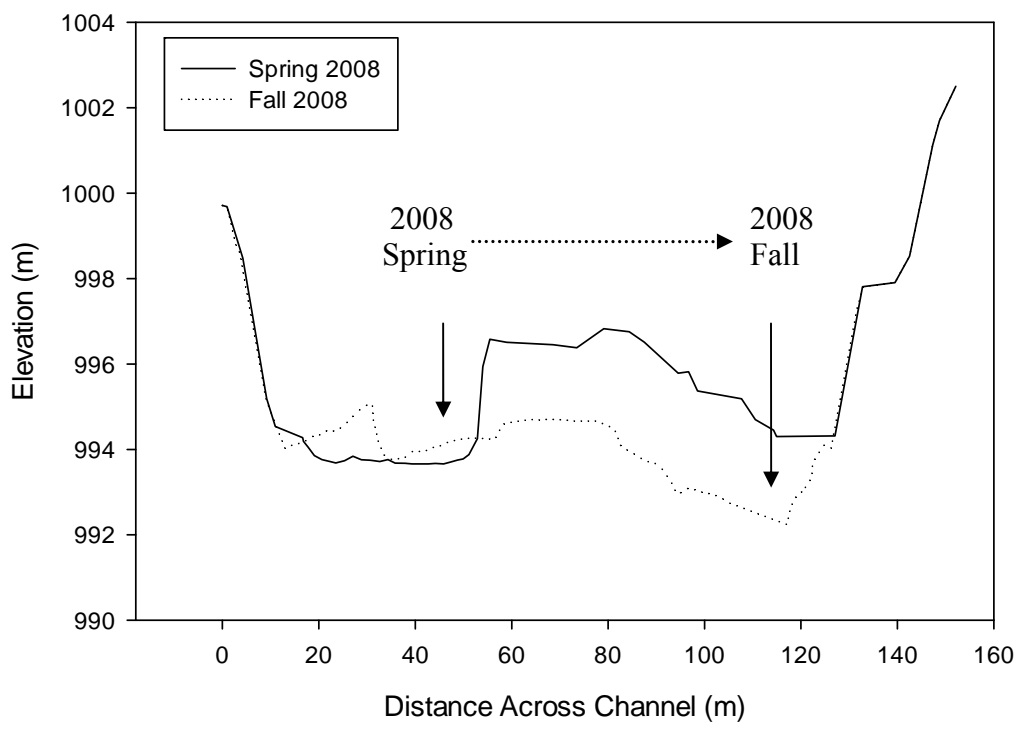
Figure 21. Spring 2008 (solid line) and Fall 2008 (dotted line) cross sections shown for Cross section VII. At this site, 3 km upstream of the dam, bed lowering of up to 2m was observed. The thalweg migrated 80 m across the active channel.

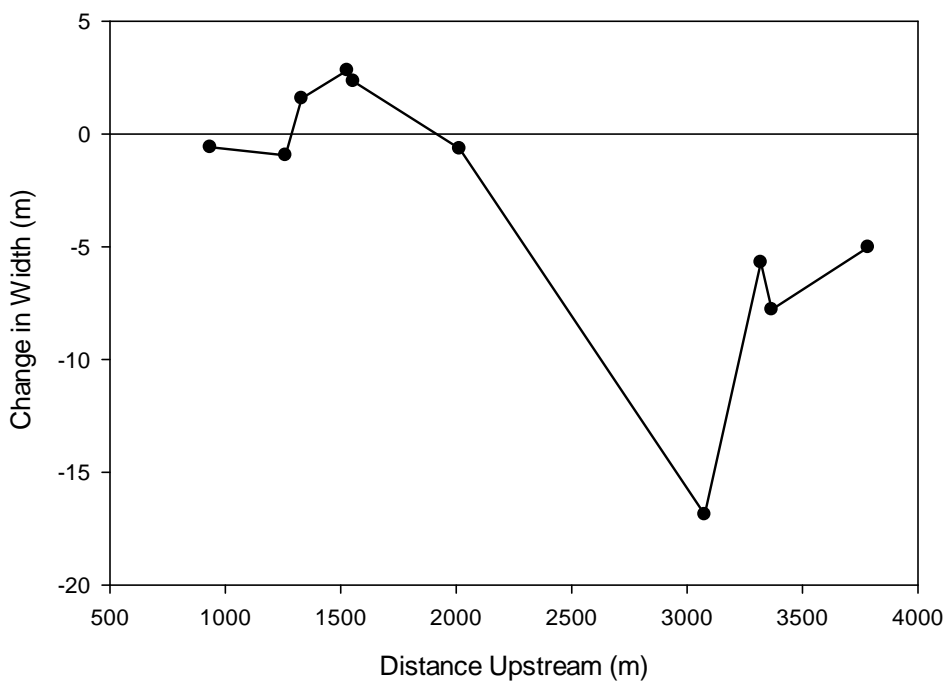
Figure 22. Distance upstream of Milltown Dam plotted against change in channel width from Spring to Fall 2008 at 1.5 year return interval flow ( $187 \text{ m}^3/\text{s}$ ).

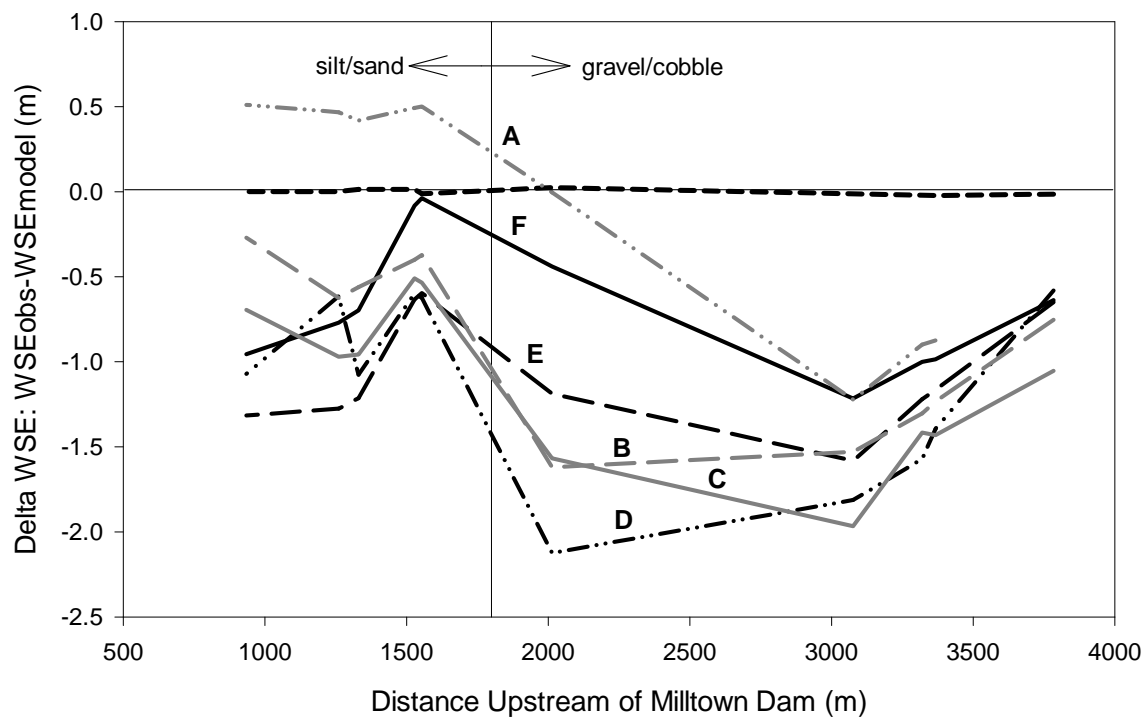
Figure 24.  $\Delta WSE$  curves throughout the hydrograph plotted against distance upstream. The bold dashed calibration line shows  $WSE_{model}$  fits the  $WSE_{obs}$  at Spring 2008 baseflow. A, the gray dash-dotted line, is the earliest date and associated discharge modeled. F, the solid black line, is the latest discharge modeled, from 9/5/08. Note the vertical line representing the gravel-sand transition in the Spring of 2008.

Date, Q (m <sup>3</sup> /s)	
---	Calibration
F	9/5/08, 24.1
E	7/10/08, 70.8
D	6/27/08, 127.4
C	6/1/08, 209.3
B	5/20/08, 277.2
A	5/15/08, 103.9

Figure 24 shows the spatial and temporal patterns of reservoir sediment erosion using the flow modeling method. The pre-erosion condition was effectively modeled and shown using the WSE analysis. The  $\Delta$ WSE approach shows that the entire modeled 3.7 km reach eroded at some point. It appears that both erosion and deposition happened concurrently at different locations in time and space. Figure 25 shows that modeled volumetric erosion occurred rapidly during the rising limb of the hydrograph, peaking close to June 11. This point of maximum modeled bed lowering occurred just after the peak of the 2008 hydrograph. The flow modeling approach developed to quantify reservoir sediment erosion throughout the 2008 hydrograph showed a similar spatial pattern of erosion seen in the pre-erosion (Spring) and Fall base-flow morphological comparison (Figure 19, 24). At the log jam complex 1.5 km upstream, the  $\Delta$ WSE failed to capture the net aggradation, as the increase in roughness caused by the log jams was not modeled in HEC-RAS. The temporal pattern of erosion shows that significantly more erosion may have occurred than can be captured by the net volumetric change. The HEC-RAS results indicate that the maximum erosion occurred on June 1, eleven days after the peak in the hydrograph, by which time a total of 260,000 m<sup>3</sup> had been eroded from the lower 4.5 km of the BFR (Table 2, Figure 25). After the BFR returned to base-flow in the fall, the net volumetric change was 72,000 m<sup>3</sup> as of 9/5/08 (Q= 24 m<sup>3</sup>/s). Based on the flow modeling approach, the peak erosion of 260,000 m<sup>3</sup> on June 1 represents 115% - 174% of the initial volume of reservoir sediment stored in the BFR arm of Milltown Reservoir (Envirocon 2005). Longitudinal profiles derived from water surface profiles surveyed are shown in Figure 26, for comparison with the pre-removal reservoir WSE.

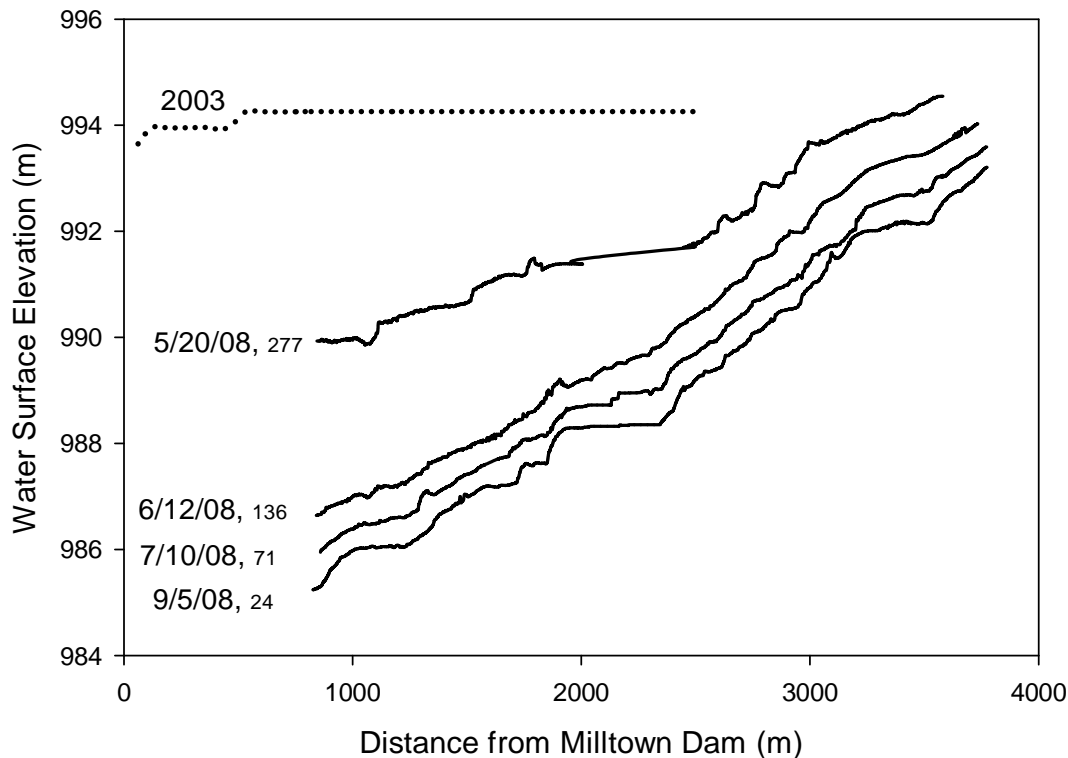
Figure 26. Water surface profiles throughout the 2008 hydrograph shown with the 2003 reservoir water surface. Dates for water surface profiles surveyed in 2008 listed with discharge ( $\text{m}^3/\text{s}$ ).

The 8 m base level reduction is evident in the evolution of the water surface through the 2008 hydrograph.

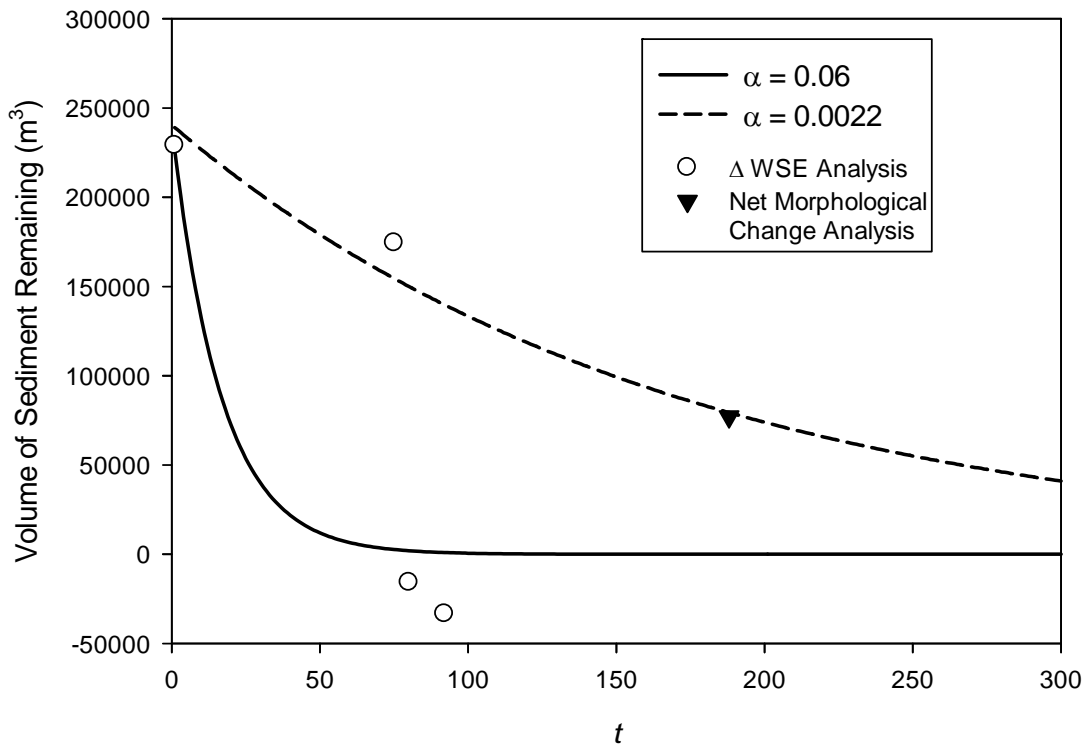
Figure 27. Exponential decay functions fit through the  $\Delta$ WSE and net morphological change estimates of volumetric erosion. The pattern of erosion in the time period examined does not appear to exponential. However, subsequent years may prove that erosion may show an exponential decay pattern.

The exponential decay hypothesis was tested by fitting two exponential decay functions to match volumetric erosion estimates. Decay curves that fit  $\Delta\text{WSE}$  and net morphological change analysis erosion estimates had  $\alpha$  values of 0.06 and 0.0058 respectively (Figure 27). First, to show the peak erosion of 260,000  $\text{m}^3$  as of June 11, 2008, an exponential decay curve was fit to the modeled data (before deposition occurred) using an  $\alpha$  value of 0.06. This is a rapid rate of decay in comparison to the more gradual erosion shown by the curve fitted to the net morphological change of 150,000  $\text{m}^3$ . Fitting the decay functions to these data shows a range of predictions for the full evacuation of the stored reservoir sediment in the BFR: 2 - 17 months.

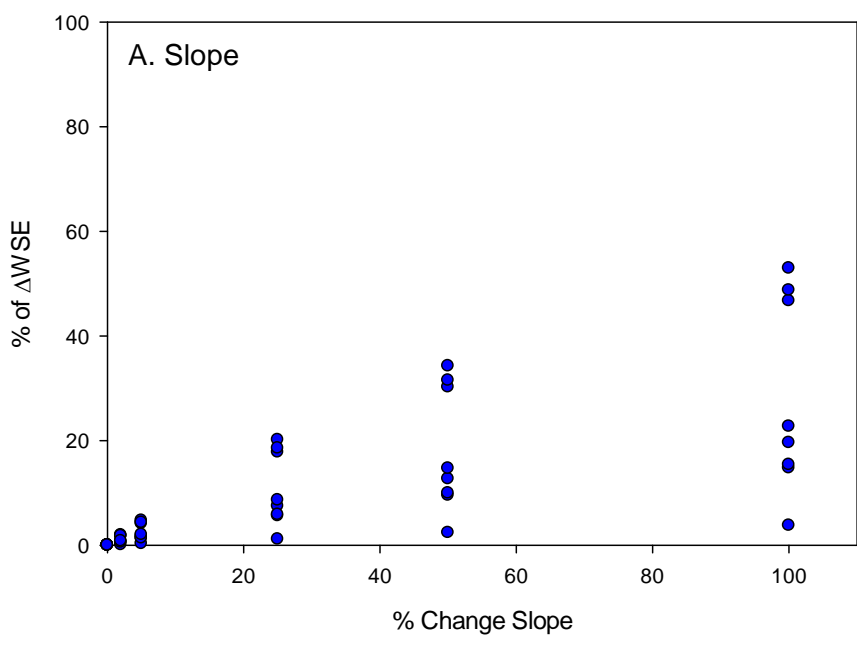
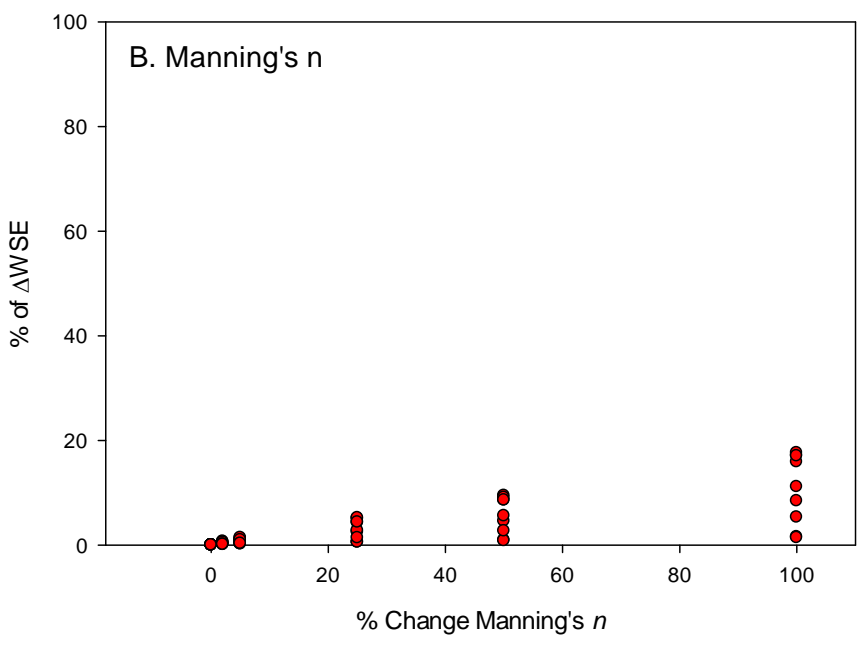
Figure 28. Sensitivity analysis of  $h$  to changes in A. Slope, and B. Manning's  $n$ . A 100% increase in Manning's  $n$  could account for ~10% of  $\Delta$ WSE, while a 25% change in slope may account for 20% of  $\Delta$ WSE.

between observed and modeled WSE. However, at cross section IV, a 100% increase in slope actually overwhelms the effect. Repeat topographic surveys showed that the channel aggraded at cross section IV.

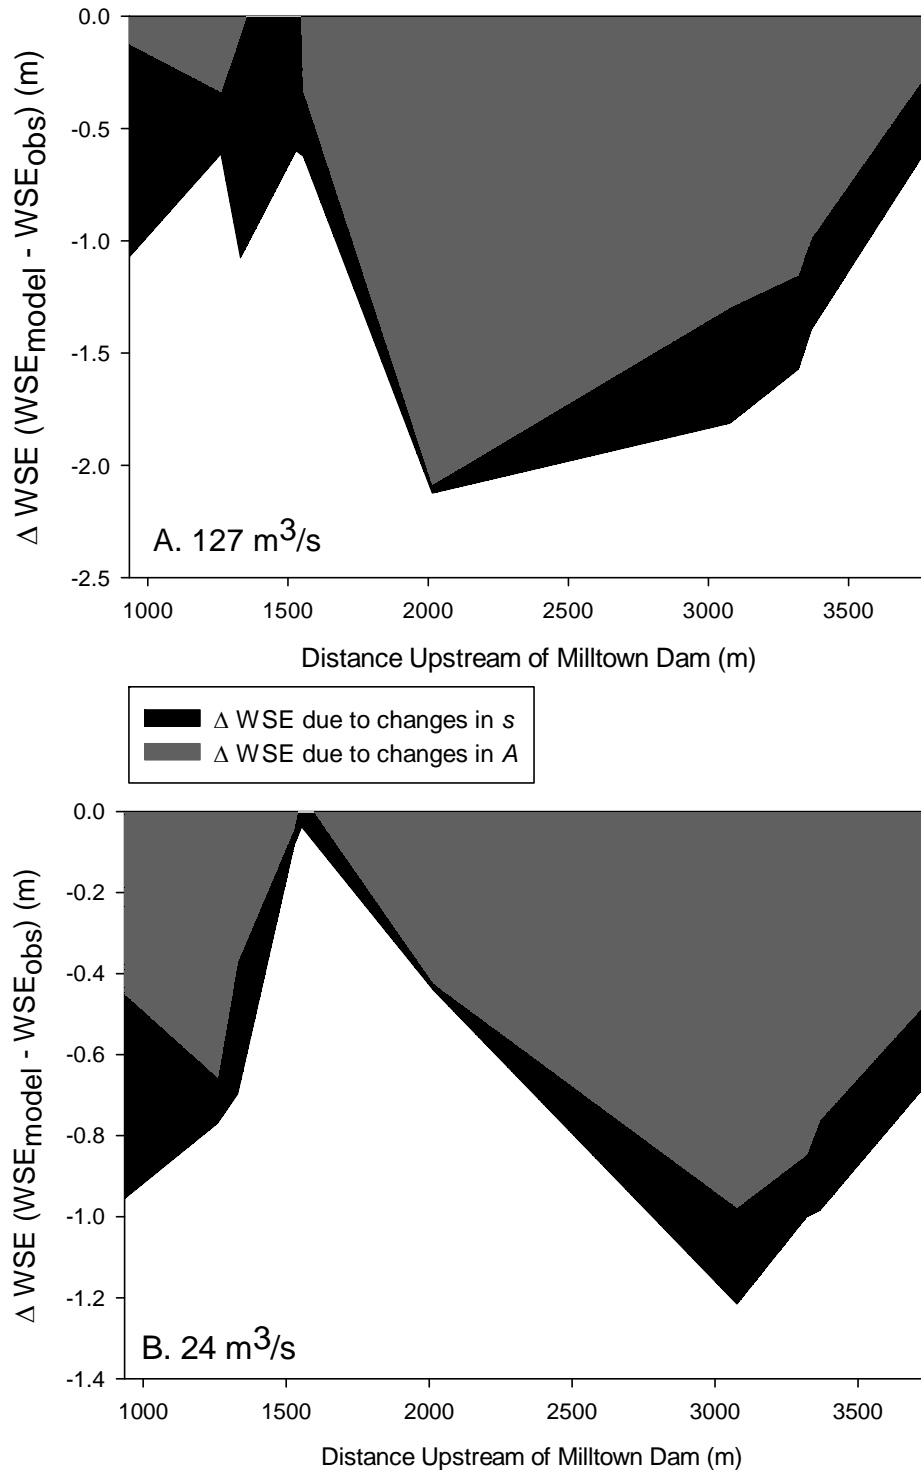
Figure 29.  $\Delta WSE$  with sensitivity analysis results incorporated for (A) 6/27/08 ( $Q = 127 \text{ m}^3/\text{s}$ ) and (B) 9/5/08 ( $Q = 24 \text{ m}^3/\text{s}$ ). The potential maximum dilutive effects of a 100% change in slope is illustrated by these two  $\Delta WSE$  analyses. The black area represents the proportion of  $\Delta WSE$  that can be explained by a 100% change in slope. The black and grey areas added together represent the total  $\Delta WSE$ .

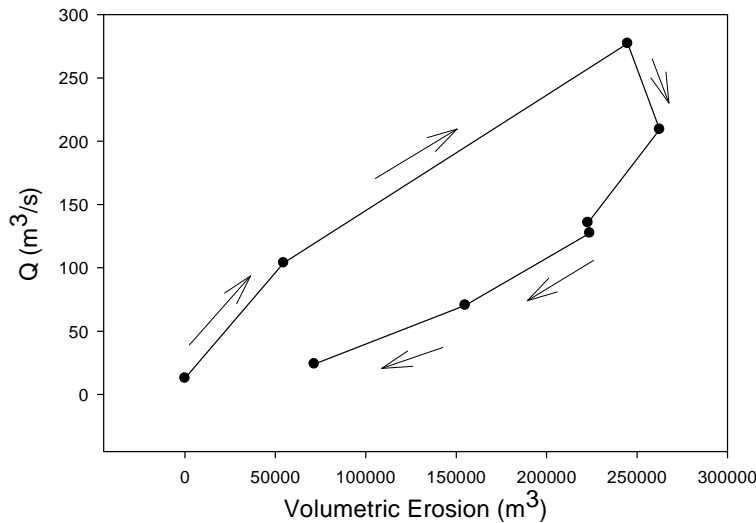
Figure 30. Hysteresis seen in volumetric erosion plotted against discharge (Q). This finding is consistent with sediment transport studies documenting similar patterns of hysteresis in sediment transport (Kuhnle 2006).

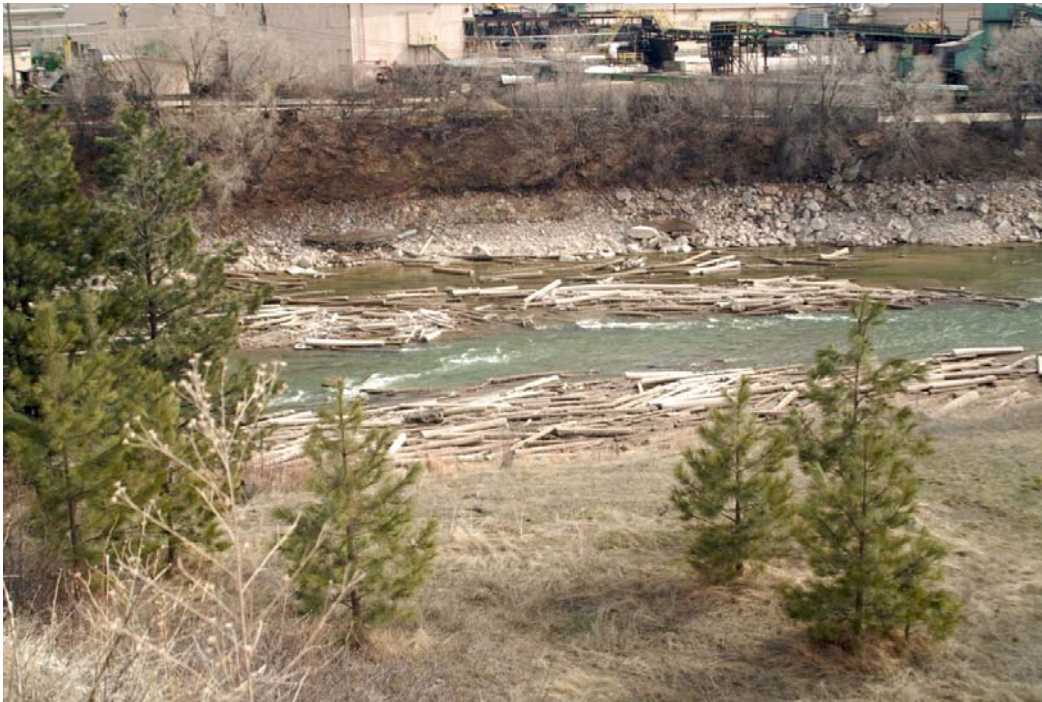
Figure 34. Lower BFR flowing for the first time since 1907 conversion to reservoir. Distinct sediment and vegetation banding shows phased reduction in base level, starting in 2006, and recently completed by the coffer dam breaching on March 28, 2008 (Photo taken 4/8/2008)
