### A Preliminary Analysis of Saw Mark Degeneration in Bone Due to the Application of Hydrated Calcium Oxide

A PRELIMINARY ANALYSIS OF SAW MARK DEGENERATION IN BONE DUE TO THE APPLICATION OF  
HYDRATED CALCIUM OXIDE

Master of Arts  
in Anthropology, Forensic Anthropology Option

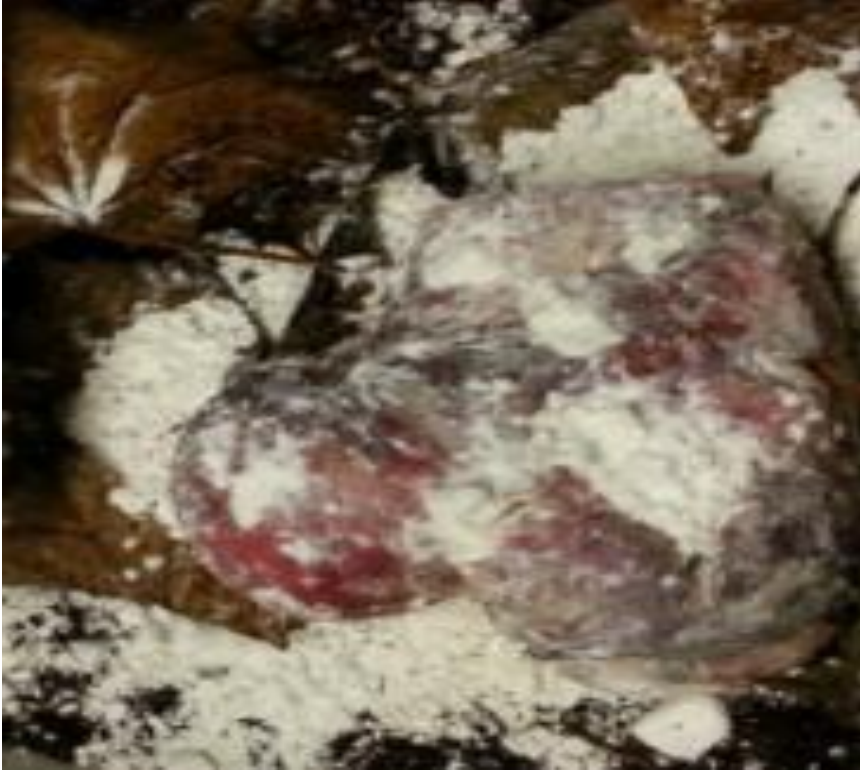
Figure 2. SS-1 end of calcium oxide exposure, 1 week.

On February 15, 2013 (7 days post-treatment) SS-1 was visually examined to determine if any changes had occurred. Upon visual examination it was noted that the muscular and connective tissues that were not touching the soil were showing signs of desiccation (Figure 2). However, the portion that was exposed to the soil showed little signs of tissue reduction and the fatty tissue still appeared to be moist. Additionally, the bone did not retain the odor of decomposition that had been present during placement of the remains. SS-1 was then removed from the disposal environment and cleaned of the calcium oxide using the protocols listed previously, however despite the cleaning process there are still locations within the cut mark that have minute portions of calcium oxide that are present. This substance appears to have solidified to the bone.

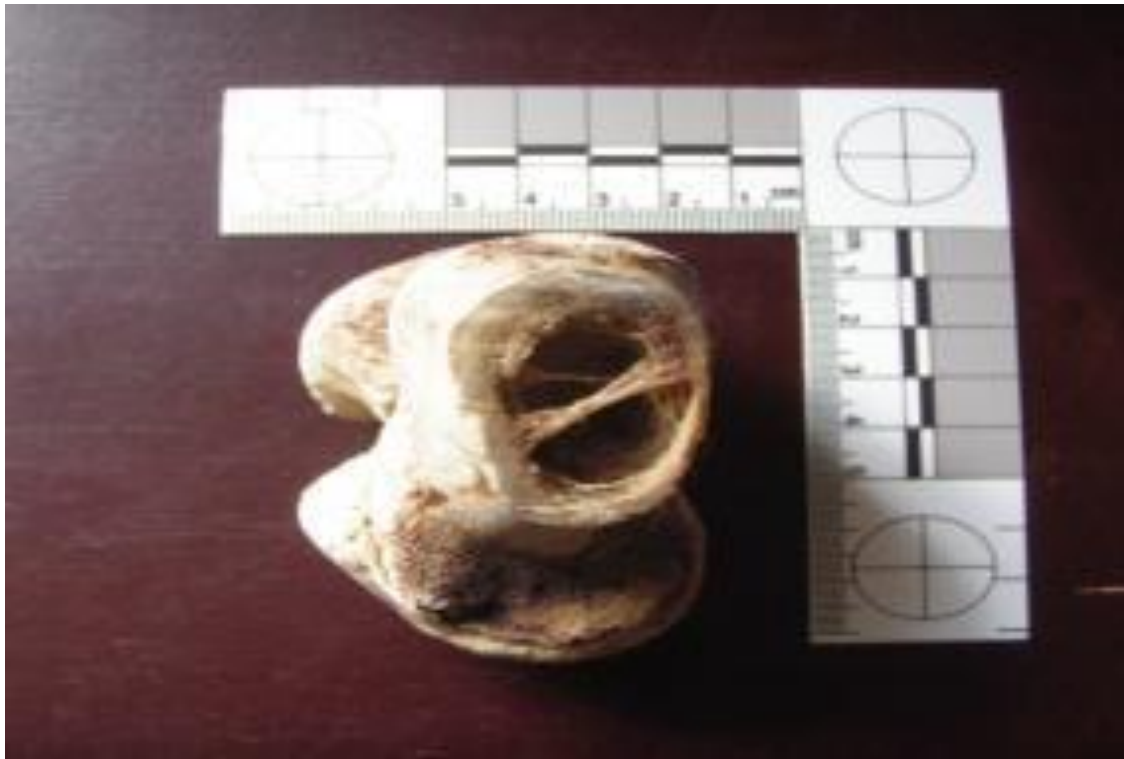
Figure 4. Overview of SS-1. Post Exposure.

During the post exposure examination the characteristics that were recorded did not differ from those made in the pre-exposure examination with exception of the appearance of two false starts that had been obscured by tissue previously. Due to the fact that there were no differences among the characteristics the classification of saw type would stand.

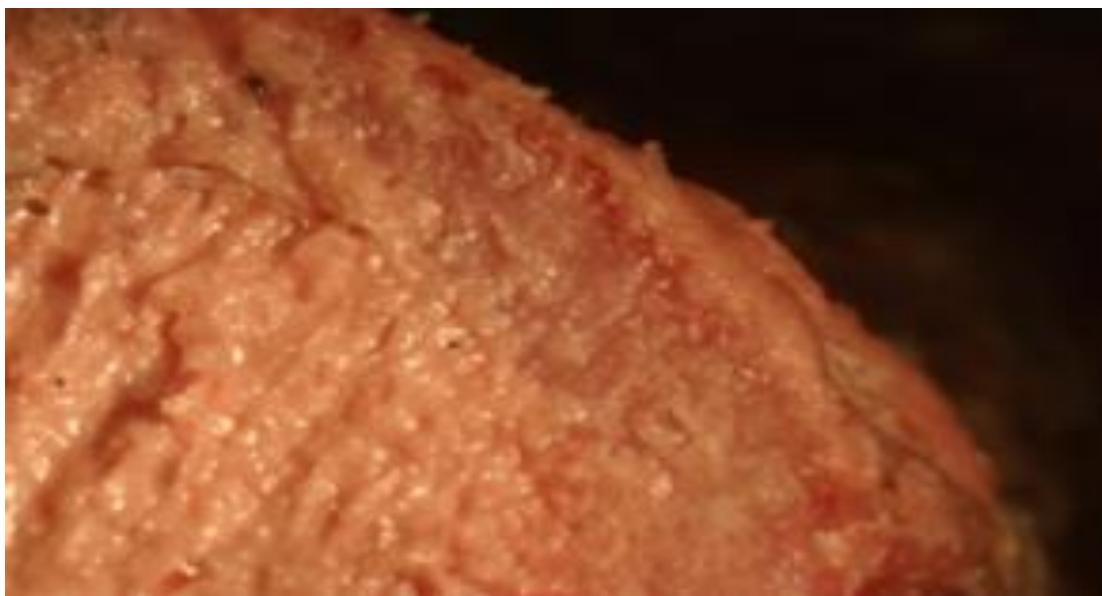
Figure 5. Examination of SS-2 prior to exposure.

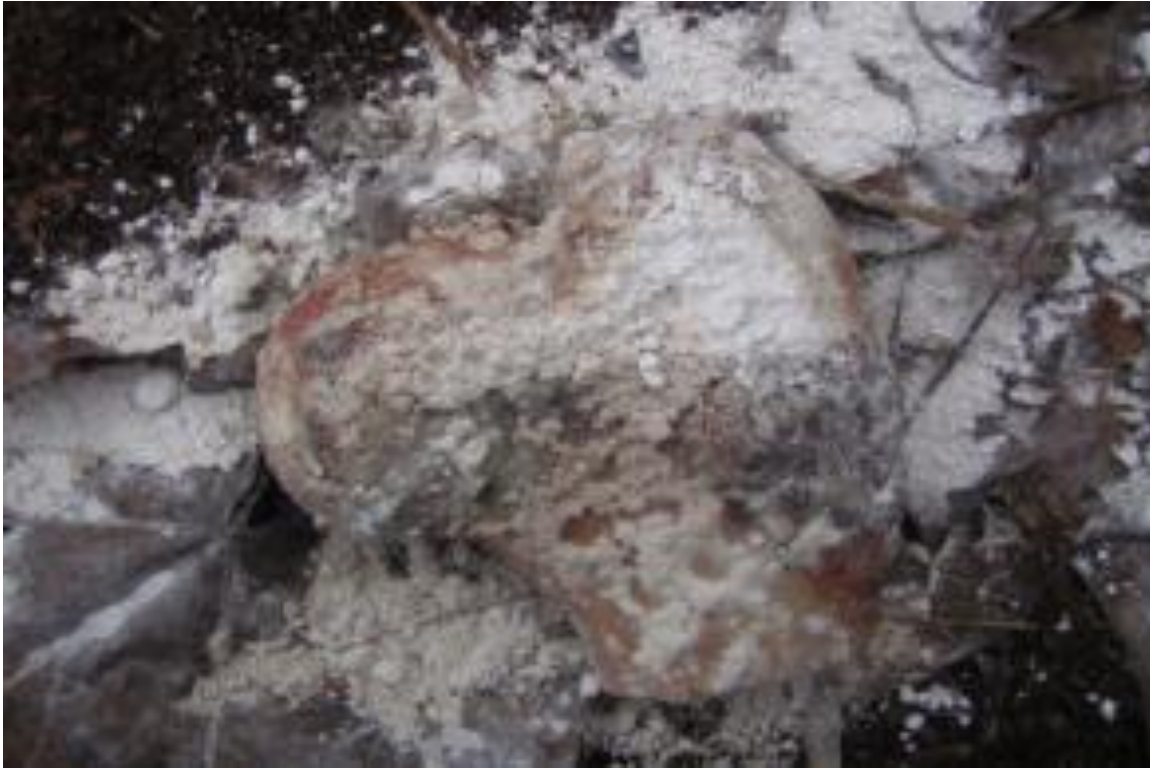
Figure 6. SS-2 at the end of the calcium oxide exposure.

On February 22, 2013 (14 days post treatment) SS-2 was removed from its depositional environment to be photographed and cleaned of the calcium oxide. During the exposure time SS-2 had experienced a brief amount of rain which lead to the calcium oxide becoming very chalk-like to the touch (Figure 6). The tissue that remained on SS-2 had a very dry appearance, while the underside still appeared moist. The smell of decomposition that had been present during initial placement was no longer there as well.

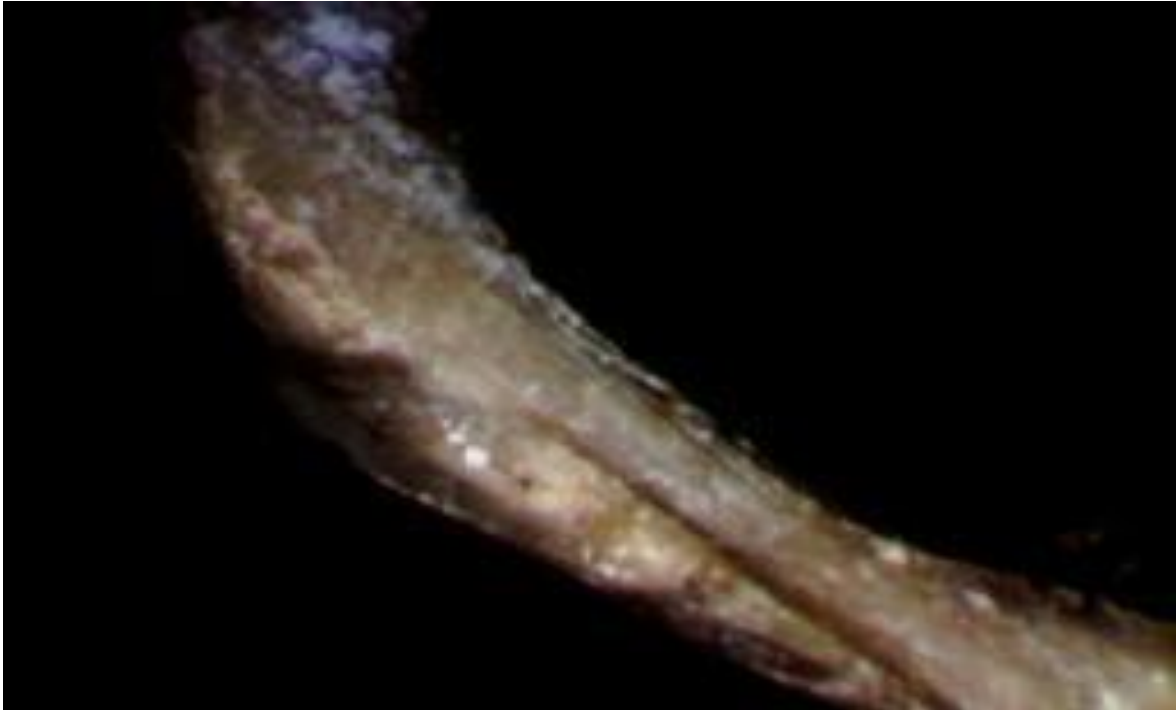
Figure 7. Microscopic view of breakaway spur and notch.

seen on the breakaway spur. While the spur remained present and small in size, the breakaway notch became more easily visible (Figure 7). There was some exit chipping that became visible after the cleaning process was complete. The initial corners of the kerf walls remained sharp and at 90°. There did not appear to be any sign of false starts being present either on the outer portion of SS-2, or within the striae. The striae appeared to be visible as they proceed to the kerf floor, as well as running parallel to the floor. The striae also appeared to be uniform as it progresses through the bone, however there did appear to be some slight harmonics present at the location of the exit chipping. Additionally, there were small remnants of calcium oxide on SS-2 that are very hard and stuck on the cut mark (Figure 8).

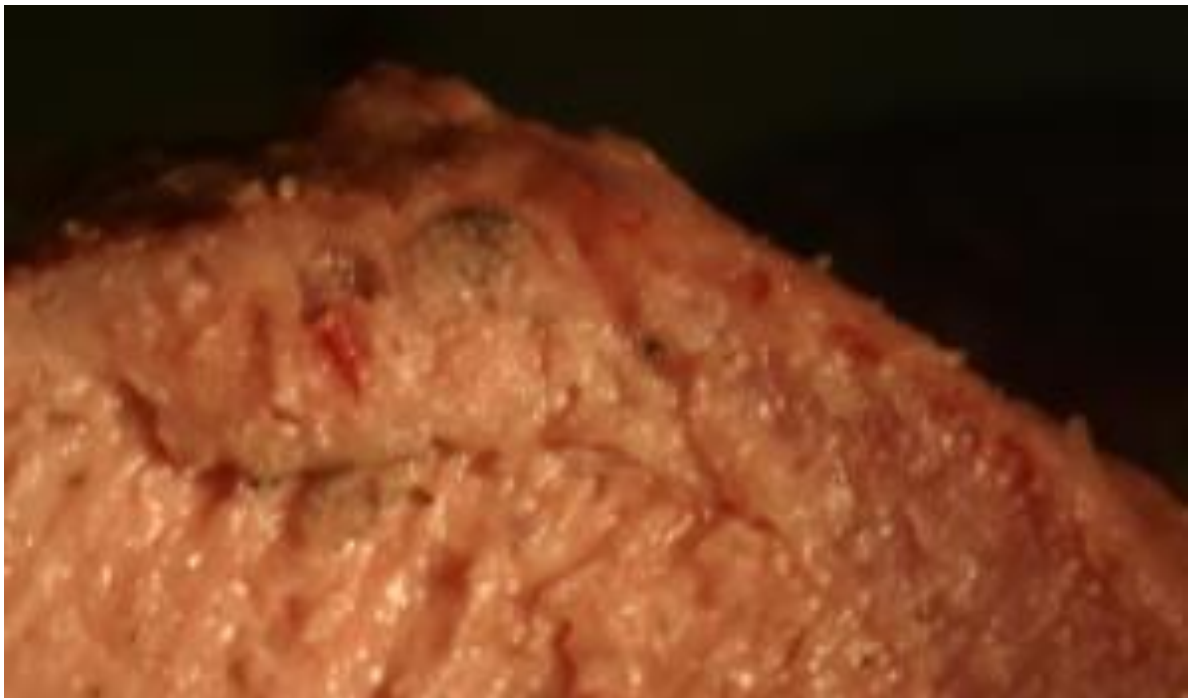
Figure 9. SS-3 post cutting.

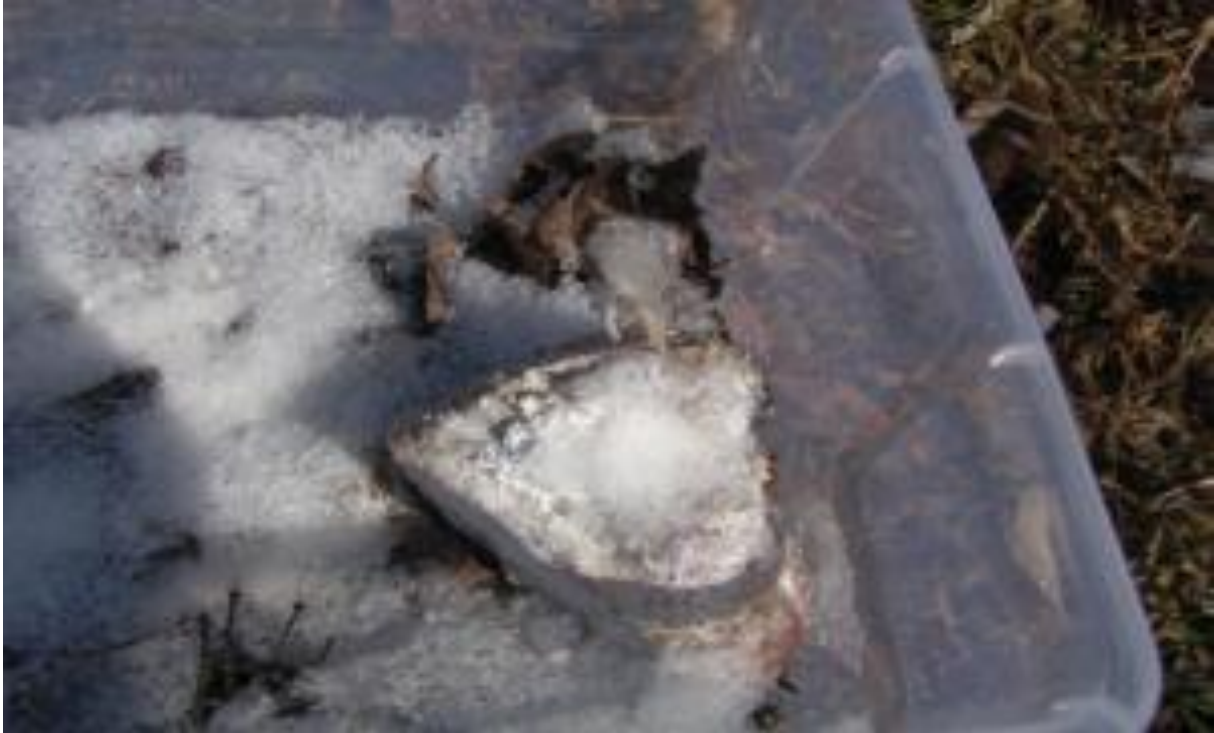
Figure 10. SS-3 at the end of the exposure period, March 1, 2013.

On March 1, 2013 (21 days post treatment) SS-3 was briefly examined prior to being removed from its deposition environment. During this examination it was noted that SS-3 had come into contact and was still partially covered with snow that had fallen a couple of days prior to the examination (Figure 10). The appearance of the calcium oxide had transitioned from a powder to wet and chalky. Additionally the smells associated with decomposition were absent during this cursory initial post exposure examination. Once SS-3 was cleaned it was then examined both visually and microscopically to assess the characteristics present. During this examination the floor configuration of the kerf was found to be flat, as well as a confirmation of the presence of a breakaway spur. The large chip that was seen during the pre-exposure examination does not appear to be a breakaway notch, however does fall within the characteristics of exit chipping. The initial corners of the kerf wall remained at the 90° measurement and remain sharp.

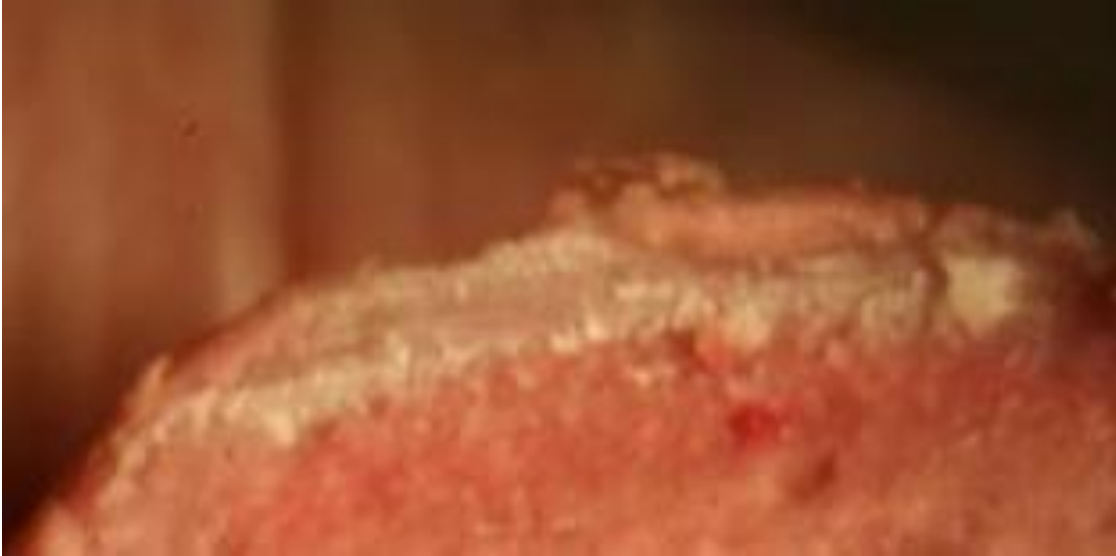
Figure 12. Initial Examination of SS-4

Specimen #4 was cut and examined on February 8, 2013 to establish the characteristics that are present prior to any chemical exposure. During this initial examination SS-4 presented with the following tissue remnants: cartilaginous, muscular and fatty. This tissue was also exuding smells that were consistent with decomposition. The initial corners of the kerf walls appeared to be at 90° over the entire circumference of the cut mark. The cut mark also exhibited a breakaway spur that was found on the tibial crest (Figure 12). This breakaway spur also showed the configuration of the kerf floor, which was flat in nature. There did not appear to be any evidence of false starts within the cut mark or on the outer portion of the bone. In examining the characteristics that are pertinent to the striations it was found that the striations were indeed very uniform and were visible to the kerf floor. These striations were also found to be parallel to the floor as well; however, the determination of the curvature of the striae could not be determined.

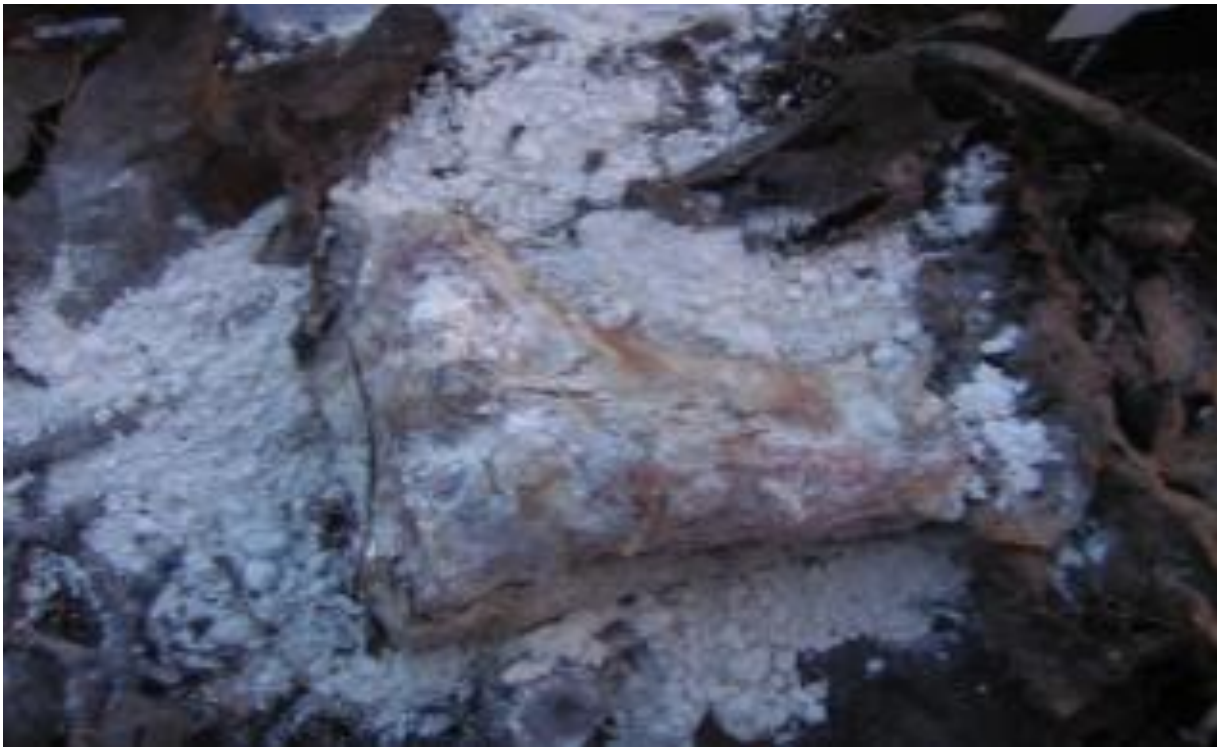
Figure 13. SS-4 at the end of the calcium oxide exposure. March 8, 2013.

fatty tissue took on a rubbery appearance. The calcium oxide surrounding SS-4 had the appearance of chalky pebbles, resulting from moisture contact during the exposure period (Figure 13). The portion of SS-4 which had remained in contact with the soil had retained a “wetter” appearance with no signs of the tissue drying. The decomposition odors that had been present during the initial examination could no longer be detected.

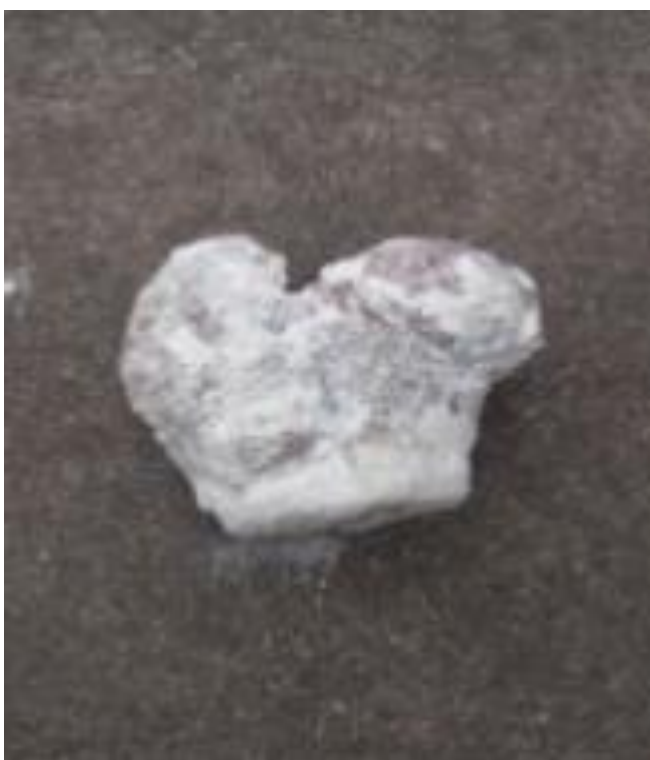
Figure 17. SS-5 upon removal of deposition environment.

desiccation. The calcium oxide that had been applied to SS-5 still remained powdered and showed no sign of contact with moisture (Figure 17). During the opening of the environment the strong odor of decomposition was still present. When examining the saw mark characteristics specific to the kerf floor there could be no determination made regarding the configuration due to the large breakaway notch that was present on SS-5 (Figure 18). There was some evidence of both entrance and exit chipping present on both sides of the cut mark. SS-5 presented two false starts at the top of the cut mark, the first of which is relatively small in size when compared to the second of these false starts. In examination of the characteristics related to the striae, while the striae appear to be organized and uniform through the cut mark, and the striae run parallel to the start of the breakaway notch the contour of the cut mark is jagged at best and therefore impossible to make a determination regarding whether harmonics are present.

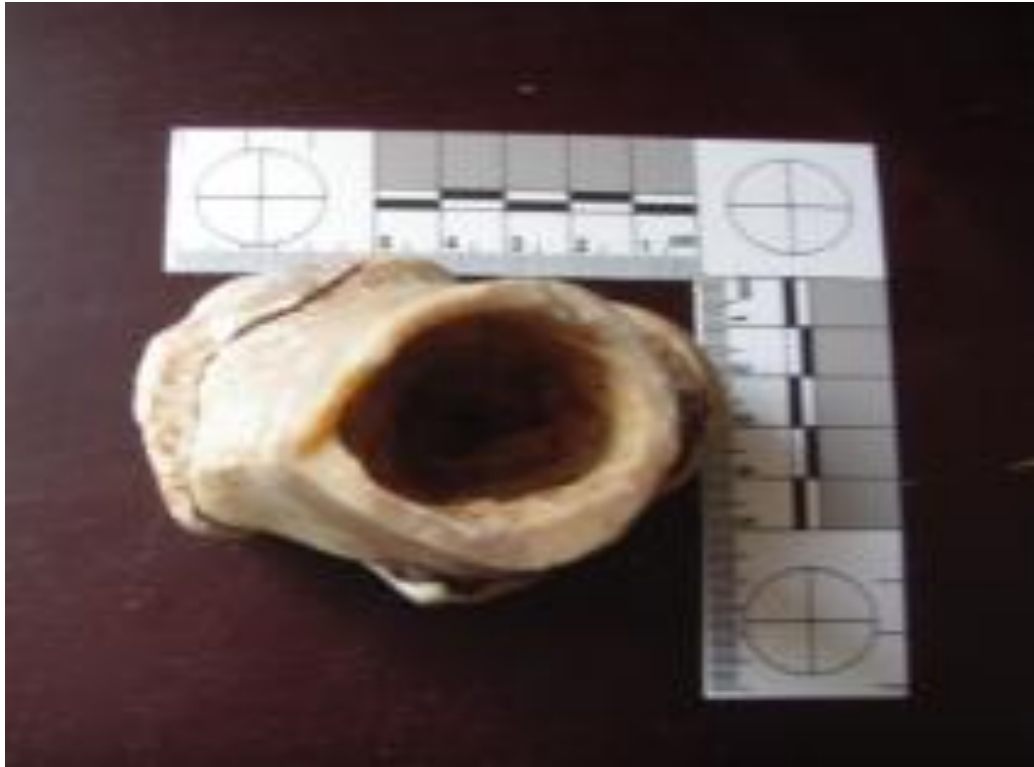
Figure 18. SS-5 displaying large breakaway notch.

During the post exposure examination the presence of two false starts provided information regarding the kerf floor that was unavailable during the initial examination. These false starts provided information that would suggest that the floor was flat, and the saw belonged to the rip saw family. However, this information could not be derived from the principal cut due to the large breakaway notch present. The characteristics of the striae indicate that the saw producing this cut was electrically powered due to the visibility and uniformity of the striations.

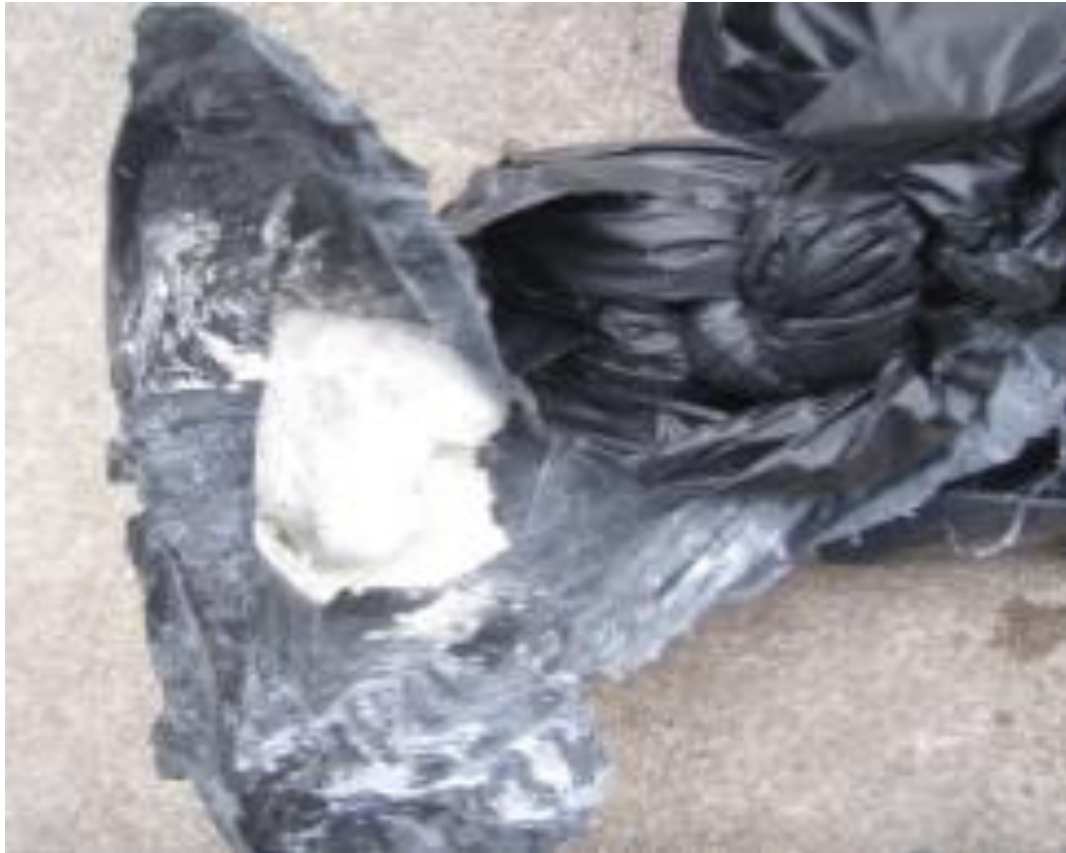
Figure 20. SS-6 during the opening of the deposition environment. February 22, 2013.

On February 22, 2013 (14 days post treatment) SS-6 was removed from the deposition environment, wherein it would be cleaned according to the procedures listed previously. Upon the opening of the environment which it was contained, SS-6 appeared as moist as it did when it was originally placed. SS-6 also presented with the pungent odor of active decomposition. The calcium oxide that SS-6 was exposed to had areas exposed to moisture during the deposition timeframe, indicating that the bag may have had a hole in it (Figure 20). After SS-6 was cleaned it was examined again both visually and microscopically to determine if characteristics could be distinguished.

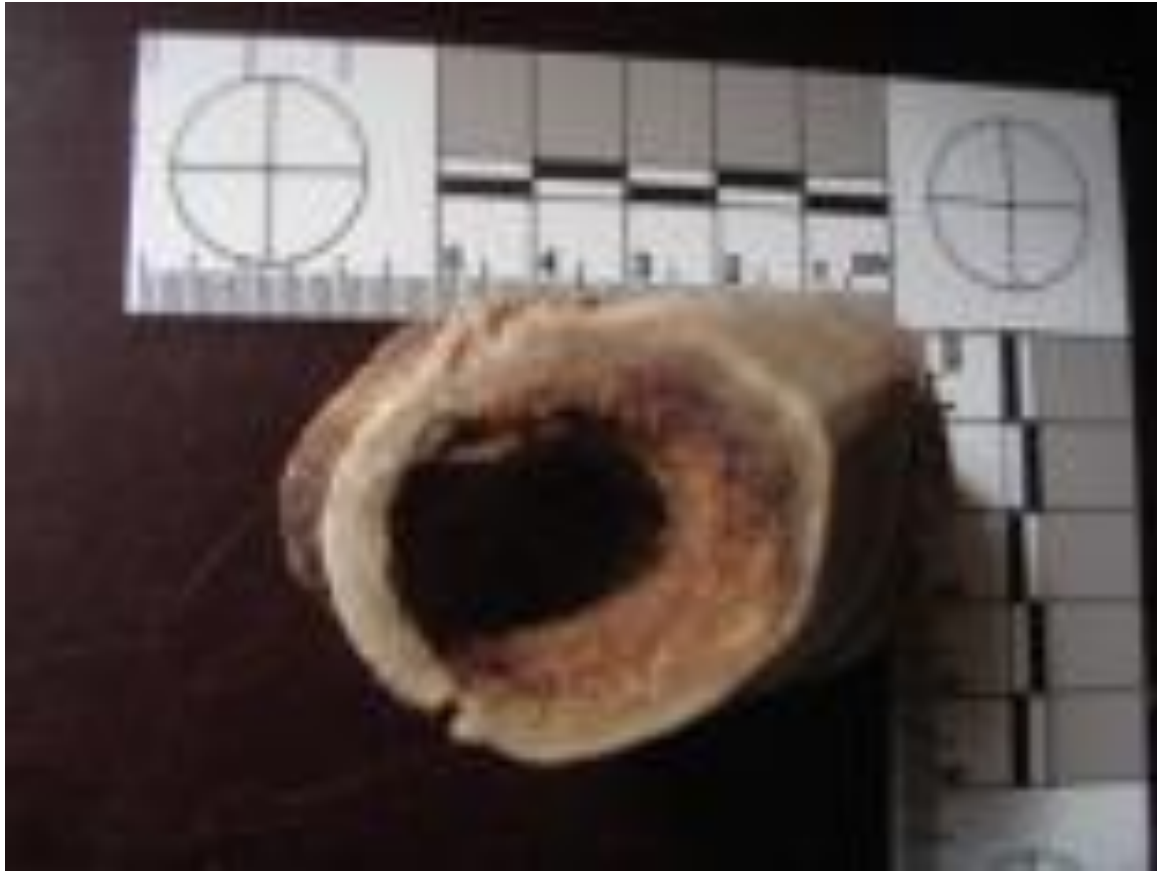
Figure 22. SS-6 post exposure. Striations of left side of the specimen.

Upon the post exposure examination of SS-6 there appear to be few deviations from what was noted during the pre-exposure assessment of the saw mark. While the striations would indicate that the saw was powered no other classification can be made regarding the saw responsible. However the differentiation of the initial corners of the kerf could be indicative of change induced by the calcium oxide, especially as the angle was noted as being 90° at the time of exposure.

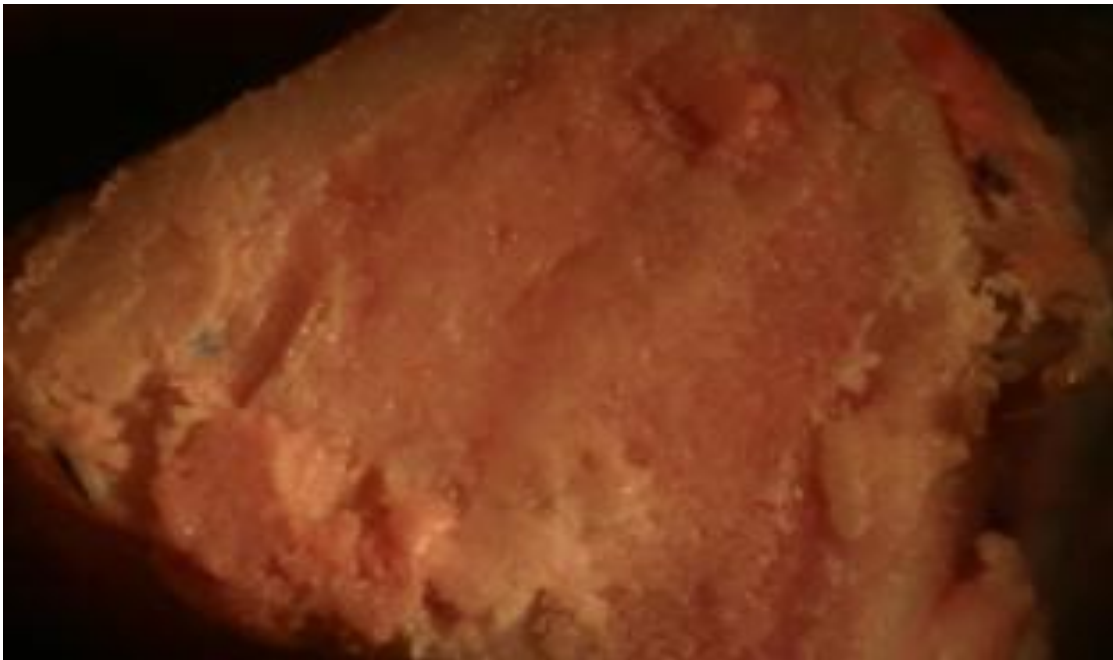
Figure 23. Initial cutting, false start located on left side of bone.

The initial cutting and examination of SS-7 was completed on February 8, 2013. During this examination it was noted that the specimen had soft tissue still attached, which was primarily muscular and fatty tissue with some cartilage present. The soft tissue was emanating an odor that is associated with the processes of decomposition. The cut marks present on SS-7 were examined and both a breakaway spur and notch could be seen; however it was not possible to determine the configuration of the kerf floor. The initial corners of the kerf wall were at 90° and the corners were sharp to the touch. The specimen did show characteristics consistent with at least one false start (Figure 23) while there were not indicators of entrance

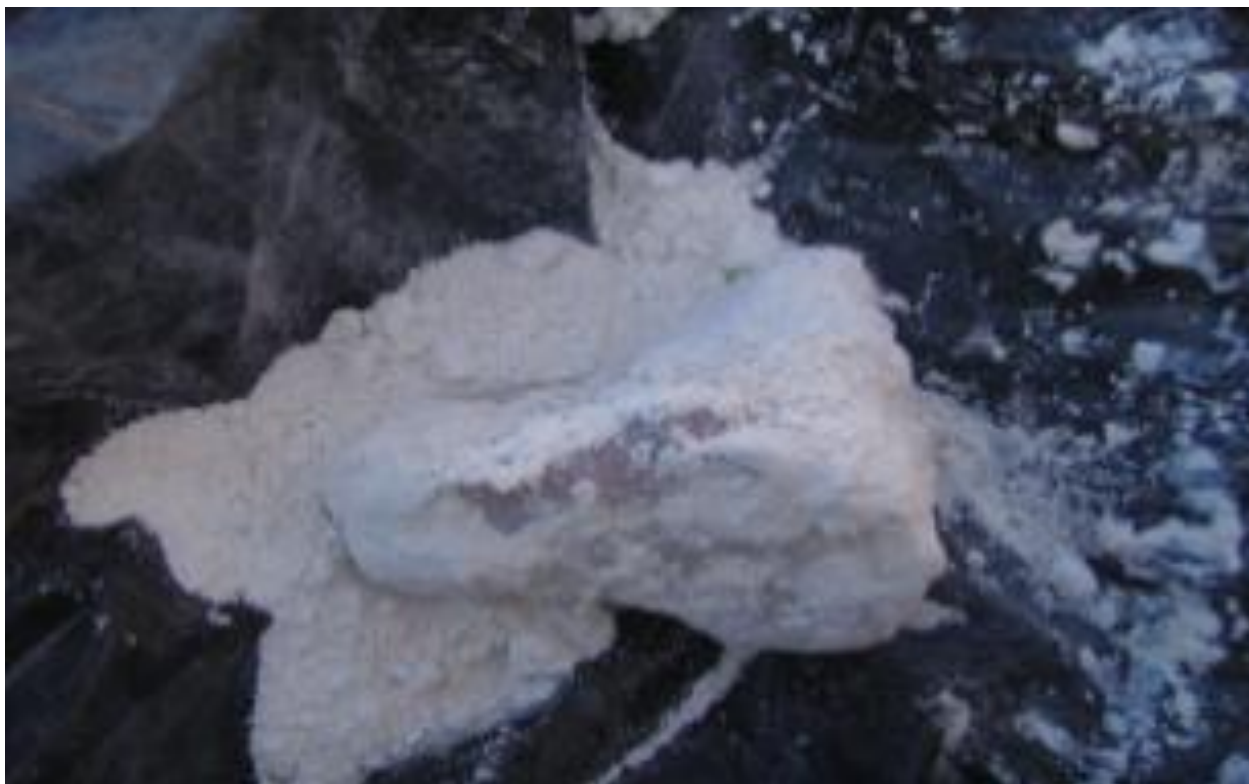
Figure 24. Post exposure of SS-7. March 1, 2013.

On March 1, 2013 SS-7 (21 days post treatment) was removed from its depositional context where it was briefly examined prior to cleaning and further examination. During this initial cursory examination, SS-7 was still releasing odors that are consistent with decomposition. Additionally the soft tissue that had been present on SS-7 still appeared moist. The calcium oxide also appeared to have come into contact with a small amount of moisture and appeared coarse and pebble-like (Figure 24). After the specimen had been cleaned the characteristics of the kerf walls were examined. SS-7 contains a relatively prominent breakaway spur which allows for the distinction of a flat kerf floor configuration to be made. Directly adjacent to the breakaway spur is the accompanying notch that can be seen. There are no signs of entrance or exit chipping; however, there is a large notch that is consistent with a false start in the cut mark (Figure 25). The initial corners of the kerf wall are all at 90° and are sharp to the touch. The striations on the kerf wall appear to be smooth and uniform (Figure 26), and are visible to the kerf floor. These striations appear to be parallel to the kerf floor as well, while there are no signs of harmonics present within this cut mark.

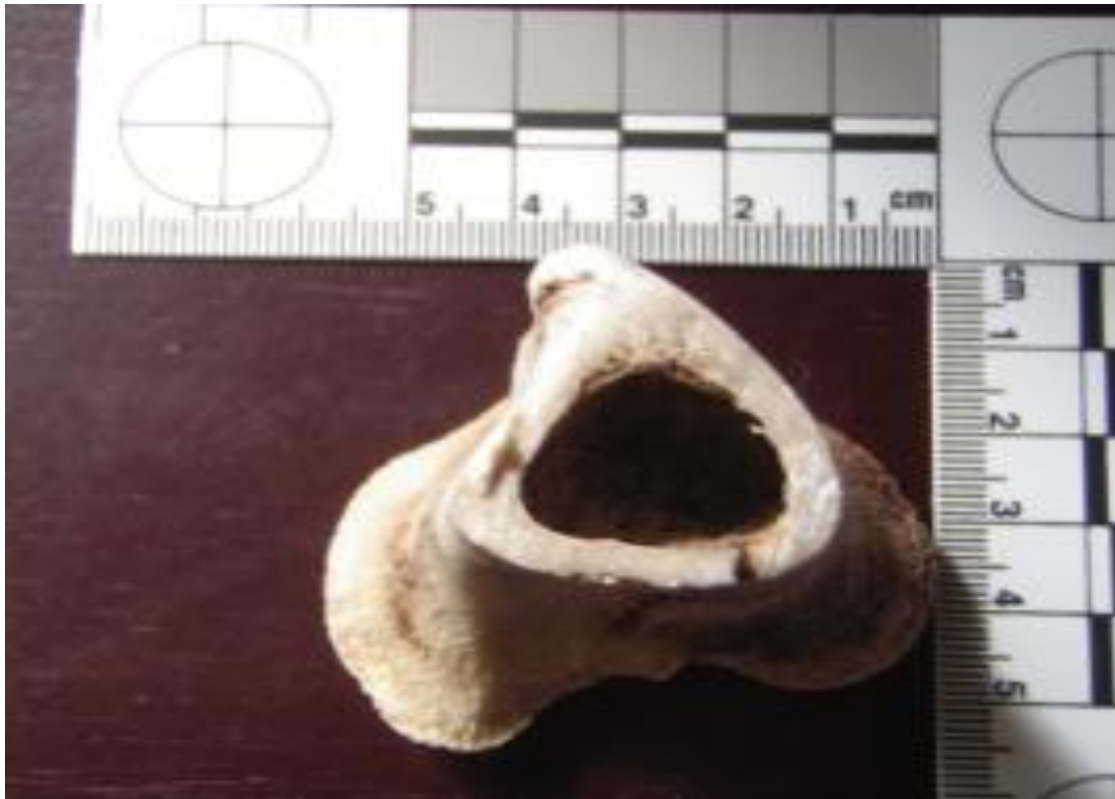
Figure 26. Breakaway spur, false start, and striations on SS-7.

Upon the post exposure examination SS-7 displayed a deviation from the original examination in that the kerf floor was able to be fully examined. During this examination the kerf floor showed that it was flat in nature, and consistent with both the alternating tooth set and chisel tooth type. The determination of this saw being mechanically powered still remains; however, the classification for this saw would be changed from indeterminate to one belonging to the mechanized rip saw family.

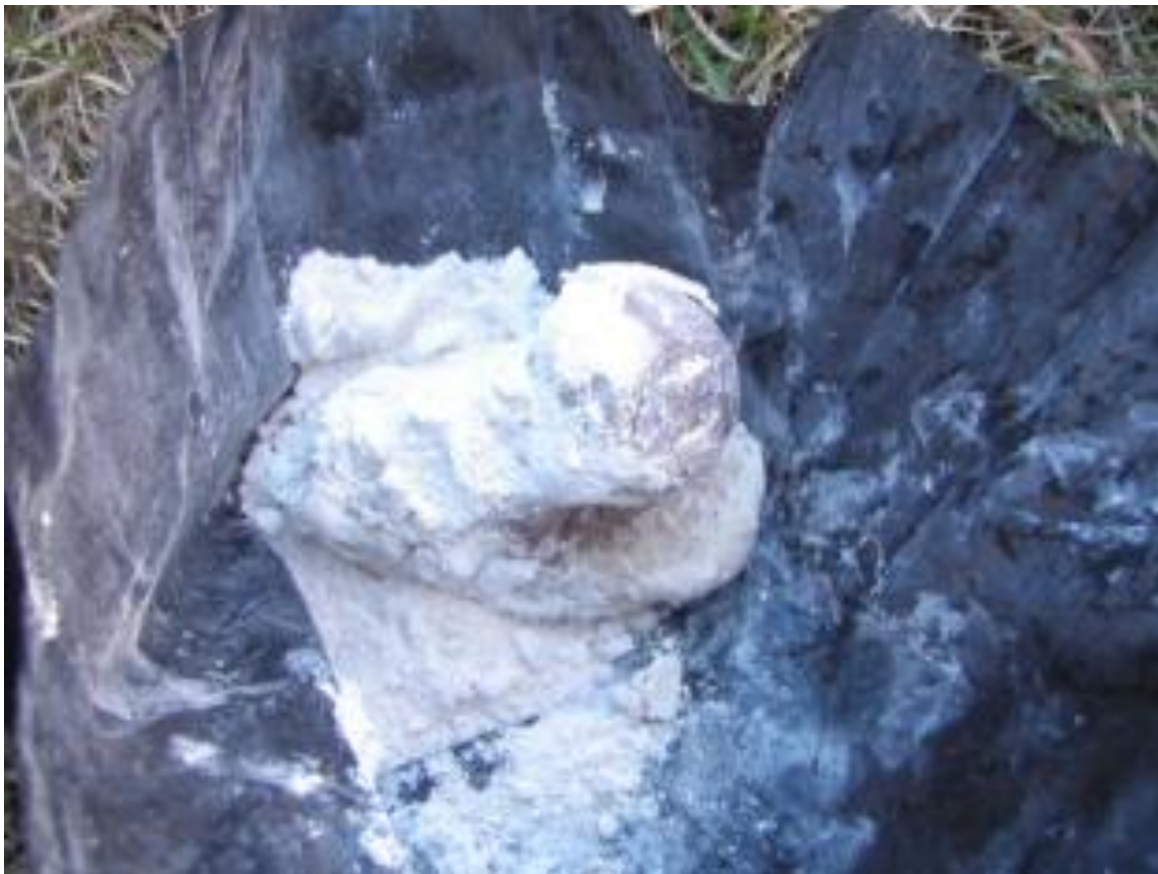
Figure 27. Conditions of the calcium oxide during retrieval of SS-8. March 8, 2013.

The afternoon of March 8, 2013 (twenty-eight days post treatment) SS-8 was removed from the depositional context that it had been exposed to. Initially when this context was opened there was a strong odor that is consistent with those of active decomposition. The calcium oxide that SS-8 had been subjected to appeared chalk-like and had the appearance of pebbles (Figure 27). Additionally the tissue that had been present on the specimen showed no obvious change in its appearance and looked as it did when it was placed. After these conditions were noted the specimen was cleaned using the aforementioned method. During the examination of the primary kerf characteristics it was found that there was a flat kerf floor configuration, as well as both a breakaway spur and notch. There was no evidence of entrance or exit chipping, nor are there indicators of false starts. The striations that are present are smooth and uniform, although there is some evidence of harmonics on the lateral aspect of the cut mark. The striations are also visible to the kerf floor and appear to be parallel to the floor (Figure 29). During this examination it became apparent that there was still calcium oxide present of the cut mark that had been resistant to the cleaning (Figure 30). Upon the cleaning of SS-8 the characteristics previously obscured have become available for examination. Due to the flat shape of the kerf floor being flat with at least one floor corner being square in shape it becomes possible to classify this saw as one with alternating tooth set and chisel style teeth

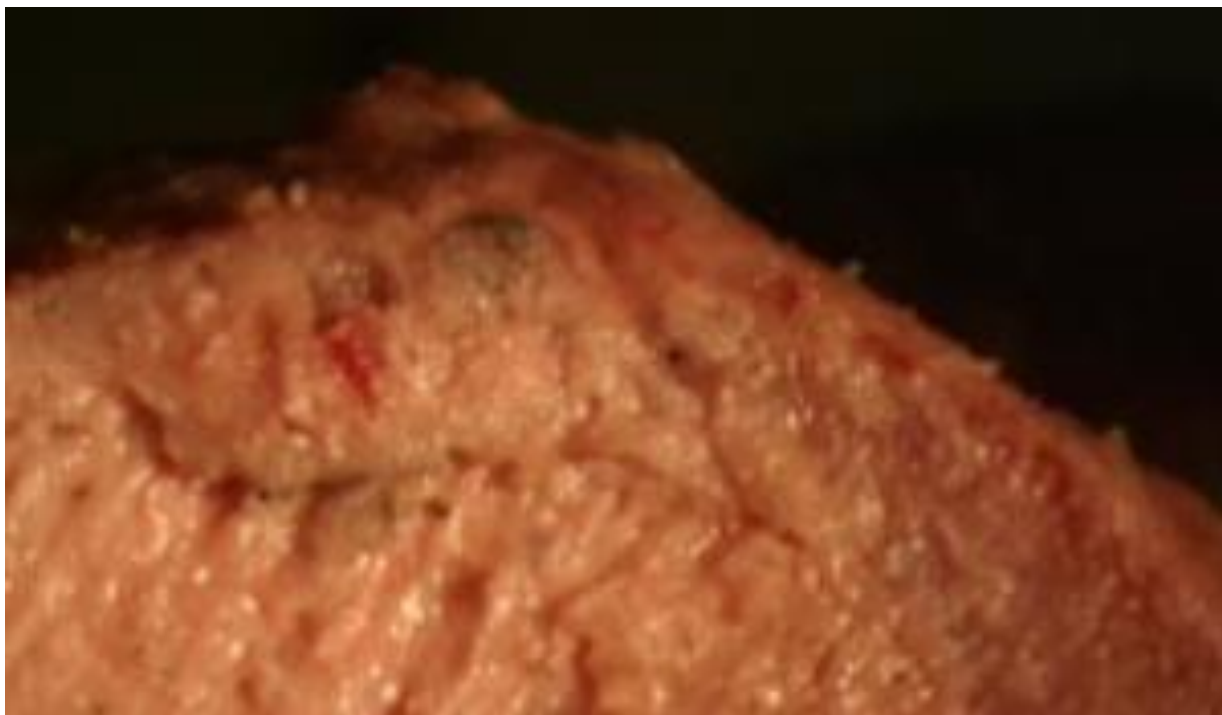
Figure 28. Tissue covering the striations of the kerf.

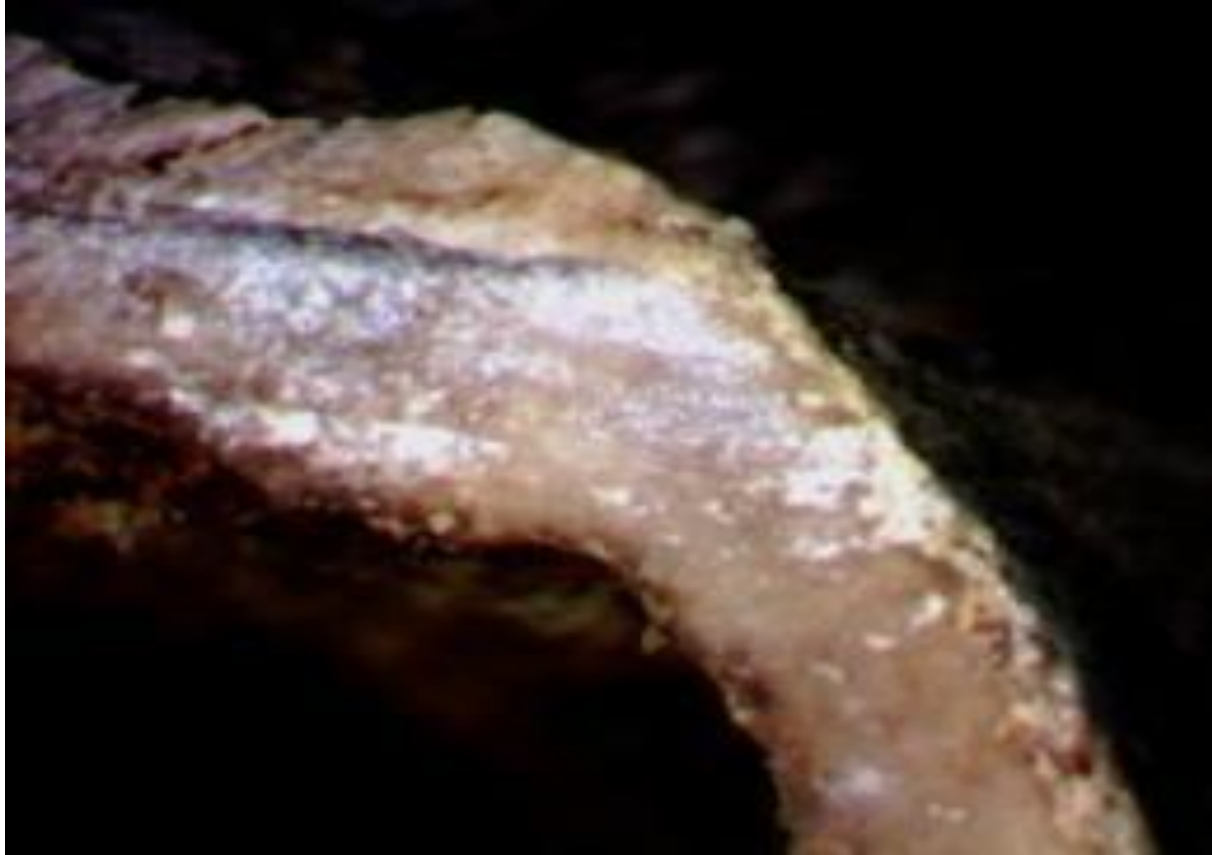
Figure 30. Residual calcium oxide found microscopically in the cut mark of SS-8.
