### Using cottonwoods as indicators of past floods along a gravel-bedded stream

USING COTTONWOODS AS INDICATORS OF PAST FLOODS  
ALONG A GRAVEL-BEDDED STREAM

Master of Science in Forestry

Using Cottonwoods as Indicators of Past Floods on a Gravel-Bedded Stream.

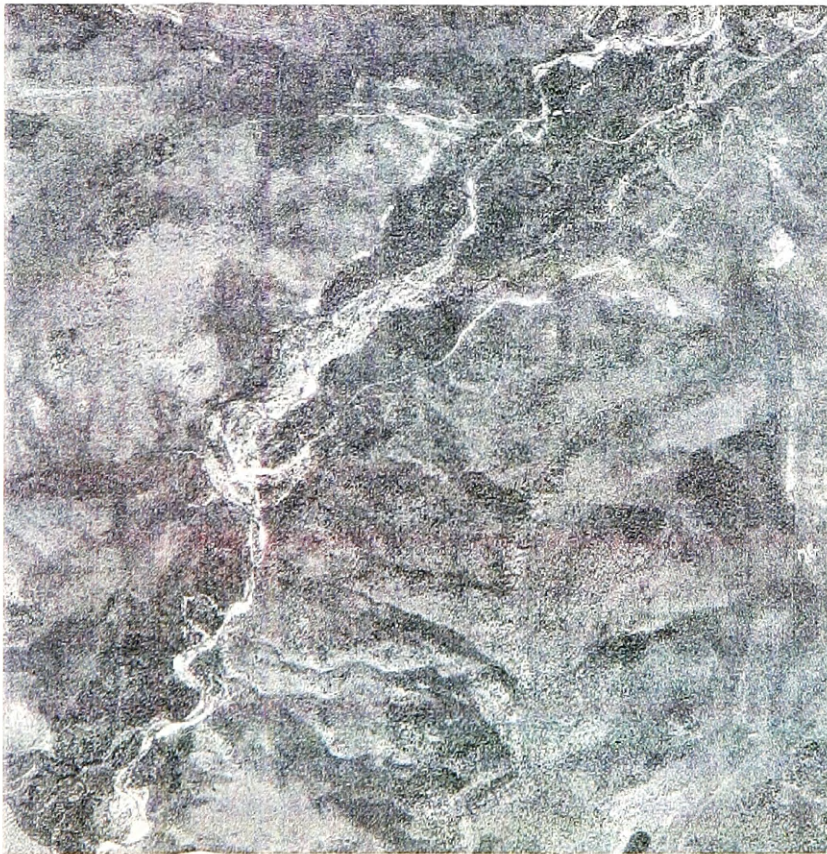
**Figure 3.2: Above, photo looking up Dupuyer Creek towards Bob Marshall Wilderness in June, 1998; below, 1995 aerial photograph of Dupuyer Creek.**

Dupuyer Creek flows northeast from the Sawtooth Mountains in the Northern Rocky Mountain Front and drains 83 square kilometers (see figure 3.2). The estimated drainage density to TRMR, excluding crenulations, is  $.98 \text{ km/km}^2$ , low for the Rocky Mountain region (Moeckel, 1997). The main stem of Dupuyer Creek at the Ranch proper is a sixth order stream. The creek bottom is cut into an alluvial valley with numerous terraces, probably laid down as glacial outwash.

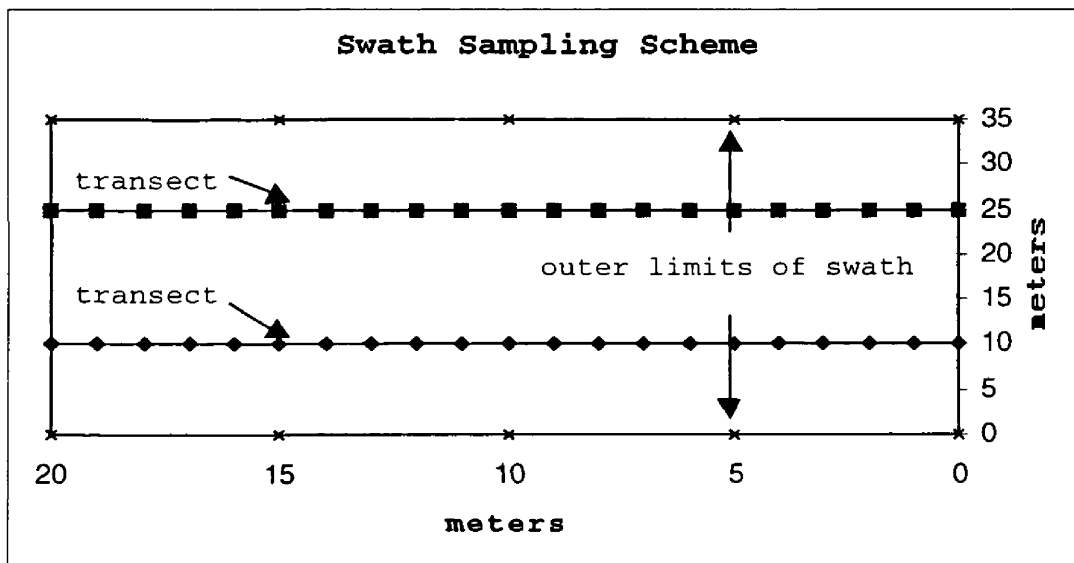
**Figure 4.1. Example of the swath sampling scheme.**

The sampling units consisted of pairs of parallel transects perpendicular to valley length. Along these transects elevation data were recorded at about 1 meter intervals. Transects were spaced 15 meters apart. Cottonwoods inside as well as 10 meters outside the paired transects were mapped to provide x, y, and z data for each tree using meter tape, compass, and laser level. This corridor, 35 meters wide, constituted a "swath" (see figure 4.1). Five swaths in all were sampled.

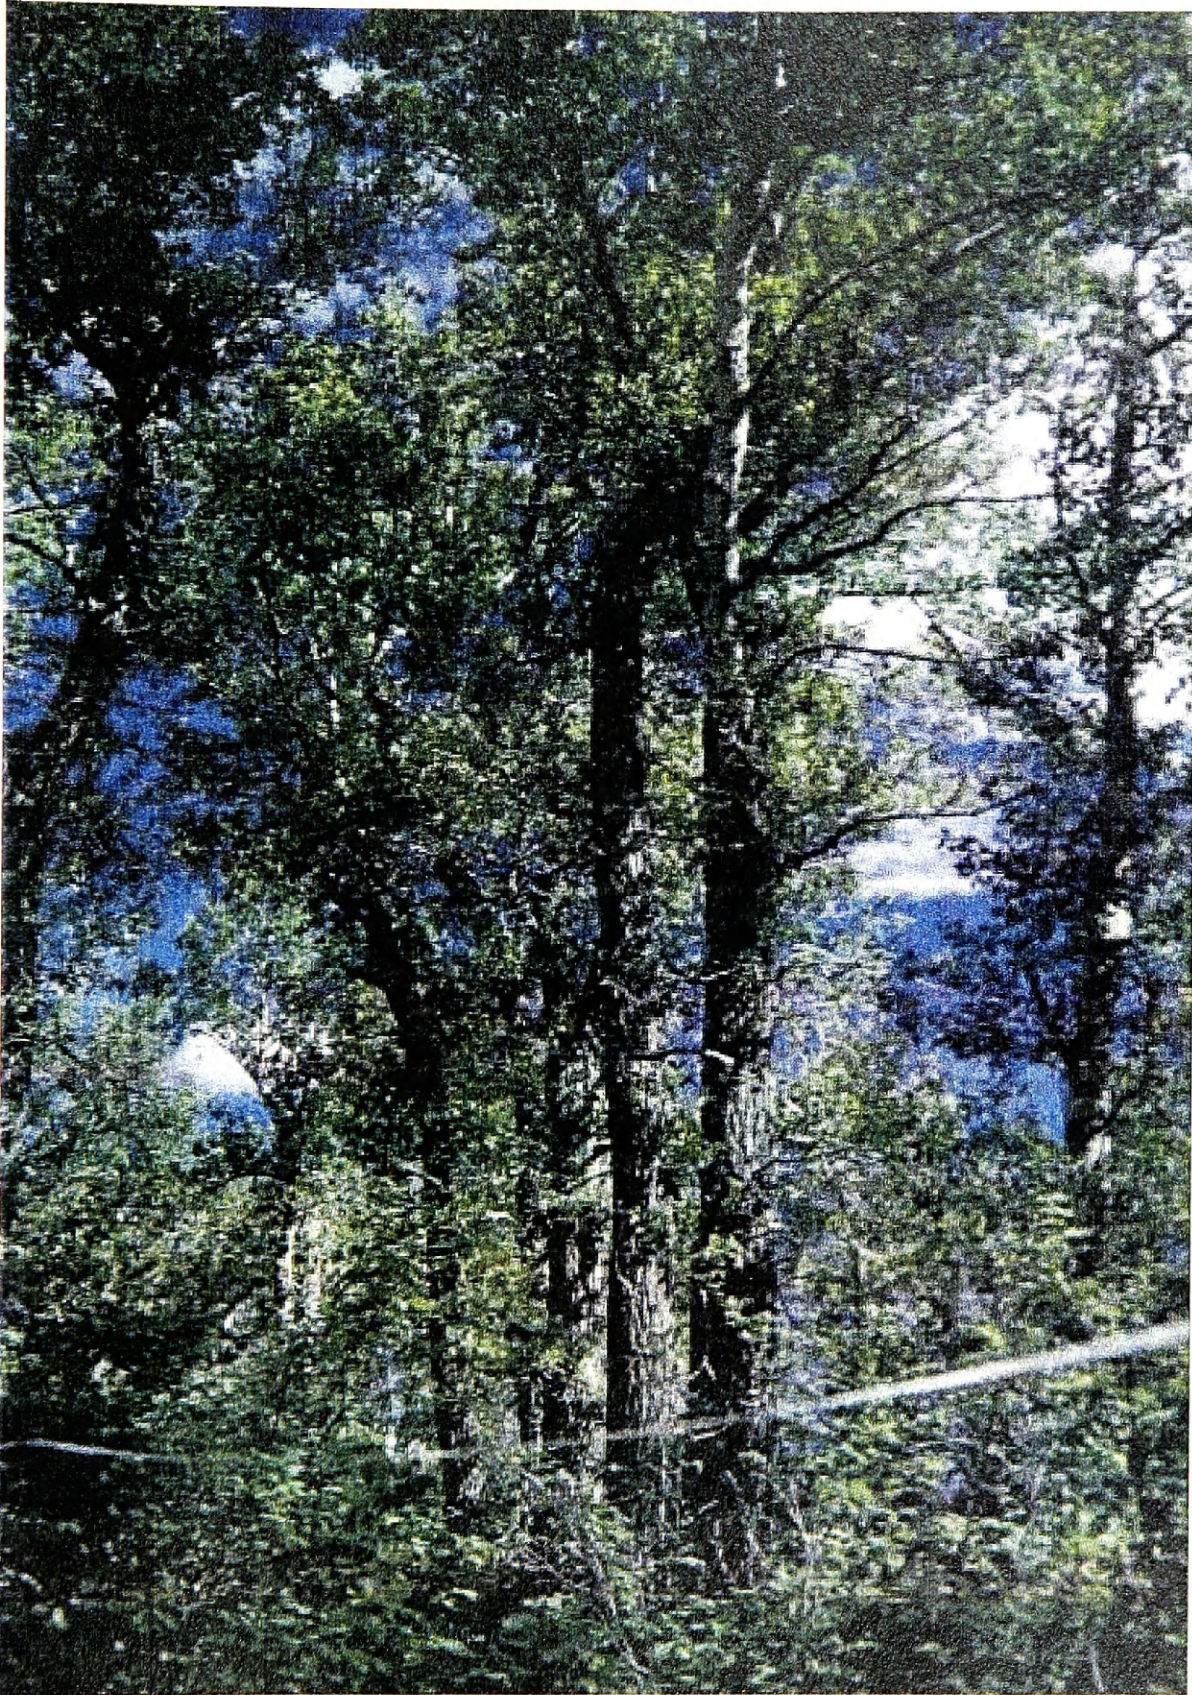
Figure 5.3: Arcuate band of large, old cottonwoods in the middle of Swath 1.

An arcuate band of large cottonwoods was discovered in the middle of Swath 1 on early examinations of the study site which suggested a possible abandoned channel (see figure 5.3). There was also a topographic anomaly present that resembled a filled-in abandoned channel. Completion of survey of Swaths 1 and 2 did not conclusively support this suspicion, nor did any channels identified in the time series of aerial photos.

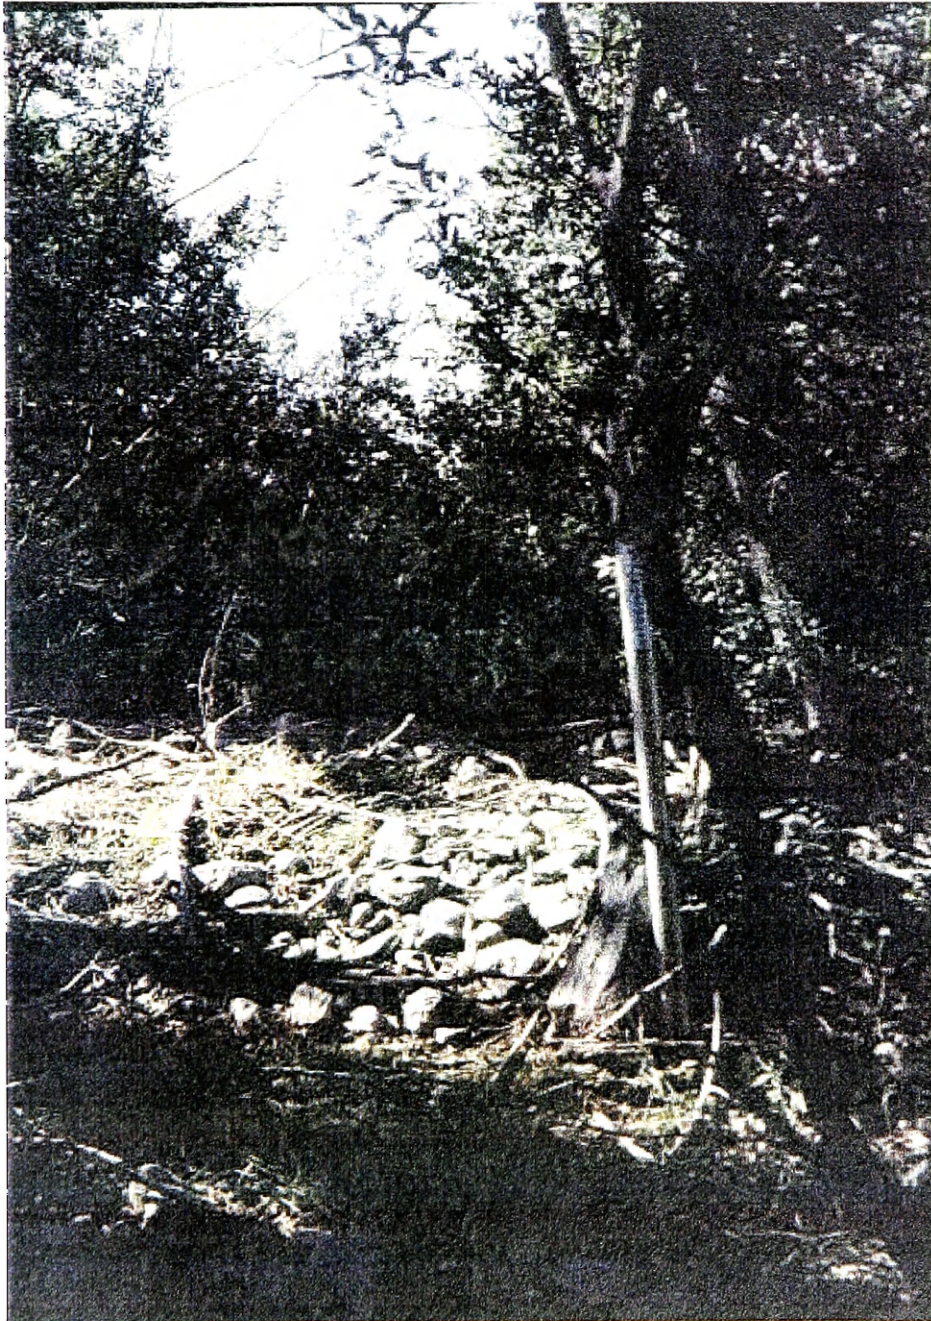
**Figure 5.7: Heap of cobbles, boulders, and organic debris from 1964 and/or 1975 flood in Swath 3.**

The meadow was flanked by bands of even-aged stands of cottonwoods, progressively older to the west. These stands comprised a thick canopied wood. The oldest trees (~100 years old) in this swath were found on the western edge of the wood. Surrounding the oldest of these trees was a heap of cobbles and boulders approximately two meters deep (see figure 5.7). The heap was probably created by the 1964 flood, the 1975 flood, or both.

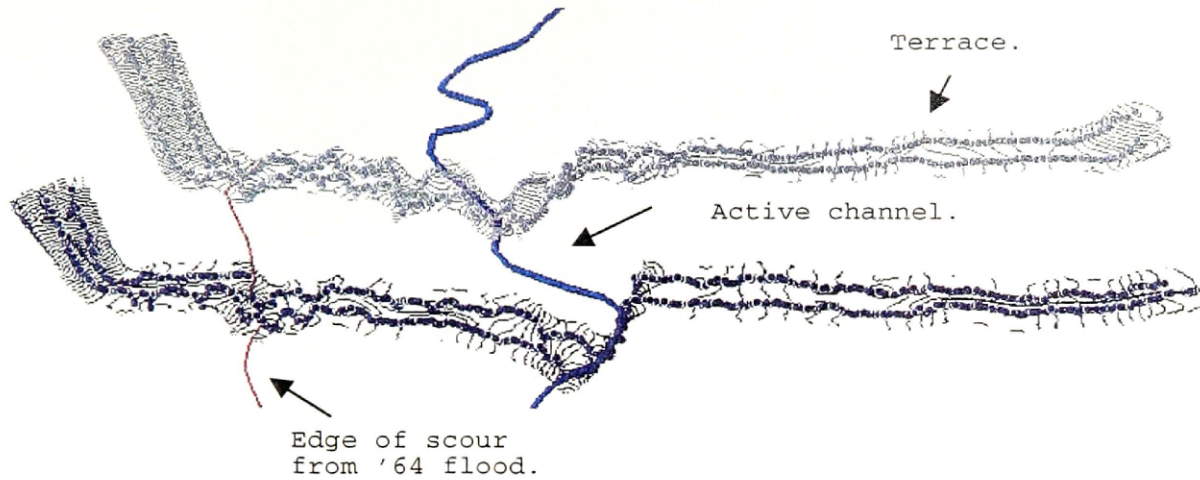
**Figure 5.8: Three-dimensional view of Swaths 4 and 5 with associated hydrologic features.**

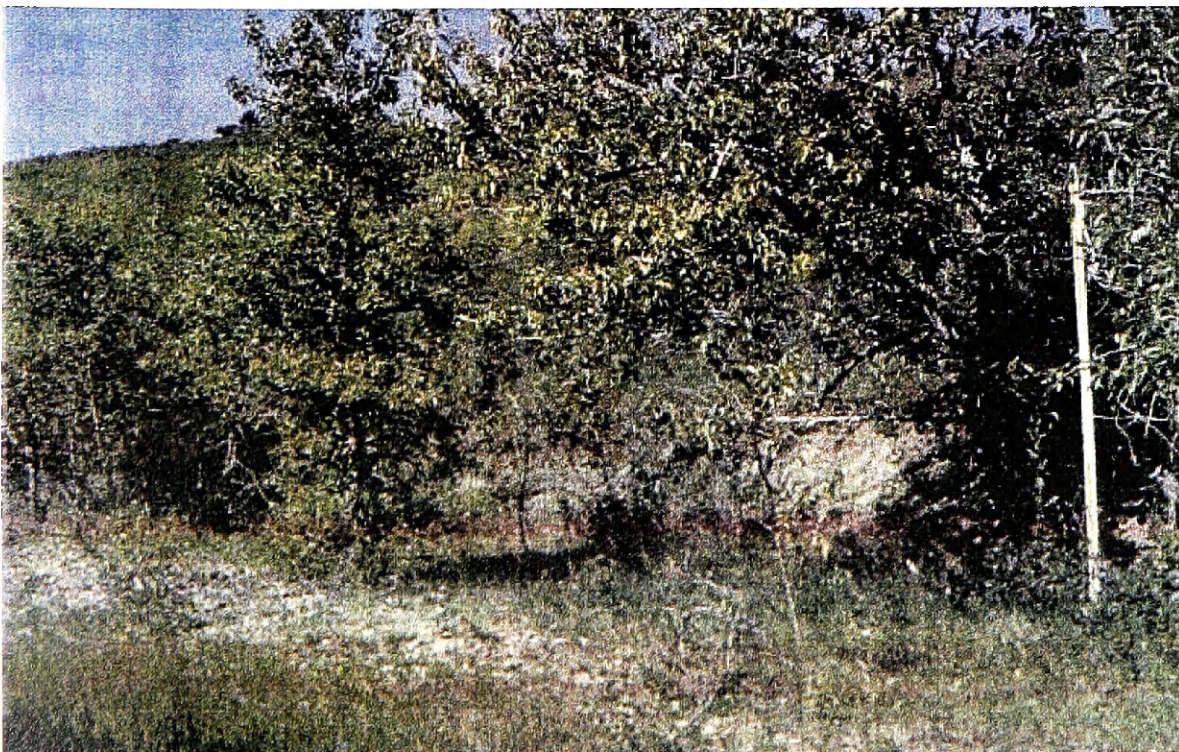
**Figure 5.11: Low cutbank on northwest side of Swath 4.**

Near the northwest end of Swath 4 a one and a half meter cutbank was discovered that extended across the majority of this section of floodplain parallel to the area of scour evident in the 1966 aerial photo (see figures 5.11 and 5.12). All the cottonwoods between this cutbank and the edge of the terrace were found to be younger than 24 years old. The 1978 aerial photo showed little vegetation left in this area as a result of the 1975 and 1964 floods. Above the cutbank trees were found to be as old as 60 years.

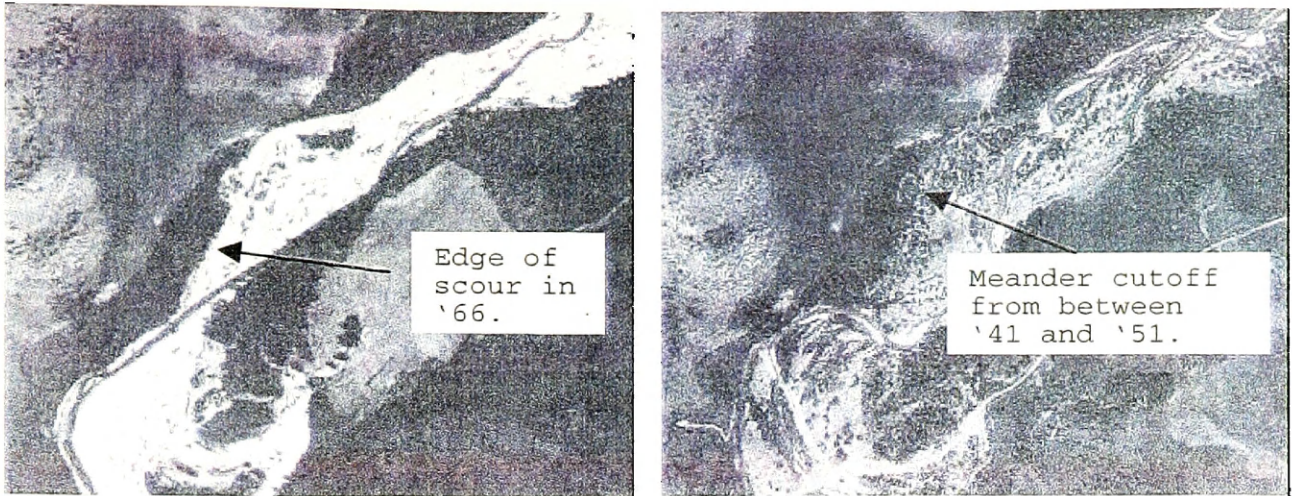
**Figure 5.12: 1966 (left) and 1995 (right) aerial photos of Swaths 4 and 5.**

The active channels identified in the 1937 through 1951 aerial photo series closely follow the cutbank mapped in this reach. A flood between 1941 and 1951 cut off a tortuous meander that is still evident on the landscape today (see figure 5.12). Subsequent floods effectively left the point bar on the inside of this meander an island, and examination of the cottonwoods on that island could provide an earlier record of flood activity on this reach.

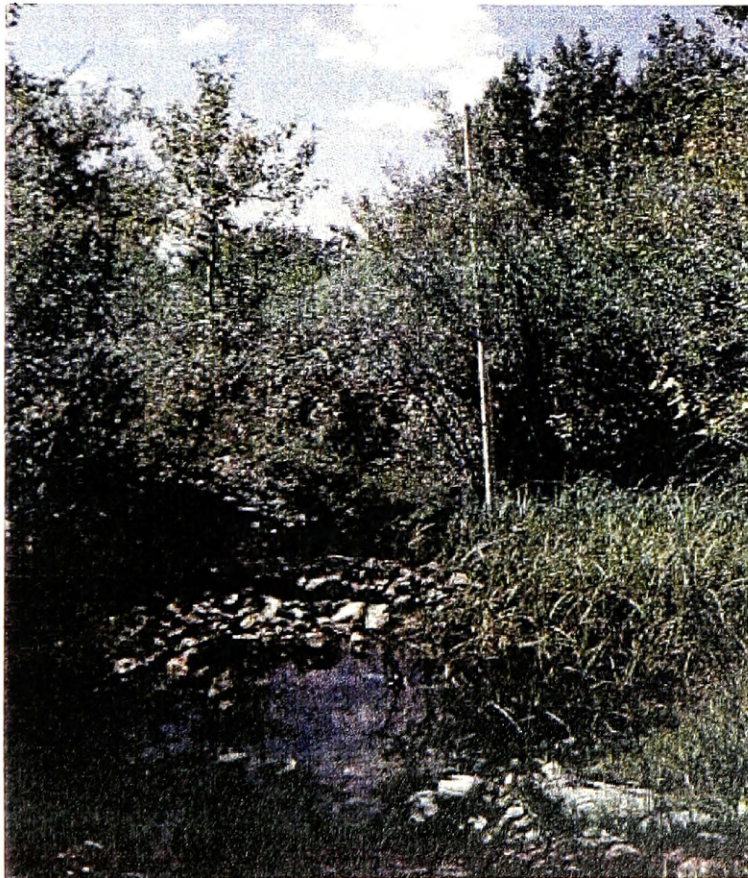
**Figure 5.13: Abandoned channel segment identified in Swath 5.**

Swath 5 was located 75 meters downstream of Swath 4. It passed through a stand of cottonwoods dominated by 75 to 100 year-old trees situated atop the terrace. Once down from the terrace scarp face, the swath proceeded through the active channel and over an irregular land surface. One cutoff chute was identified. The northwest end of the swath passed through a noticeably wet channel segment at the base of the continuation of the cutbank identified in Swath 4 (see figure 5.13). Cottonwood canopy above the cutbank was dominated by the 40 year-old age class.
