Watershed Management Tools: Hazardous Site Case History, Reference Stream Analysis, and GIS Analysis of Fire Risk

Portfolio

Hazard Remediation Options For a closed Pulp Mill on the Clark Fork River

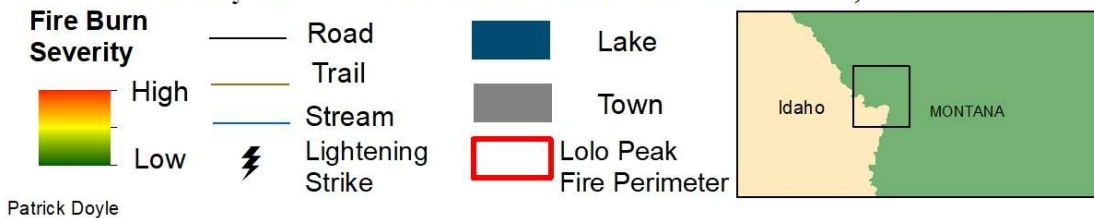
Severity of the 2017 Lolo Peak Fire near Lolo, Montana

Figure 1: The extent and burn severity of the 2017 Lolo Peak Fire. Severity data was taken from the National Forest Service map and georeferenced in ArcMap. The fire burned 53,436 acres over the course of about 3 months. The burned area was almost entirely in either the Lolo National Forest or the Bitterroot National Forest. The black lightning bolt shows start point.

The fire continued to spread north, nearly reaching Highway 12 and moving east along the northern slope of the mountain. The dozer lines kept the fire from moving too far east, where the towns of Lolo and Carlton stood. Instead, the fire moved south along the eastern slopes of the mountains. By September, the fire had burned 39,400 acres and was 31% contained (Mtn News, 2017). The fire would continue to burn south with a small section burning from the western portion to the eastern portion, leaving a patch of unburned area in the center, north of Sweeney Peak. By the end of September, the fire perimeter was no longer growing (InciWeb 2017). The entire burned area encompassed 53,436 acres (Figure 1).

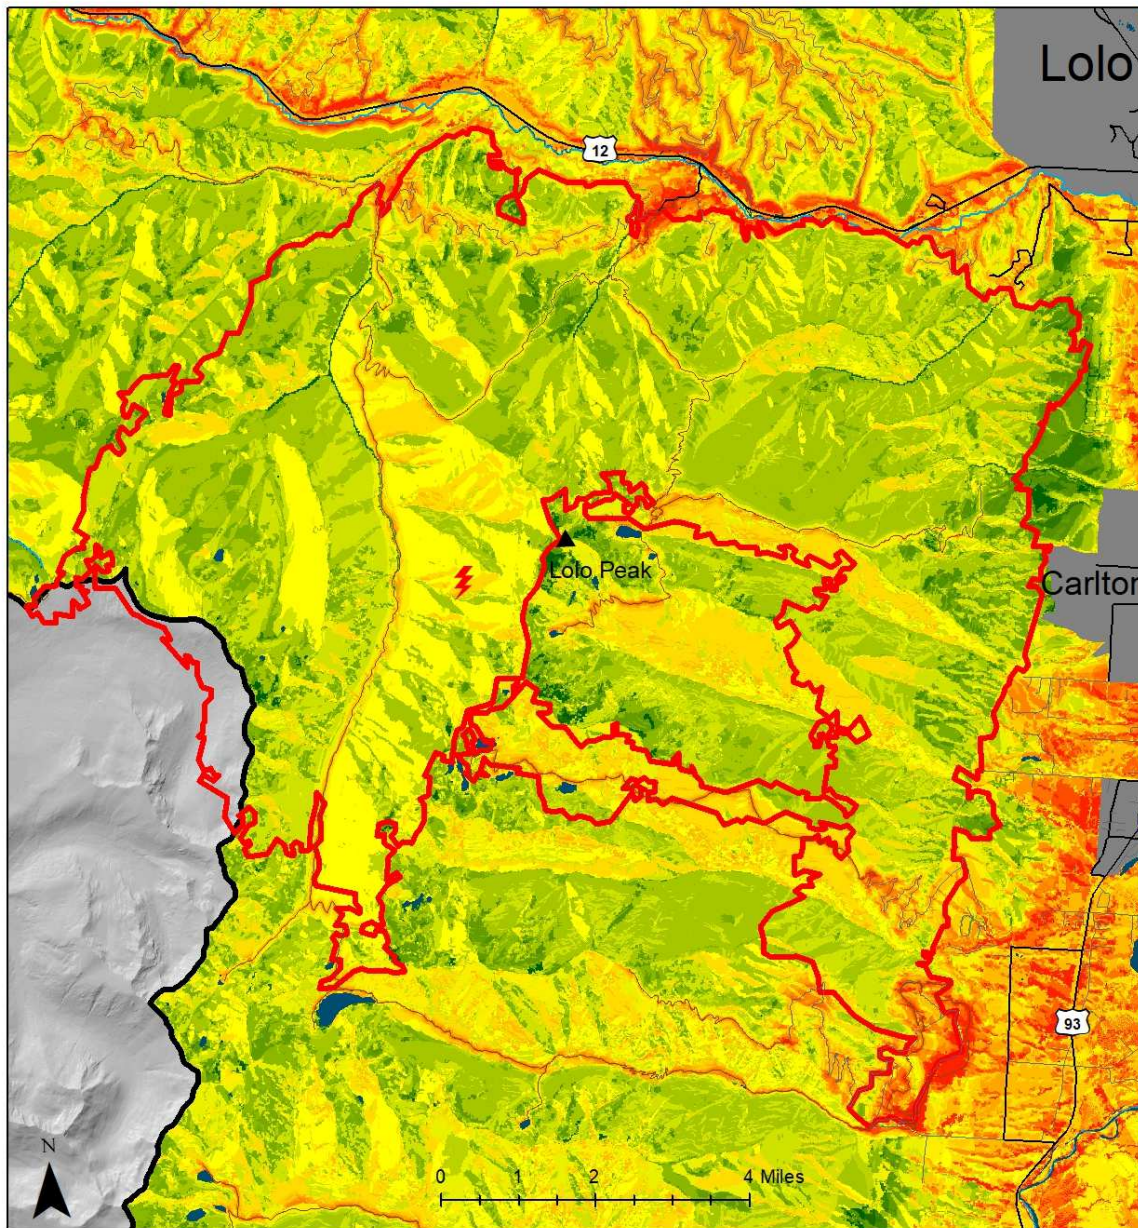
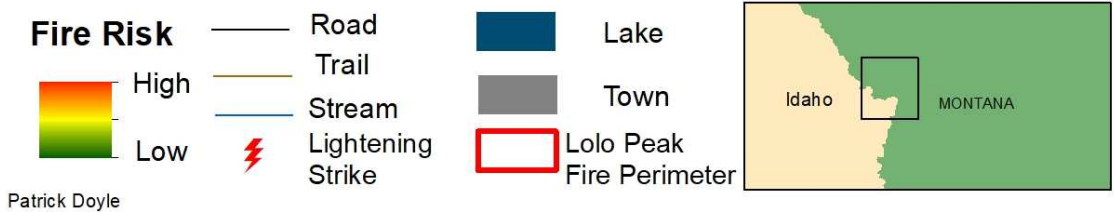
Fire Ignition Risk Around Lolo Peak, MT

Figure 3: Risk of fire ignition in the area of Lolo Peak. The 2017 Lolo Peak fire is represented by the red outline and its starting point as a red lightning bolt near the center of the map. Areas of highest risk are located near roads and trails due to the increased likelihood of people.

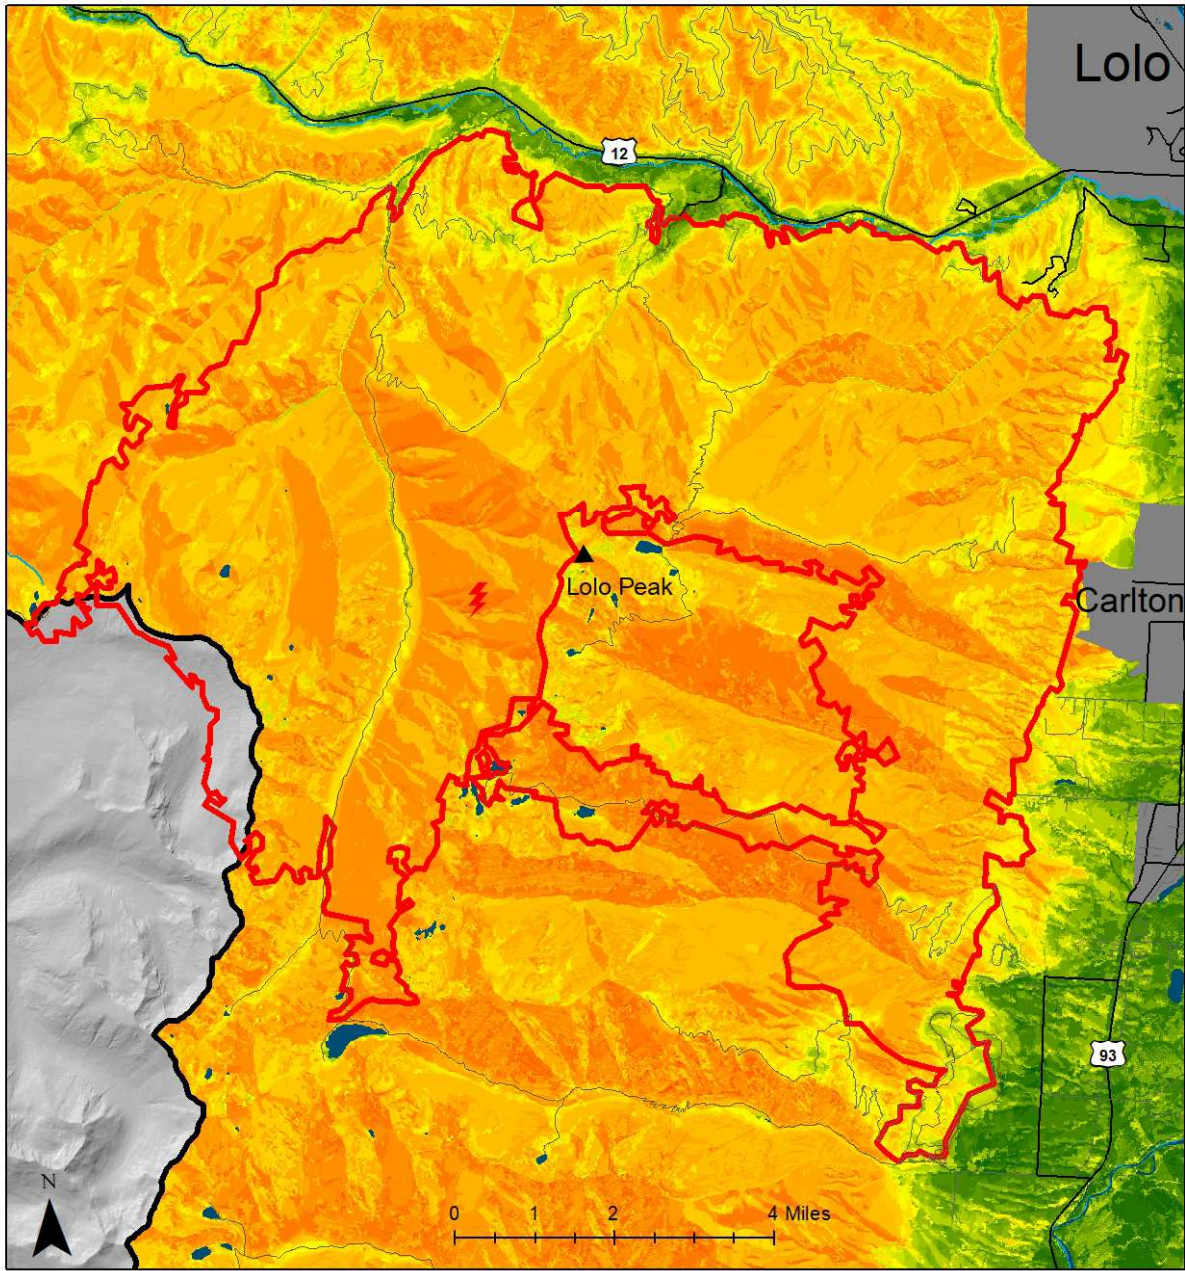
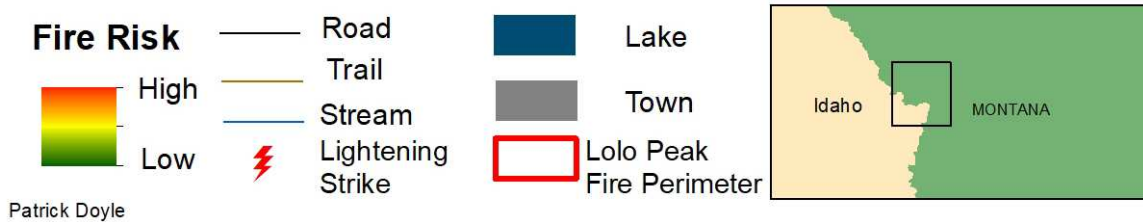
Fire Spread Risk Around Lolo Peak, MT

Figure 4: The fire spread risk around Lolo Peak. The 2017 Lolo Peak Fire perimeter and starting location are also represented. Risk areas do not predict fire progression, due to factors such as wind speed and the fire suppression activities.

Figure 4 shows the spread risk of fire around Lolo Peak. As expected, the areas with more roads have a smaller risk of fire spreading. These areas also have lower risk due to slope and vegetation type. The areas with limited access (national forest lands) show a high risk of fire spreading. Trails and roads sometimes predicted barriers in some areas such as the north area of the fire, but due to dozer and hand lines being constructed away from the trails as the fire progressed, they may not be accurate representations of fire spread barriers.

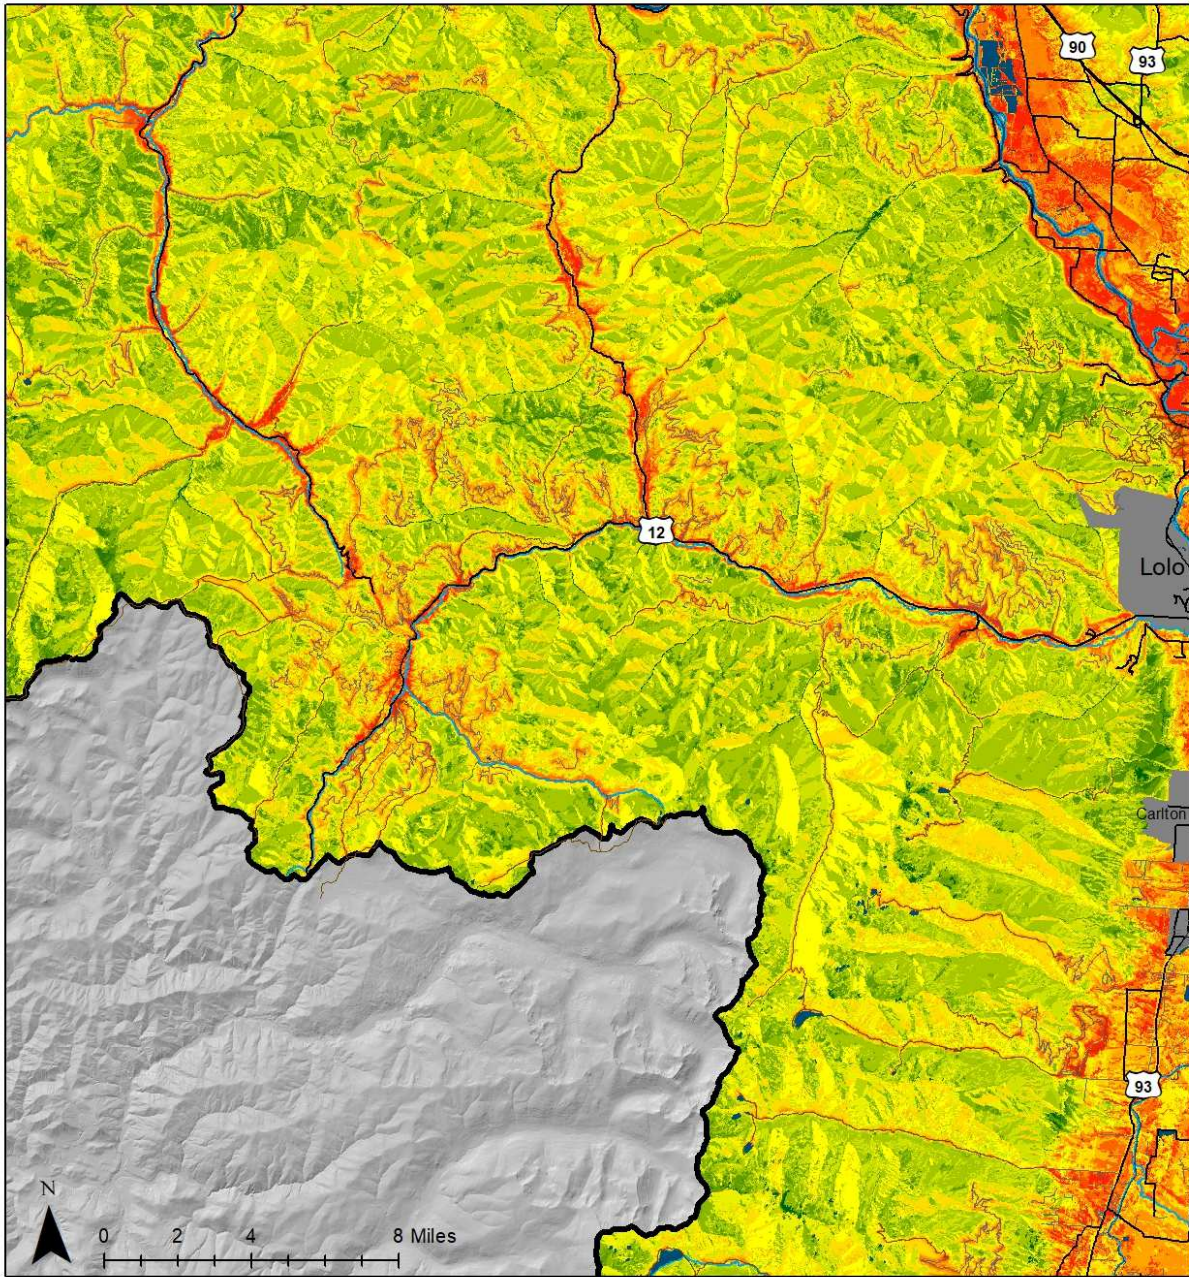
Fire Ignition Risk Near Lolo, MT

Figure 5: Ignition risk in the area west of Lolo, primarily part of the Lolo National Forest. Areas of increased risk are those near roads and trails.

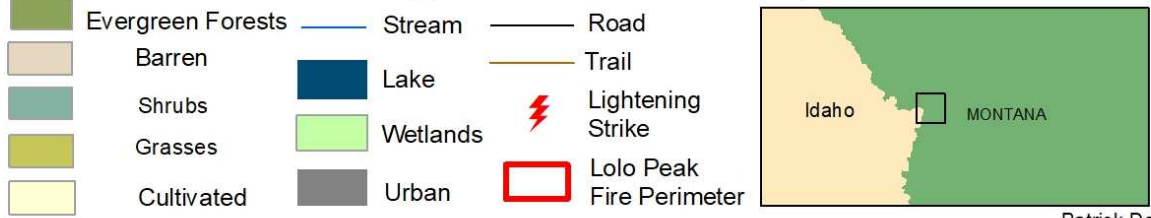
Land Type Around Lolo Peak, MT

Figure 8: Land Classification around Lolo Peak. Coniferous forests are the predominant land type in the area (Land type taken from the 2011 NLCD).

Figure 8 is a map of the different land types classified by the NLCD in the area of the Lolo Peak Fire. The burned area is predominantly coniferous evergreen forests. In some areas where the land type is classified as shrubs there are less severe burns, such as the visible checkerboard pattern in the northern section and the north side of the creek in the northeastern burn area, while in other areas the severity is higher, such as the western side of South Lolo Creek (west of the checkerboard pattern).

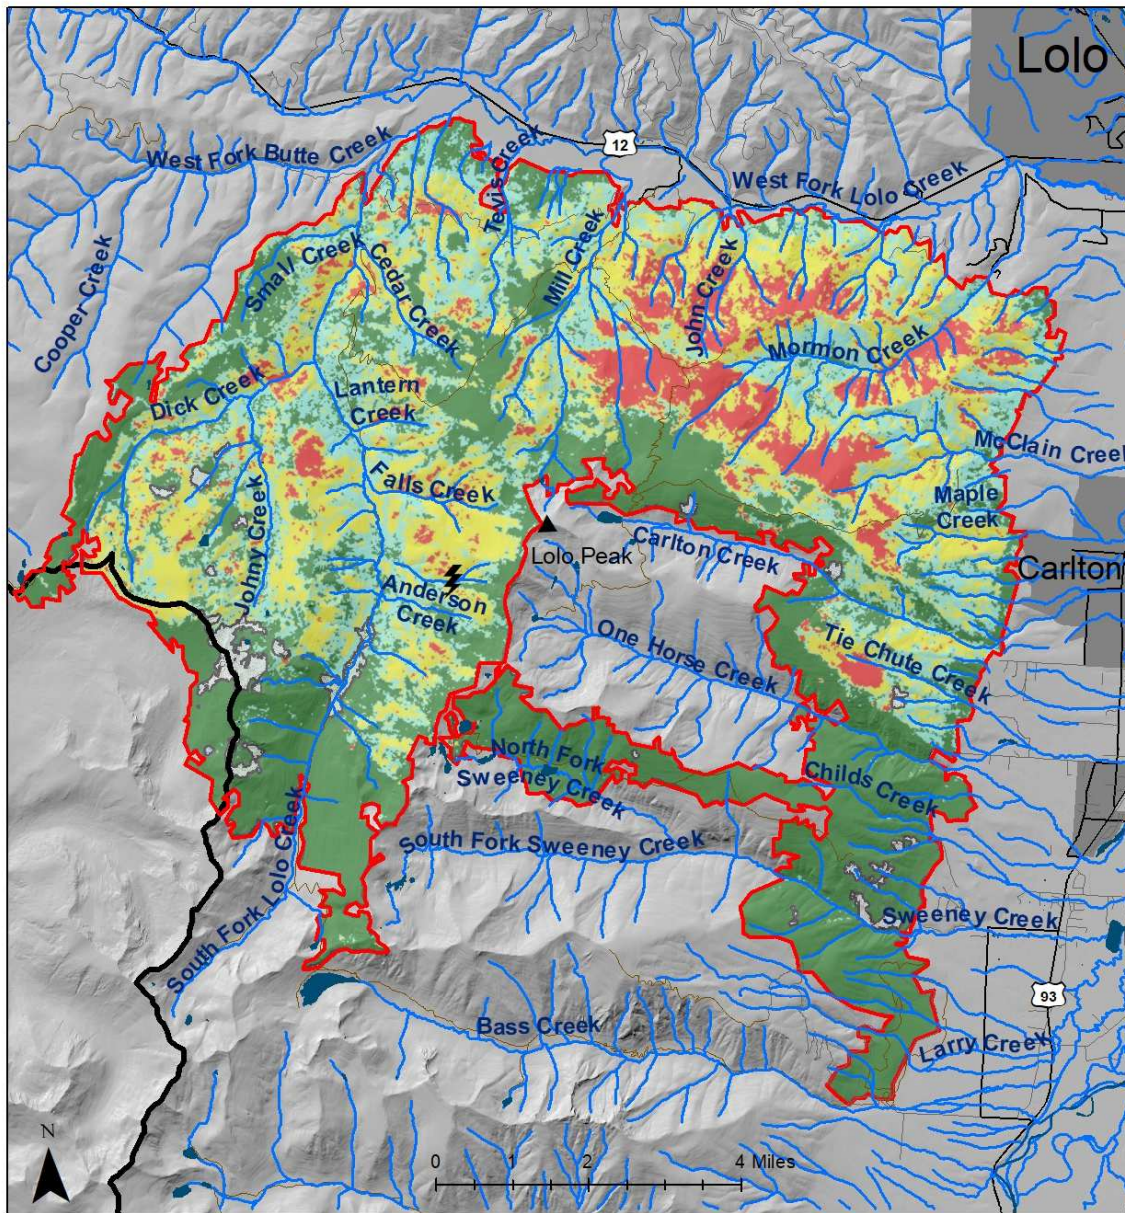
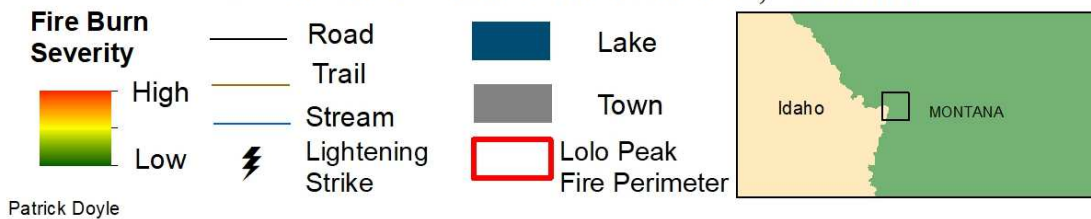
Creeks In or Near Lolo Peak Fire, Montana

Figure 9: Creeks in the area of the 2017 Lolo Peak Fire. Many creeks in the northern section of the burned area had most of their drainage areas burned.

The creeks in the burn area are mapped in Figure 9, along with the burn severity. It can be observed that large areas of certain creek's drainages are moderately to severely burned. Figure 10 shows the watersheds of these creeks (in the 12 digit Hydrologic Unit Code). Using the burn parameter and severity data, along with watershed boundaries, the total acres burned and acres severely burned of each watershed was calculated. This is displayed in a table in Figure 11.

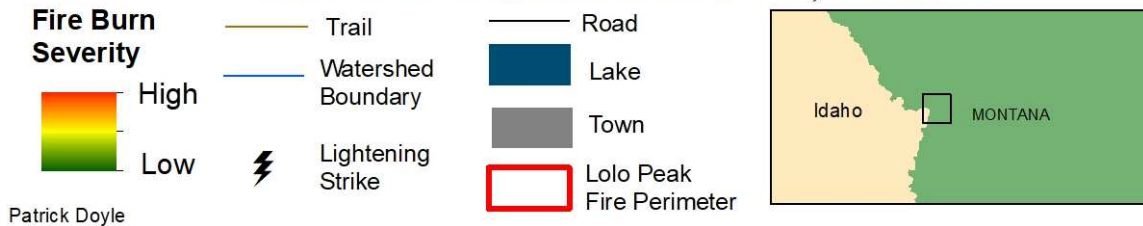
Watersheds Around Lolo Peak Fire, Montana

Figure 10: Watersheds in the area of the 2017 Lolo Peak Fire, identified by 12 digit Hydrologic Unit Code names. The damage to watersheds will be most prominent in the South Fork of Lolo Creek watershed and Lower Lolo Creek watershed.

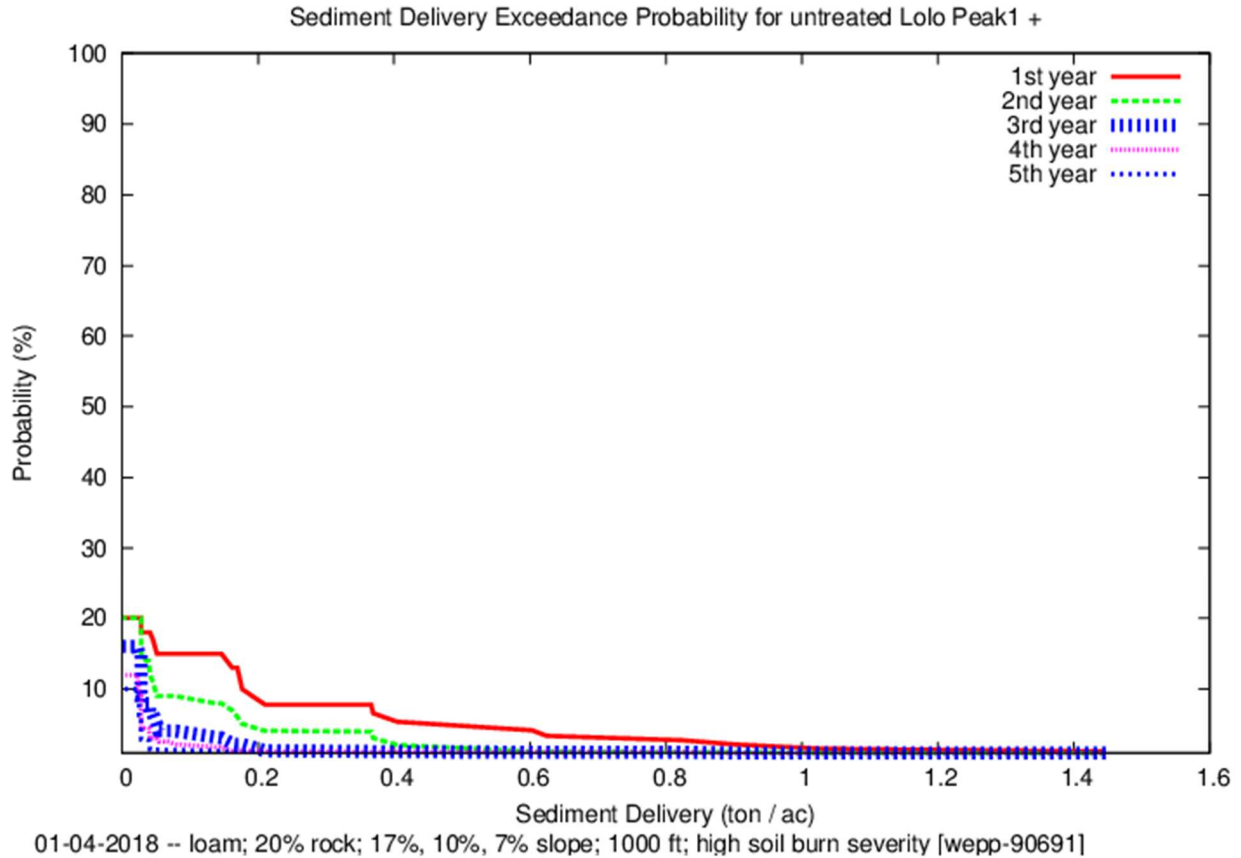
Figure 2: The prediction of the ERMiT model for a slope above Mormon Creek.

The Erosion Risk Management Tool (ERMiT) uses the climate, soil texture, rock content, vegetation, hill slope and length and the burn severity to predict erosion for the first five years after a fire. The horizontal length is limited to 1000 feet, and the climate data were limited for the Lolo Peak area. The prediction of the model for a section of high burn severity by Mormon Creek can be found in Figure 13. According to this model, there is not a high chance of excessive erosion. However, if applied to the entire high severity burn area (2711 acres in the Lower Lolo Creek watershed), the sediment eroded from these areas could be over 200 tons. So while the model is limited, it provides a base line of what could be expected in terms of erosion.
