Robert W. Lankston

Montana Memory Project Photo umt010970

Initial Metadata Title: Polleys Lumber Company, Unloader and Railroad Ties
Initial Metadata Date: 1930

Trees to Ties to Track

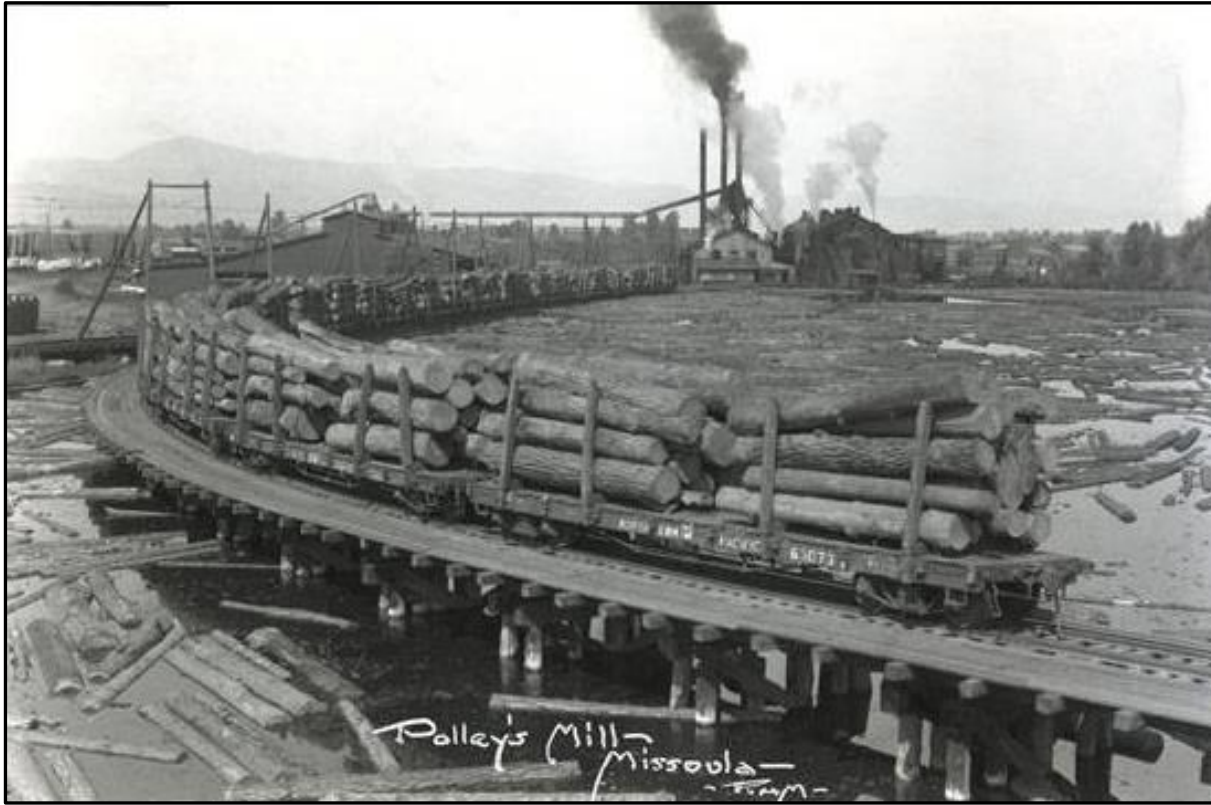
Figure 1. Northern Pacific Rail Cars Loaded with Logs on the Northern Pacific Spur at the Polleys Lumber Company Mill Log Pond. The Northern Pacific spur actually was on a trestle bridge in order to cross the southeast corner of the log pond. The Milwaukee Road spur joins the Northern Pacific spur in the left center of the photo near the trolley wire support with the sloping back brace pole. Other trolley wire supports have similar back bracing. The back bracing can be seen more clearly in [umt016885](#). This is MMP photo [umt010978](#).

Archives West (2018) indicates that Edgar Hovey Polleys started his lumber company in Missoula in 1910 with the construction of a mill on the south side of the Clark Fork River, southwest of the center of the city in those days. Based on Sanborn Fire Maps of Missoula from the early 20th century, the Polleys property extended from the west side of the Northern Pacific¹ Bitterroot Branch Line westward almost to California Street. The north-south extent of the plant was from the river to the right of way of the Chicago, Milwaukee, St. Paul, and Pacific Railroad, i.e., the Milwaukee Road, essentially to Dakota Street. Both railways served the mill (Figure 1).

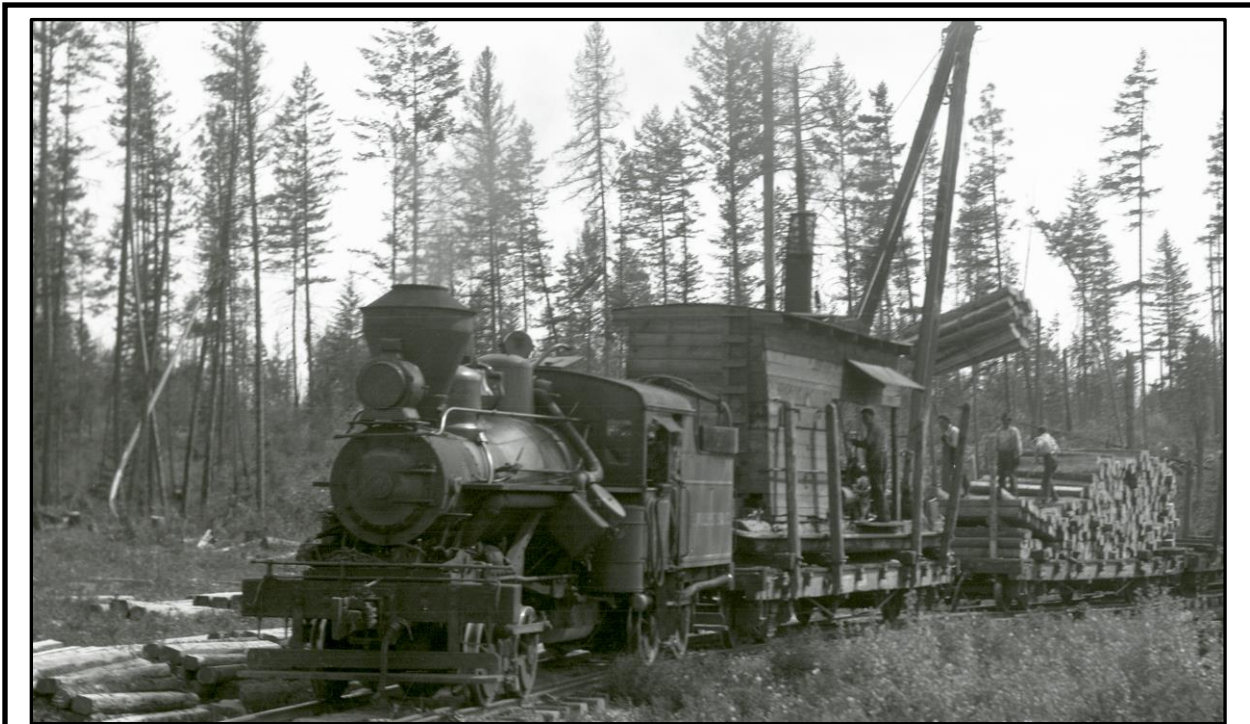
Figure 3. Polleys Lumber Company Locomotive #2 Loading Railroad Ties onto a Flatcar. Ties to be loaded can be seen in the lower left foreground. The “2” is barely visible on the smokebox door even in the original photo. This is MMP photo [umt010969](#).

Figure 3 shows locomotive #2 pulling a flatcar on which is mounted a steam powered simple derrick, commonly called a jammer. The jammer is lifting ties from beside the railroad tracks onto a second flatcar.

Ties, such as those being loaded in Figure 3, made their way to the site where a new segment of the lumber company's railway was being built, i.e., the lead photo. The lumber company railroads were often laid with no significant road bed preparation. The railway needed to last just long enough to remove the merchantable timber from an area. The roadbed did not need to be smooth as with a line that carried passengers. The logs did not complain about a rough ride as human passengers might have done.

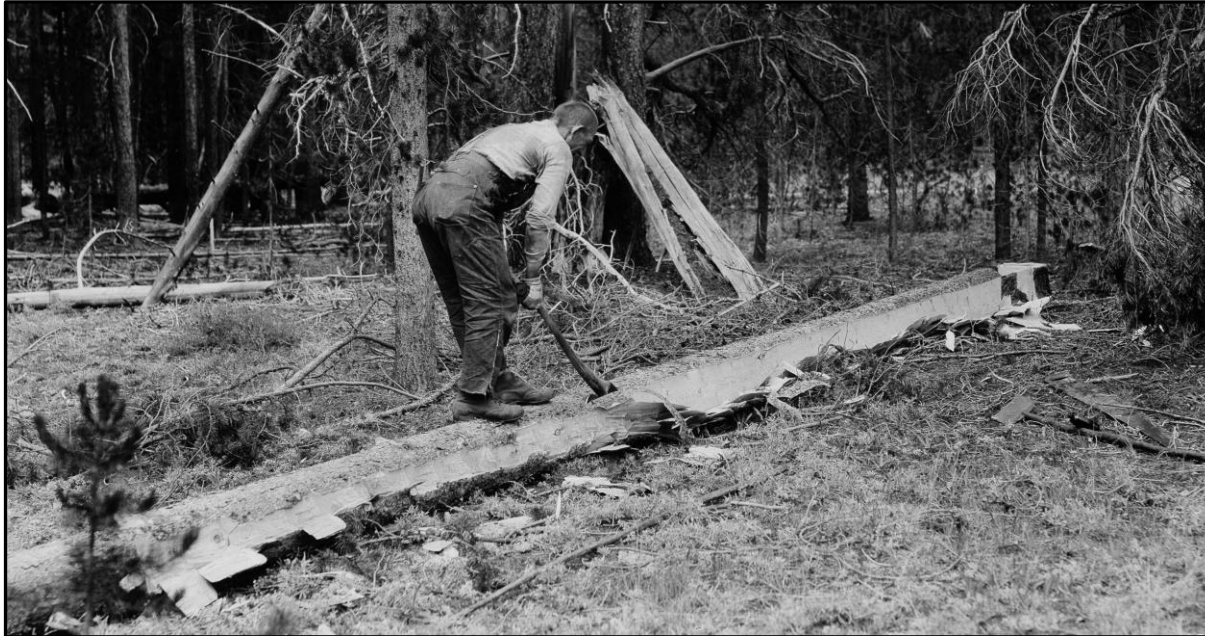
Figure 4. A Tie Hack Cutting the Face of a Railroad Tie (USDA Forest Service, 2018). This photo is credited to Kenneth D. Swan. The date for this photo is August 12, 1924. In addition to the broad axe in use by the worker, one can see his hand saw and a bark scraper on the ground at the right edge of the photo.

I have not found information on how the ties for the Polleys Company railroad were prepared and delivered from where the trees were felled to the loading point beside the railway (Figure 3). However, initially, the workers who prepared the ties were called tie hacks and worked with hand tools (Figure 4). McKay (1994) devotes a large section of her report to the Flathead National Forest to the production of railroad ties.

The Swan photo in Figure 4 is dated 1924. McKay (1994) indicates that by 1930, most of the ties in the Flathead National Forest were being cut in the woods using portable tie saw mills. Similar mechanization was likely used in places other than the Flathead National Forest. [Figure 88](#) in McKay's (1994) report shows a portable tie mill operation.

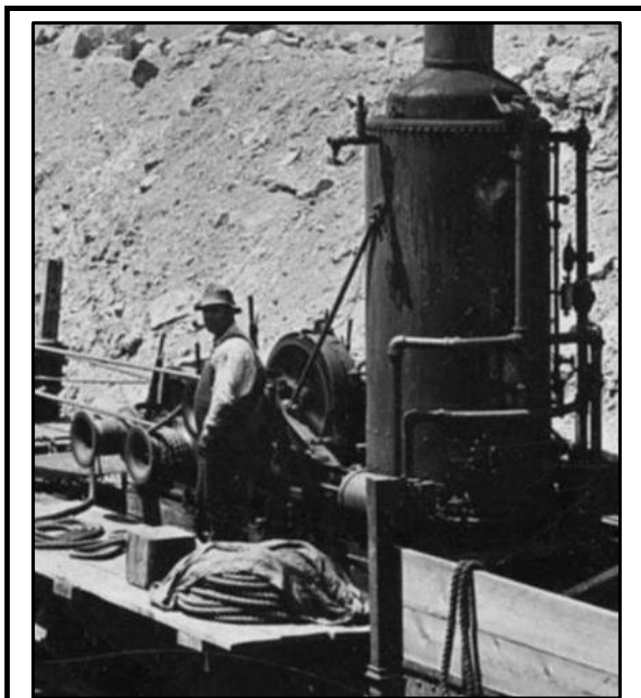
Figure 6. Steam Powered Cathead Winches for a Railroad Derick or Track Laying Machine. slatonharveyhouse.com (2017)

Some track laying machines had their own on-board steam engine, e.g., the Hurley machine (oil-electric.com, 2011b), for both material handling and locomotion. A photo on the slatonharveyhouse.com (2017) site shows a steam engine, sometimes called a donkey engine, and the draw works for what may have been a track laying machine. Figure 6 is just the part of the slatonharvelhouse.com photo that shows cathead winches that might be similar to what was in the operator's "cage" sketched in Figure 5.

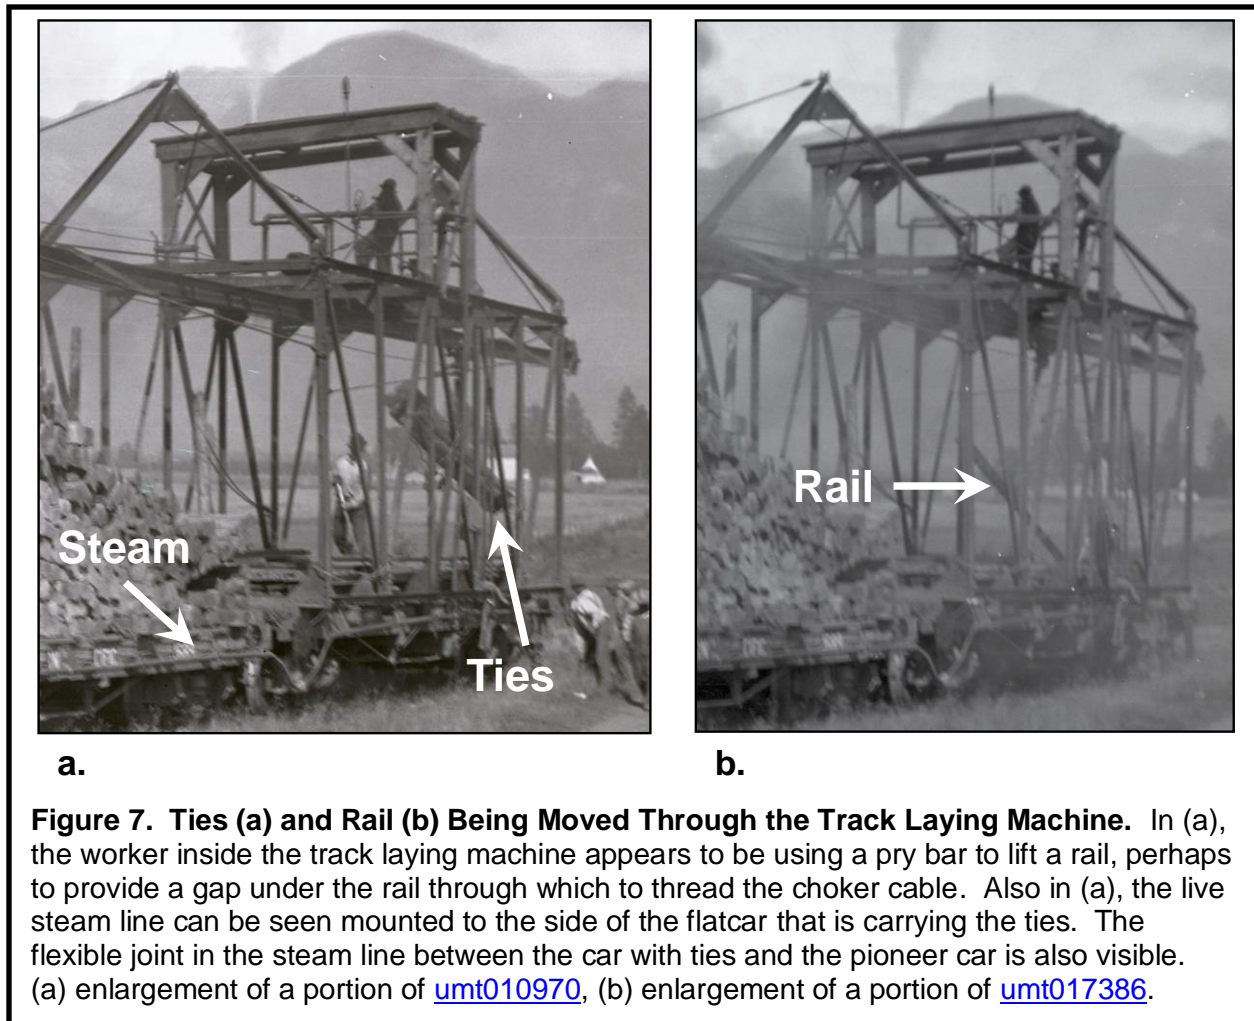
see a worker on the pioneer car and a bundle of ties in the lead photo and in the enlargement in Figure 7a. The ties would be released, and the workers on the ground, as seen in the lead photo, would lay the ties in place. More bundles of ties would be delivered past the end of the track until enough ties were laid to accommodate the next pair of rails.

After laying enough ties to accommodate the length of the rails, the choker hitch assembly would be drawn back into the heart of the pioneer car, which carried the rails. A worker would then set the choker hitch around a rail, and the draw works would move the rail over the newly laid ties (Figure 7b). The rails were about 30 feet long, which suggests that the gantry boom extended at least 15 feet past the end of the pioneer car. Of course, this operation was repeated in order to lay the second rail parallel to the first one in a section.

Before I had completed my editing of the original article to include the view of the mill (Figure 1) and the track laying machine in Figure 7, the Mansfield Library archive technician, who scans the photographs for the Montana Memory Project and who knew of my interest in the photos of the track laying process, happened to scan the photo in Figure 8. The track laying machine in Figure 8 is remarkably similar to that in the lead photo. Figure 8 shows the area in front of the pioneer car, an area not imaged in the McKay photos. In Figure 8, ties have been laid, and one rail has been put down. The

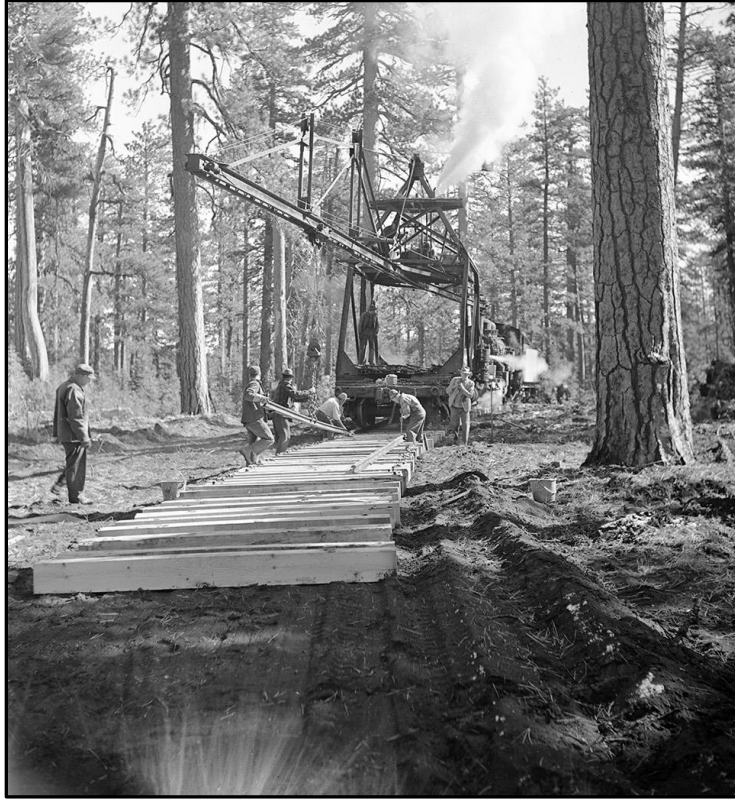
Figure 8. Track Laying for the Fruit Growers Supply Railroad in 1946 at Halls Flat, California. *Image courtesy of University of Montana, Mansfield Library, Archives and Special Collections, Phillip C. Johnson Collection: Photo number 92.1874. (As of 12-26-2019, this photo was not in the Montana Memory Project collection.)*

second rail is being lowered into position from the gantry crane. The photo shows, as is suggested in the McKay photos of the Ronan, Montana, area, that minimal roadbed preparation had been done. I do not know whether the ties were subsequently ballasted.
