## Investigation on the Corrosion of Coated Steel Plates with Impact Defect using Divided Steel Plates

### Abstract

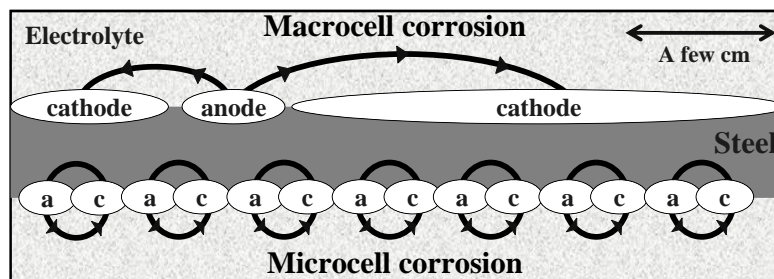
Figure 1. Concept of Macrocell and Microcell corrosion [5]

With these two concepts, the corrosion behavior in coated steel plates with defects is better presented in detail. Microcell corrosion is the type of corrosion in which the anode and the cathode are adjacent to each other in a microscopic scale. This type of corrosion occurs uniformly throughout the steel surface. On the other hand, macrocell corrosion is the type of corrosion in which the anode and the cathode are physically separated by some finite distance away from each other on the steel surface. Macrocell corrosion on the steel surface occurs when the individual parts of the steel surface are exposed to different environment situations. Different environment situations generate potential difference on the steel surface. The macrocell corrosion current can then flow from the parts with high potential to the portions with low potential on the steel surface [6]. The presence of defects in coated steel plates creates a similar situation since the defect part is directly exposed to the high chloride ion content of the marine environment, thus creating a potential difference with the sound or intact coated parts of the surface.

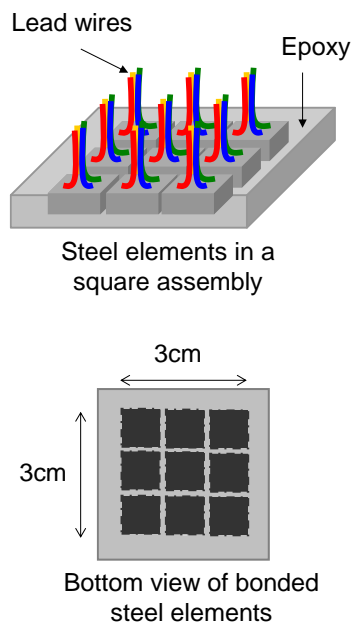
**Figure 2. Square divided steel plates developed by Otsuki, Min, Madlangbayan and Nishida [7]**

In 2007, Otsuki, Min, Madlangbayan and Nishida published a method that can address the measurement of macrocell as well as microcell corrosion in coated steel plates with unpainted defects [7]. The method utilized divided steel plates as shown in Figure 2. An important feature of the divided steel plate is that its steel elements can be connected and disconnected to one another. When the lead wires are interconnected, the divided steel plate has its elements connected and can therefore act as an undivided steel plate. When the lead wires are disconnected from each other, zero resistance ammeters can be connected to the lead wires between each element. This way, the steel elements are reconnected to one another thus the assembly can once again act as an undivided steel plate. Zero resistance ammeters can be conveniently used to measure the macrocell current flowing between its steel elements. Also, the polarization resistance at each steel element can be measured on a periodic basis. The polarization resistance values can in turn be used to express the microcell corrosion current density at each element. Therefore with the use of the divided steel plate evaluation method, a way to present the details of the macrocell as well as microcell corrosion of coated steel plates was made possible.

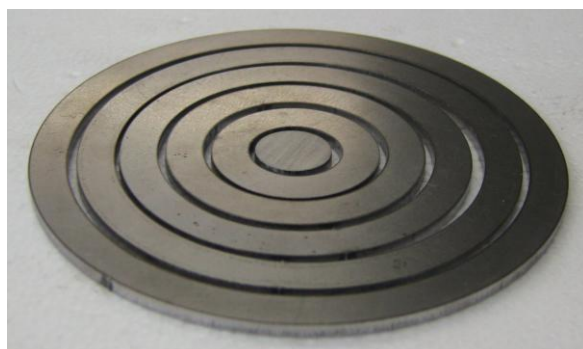
**Steel cut into concentric rings**

**Figure 3. Divided steel plates in circular form**

In this study, the method of using divided steel plates was further refined. Divided steel plates in circular form were developed and fabricated. It was fabricated by using an assembly of 5 concentric steel rings around a circular plate as the common center (Figure 3). The rings and center plate follow the Steel Structure 400 (SS400) conforming to the Japanese Industrial Standard (JIS G 3101) specification. Each steel element was chemically cleaned by sequentially soaking it in 10% diammonium hydrogen citrate bath for 24 hours, rinsing in pure water and finally drying in an air tight container filled with moisture absorbing silica gels. After drying, each steel element was soldered with lead wires and then bonded with the other steel elements using slow curing epoxy having a spacing of 0.17cm forming a 12.5cm circular divided steel plate as shown in Figure 4. The lead wires were then interconnected to each other, and by doing so, all the divided steel elements became interconnected to one another thus acting as a unit steel plate. For comparison purposes, undivided circular steel plates, following the same grade and specification, were prepared as well.

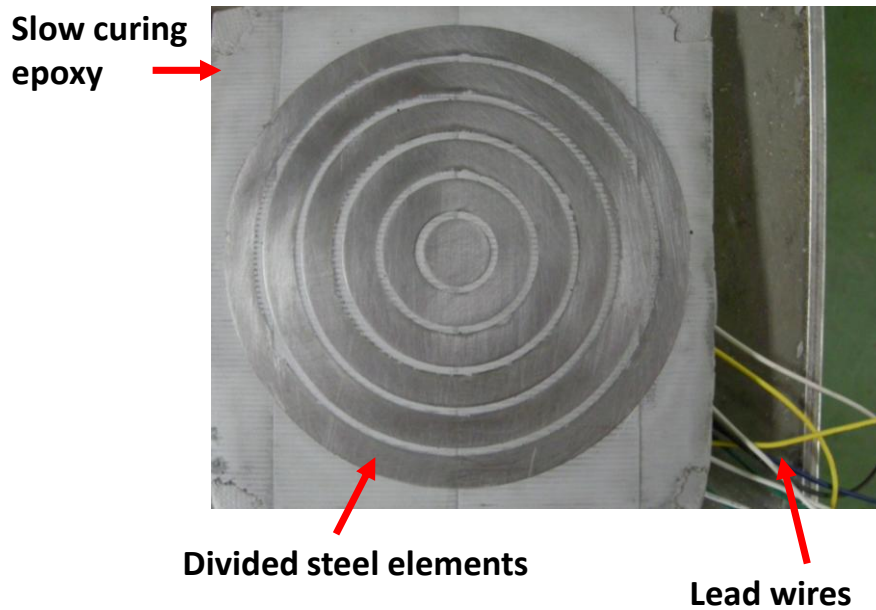
**Figure 4. Circular divided steel plates bonded in epoxy**

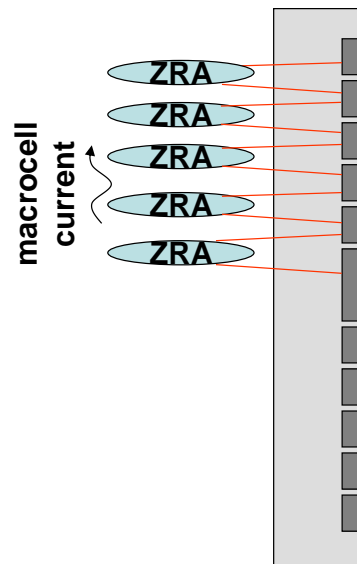
Divided steel plate in section view

Figure 5. Illustration of measurement of macrocell corrosion current

The macrocell corrosion current flowing between the steel elements of the divided steel plates was measured using zero resistance ammeters (ZRA). The measurement set-up is illustrated schematically in Figure 5. The lead wires of each steel element were first temporarily disconnected from each other. Zero resistance ammeters were then connected to the lead wires thus effectively reuniting all the steel elements together as single circular plate. The actual test procedure is shown in Figure 6.

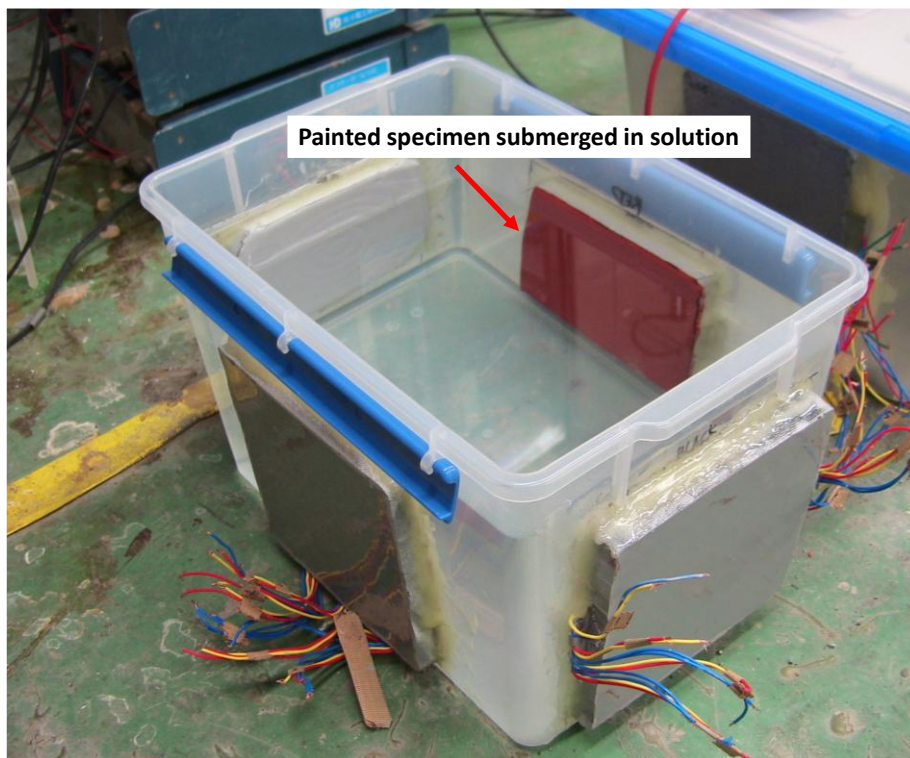
Figure 6. Submersion of painted steel plates in artificial sea water

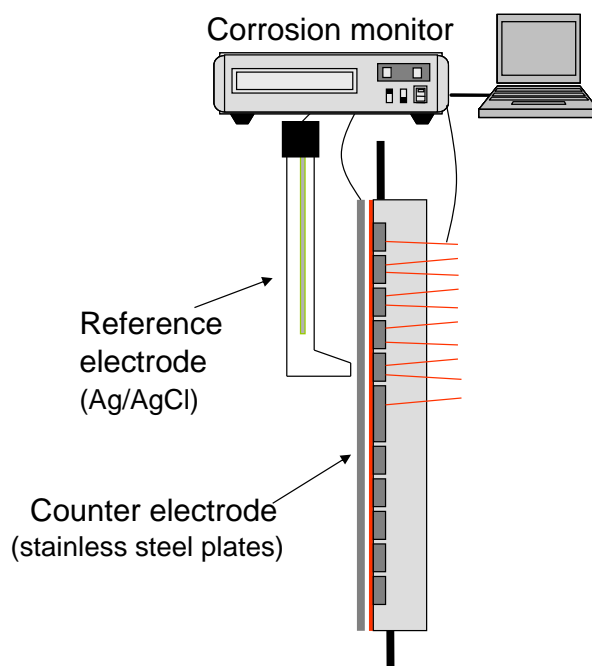
**Figure 7. Measurement of halfcell potential and microcell corrosion current**

The halfcell potential and polarization resistance of all steel elements were monitored periodically using the three electrode cell setup of the AC impedance corrosion monitor (Riken Denshi Corrosion Monitor-CT7). The reference electrode used was Ag/AgCl while a stainless steel plate was used as the counter electrode. The measurement setup is shown in Figure 7. The lead wires of each steel element were temporarily disconnected from each other. For every measurement, one wire is connected to the corrosion monitor to act as the working electrode. Therefore divided steel plates basically allow one to control which steel element will serve as the working electrode for examination while the assembly is being submerged in the bulk solution. After each steel element has been used as the working electrode in each measurement, the lead wires were once again interconnected.

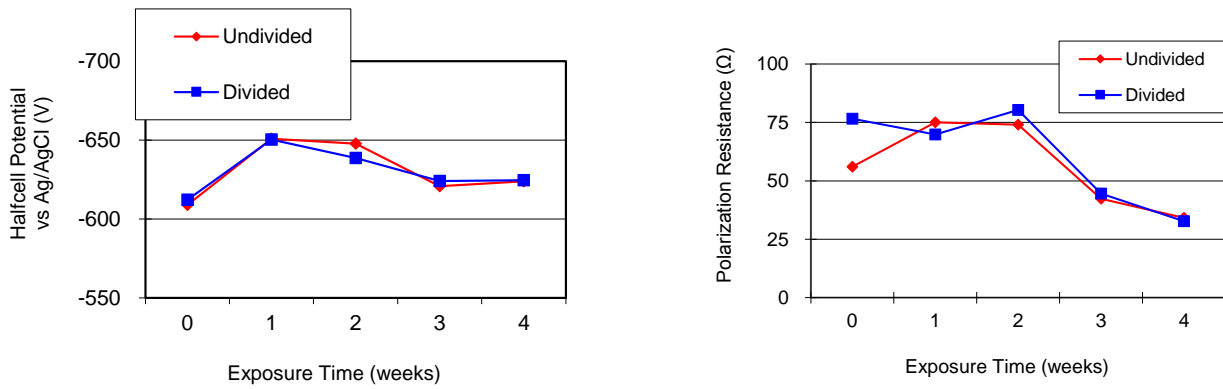
Figure 8. Halfcell potential and polarization resistance of divided and undivided steel plates

The results of the monitoring of the halfcell potential and polarization resistance of the bare or uncoated divided and undivided steel plates for a period of 4 weeks are shown in Figure 8. The results confirm that the trend of halfcell potential and polarization resistance of the divided steel plate is very similar to that of the undivided form especially at the later stages of exposure. This indicates that a divided steel plate has the capacity to act as an undivided steel plate by showing similar polarization behavior. This finding is important because it becomes possible to measure the macrocell corrosion current between two separate areas of a steel plate using zero resistance ammeter as the measuring instrument. Thus in this study, measurement of macrocell corrosion for coated steel plates proceeded.

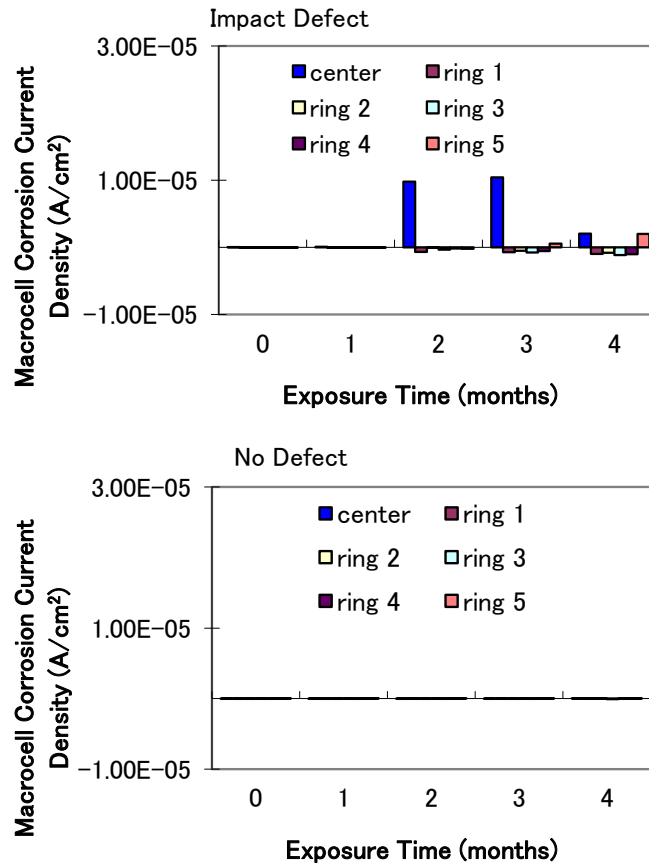
Figure 9. Macrocell corrosion current densities

The influence of impact defect on steel plates coated with oil alkyd paint was assessed by measuring the macrocell and microcell corrosion current density at the defect part and at the sound parts through the use of divided steel plates. The results of the investigation of macrocell corrosion current density are presented in Figure 9. It was confirmed that macrocell corrosion occurred between the steel element with impact defect and the steel elements with sound coating. The center steel element with impact defect acted as the anode while the rest of the surrounding sound steel ring elements all acted as cathode. However, this was not the case for all steel elements throughout the duration of the four month exposure period. The steel element labeled as “ring 5” acted as cathode from 0 to 2 months exposure period. But during the third and fourth month exposure period, it acted as anode. This shift in polarity can be explained by the fact that during the first two months of exposure, as ring 5 underwent cathodic reaction, its coating may have experienced early loss of bonding from the steel substrate [8]. By the third month exposure period, the coating may have degraded and ruptured leaving ring 5 with no protection at all. At this point, the center steel element and ring 5 become the anodic elements in the macrocell corrosion process.

In the case of the divided steel plates without impact defect, it was observed that there was no macrocell corrosion that occurred even until the 4<sup>th</sup> month exposure time. Therefore it can be deduced that impact defect can be a cause of macrocell corrosion and therefore its occurrence should be prevented as much as possible.

In this study, the relationship between macrocell and microcell corrosion can also be seen. In Figure 10, the microcell corrosion at the outer rings gradually increased with time. For the same period of time, the macrocell corrosion for the said rings also gradually increased (Figure 9). The reason for this is that the coating on the outer rings degraded due to cathodic reaction during macrocell corrosion process. During this process, the defect area at the center ring acted as the anode while the outer rings acted as cathode. Consequently, this process led to the degradation of the coating in the outer rings that eventually paved way for the gradual increase in the microcell corrosion. The same finding was discussed in the study of Nishida, Otsuki, Annaka and Wada. [9].

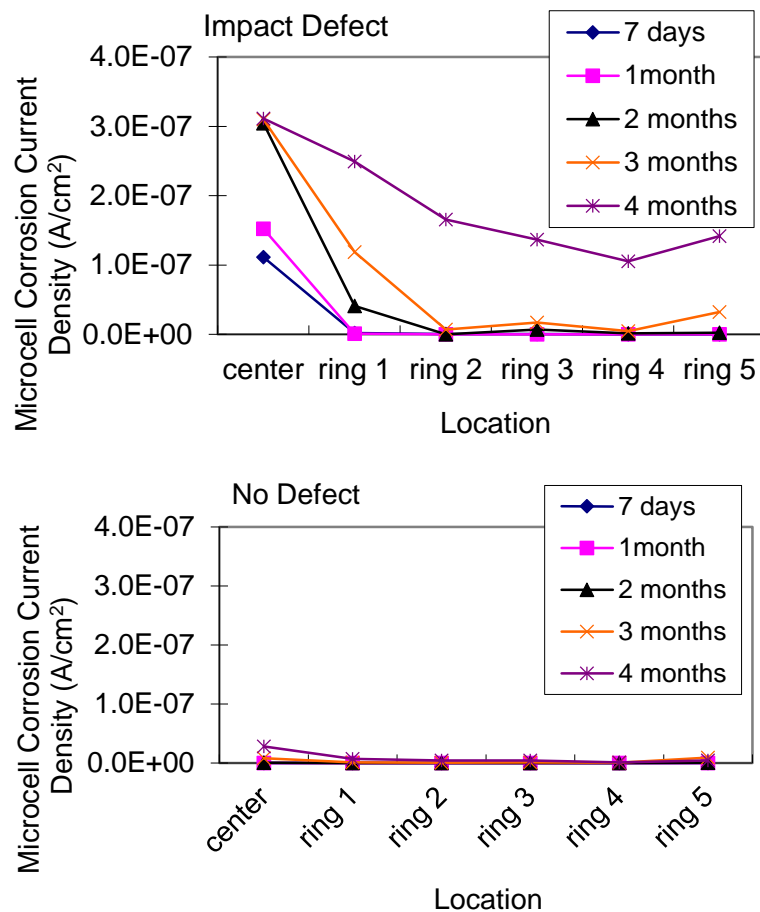
Figure 10. Microcell corrosion current densities

The results of the microcell current density tests in oil alkyd coated steel plates are shown in Figure 10. It was confirmed that the microcell current density at the steel element with impact defect is much higher than the surrounding steel elements with sound coating. It was observed that the microcell current density of the steel elements with sound coating increased with time. This indicates that polarization resistance of the steel plate decreased as the corrosion activity underneath the coating increased.

In the case of the coated steel plate specimens without impact defect, the microcell current density values at the sound coated steel rings were lower throughout the 4 month exposure time compared to the specimens induced with impact defect. This confirms that in coated steel plates, the impact defect can influence the corrosion resistance of its neighboring sound portions by causing a reduction in their polarization resistance thus causing the increase in their microcell current densities.
