Effect of Soil Types on the Development of Water Levels and Erosion Processes during Overtopping Test

Marwan Adil Hassan ^a, Mohd Ashraf Mohamad Ismail ^{b*}

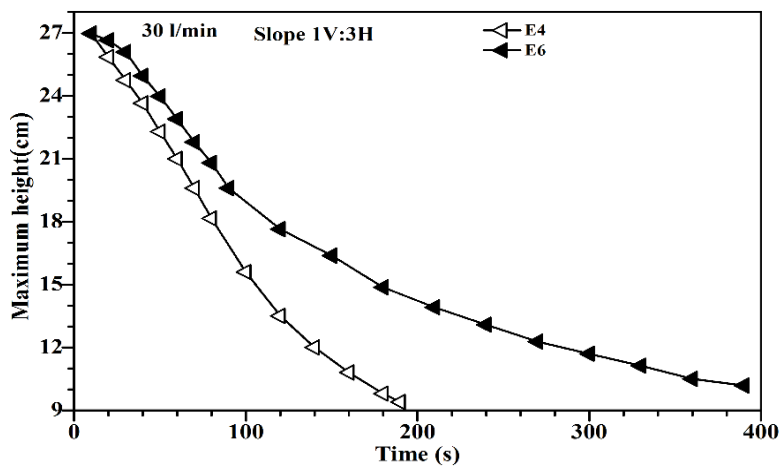
Figure 12. Comparison results of reduction dike heights inside the pilot channel

Figure 12 shows the comparison between the results of vertical erosion process for E4 and E6. The slight reduction of dike height is occurred at the beginning of breach failure initiation at $t = 20$ seconds with dike heights of 25.85 and 26.65 cm for E4 and E6, respectively. This is due to the higher matric suction in soil layers below dike crest while the velocity of infiltration water is still slow to overcome the shear strength of particles. The slope failure occurred near the dike crest in E4 while it occurred near the toe of downstream slope in E6. Increasing the water velocity above the downstream slope leads to lowering dike height into 18.16 and 20.8 cm for E4 and E6, respectively at $t = 80$ seconds. Soils with a high proportion of sands increase the materials erodibility while the rate of breach channel failure is tended to decrease with a high amount of fine sands in E6. The silt and clay particles absorb water content and thus decrease the availability of water volume to initiate gully erosion. For E6, The dike slope instability resulted in steepness slope in which the breach failure mechanism is developed into headcut failures. The latter failure imposed erosive forces on the toe of the downstream slope that increases the erodibility of dike materials along the flume channel. The noticeable failure of dike slope for E4 is observed in the upper part of the downstream slope and then developed gradually into the lower part. Steepness slope has occurred similar to that occurred in E6 in which the majority of the transition area between downstream and upstream slopes and area of the upstream slope are highly eroded. The majority of the upstream slope are eroded at $t = 160$ and 300 seconds with dikes height of 10.81 and 11.7 cm, respectively. The breach channel slope, for both soils, is becoming gentler during the progressive erosion process in upstream slope and gradually remained constant through the rest of breach failure in which the materials erodibility is no longer effect on dike construction. Comparisons between E4 and E6 show the differences between the rates of erosion process with particles. The very silty sand soil is more resistance against vertical erosion failure in which it lasted until $t = 390$ seconds.

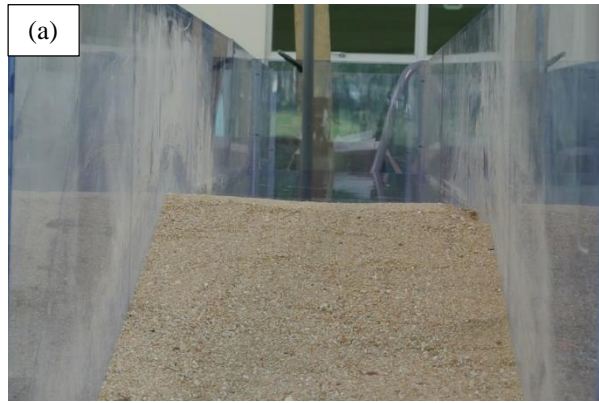
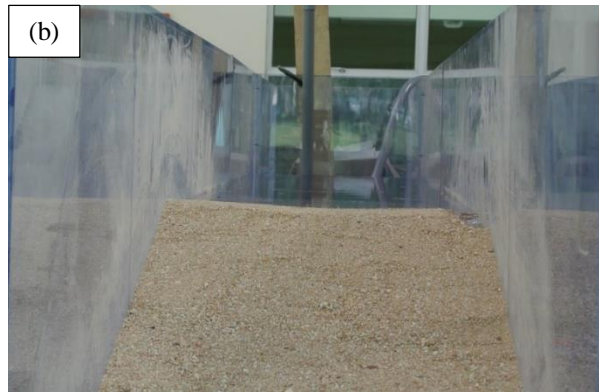
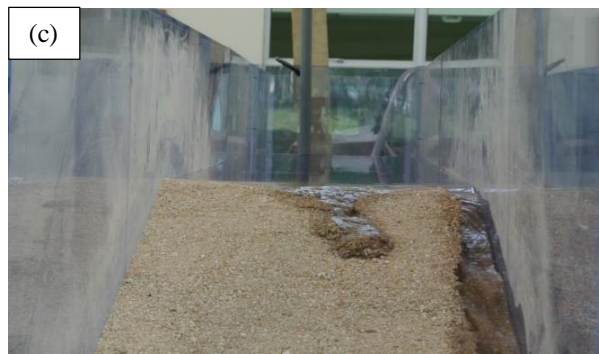
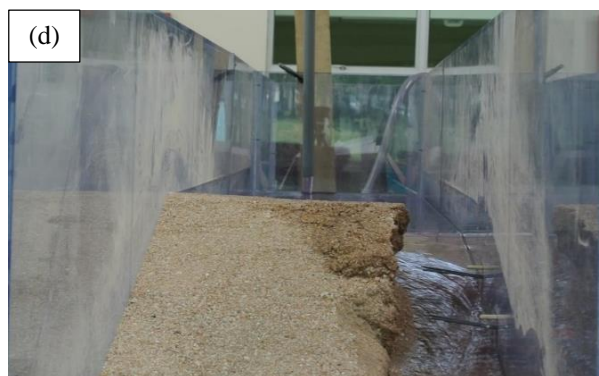
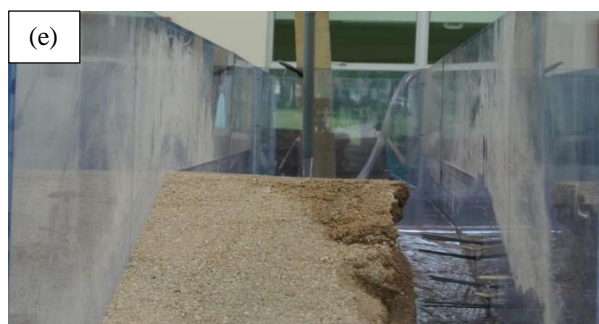
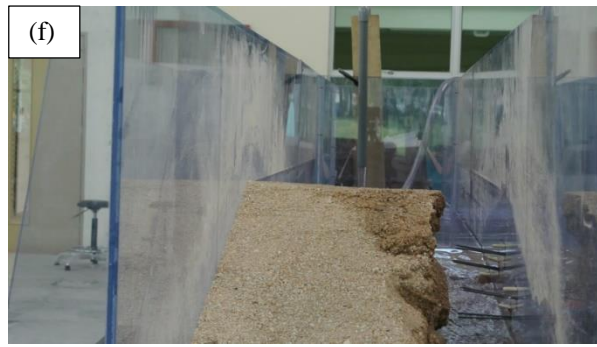
Figure 13. The development of horizontal erosion process due to overtopping failure: (a) Zero seconds; (b) 20 seconds; (c) 50 seconds; (d) 100 seconds; (e) 150 seconds and (f) 190 seconds

Figure 13 shows the development of horizontal erosion process due to overtopping failure that captured through camera-video system installed in front of downstream slope. Similar to vertical erosion process, the measurements for the horizontal erosion started from the flow cross the dike crest and ends until the erodibility process of dike materials is stabilized. Figures 14 and 15 show the horizontal erosion process for E4 and E6, respectively. The reduction of dike width is plotted against the horizontal distance of dike construction. The velocity of horizontal erosion is less compared with vertical erosion in the beginning of water cross above pilot channel until the toe of the downstream slope. For both soils, the beginning of noticeable reductions of dikes widths have occurred when the vertical erosion process started to erode the lower part of the downstream slope. This is due to the quick saturation of dike soil below dike crest that accelerates the vertical erosion process. The shear stress of flow water is increased in vertical erosion compared with horizontal erosion and increased the erodibility rate. The reduction of dikes width is small at $t = 10$ and 20 seconds for E4 and E6 due to higher suction with soil particles. The breach channel failure is started to develop laterally at $t = 30$ and 40 seconds for E4 and E6, respectively in which the top and toe sections are rapidly eroded compared with the middle of dike embankment. Nevertheless, the proportion of width reduction is higher in E4 compared with E6 because of higher water content absorption with particles in the latter. The vertical slope of breach channel is saturated in the horizontal direction and thus overcome the tensile stress of soil particles; consequently, large slope material is eroded along the bed of flume channel at $t = 50$ and 70 seconds for E4 and E6, respectively. The enlargement of breach channel is continued till the upstream slope due to the continuous saturation of vertical slopes on downstream, upstream slopes as well as the transition area between the downstream and upstream slopes at $t = 70$ and 120 seconds for E4 and E6, respectively. Most of the dikes widths are eroded at $t = 190$ and 390 seconds, for E4 and E6, respectively in which the horizontal and vertical erosion processes are no longer effect on dike stability.

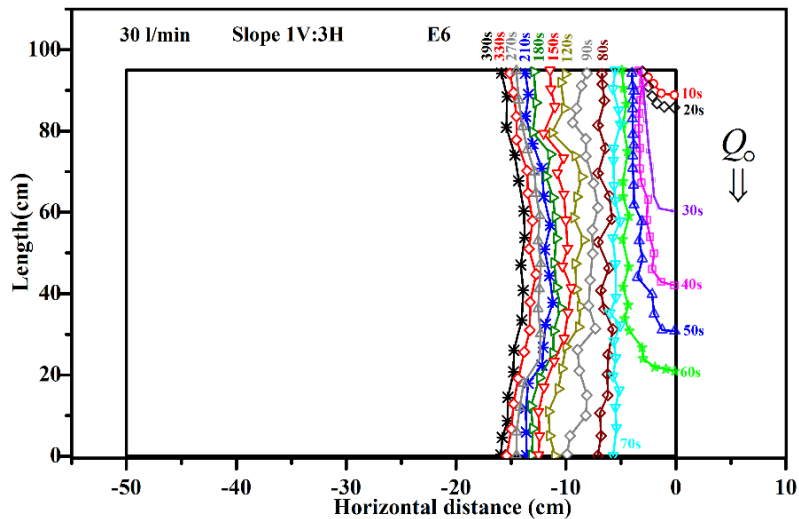
Figure 15. Reduction of dike width due to lateral erosion process for E6
