Plum Run Stream Organism Survey

Plum Run and its Watershed: A Short Course in Stream Ecology

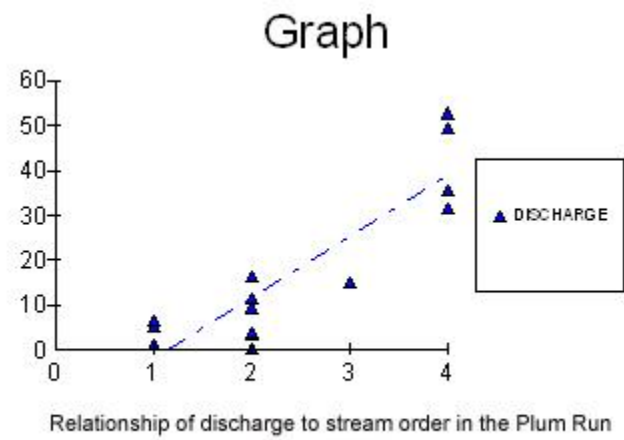
L/sec. Figure 5 is a chart showing the 14 relationship between stream order and the discharge

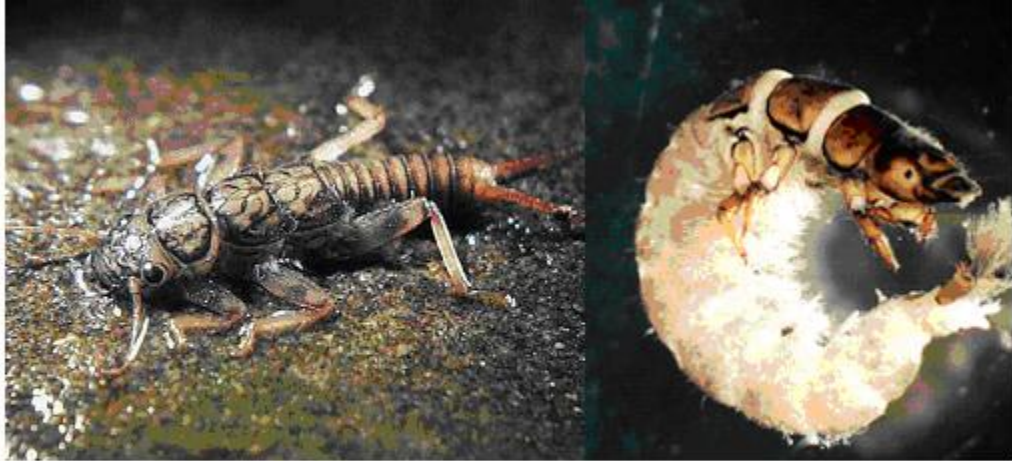
directly or indirectly to both the physical habitat and to water chemistry. “Bioassessment” of the numbers and kinds of species present can thus provide a valuable indication of environmental degradation at a site. For example, aquatic insects such as stonefly larvae (shown in Figure 7a), require cool water, and are likely to be found only in smaller (e.g., first order) stream segments surrounded by trees that shade the stream and maintain cool water temperatures. Cooler water also holds more oxygen, often required by invertebrates found in shallow streams. Most net-spinning caddisfly larvae (Figure 7b) are more tolerant of warmer water and are more typical of larger downstream sites.

Fig. 7 a-b. Images of (a) a stonefly larva (<http://www.nps.gov/olym/insect/plecoptera.htm>) and (b) a net-spinning caddisfly larva (<http://www.csuchico.edu>).

To find out where individuals of the stonefly family Leuctridae were abundant in the Plum Run stream network, ask the question regarding its occurrence. To do so, refer to the sites data table below. Find the column heading “LEU” and look for those sampling sites (the ID column) where “LEU” is larger than 100. Site 2 contains more than 100 individuals of the stonefly family Leuctridae [highlighted in light blue in this map](#). Based on the table below, what [stream order](#) is Site 2? Based on [pictures](#) of Site 2 what kind of vegetation surrounds the stream segment? It may not surprise you that a principal diet of these stonefly larvae is leaves that fall into the stream from the surrounding trees. To further test your understanding of invertebrate occurrence, determine which three sites have in excess of 100 individuals of the pollution-tolerant net-spinning caddisfly larvae (column: HYD). Where do these [sites occur](#) within the stream network? .

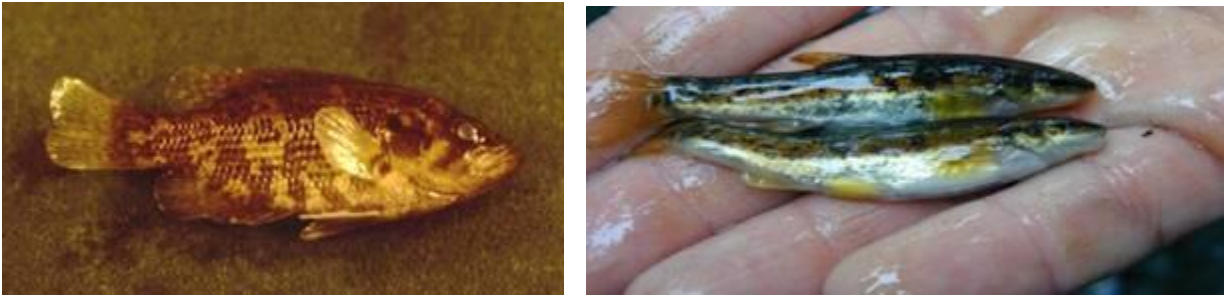
example, most species of the family Centrarchidae (bass and sunfish) in Plum Run are confined to larger pools near the mouth of Plum Run, and actually leave Plum Run for the larger Brandywine Creek during winter. Rock bass (Fig. 8a) are found further upstream further than other centrarchids. To observe its distribution, view the [map](#) of the locations of sites with Rock bass (blue dots). How far up into the watershed does its distribution extend?

Fig.8a-b. Pictures of (a) Rock Bass and (b) Black Nose Dace.

By contrast, many of the smaller minnow species (family Cyprinidae) such as Blacknose Dace (Fig. 8b) are year-round residents. View the [distribution](#) map for the Black Nose Dace. At which sites is it NOT present?
