Plum Run Restoration of the Culvert in the Gordon Natural Area

by Israel Berrios, Katie Walston and Kristen Koller

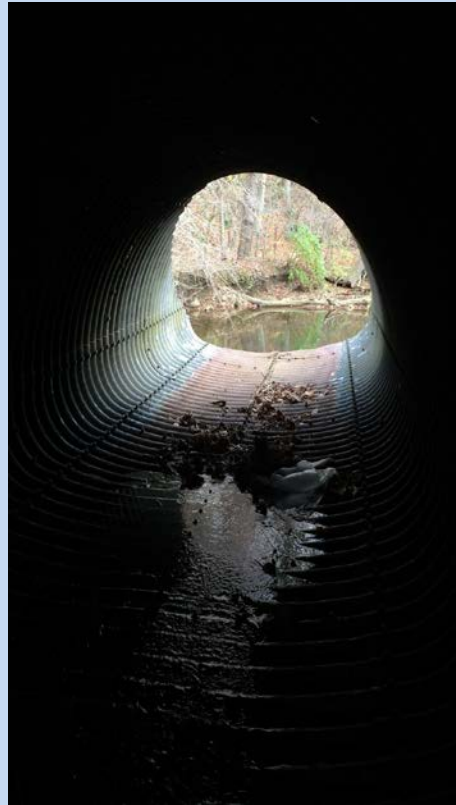
Problem: Culvert

- The water flows around and under the culvert rather than through it
- Connectivity is greatly reduced
- Discharge has decreased (the culvert acts as a dam, which is not the original purpose)
- Only during heavy rain events is water level high enough to flow through

Taking out the corrugated round culvert (A) and replacing it with a structural plate-arch (C).

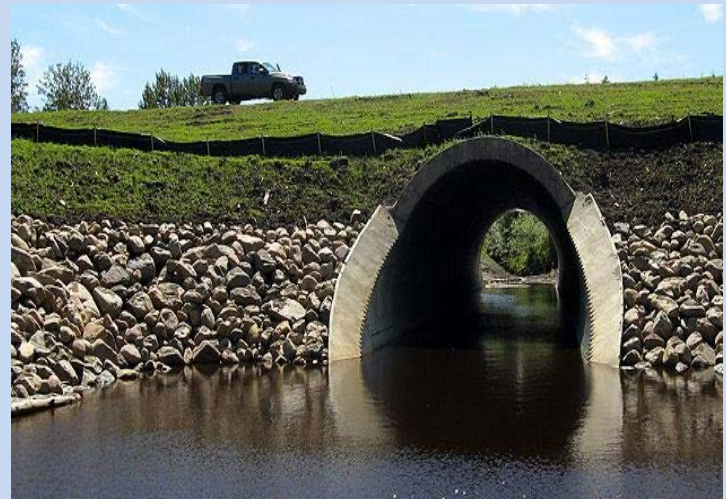
Benefits to Using a Structural Plate Arch

- Natural streambed is left mostly unchanged so there are no issues with water flowing under or around the culvert
- Little to no significant change to water velocity so sediment deposition won't be that big of an issue on the inlet end of the culvert
