## Heritage Stone 1. Repair and Maintenance of Natural Stone in Historical Structures: The Potential Role of the IUGS Global Heritage Stone Initiative\*

Dolores Pereira<sup>1</sup> and Brian R. Marker<sup>2</sup>

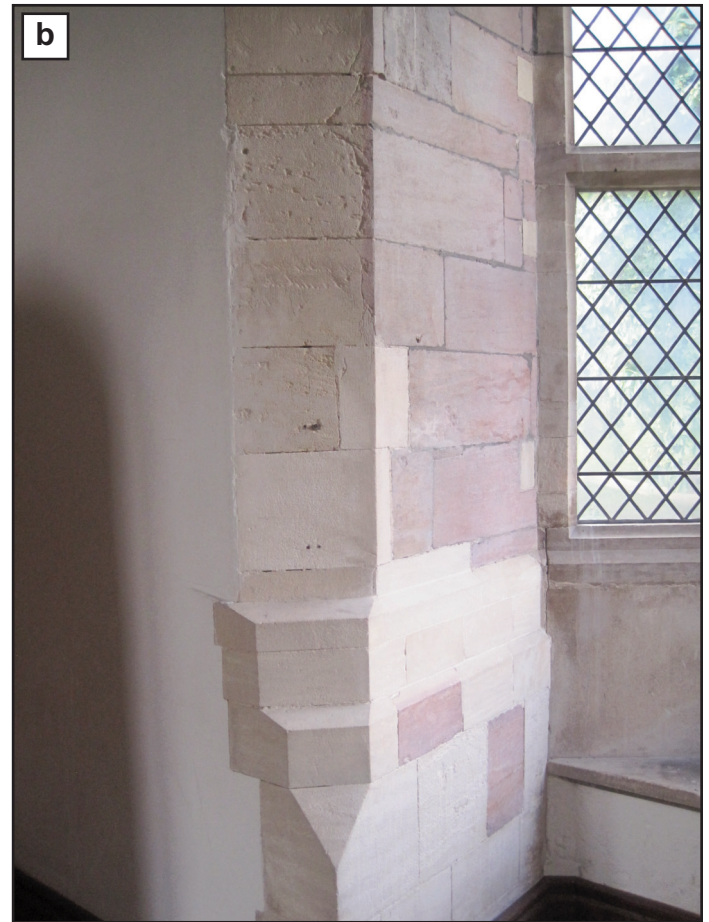
**Figure 4.** Examples of controversial or poor practices of stone usage. a) Queen Elizabeth II Courtyard, British Museum, London; b) contrasting replacement of stone in the interior of the Lincoln Cathedral, and c) replacement with stone of a different colour disrupting the original colour pattern in the exterior of the cathedral, Chipping Norton, Oxfordshire.

The British Museum was founded in 1753 as the world's first national public museum. The present building on the site was constructed in stages between the 1820s and 1850s using granite for the base courses and *Portland Stone* (Tithonian, Upper Jurassic) for the main body of the structure ([http://www.britishmuseum.org/about\\_us/the\\_museums\\_story](http://www.britishmuseum.org/about_us/the_museums_story)). In 2000, an internal courtyard was roofed over to form the Queen Elizabeth II Great Court, expanding visitor space by some 40%. The original Ionic portico of the courtyard had been demolished in the late 19<sup>th</sup> century. It was to be replaced (Fig. 4a) and the specification stated that the work should use 'stone from Portland.' In the event, Middle Jurassic stone imported from France (via Portland) was used, causing a major controversy in which some people considered that the stone was inappropriate while others praised the major architectural achievement ([www.theguardian.com/the\\_observor/2000/nov/12/2](http://www.theguardian.com/the_observor/2000/nov/12/2)). The colour and texture do not match and, since this part of the building is sheltered from weathering, the contrast is unlikely to decrease over time. This illustrates the importance of precise specification of stone but also raises the question of whether some changes should be allowed for architectural reasons.

rent repair and maintenance work employs appropriate stone but the building shows evidence of 19<sup>th</sup> and early 20<sup>th</sup> century interior work that is aesthetically unpleasing. Parts of the interior walling were originally built with red sandstone (Triassic) but some repairs were made with white limestone (Lincolnshire Limestone; Bajocian, Middle Jurassic) (Ashton 1980), of a type used extensively elsewhere in the cathedral. This resulted in an irregular patchwork of contrasting colours (Fig. 4b) that some consider undesirable.

Many buildings in the town of Chipping Norton date from the 18<sup>th</sup> century and were constructed mainly with *Hornton Stone* (bioclastic ferruginous limestone; Pleinsbachian–Toarcian, Lower Jurassic). This stone is susceptible to spalling. Chipping Norton Limestone (oolitic limestone; Bajocian, Middle Jurassic) (Horton and Edmonds 1987; Radley 2003, 2009) was used for detailing around windows in the structure illustrated in Figure 4c, providing a pleasing contrast. That colour pattern was disrupted by later repairs that used Middle Jurassic limestone in place of some of the darker Hornton Stone (Fig. 4c); the result is not likely to become visually compatible even after a period of weathering.

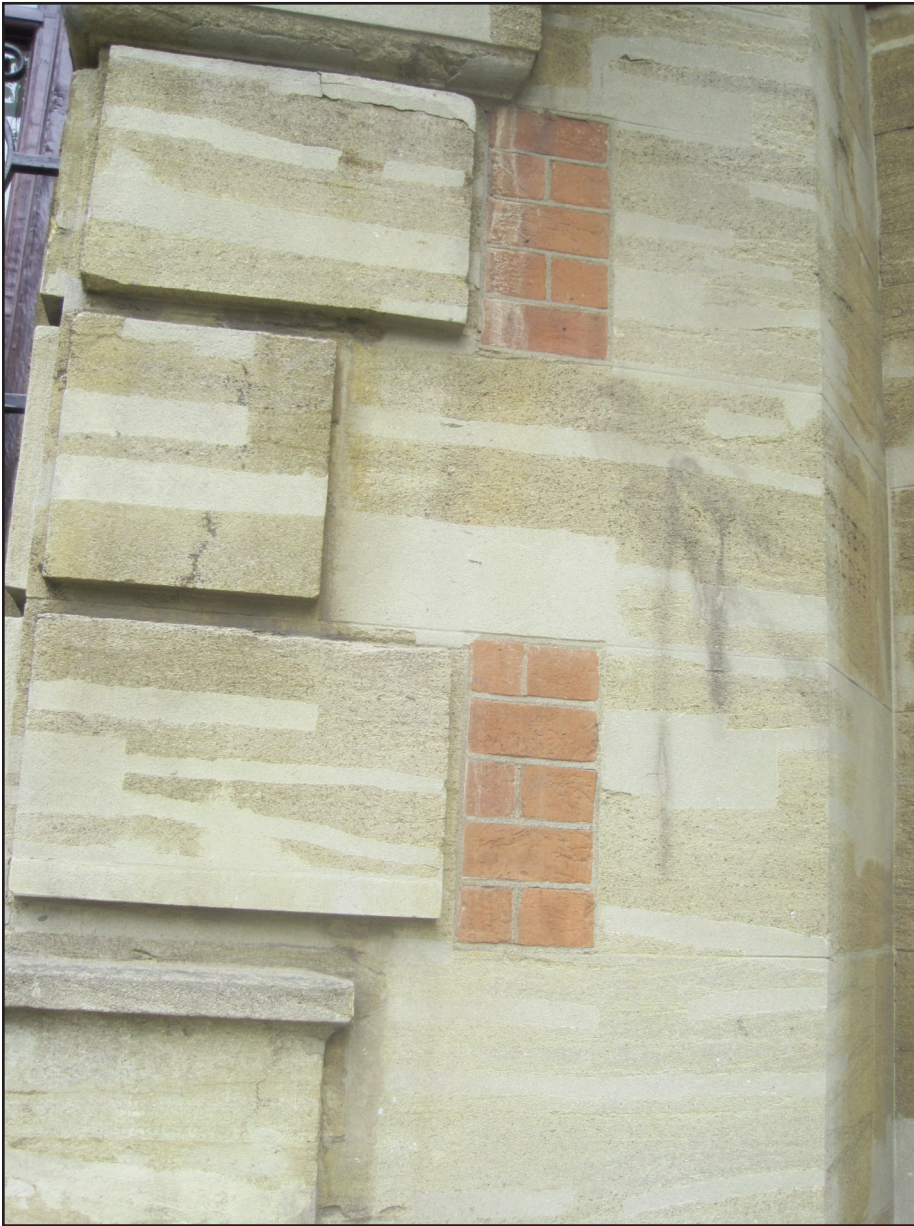
**Figure 7.** Part of the façade of a bank in Hampstead, London, showing inappropriate use of cement and brick in repairs to Douling Stone.

observed at the front of a bank in Hampstead, London. The façade was constructed with *Doulting Stone* from Avon (crinoidal biosparite; Bajocian, Middle Jurassic), which contains numerous large *Thalassinoides* burrows (Richardson 1915). The infilled burrows are more porous than the body of the rock, and weather more quickly. During ‘repair,’ the hollows associated with these burrows were simply cemented over but some red bricks were also used to replace seriously weathered stone blocks, producing a poor visual result (Fig. 7). While this is a minor building, these repairs detract from the late 19<sup>th</sup> century terrace of which it is a part.
