# Mirrors of the Architectural Moment: Some Comments on the Use of Historical Photographs as Primary Sources in Architectural History\*

Martin Segger

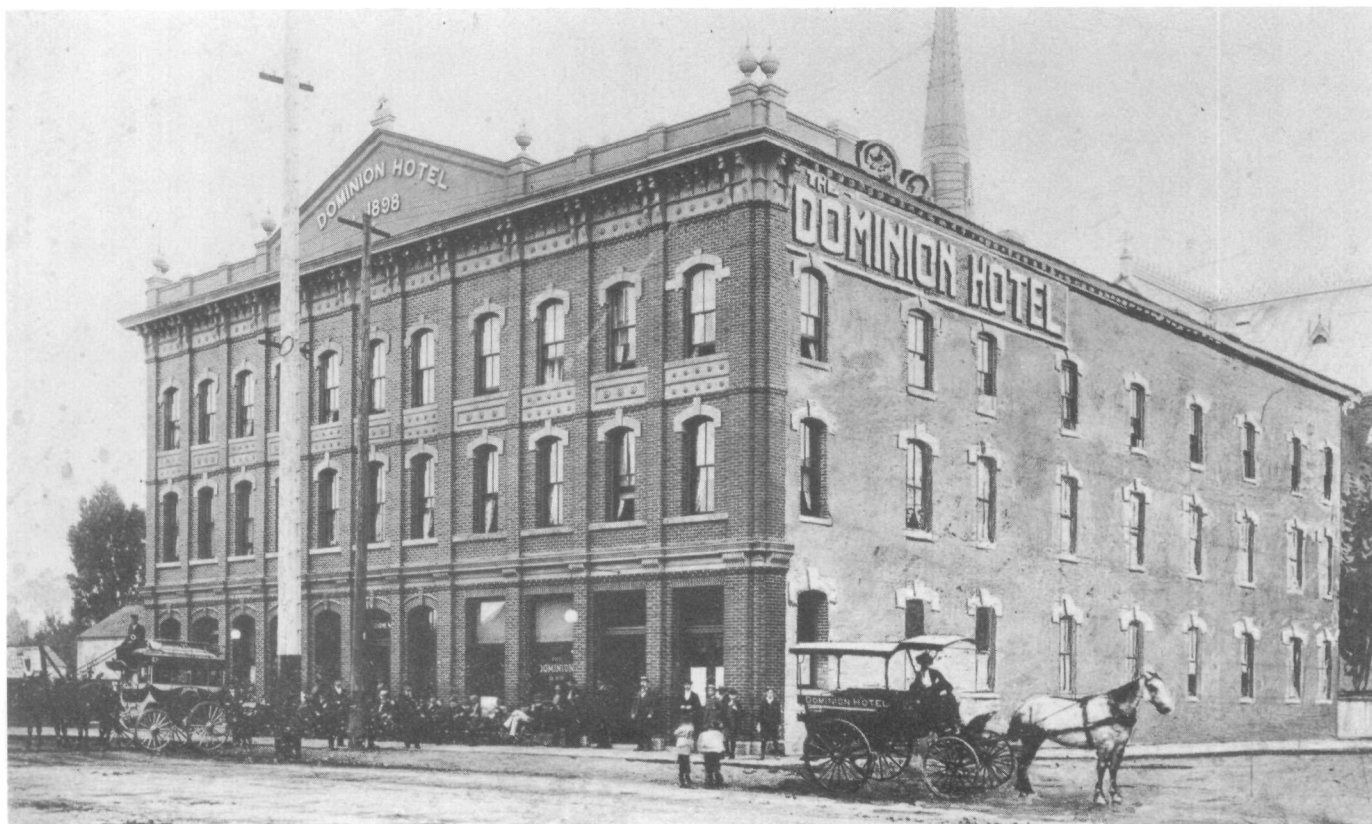
Fig. 1. Dominion Hotel, Victoria, ca. 1898. This heavily retouched photograph reveals extensive “improvements” on the evidence. The receding cornice line on the façade to the right has been painted in, and an architectural embellishment to the parapet above added or enhanced. The name of the hotel has been crudely emphasized or completely painted in. The brick wall of that façade has been over painted, and the lower two courses of windows may have been completely invented, except for those adjacent to the front façade. A tree and fence have been added along with the sidewalk on the far right. Even the horse and carriage look suspicious, and at least one utility pole has probably been removed. This photograph may have been intended for reproduction in a city directory or promotional handbill. (Photo: Provincial Archives of British Columbia [PABC], no. 68358.)

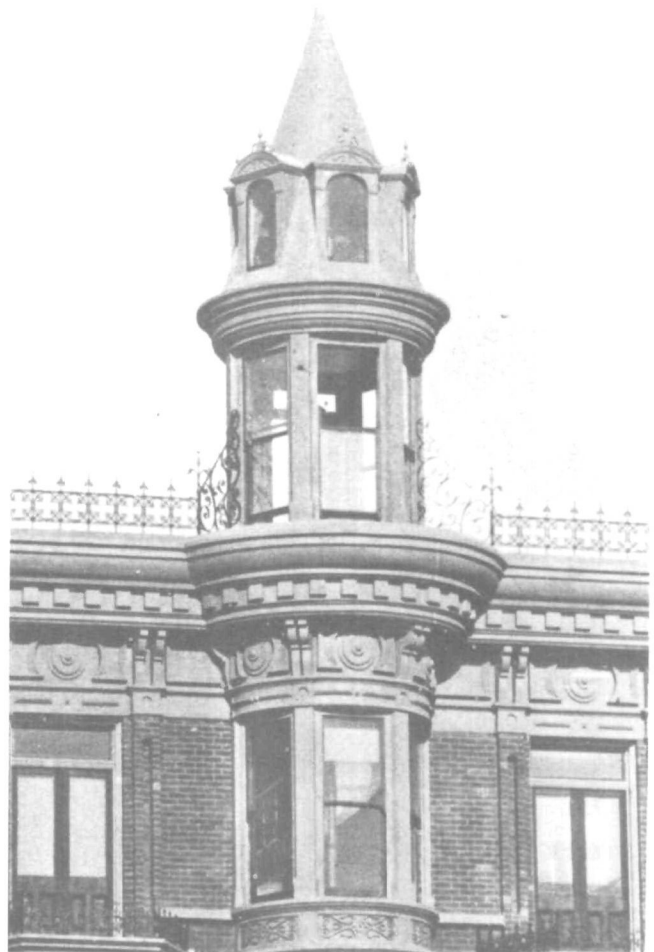
Fig. 3. Detail of R. Maynard's photograph of Hotel Dallas, by P. Graham.

Photographs taken during construction yield extensive information, not only as to the first result of the architect's and builders' efforts allowing direct comparison to contract and plans, but also as to building practices. Here note the scaffolding and treatment of debris in the foreground. The crew poses on the sidewalk, providing a scale for the size of the structure. Resolution is such that enlargement details expose through the windows views of light fixtures and baluster profiles of the central stairwell leading to the tower. Open sashes in the tower suggest through-stairshaft air circulation and venting. The photograph was probably commissioned by the contractor.

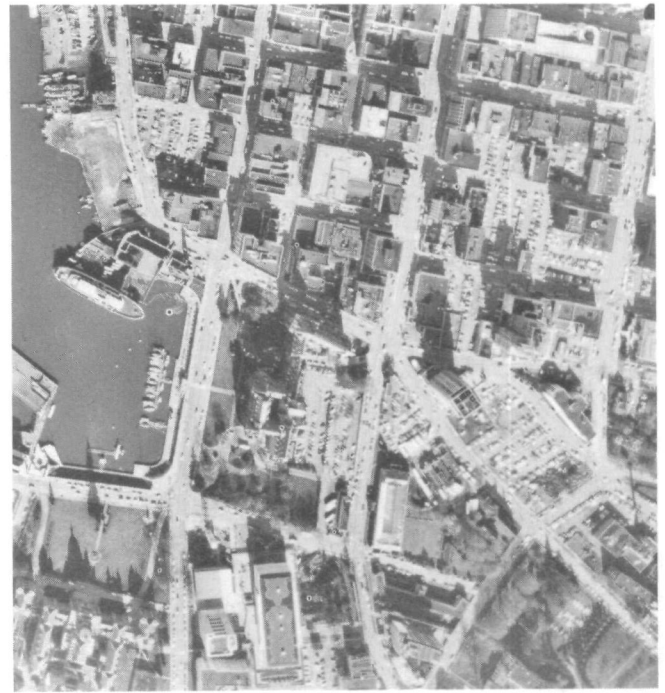
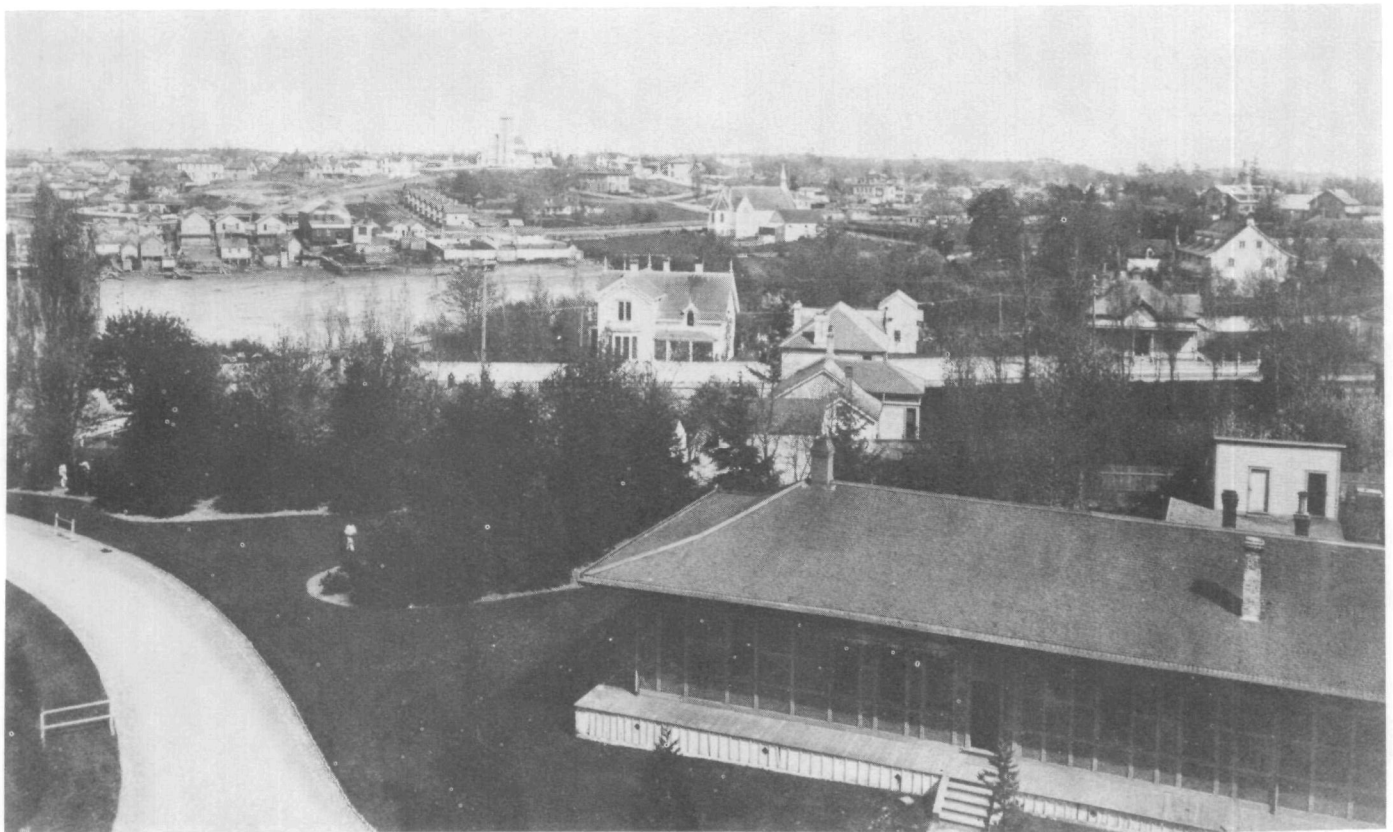
Fig. 4. Aerial photograph, Victoria. (Photo: BC 5568 9215, City of Victoria.)

Fig. 5. View from the tower of the Colonial Administration Building, Victoria, by R. Maynard, ca. 1880. (Photo: PABC, no. 85956.)

Only a few constant landmarks – the rise of Church Hill, the churches themselves, and an institutional building such as the convent school – remain to assist the historian transpose building locations from this early panorama to a modern aerial photo where even major geographical features such as the James Bay shoreline (filled in for the Empress Hotel) have changed beyond recognition.

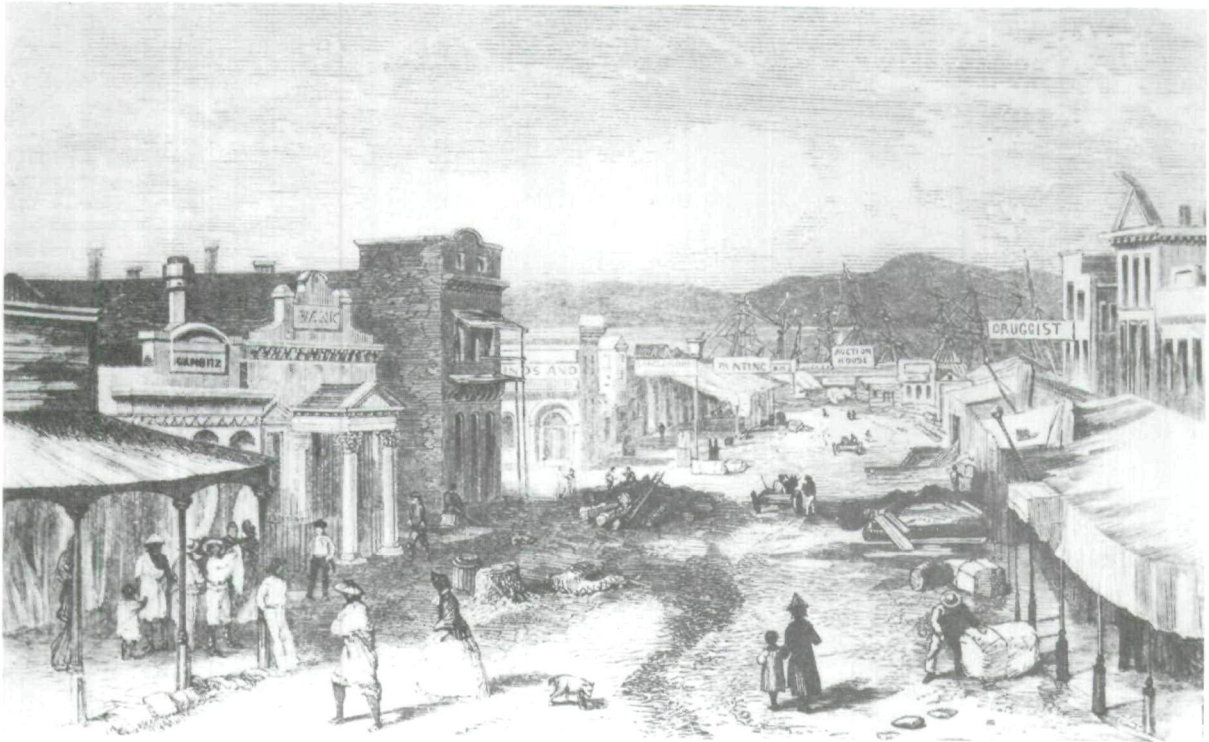
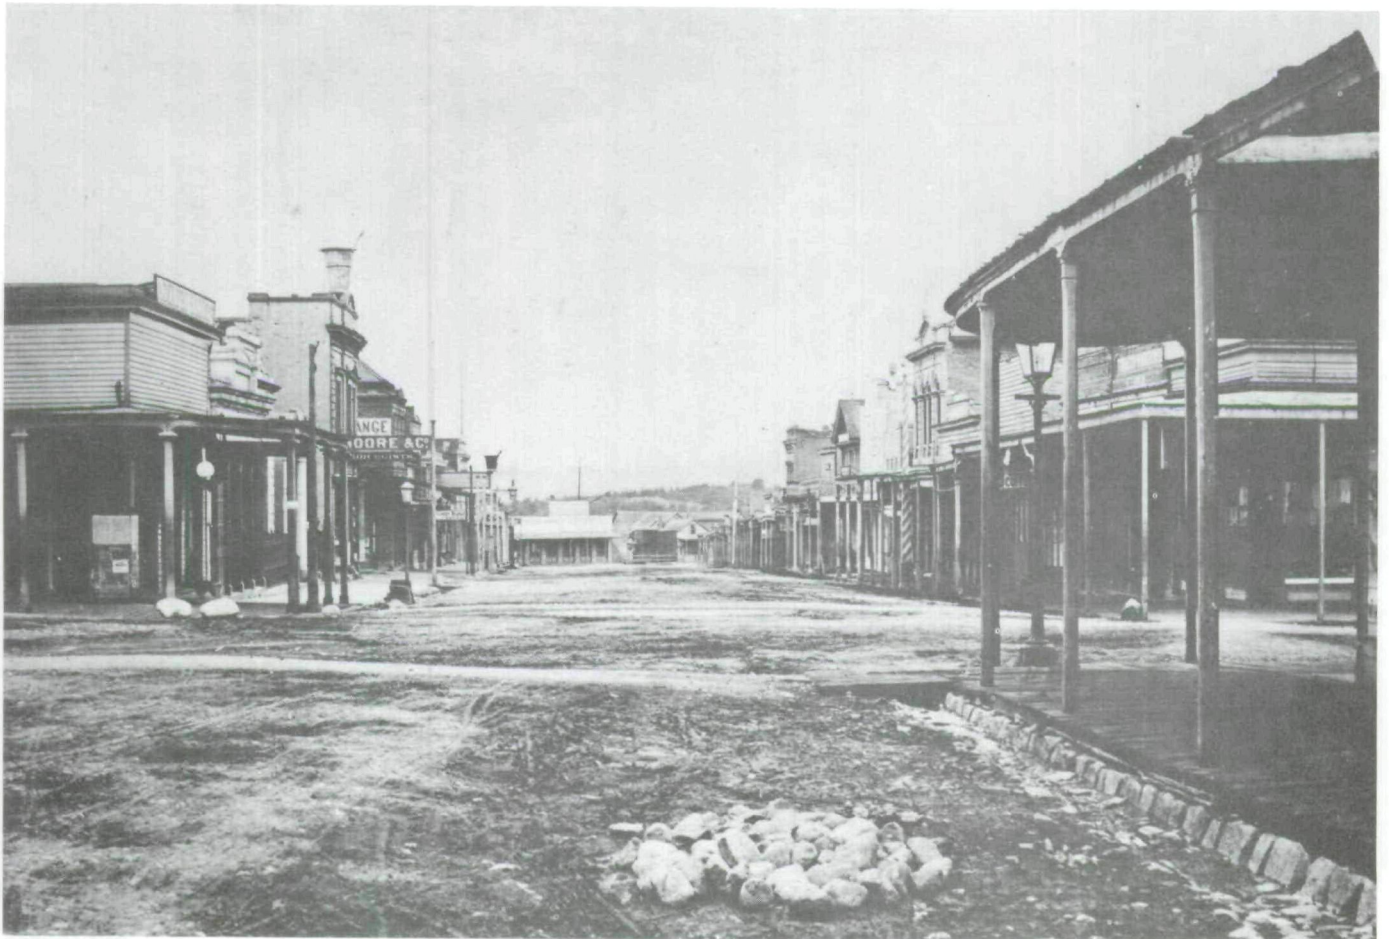
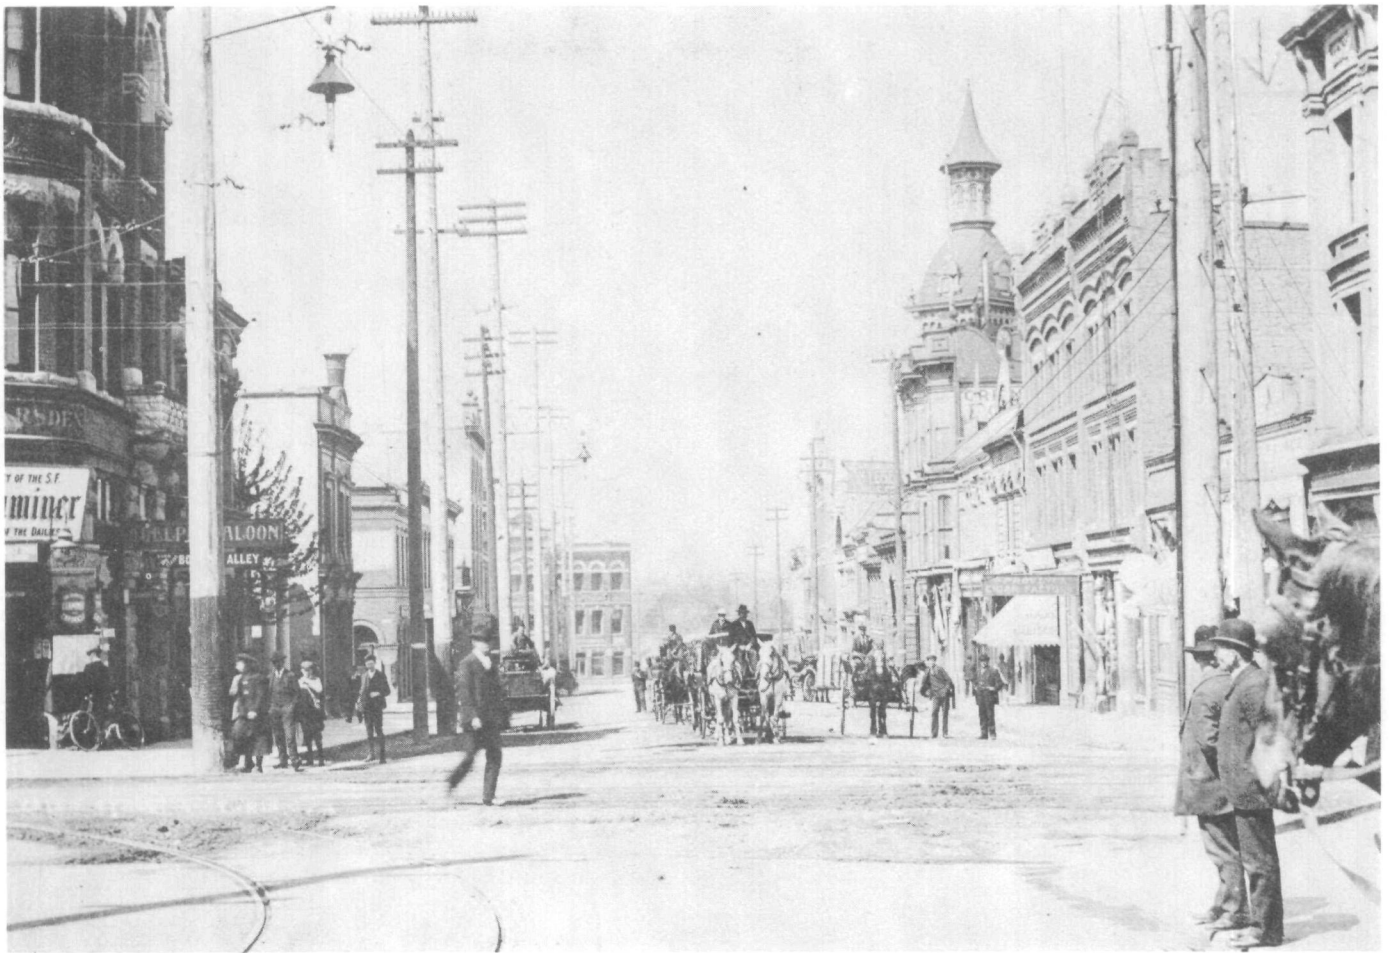
Fig. 6. Yates Street, Victoria, ca. 1862. From an etching. (Photo: PABC, no. 22527.)

Fig. 7. Yates Street, Victoria, ca. 1865. (Photo: PABC, no. 3712.)

Fig. 8. Yates Street, Victoria, ca. 1895. (Photo: PABC, no. 23891.)

Two near-contemporary records, print and photograph, allow a visual check on the artistic licence and scenic romanticizing found in the former. Features such as the pestle and mortar of the druggist and façade details such as verandah posts and cornice lines provide clues for comparisons. The photograph, however, lacks street life, a colourful social *ambiance* provided by the figures in the print. It is possible again to transpose a few of the 1860s structures to the 1890 near-identical view. Here, however, gas lamps have given way to a forest of electrical services, as well as drains and streetcar tracks. The street is again alive, indicating developments in photographic technique rather than improvement in the city's social and economic life.

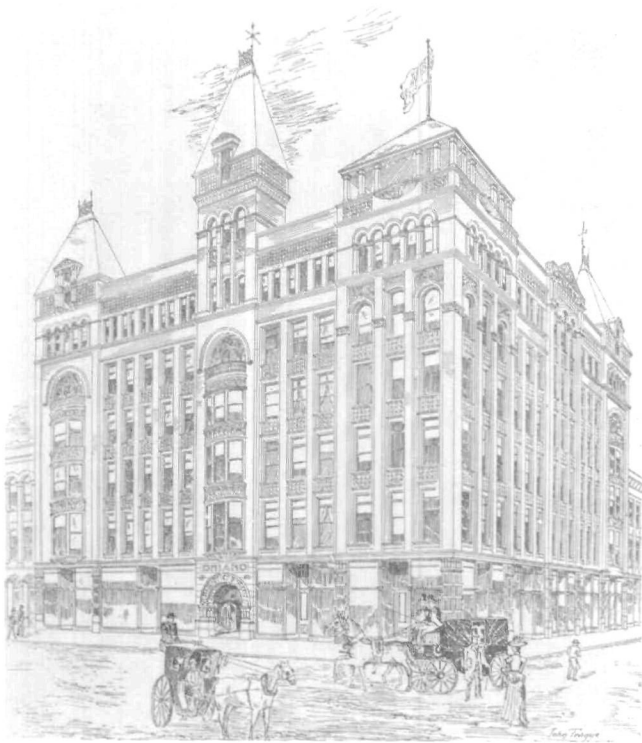
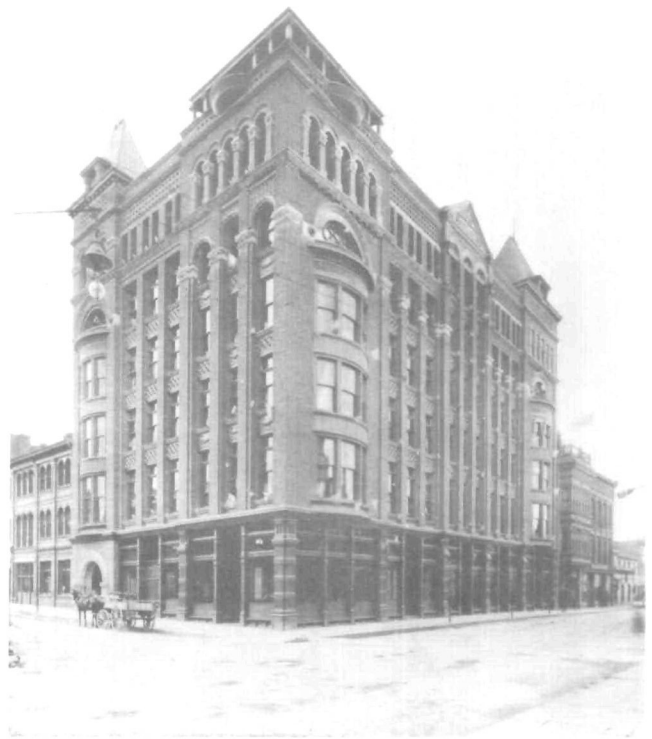
Fig. 9. Architect's sketch of the Driard Hotel, Victoria, by John Teague, ca. 1890. (Photo: PABC, no. 24447.)

Comparison of the photograph with the architect's sketch, both similar views, is informative. The sketch fills in the roof-top details lost by the camera's angle of view. Also revealed is that the left façade was only half completed and the central tower was compressed at the cornice level. A further rather odd amendment is the change from a pier treatment of the right side of the corner tower to bow windows. The final product, a compression of the original plan, is a jumble of the original elements. From the evidence of the sketch, however, we are able to absolve the architect of the rather unhappy final design. Note that the street is deserted in the photograph save for a shadowy figure on the extreme right. This is a conscious picture of a building.

Fig. 10. Driard Hotel, Victoria, ca. 1892. (Photo: PABC, no. 27716.)

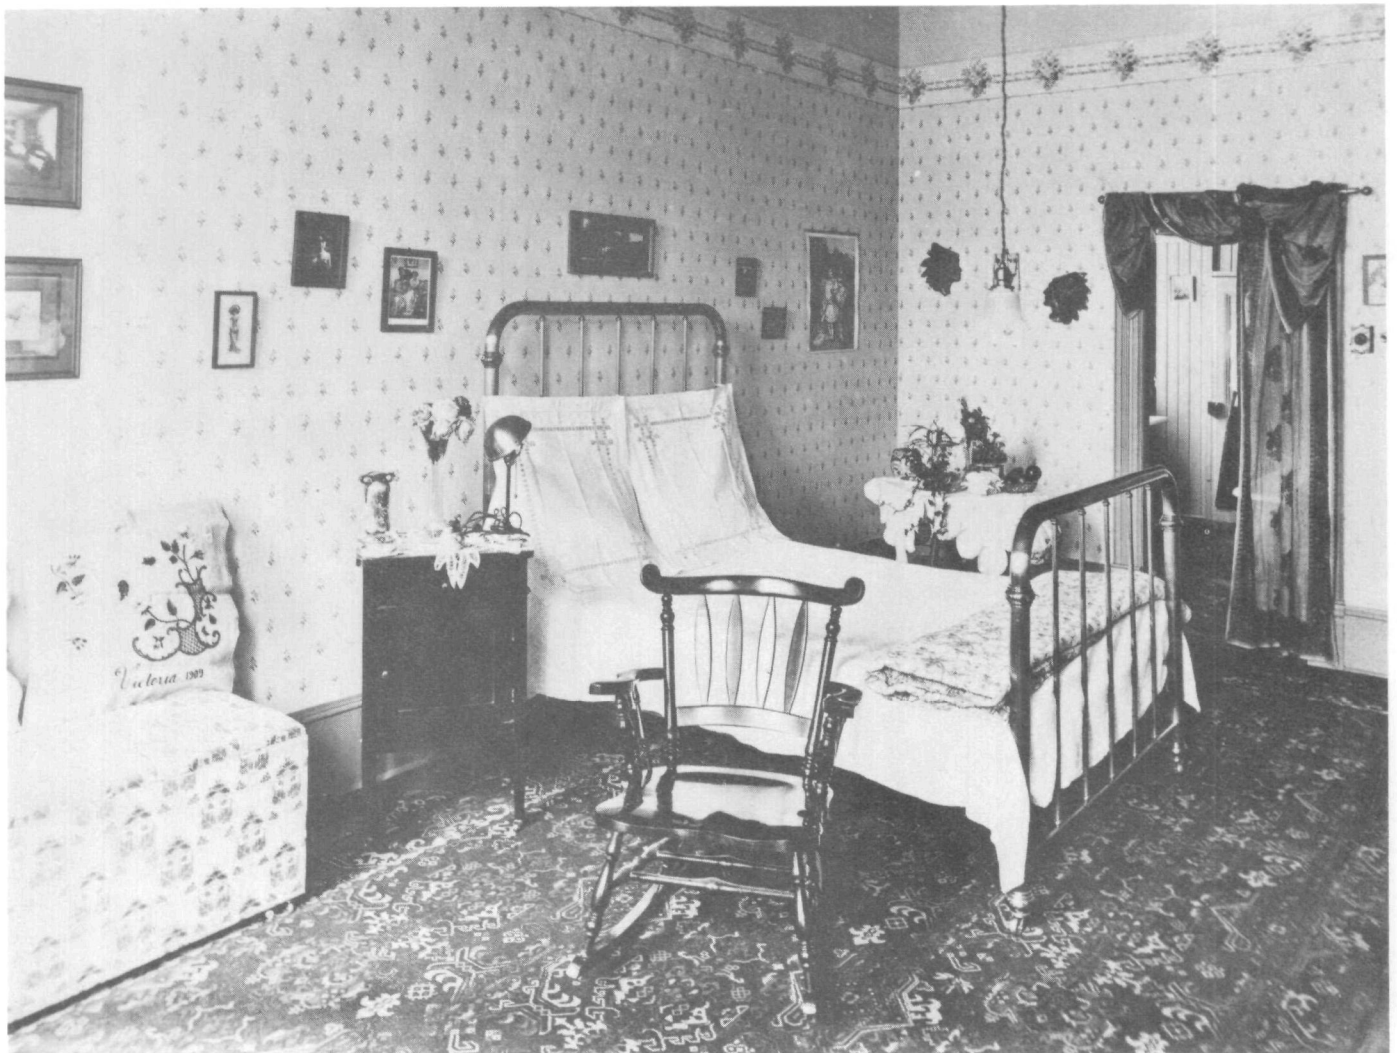
Fig. 11. Guest room, King Edward Hotel, Victoria (1909?). This superficially innocent photograph is carefully contrived for aesthetic effect. The chair beckons the viewer into the picture. More importantly, it fills a gaping hole in the composition and provides focal depth in the foreground, carrying the eye over the bed and skilfully out through the nonchalantly open diaphanous *portières* to the bathroom beyond. The bedside cupboard is angled into the room toward the camera, and both this and the far table are accented with floral and fruit compositions. Is the embroidered pillowcase a less-than-subtle hint as to the date? This photograph was probably intended for use in the hotel's promotional literature. (Photo: PABC, no. 75672.)
