Road Alignment and Gradient Issues in the Maintenance of Logging Roads in Tanzania

W.S. Abeli¹
D.T.K. Shemwetta¹
R.E.L. Ole Meiludie¹
M. Kachwele²

¹*Sokoine University of Agriculture,
Morogoro, Tanzania.*

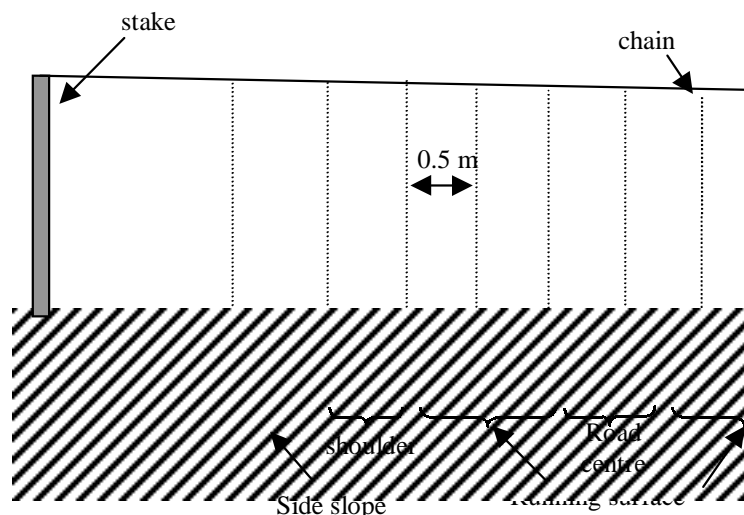
To record soil loss (or gain) across a station, a measuring chain was held tightly on top of these stakes to measure height difference between the road surface and the chain, at an interval of 0.5 m across the road. Figure 1 shows points across the road where soil loss measurements were taken. The position of each point measured was recorded to indicate whether it was on the side slope, shoulder, running surface or centre of the road. After every three months, same points were measured for a period of two and a half years (1994-1996). Road gradients for all stations and curve radii of all curves within the study area were measured at the beginning of the study. A sample of field data for one station is summarized in Table 1.

Figure 1. Layout of road cross-sectional data points.

To find out if traffic had any effect on road deterioration, soil loss measurements on different parts of the road cross-section with varying traffic or tyre pass intensities were taken. At each station, cross-sectional soil loss due to traffic was determined on the following main road parts: road side (slope/shoulder) vehicle running surface and centre of the road (Figure 1).

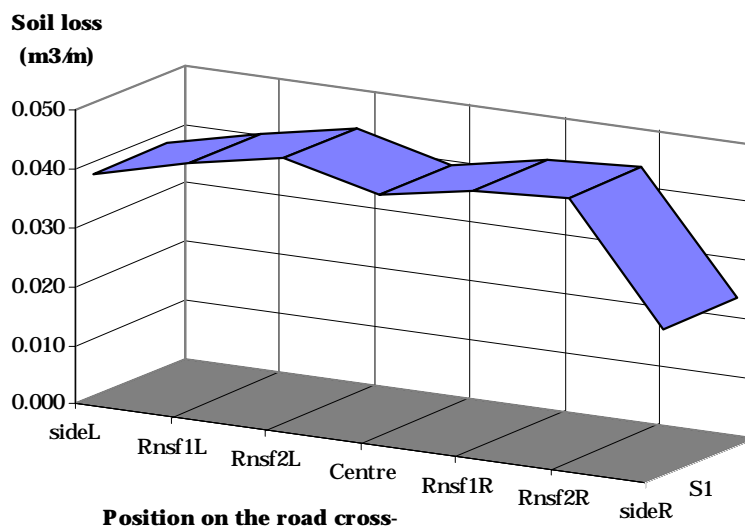
Traffic was considered to be one of the most important factors contributing to soil loss or road deterioration in this study. With more traffic, it was expected that the rate of road deterioration would be higher due to abrasion, crushing and disintegration of the surface materials into dust. Soil loss data collected on different parts of the road cross-section showed that those areas with least traffic loads or passes had minimum soil loss compared with those parts of the road where traffic goes over more often. Figure 2 shows that the least soil loss ($0.025\text{m}^3/\text{m}$) was on

the roadside where traffic rarely goes over, while on the road running surfaces there was more soil loss ($0.043\text{m}^3/\text{m}$).

Figure 2. Soil loss across the road.

On the other hand, the centre of the road (where traffic is usually minimum and where surface materials are usually pushed to), had less soil loss ($0.041\text{m}^3/\text{m}$) than the road running surfaces.

When the volumes of surface layer materials lost in different parts of the road cross-sections were analysed statistically, it was found that there was a significant difference between soil loss on the road sides and on the running surfaces at 5% probability level ($p=0.0018$).

The difference was also significant between the road side and the centre of the road ($p=0.0382$ at 5% probability level). However, despite the running surfaces experiencing more soil loss than the centre of the road, the difference was not significant at 5% probability level ($p=0.3343$).
