# Self-apposing stent fracture in the context of myocardial bridging leading to in-stent chronic total occlusion: When the muscle trumps the metal

Lorenzo Azzalini, Marco B. Ancona, Satoru Mitomo, Mauro Carlino, Antonio Colombo

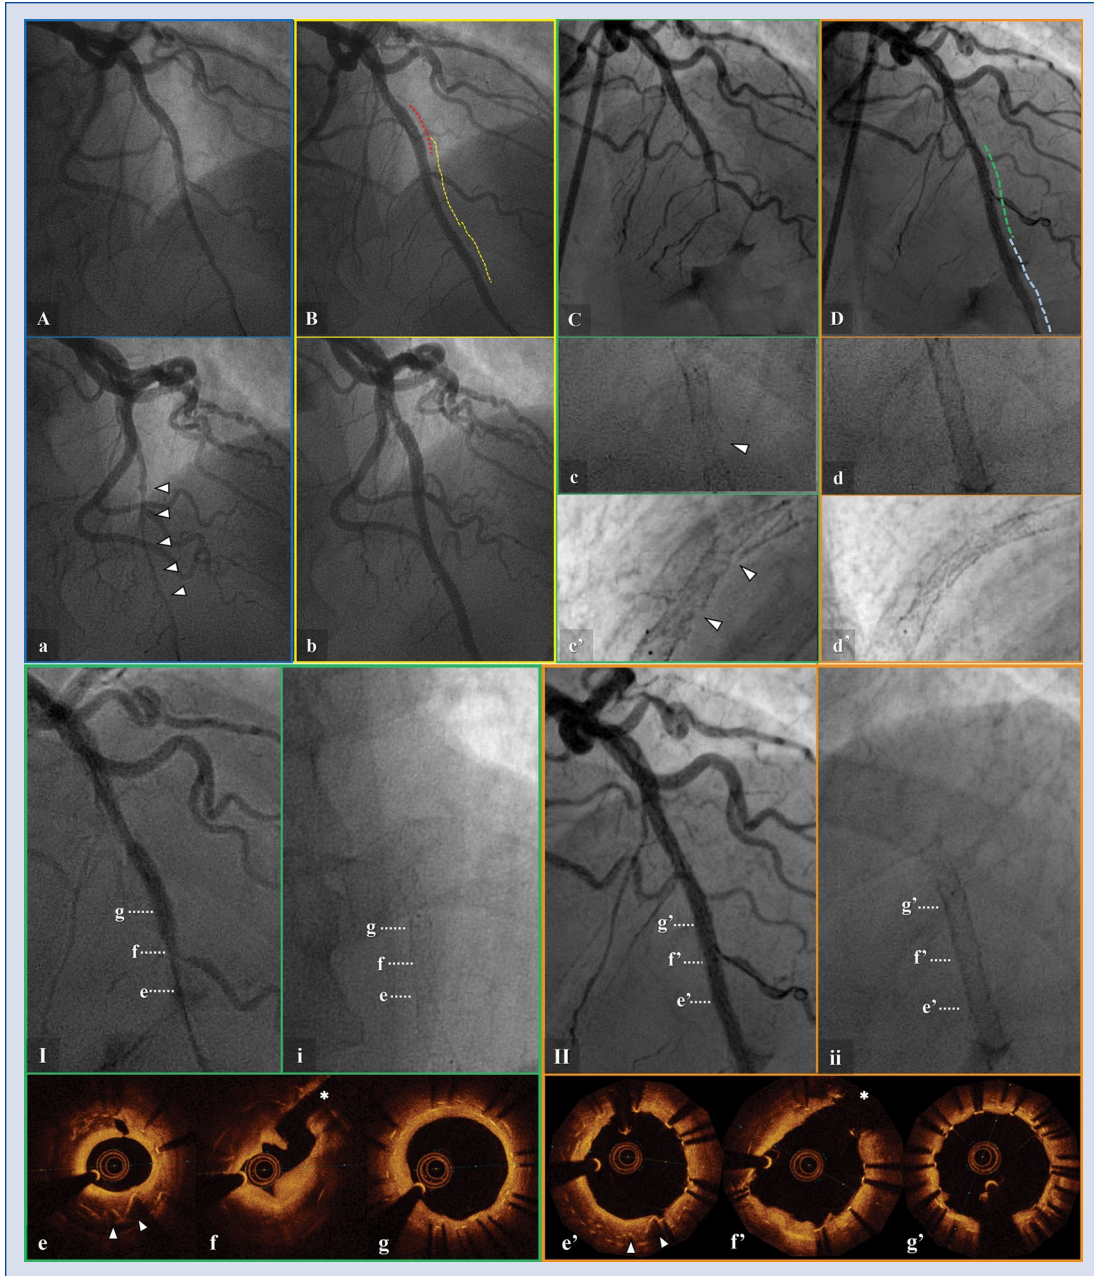
**Figure 1.** Baseline coronary angiography showing myocardial bridging with milking (**A**. Diastole, **a**. Systole; arrowheads: milking). Percutaneous coronary intervention was performed (red line: Biomatrix 3.5 × 11 mm; yellow lines: Stentys 3.0–3.5 × 27 mm and 2.5–3.0 × 22 mm; **B**. Diastole, **b**. Systole). Fifteen months later, chronic total occlusion was documented (**C**), with plain fluoroscopy showing fractured stent at two sites (arrowheads; **c**. Cranial view, **c'**. Lateral view). Additional drug-eluting stent (DES) implantation, as well as treatment with drug-eluting balloon (DEB), were performed (**D**, green and light blue line, respectively), with good result (**d**. Cranial view, **d'**. Lateral view). **I**. Coronary angiography and (**i**) plain fluoroscopy after in-stent occlusion recanalization with a small balloon. **e–g**. Optical coherence tomography (OCT) images at each level indicated in **I** and **i**. **e**. Arrowheads indicate fractured stent struts, **f**. Asterisk indicates side branch, **g**. Overlap of previous stents. Final result (**II**. Coronary angiography, **ii**. Plain fluoroscopy) after revascularization with DES and DEB. **e'–g'**. OCT images at each level indicated in **II** and **ii**. **e'**. Arrowheads indicate fractured stent struts compressed by new DES. **f'**. Asterisk indicates side branch. **g'**. Multiple overlapping struts of previous and new stents.

A 55-year-old man presented with angina and severe anteroapical ischemia. He had suffered non-ST-elevation myocardial infarction 15 months earlier at another institution. The culprit lesion was located on the mid left anterior descending (LAD), in the context of myocardial bridging (MB) with systolic compression (milking effect) (Fig. 1A). Three overlapping drug-eluting stents (DES), including two self-apposing Stentys Xposition S, were implanted in the MB segment with optimal result (Fig. 1B).

Coronary angiography revealed in-stent chronic total occlusion of the mid LAD, associated with fracture of the most proximal Xposition S (Fig. 1C). The lesion was crossed antegradely and predilated. Optical coherence tomography confirmed self-apposing stent fracture (Fig. 1e–g). After further lesion preparation with non-compliant and scoring balloons, a 3.0 × 28 mm Boston Scientific Synergy DES was implanted and post-dilated. The distal vessel was treated with a 2.5 × 30 mm drug-eluting balloon. Optimal angiographic (Fig. 1D) and optical coherence tomography (Fig. 1e'–g') result was observed. The patient was asymptomatic at 9-month follow-up, and a stress-echocardiogram was negative for ischemia.
