Mechanical compression of the left brachiocephalic vein detected during pacemaker implantation

We present a case report of pacemaker implantation in a patient with a significantly reduced patency of the left brachiocephalic vein due to mechanical compression of the vessel by the brachiocephalic trunk and the sternum.

Folia Cardiologica 2017; 12, 4: 413–416

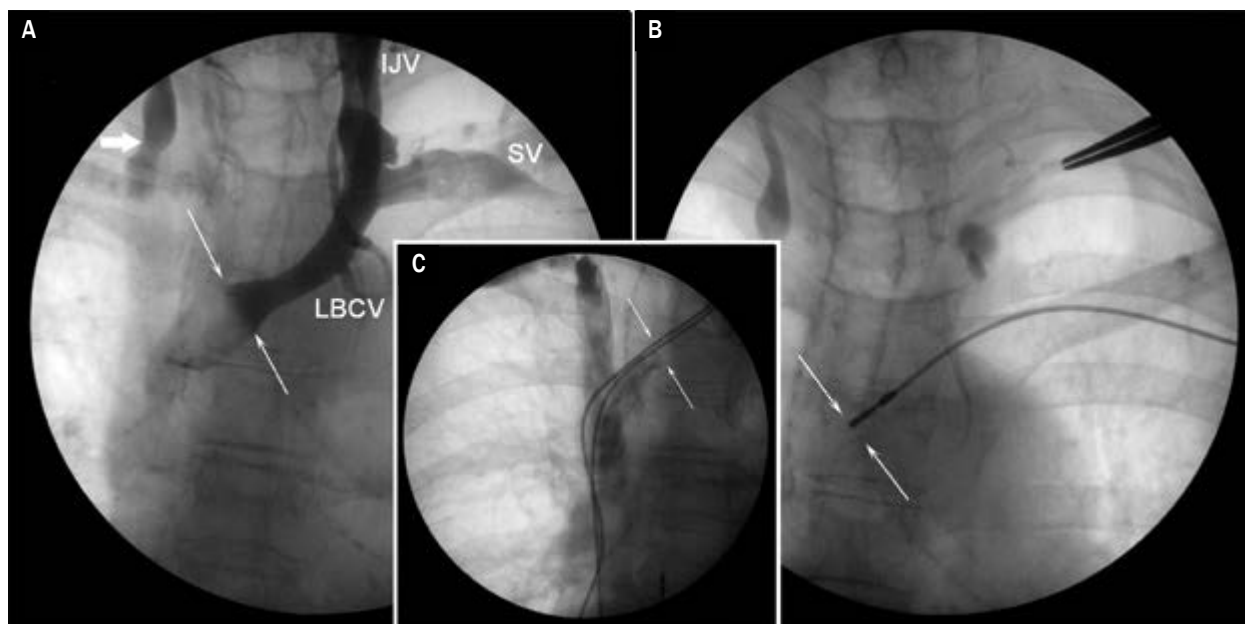
Figure 1A. Selective contrast administration into the left CV revealed left brachiocephalic vein (BCV) obstruction above the level of the tracheal bifurcation (arrows). Note the retrograde flow of contrast into the left internal jugular vein (IJV), with the lumen diameter similar to that of the left subclavian vein (SV) and the left BCV. Note the retrograde flow of contrast into the right IJV (thick arrow) via the sigmoid sinus; **B.** The site of difficulties in cardiac lead advancement, corresponding to the level of contrast flow blockage in panel A (arrows). Localized contrast agent retention in both IJVs near venous valves; **C.** Right-sided contrast administration into the CV showed retrograde flow into the left BCV up to the point of lumen narrowing indicated in panel A (arrows)

After her sinus rhythm was restored, the patient was qualified for a preventive therapy via permanent cardiac pacing. On June 2, 2017, a cardiac lead was introduced via cephalic vein (CV) cut-down through the left deltopectoral approach. In order to explain difficulties in cardiac lead advancement a contrast agent was administered through the lead insertion site. Posteroanterior fluoroscopy revealed contrast flow blockage in the left BCV at the level slightly superior to the tracheal bifurcation. Retrograde contrast enhancement of the ipsilateral and, subsequently, contralateral (right) internal jugular veins (IJVs) could be seen (Figure 1A). Another venography approach, this time via right antecubital venous access, demonstrated retrograde contrast enhancement of the medial segment of the left BCV, which confirmed the site of the vessel's compression (Figure 1C). Eventually, transvenous cardiac lead placement for the CIED implantation was performed via a left-sided approach (a Sensia DR pacemaker, Medtronic; with a Solia S 53 atrial lead and a Solia S 60 ventricular lead, Biotronik). Our initial difficulty with lead advancement through the vascular narrowing was overcome by the use of a guidewire, which was also used in the case of the other lead. One factor which may have facilitated catheter/ /guidewire advancement were breathing-related variations in the distances between the anatomical structures com-

Fluoroscopy images obtained during the initially unsuccessful attempts of advancing a cardiac lead through the narrowing may misleadingly suggest an association with the visible tracheal deformity. Such association, however, can be excluded based on the natural anatomical distance between these two structures (Figure 1A–C).

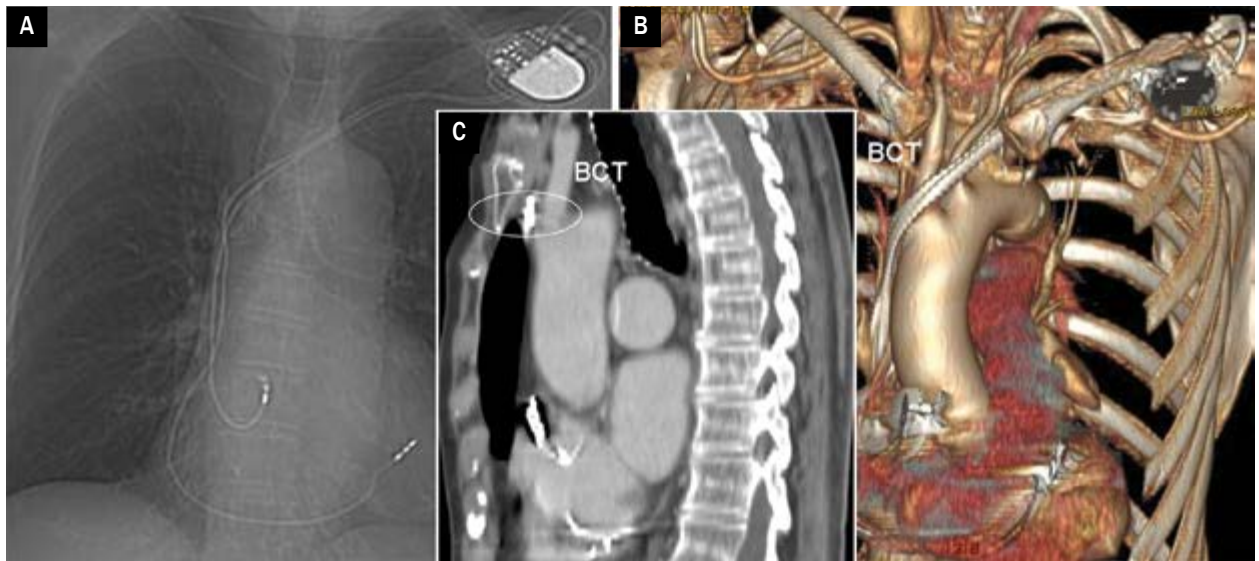
Figure 2A. Chest radiogram (P-A view); **B.** The position of the left brachiocephalic vein (BCV) in relation to large vessels of the upper mediastinum. Image reconstruction adjusted to visualize the intravenous cardiac leads. A 3-D computed tomography (CT) reconstruction illustrating a typical position of the left BCV, i.e. anterior to the brachiocephalic trunk (BCT), left common carotid artery, and left subclavian artery; **C.** A sagittal CT reconstruction showing the left BCV, with a cardiac lead in its lumen, coursing between the BCT and the sternum (oval)

In order to identify the cause of left BCV narrowing, computed tomography (CT) angiography was performed after the CIED implantation procedure. CT scans demonstrated that the space between the sternum and the BCT, where typically the left BCV passes, was markedly reduced (Figure 2B, C).
