Nondestructive Damage Detection Based on Modal Analysis

T. Plachý, M. Polák

Three studies of damage identification and localization based on methods using experimentally estimated modal characteristics are presented. The results of an experimental investigation of simple structural elements (three RC-beams and three RC-slabs) obtained in the laboratory are compared with the results obtained on a real structure (a composite bridge – a concrete deck supported by steel girders) in situ.

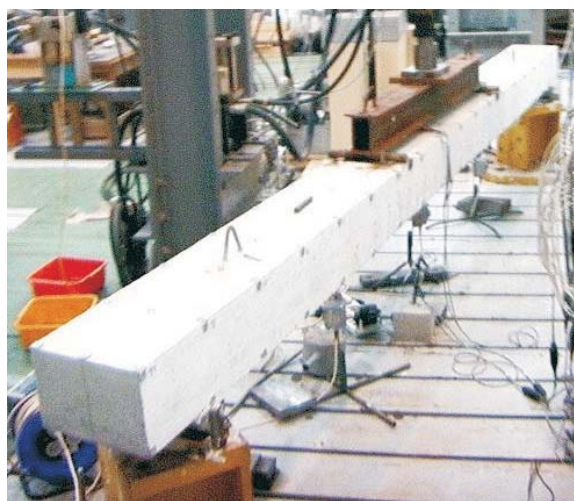
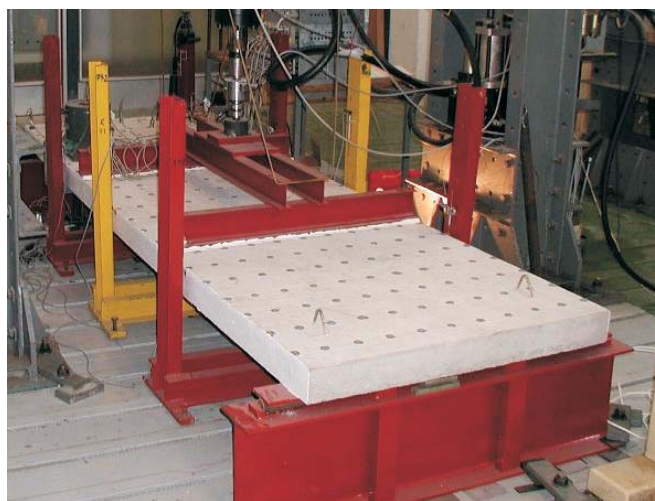
Fig. 1: View of the reinforced concrete beam and slab

Three reinforced concrete beams with dimensions $4.5\text{ m} \times 0.3\text{ m} \times 0.2\text{ m}$ were prepared for the purposes of the test. The beam was placed on a cast steel bearing to achieve a good agreement with theoretical boundary conditions. It was a simply supported beam with a span length 4.0 m with cantilevered ends 0.25 m on both sides.

made for the purposes of the test. The slabs were simply supported on two opposite sides with a span of 3.0 m and cantilevered ends 0.1 m.

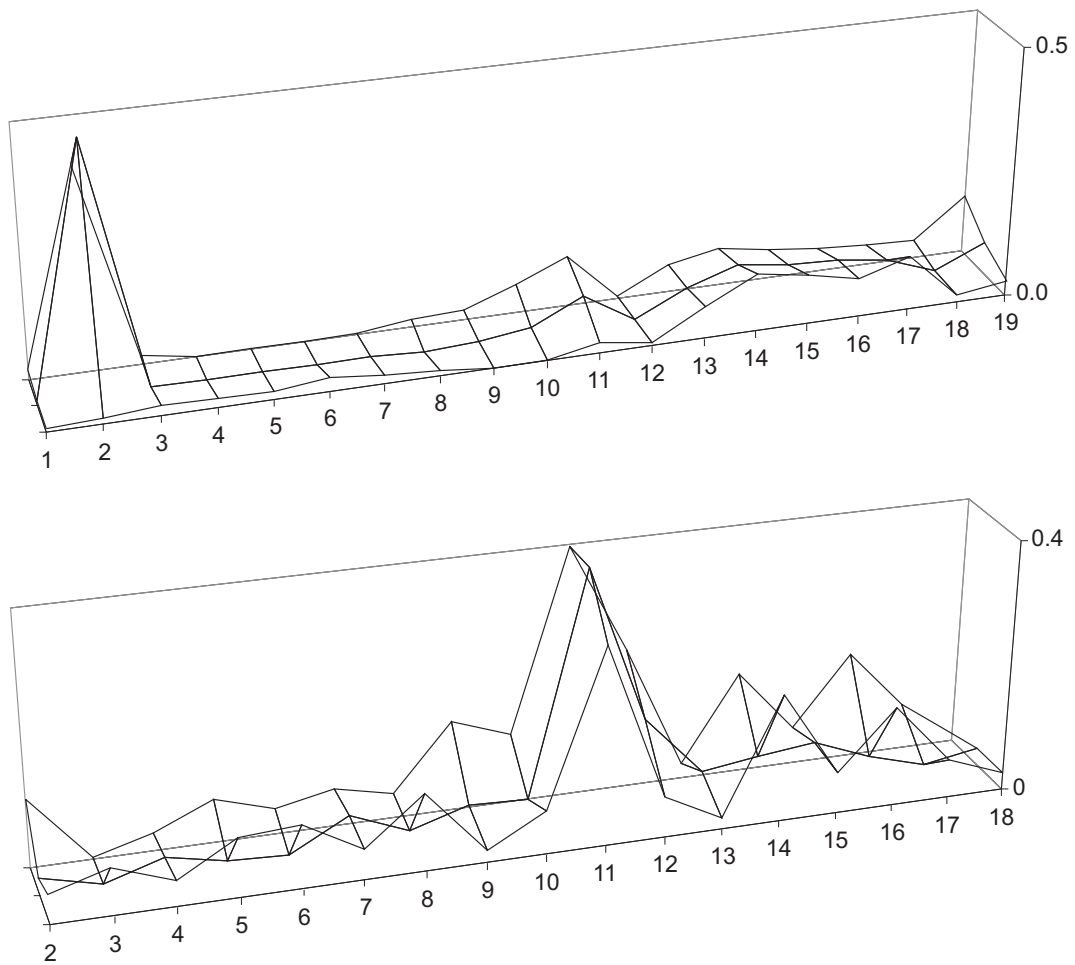
Fig. 2: Comparison of the dynamic behavior of beam No. 3 between the last but one and the last load step – functions $(1-COMAC_{(x)})$ and $CAMOSUC_{(3),x}$

In order to localize of the cracks induced by the load increase during experimental and theoretical studies on structural elements the $CAMOSUC_{(j),x}$ (Fig. 2 and 4), the change of the modal flexibility matrix and especially the second derivative of the change of the diagonal members of the modal flexibility matrix seem to be most appropriate (Fig. 3 and 5).

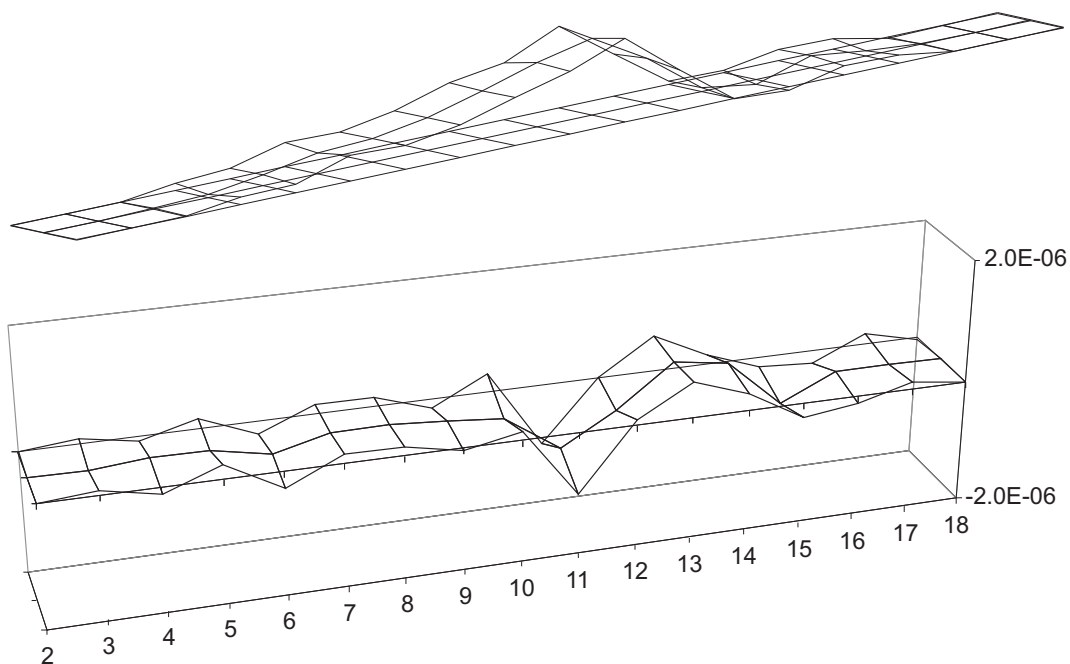
Fig. 3: Comparison of the dynamic behavior of beam No. 3 between the last but one and the last load step – change in the modal flexibility matrix $[\delta]$ and the second derivative of the change in the modal flexibility matrix $[\delta]$

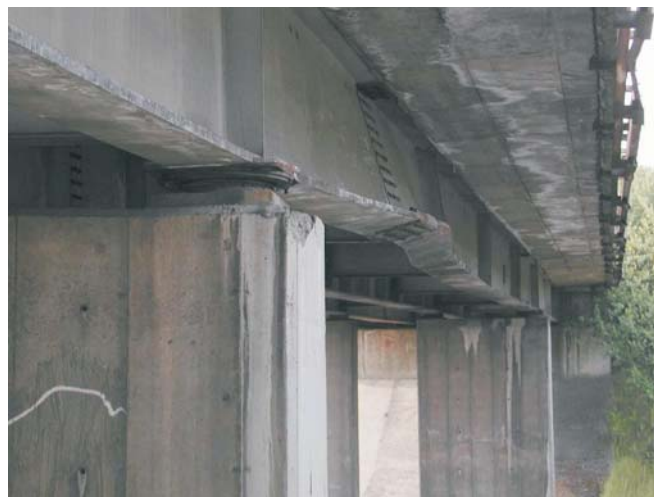
Fig. 6: View of the damaged main girder of the bridge

The bridge under investigation crosses highway D5 near the village of Vráž in the Czech Republic. The bearing structure of this composite bridge consists of four main steel I-girders and a reinforced concrete slab. It is a three-span continuous bridge with spans 11.7 m + 35.1 m + 11.0 m. In March 2001 the bridge was damaged by a crash. A heavy vehicle (excavator) being ferried along the D5 crashed into its two main girders. The consequences of this crash was a permanent buckle of the main girder (15 cm at the point of impact), and damage to the connection between the main girder and the crossbeam (Fig. 6).

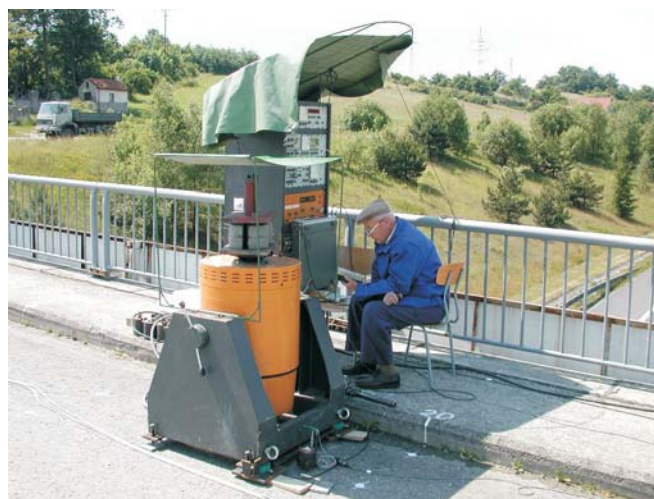
Fig. 7: The TIRAVIB 5140 electrodynamic exciter and its placement on the bridge

An experimental modal analysis was carried out twice on this bridge – for the damaged state and for the state after reconstruction of the bridge. To vibrate the bridge, (Fig. 7) a TIRAVIB 5140 electrodynamic exciter was used. The driving force was white noise type in the range 0–20 Hz, which was measured by S-35 LUKAS force transducers. The response of the bridge was measured only in the vertical direction in a chosen net of points (280 points – 28 cross sections and points in each cross section) on the upper face of the bridge by B12/200 HBM accelerometers. The data acquisition was performed by the 2550B Spectral Dynamics Vibration Control System with a Sun control computer. The STAR Spectral Dynamics program was used for modal characteristics evaluation.

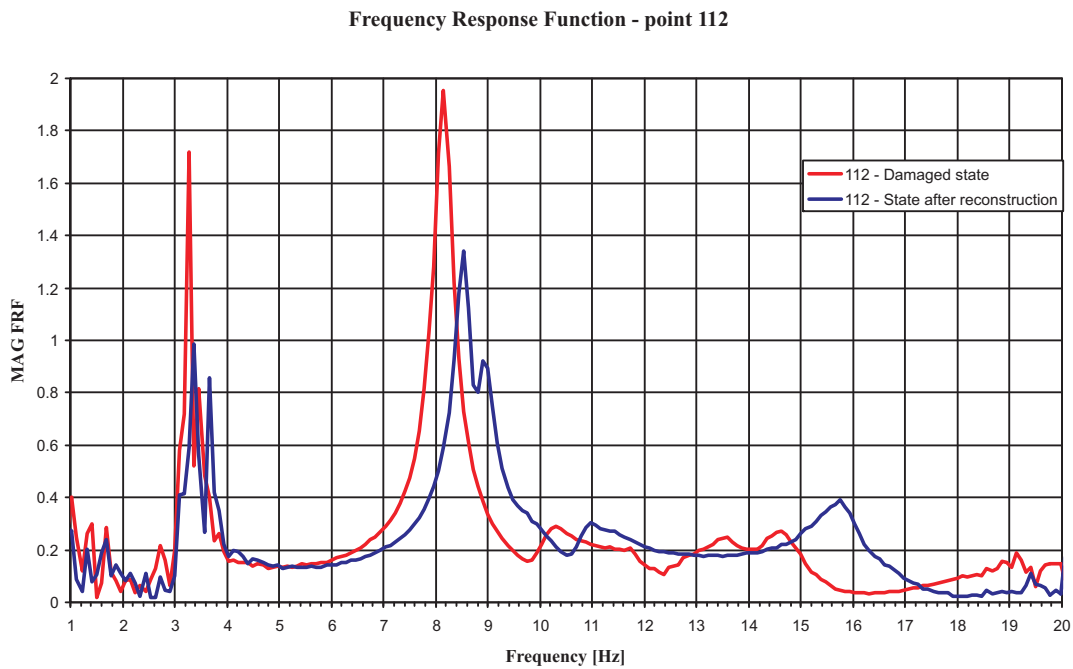
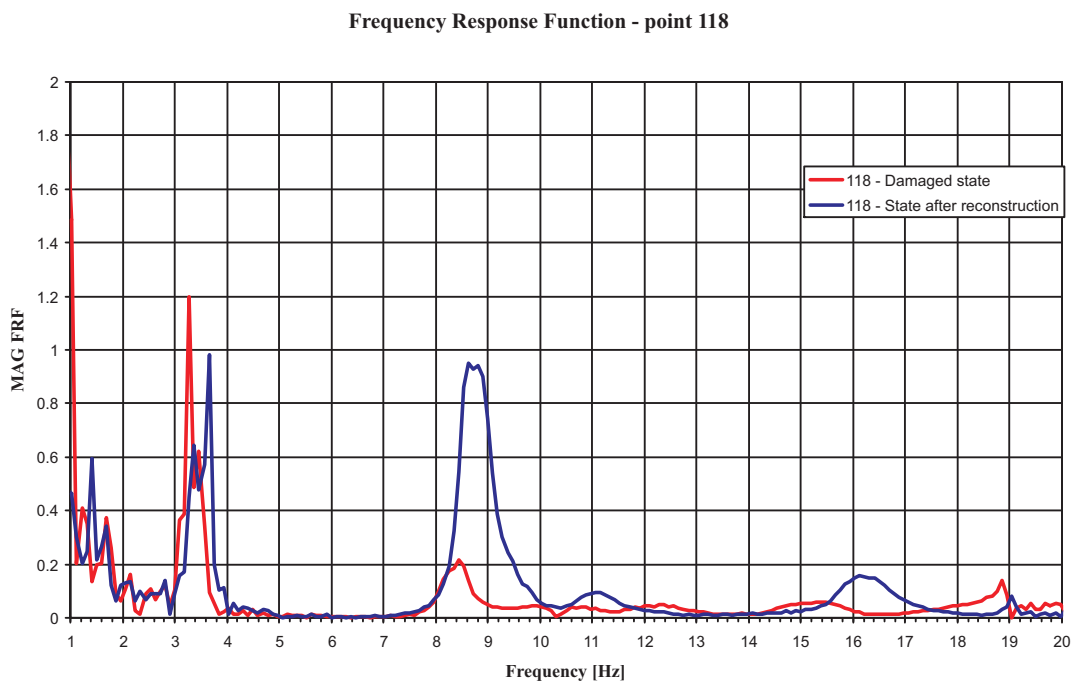
Fig. 8: Comparison of the Frequency Response Functions measured at points 112 (the point at upon the middle of the damaged part of the main girder) and 118 (the point in the same cross section on the exterior undamaged main girder) in the damaged state and in the state after reconstruction

Just from a visual comparison of the characters of the natural modes evaluated in the damaged and repaired states (Fig. 10–13) and the measured frequency response functions

(Fig. 8), it is clear that the changes resulting from the reconstruction of the damaged girder are substantial. For this reason, the natural modes of the two verified states of the bridge were compared with each other using the $MAC_{(i,j)}$ assurance criterion (Tab. 1, Fig. 9). Table 1 shows are highlighted values of $MAC_{(i,j)}$ for the modes that have very similar characters. A visual comparison of these modes as shown in Fig. 10–13.

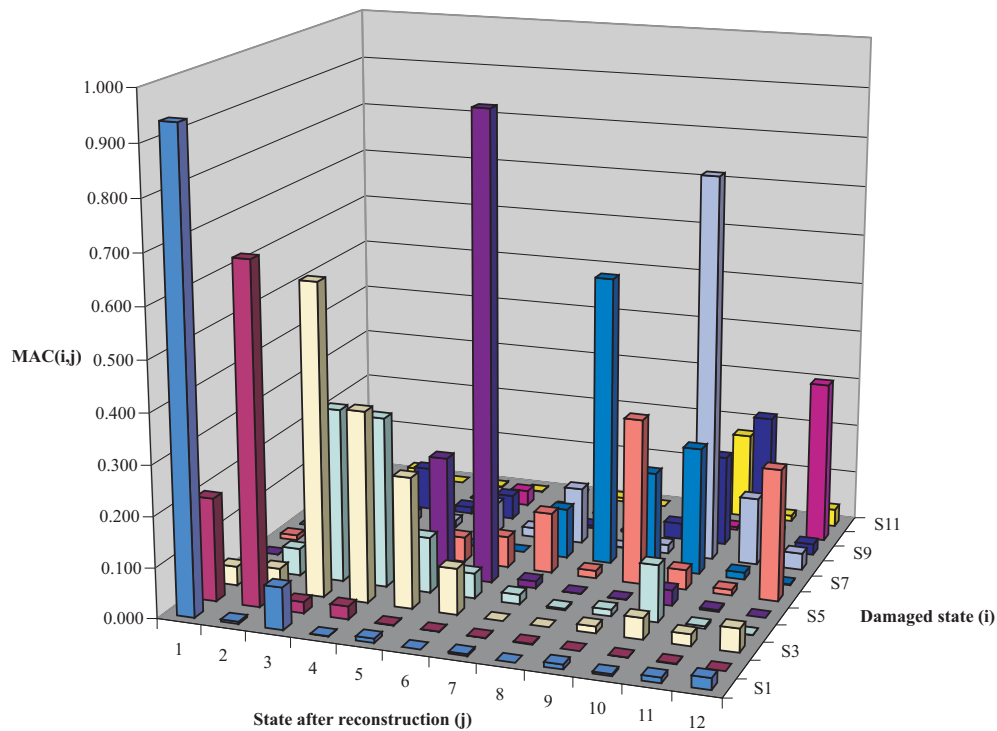
Fig. 9: The bridge across highway D5 near Vráž – comparison of natural modes from the 1st and from the 2nd stage of the experimental investigation of the bridge, using MAC

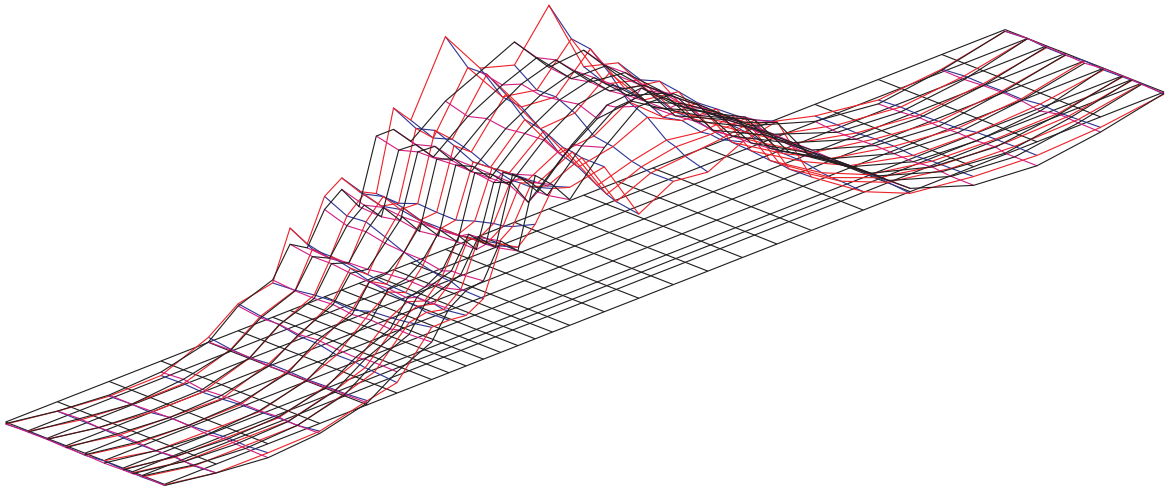
Fig. 10: Visual comparison of the real parts of the natural modes for the state after reconstruction (the first natural mode) and for the damaged state (the first natural mode) – $MAC_{(1,1)} = 0.937$

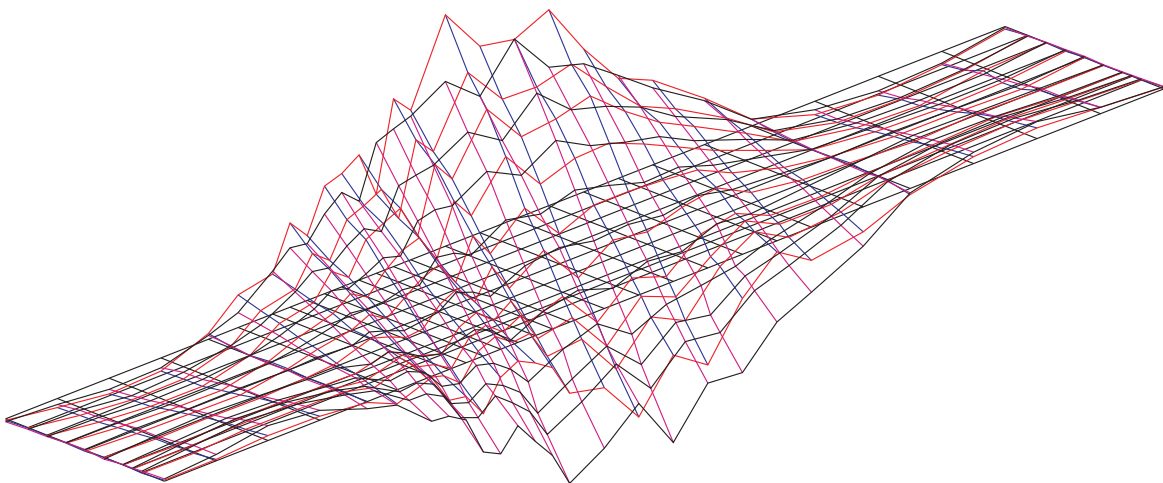
Fig. 11: Visual comparison of the real parts of the natural modes for the state after reconstruction (the second natural mode) and for the damaged state (second natural mode) – $MAC_{(2,2)} = 0.674$

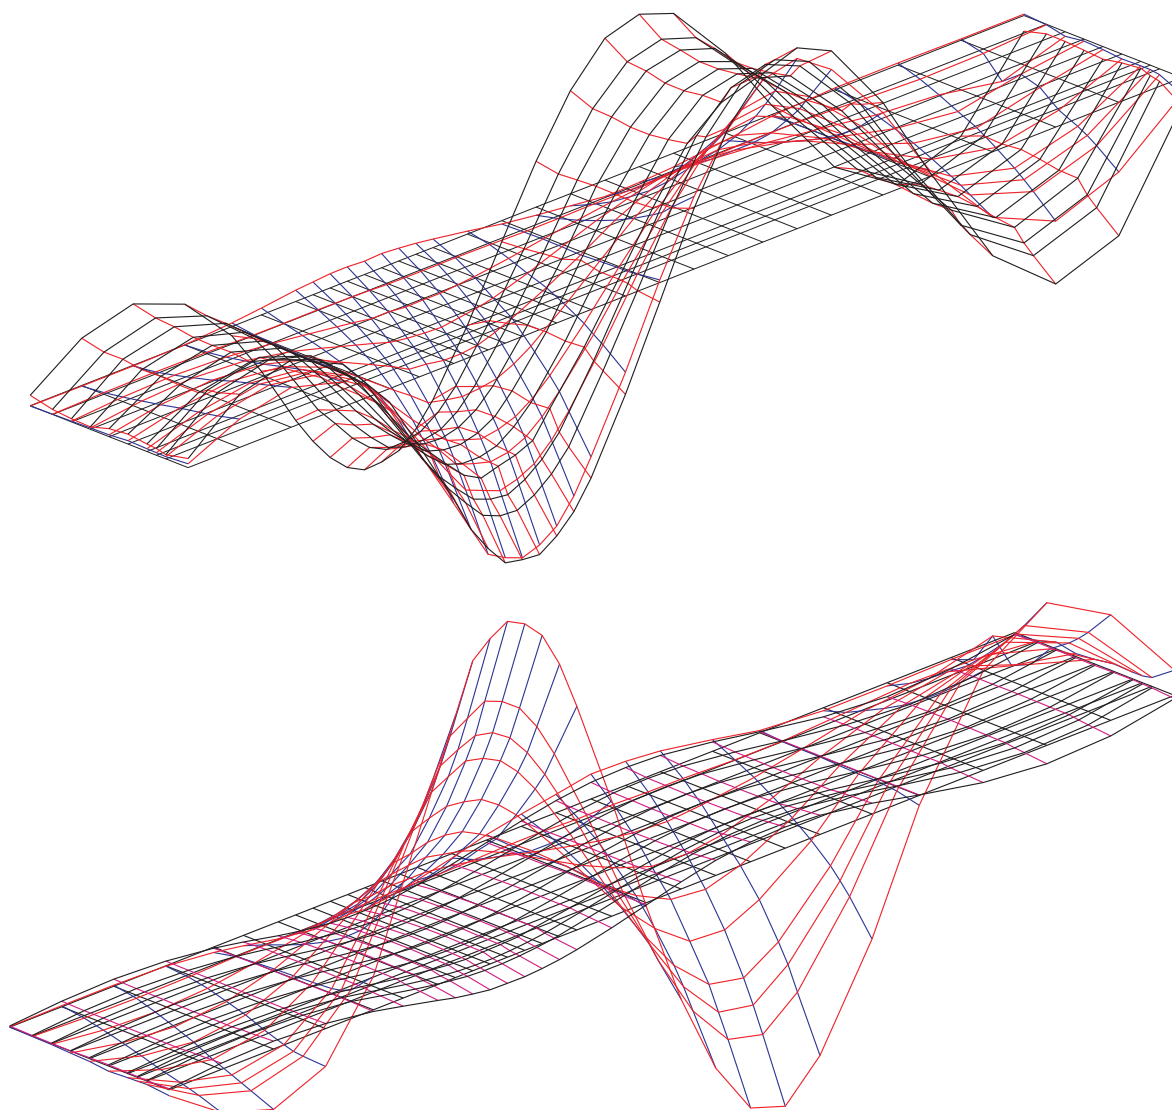
Fig. 12: Visual comparison of the real parts of the natural modes for the state after reconstruction (third natural mode) and for the damaged state (third natural mode) – $MAC_{(3,3)} = 0.618$. (above – comparison in the section of the damaged girder, below – comparison in the section of the undamaged girder.)

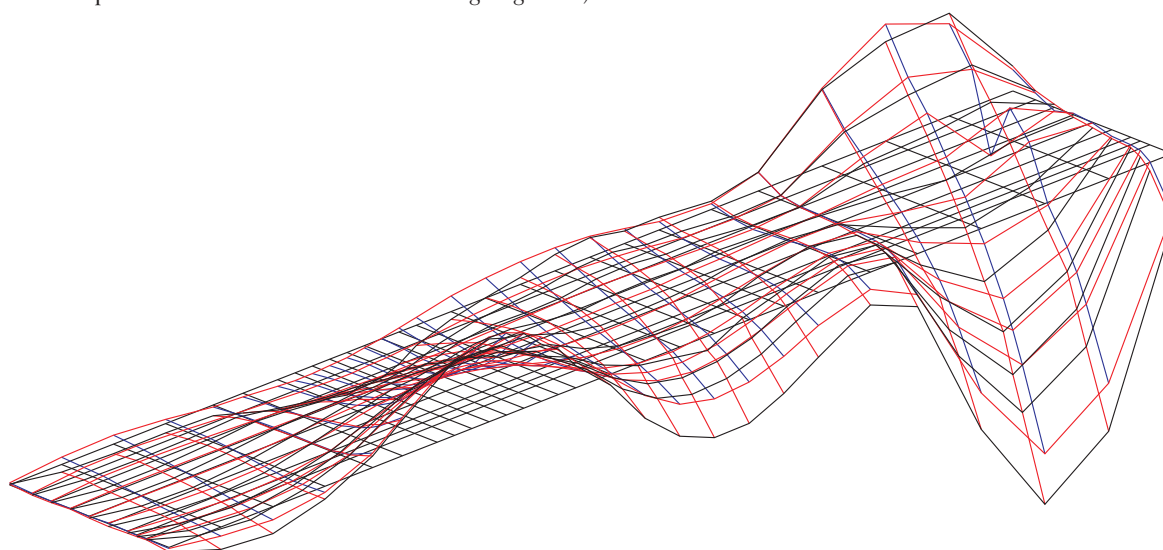
Fig. 13: Visual comparison of the real parts of the natural modes for the state after reconstruction (sixth natural mode) and for the damaged state (fifth natural mode) – $MAC_{(6,5)} = 0.928$

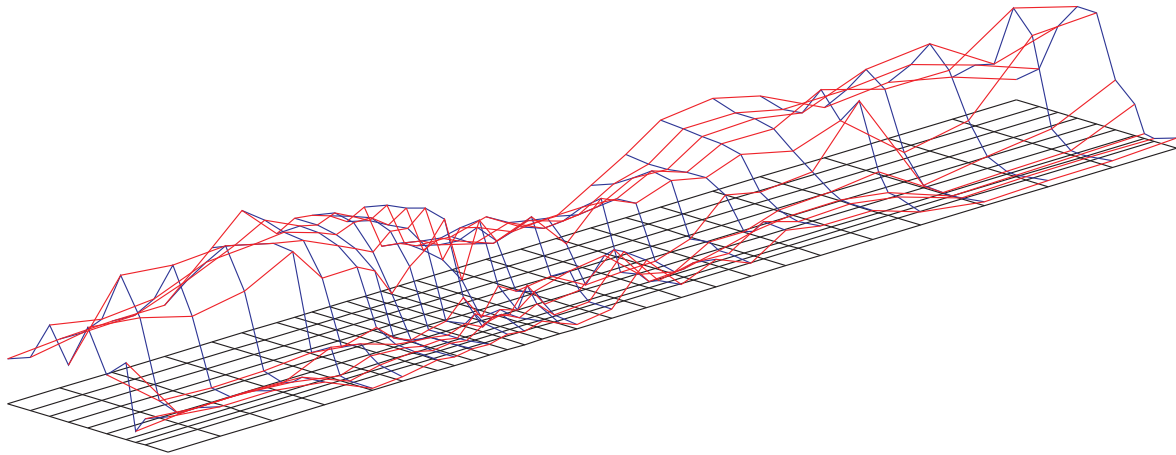
Fig. 14: The change in the dynamic behavior of the bridge (damaged state – state after reconstruction) described by function (1-COMAC), used natural modes No. 1, 2, 3, 5, 7, 8 (damaged state) and 1, 2, 3, 6, 8, 10 (state after reconstruction), max. value shown in the figure is 0.887 (i.e. $\text{COMAC}_{(128)} = 0.113$) at point 128

Not only $MAC_{(i,j)}$ was used for the comparison of natural modes but also $COMAC_{(p)}$ (Fig. 14), the change of the curvature of natural modes $CAMOSUC_{(j),p}$ (Fig. 15–18), the change of the modal flexibility matrix $[\delta]$ and the second derivative of the change of the diagonal members of the modal flexibility matrix $\Delta\delta''$ (Fig. 19 and 20) were used.

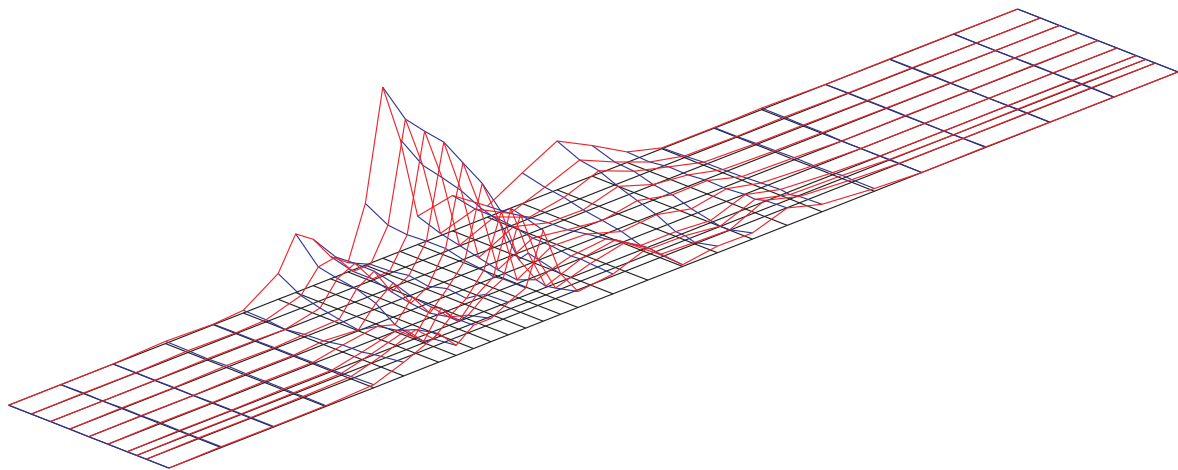
Fig. 15: The change in the dynamic behavior of the bridge (damaged state – state after reconstruction) described by the change of the curvature of the first natural mode $\text{CAMOSUC}_{(1)}$ calculated in the longitudinal direction of the bridge

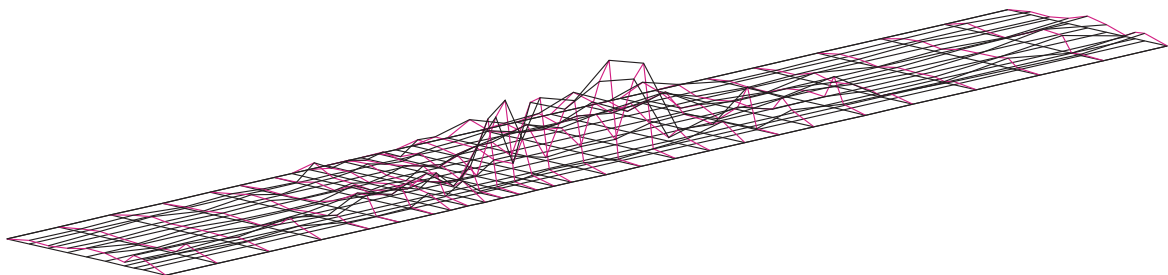
Fig. 16: The change of the dynamic behavior of the bridge (damaged state – state after reconstruction) described by the change of the curvature of the first natural mode $\text{CAMOSUC}_{(1)}$ calculated in the transversal direction of the bridge

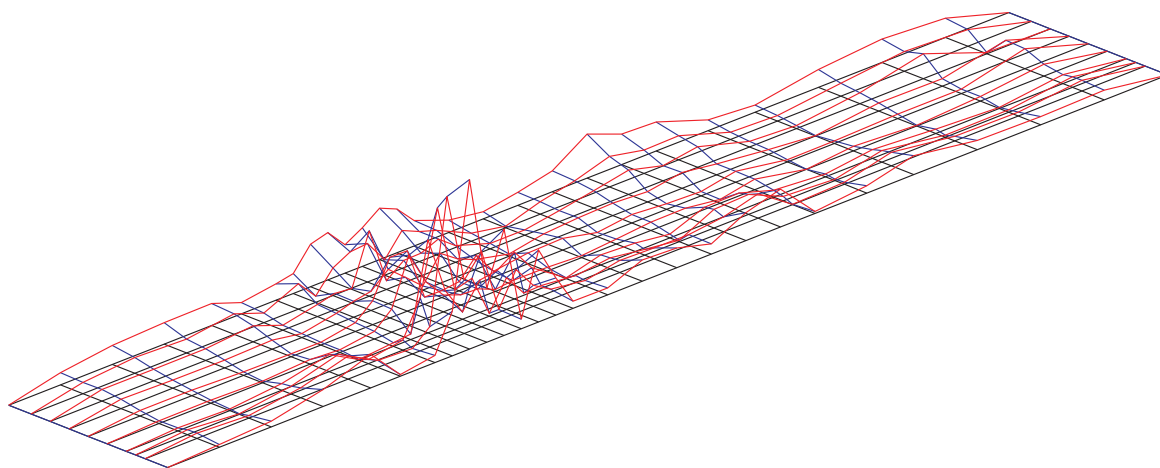
Fig. 17: The change of the dynamic behavior of the bridge (damaged state – state after reconstruction) described by the change of the curvature of the third natural mode $CAMOSUC_{(3)}$ calculated in the longitudinal direction of the bridge

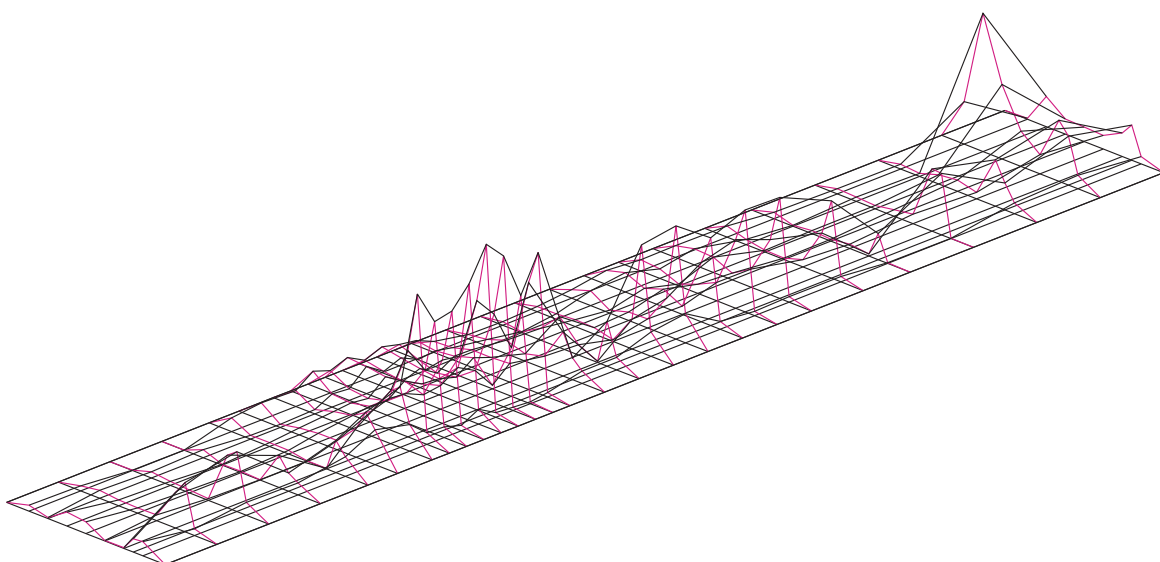
Fig. 18: The change in the dynamic behavior of the bridge (damaged state – state after reconstruction) described by the change of the curvature of the third natural mode $CAMOSUC_{(3)}$ calculated in the transversal direction of the bridge

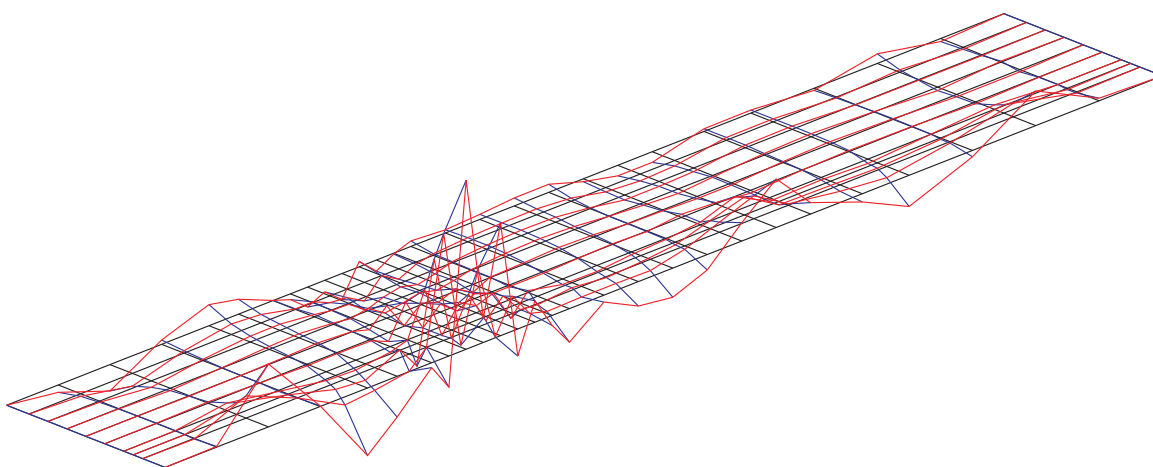
Fig. 19: The change in the dynamic behavior of the bridge (damaged state – state after reconstruction) described by the second derivative of the diagonal members of the modal flexibility matrix $\Delta\delta''$ computed in the longitudinal direction of the bridge, used natural modes No. 3, 5, 7, 8 (damaged state) and 3, 6, 8, 10 (state after reconstruction)

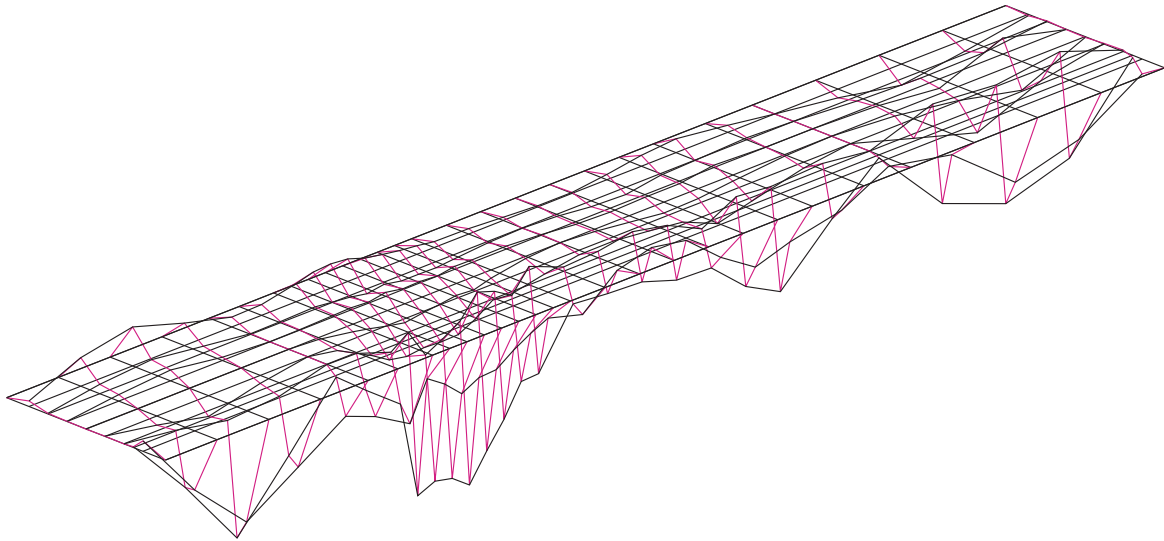
Fig. 20: The change in the dynamic behavior of the bridge (damaged state – state after reconstruction) described by the second derivative of the diagonal members of the modal flexibility matrix $\Delta\delta''$ computed in the transversal direction of the bridge, used natural modes No. 3, 5, 7, 8 (damaged state) and 3, 6, 8, 10 (state after reconstruction)
