PLANT SURVIVAL IN THE FLOODPLAIN RESTORATION OF CRABTREE SWAMP, HORRY COUNTY, SC

REFERENCE: *Proceedings of the 2012 South Carolina Water Resources Conference*, held October 10-11, 2012, at the Columbia Metropolitan Convention Center.

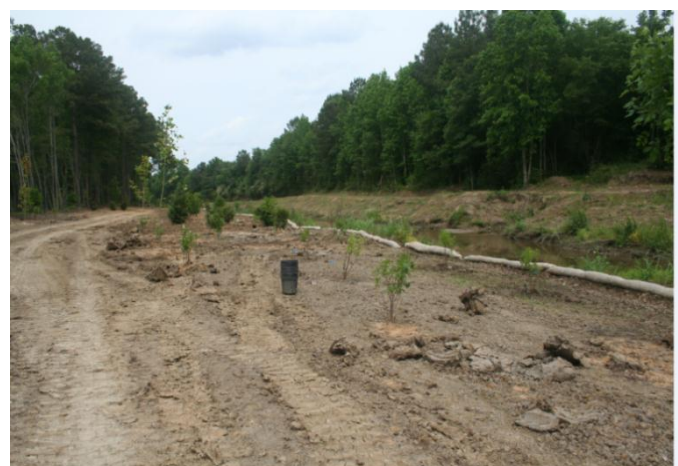
Figure 2. (a) Left hand photograph shows steepened banks of Crabtree Canal prior to restoration. (b) Right-hand photograph shows restored floodplain during planting. Erosion control logs are located at top of bank in the aquatic zone.

In May 2009, construction began at the chosen demonstration site to reconnect the floodplain along a ½-mile segment of one bank of Crabtree Canal (Figures 1 and 2b). A second ½-mile segment is undergoing restoration, 0.3 miles upstream of the first site on the opposite bank.

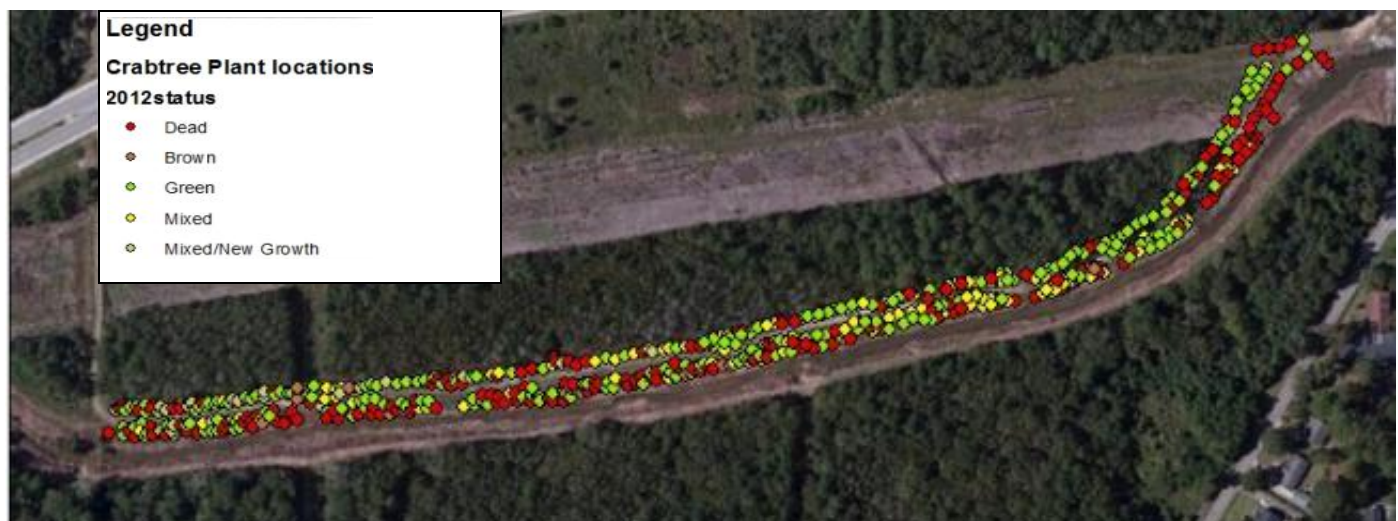
Figure 3. GIS datalayer showing status of planted trees following a survey conducted in July 2012.

As shown in Figure 3, plant mortality was highest in areas subject to high-energy floodwater regimes, i.e. the aquatic zone. This area also had a higher percentage of plants categorized as mixed, a sign of stress. Data are
