# CRABTREE SWAMP STREAM RESTORATION IN HORRY COUNTY, SOUTH CAROLINA

REFERENCE: *Proceedings of the 2010 South Carolina Water Resources Conference*, held October 13-14, 2010 at the Columbia Metropolitan Convention Center.

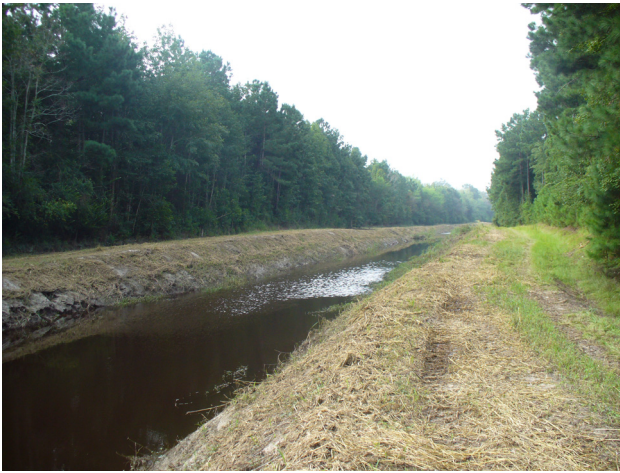
**Figure 1. Pre-restoration channel configuration.**

conditions, outstanding problems, and management challenges. While Crabtree Swamp was originally a low-gradient coastal plain tributary to the Waccamaw River, the stream system was significantly modified by channelization projects in the 1960s (U.S. Army Corps of Engineers) and the 1980s (U.S. Department of Agriculture (USDA)). These efforts, spearheaded by the formation of the Crabtree Swamp Watershed Conservation District, aimed to improve drainage for agricultural lands. The outcome was a deep, trapezoidal channel known as Crabtree Canal (**Figure 1**). This shape has effectively disconnected the channel from its former floodplain. In the past 20 years, more intense urban land uses have replaced agricultural uses and increased stormwater runoff. Crabtree Canal now exhibits symptoms of stress such as bank failure (**Figure 2**), erosive channel velocities, high sediment loads during rain events, episodic flooding, federal 303(d)-listed water quality impairments for dissolved oxygen and fecal coliform, invasive vegetation (e.g. johnsongrass), and poor wildlife habitat quality.

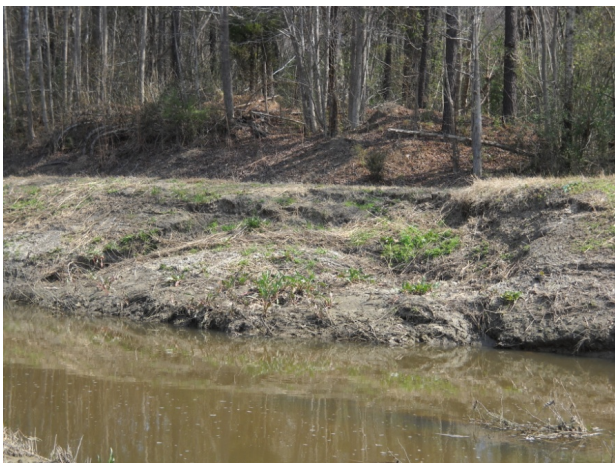
**Figure 2. Bank failure is a symptom of stress.**

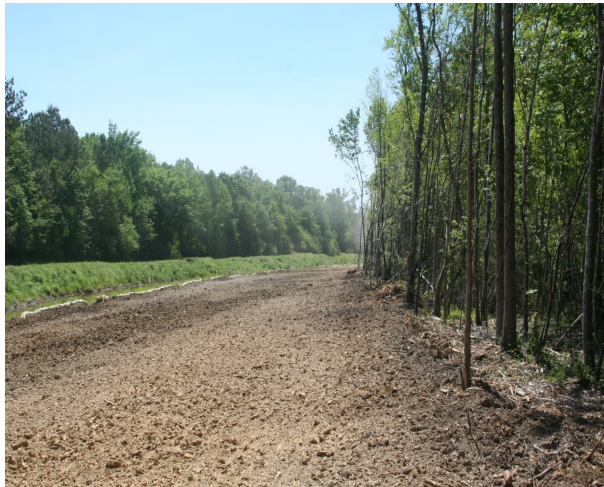
**Figure 3. Post-construction restoration design.**

Once the design phase was complete, the City of Conway and Horry County bid out and oversaw the construction phase. State and federal permit approvals for channel maintenance were acquired prior to construction. During construction, accumulated spoil material from dredging and historic channel and bank maintenance was excavated from the bank and adjacent berm and removed to a neighboring parcel. The bench elevation was designed to be inundated during the 2-year storm event as the slope rises to meet the existing grade of the former

floodplain (**Figure 3**) that had been isolated behind the berm. The excavated slope was stabilized for erosion control with sediment tubes and grasses.

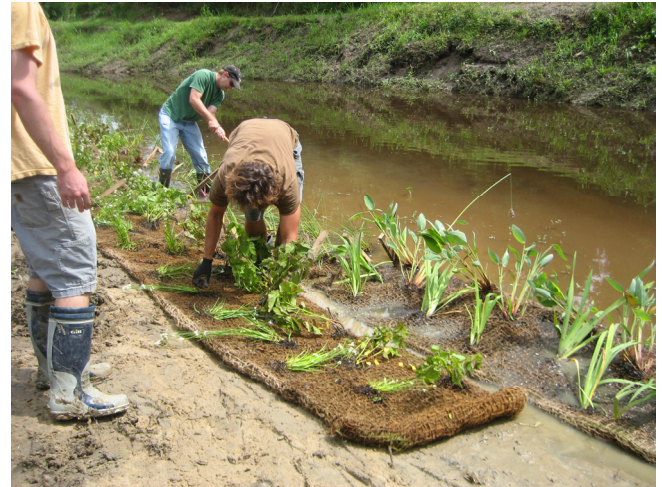
**Figure 5. Installation of pre-rooted aquatic carpets.**

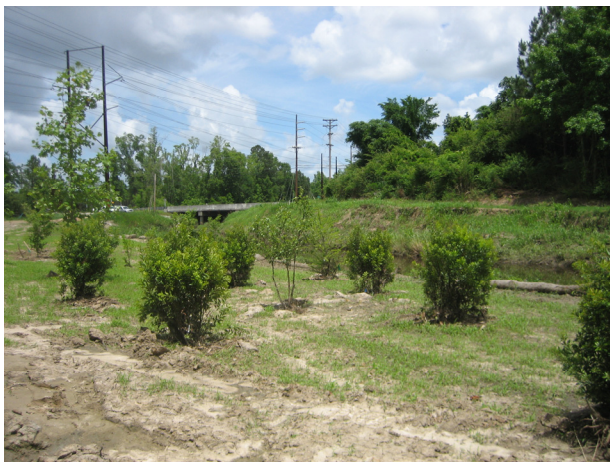
**Figure 4. Native plantings on restored floodplain.**

With funding from the U.S. Fish and Wildlife Service, over 500 trees and shrubs of species native to coastal floodplains were planted in the native soils with little soil amendment. A machine auger, staff and volunteers were used to install the plants during early May 2009. Ideally, planting would occur during cooler months, but the contractual process for construction forced a later start. Plantings were arrayed to allow limited equipment access to the bench and to the channel for maintenance (**Figure 4**). Experimental aquatic coir-fiber mats with pre-rooted wetland plants (**Figure 5**) were secured to the bank edge in hopes of re-establishing native aquatic and wetland species. When mature, the floodplain and aquatic plantings will offer suitable wildlife habitat. Wildlife activity has been observed at the site.

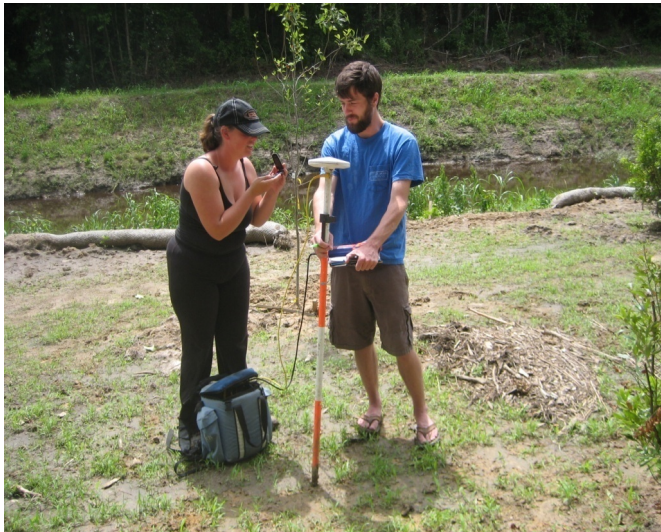
**Figure 6. Students perform inventory of plantings.**

For this project, the partners decided to assess the key elements of wetland systems – hydrology, soils, and vegetation. CCU students maintain and monitor Global™ water loggers both immediately upstream and downstream of the restoration site to assess the frequency of site inundation. They also monitor rain gauges arrayed throughout the watershed. The students conduct annual soil accumulation profiling with a laser level on permanent transects to track the shape of the floodplain over time. Finally, students perform a quarterly inventory of the plantings (**Figure 6**) using a Global Positioning System (GPS) to assess their condition and survival. The data is maintained in a GIS system so that individual and species plant survival and success can be easily tracked. After one year, plantings achieved a 70% survival rate. Some species (e.g. ti-ti, persimmon, green ash, and sycamore) exhibited exceptional survival, while others (e.g. tulip poplar, eastern red cedar, and southern red oak) struggled to survive. Future monitoring may include groundwater monitoring and hydrogeomorphic wetland assessment.
