### Slave Housing: In Search of Endangered Architecture

#### SLAVE HOUSING: IN SEARCH OF ENDANGERED ARCHITECTURE

# A Thesis Presented to the Graduate School of Clemson University and the College of Charleston

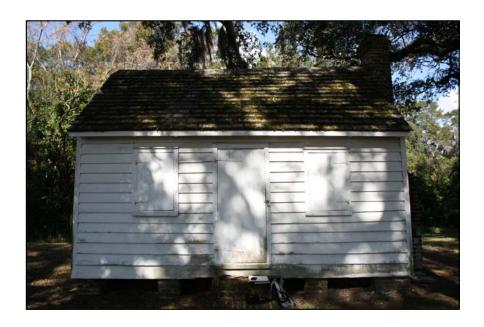
### MCLEOD PLANTATION SLAVE HOUSE NO. 1

## MCLEOD SLAVE HOUSE NO. 1 ARCHITECTURAL AND STRUCTURAL

**AS – BUILT DRAWINGS**

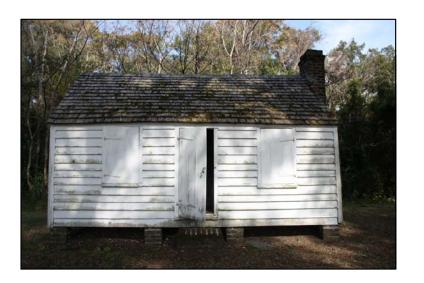
# MCLEOD PLANTATION SLAVE HOUSE NO. 2

# ARCHITECTURAL AND STRUCTURAL

**AS – BUILT DRAWINGS**

McLeod Slave House No. 2 (MSH-2) is a one – room, single story, timber frame, with gable roof that has rake on the ridge. The structure sits on low brick pier foundations. The walls are clad with colonial siding clapboard. The roofing material is made of wood shingles. The wood shingles were restored in the 1990's during the Historic Charleston Foundation (HCF) ownership. The restoration of the wood shingle roof was initiated after historic photographs showed that the structure was roofed with raked wood shingles before it was roofed with asphalt. Some of the exterior cladding were also restored or replaced during the stabilization initiatives conducted by the HCF.
