Castle Pinckney: Past, Present, Future

A Thesis
Presented to
The Graduate Schools of
Clemson University and the College of Charleston

Chapter Seven - Conditions Survey

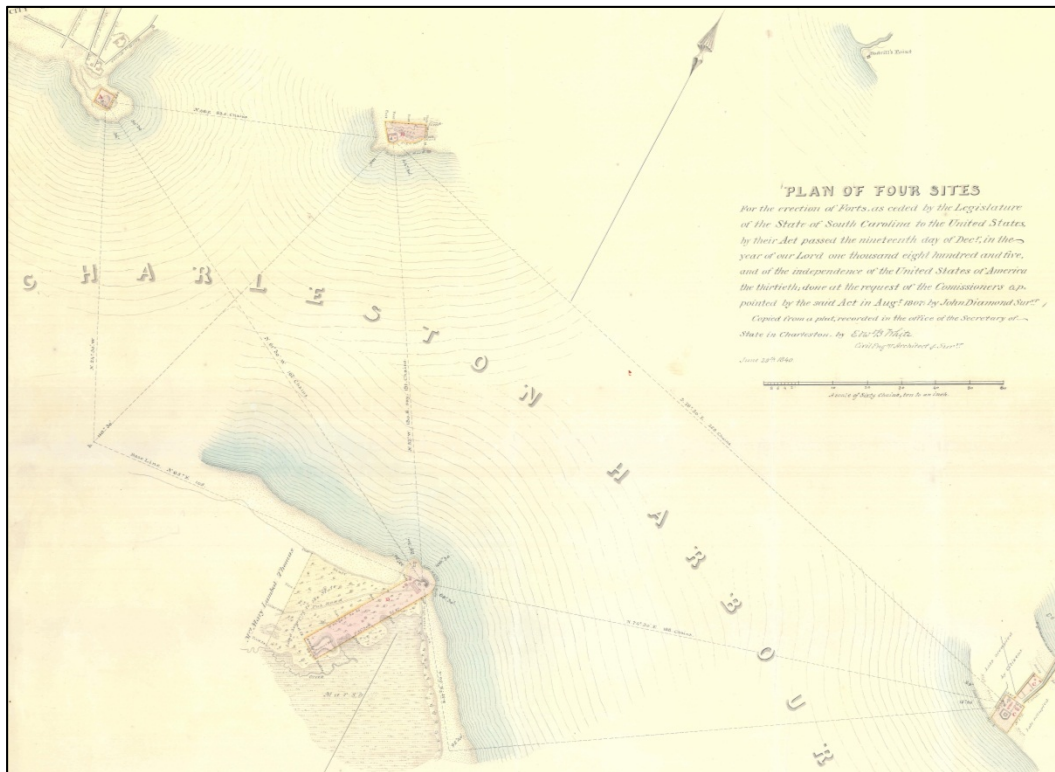
Figure 1.1
Plan showing four sites and their fortifications. Fort Pinckney is left of center at the top of the image
National Archives II, Cartographic and Architectural Records, RG no. 77, Dr. 64, Sheet 19

Fort Pinckney was located just over a mile from the tip of the Charleston Peninsula, which, at the time, was the site of Fort Mifflin, and would later become known as “The Battery”. (Figure 1.1.) The fort consisted of earth walls faced with timber on the exterior and according to an early drawing of the site contained three buildings, the largest one was likely a barracks to house the garrison, while the other two small buildings could have served a variety of

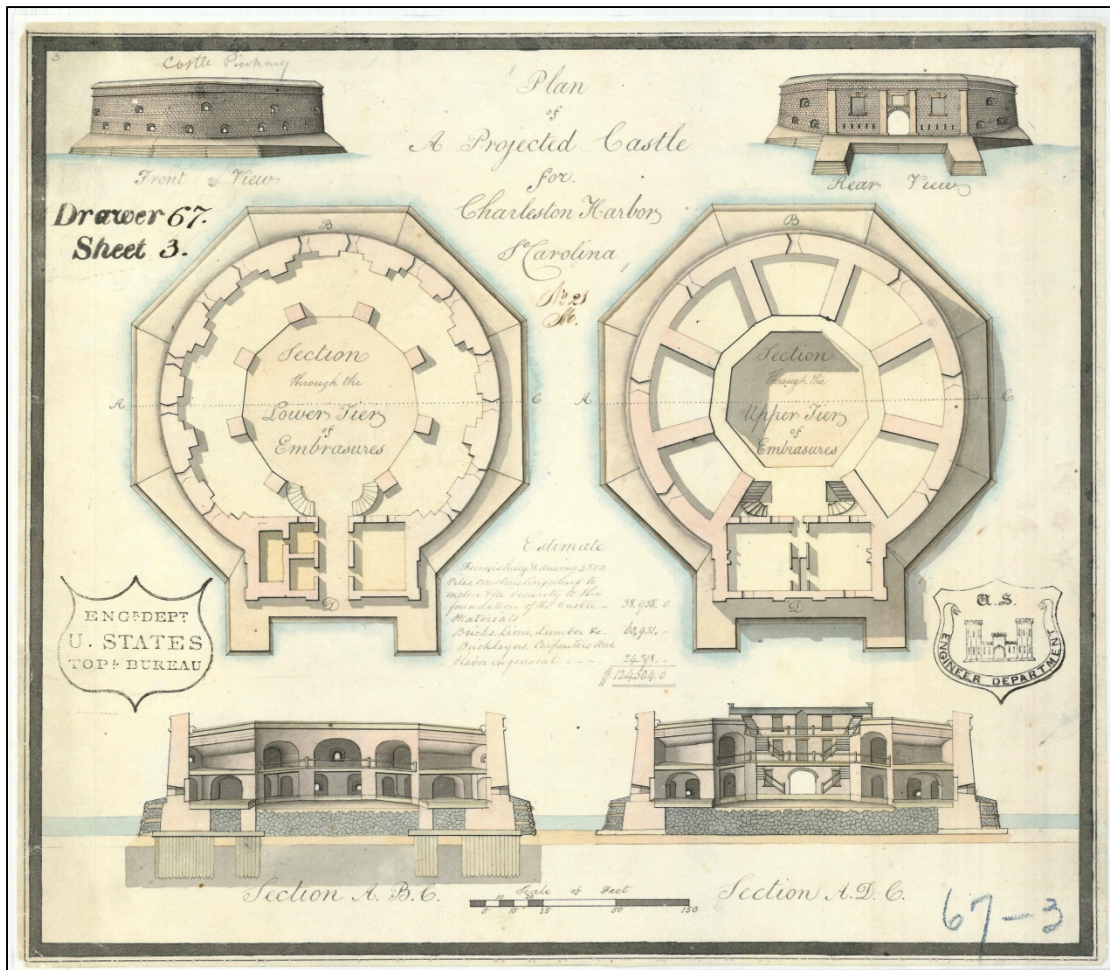
Figure 2.1
Drawing showing an unexecuted design for a castle style fort in Charleston Harbor
National Archives II, Cartographic and Architectural Records, RG 77, Dr. 67, Sheet 3

The main reason the design for this projected castle was abandoned was most likely the extravagant cost required to build it. The drawing includes an estimate for construction, totaling \$124,504.00, well over ten percent of the one million dollars appropriated by congress for the defense of the entire country. The estimate sheds light on the requirements and costs of building what, at the time, was a state of the art military installation: \$38,955.00 for "furnishing and driving 4500 piles, constructing wharf to enclose and for security to the foundation of the castle", \$60,951.00 for "bricks, lime, lumber, etc.", and \$24,504.00 for "bricklayers, carpenters work, labor in general . . .".²⁸

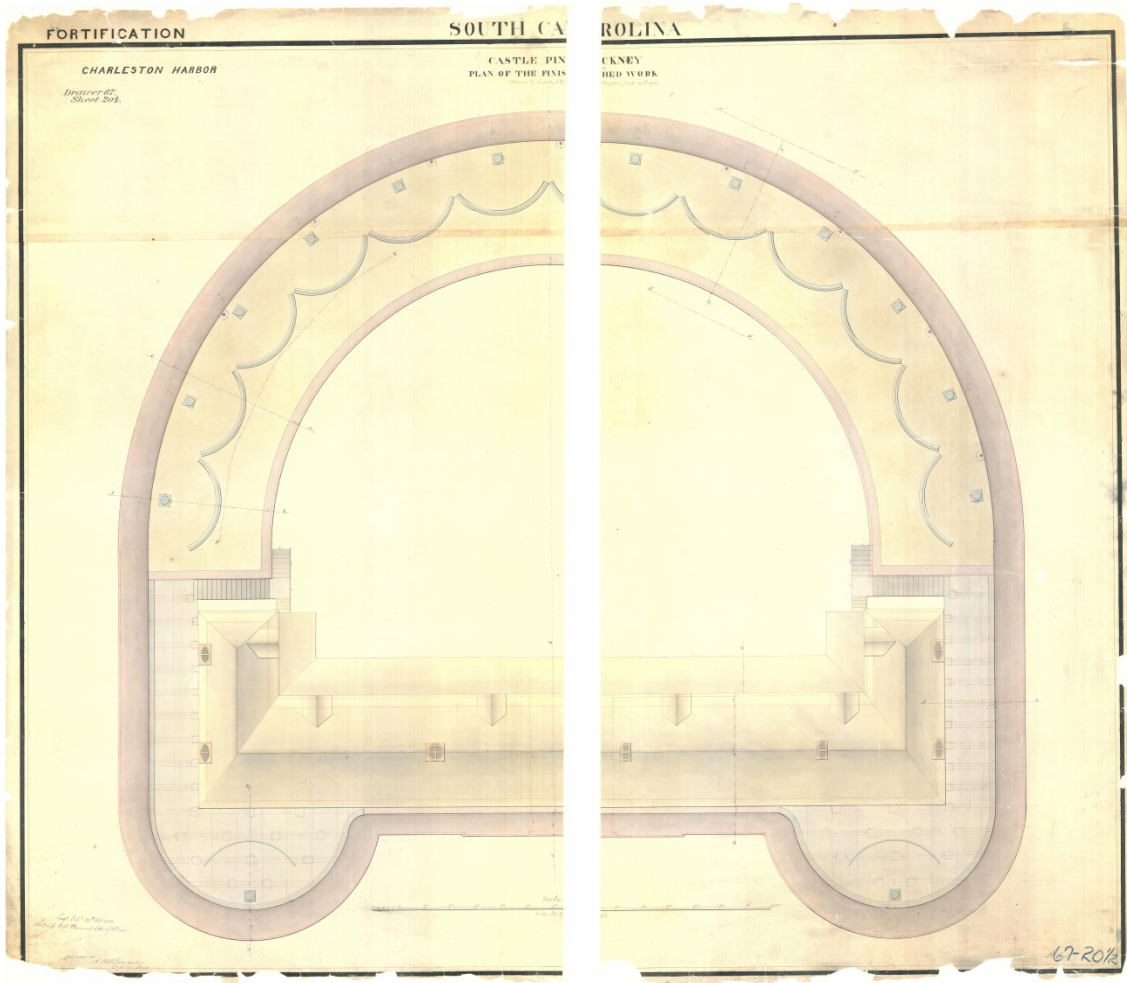
Figure 3.9
1841 plan of the barquette tier at Castle Pinckney. Drawn by Lieut. James Trapier, Corps of Engineers.
National Archives II, Cartographic and Architectural Records, RG 77, Dr. 67, Sheets 20.5 (1 & 2)

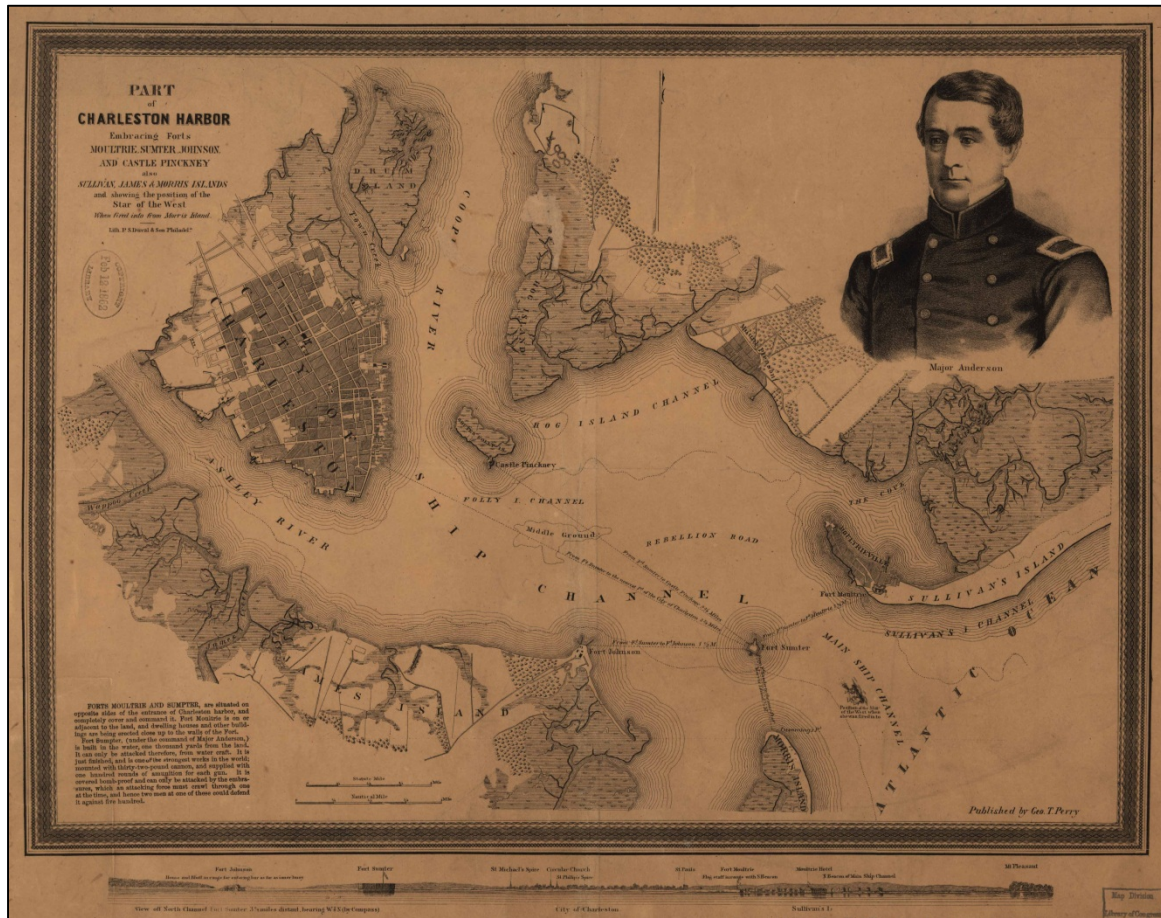
Figure 4.1

Early map showing the Confederate defenses of Charleston Harbor, published 1861. *Part of Charleston Harbor Embracing Forts Sumter, Johnson, and Castle Pinckney*. Map. Philadelphia: P.S. Duval & Son, 1861. Library of Congress, *Map Collections*

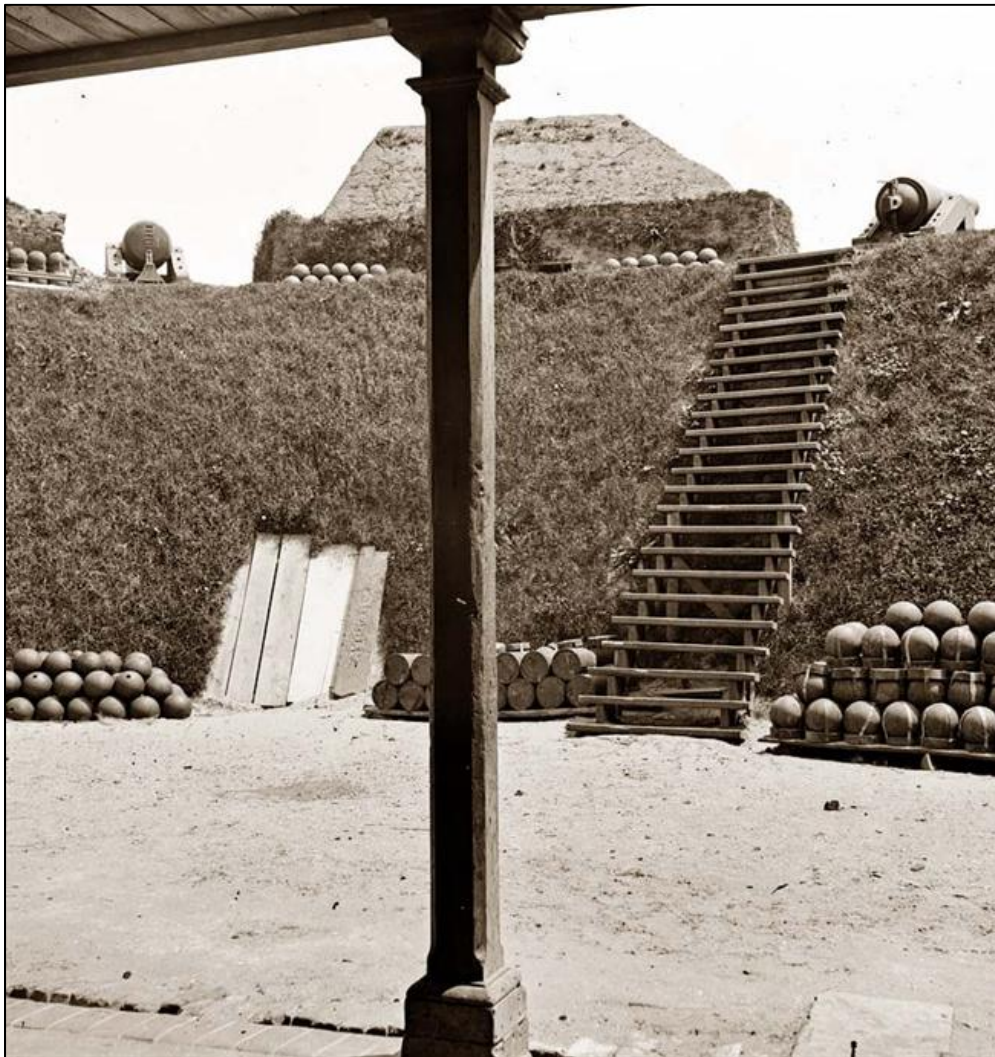
Figure 4.8

Photograph taken from barracks portico facing south, showing Castle Pinckney’s conversion to an earth work, note guns on either side of the large merlon.

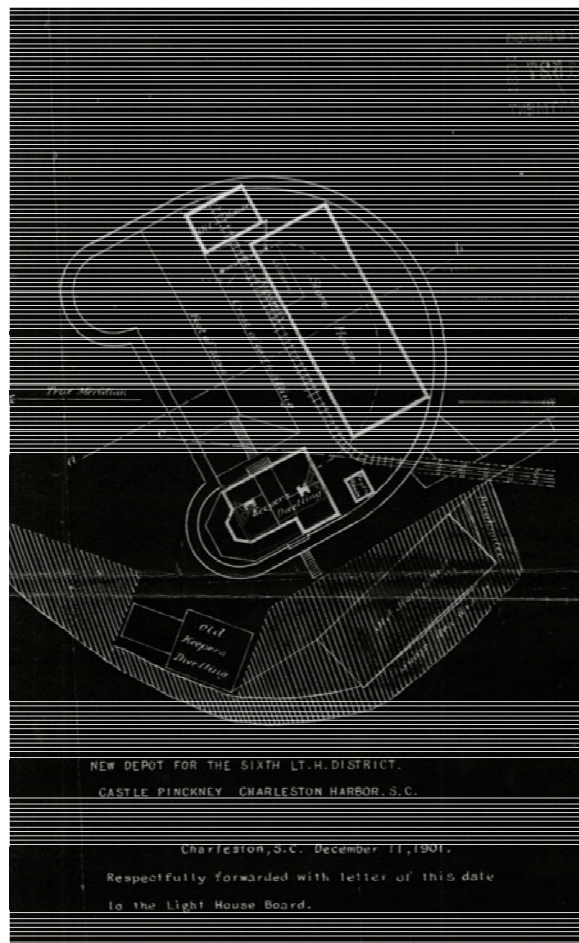
Figure 5.1
1901 plat showing proposed upgrades to fort interior for new light house depot. Note
"old keepers dwelling" and "old storehouse" outside fort.
National Archives I, Records of the Lighthouse Service, 1790 – 1939. Record Group

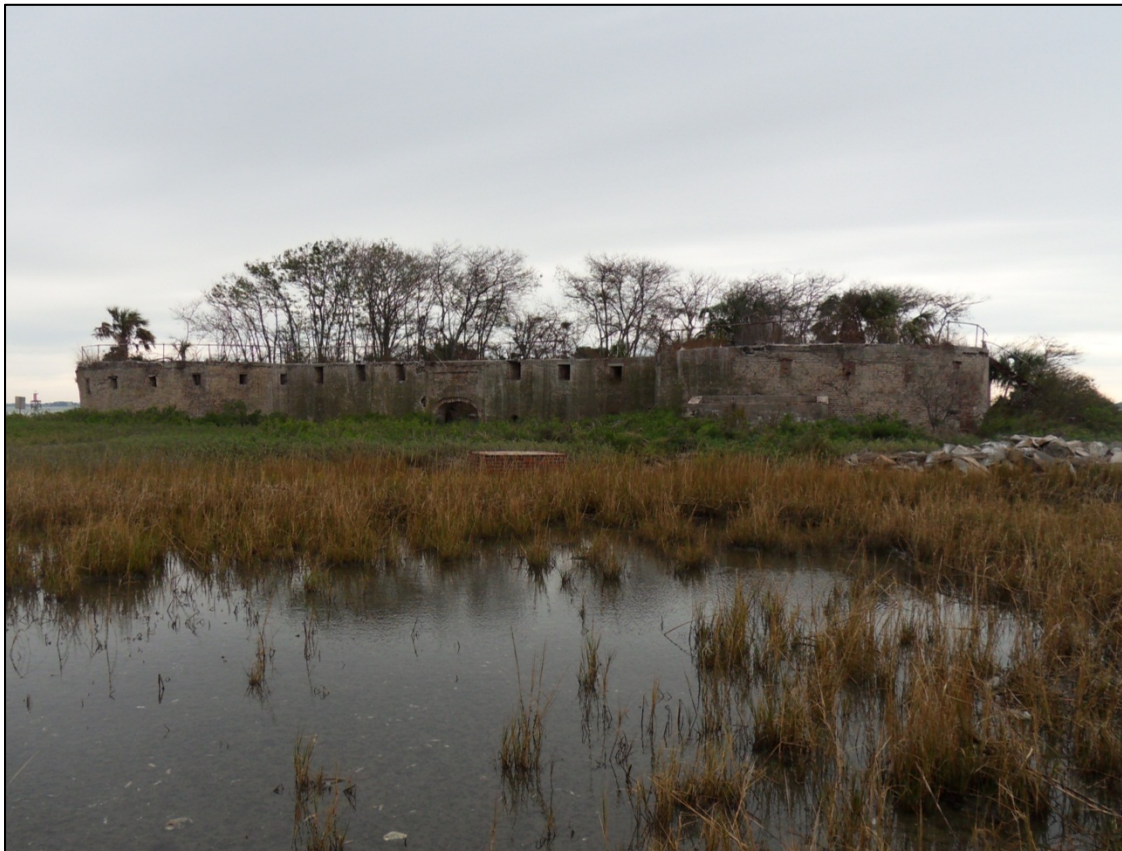
Figure 5.3
Castle Pinckney at high tide, 10 December 2011
Photograph by author

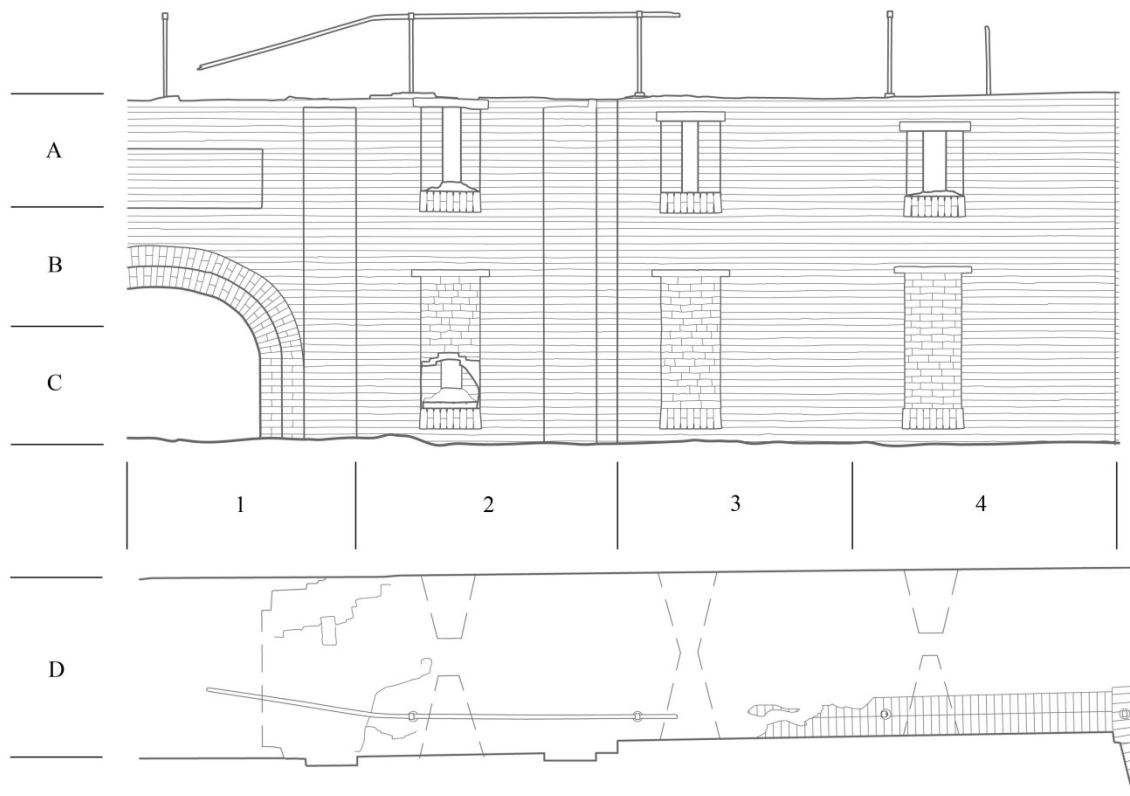
Section 01: North façade

<u>Item No.</u>	<u>Grid Ref.</u>	<u>Defect Description</u>	<u>Size</u>	<u>Comments</u>	<u>Repair Priority</u>
1	1 / A-C to 4 / A-C	Extensive growths of moss and other microflora conceal the condition of the masonry and mortar joints.	400 sf	Cleaning of organic growth is necessary for further assessment of masonry conditions and enabling further work	1
2	1 / A-B	Decay of mortar joints (Figure 7.1: Detail above arch showing)	12 sf	After cleaning, joints should be repointed with appropriate historic mortar mix	2
3	2 / A	Exposed brownstone header	2 sf	Continued exposure will lead to irreparable deterioration. Header should be preserved as part of a plan to consolidate the top of the wall	2
4	2 / D	Large tree growth		The root system of the tree has penetrated the wall interior and caused cracking in the upper portions of the wall.	2
5	2 / A	Open and fractured mortar joints with minor brick displacement	15 linear ft.	Penetrating roots have caused mortar loss and brick displacement	2

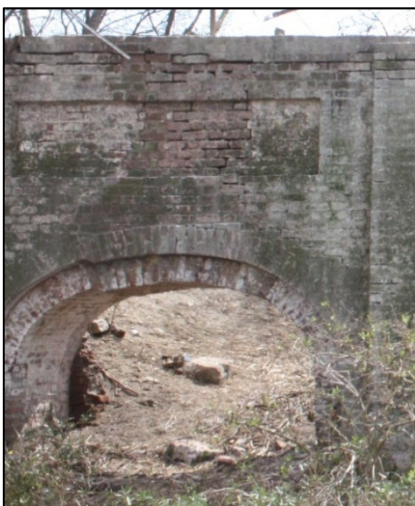
Figure 7.1: Detail above arch showing mortar joint decay and organic growth

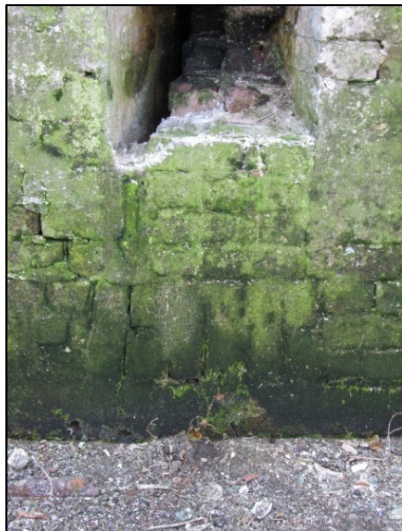
Figure 7.2
The highest proliferation of moss and microflora, at the base of the wall

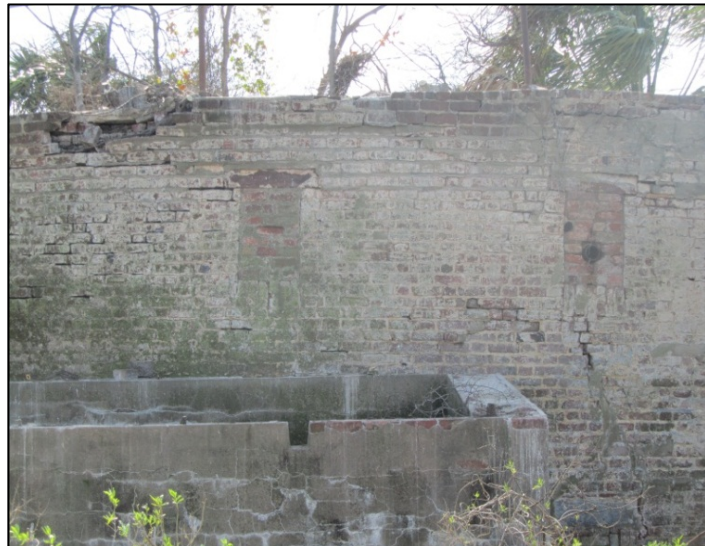
Figure 7.3
Major horizontal and diagonal fracturing and spalling brownstone header

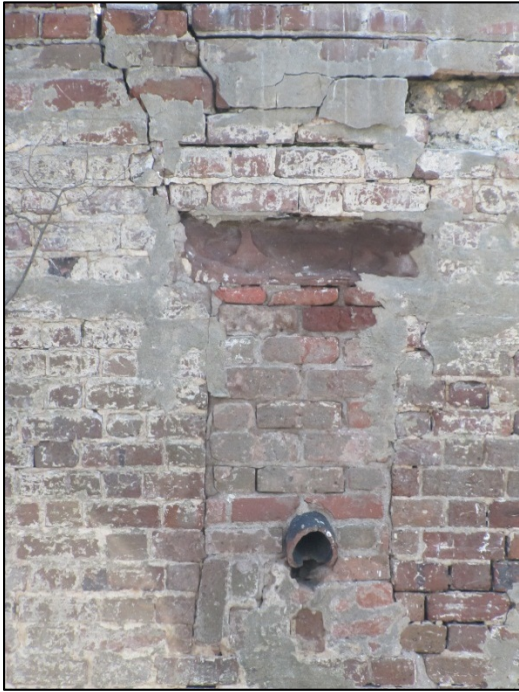
Figure 7.4
Damage caused by Portland cement; spalling
brownstone header and fracturing brick

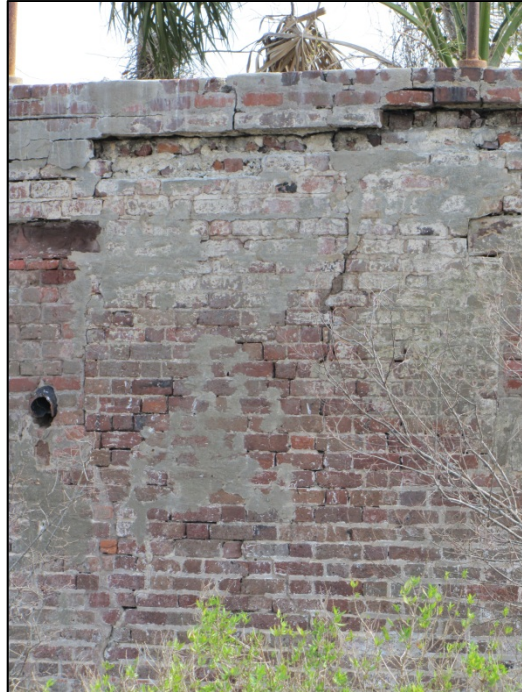
Figure 7.5
Further damage caused by Portland cement;
brick and mortar loss

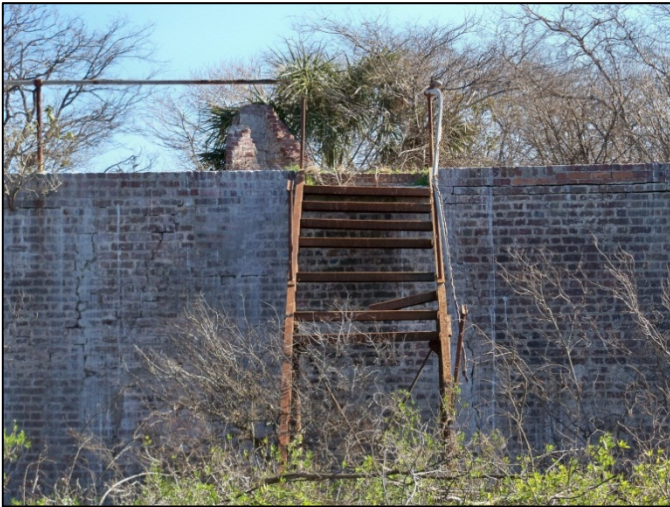
<u>Item No.</u>	<u>Grid Ref.</u>	<u>Defect Description</u>	<u>Size</u>	<u>Comments</u>	<u>Repair Priority</u>
16	1 / A-B, 3 / B-C	Masonry fracturing (Figure 7.7)	10 linear ft	Accelerated settling and wall movement in adjacent sections of the wall is causing stress fractures.	3
17	3 / A to 4 / A	Minor fracturing and decay of mortar joints (Figure 7.7)	25 linear ft	Incompatibility between the modern addition of several courses of brick at the top of the wall and historic bricks have caused fracturing and mortar loss	3

Figure 7.7
Showing both stress fracturing and fracturing due
To incompatible masonry

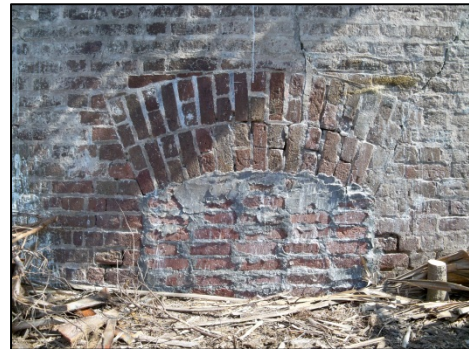
Figure 7.6
Bricked up opening

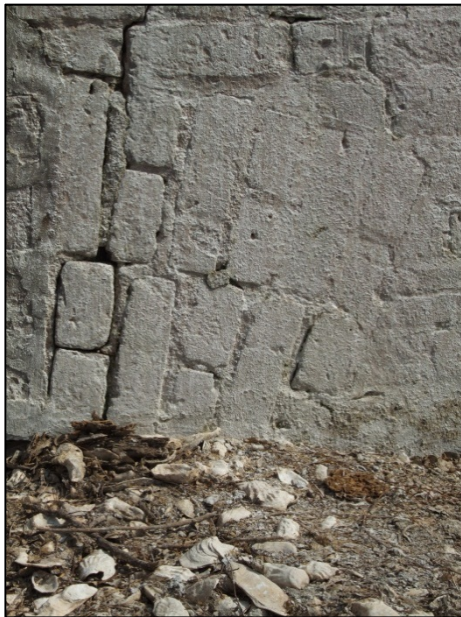
Figure 7.8
Showing heavy guano accumulation

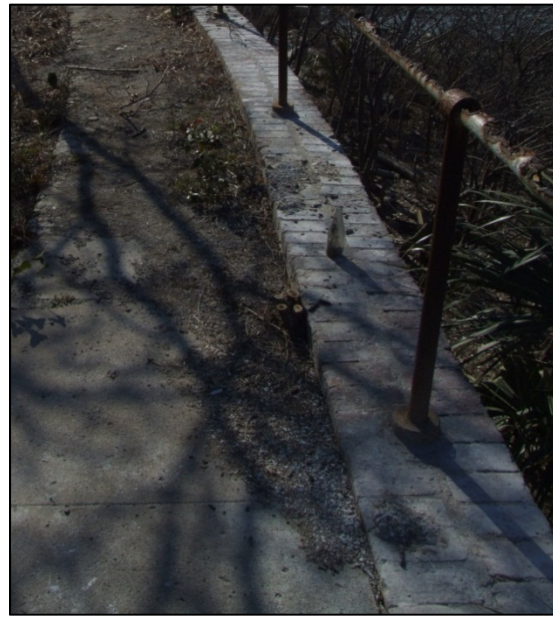
Figure 7.9
Large tree growth on top of wall

<u>Item No.</u>	<u>Grid Ref.</u>	<u>Defect Description</u>	<u>Size</u>	<u>Comments</u>	<u>Repair Priority</u>
18	1 / A	Minor fracturing and mortar joint decay		Large plant growth on top of the wall has caused minor fracturing and mortar loss	3
19	3 / C to 4 / C	Stress fractures above opening	6 linear ft	Settling and the weight of the above wall have caused stress fractures in the brick arch and above	2
20	2 / A-C to 4 / A-C	Pelican soiling (Figure 7.8)	225 sf	Use of the structure as a pelican nesting ground as led to an abundance of guano, a deteriorative substance which conceals masonry conditions beneath	1
21	1 / D to 4 / D	Large tree growth (Figure 7.9)		Tree root systems have penetrated the masonry joints	2

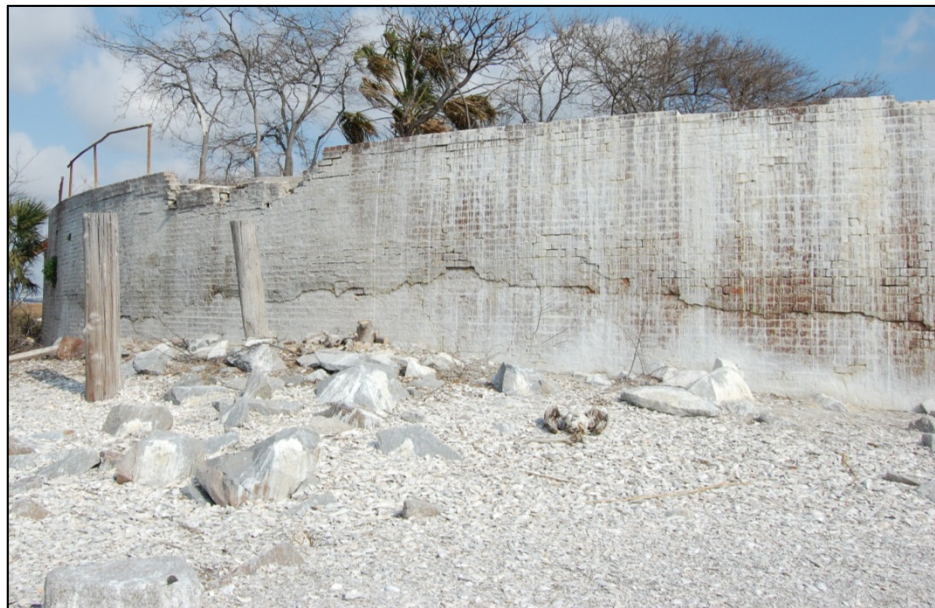
<u>Item No.</u>	<u>Grid Ref.</u>	<u>Defect Description</u>	<u>Size</u>	<u>Comments</u>	<u>Repair Priority</u>
22	1 / B-C to 4 / B-C	Major fracture	45 linear ft	Significant settling and outward pressure from the interior earth fill appears to be the cause of massive fracturing which could likely lead to catastrophic failure	1
23	1 / A to 2 / A, 1 / D to 2 / D	Major fracturing and masonry displacement	48 sf	Modern alterations have damaged the top and face of the wall, leaving the wall interior exposed and leading to accelerated fracturing and decay	2
24	4 / A-B	Missing brick	15 sf	Cause of missing brick patch is unknown. Evidence suggests impact damage, has left the wall interior exposed	2
25	1 / A-C to 4 / A-C	Pelican soiling		Nearly the entirety of section 07 is covered with a heavy accumulation of pelican guano	1
26	1 / A to 4 / A, 1 / D to 4 / D	Minor fracturing, masonry displacement, mortar joint decay		Small to large plants have taken root in much of the top of the wall causing fracturing and decay	2

Figure 7.10
Showing major horizontal fracture

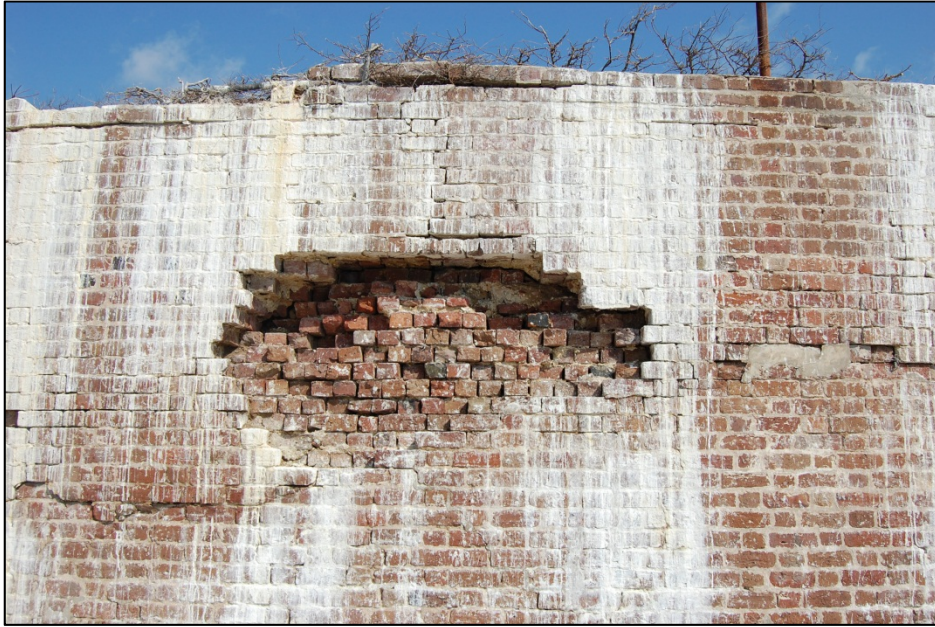
Figure 7.11
Showing missing brick patch. Damage caused by vegetation at top of wall is visible

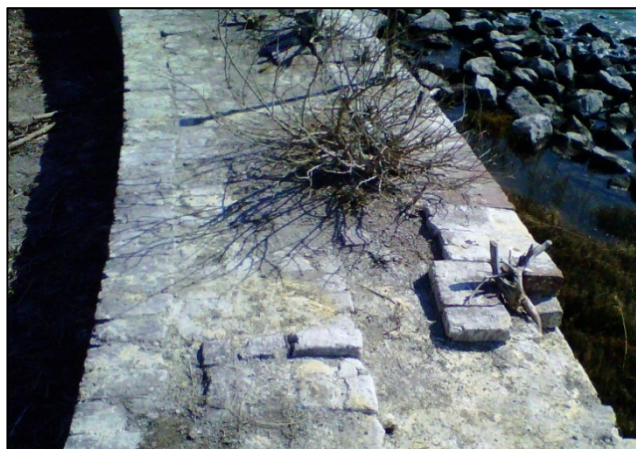
Figure 7.13
Invasive plant growth

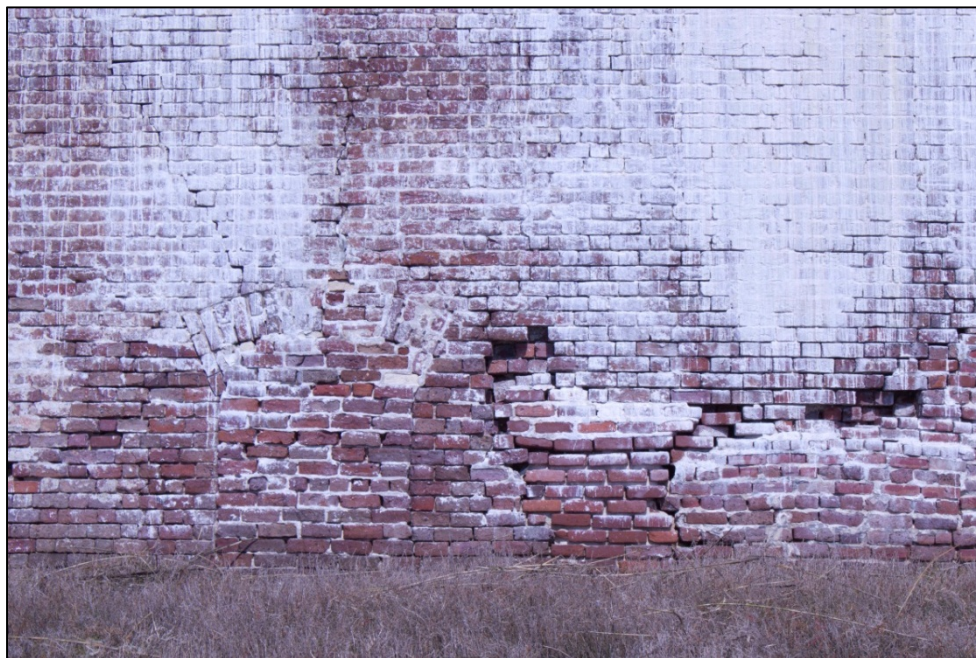
Figure 7.14
Showing diagonal fracturing above embrasure arch and adjacent under fired brick erosion

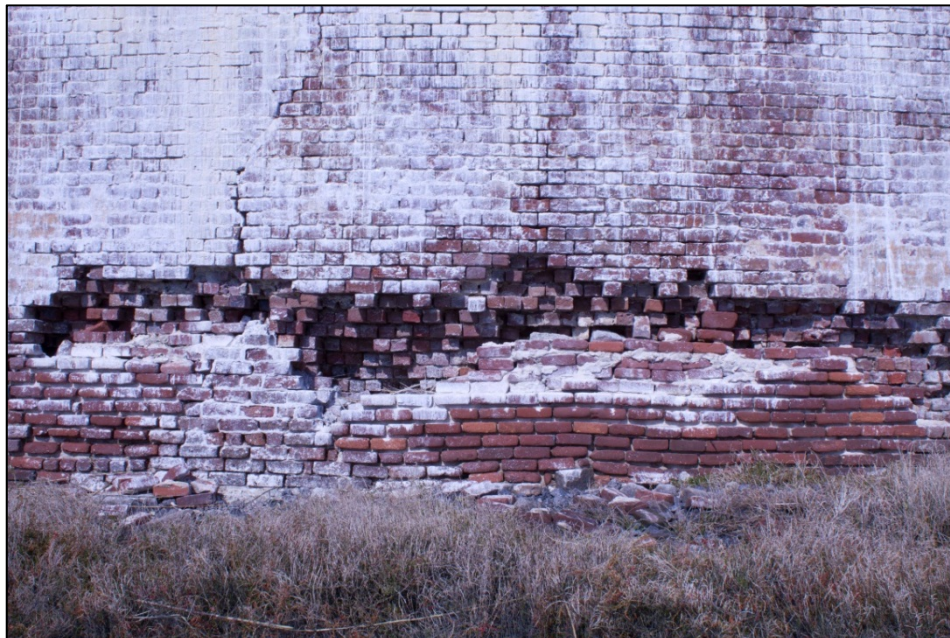
<u>Item No.</u>	<u>Grid Ref.</u>	<u>Defect Description</u>	<u>Size</u>	<u>Comments</u>	<u>Repair Priority</u>
38	1 / C to 4 / C	Severe masonry erosion and displacement (Figure 7.15)	120 sf	The combination of wave action and under fired bricks have led to major erosion and brick loss causing instability in adjacent areas of the wall	1
39	1 / B to 4 / B	Major diagonal fracturing (Figure 7.15)		Masonry failure at the base of the wall is causing stress fracturing in the area above	1
40	4 / B-C	Missing bricks (Figure 7.15)		Masonry displacement on the surface of the wall, caused by erosion, fracturing, settlement, and mortar joint decay have led to exposure of wall interior	2
41	1 / A-C to 4 / A-C	Pelican soiling		Much of section is covered with a heavy accumulation of pelican guano, concealing masonry conditions beneath	1
42	1 / A to 4 / A, 1 / D to 4 / D	Fracturing and masonry displacement		Fracturing at the top of the wall due to erosion and invasive plant growth	2

Figure 7.15
Showing erosion caused by water at base of the wall, and resultant brick loss and stress fracturing

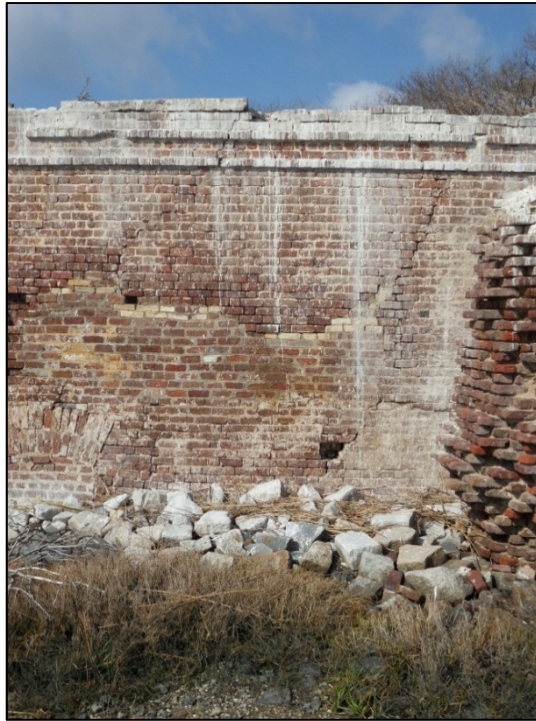
<u>Item No.</u>	<u>Grid Ref.</u>	<u>Defect Description</u>	<u>Size</u>	<u>Comments</u>	<u>Repair Priority</u>
43	1 / A-B to 2 / A-B	Major diagonal fracturing (Figure 7.16)	16 linear ft	Part of the wall in this section has been relaid with a Portland cement mortar, causing the surrounding masonry to fracture	2
44	1 / A-B to 2 / A-B	Portland cement repair	20 sf	A modern Portland cement repair is causing damage to the surrounding masonry due to incompatibility and differential movement	2
45	2 / A-C to 4 / A-C, 2 / D to 4 / D	Unstable masonry (Figure 7.17)		The large additional exterior masonry wall was never intended to be exposed and is susceptible to rapid erosion and decay	2
46	1 / A to 4 / A, 1 / D to 4 / D	Fracturing and masonry displacement		Fracturing at the top of the wall due to erosion and invasive plant growth	2

Figure 7.16
Showing Portland cement patch and adjacent
diagonal fracturing

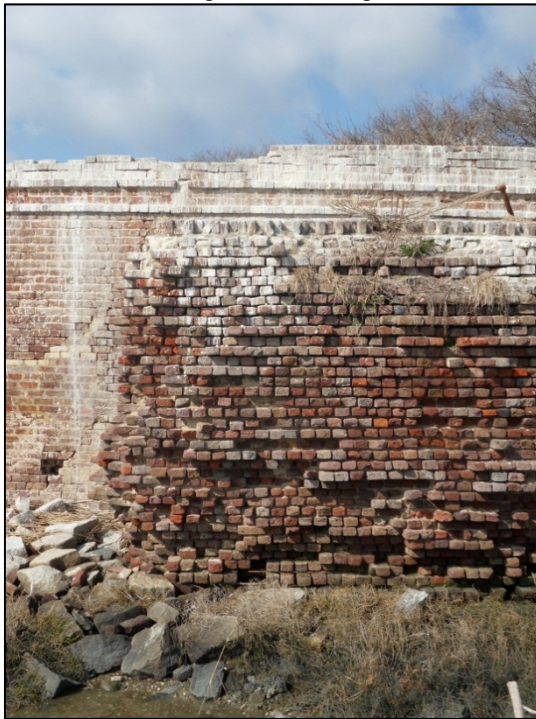
Figure 7.17
Showing unstable outer masonry wall

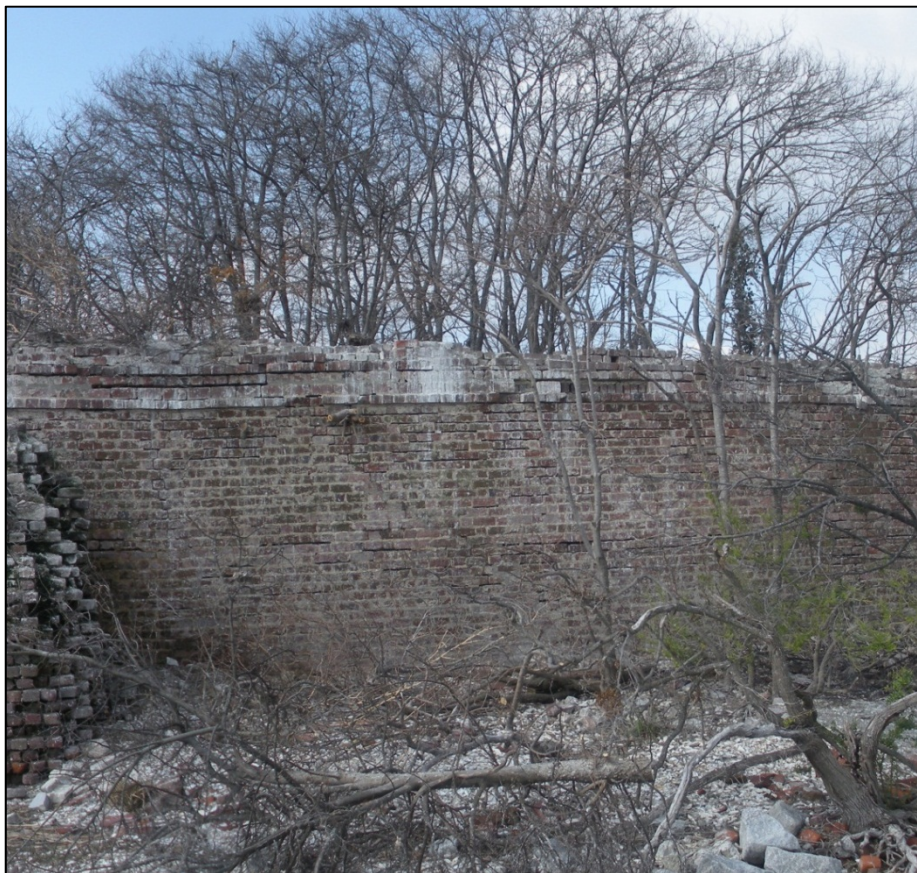
Figure 7.18
Showing extensive large tree growth and resultant deterioration of masonry at the top of the wall

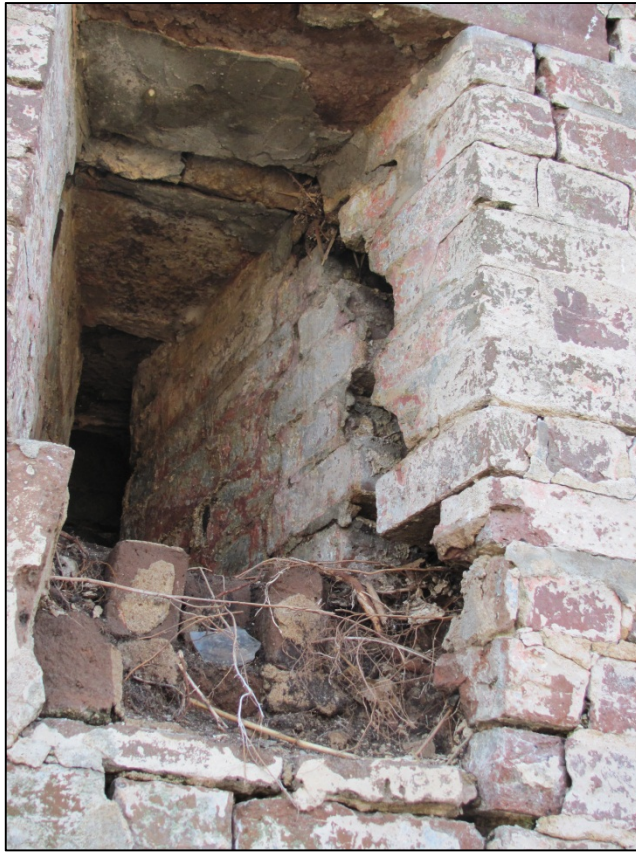
Figure 7.19
Showing large stress fracture in opening

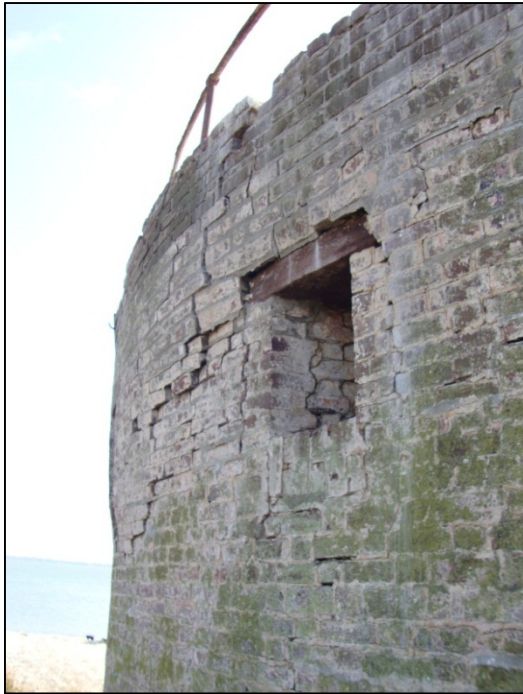
Figure 7.20
Showing wall leaning and fracturing due to settlement

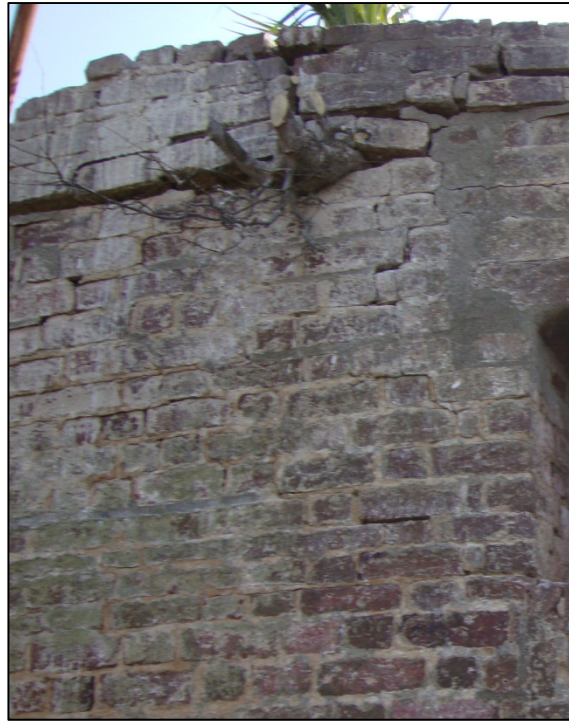
Figure 7.21
Showing large plant growth and resultant fracturing

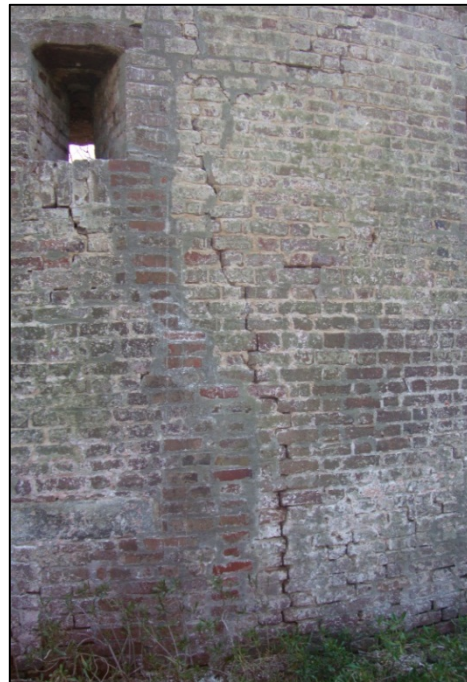
Figure 7.22
Showing fracture paralleling modern brick patch

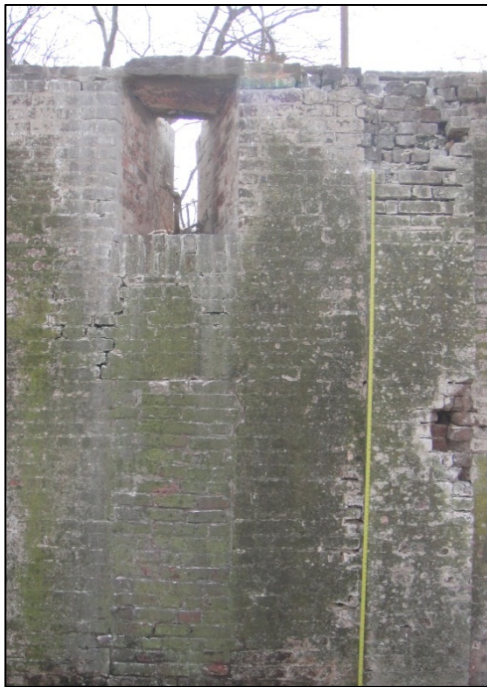
Figure 7.23
Showing exposed brownstone header and brick displacement

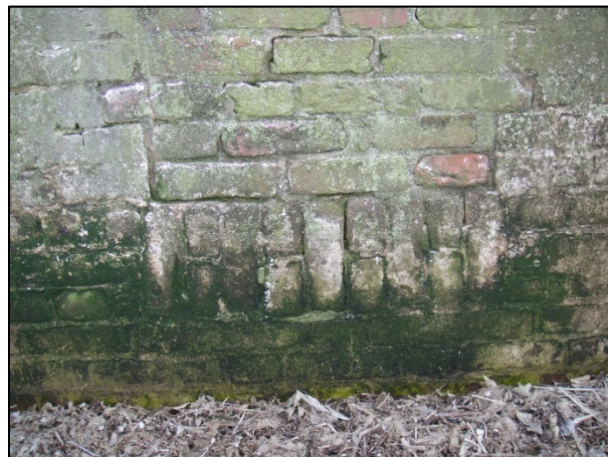
Figure 7.24
Showing moss growth

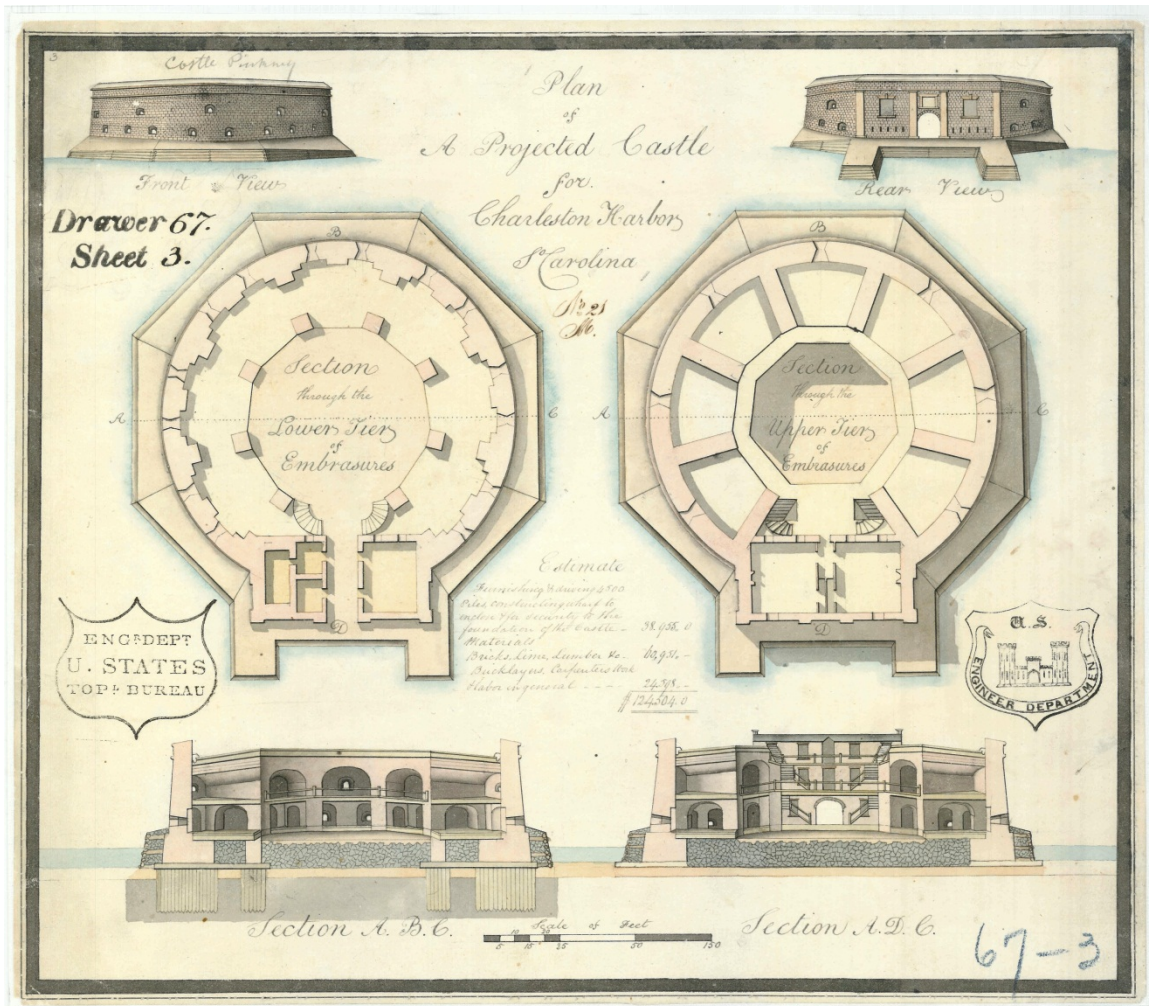
Figure B.1
 "Plan of Projected Castle for Charleston Harbor." Drawing by unknown, date unknown. Drawing shows an early design for a new castle style fort in Charleston Harbor. It is likely a precursor to the final design for Castle Pinckney. National Archives II, Cartographic and Architectural Records, RG 77, Dr. 67, Sheet 3

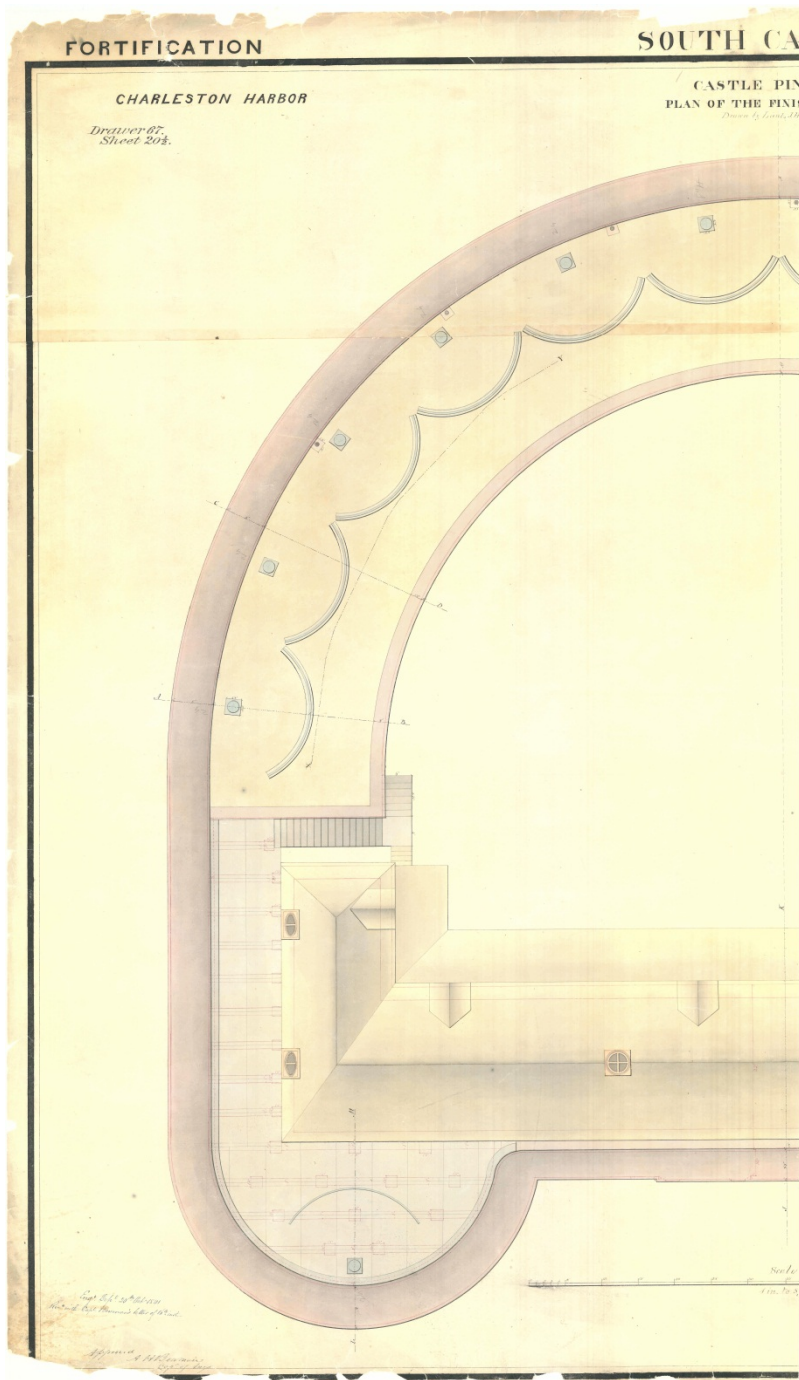
Figure B.13.1
 “Castle Pinckney, Plan of the Finished Work.” Drawn by Lieut. James H. Trapier, 1841. After several years of planning and studies, these drawings are a remarkably complete and detailed documentation of Castle Pinckney after its thorough repair. Figures B.13.1 and B.13.2 show the barbettes, roof plan, and platforms. National Archives II, Architectural and Cartographic Records, RG 77, Dr. 67, Sheet 20.5 (1)

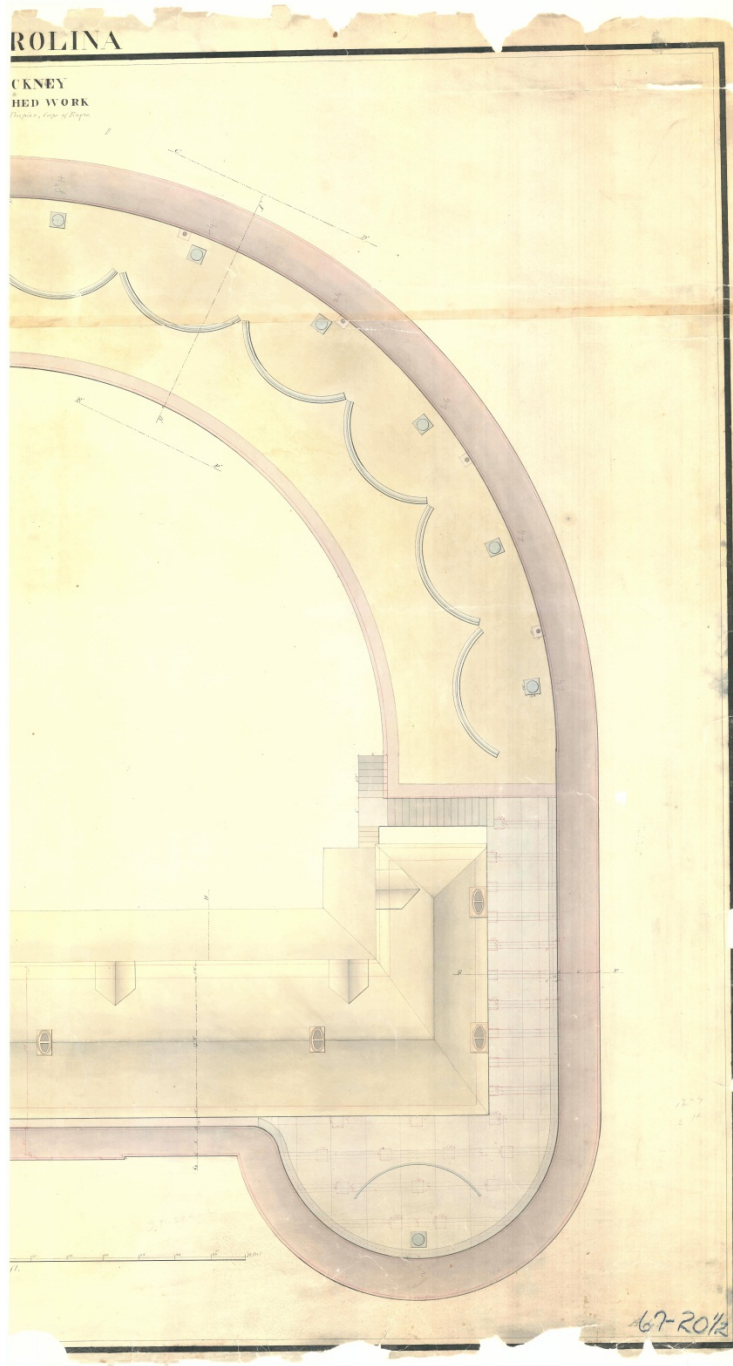
Figure B.13.2
"Castle Pinckney, Plan of the Finished Work." Drawn by Lieut.
James H. Trapier, 1841. National Archives II, Architectural and
Cartographic Records, RG 77, Dr. 67, Sheet 20.5 (2)
