Castle Pinckney: Past, Present, Future

A Thesis
Presented to
The Graduate Schools of
Clemson University and the College of Charleston

Chapter Seven - Conditions Survey

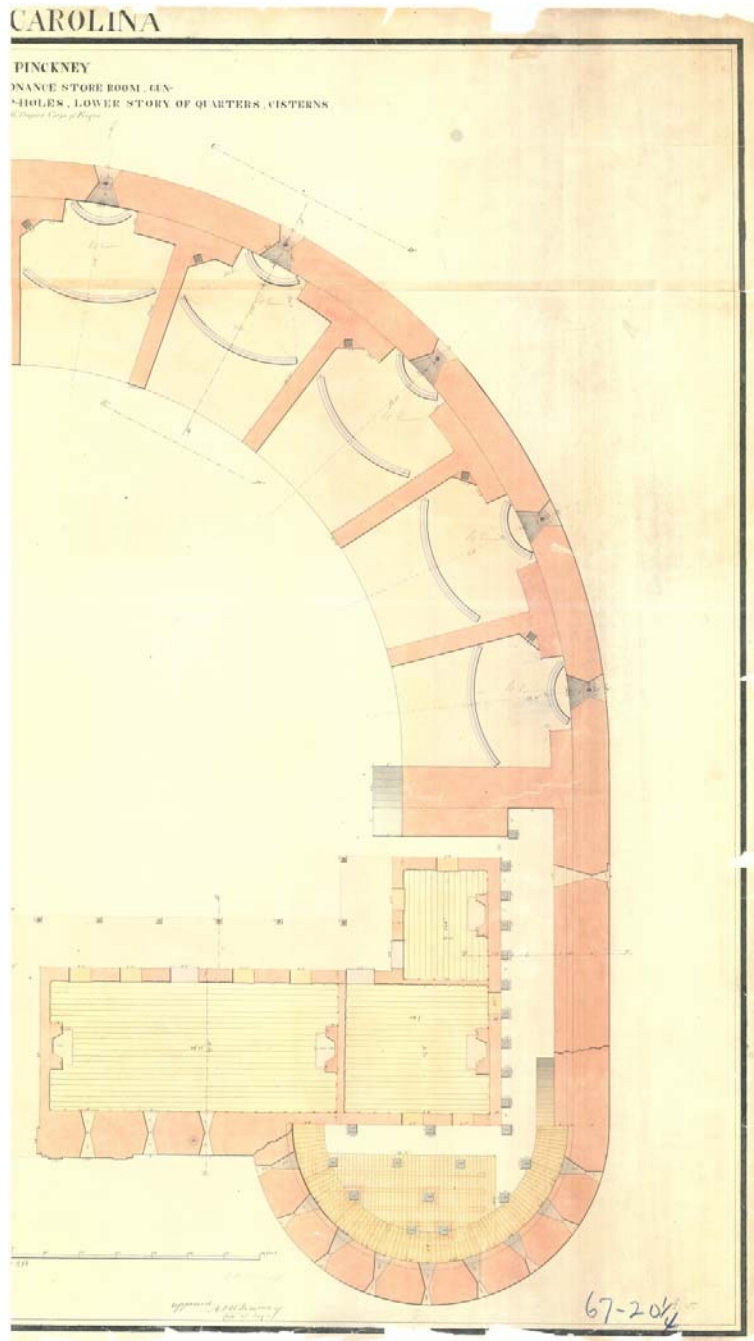
Figure B.14.2
"Castle Pinckney, Plan of the Magazine, Ordnance Store Room, Gun Casemates, Upper and Lower Tier of Loop Holes, Lower Story of Quarters, Cisterns." Drawn by Lieut. James H. Trapier, 1841. National Archives II, Architectural and Cartographic Records, RG 77, Dr. 67, Sheet 20.25 (2)
