APPLICATION OF BAMBOO FOR FLEXURAL AND SHEAR REINFORCEMENT IN CONCRETE BEAMS

A Thesis
Presented to
the Graduate School of
Clemson University

In Partial Fulfillment
of the Requirements for the Degree
Master of Science
Civil Engineering

by
Nathan Alan Schneider
August 2014

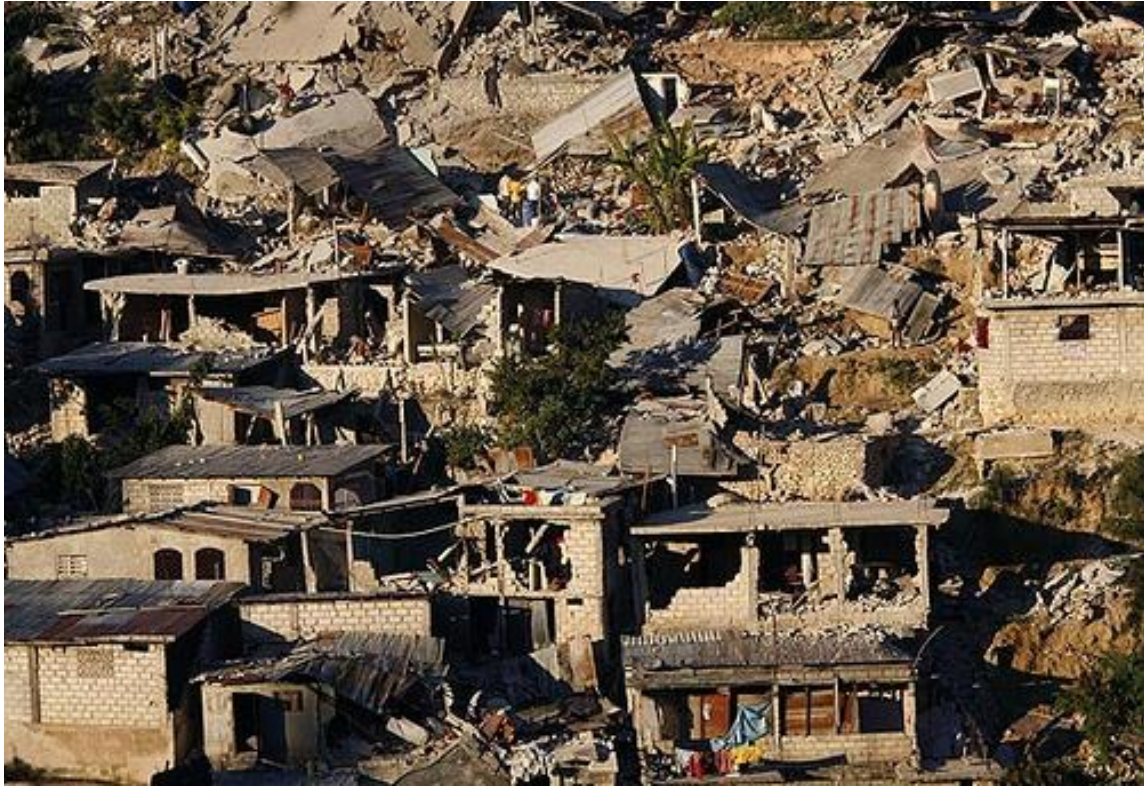
Figure 2.2 Earthquake damage
(LA Times)

Immediately following the earthquake, international engineering teams traveled to Port-au-Prince to investigate the nature and cause of the structural failures. The catastrophic damage resulted from poor construction methods and materials, including improper use of steel reinforcement. Unreinforced concrete masonry walls were observed

to have collapsed under out-of-plane loading. The damage from the earthquake can be seen in Figure 2.2.

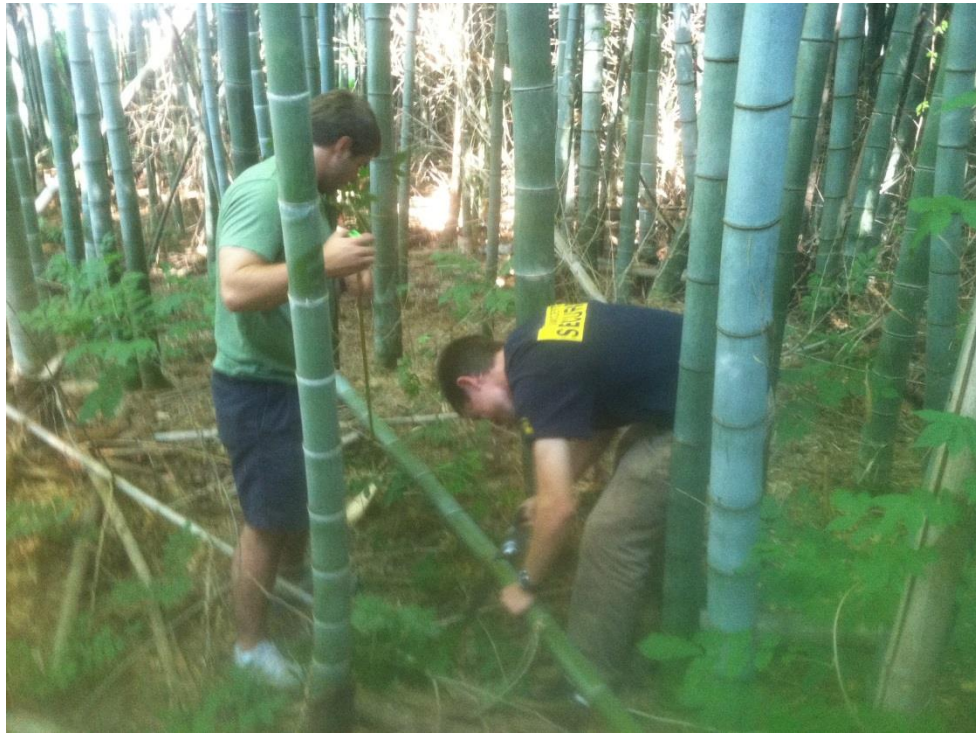
Figure 4.1 Harvesting Moso bamboo from the Clemson Experimental Forest

Harvesting was done with a hand saw and a machete. The skin of the bamboo is very hard and the machete is ineffective to cut through the entire culm. The machete was used to remove the small branches protruding out from the nodal regions of the culm. When cutting the bamboo it is important to cut just to the outside of a node. This ensures that the final bamboo stalk has nodes very near both of its ends. The nodes, which contain the diaphragms separating the internodal regions, prevent longitudinal cracks from emerging and spreading over the length of the culm. The reinforcement provided by the nodes is important when splitting the bamboo. While harvesting, the longitudinal bamboo was cut to roughly 8 feet (2.5-m) and the stirrup bamboo was cut to approximately 5 feet (1.5-m). Later, the bamboo was cut down to its required length. Figure 4.1 shows the bamboo being harvested from the Clemson Experimental Forest.

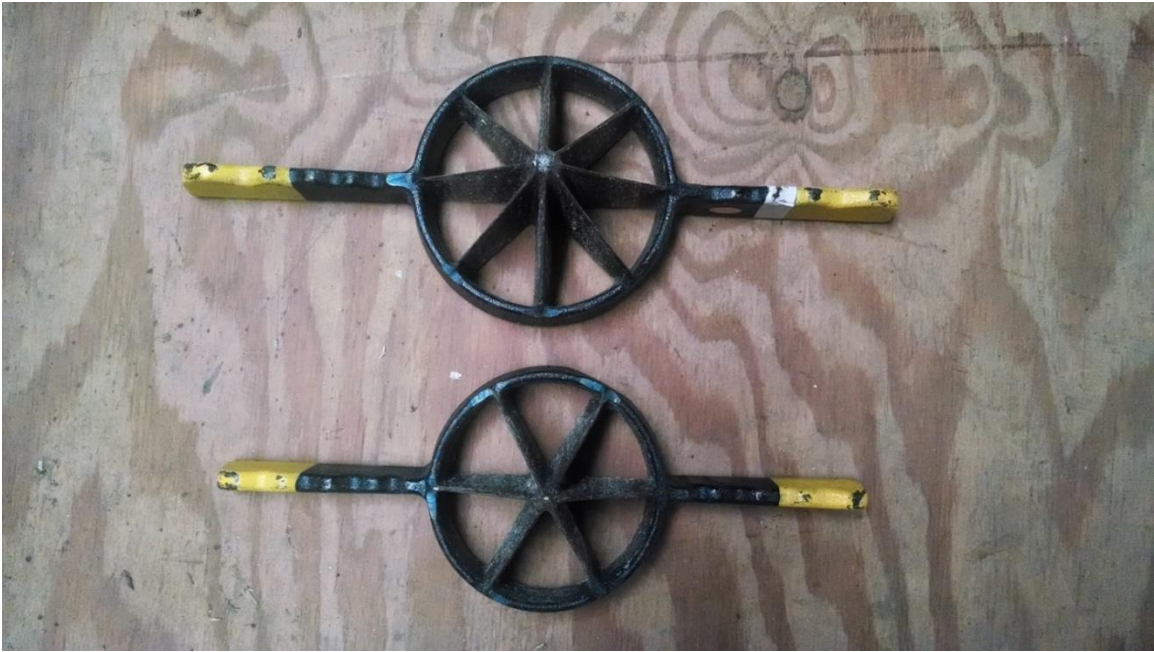
Figure 4.2 Bamboo splitters, 6-cut and 8-cut

Bamboo splits very easily along its fibers which run parallel to its length. There are many methods of splitting bamboo with relatively any sharp blade, but for this research the splitting was done with manufactured bamboo splitters. The splitters were purchased from Hida Tool & Hardware Co.⁴ A picture of the two bamboo splitters used can be seen in Figure 4.2. The 6-cut splitter had an inside diameter of 4 inches (102-mm) and the 8-cut splitter had an inside diameter of 4.5 inches (114-mm). The largest diameter bamboo which could be split was 3.5 inches (90-mm) in the 8-cut splitter with inside diameter of 4.5 inches (114-mm). During the splitting process, the bamboo spreads out, so the bamboo must be at least 1 inch (25-mm) smaller than the inside diameter of the splitter to prevent it from getting stuck. Both splitters were used to achieve uniform strip widths of about 1 inch (25-mm) for the longitudinal bamboo and about 0.75 inches (19-mm) for the stirrups. The average cross-sectional area of the longitudinal bamboo was 0.31 square inches (200-mm²) which is the same cross sectional area as an imperial #5 rebar. The average cross sectional area of the stirrups was 0.20 square inches (129-mm²) which is the same cross sectional area as an imperial #4 rebar. Splitting should be done within a few days after harvesting to prevent the bamboo from drying out which causes longitudinal cracks to form.

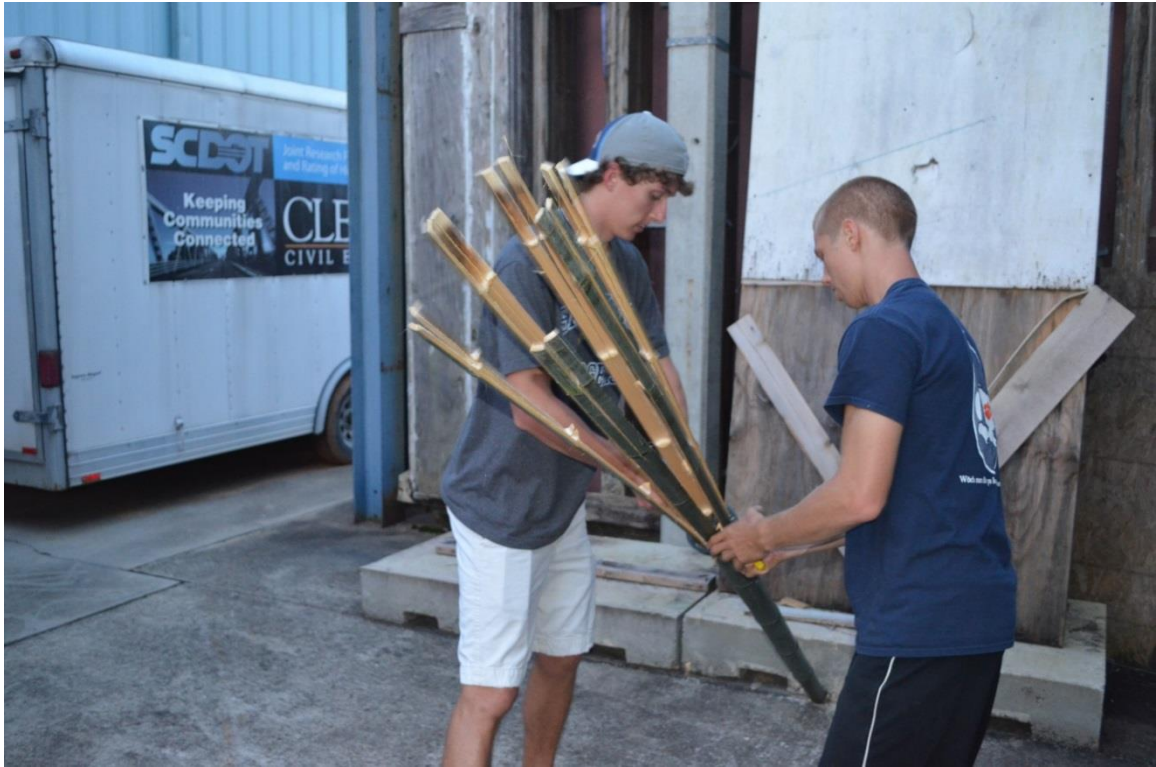
Figure 4.3 Splitting technique

To split the bamboo, two people are needed. One holds the bamboo culm steady against an immovable object while the other person hammers the bamboo splitter into the end of the culm to start the splitting. It is necessary to center the splitter on the culm or the result will be strips of varying widths. Also, since the splitters are made from cast iron, it is necessary to not strike the splitter directly with a hammer, but rather to strike a wooden block placed on the splitter. After the initial split has started, the splitter should be held tightly and the bamboo culm should be forcefully pounded into the ground or an immovable object to finish the splitting. The splitting technique can be seen in Figure 4.3.

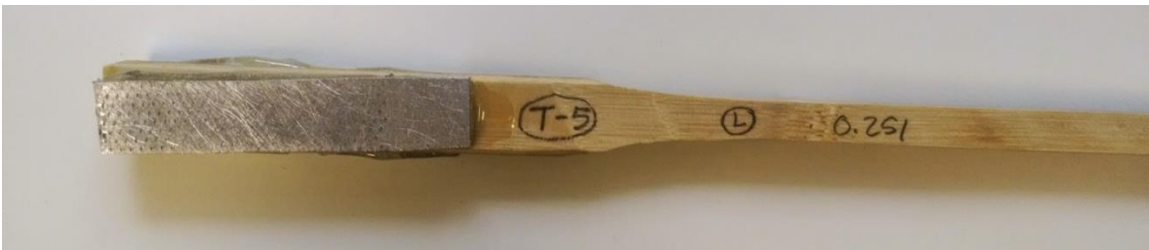
Figure 5.2 Epoxied end tab, front view

Aluminum tabs with a thickness of 0.1 inch (2.5-mm) were epoxied to the ends of the bamboo specimens to prevent the UTM grips from crushing the bamboo. The width and length of the aluminum end tabs varied but were roughly 0.5 inch (12.5-mm) wide and 2-inch (50-mm) long. Fully extended, the grips only had an opening of 0.5 inch (12.5-mm) so the bamboo specimens had to be less than 0.3 inch (7.5-mm) thick to ensure they would fit in the grips with the aluminum tabs epoxied on. The epoxy used was Devcon 5-minute, two-part epoxy with a tensile strength of 1500 psi (10.34 MPa). The end tabs can be seen in Figure 5.2 and Figure 5.3. In total, 30 specimens were tested.

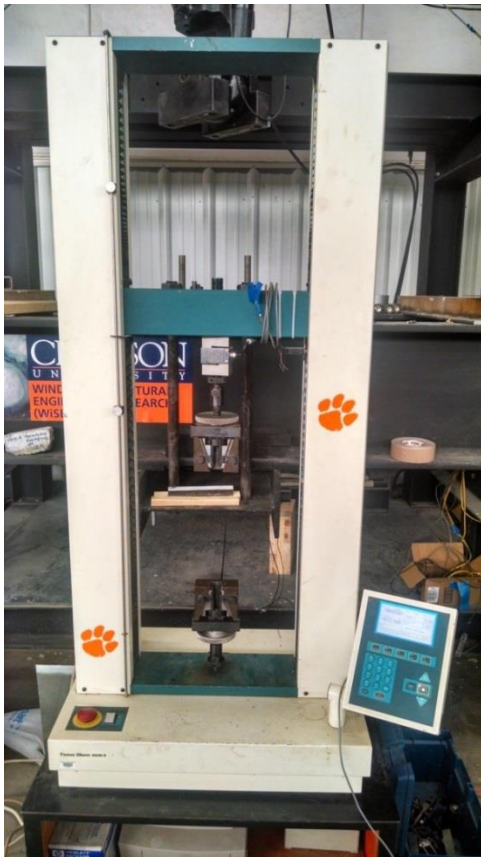
Figure 5.4 Tinius Olsen 10-kip UTM

The specimens were tested in a 10-kip (50 kN) Tinius Olsen UTM, as shown in Figure 5.4, with V-grips. The V-grips are designed to apply more pressure as the specimen is pulled in tension. An enlarged picture of a grip can be seen in Figure 5.5.

The specimens were loaded continuously at a rate of 0.05 in/min (0.02-mm/s) until failure. The resulting force-displacement data was recorded through a MATLAB script written by Dr. Weichi Pang.

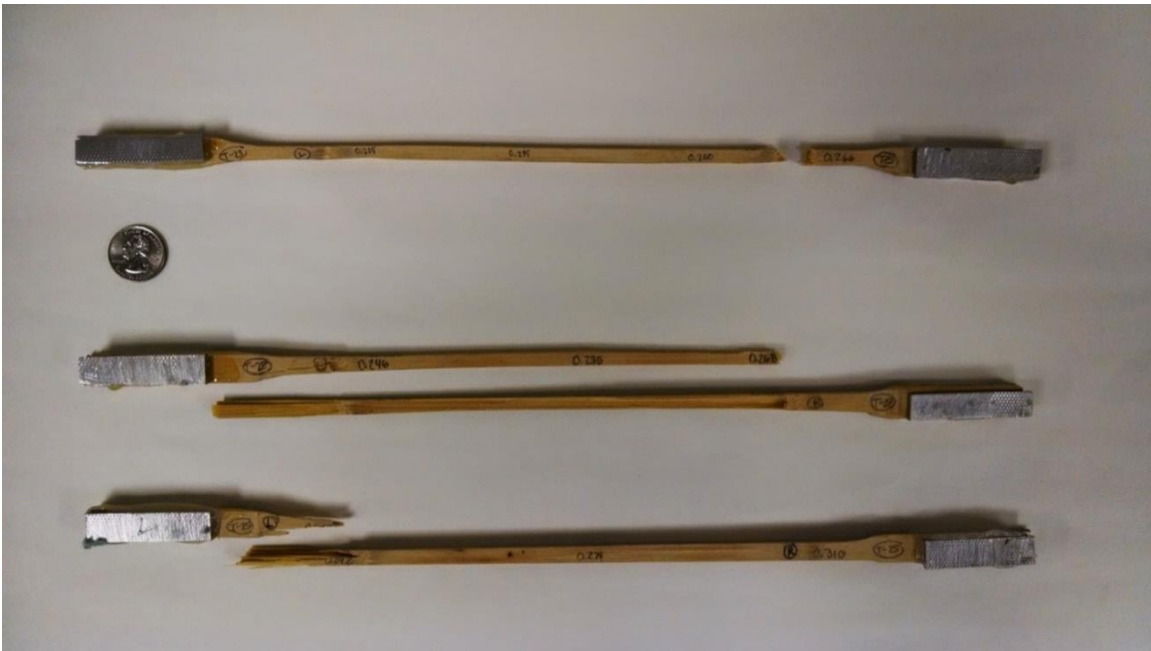
All tensile specimens failed in a brittle manner at a node. This was expected based on reviewing previous literature. Amada (1997) has described the fiber distribution in the nodes to be chaotic, which is an explanation for their brittle behavior. The failure mechanisms of the tensile samples included clean break through node, diagonal split from node to node, and diagonal split from node to tab. The failure modes are shown in Figure 5.6.

Figure 5.6 Tensile specimen failure modes

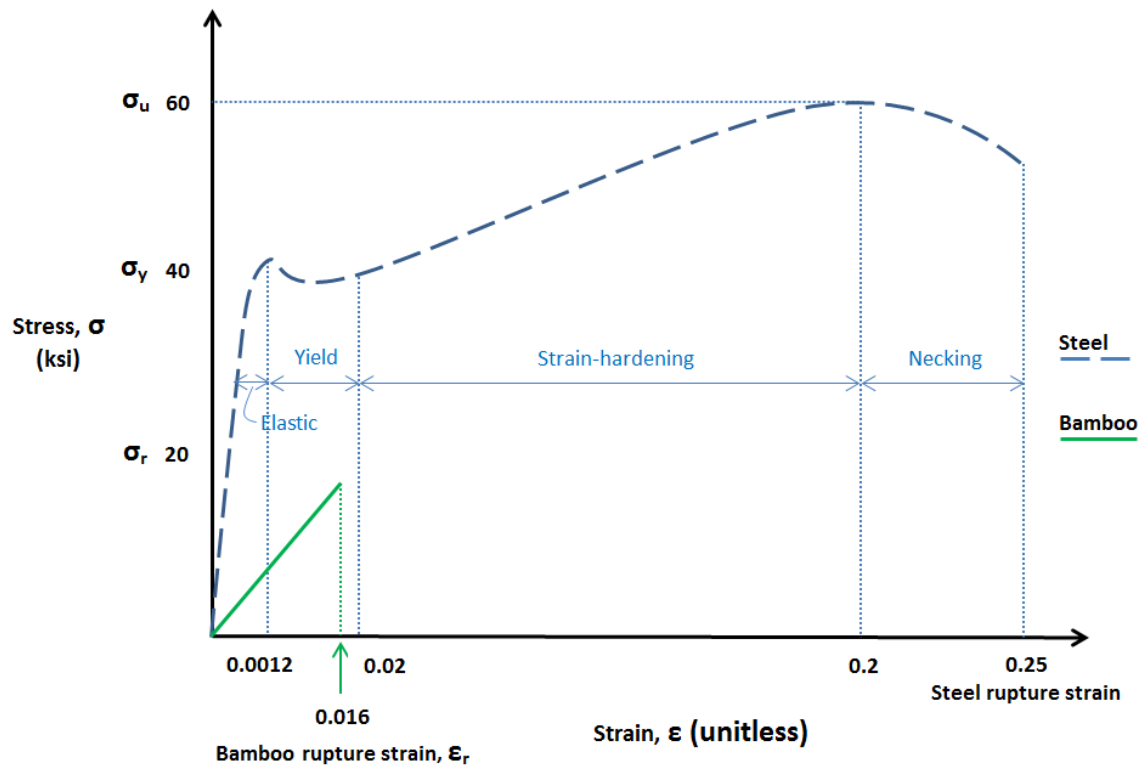
A comparison between the stress-strain curves of bamboo and low carbon steel rebar can be seen in Figure 5.12. It is important to notice the ductile nature of the steel compared to the brittle nature of the bamboo.

Figure 5.12 Comparison of stress-strain curves for low carbon steel and bamboo

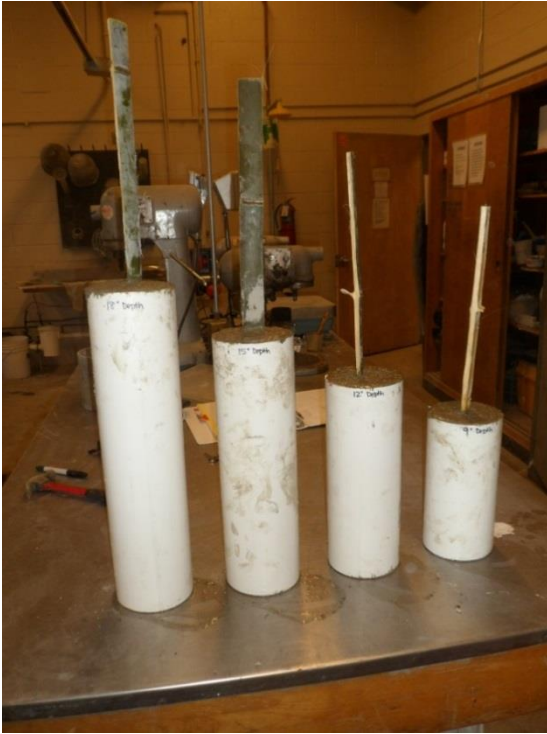
Figure 5.17 Pullout specimen embedment depths

The pullout specimens were similar to the tensile specimens described in Section 5.1.1. However, the bond strength bamboo specimens differed from the tensile specimens in that only one end had a “dog-bone shape.” The other end was straight and was embedded into a 4-inch (102-mm) diameter concrete cylinder. Four different embedment lengths were tested and can be seen in Figure 5.17. The embedment depths included 9 inches (229-mm), 12 inches (305-mm), 15 inches (381-mm), and 18 inches (457-mm).

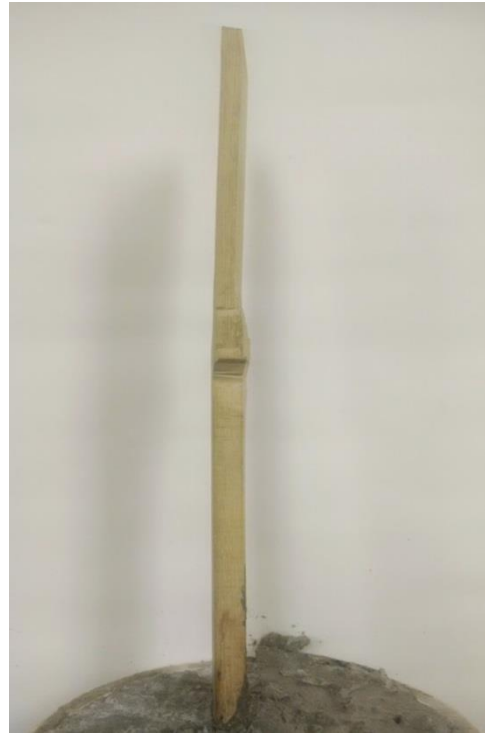
Figure 5.18 Pullout specimen grip end

Similarly to the tensile specimens, the grip ends of the bamboo specimens had to be sanded level to remove the natural curvature of the bamboo so the aluminum tabs could be epoxied to the ends and a tight hold could be achieved in the grips. The grip end of the pullout specimen without the aluminum tabs can be seen in Figure 5.18.

The pullout specimens proved difficult to test. The reduced cross-sectional area of the bamboo at the grip, combined with the concentrated pressure of the grips cutting into the bamboo, facilitated failure at the grip end of the specimens. The reduced cross-sectional area of the pullout specimen can be seen in Figure 5.18.

specimens had a small cross-sectional area and the ultimate stress was achieved at this location, preventing grip failure. A solution to the grip failure problem is to use a harder metal for the end tabs and use thicker tabs. Steel would be a good option since it has a hardness value of between 4.0 – 4.5 on Mohs hardness scale, but steel tabs were not used since all the samples had already been prepared with the aluminum tabs at the time of testing.

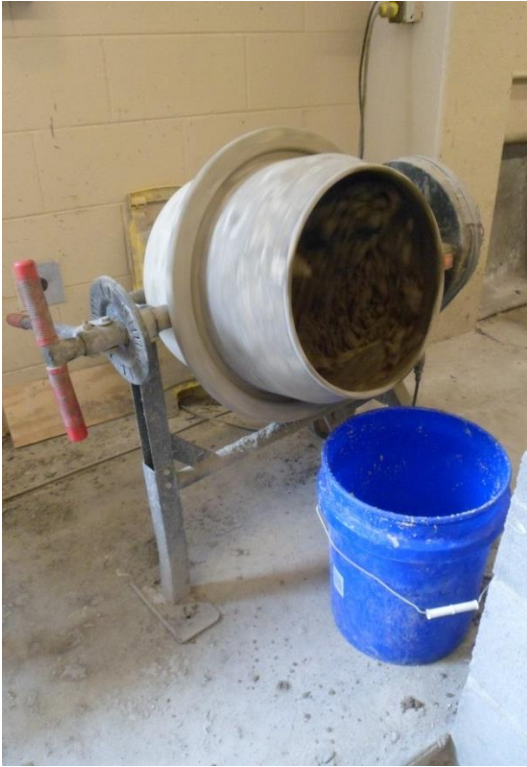
Figure 5.19 Portable concrete mixer

After the bamboo specimens were prepared, they were placed in the PVC pipe which was then filled with either QUIKRETE® Concrete Mix (No. 1101) or the concrete mixture used for the beam specimens. The QUIKRETE® Concrete Mix specimens were mixed in a portable concrete mixer as shown in Figure 5.19. About 9 pt. (4.3 L) of water was added for each 80 lb. bag of concrete as per the mixing instructions. Each specimen was filled in 4-inch (102-mm) layers – with each layer being compacted – before the next layer was added as per ASTM C31. Each specimen was air cured with a damp cloth covering the concrete during the initial curing phase. The phase two pullout specimens can be seen in Figure 5.20. A total of 23 bond strength samples were prepared and tested.

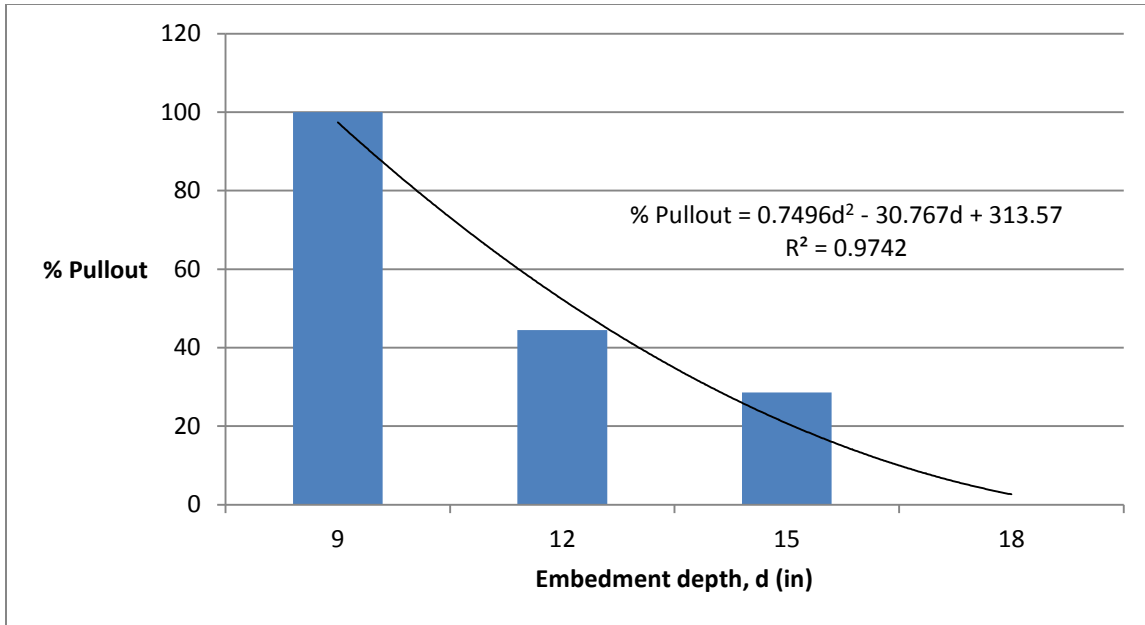
Embedment depth (in)	Total samples	# Pullouts	% Pullout
9	1	1	100
12	9	4	44
15	7	2	29
18	6	0	0

Figure 5.23 % Pullout at different embedment depths

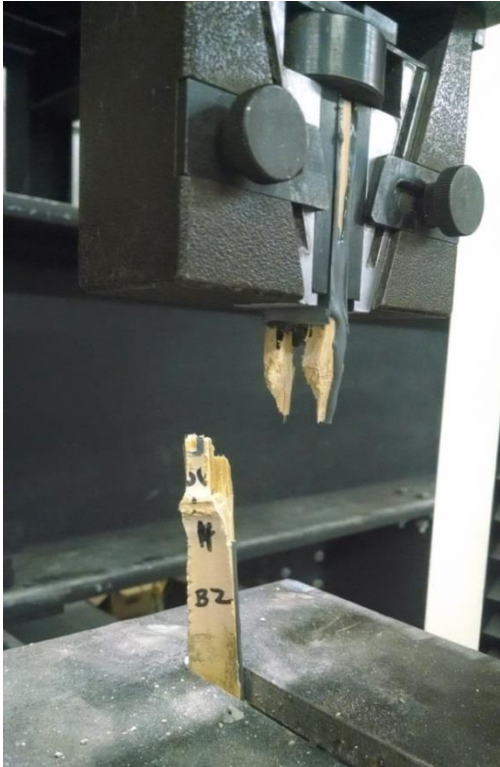
Figure 5.24 Bond specimen grip failure

reached and making these test results inconclusive. Figure 5.24 shows the grip failure for specimen BW 14, while Figure 5.25 shows pullout failure for specimen BW 15.

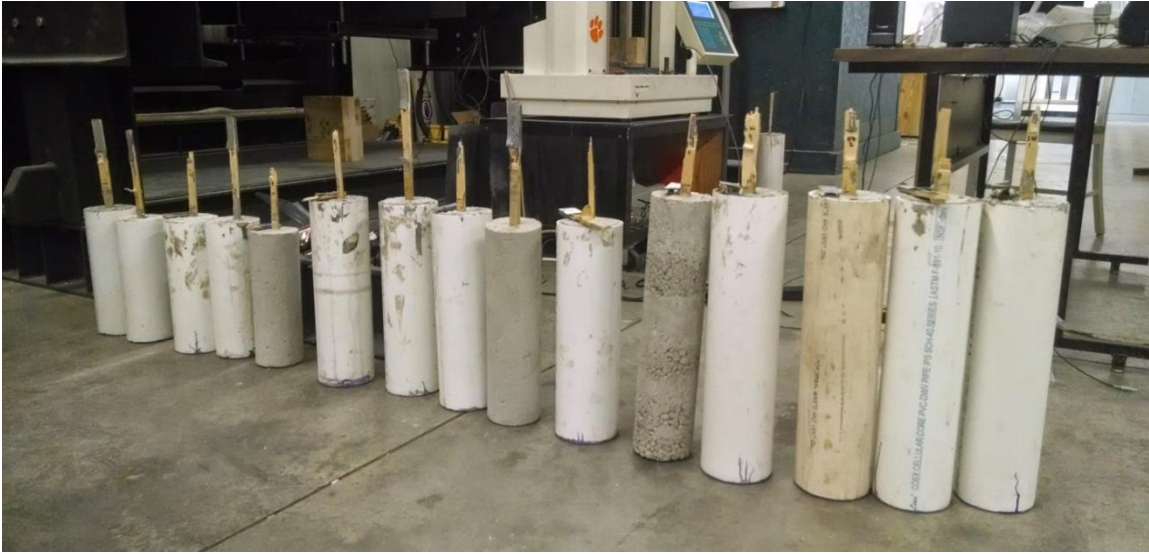
Figure 5.26 Tested bond strength samples

Figure 5.26 shows the tested bond strength samples. The comprehensive data of the bond strength tests can be found in Appendix B.

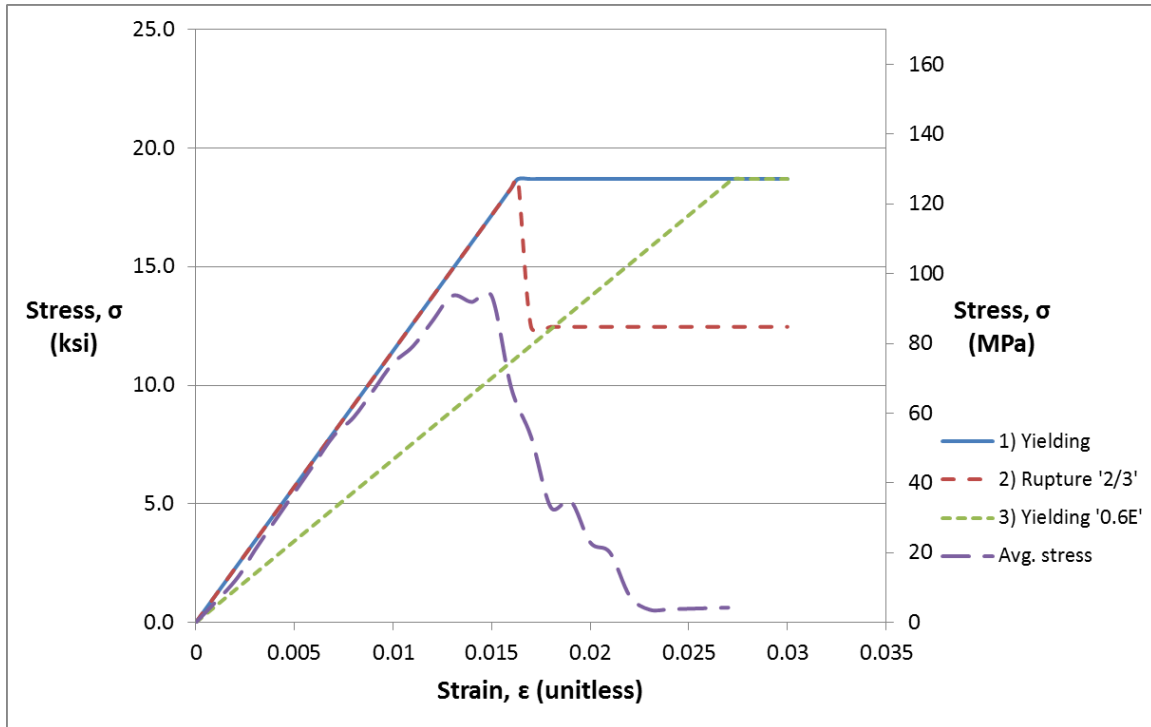
stress-strain diagrams for these models are shown in Figure 6.1 and compared to the results from the component tensile tests (average stress of combined bamboo). The three models were used to predict the capacities of each beam and the results were compared to the actual beam capacities after testing.

Figure 6.1 Stress-strain curves of three bamboo models

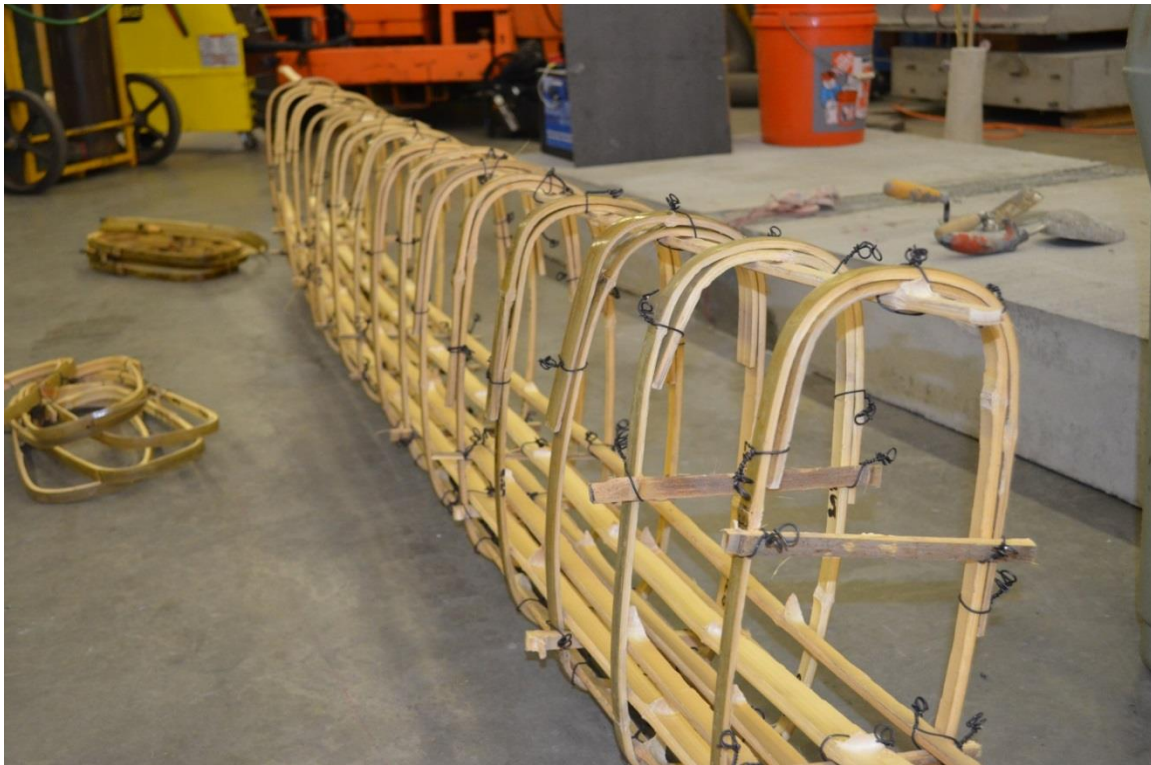
The longitudinal reinforcement was made from 1 inch (25-mm) wide bamboo strips. The average cross-sectional area of the longitudinal bamboo was 0.31 in² (200-mm²) which is the same cross sectional area as an imperial #5 rebar. The bamboo reinforcement cage preparation is described in more detail in Section 6.2.1. The bamboo cage for flexure beam, F1, can be seen in Figure 6.8.

Figure 6.8 Bamboo cage for flexure beam, F1

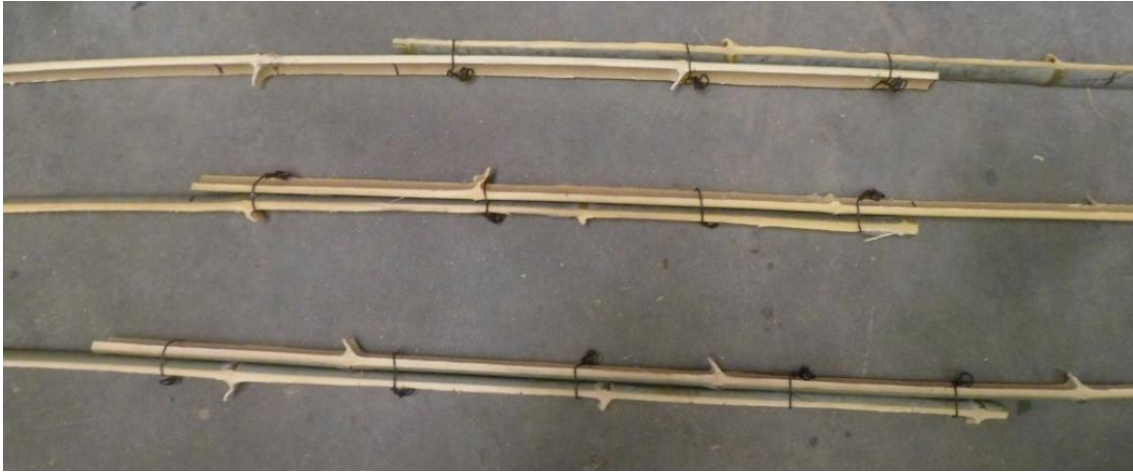
Figure 6.10 Lap-splicing of flexural reinforcement

In this research, three beams were tested using different lengths of lap-splicing for the bottom layer of reinforcement. The lap-splice lengths were chosen based on the results from the component bond strength tests described in Chapter 5. The pullout tests indicated the range of development lengths to be from 15 to 31 inches (38 – 79-cm) with an average of 25 inches (51-cm). Three different lap-splice lengths were chosen to be tested: 12-inch (30-cm), 18-inch (46-cm) and 24-inch (61-cm). Each lap-splice was tied with steel rebar ties spaced at about 5 inches (127-mm). Each lap-spliced beam had 4 layers of flexural reinforcement and had stirrups spaced at 6 inches (152-mm) with the exception of along the splice, where the stirrup spacing was 4 inches (102-mm). The lap-spliced beam testing matrix can be seen in Table 6.8 and the three varying splice lengths of the bamboo can be seen in Figure 6.10.

* Note: Lap-splice lengths are surrounded by stirrups with a spacing of 4.0 inches (102 mm)

The dimensions of the lap-spliced beams are the same as the flexure beams: 10 inches (25-cm) wide by 20 inches (51-cm) deep by 90 inches (230-cm) long. The lap-spliced beams were designed the same as the flexure beam, F2, apart from the bottom layer of longitudinal reinforcement being spliced. Strain gauges were spaced evenly at 4 inches (102-mm) on center along the lap-splice as well as on stirrups a distance 'd' from the supports.

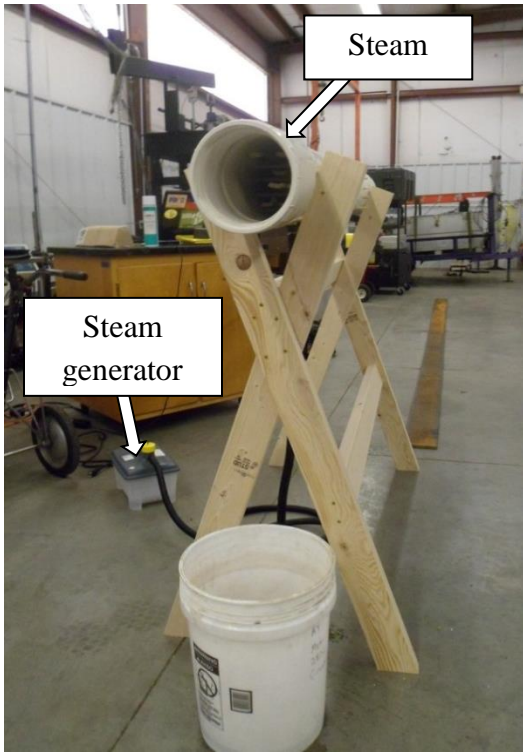
Figure 6.12 Steam box set-up

The steam box was constructed from a 6-inch (152-mm) PVC pipe with two end caps. Dowel rods with a diameter of 0.25 inch (6-mm) were used to support the bamboo strips within the PVC pipe in four layers. To secure the dowel rods, holes were drilled into the side of the pipe and the rods were inserted into the holes. An Earlex SS77USG Steam Generator was used to produce the steam and was connected to the side of the PVC pipe via the hose provided with the generator. Highland Woodworking⁵ provides a datasheet with the steamer specs as well as a steamer manual. Detailed instructions to build a steam box are also included on their website. The supports for the steam box were constructed from 2x4 lumber. The steam box set up can be seen in Figure 6.12 and a close-up of the stirrup strips can be seen in Figure 6.13.

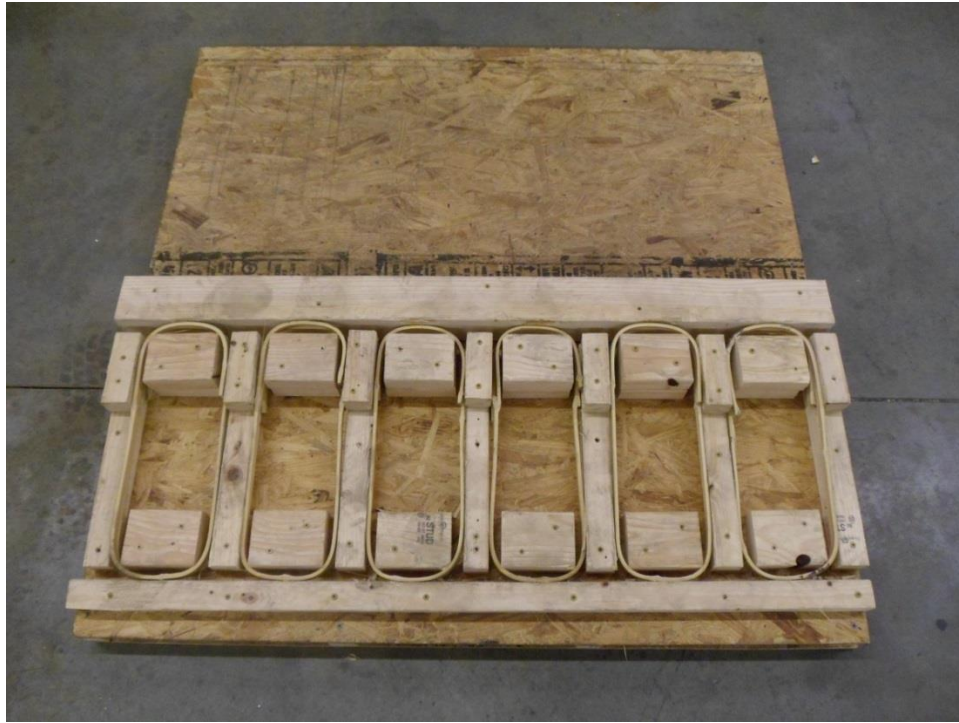
Figure 6.14 Bending forms

The bending forms were constructed from a sheet of OSB sheathing with 2x4 lumber screwed to it outlining six stirrups. A 1 inch (25-mm) gap was provided between the 2x4 lumber where the steamed bamboo pieces were bent into shape and left to cool. The bending forms can be seen in Figure 6.14 and the bending process can be seen in Figure 6.15. Once the bamboo stirrups cooled they were removed from the bending forms and secured into shape with rebar ties as shown in Figure 6.16.

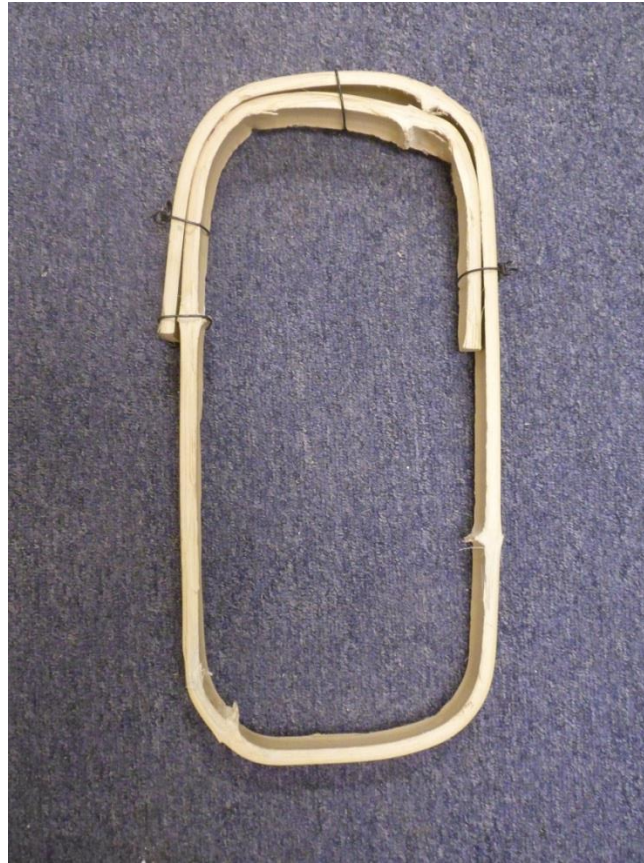
Figure 6.17 Bamboo closed stirrup

Bamboo stirrups have been made with 0.5 inch (13-mm) wide strips. The outside dimensions of each stirrup are roughly 7 inches (178-mm) wide by 17 inches (432-mm) tall to provide 1.5-inch (38-mm) cover to the surface of the concrete beams. The stirrup shape was made by heating strips of bamboo in a steam box and then bending them into wooden forms. This is a new stirrup design and was used for all the beams. The closed stirrup shape has an advantage over open stirrups when torsion is expected. The closed stirrups were also expected to confine the core of concrete better than open stirrups. However, under the monotonic loads of this research, no advantage was. A typical stirrup can be seen in Figure 6.17.

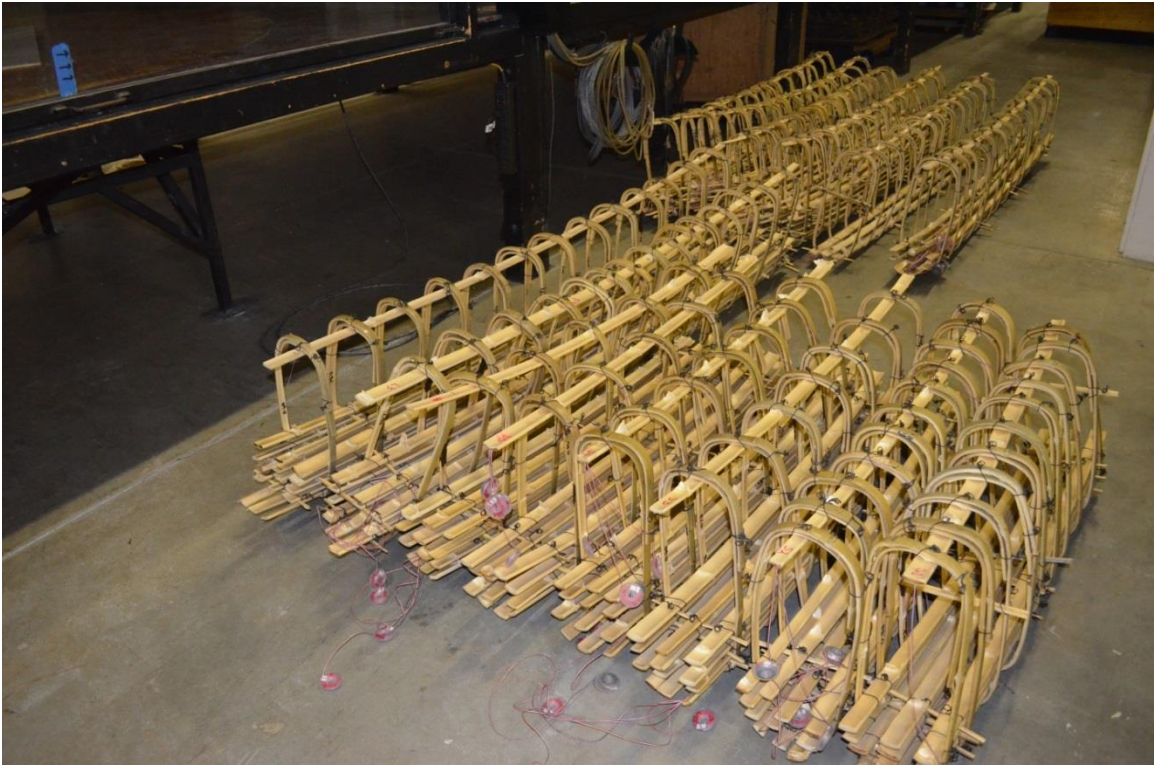
Bamboo cages, similar to the traditional rebar cages, were used to reinforce the beams and increase their shear and moment capacities. The constructed bamboo cages can be seen in Figure 6.18. The cages were constructed from longitudinal bamboo strips 1 inch (25-mm) wide and 87 inches (220-cm) long and bamboo stirrups which are described in Section 6.2.1.2. All the connections were made with 6-inch (152-mm) rebar ties.

Figure 6.18 Constructed bamboo cage

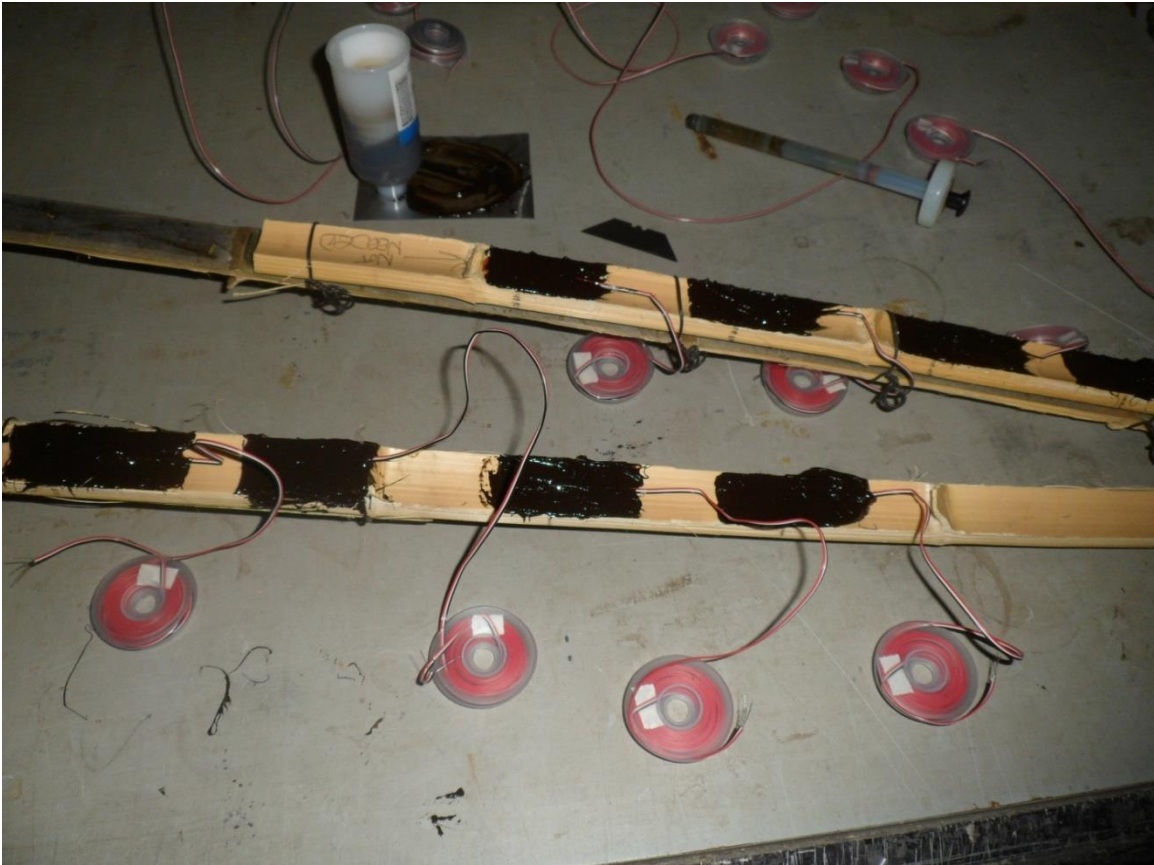
Figure 6.20 Strain gauge installation on lap-spliced reinforcement

The gauges were installed on the bamboo using M-Bond AE-10 adhesive which was also purchased from Vishay Micro Measurements and allowed to cure for 8 hours. It is very important to install the strain gauges correctly to increase the chances of obtaining useful data. The harsh environment of wet concrete can cause the strain gauges to malfunction, and they must be properly protected with a polysulfide coating (M-Coat J). The strain gauge installation on the lap-spliced reinforcement can be seen in Figure 6.20.

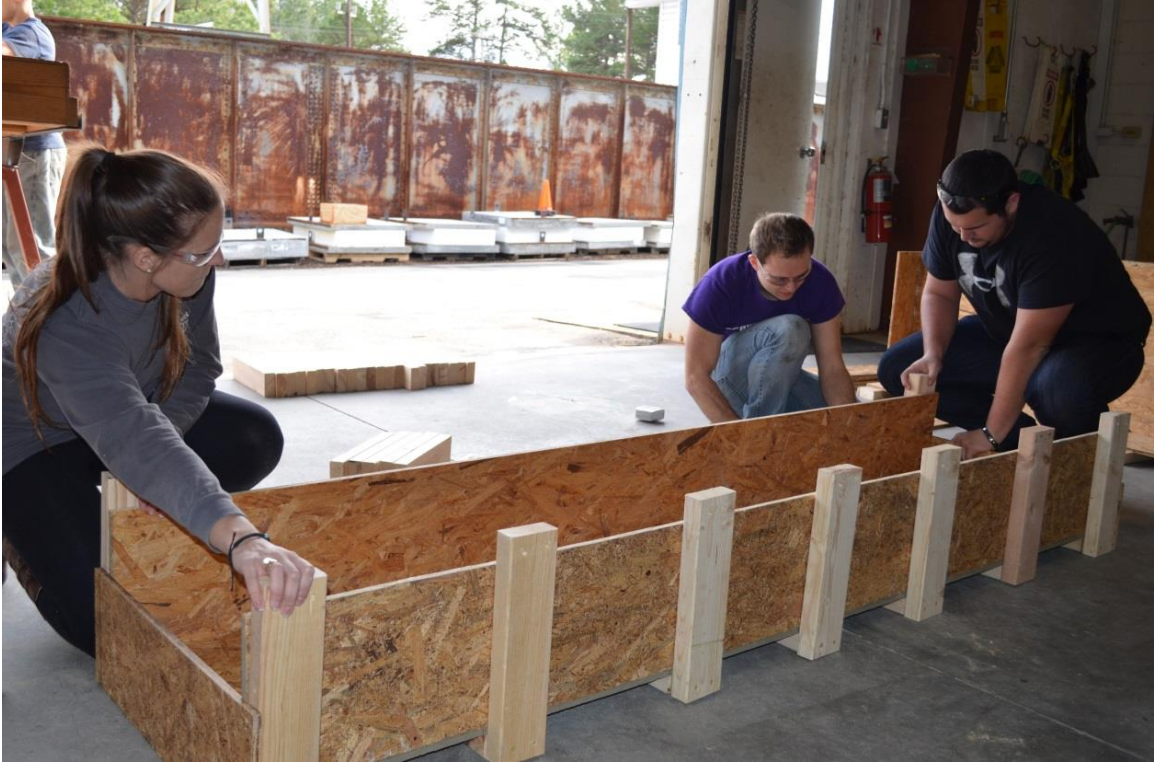
Figure 6.21 Beam formwork preparation

The formwork for the beams was made from 2x4 lumber and 7/16 inch (11-mm) OSB sheathing as shown in Figure 6.21. A gap under the beam was provided for the forklift. The inside joints were sealed with caulk to prevent concrete from flowing out through the gaps. After the joints were sealed the inside of the forms were coated with WD-40 as a de-bonding agent.

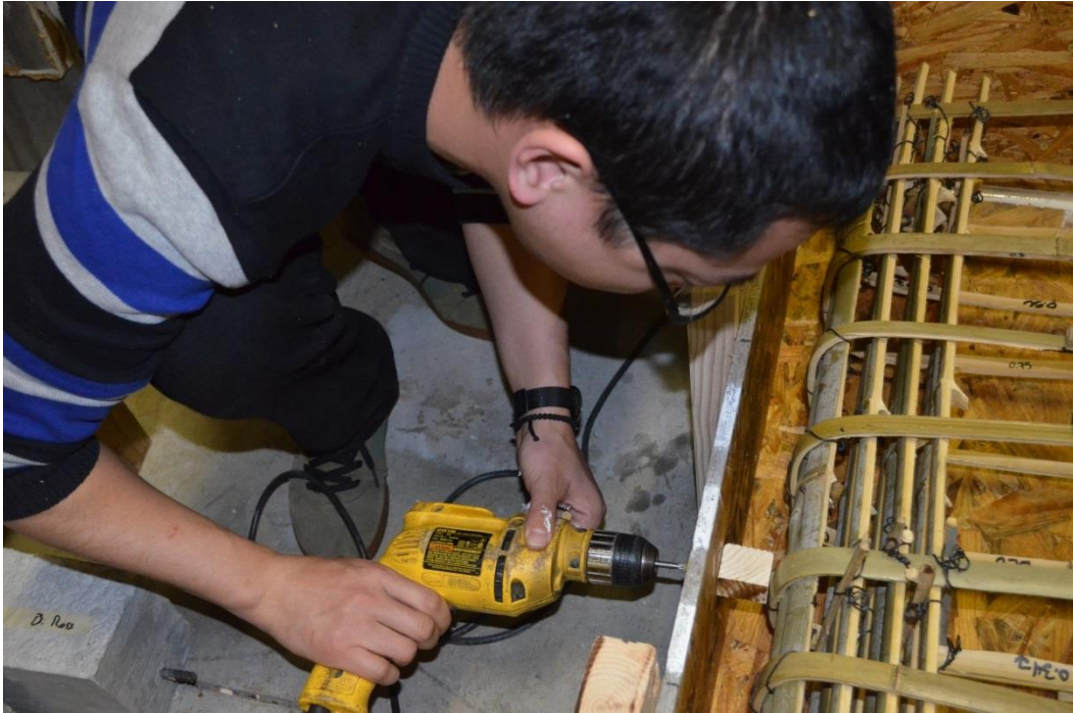
Figure 6.22 Installation of block spacers

To provide the 1.5-inch (38-mm) cover, small wood blocks were screwed into the forms as shown in Figure 6.22. The blocks also helped to straighten out the curvature in

bamboo cages which occurred as the bamboo dried out. The completed forms can be seen in Figure 6.23.

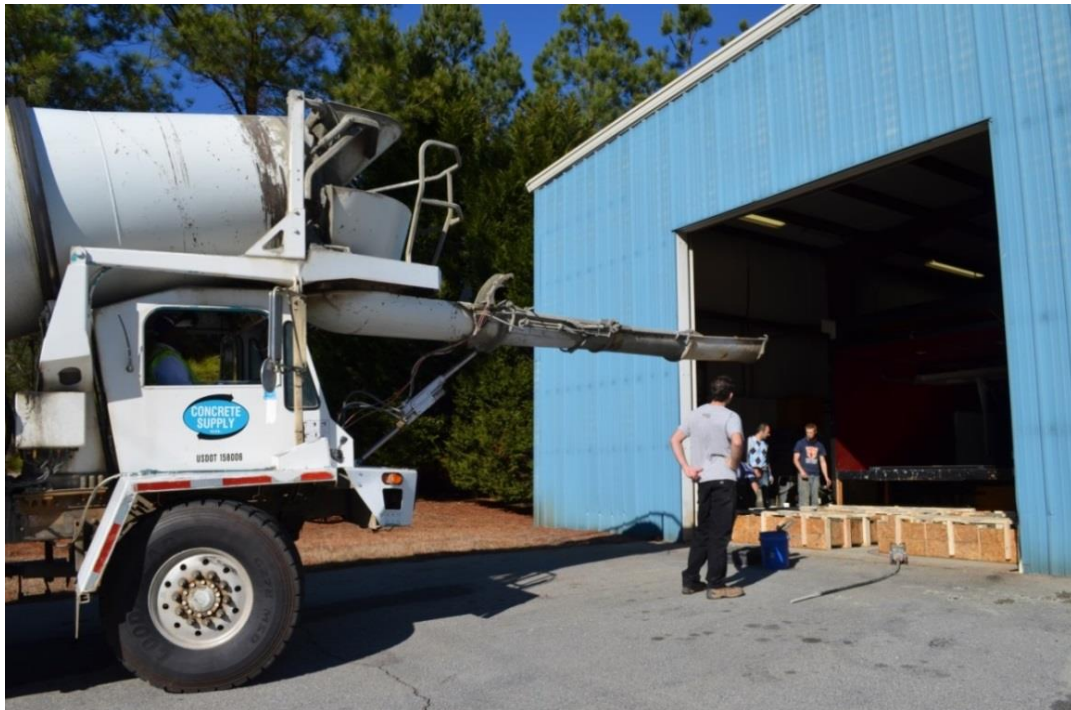
Figure 6.24 Front discharge mixer truck

The concrete was cast around noon on January 14, 2014 in Clemson, SC. During casting, the air temperature on day of pour was 66 °F (19 °C). The concrete was cast inside since temperatures were expected to drop to below freezing outside during the night. A front discharge mixer truck delivered the concrete as shown in Figure 6.24. The beams were finished smooth with a hand trowel as shown in Figure 6.25.

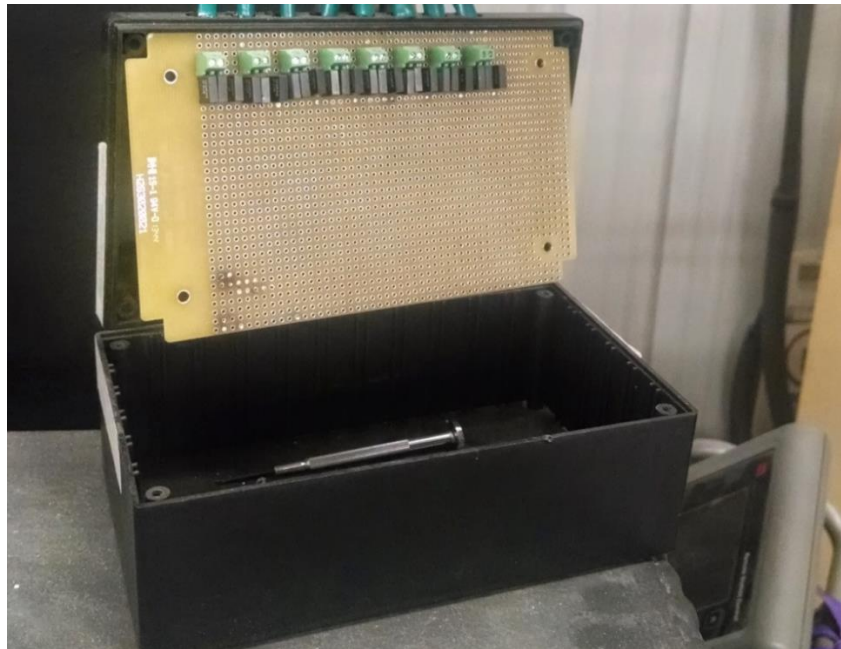
Figure 6.31 Wheatstone bridge circuit box

A total of eight Wheatstone bridge circuits were soldered to a circuit board and a 2-pole PC mount terminal block was used to connect the lead wires from each strain gauges to the active arm of the Wheatstone Bridges. The Wheatstone bridge circuits can be seen in Figure 6.30 and the completed circuit box with the connected strain gauge lead wires can be seen in Figure 6.31.

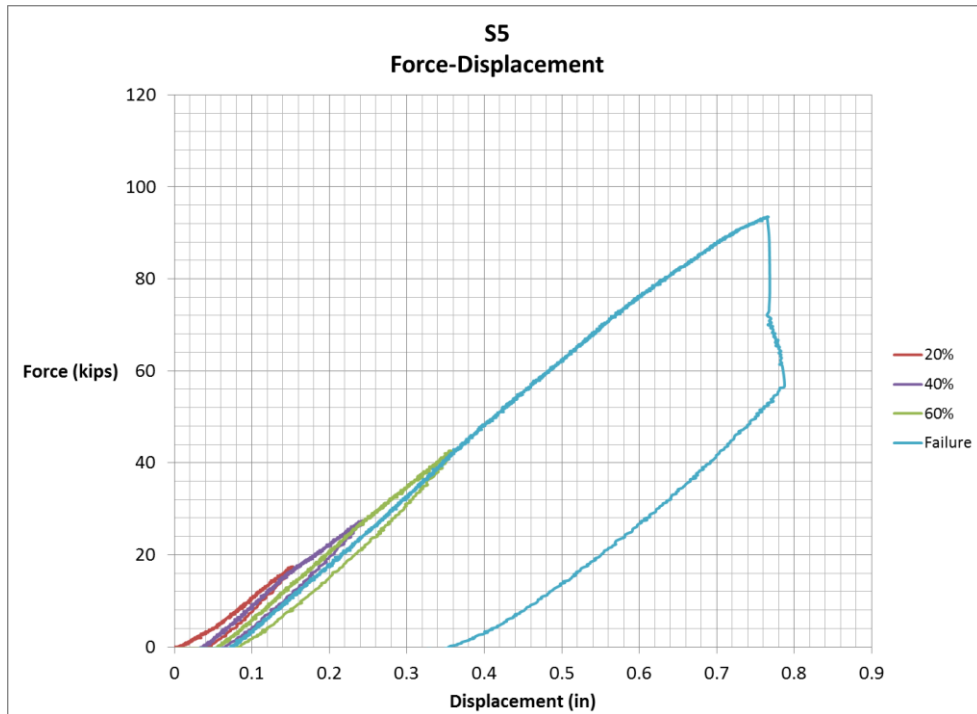
Figure 7.5 Force-displacement curve for S5

The damage in the beams is evident after each loading cycle by the widening of the force-displacement curves. After each loading cycle, the beam experiences a greater deflection under a given force.
