APPLICATION OF BAMBOO FOR FLEXURAL AND SHEAR REINFORCEMENT IN CONCRETE BEAMS

A Thesis
Presented to
the Graduate School of
Clemson University

In Partial Fulfillment
of the Requirements for the Degree
Master of Science
Civil Engineering

by
Nathan Alan Schneider
August 2014

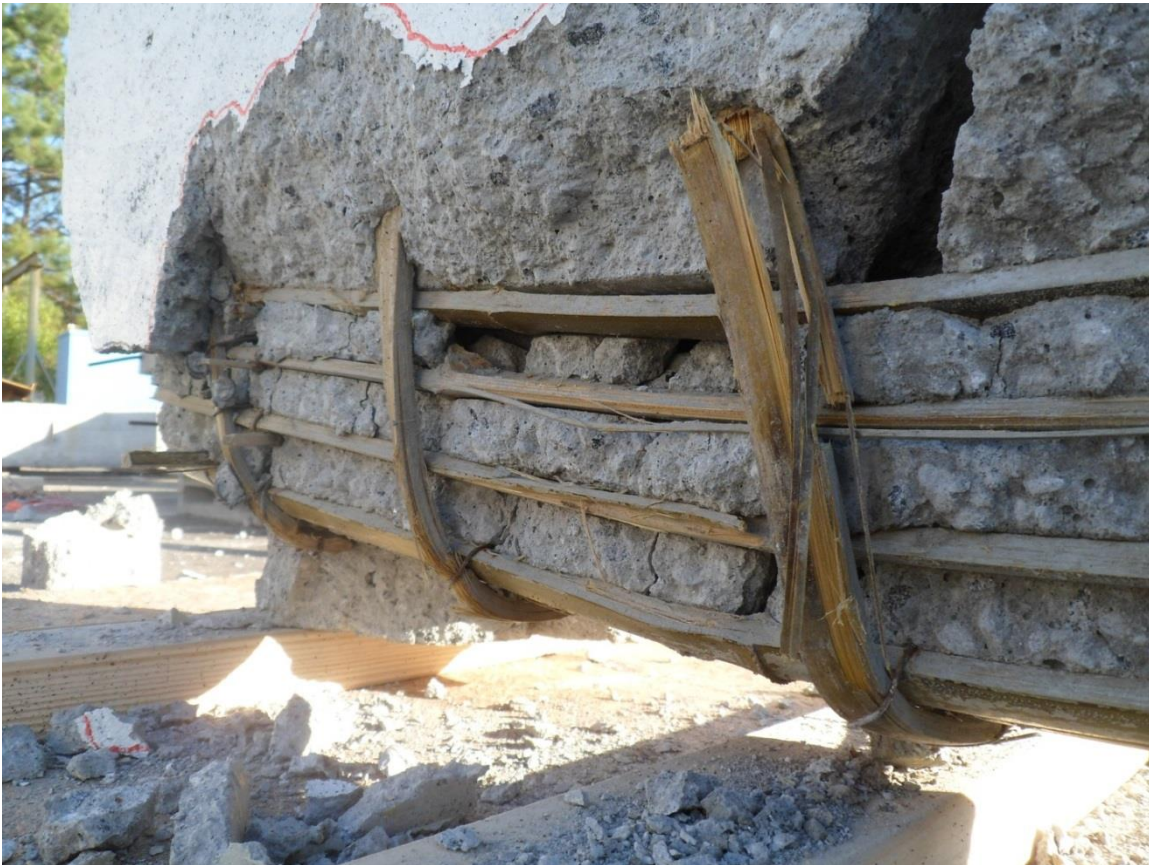
The failure of the stirrups occurred both near the bent radius and also in the middle of the stirrup, indicating that there was not a significant strength loss upon bending the stirrups. Figure 7.8 shows a failure in the middle of a bamboo stirrup.

Figure 7.8 Failure in middle of bamboo stirrup of beam S3

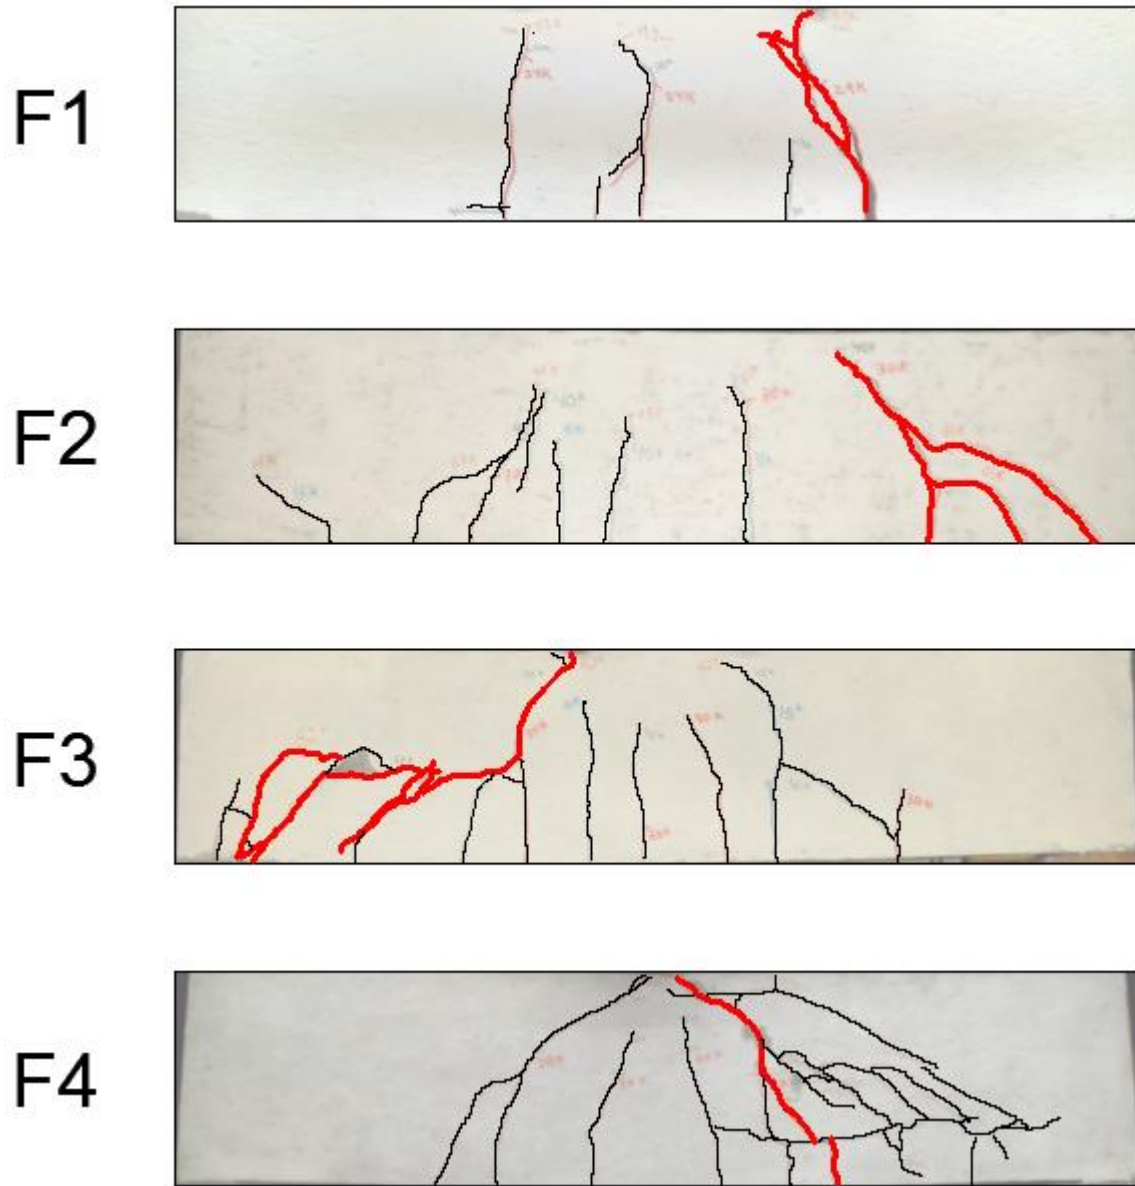
Figure 7.18 Front crack patterns for the flexure controlled beams

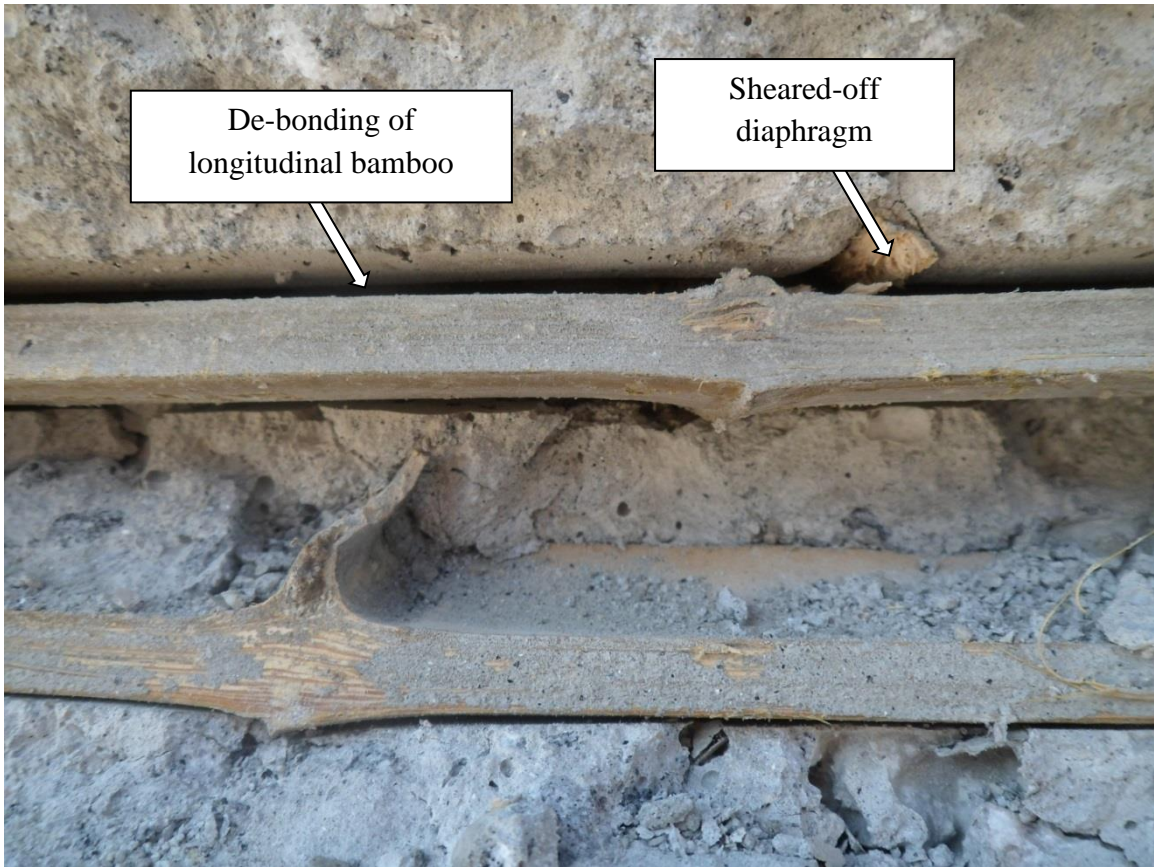
Figure 7.19 Longitudinal bamboo slippage in beam F3

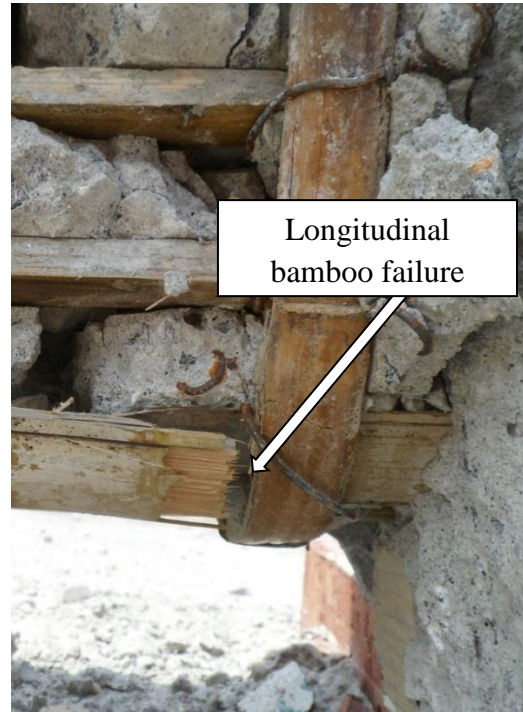
Figure 7.20 Longitudinal bamboo failure in beam F1

Figure 7.21 Longitudinal bamboo failure in beam F1 (close-up)

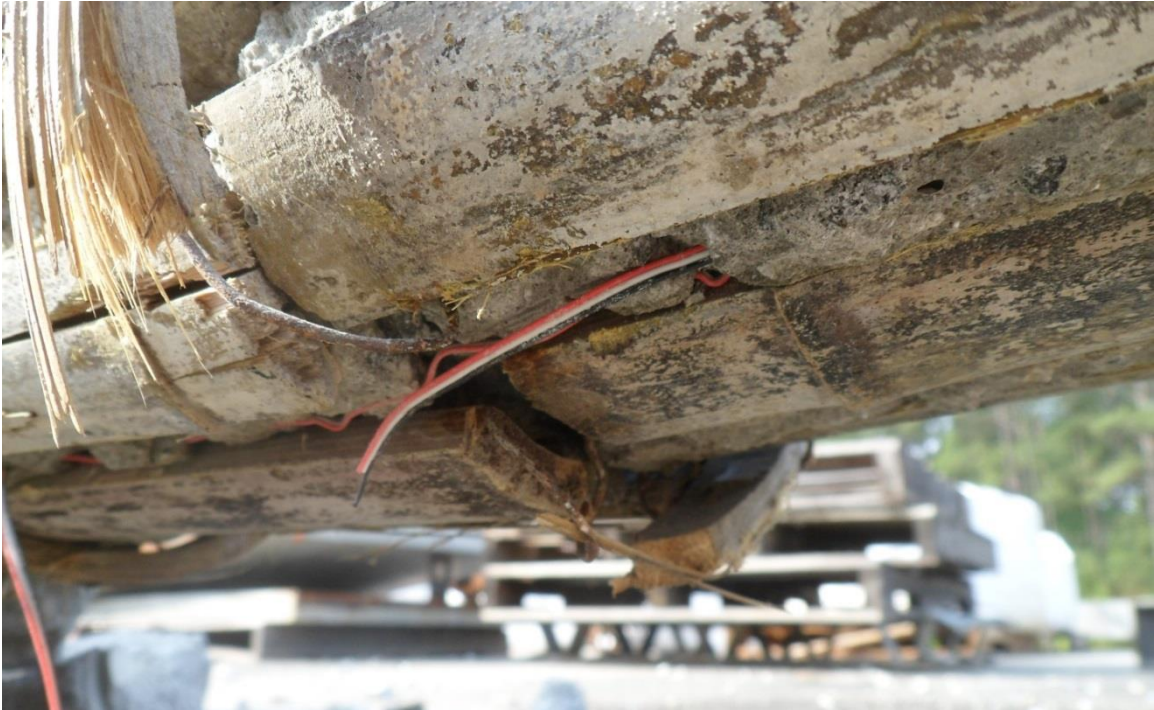
Figure 7.22 Longitudinal failure at stirrup location in beam F4

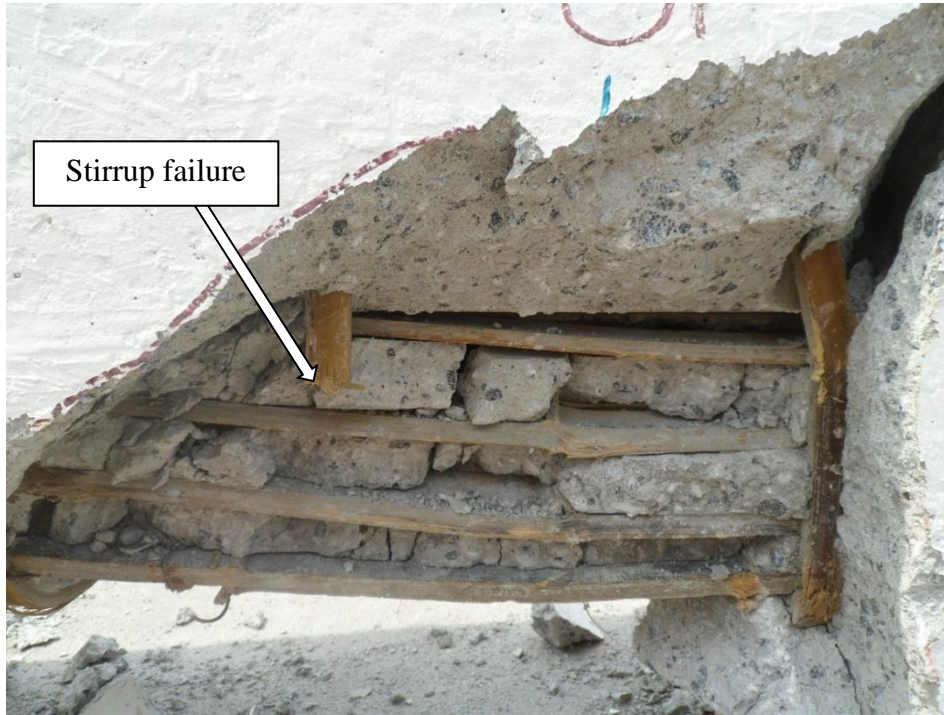
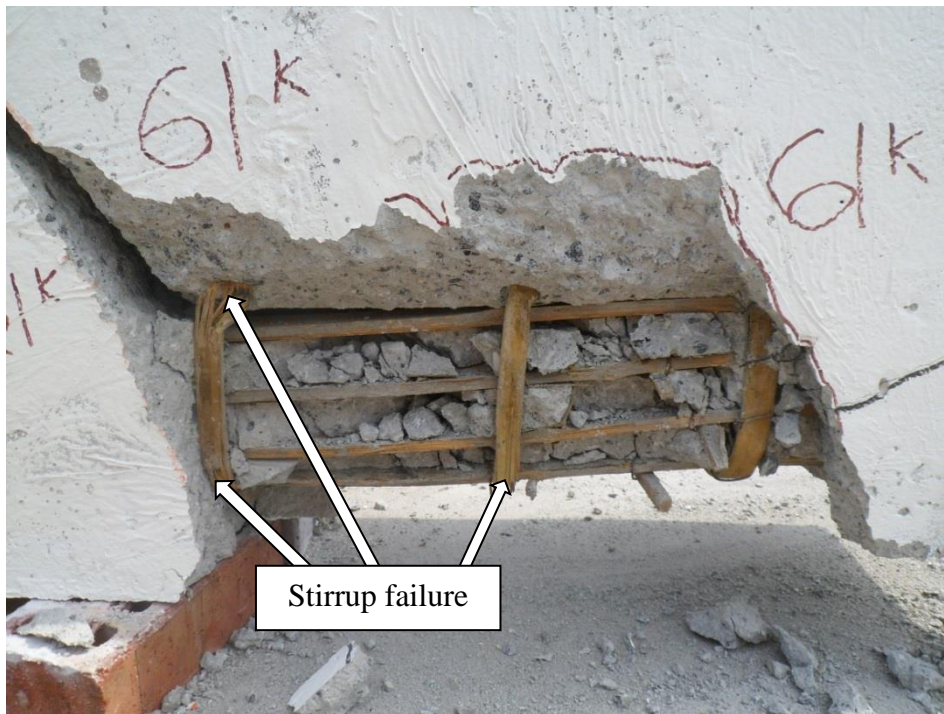
Figure 7.32 Stirrup failure in front face of beam L2

Figure 7.33 Stirrup failure in back face of beam L2

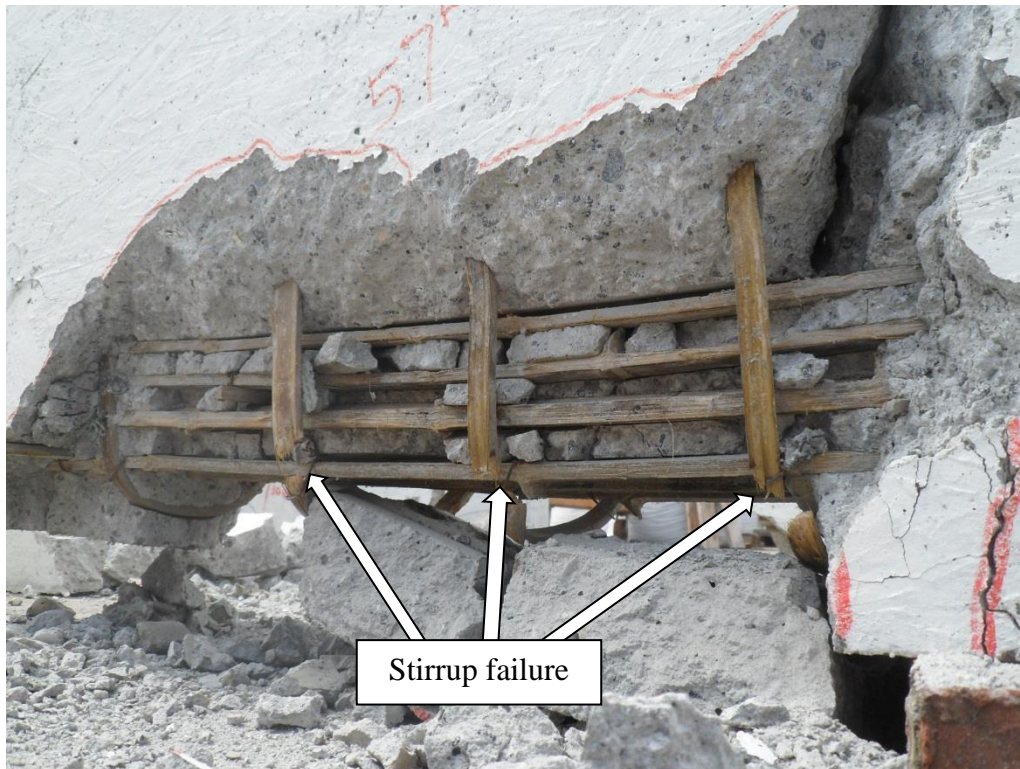
Figure 7.34 Stirrup failure in front face of beam L3

Figure 7.35 Stirrup and longitudinal failure in back face of beam L3
