CHARACTERIZATION OF POTENTIAL WEAR SOURCES IN KNEE
ARTHROPLASTY PROSTHESES AFTER IN VIVO FUNCTION

A Thesis
Presented to
the Graduate School of
Clemson University

In Partial Fulfillment
of the Requirements for the Degree
Master of Science
Bioengineering

by
Nicole Elizabeth Durig
May 2013

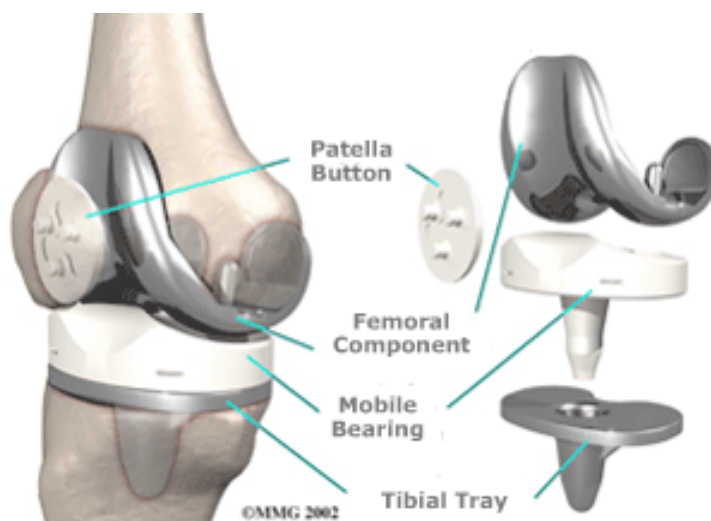
Figure 1.1: Typical total knee arthroplasty components [13]

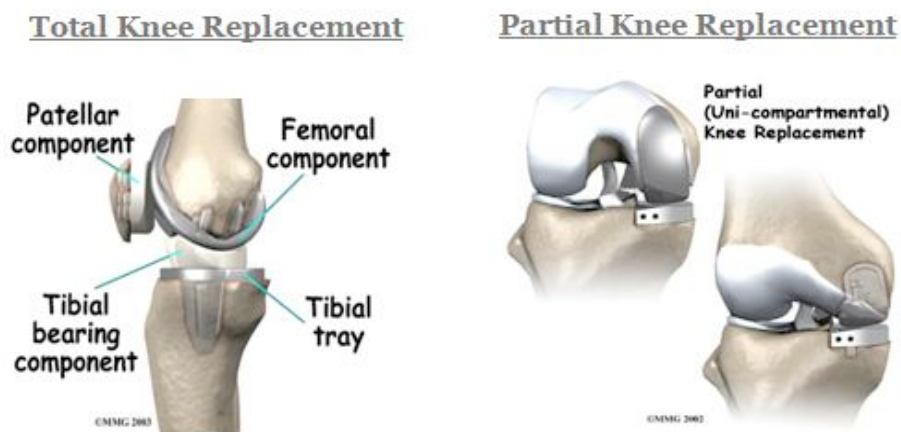
Figure 1.2: Image demonstrating difference between TKA and UKA [87]

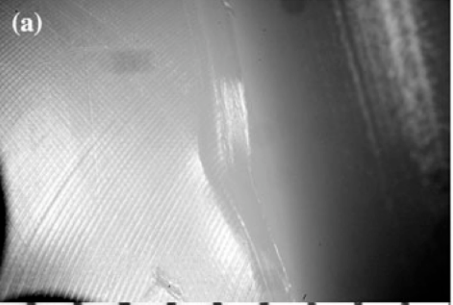
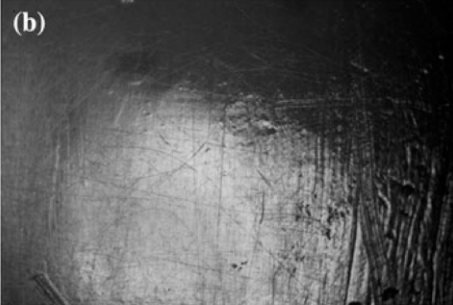
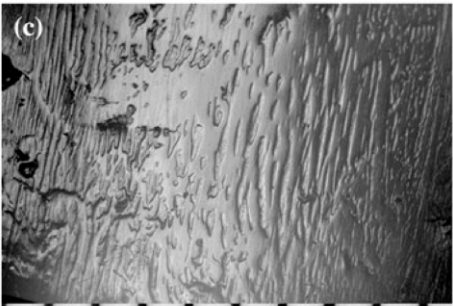
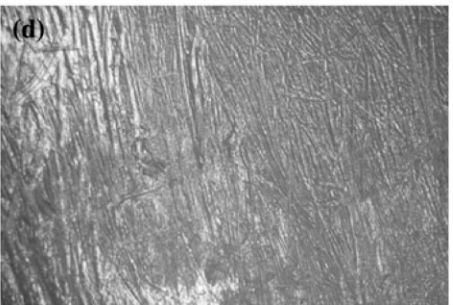
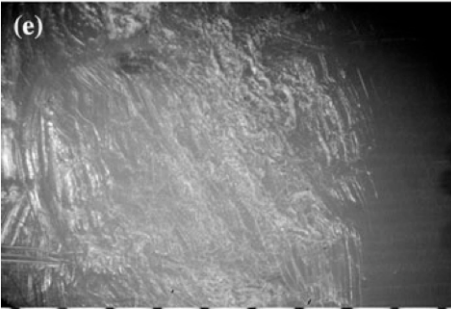
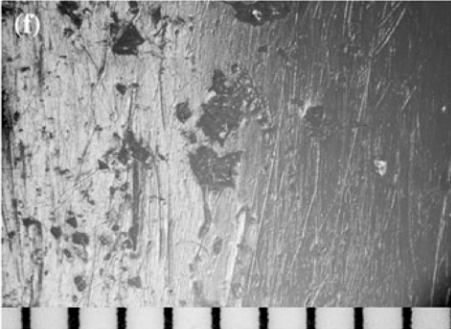
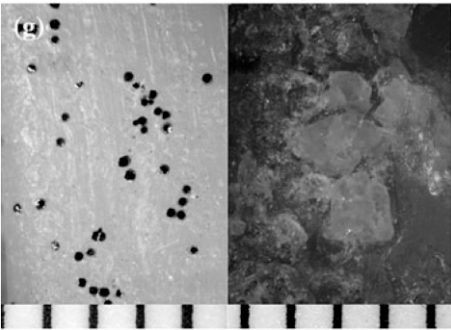
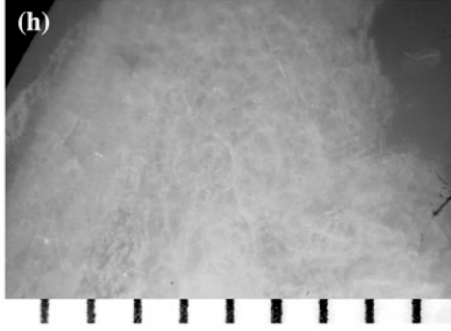
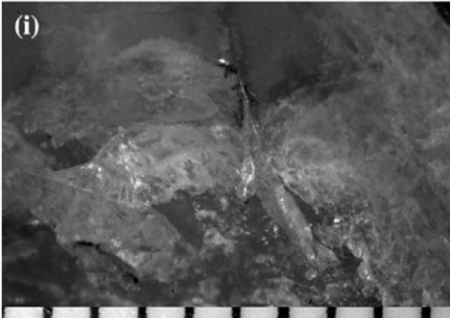
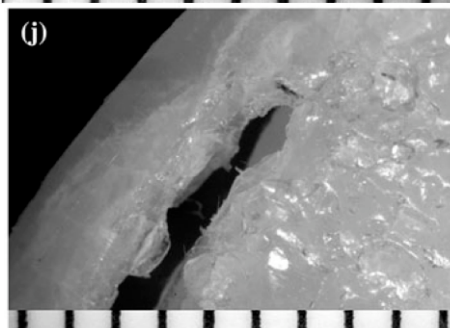
Figure 2.1: Previously published polyethylene damage mode atlas showing characteristic damage modes of the articular surface of polyethylene, a damage mode descriptions, and images of typical, visual presentation [47]

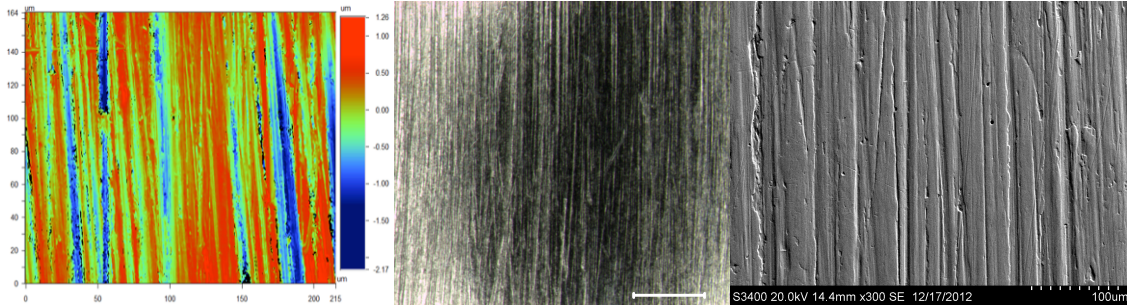
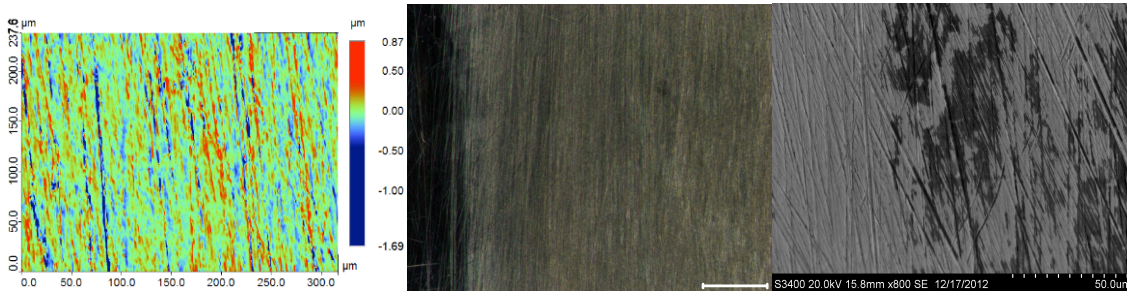
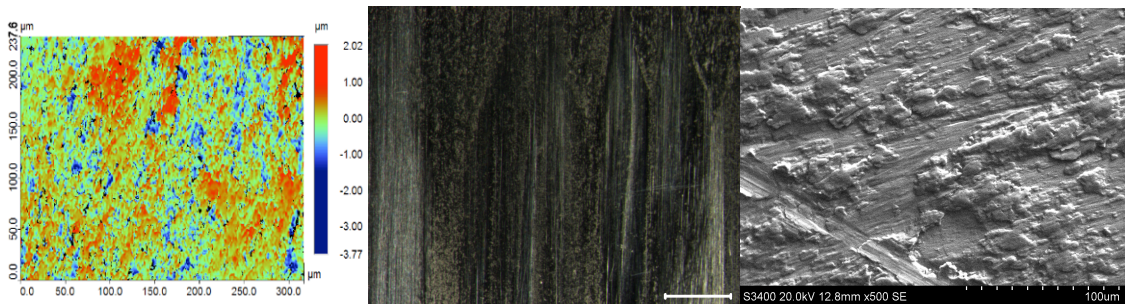
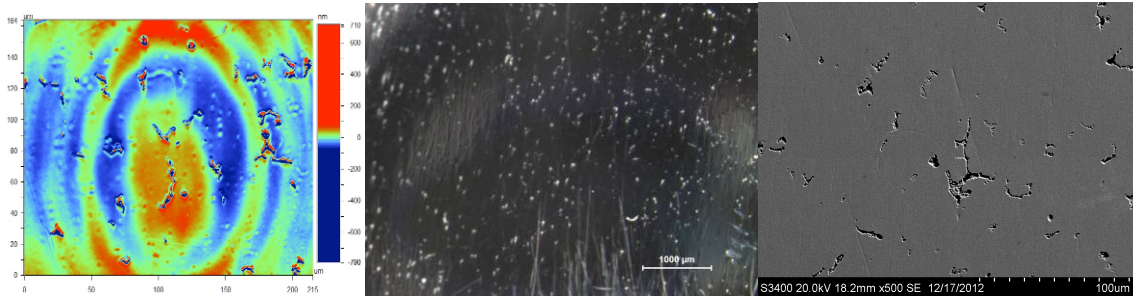
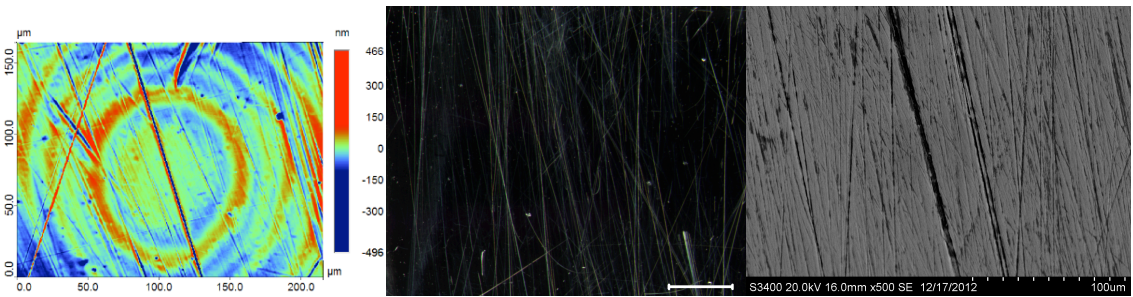
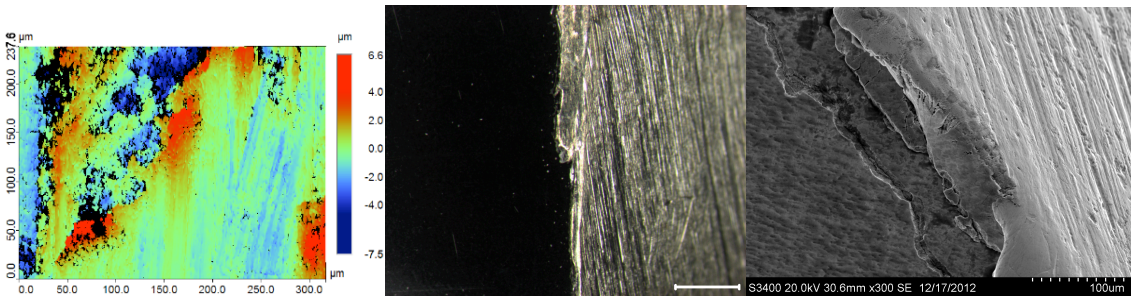
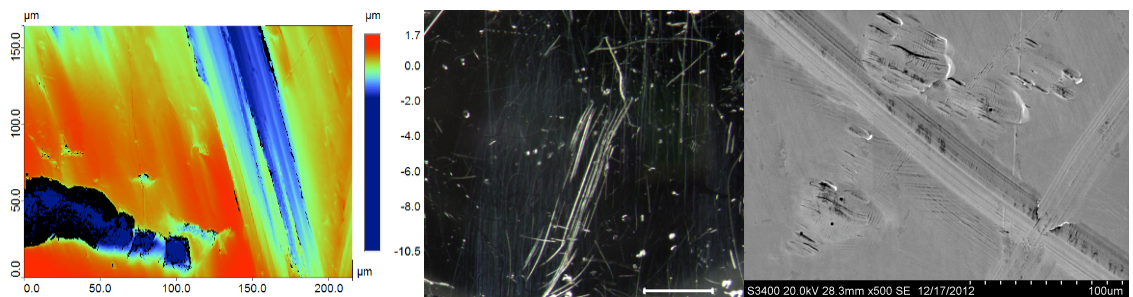
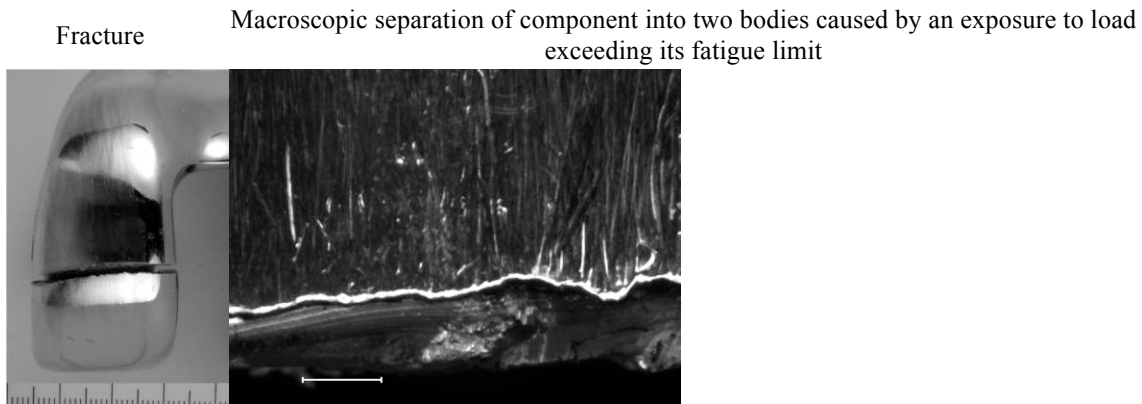
Figure 2.2: Damage atlas for metal bearing surfaces, demonstrating characteristic damage modes following in vivo function with associated description and visual presentations acquired using optical stereomicroscopy (12x magnification), interferometry (20-50x magnification), and SEM (50-500x magnification). [3]

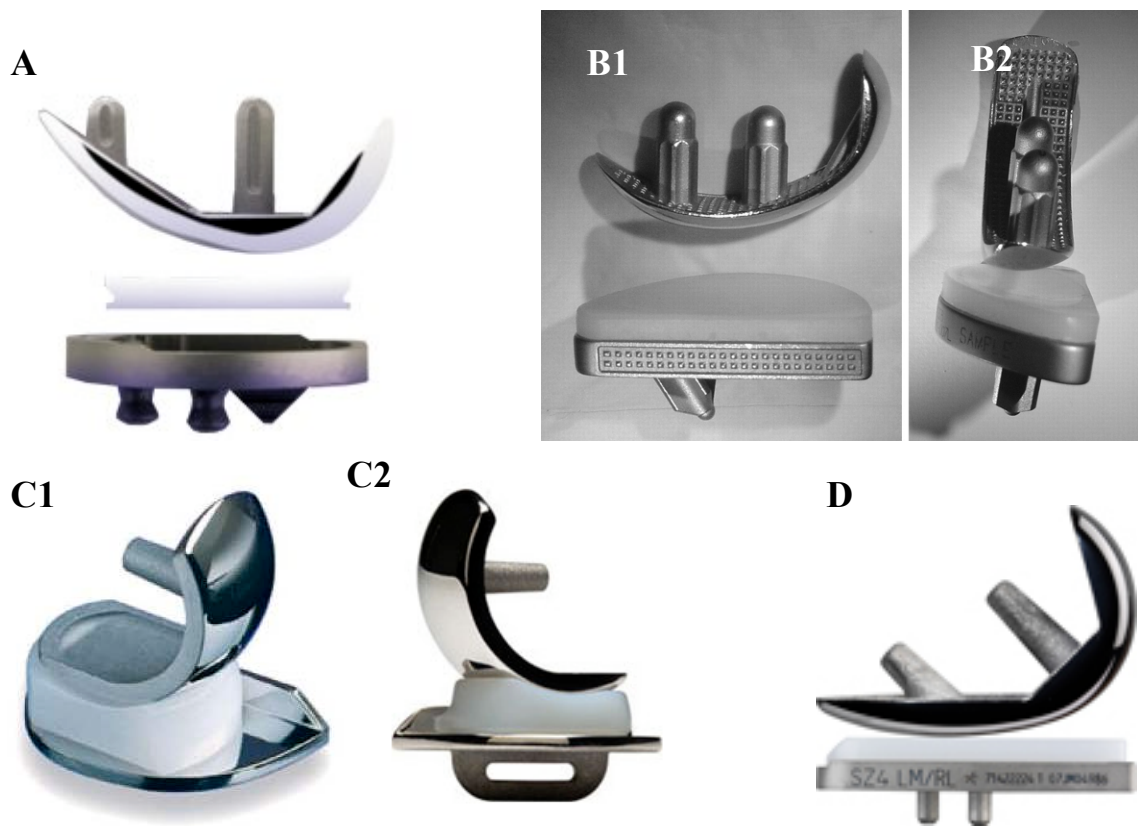
Figure 2.3: UKA with similar designs to those analyzed in the current study, including (A) Zimmer MG UKA; (B1, B2) Osteonic Single Compartment UKA, a second-generation design that was introduced in 1990 to supersede the Omnifit [26]; (C1, C2) Oxford Mobile-Bearing UKA, with round on flat conformity; and (D) Smith and Nephew Journey UKA, with round on flat conformity

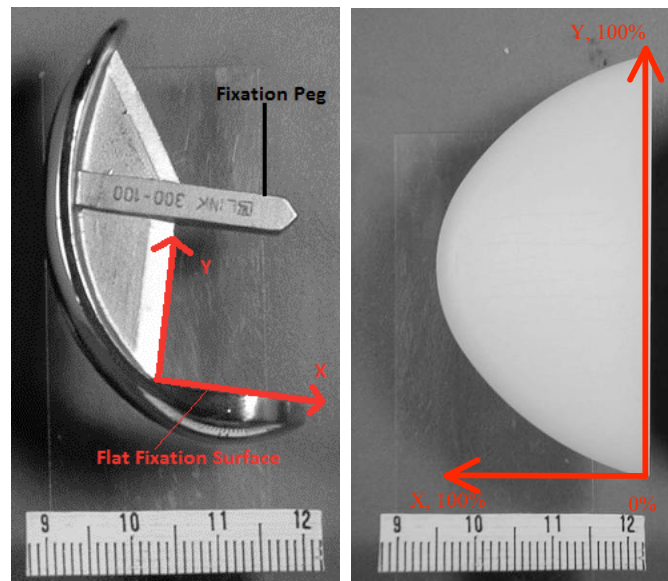
For the tibial components, the reference features included the flat intracondylar side and the anterior and posterior rim of the insert, as previously described by Harman, et al. [52] Thus, the tibial damage patterns were measured in a grid covering the entire bearing surface that was defined relative to the anterior-posterior and medial-lateral periphery of the articular surface.

Figure 2.4: Coordinate systems for the femoral and tibial components

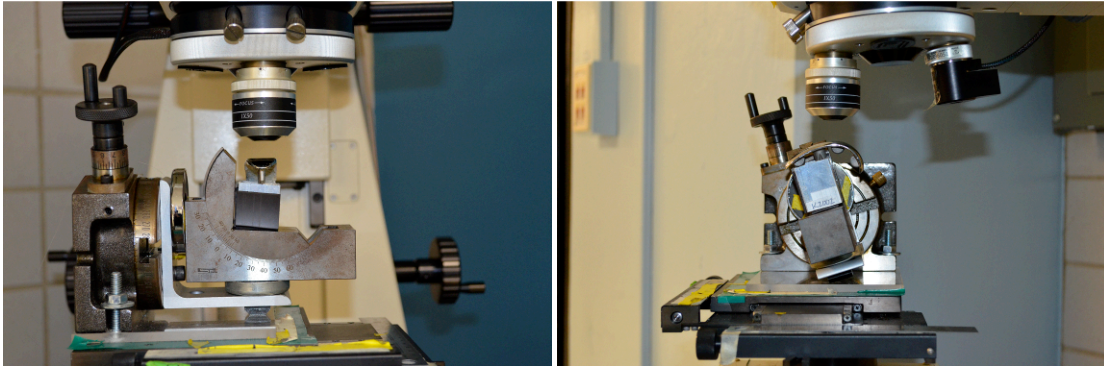
box and then secured using SuperDent dental acrylic (MainStar America LLC, Miami, FL). Each femoral component was then mounted onto a customized jig, allowing for controlled positioning in the sagittal and frontal planes during analysis, as seen in Figure 2.6.

Figure 2.6: UKA femoral component mounted on customized jig and placed on stage of non-contact profilometer, demonstrating ability to control motion in frontal plane (left) and sagittal plane (right)

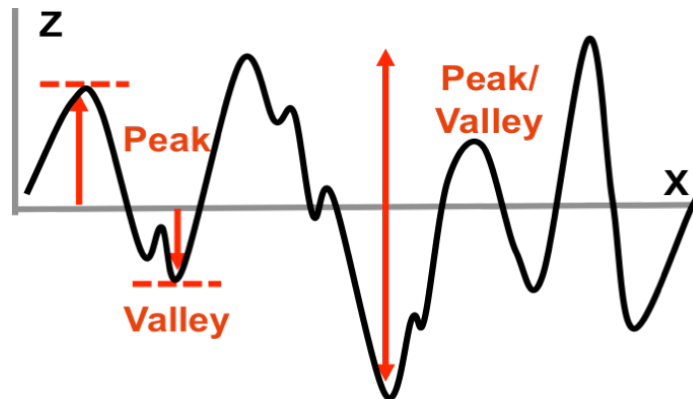
Figure 2.7: Simplified visual of peaks, valleys, and peak-to-valley separations on surface of metallic femoral component

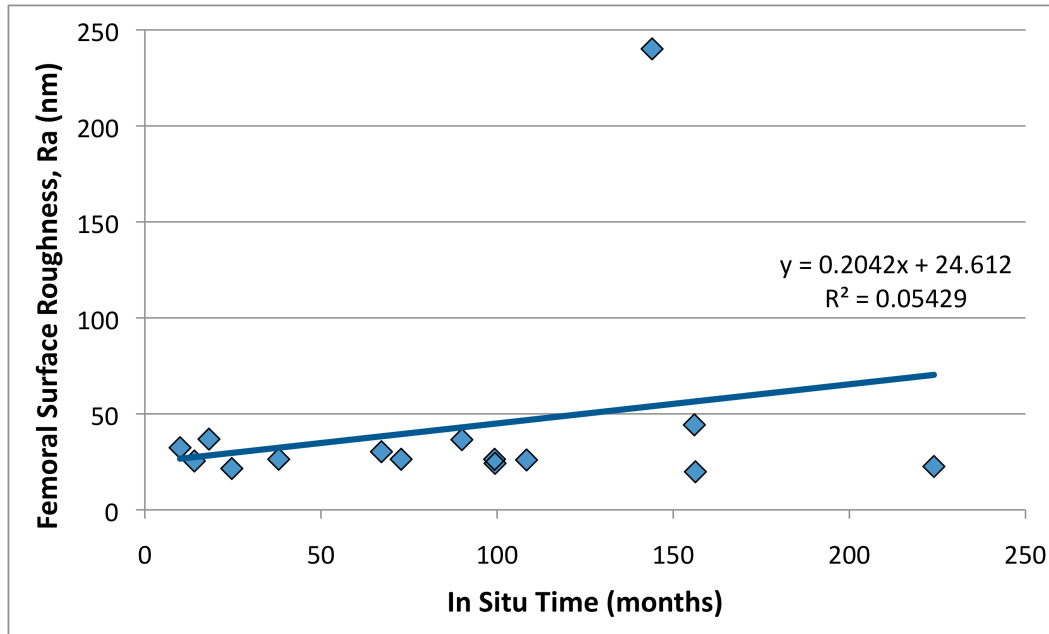
Figure 2.8: Average UKA femoral component surface roughness (Ra) versus in situ time.

vivo duration. Despite a broad range of functional in situ time experienced by these UKA, the Ra and Rpm values did not change significantly following in vivo duration. When average roughness (Ra and Rpm) is plotted versus in situ, there was no significant correlation (linear regression $R^2 < 0.1$, $p = 0.558$), Figure 2.8 and 2.9).

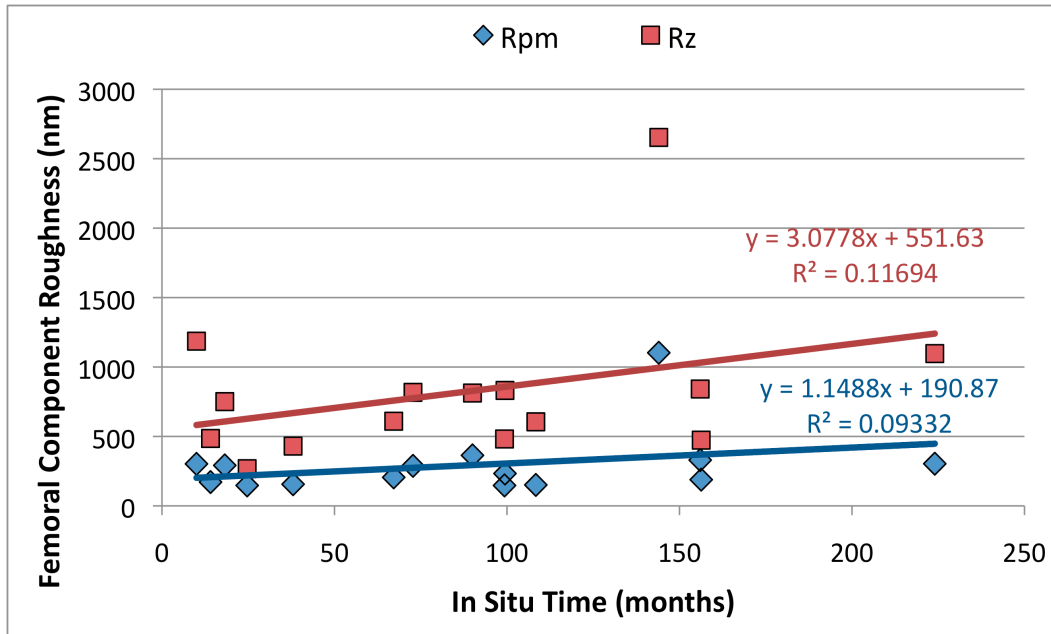
Figure 2.9: Average UKA femoral component profile peak height surface roughness (Rpm) and mean maximum profile (Rz) versus in situ time

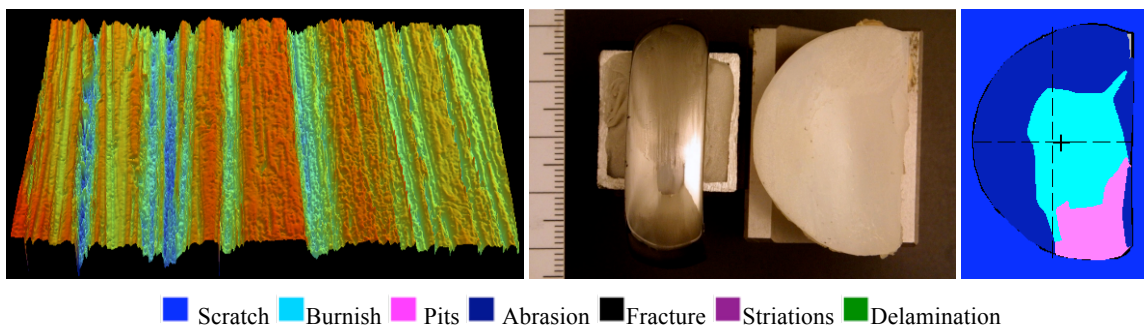
Within the specimen collection, one UKA with notably high Ra and Rpm values was noted. This component functioned for an extended period of time (12 years) and had evidence of extra-articular abrasion associated with contact between the femoral bone and the periphery of the polyethylene insert (Figure 2.10).

Figure 2.10: Representative 3D profilometry surface data of femoral component (left), gross photograph (19 pixels/mm) of femoral and tibial components in anatomical position (center), and polyethylene damage map (right) are shown for the outlying UKA with severe abrasive damage and associated high femoral surface roughness values

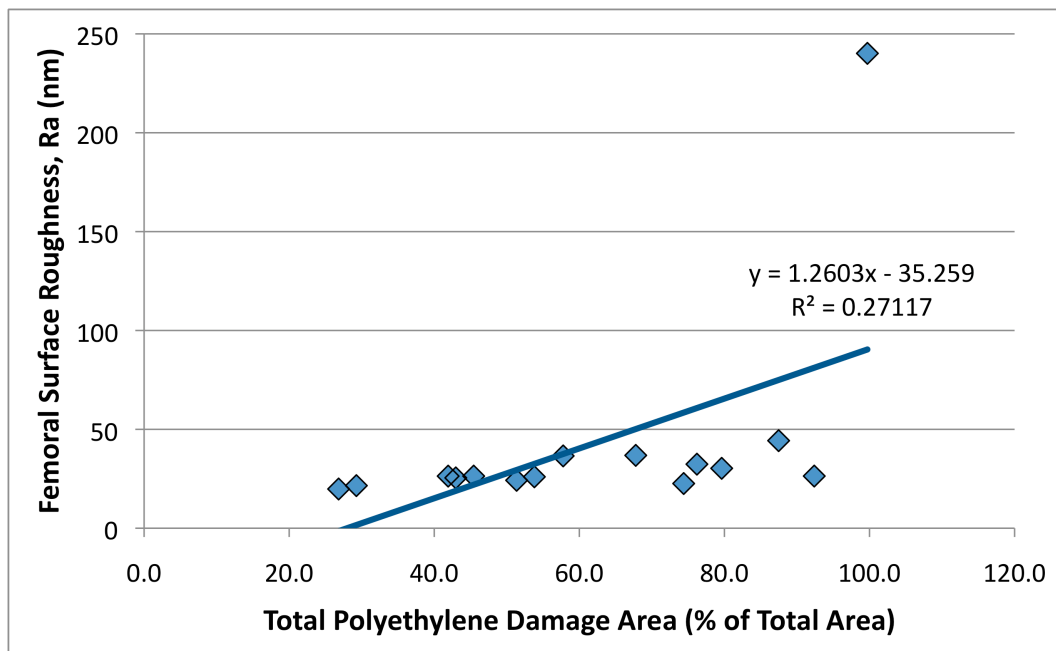
Figure 2.11: Average UKA femoral component surface roughness (Ra) versus total polyethylene damage area. Total polyethylene damage is reported as the surface area damaged as a percent of the total surface area

Damage area on the polyethylene inserts averaged 57.7 ± 24.0 (range 16.7-99.7) %, with scratching (13/19, 68%), abrasion (12/19, 63%), burnishing (10/19, 53%) and pitting (10/19, 53%) as the most common damage modes. Polyethylene damage area is reported as the surface area damaged as a percent of the total articular surface area. Despite a large variation in polyethylene damage modes, surface roughness values showed no statistical correlation to mode of polyethylene damage or polyethylene damage area, as seen in Figures 2.11 and 2.12.

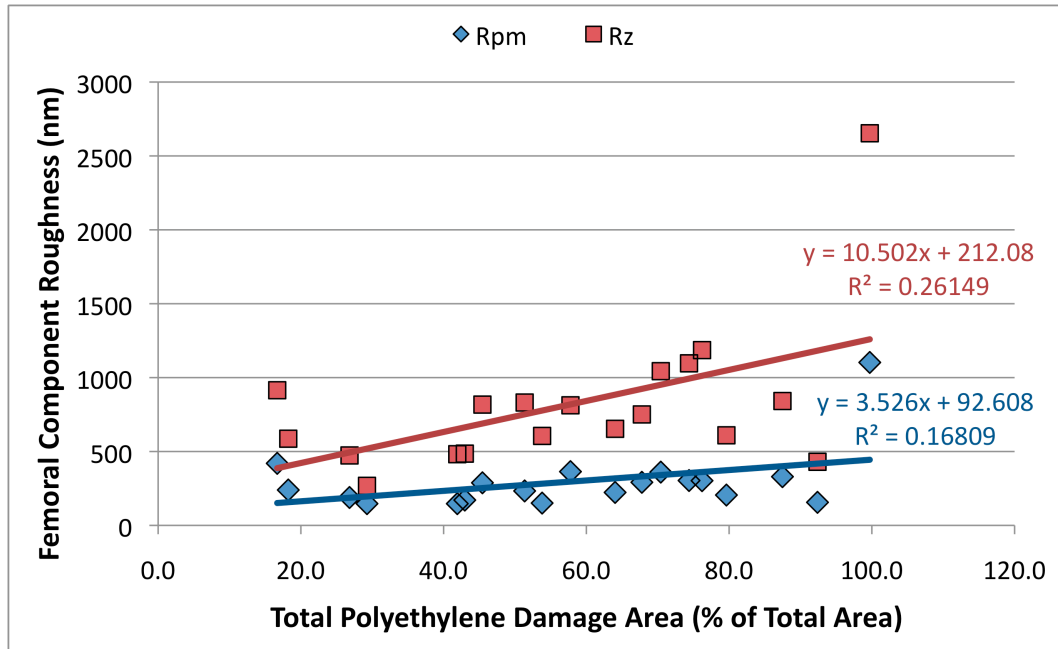
Figure 2.12: Average UKA femoral component profile peak height (Rpm) and mean maximum profile (Rz) surface roughness versus total polyethylene damage area. Total polyethylene damage is reported as the surface area damaged as a percent of the total surface area

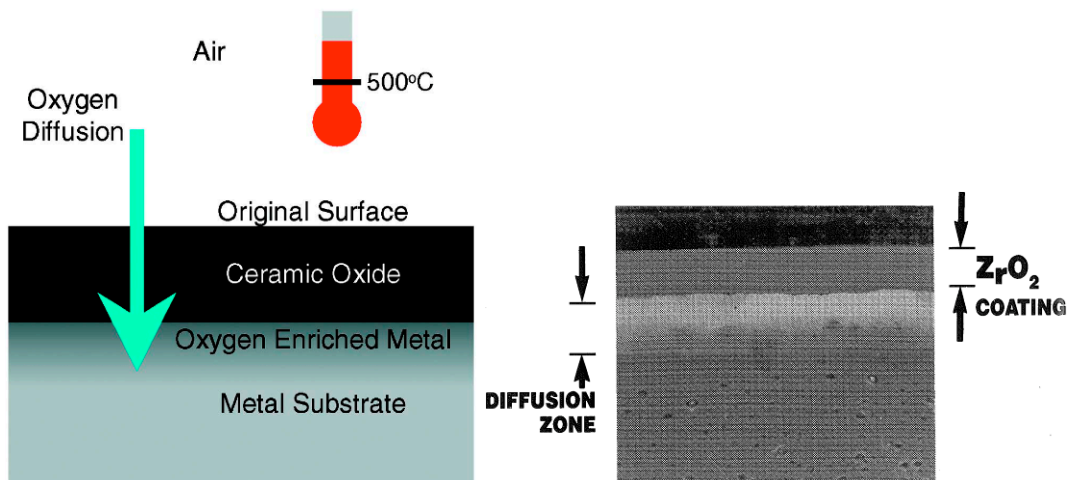
transition of chemical, mechanical and physical properties (Figure 3.1). [32] Due to the mechanically stable ceramic surface that is 4-5 μm thick, this material is known to have high resistance to abrasion, adhesion and delamination. [32, 42, 43, 53, 78, 89] Several studies have shown this damage resistant surface results in rates of polyethylene wear that are more than six-fold less than articulation against CoCrMo femoral components. [32, 44, 79] Although the material is known to have high hardness and toughness with decreased surface roughness and excellent bonding between the ceramic and metallic layers, the underlying bulk material has the least favorable properties of all metals used for bearing surfaces in knees. [42, 89]

Figure 3.1: Simplified depiction (left) [79] and photomicrograph (right) [31] of oxidized zirconium alloy

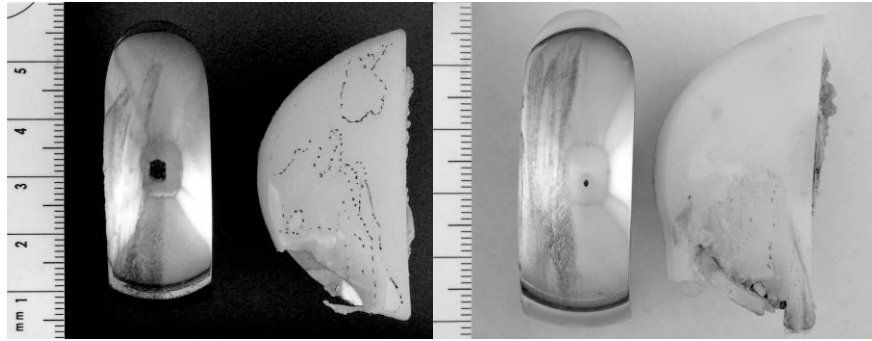
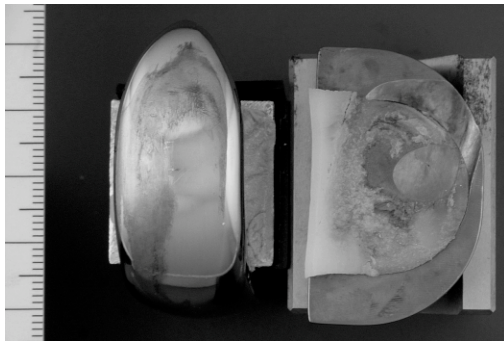
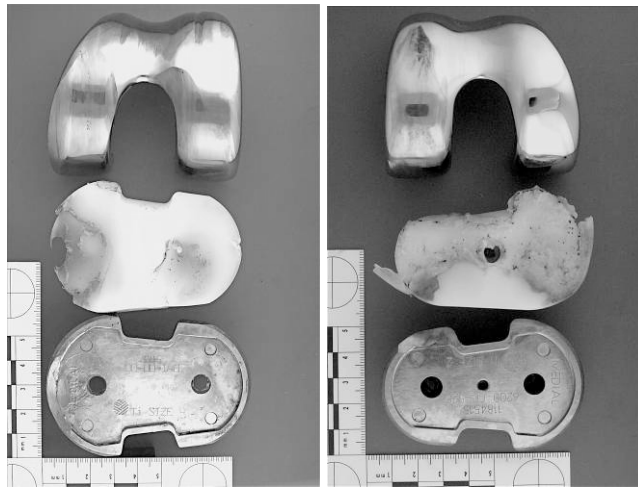
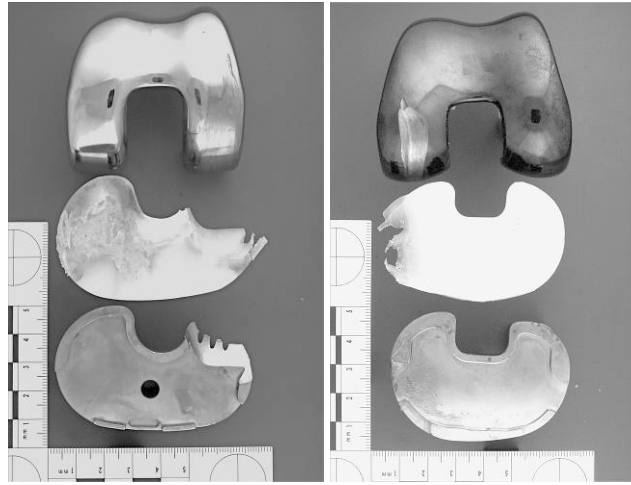
Figure 3.2 demonstrates all prostheses analyzed in the current study, including their material composition. Four material pairs were identified from these prostheses with mode II wear and metal-on-metal contact. Cobalt-chromium-molybdenum (CoCrMo) alloy femoral components and CoCrMo tibial baseplates were used in 2 UKA. CoCrMo femoral components and titanium-aluminum-vanadium (TiAlV) alloy tibial baseplates were used in 1 UKA and 2 TKA. A TiAlV femoral component and TiAlV baseplate were used 1 TKA. Finally, an Oxinium (Smith & Nephew, Memphis, TN) femoral component and TiAlV baseplate was used in 1 TKA. Each of the tibial inserts for the TKA and UKA were composed of UHMWPE. This information is simplified in Table 3.3.

Figure 3.2: UKA and TKA prostheses analyzed in the current study, including (A) Endosled Waldemar Link UKA from Germany, (B) Johnson & Johnson UKA, (C1, C2) InterMedics Natural Knee, (D) Richards TKA and (E) Smith & Nephew Genesis II

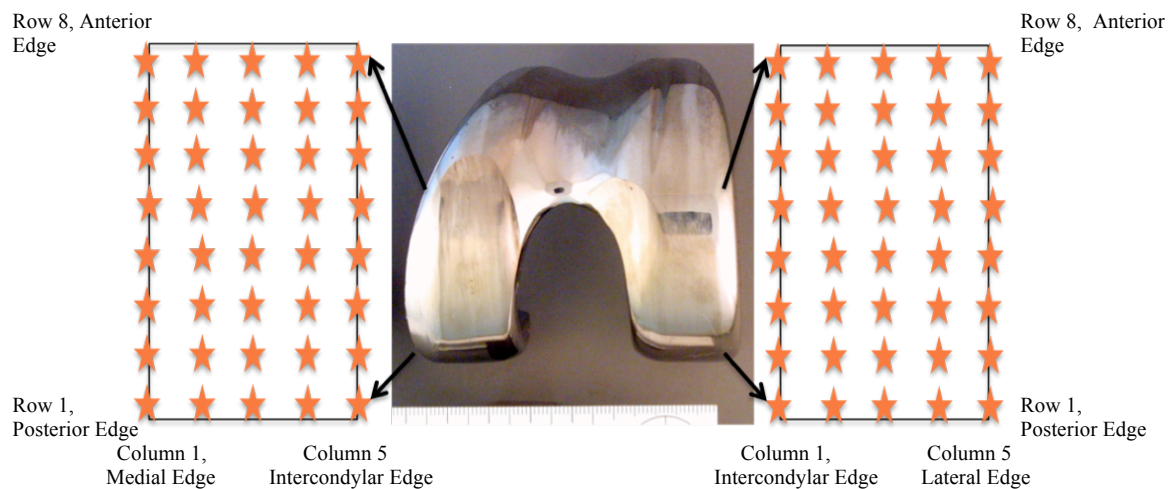
Using the protocol defined in Study 1, the dimensions of the retrieved components were used to define a uniform 3-dimensional grid of 40 regions equally spaced across the entire articular surface of each femoral component (Figure 3.3). The 40-point grid, distributed in eight rows and five columns, was distributed across both condyles of the TKA and the single articular surface of the UKA, as they all share very similar geometry.

Figure 3.3: Distribution of 40 regions equally spaced across each condyle of TKA femoral component and corresponding zones for analysis

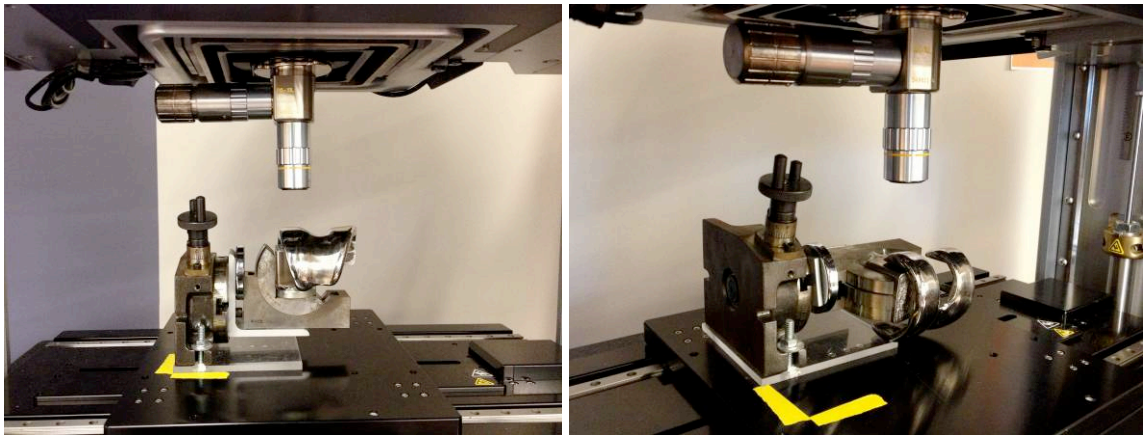
an aluminum box, such that the flat fixation surface of the posterior condyle was flush with the exterior face of the box. Each of the femoral components was then mounted onto a customized jig, allowing for controlled positioning in the sagittal and frontal planes during analysis, as seen in Figure 3.4. Surface roughness measurements at each of the forty regions included the same parameters retrieved in Study 1, which are described in Table 2.3 and Figure 2.7. Again, these parameters were chosen due to their relevance to previous studies of metal surfaces in joint replacement. [3, 28, 34, 36, 66, 72, 75, 77]

Figure 3.4: TKA femoral component mounted in aluminum block on customized jig and placed on stage of non-contact profilometer, demonstrating ability to control motion in frontal plane (left) and sagittal plane (right)

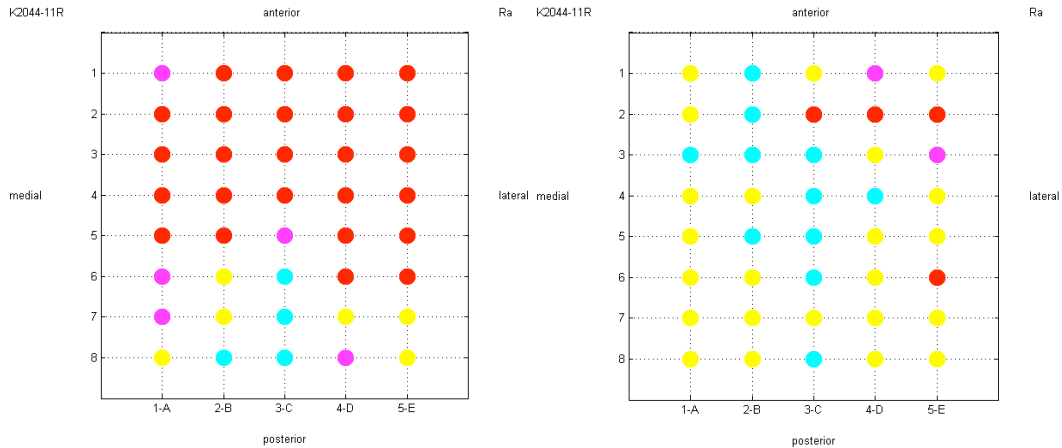
Figure 3.5: Roughness (Ra) plot of both TKA condyles where the lateral (left) experienced polyethylene wear-through and the medial (right) condyle did not. Red indicates a Ra value greater than 120 nm, pink indicates values between 81 and 120nm, yellow indicates values between 51 and 80nm, and cyan indicates values between 21 and 50nm

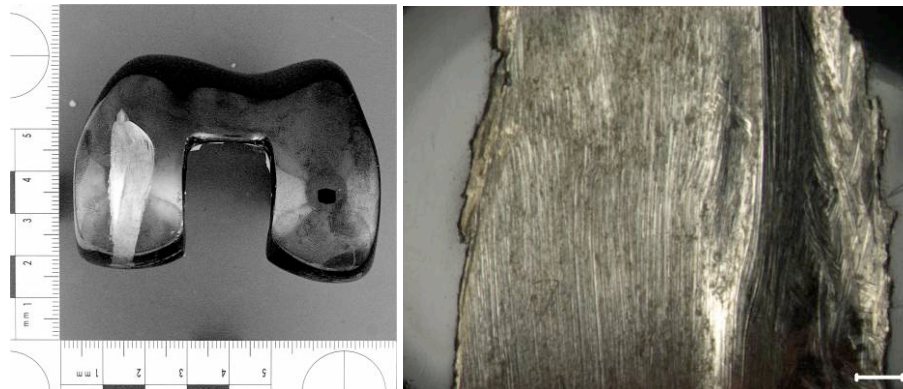
Surface roughness quantification of the Oxinium femoral component was unable to be completed in rows 2-5 due to the gross removal of the articular surface. This dimensional change in the surface was considered a rare catastrophic failure, such that taking the surface roughness of the underlying material would be irrelevant to our study. Thus, surface roughness values were only acquired for the surrounding articular surfaces, rather than the zones with deep removal.

Figure 3.6: Gross image (left) and stereomicroscope image at 6x magnification (right) of gross removal of articular surface on Oxinium TKA femoral component

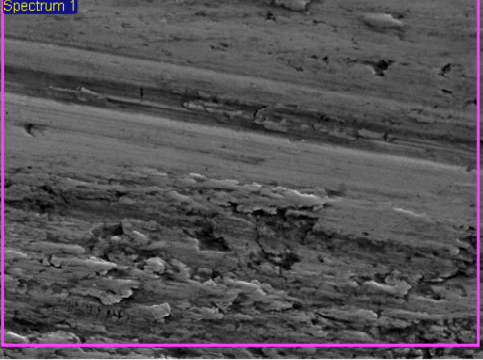
UK2024_04R	CoCrMo	CoCrMo

SEM analysis confirmed the presence of severe damage on the articular surface of bearing couples of the same material, including the CoCrMo alloy on CoCrMo alloy and

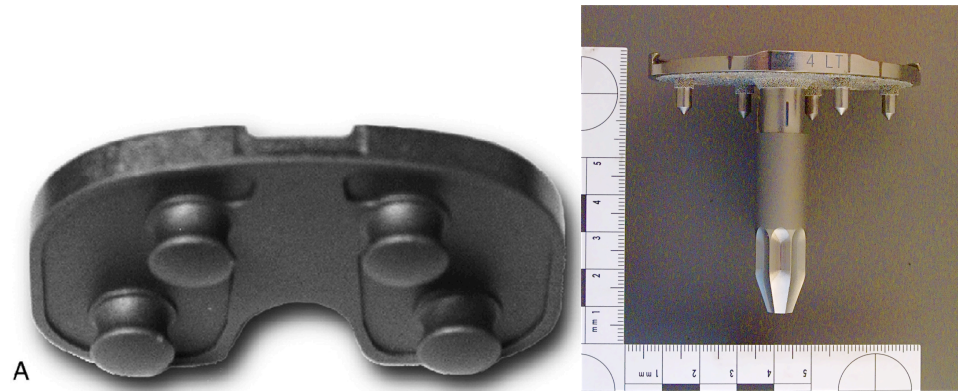
Figure 4.2: Representative images of tibial components that incorporate a pegged-only design (left) [20] and those that incorporate both pegs and a central stem (right)

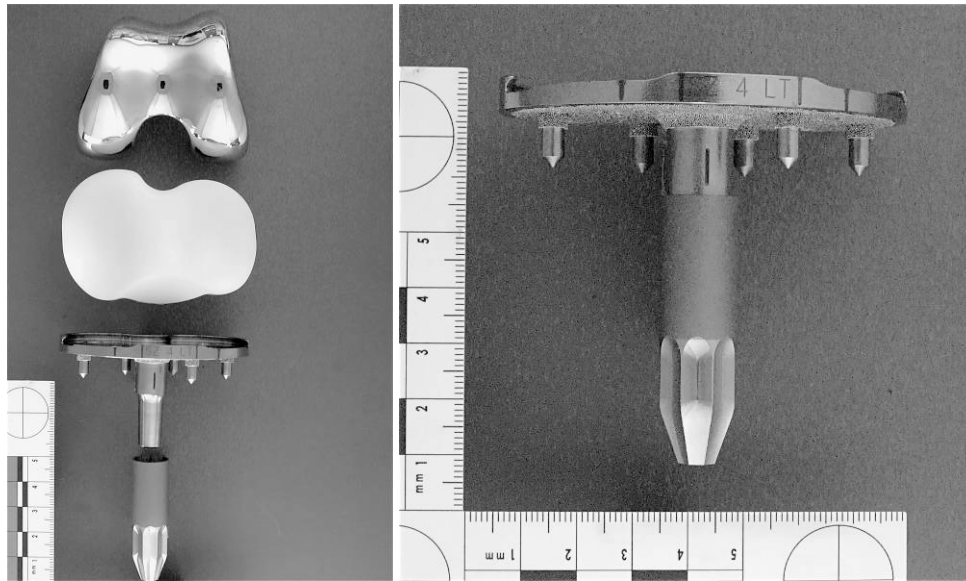
Figure 4.3: Gross photographs of each individual component of Profix TKA (left) and assembled tibial component with stem of current study (right)

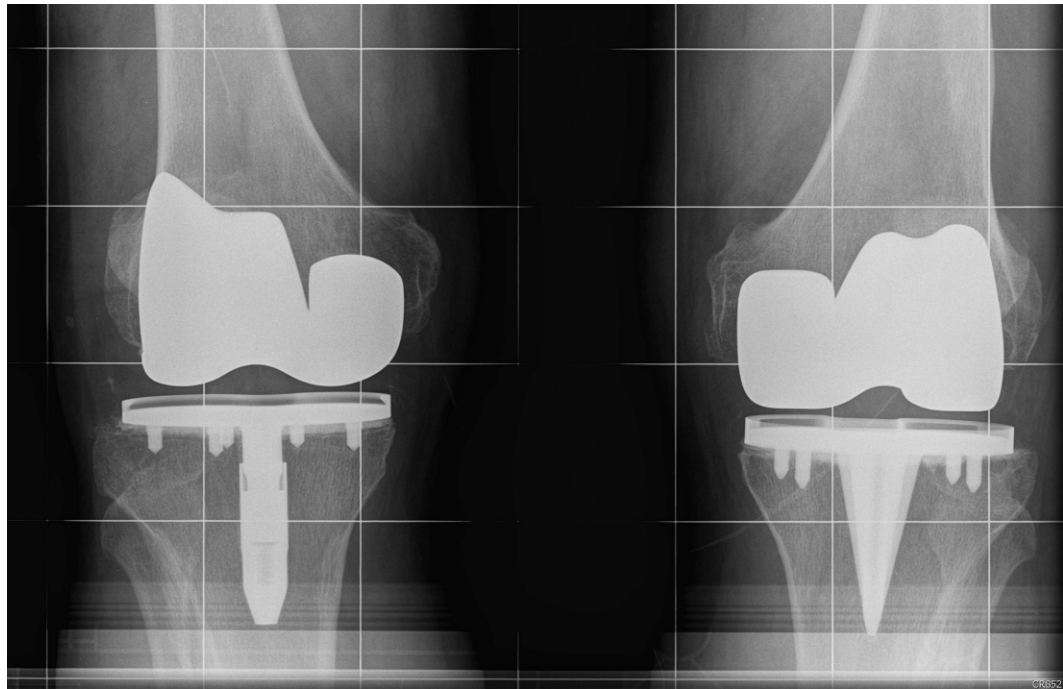
Figure 4.4: Radiograph with Profix Total Knee System (left) and Natural Knee (right)

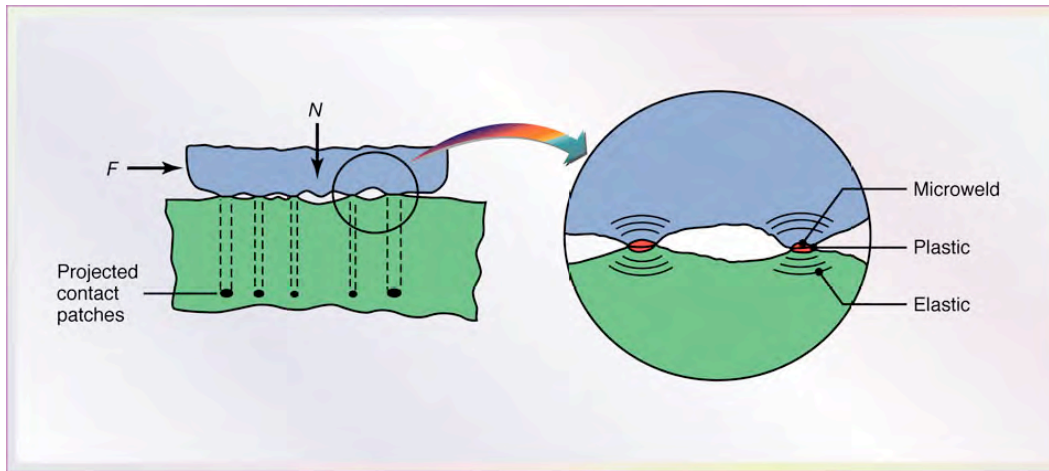
Figure 5.3: Simplified cartoon demonstrating real contact area between two bodies in contact

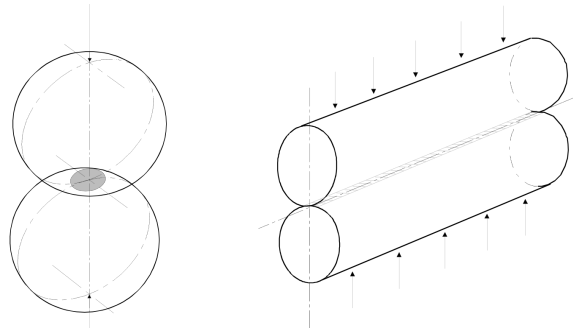
Figure 5.4: Representative image of point (left) and line (right) contact determined by shape and conformity of bearing surfaces

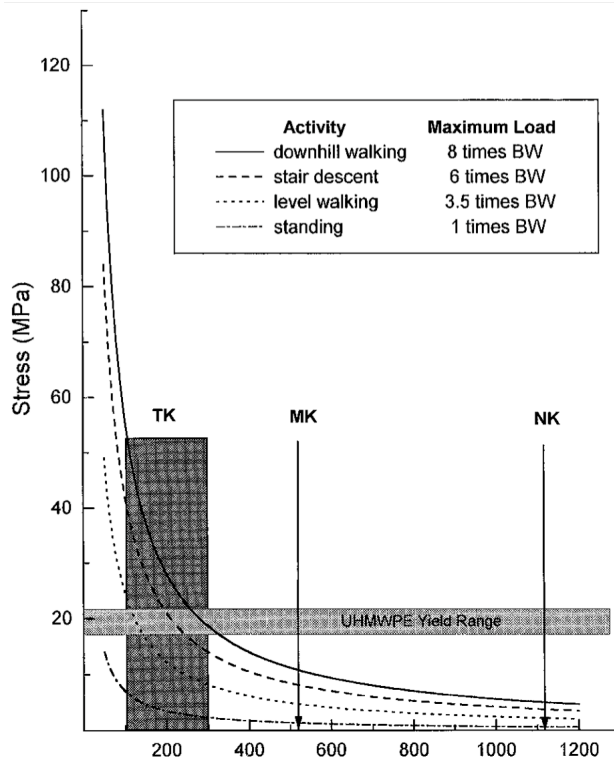
Figure 5.5: Tibial plateau stress versus contact area for different daily activities for a 70kg female. Uniform stress distribution is assumed. The horizontal bar indicates the yield range of polyethylene while the vertical bars demonstrate the range of tibiofemoral contact area of tested knee prostheses (TK), a knee joint after meniscectomy (MK) and a natural knee joint (NK) [63]
