# The Colonist's Concrete: A Preservation Plan for the Seventeenth-Century Tabby Floor Found at the Miller Archaeological Site

A Thesis  
Presented to  
the Graduate Schools of  
Clemson University and College of Charleston

In Partial Fulfillment  
of the Requirements for the Degree  
Master of Science  
Historic Preservation

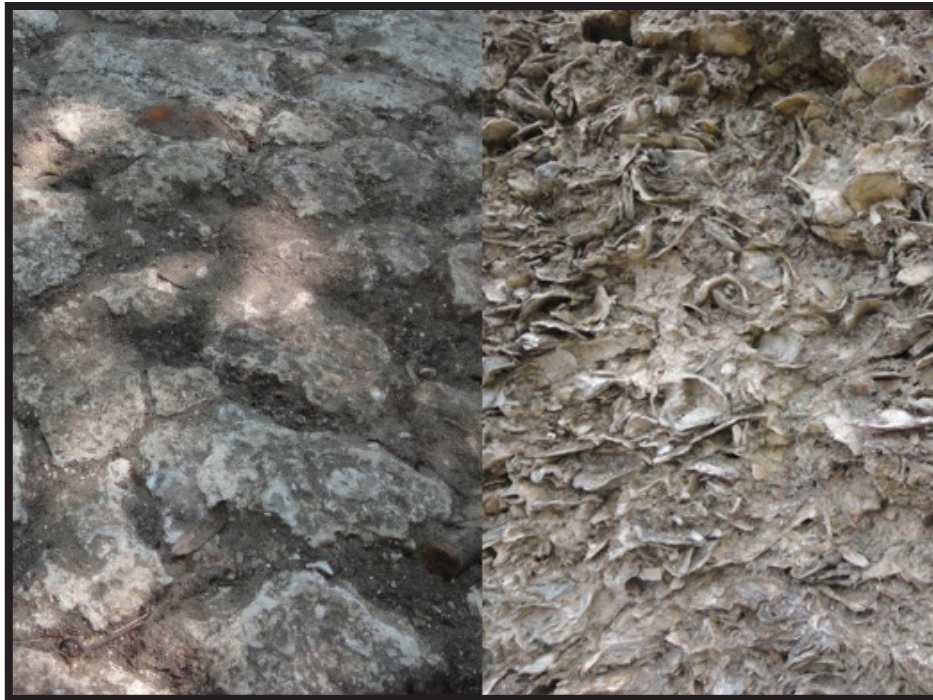
*Figure 3. Image Comparing tabby from the Miller Site (left) to Colonial Fort Dorchester (right), (Photographs by author, 2014).*

of lime, sand, water and an aggregate, based on material composition alone the floor calls for a new label of identification. The floor at the Miller Site offers a new category in the broader realm of augmented earthen flooring, more accurately described as “lime concrete” than tabby as it is historically defined. The Miller Site floor plays a pivotal role in the longstanding tradition of utilizing carbonic materials to create a floor surface, and combined with its rarity, provides a measure for significance that demands conservation.

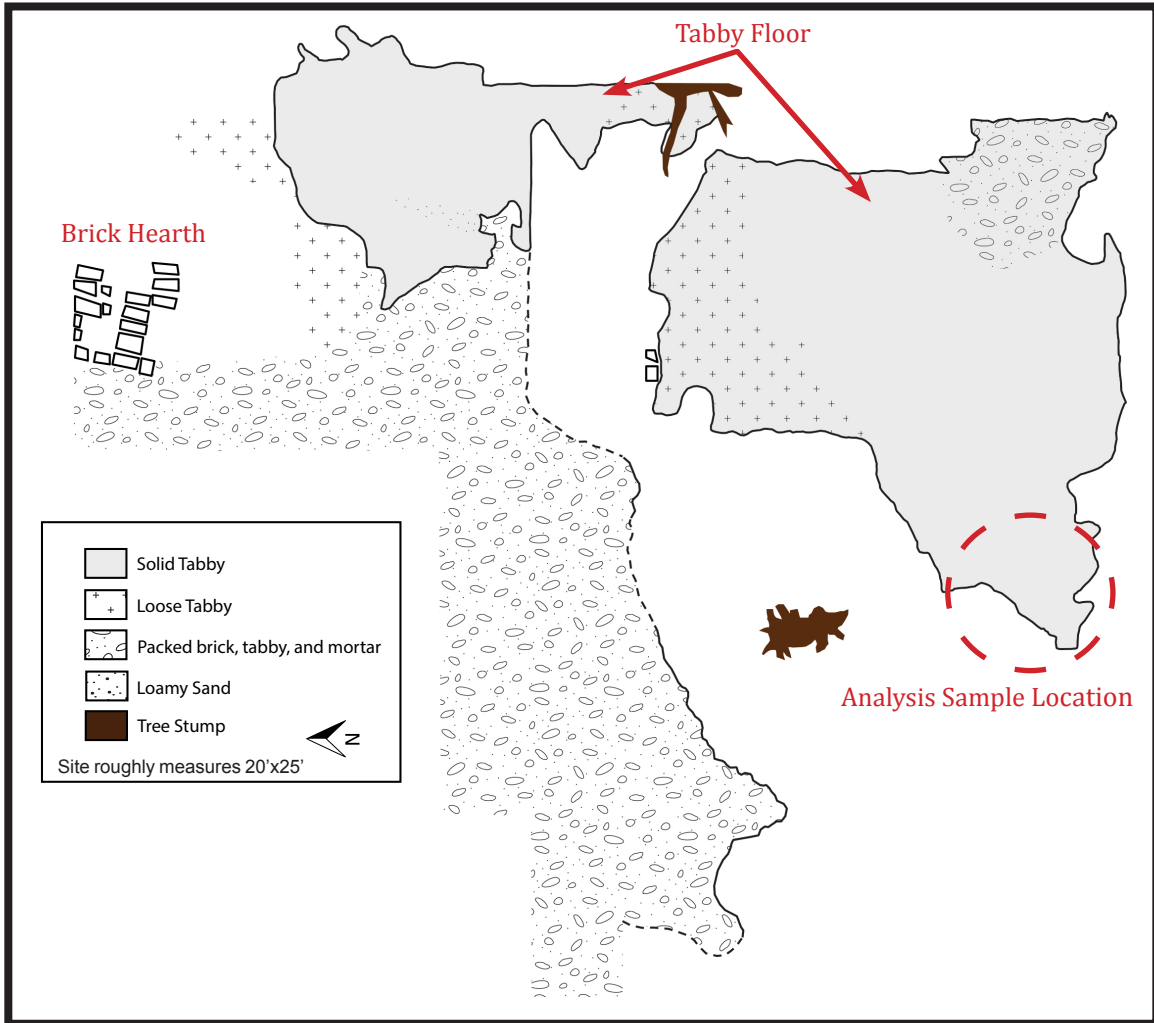
Figure 7. Archaeological Plan of the Miller Site Including Architectural Features. (Plan illustrated by Andrew Agha and the author).

Since 2009, archaeological excavations uncovered both artifacts and structural evidence of the LeSade homestead. Evidence of the structure that once sat at the Miller Site include a tabby floor, two brick piers believed to have supported the structure, as well as a brick fireplace hearth (Figures 7 through 10). It is believed the floor would have served as a ground-level basement or crawlspace, utilized by slaves. The brick piers would have supported a one or possibly two-story wooden structure above. Artifacts found on the tabby floor, as well as the surrounding site, all suggest a late seventeenth century date.

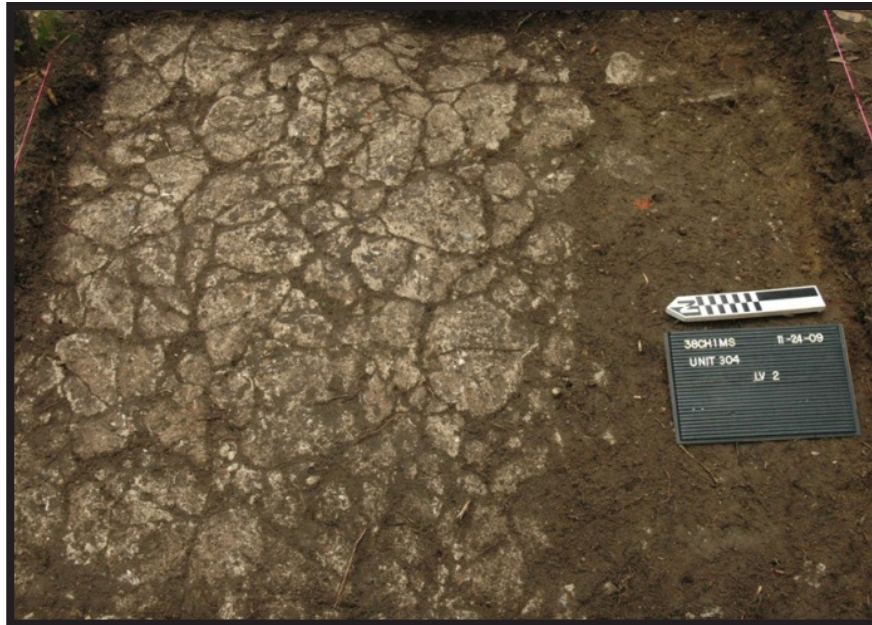
*Figure 8. Image Showing Tabby Floor at the Miller Site (Charles Towne Landing, 2009).*

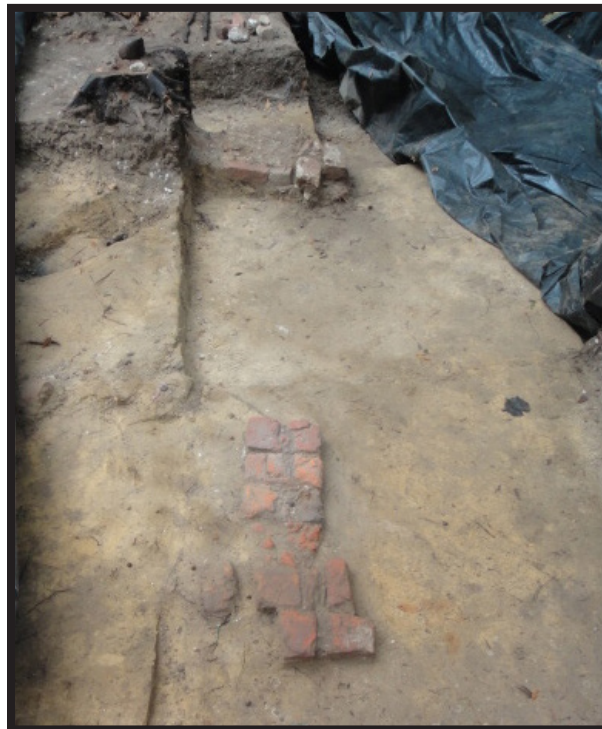
*Figure 9. Image Showing Brick Piers at the Miller Site (Photograph by author, 2014).*

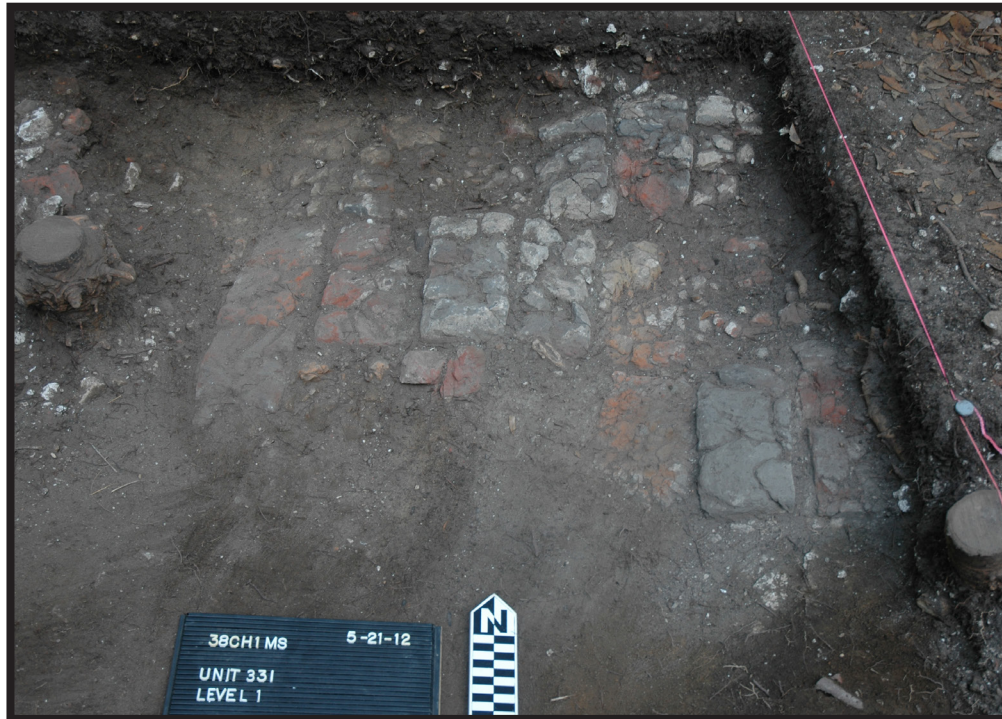
*Figure 10. Image Showing the Brick Hearth at the Miller Site (Charles Towne Landing, 2012).*

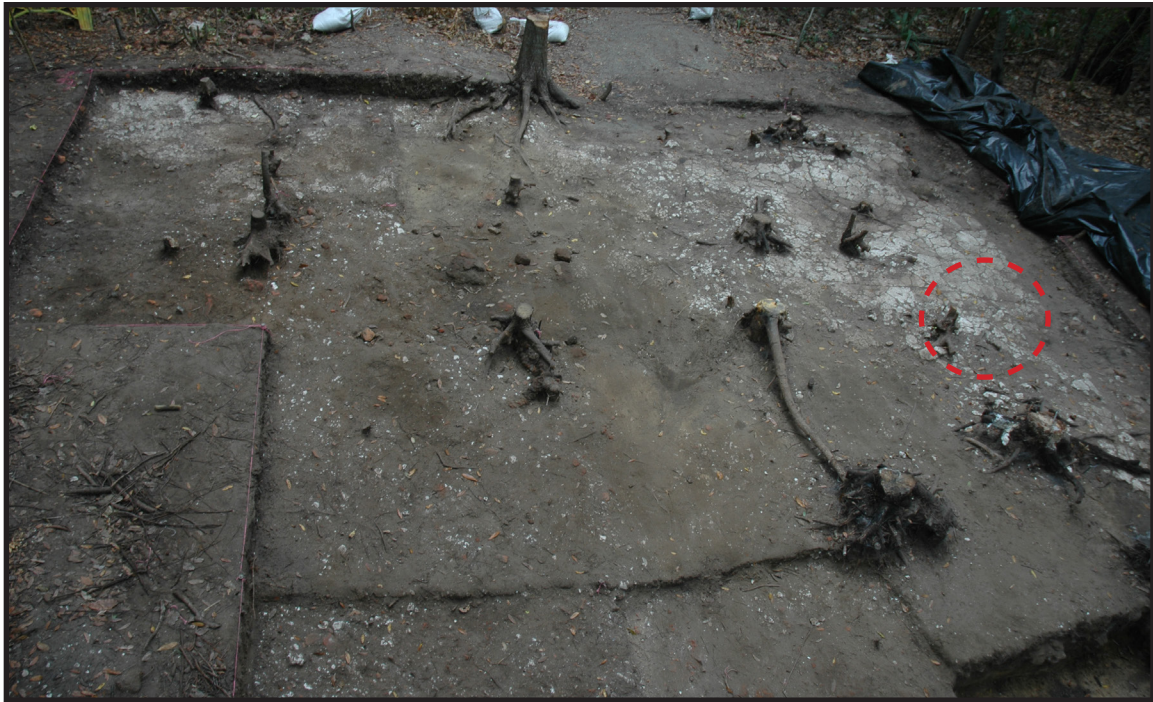
*Figure 13. Image showing Extents of Miller Site Tabby Floor and Approximate Location Sampling Identified (Photograph by Charles Towne Landing, 2010).*

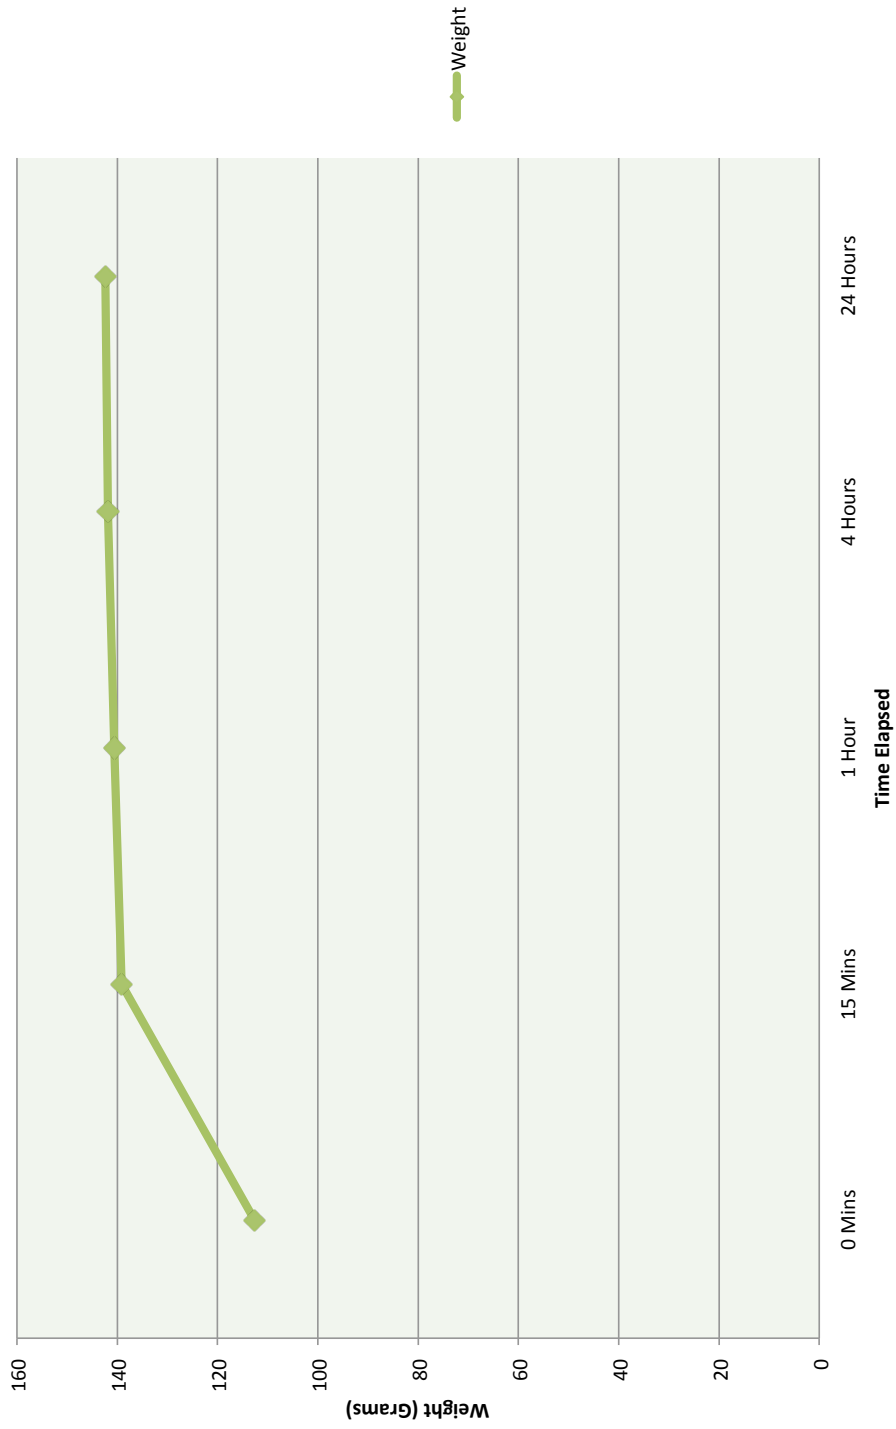
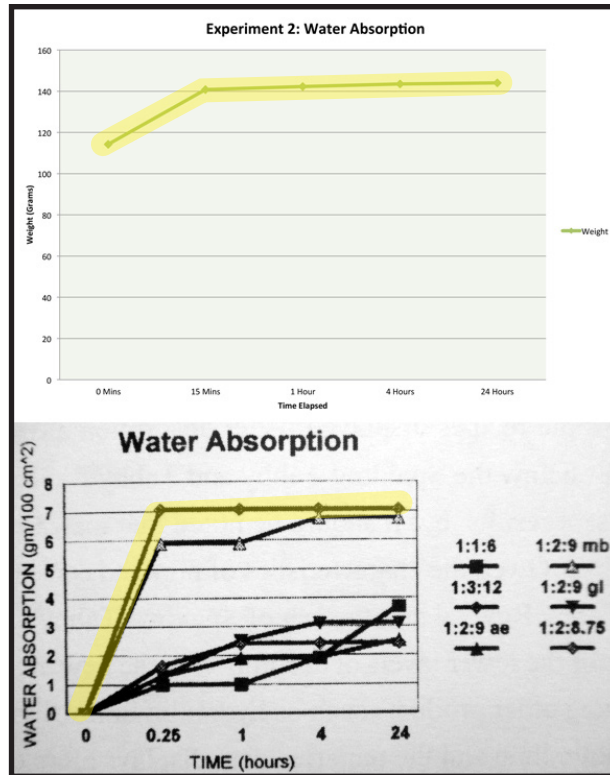
**Graph 1: Water Absorption of Miller Site Tabby**

Figure 14. Comparison of Graphs Depicting Water Absorption (Graphs by author and *The Lost Art of Tabby* page 113).

water, as well as “1:2:9mb,” comprised of Portland cement, lime, sand, oyster shell, microballoons (mb), and water (Figure 14). The microballoons expand when in contact with water in order to mimic the natural voids in tabby. This similarity is noteworthy as it reaffirms the results of the compressive strength test, and bolsters the “1:2:9” recipe created by Sickels-Taves as an appropriate restoration mix. Interestingly, the Miller Site samples absorbed water at a rate more similar to a mix with modern additives rather than other tested historic recipes. It is possible that the Miller Site tabby is more closely related to a modern mixture rather than historic structural tabby because it is a different material all together.

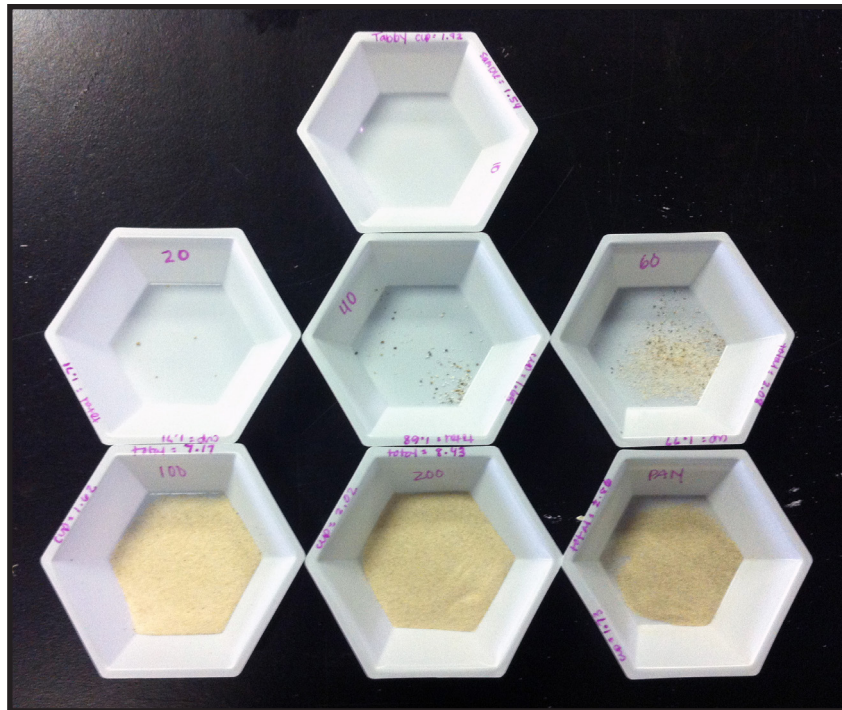
Figure 15. Image Showing Results of Sieve Test after Acid Digestion (Photograph by author, 2013).

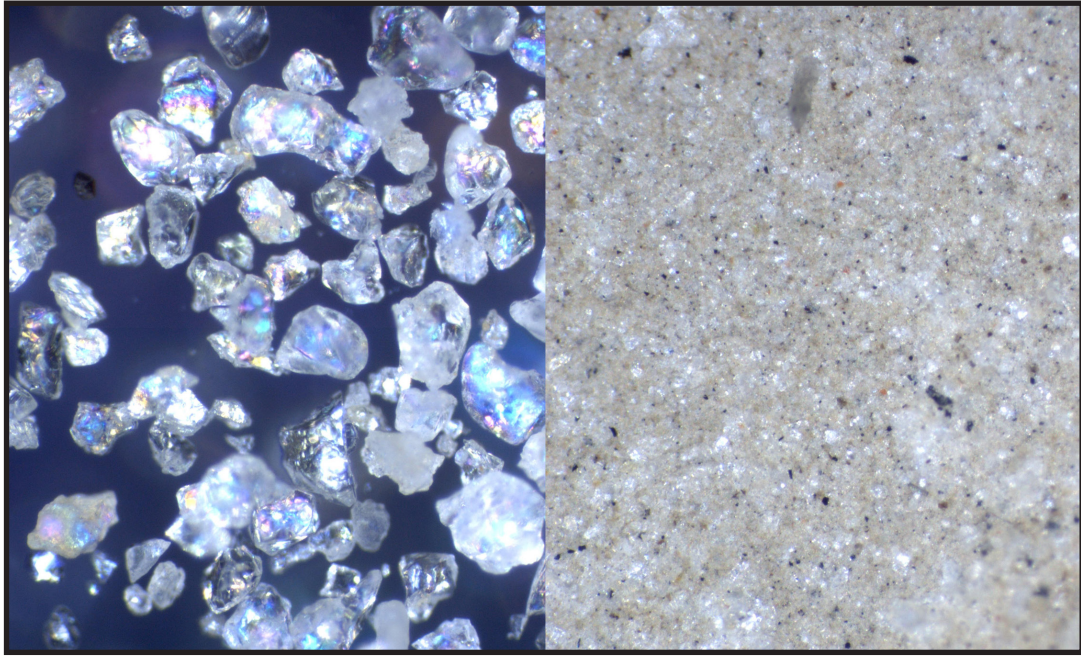
Figure 16. Photomicrograph of Miller Site Tabby Aggregate (left) and Fines (right) at 4X Magnification. (Photographs by author, 2013).

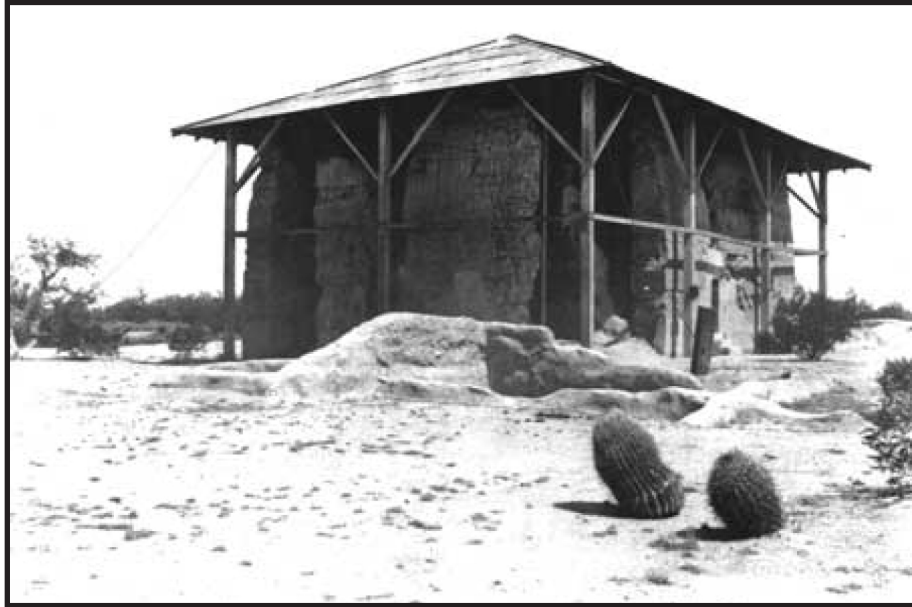
*Figure 21. Image Showing the Original Shelter over Casa Grande circa 1903 (National Park Service, [www.nps.gov](http://www.nps.gov)).*

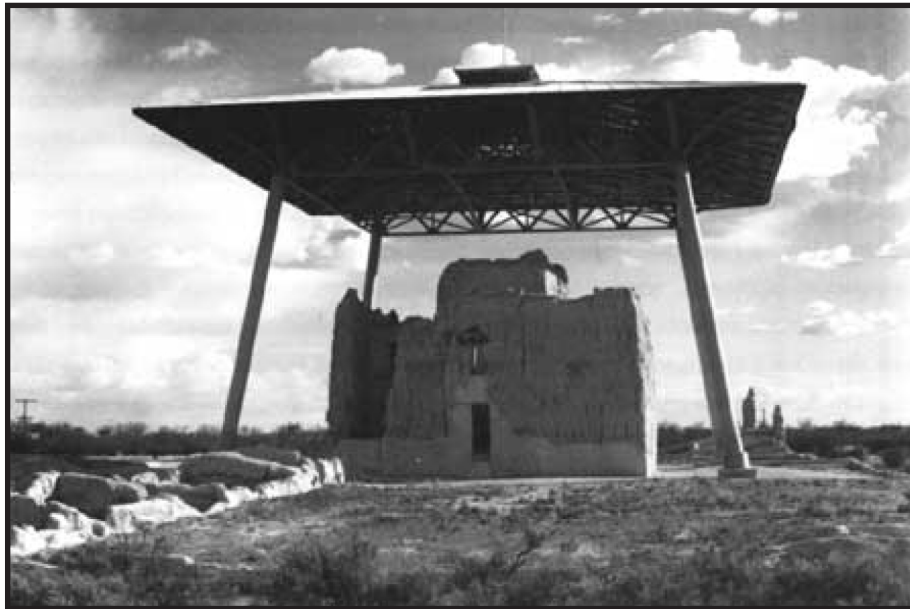
*Figure 22. Image Showing the Current Shelter over Casa Grande circa 1932 (National Park Service, [www.nps.gov](http://www.nps.gov)).*

Though the cost of repainting the roof at Casa Grande is high, adaptations of coverings like it might be appropriate at the Miller Site. Rather than high quality, desert-grade paint, cost effective asphalt singles could be used in its place. Similarly, a proposed shelter could forgo skylights, and copper louvers in favor of a simple wood-trussed design. In this way, an overall lower budget is achievable by eliminating unnecessary attributes and reducing the project's scale. Replacing a shelter roof every fifteen to thirty years would be a small price to pay for conserving a vestige of South Carolina history.

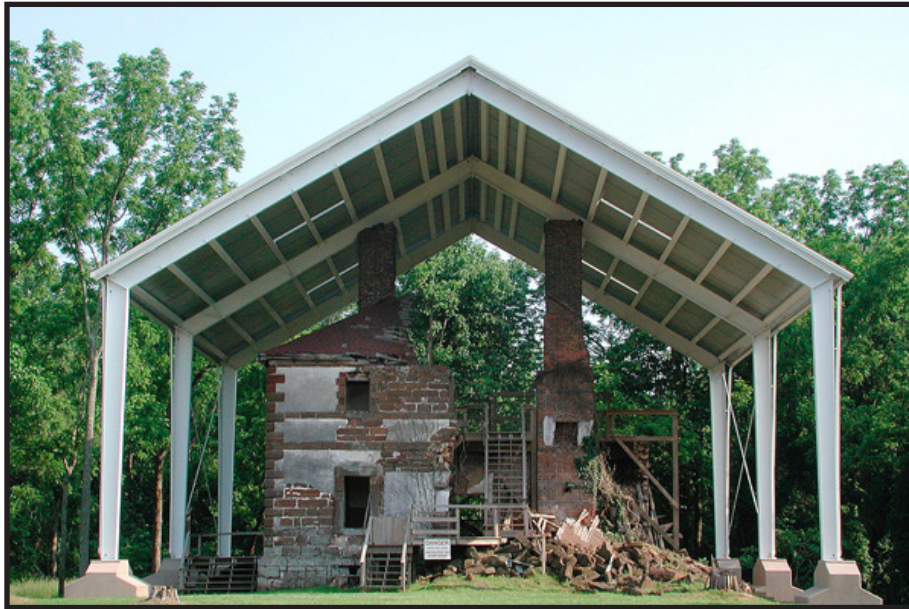
*Figure 23. Image Showing the Shelter over Menokin circa 2000 (Menokin Foundation).*

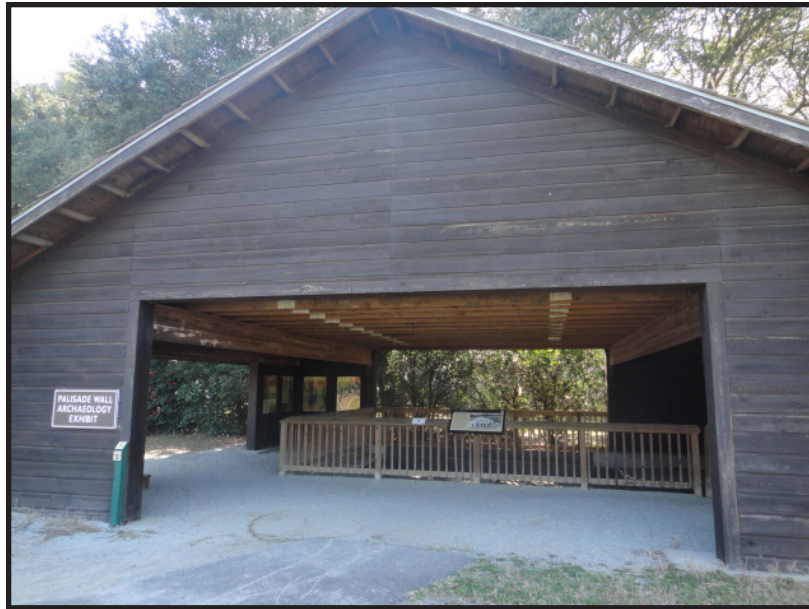
*Figure 24. Image Showing the Precedent for Shelters at Charles Towne Landing (Photograph by author).*

alize how a structure of the same dimensions might have occupied the site in the seventeenth century. The precedent for shelters at Charles Towne Landing was previously set when a similar permanent archaeology exhibit was established within the palisade walls (Figure 24). The current exhibit fully covers a faux archaeology site, provides adequate shade and protection for visitors, and offers explanatory signage. This shelter requires minimal maintenance. Maintenance would include any necessary repairs to the structure, raking, and cleaning of debris. The current sheltered exhibit is geared more towards the explanation of archaeological methods and is not an actual open and active site. A simple shelter, similar in size and adapted from examples at the park and Casa Grande would cost the park relatively little but assure a large degree of conservation.
