# Three Hoes in the Kitchen: The Conceptualization of Peachtree Plantation, St. James Santee Parish, South Carolina

A Thesis  
Presented to  
the Graduate School of  
Clemson University

In Partial Fulfillment  
of the Requirements for the Degree  
Master of Science  
Historic Preservation

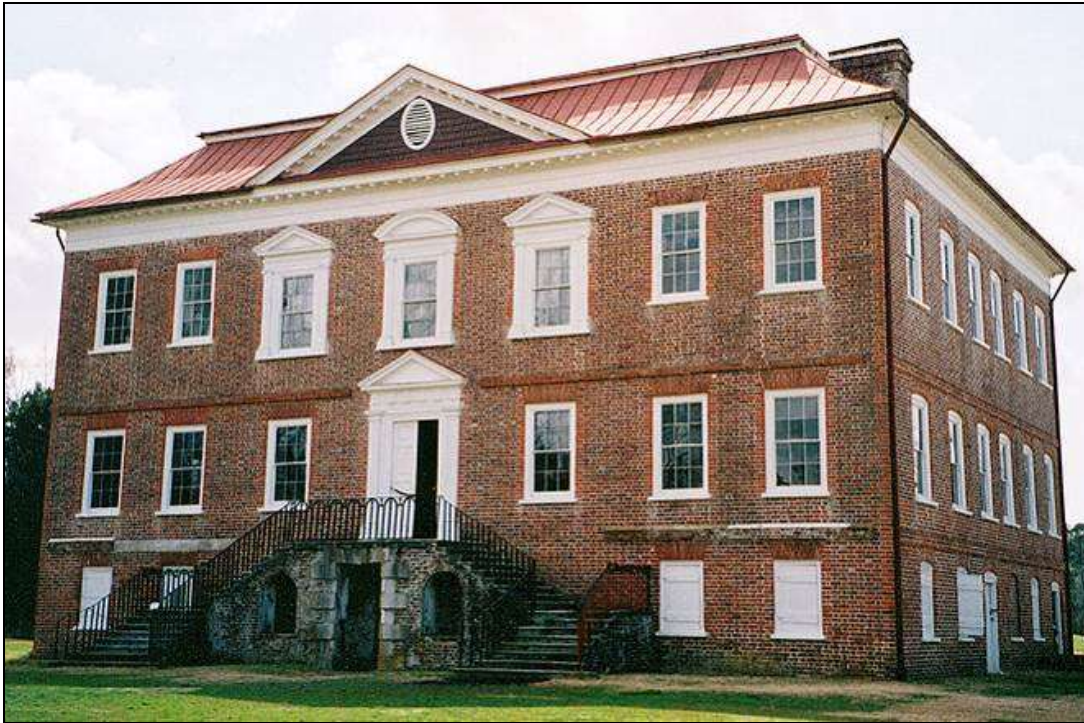
**Figure 7. East façade of Drayton Hall.**

The east elevation of Drayton Hall faces the Ashley River and consists of a dressed limestone landing atop a brick foundation and flanked by stairs, which are parallel to the structure and curve down to the ground surface (Figure 7). Wrought iron hand rails are present along the stairs and landing. There is a simple pediment with modillion cornice over the central entry door on the principal level and is flanked by a molded architrave and simple Doric pilasters. The three central windows on the second floor have pediments and are flanked by ionic pilasters. The window above the entry door is an arched pediment while the two flanking windows are gabled. A pediment is also present at the roof line of the east elevation and is similar to that of the west elevation.

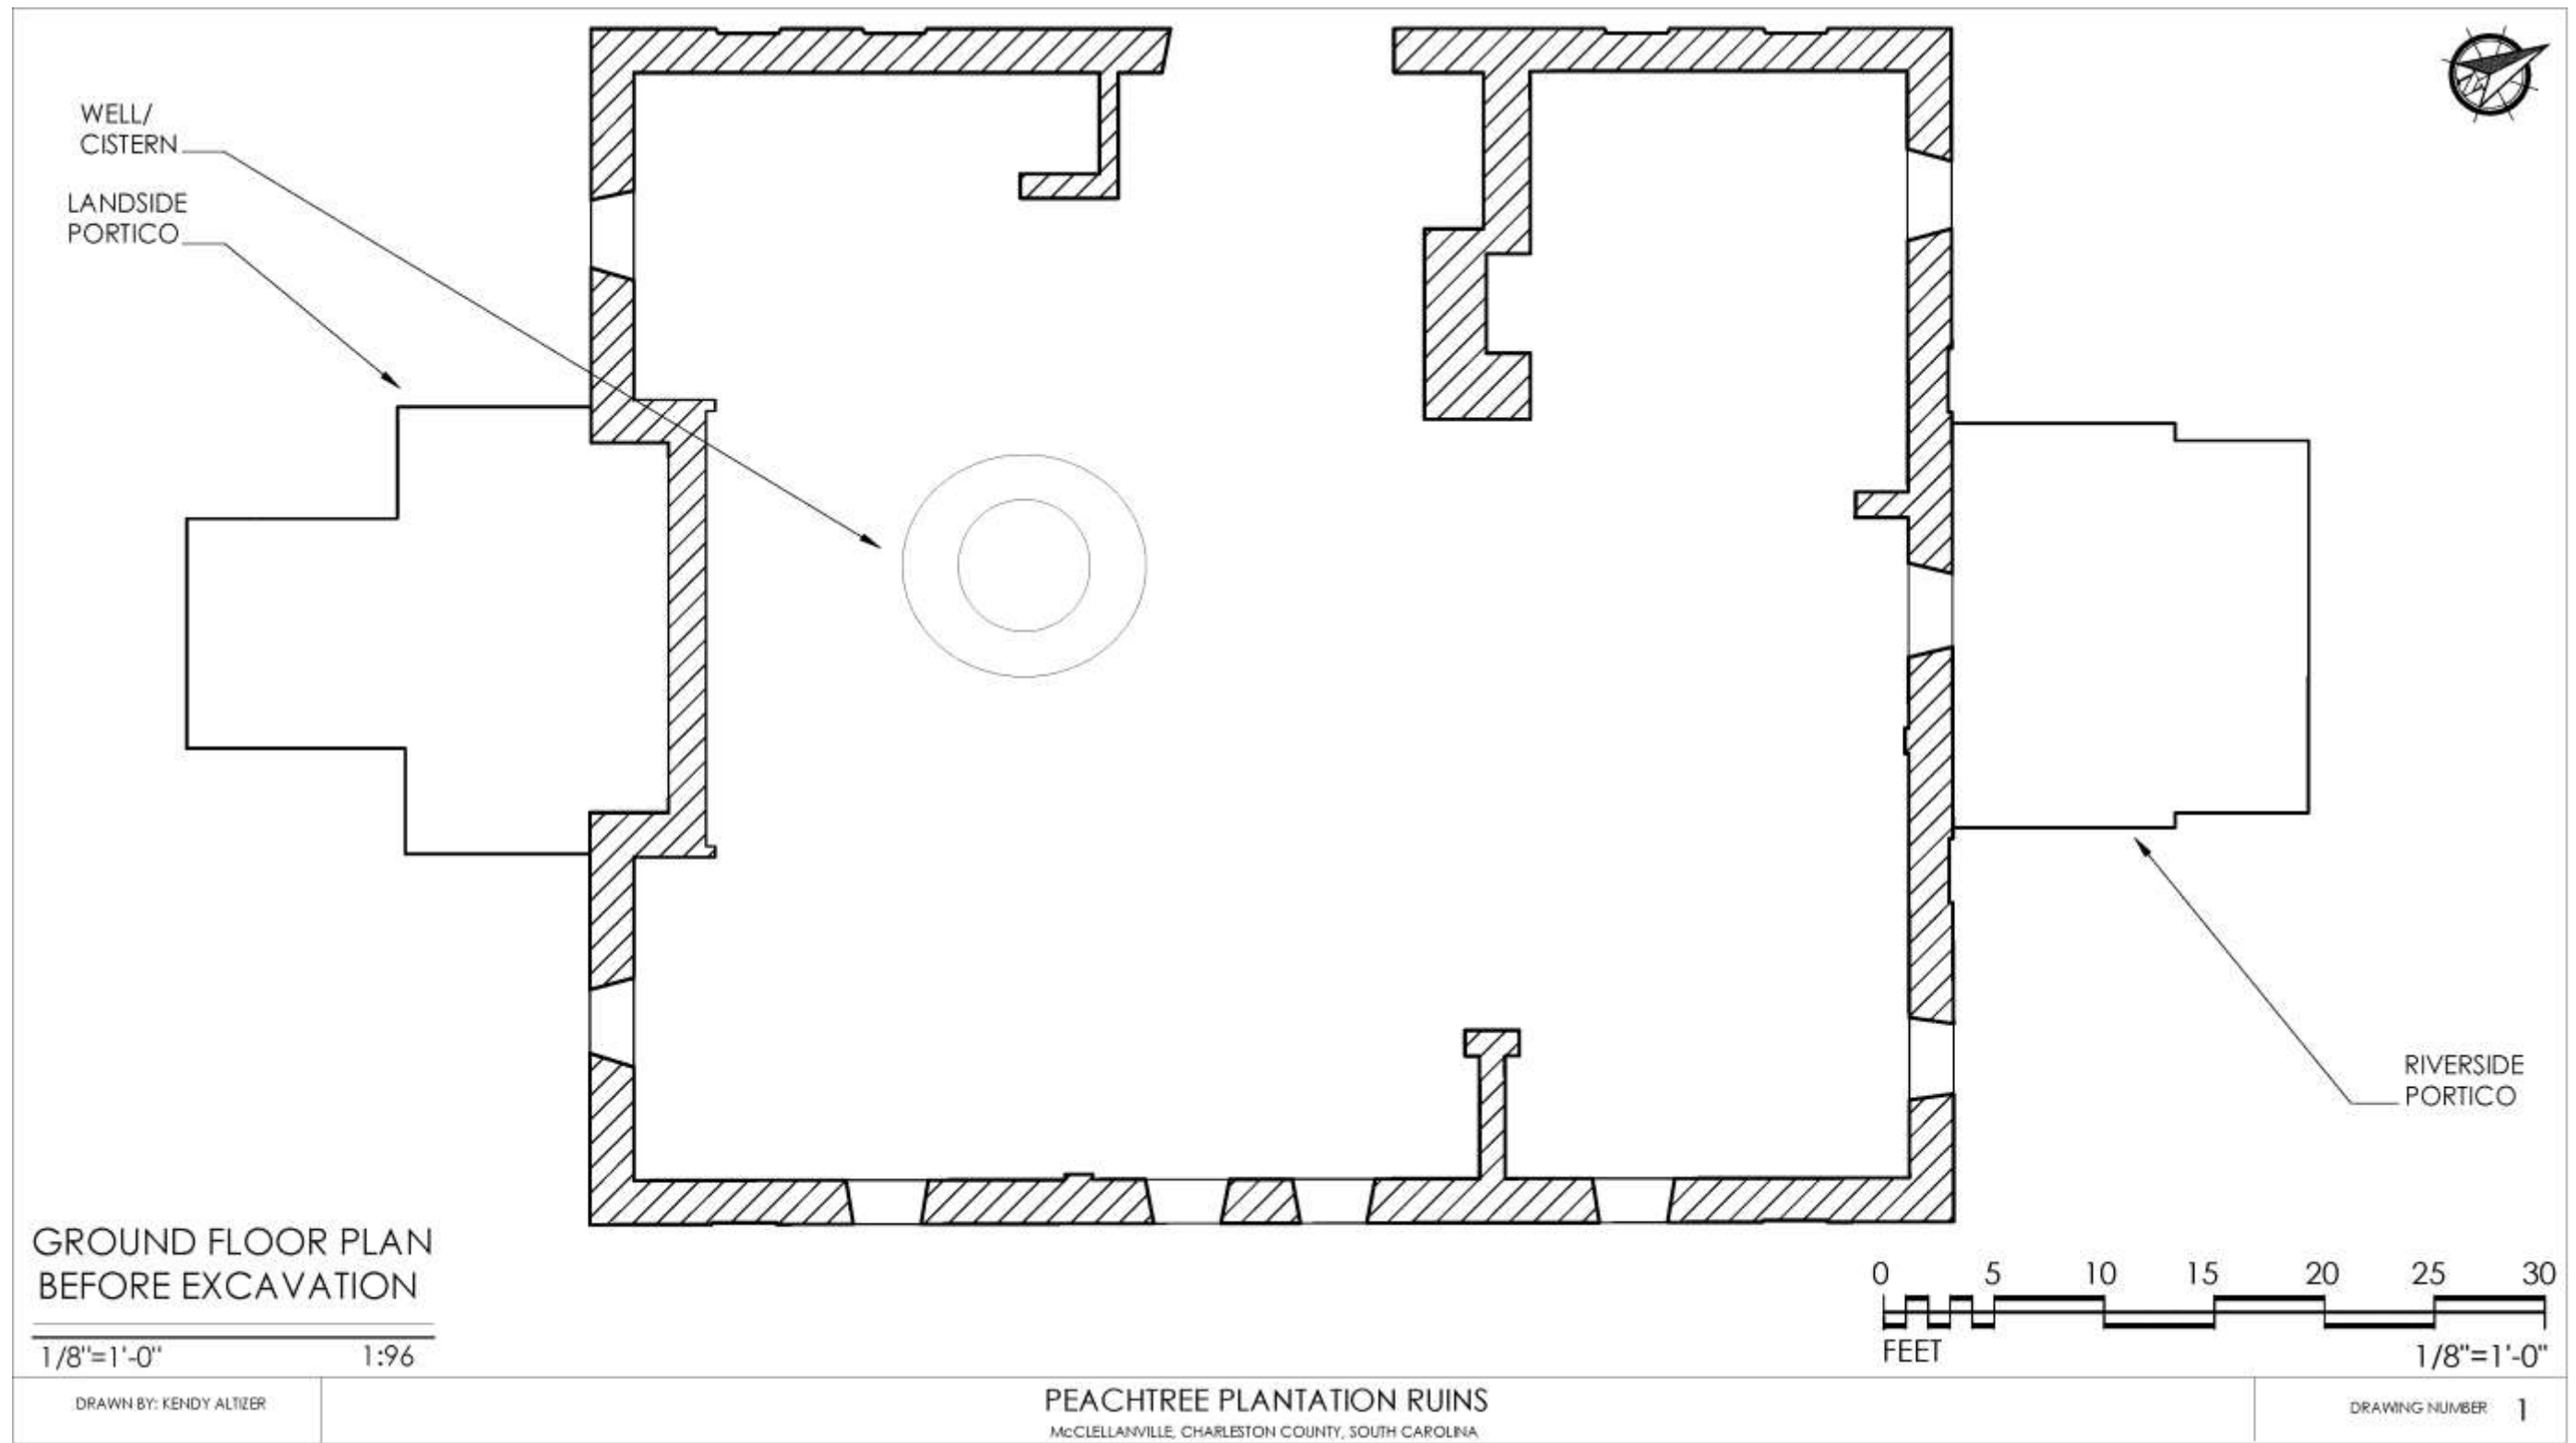
Figure 19. Floor Plan of Peachtree Plantation before archaeological excavation.

The Peachtree ruin measures 54 feet 4 inches by 61 feet 9 3/4 inches and encloses approximately 3,356 square feet per level or at least 6,712 square feet in total (Figure 19).<sup>88</sup> It is constructed entirely of English bond laid brick; the exterior is stuccoed and scored to resemble stone (Figure 20). The score marks are now faint trace blocks measuring 9 inches tall by 18 inches wide. The riverside elevation, western extent, shows evidence of repairs to the stucco.

The only remaining interior walls still intact are varying sizes of stubs located along the perimeter of the structure (see Figure 19). Before archaeological excavation, there was no visible evidence of remaining walls other than these. Observing the interior from the landside portico, two larger walls are present on the west side of the ruin while smaller remnants of walls are present on the east side (Figure 38 and Figure 39). Remnants of plaster are present on both levels of the interior and visible on most remaining walls.

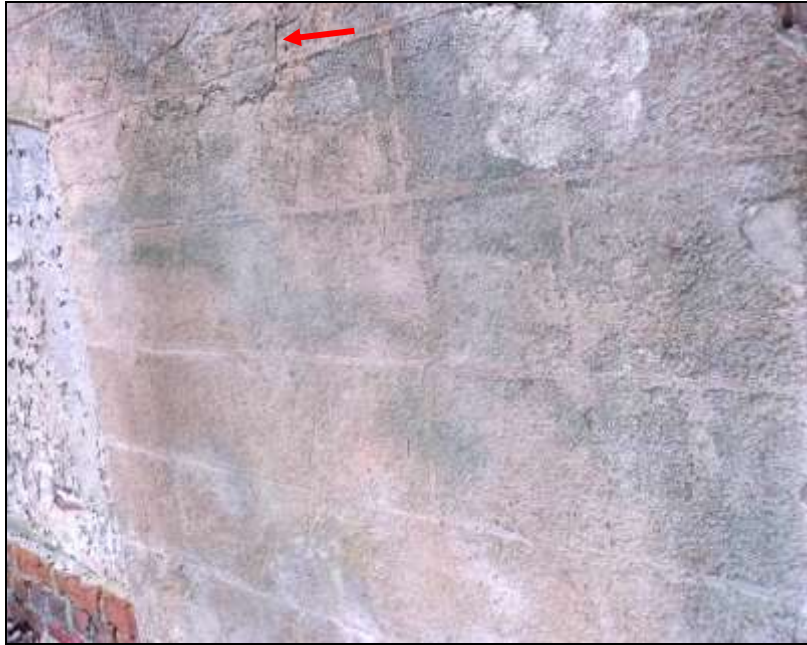
**Figure 20. Riverside elevation showing a section of stucco with possible repair.**

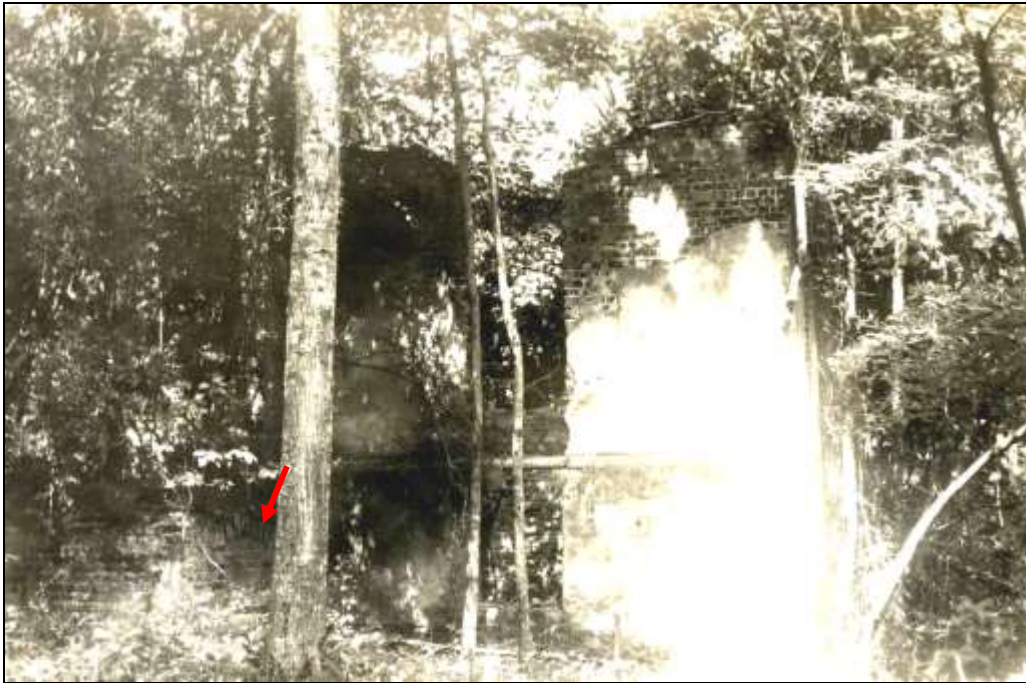
**Figure 27. Dr. Johnson's photo of the landside elevation showing evidence of a relieving arch on the east side of the portico block, July 1930.**

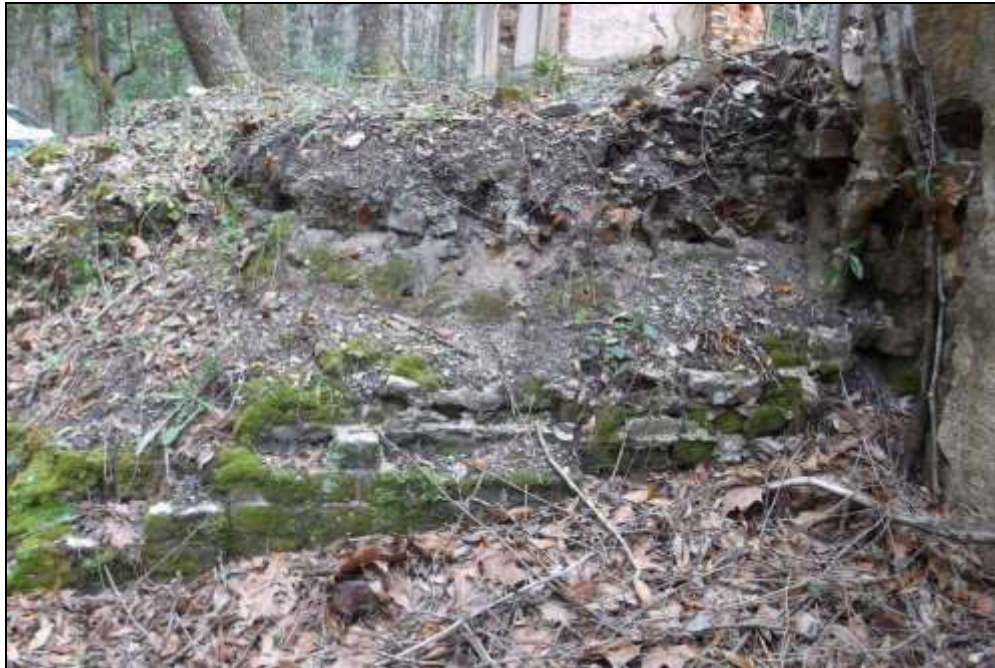
**Figure 28. Landside portico, view northwest, showing the remains of the portico block.**

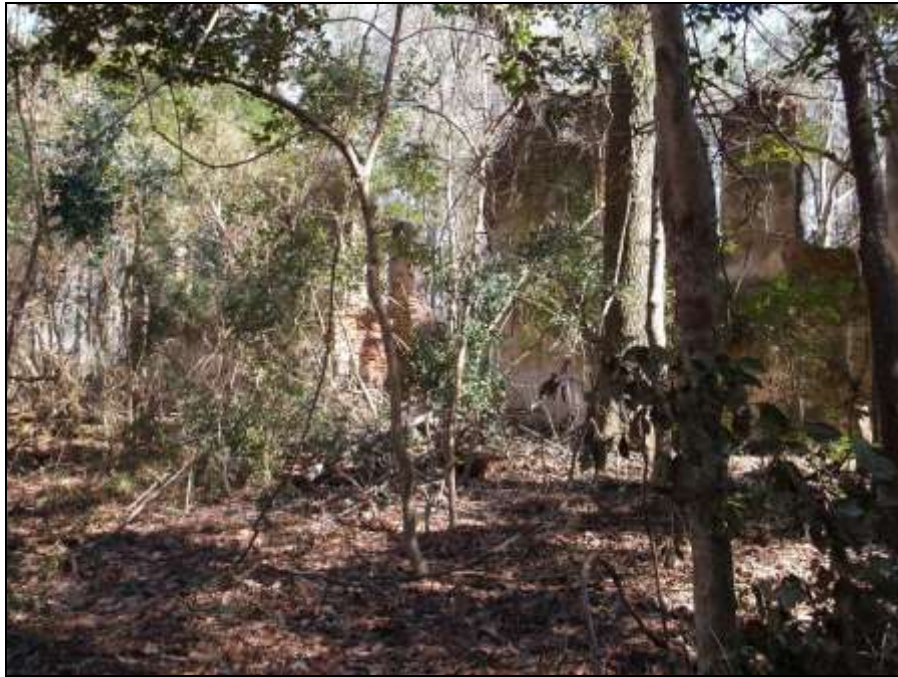
**Figure 35. West elevation overview.**

The west elevation contains the only door opening into the ground level (Figure 35). It is six bays wide and mirrors the eastern elevation in form. The only remaining intact segmental arch is present on the northern bay (Figure 36). Similar to the east elevation, the portion of exterior wall containing the center bays is missing. However, enough evidence remains of these outer openings to delineate a door opening on the northern side and window openings on both levels of the southern side (Figure 37). There are no true window openings present on the ground level of the western elevation with the exception of the window opening in the central bay, south of the door opening.

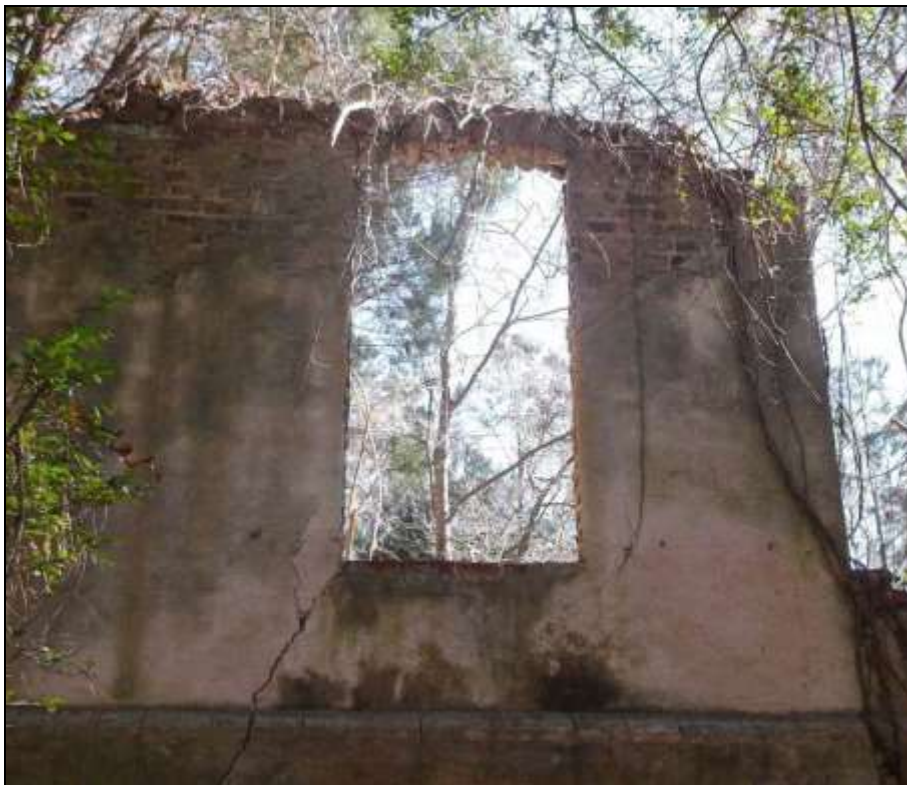
**Figure 36. Segmental arch at the northern extent of the west elevation.**

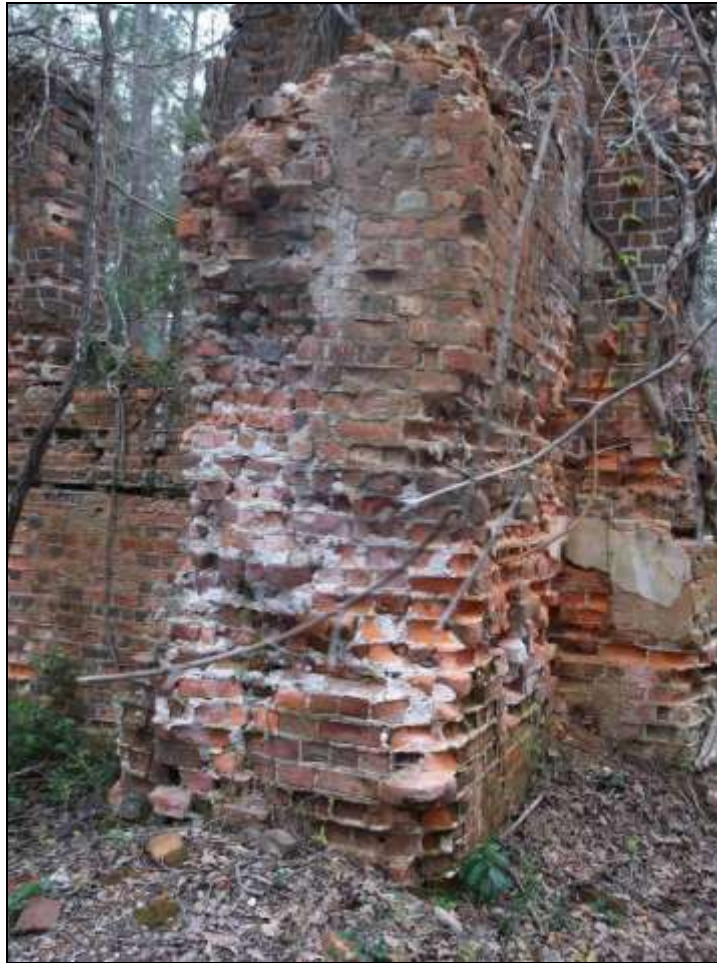
**Figure 42. West elevation, interior remnant flue stack.**

An interior wall remnant with flue stack is present perpendicular to the west elevation, south of the large central opening (Figure 42). The remains of this wall measure 4 feet 7 inches long east-west and 10 inches thick. The wall returns south, measuring 4 feet 5 inches long. This portion of the wall is 1 foot 1 inch thick.

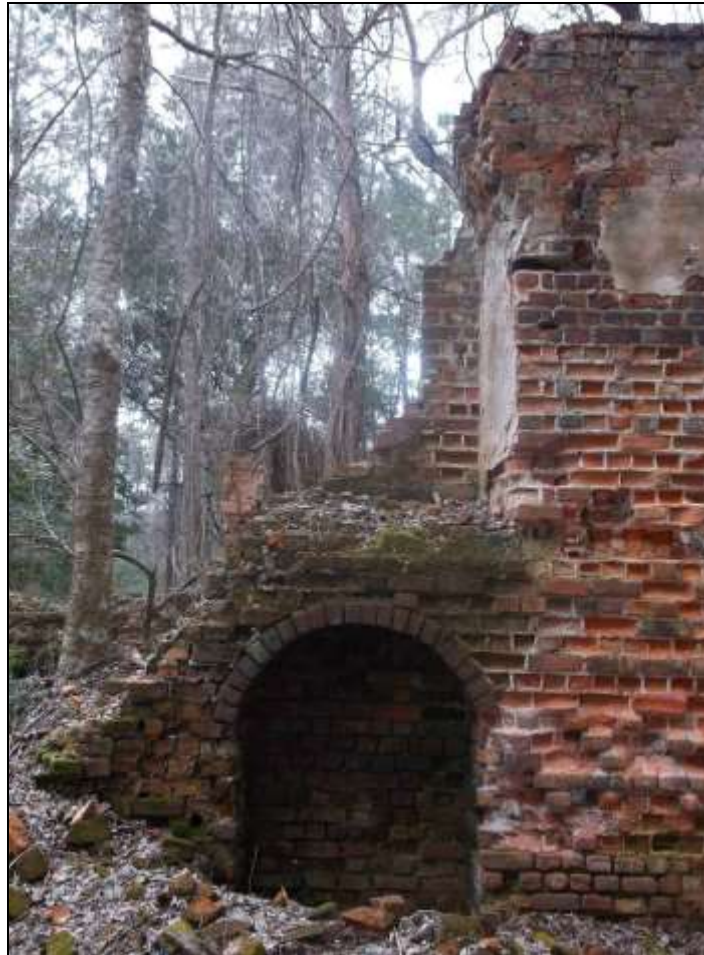
**Figure 43. West elevation, interior wall with relieving arch.**

Another larger wall containing a relieving arch and the remnants of a chimney stack is located just north of the central opening (Figure 43). It is also perpendicular to the west elevation and its south side forms a rectangular box. This section of the wall measures 7 feet 1 inch long and is 2 feet 1 inch thick. The north side of this wall contains a relieving arch at its eastern extent. The arch measures 4 feet six inches wide and the entire chimney base is 4 feet 9 inches thick.

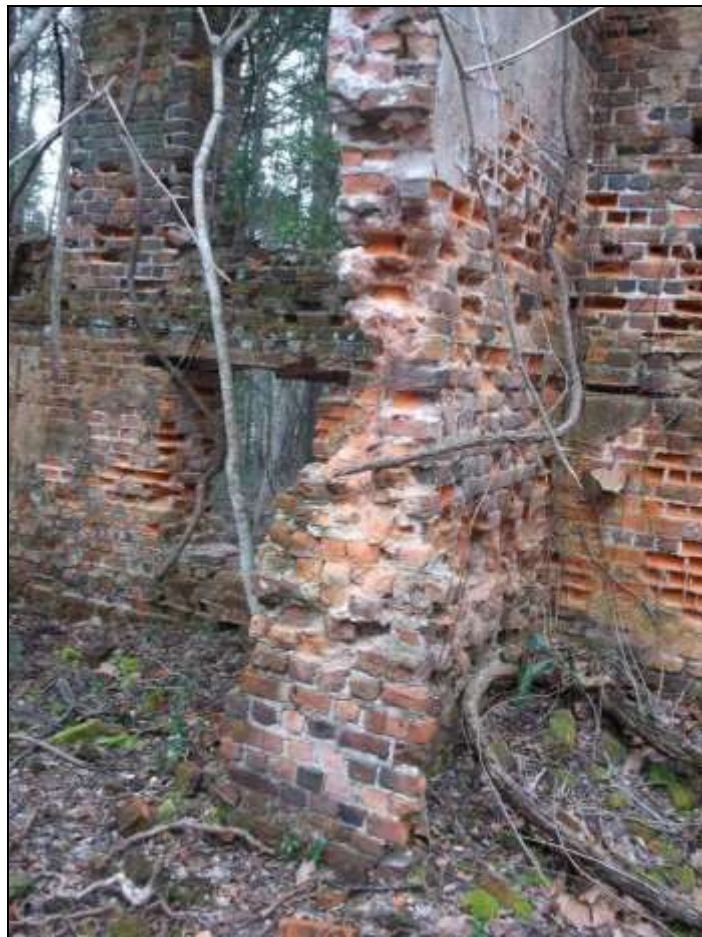
**Figure 46. East elevation, interior T-wall.**

A T-wall is present perpendicular to the eastern elevation between the central bays and the two northern bays (Figure 46). This wall measures 1 foot 2 inches thick and extends west 6 feet 9 inches. The T portion of the wall is faced, indicating this wall is part of a passage way, similar to the interior design of Drayton Hall and the Miles Brewton House.

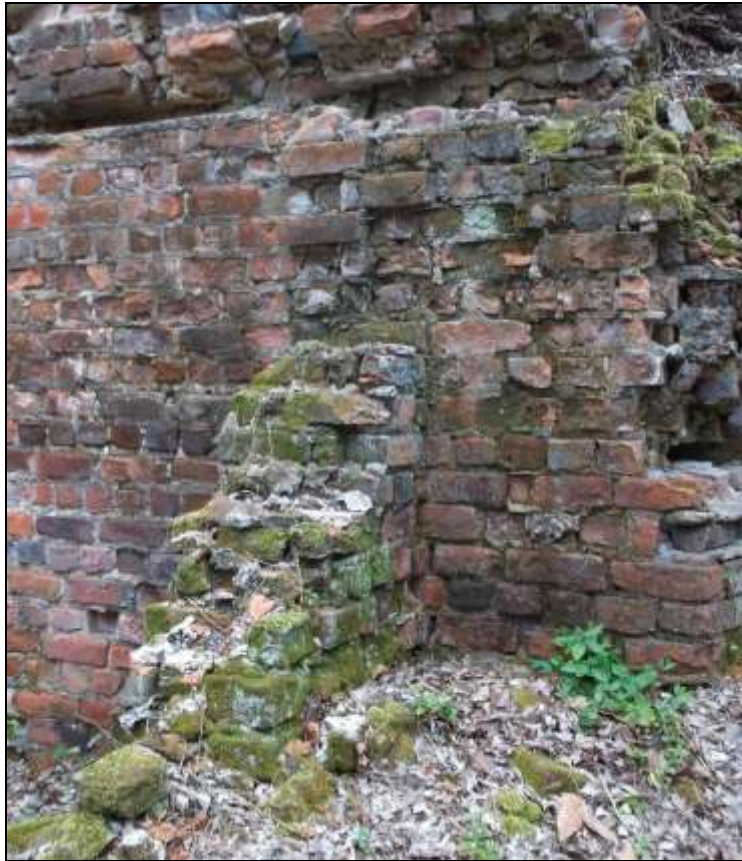
**Figure 48. Interior riverside elevation, west side showing interior wall remnant.**

There are also the remains of two walls flanking the interior ground level window of the riverside elevation (Figure 48). These do not correspond to the extent of the portico block as is evident on the interior landside elevation, but are set closer to the window opening. These remnant walls are 1 foot 2 inches thick and are perpendicular to the riverside elevation. There is very little remaining evidence of the eastern wall. However, the western wall extends 2 feet 4 inches into the interior. The only other wall remnant visible is located on the eastern elevation between the southern and central bays. Like the

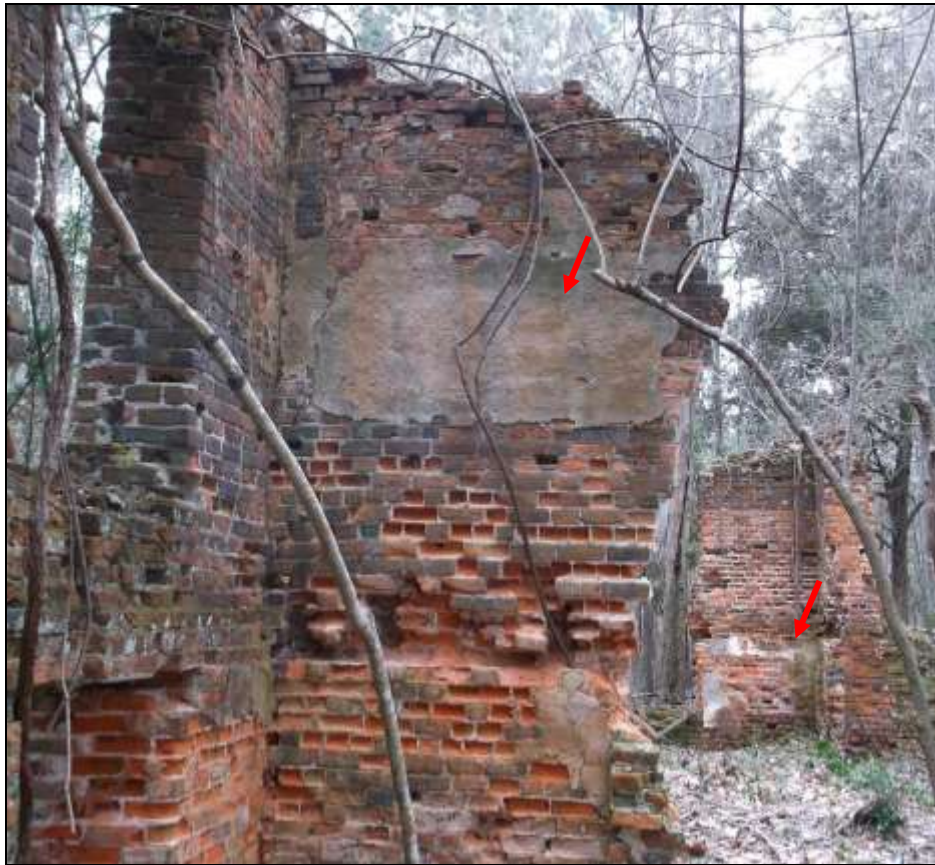
**Figure 51. Interior eastern elevation showing the remnants of plaster on interior walls.**

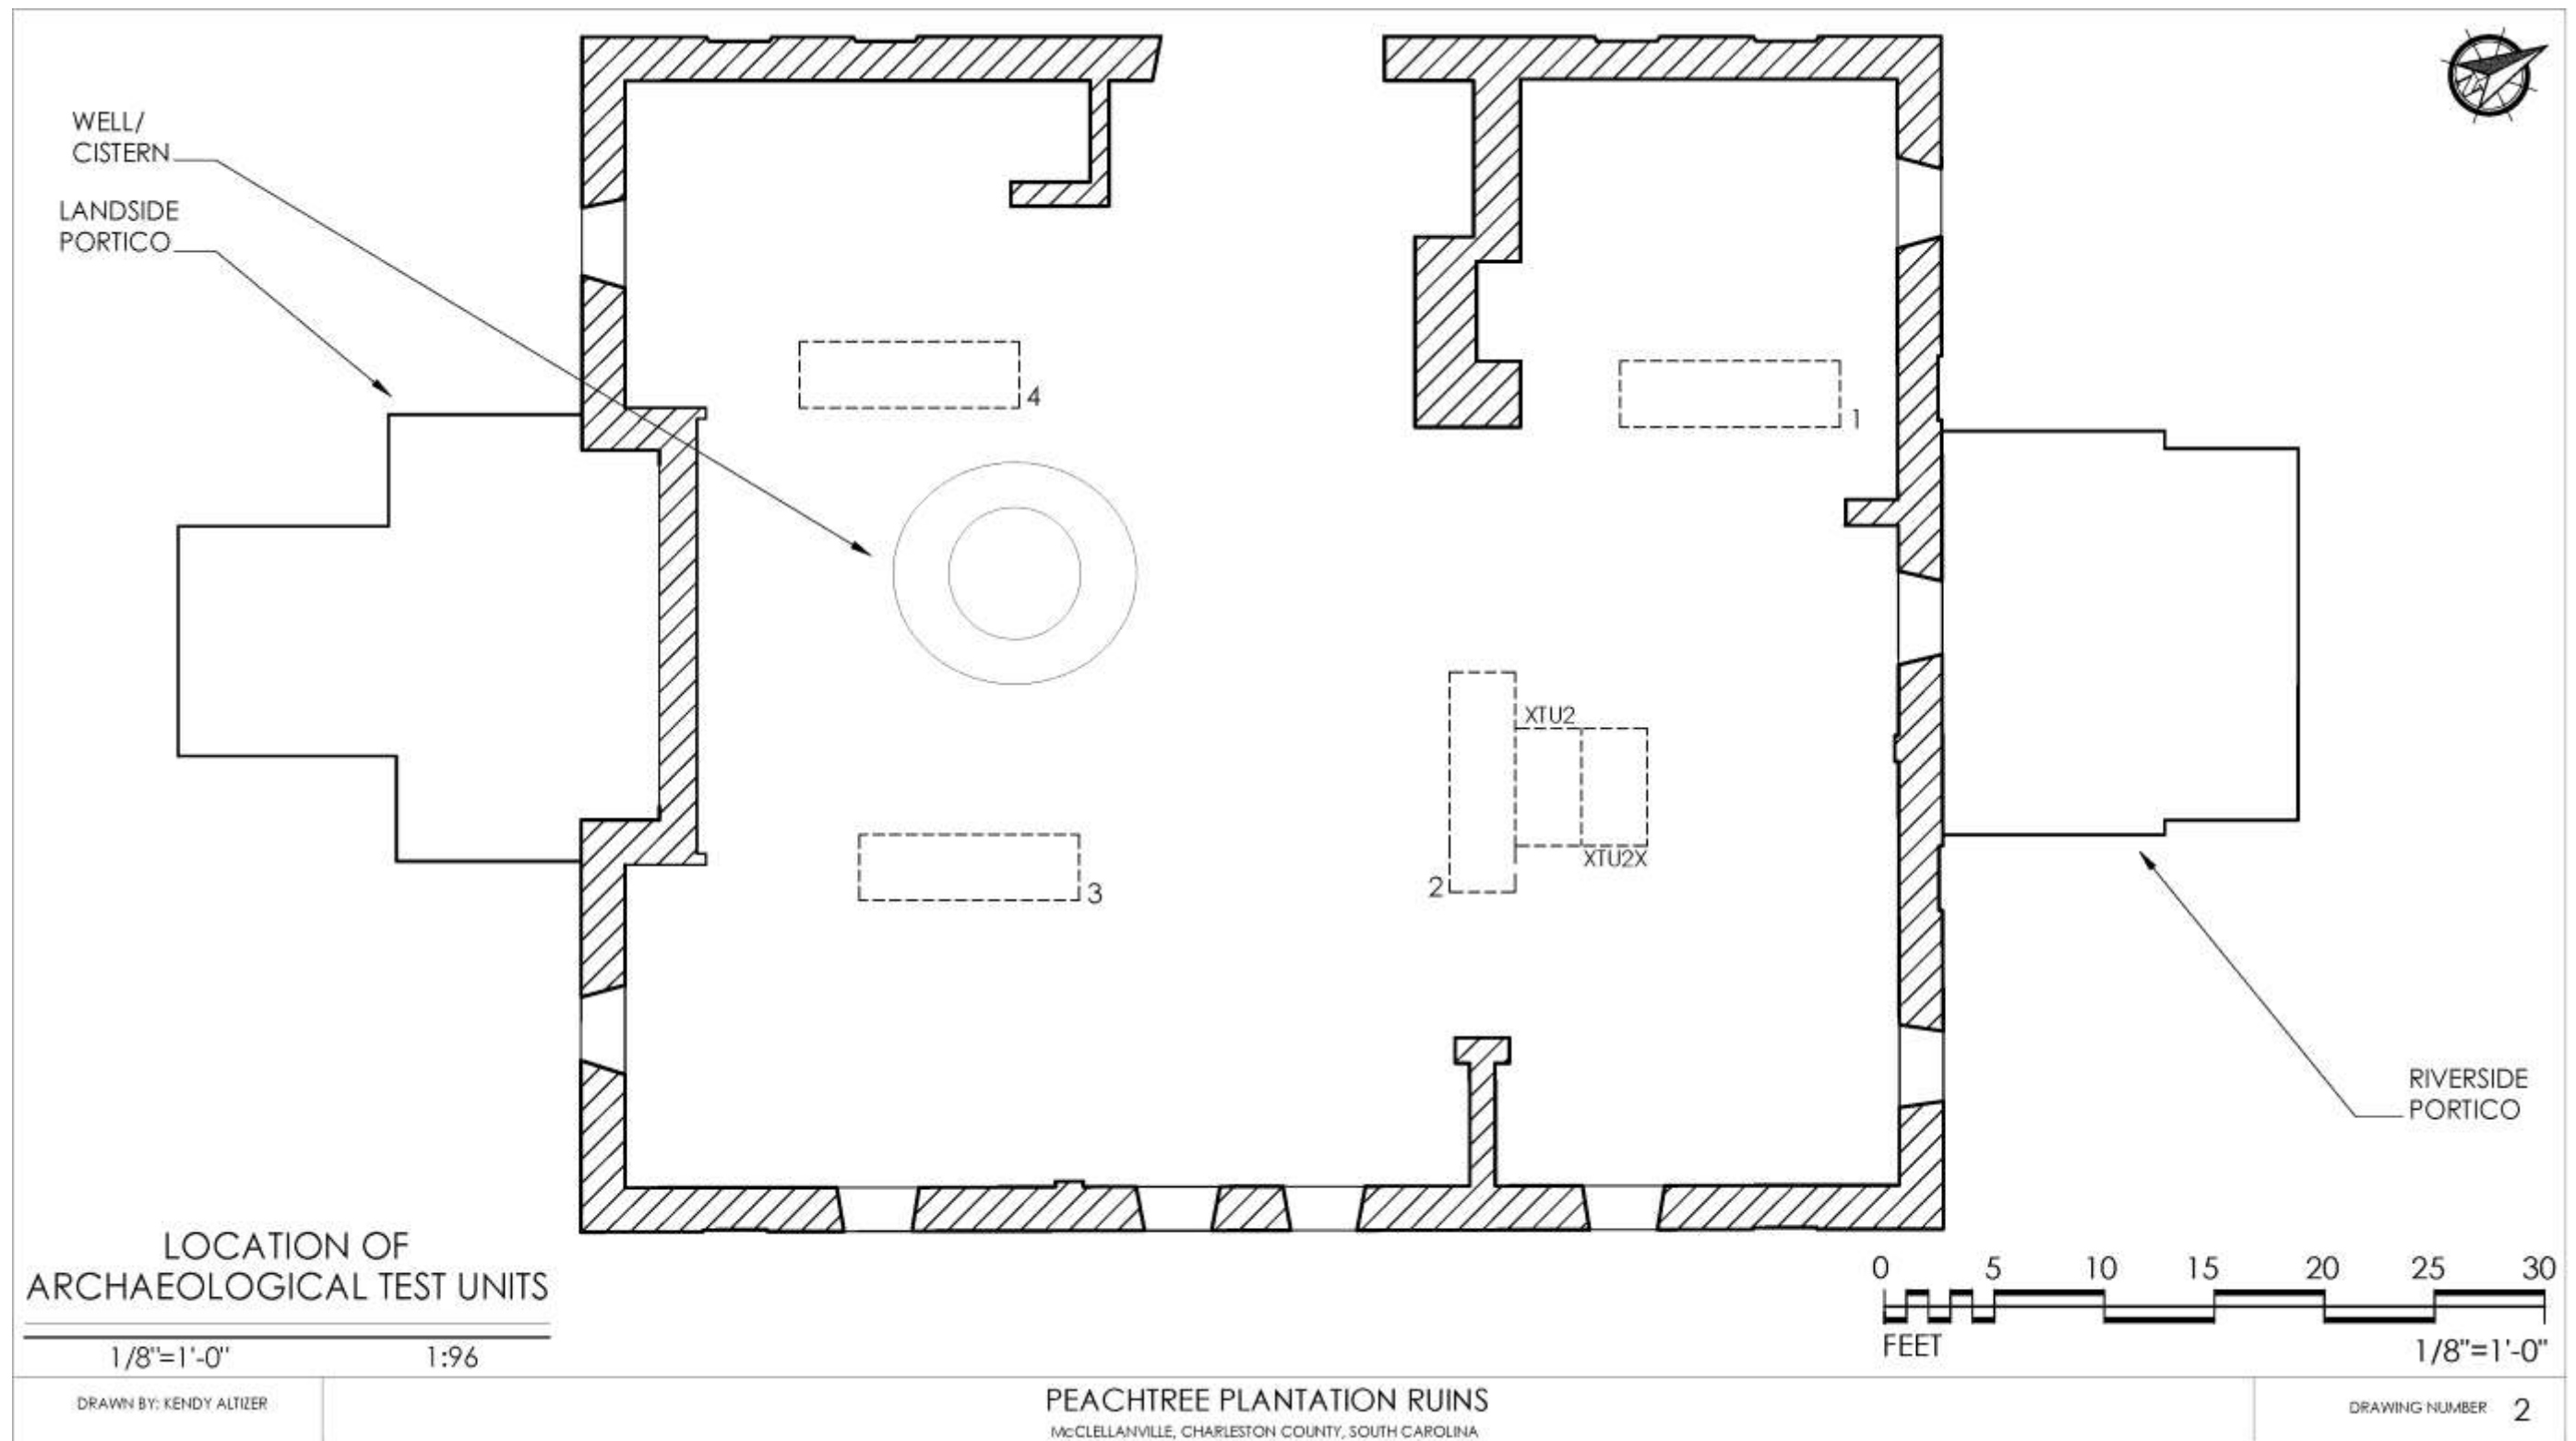
Figure 53. Location of archaeological test units.

Test Unit 4 is located in the southwest portion of the interior of the ruin (see Figure 53, Figure 54). This was the first unit excavated and was used as a starting point to determine the presence and extent of subsurface wall remnants. The unit is located on the slope of a small rise and its southern extent is at the bottom of the rise. Zone A was encountered between 0 and 13 inches below the current ground surface. Zone B consisted of broken brick, mortar, plaster and charcoal intermixed with sediment and few artifacts. Zone C was characterized by a mix of charcoal, sandy-loam sediment and artifacts, and was approximately 6-12 inches thick.

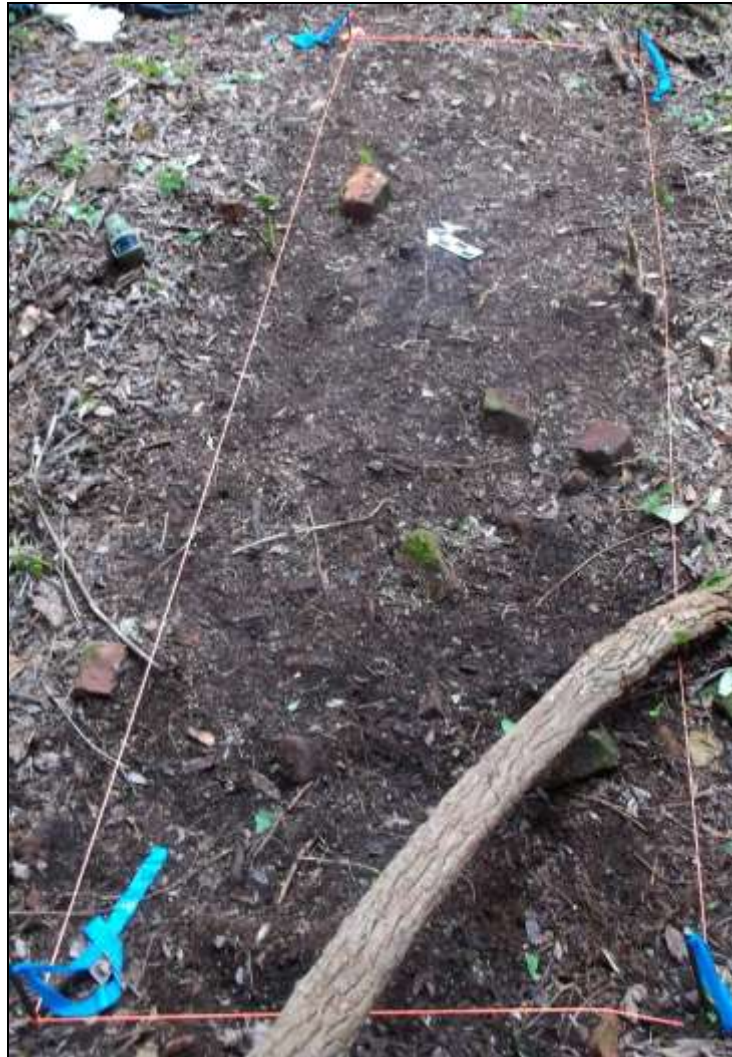
**Figure 54. Test Unit 4, before excavation; view northeast.**

Intact wall remnants were covered by less than 6 inches of sediment and form a corner. A section of east-west wall was uncovered at its intersection with a north-south wall, forming a corner. The east-west section extends west, beyond the boundary of the test unit. The exposed section measures 3 feet in length and is approximately 3 feet high. This section of exposed wall is constructed of English bond laid brick. Evidence of plaster was encountered during excavation. However, the plaster was very fragile and fell away from the wall during the process of excavation. The remains of this wall are in fair condition and bare evidence of the fire and subsequent water intrusion. This has caused the brick and mortar to erode. Demolition and salvage of bricks may also be a factor in this section of the ruin.

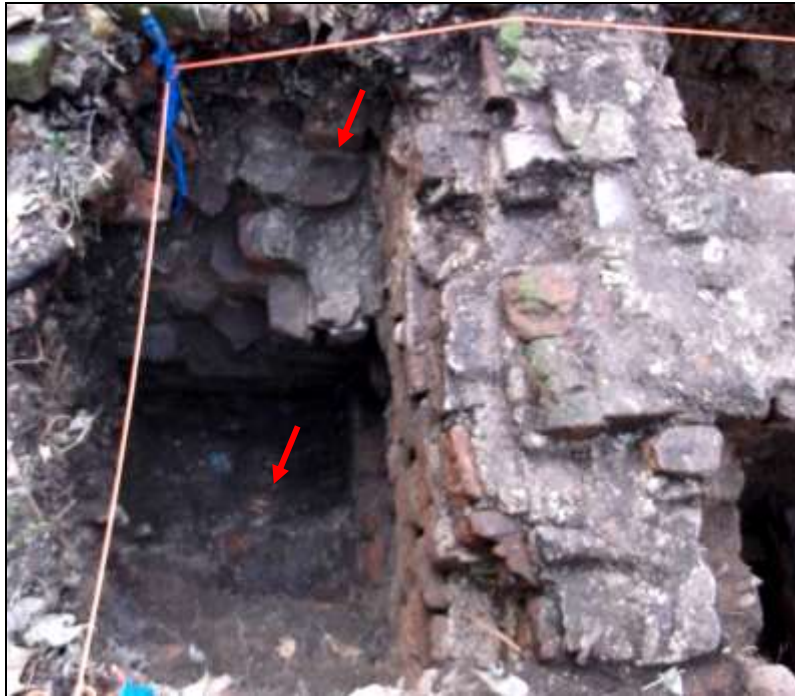
**Figure 66. East side of Test Unit 2 showing relieving arch remnant and glazed brick floor; view southwest.**

Architecture comprised the majority of the original test unit in its central and eastern portions. What appeared first as a square pocket that should have contained a door frame timber was a chimney flue (Figure 65). The remnants of a small stew stove were encountered just east of this flue. A north-south wall flanks the chimney flue to the west. Another wall is also present on the east side of the unit, and forms the east wall of the oven. Its northern termination was encountered in the north wall of Test Unit 2; however, it continues south beyond the southern boundary of the unit. The remaining two feet of the eastern portion of the test unit exposed a section of damaged, filled-in, relieving arch of a chimney base (Figure 66).

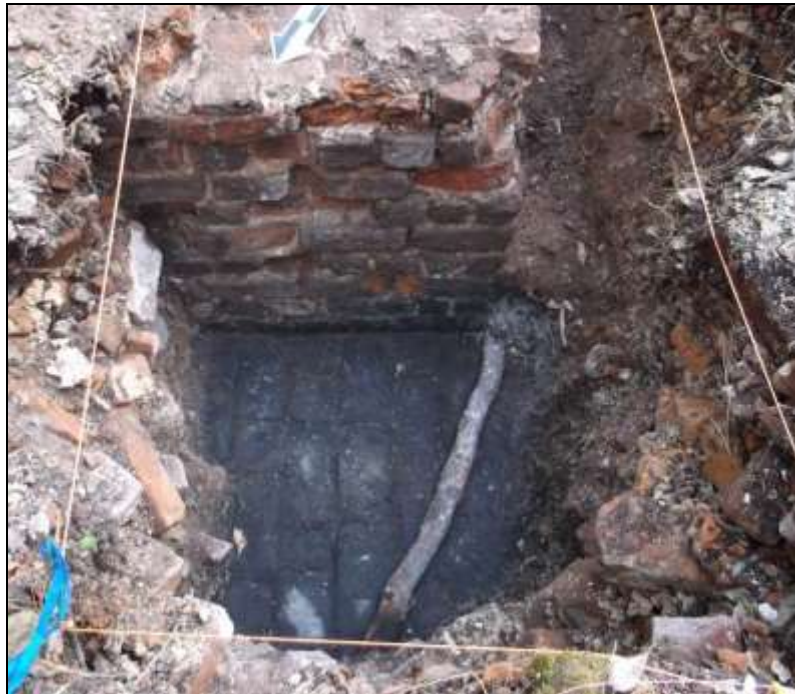
**Figure 67. West side of Test Unit 2 showing charcoal residue on the unit floor and wall section with eroding brick; view southeast.**

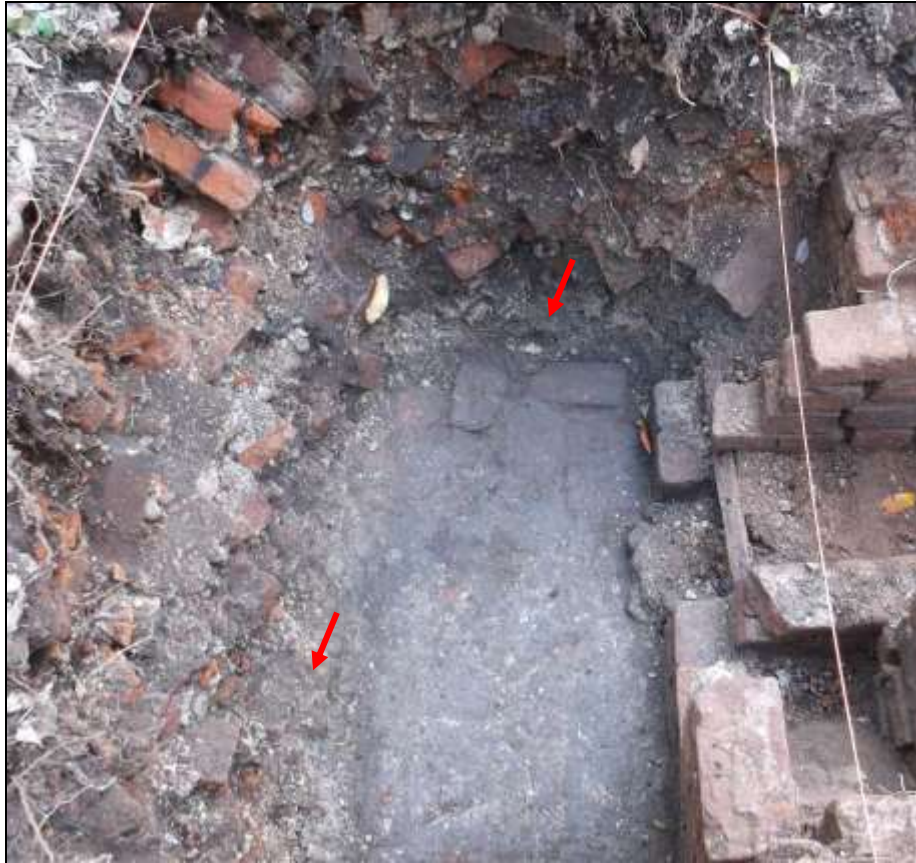
**Figure 69. Test Unit 2 extension, XTU-2, post excavation showing remnants of collapsed plastered wall.**

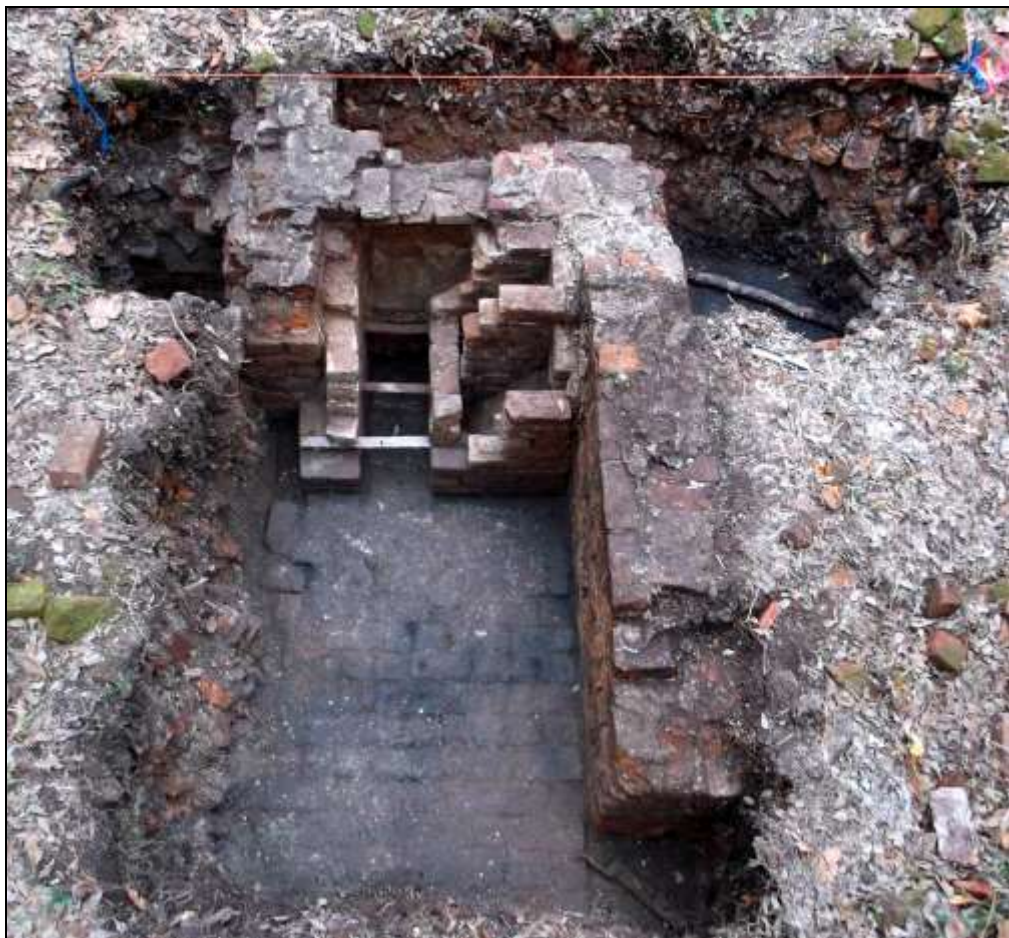
**Figure 70. Test Unit 2 and extensions, post excavation.**

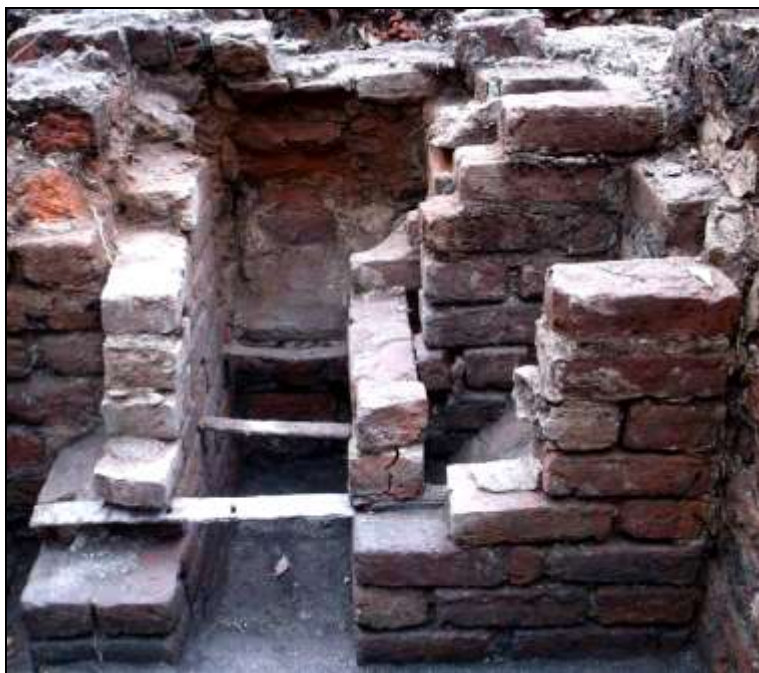
**Figure 71. Close-up of stew stove and chimney flues.**

The chimney flues and stew stove are in remnant condition (Figure 71). The effects of the fire, as well as subsequent episodes of salvage activity and wall collapse, have impacted them. The stew stove measures 2 feet 5 inches north-south by 10 3/4 inches east-west (Figure 72). The floor of the stove is 2 inches below the ground floor level and measures approximately 3 feet 3 1/2 inches from the floor to the top of the exposed architecture. The south side of the stew stove curves into the wall and remnants of plaster are still in place. The chimney flues measure 6/58 inches east-west by 71/2 inches north-south at their top openings (Figure 73). The southern chimney flue is 2 feet 9 inches tall while the northern chimney flue is 2 feet 2 inches tall. They are constructed of brick and mortar and the mortar has eroded away in the majority of the joints and the flues are pulling away from the wall. Remnants of plaster are present toward the bottom of the flues, near their connection to the stew stove.

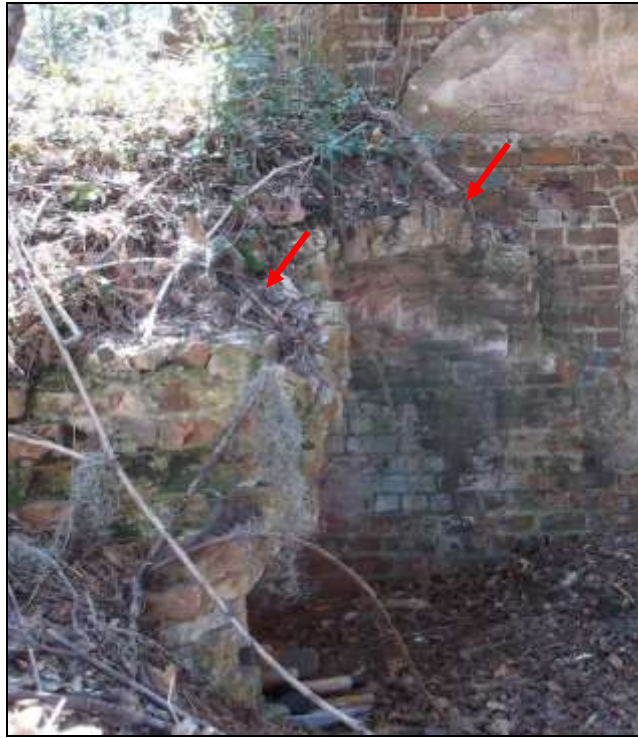
**Figure 97. Western extent of the riverside portico showing damage by vegetation.**

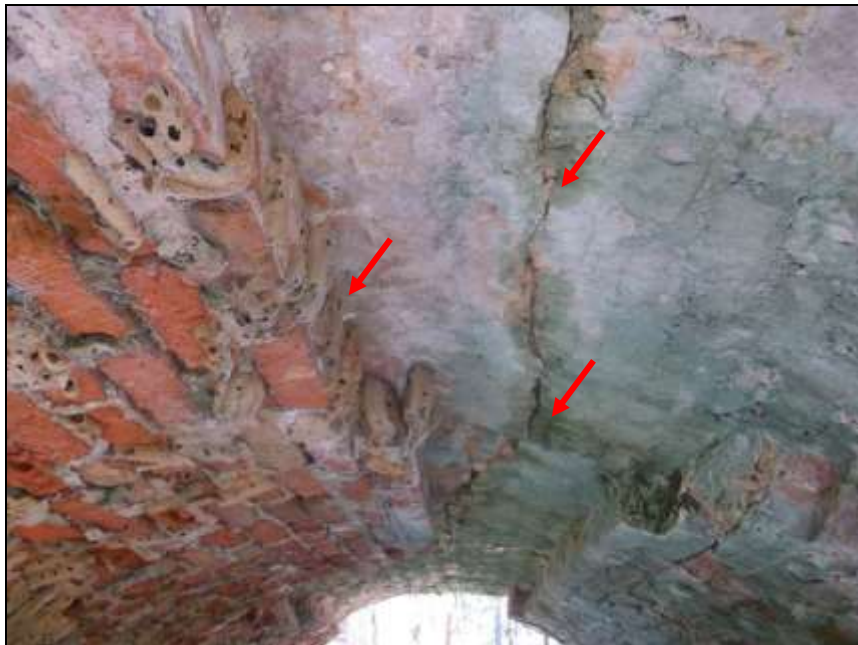
**Figure 98. Interior of the riverside portico tunnel arch showing water damage, missing brick and structural crack.**
