# Three Hoes in the Kitchen: The Conceptualization of Peachtree Plantation, St. James Santee Parish, South Carolina

A Thesis  
Presented to  
the Graduate School of  
Clemson University

In Partial Fulfillment  
of the Requirements for the Degree  
Master of Science  
Historic Preservation

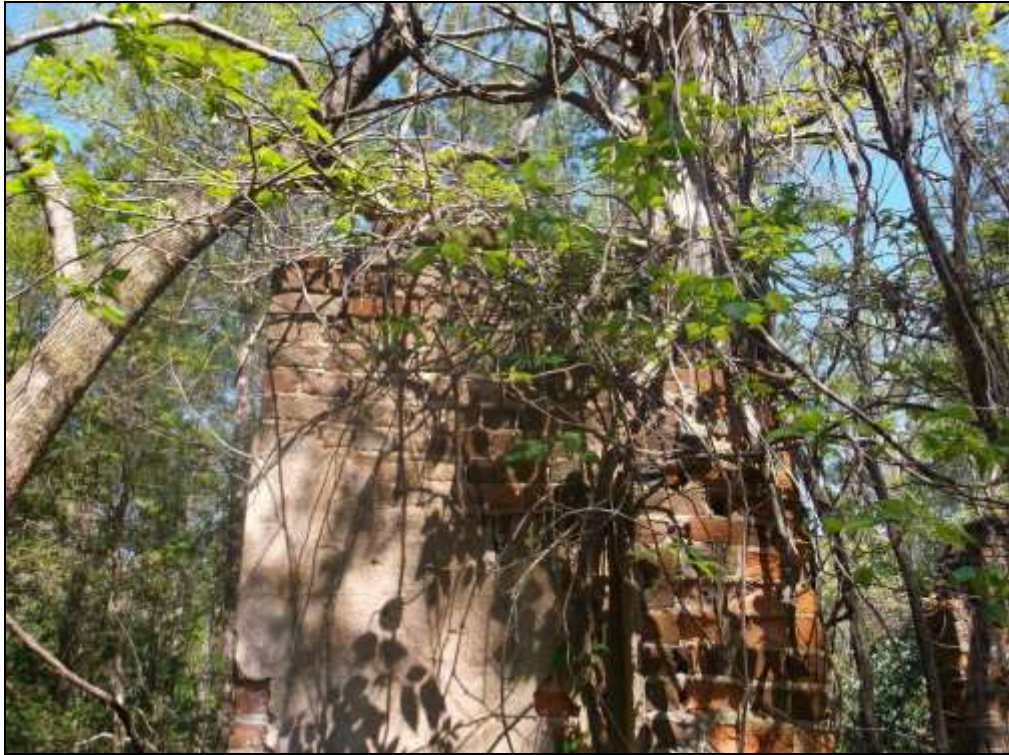
**Figure 99. Interior wall remnants showing vegetation growth at the top of the wall.**

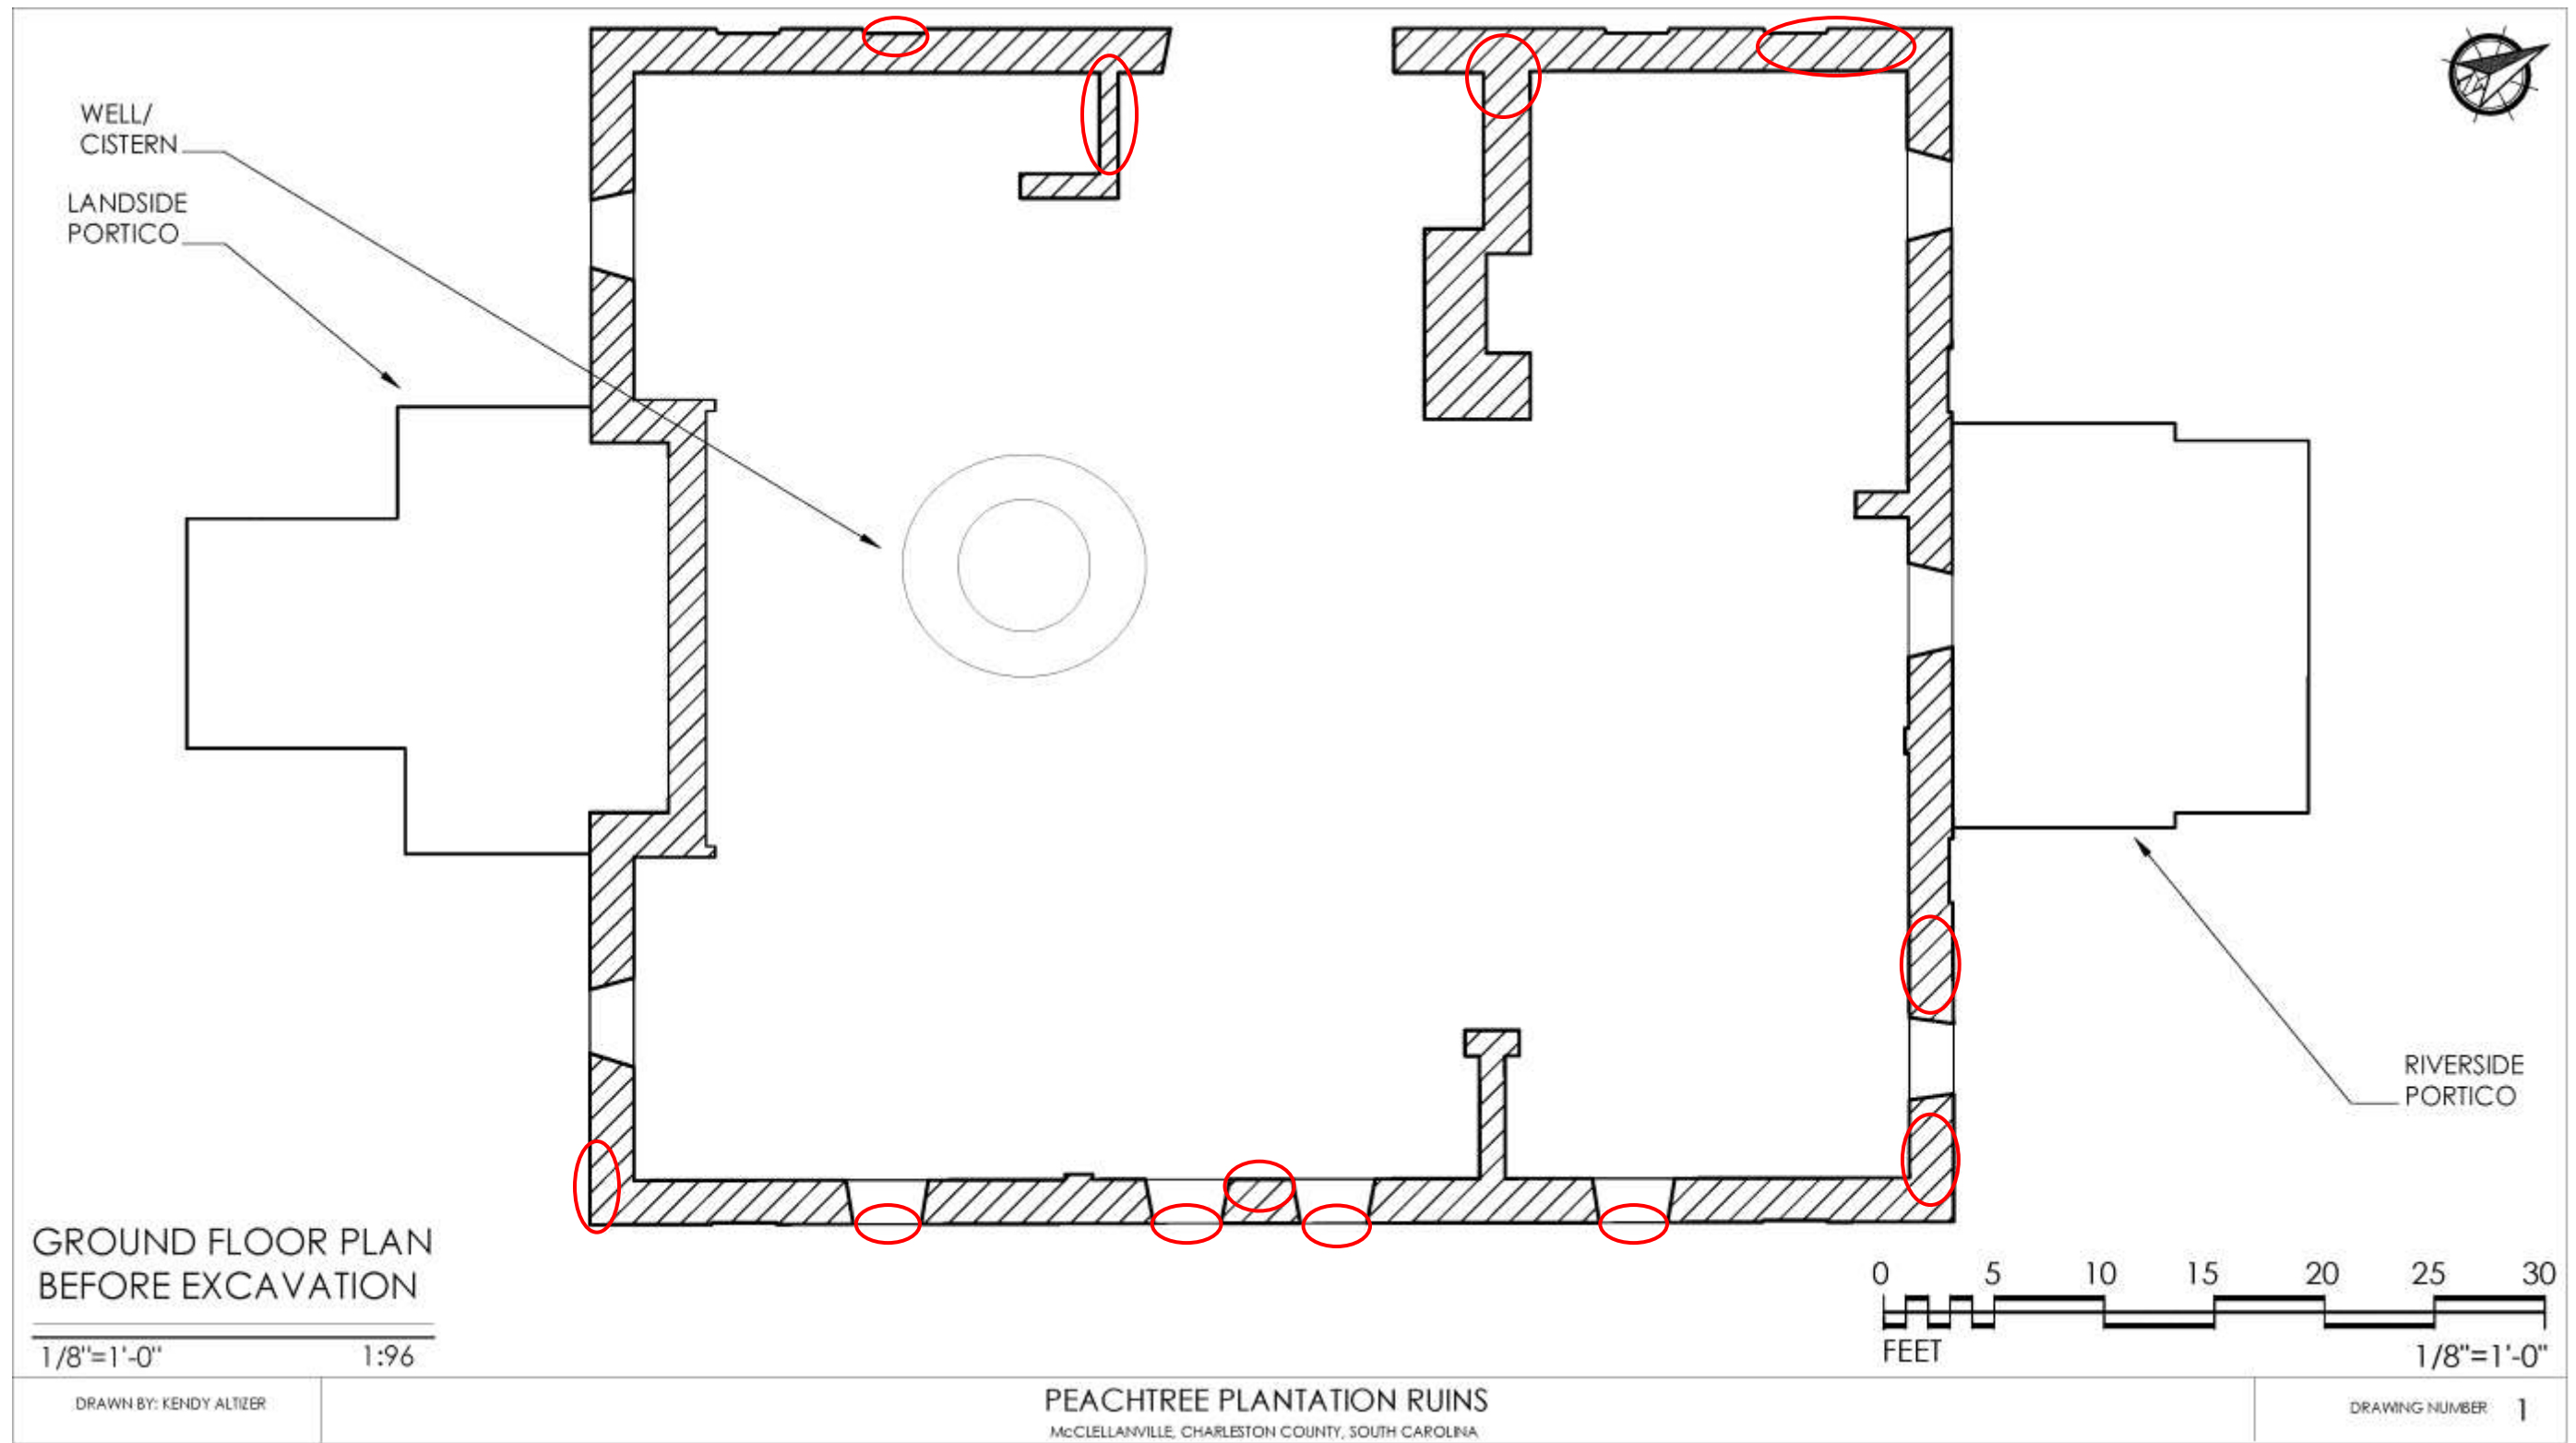
Figure 100. Peachtree floor plan showing areas of structural shifting.

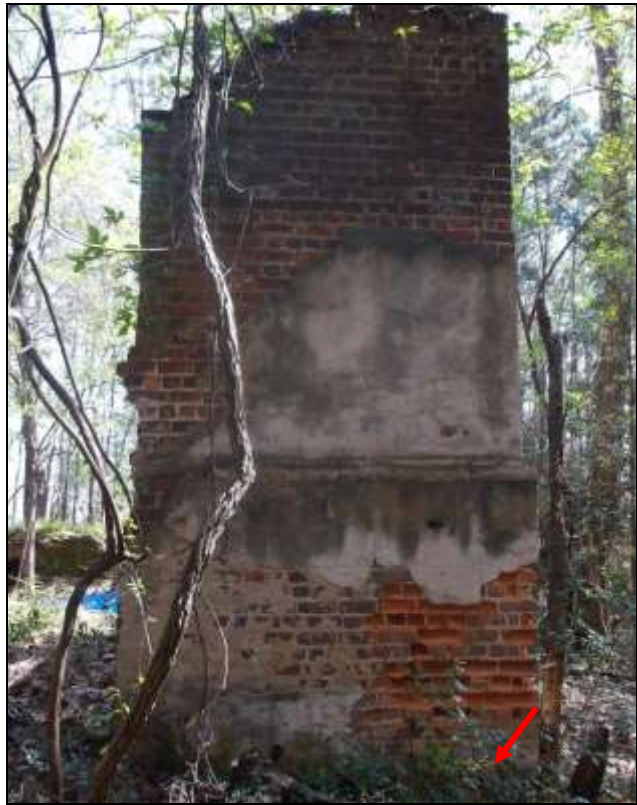
**Figure 101. Location of foundation crack in landside elevation eastern extent.**

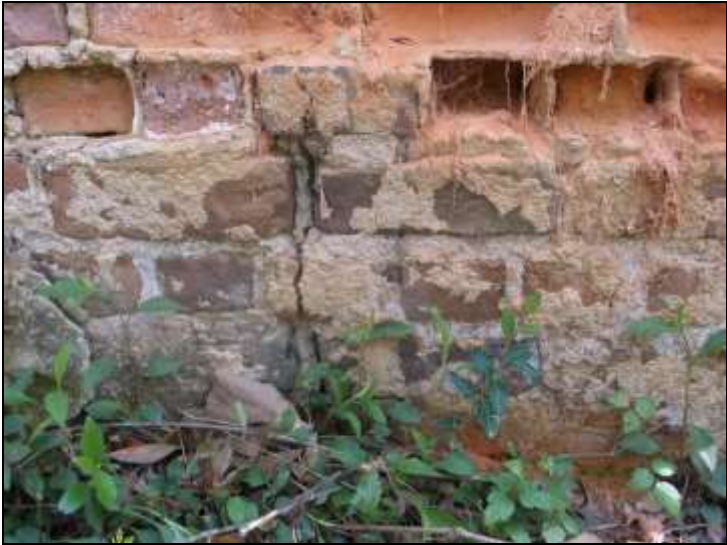
**Figure 102. Close-up of foundation crack, landside elevation, eastern extent.**

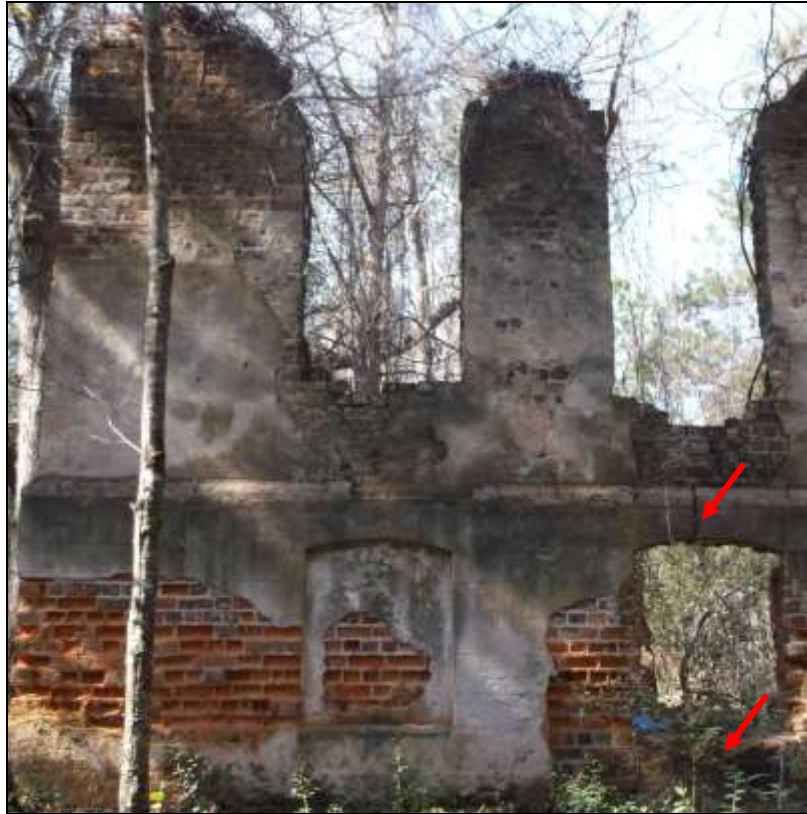
Figure 103. East elevation, southern extent showing bays 1 and 2, and crack in window sill in bay 2.

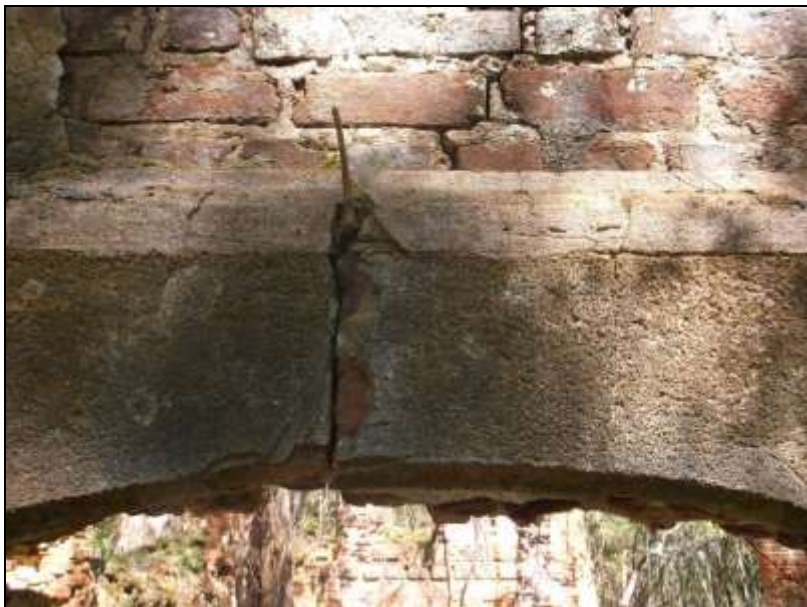
Figure 104. East elevation, bay 2, showing cracking above the window opening.

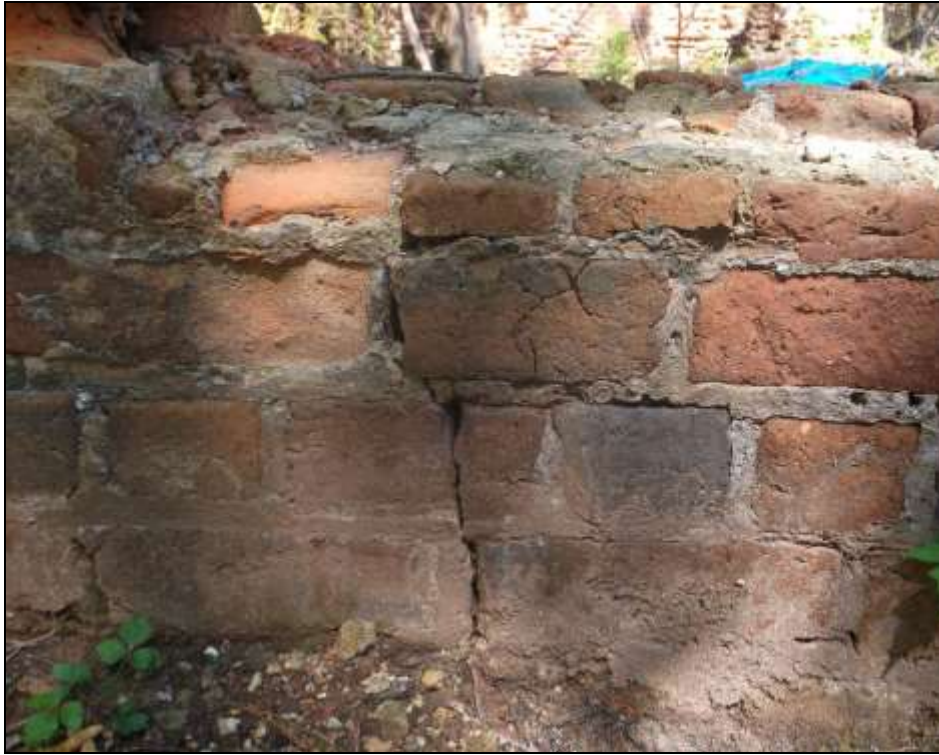
**Figure 105. East elevation, bay 2, showing cracking below the window opening.**

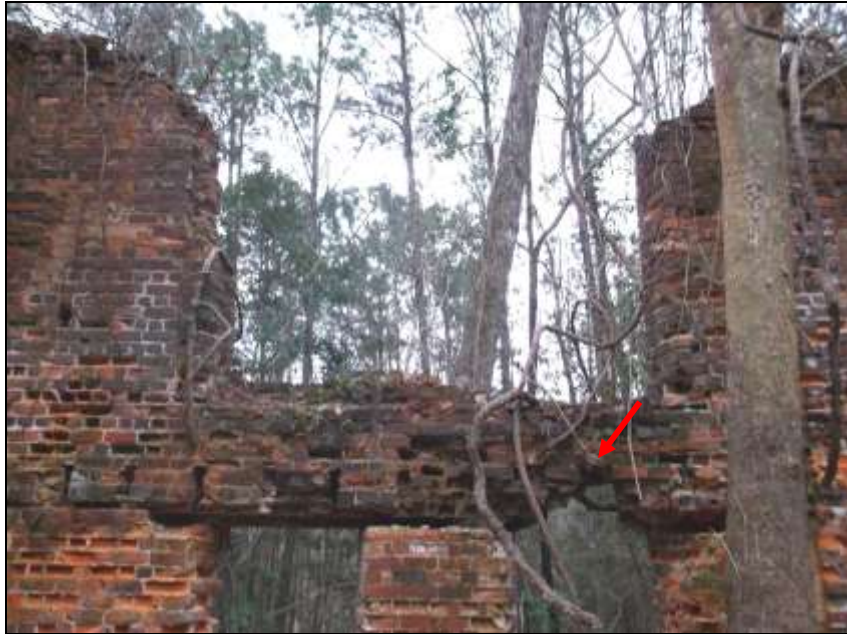
**Figure 107. East elevation interior, central bays, showing missing wall between bays 3 and 4 and missing bricks in bay 3.**

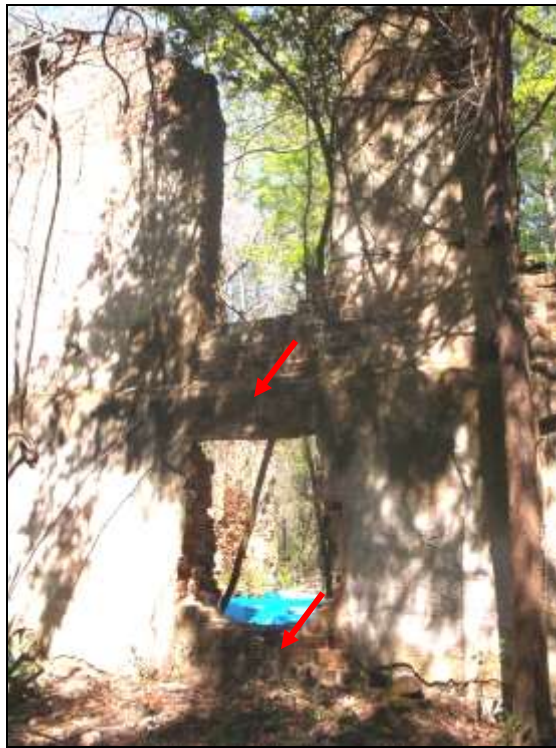
**Figure 108. East elevation, bay 5 overview. Showing location of cracked window sills.**

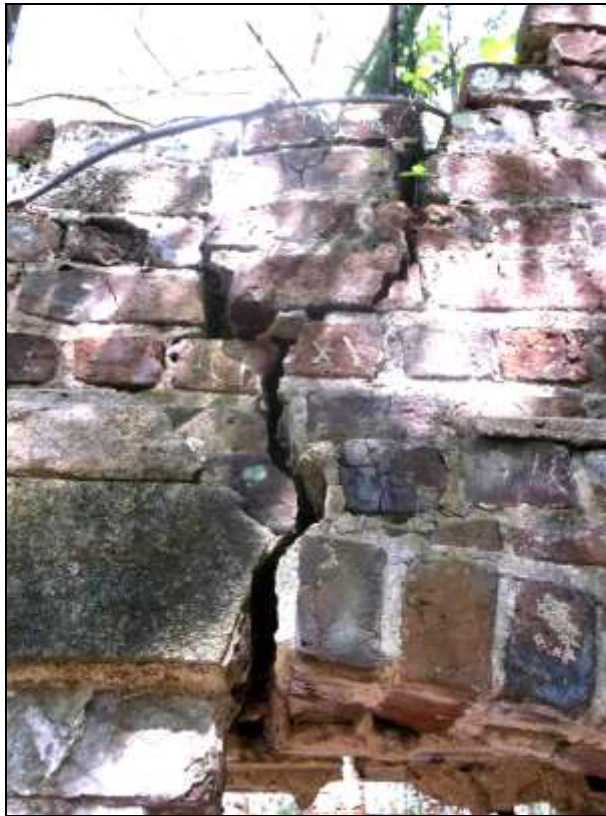
**Figure 109. East elevation bay 5, close-up of crack between upper and lower window openings.**

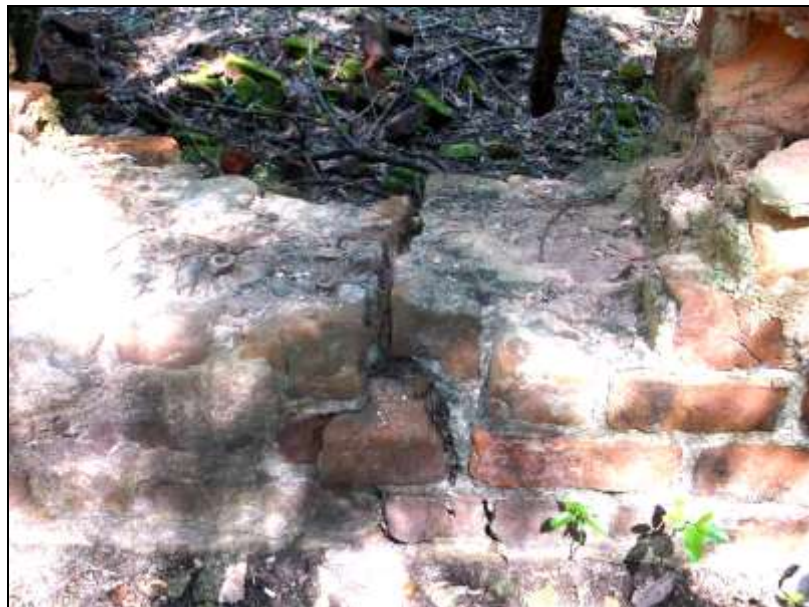
**Figure 110. East elevation bay 5, close-up of crack through bottom window opening.**

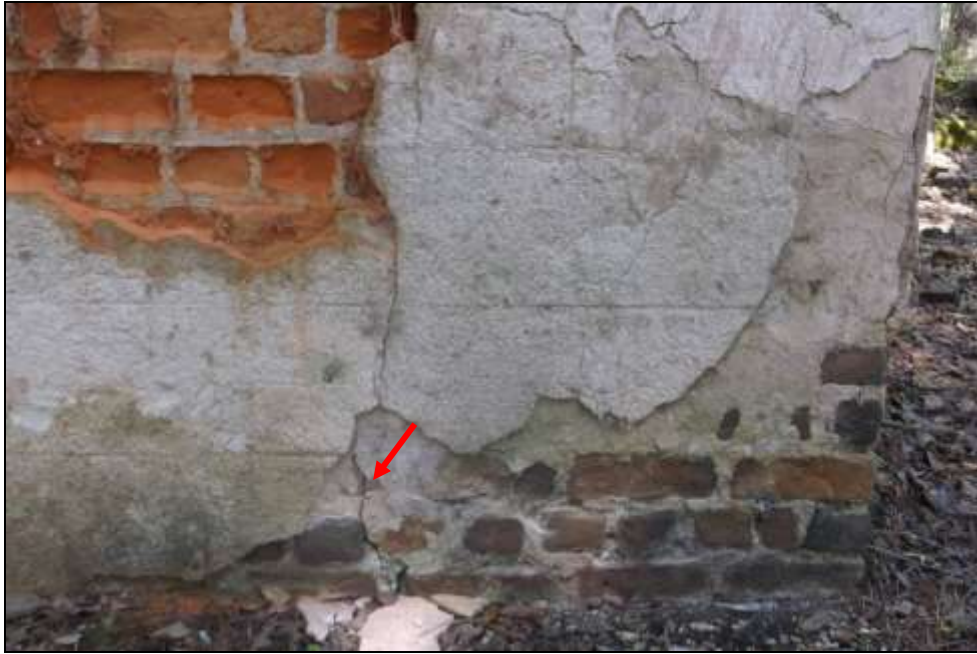
**Figure 111. East elevation, northern extent, showing foundation crack.**

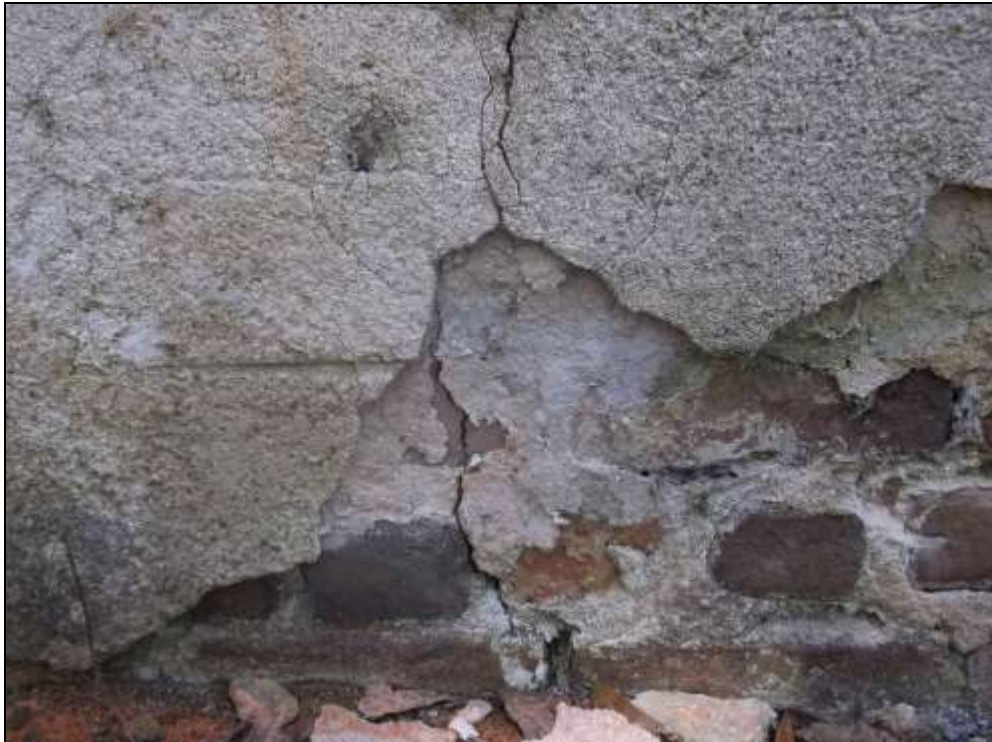
**Figure 112. East elevation, northern extent, close-up of foundation crack.**

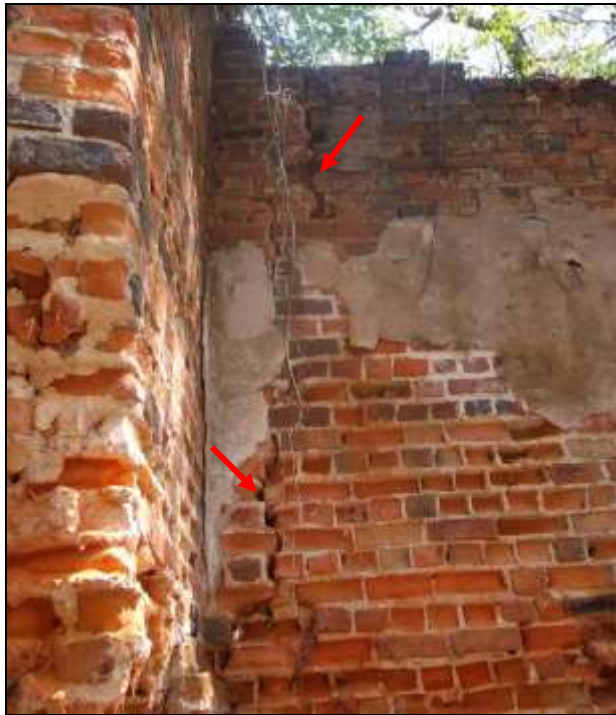
**Figure 113. East elevation interior, northern extent, showing structural cracking at the northeast corner.**

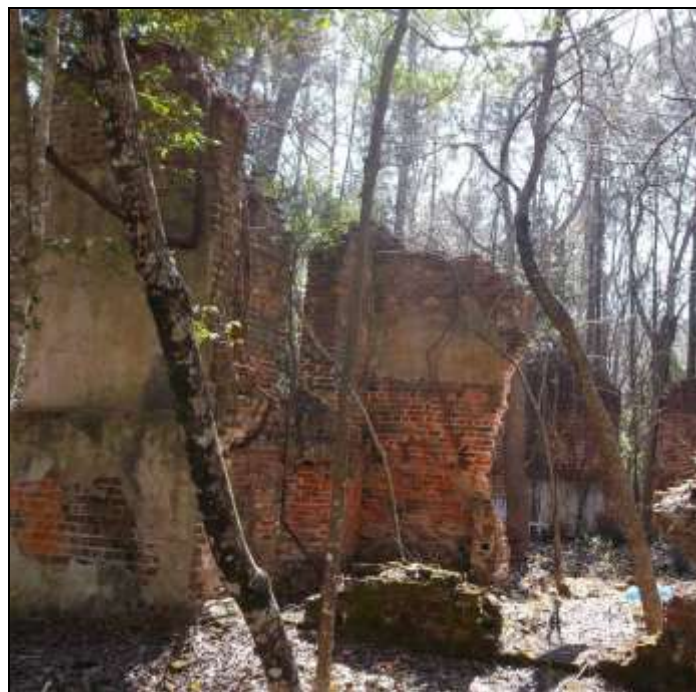
**Figure 114. Riverside elevation, eastern extent, showing missing sections of wall.**

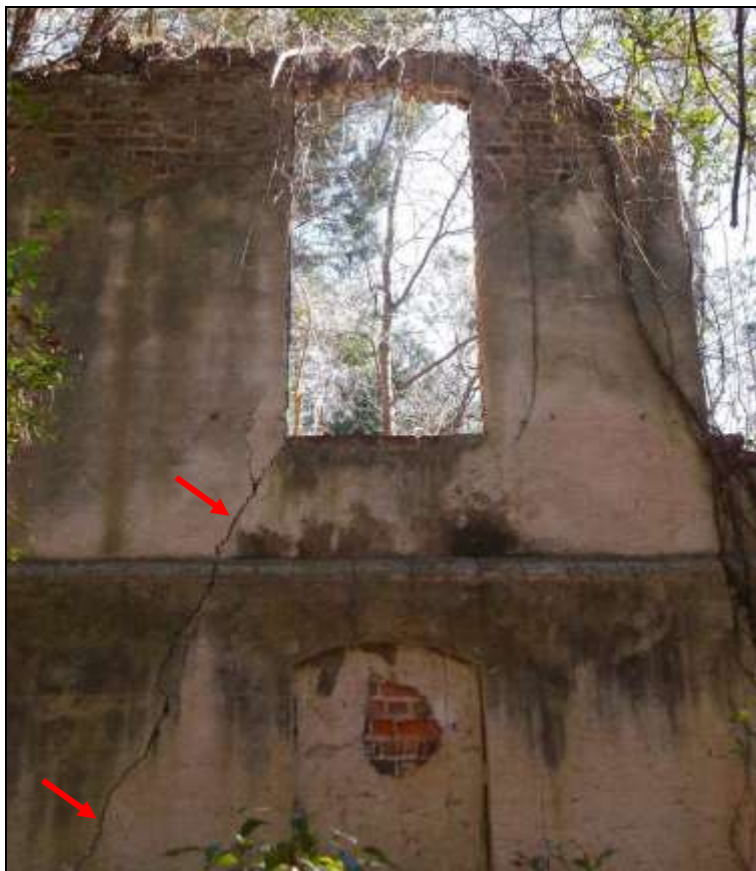
**Figure 115. West elevation, northern extent, showing structural crack at the window opening.**

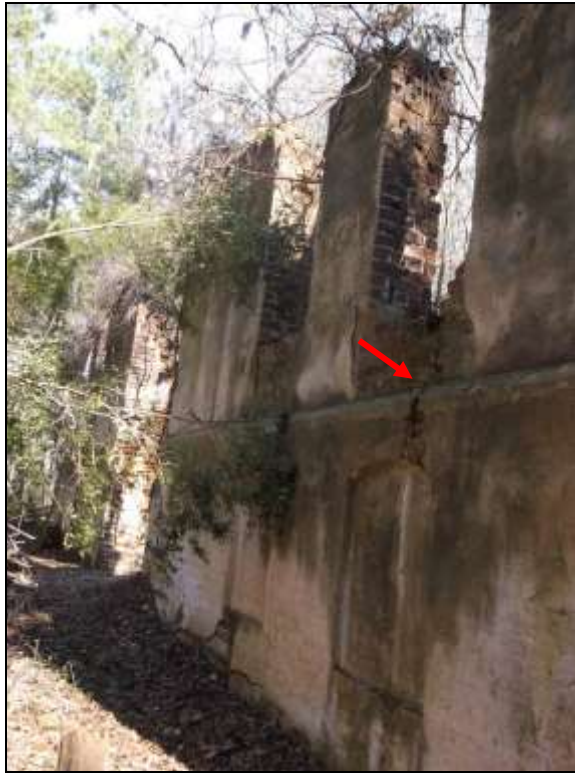
**Figure 116. West elevation, southern extent showing crack in bay 5.**

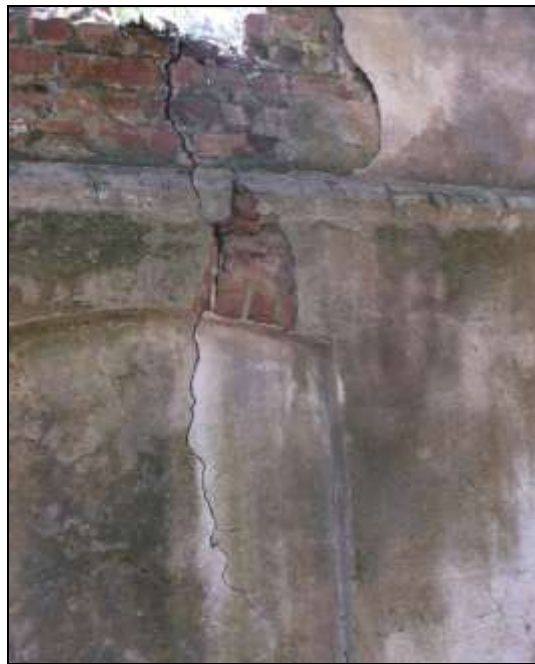
**Figure 117. Close-up of crack in upper window sill through to blind window in bay 5, western elevation.**

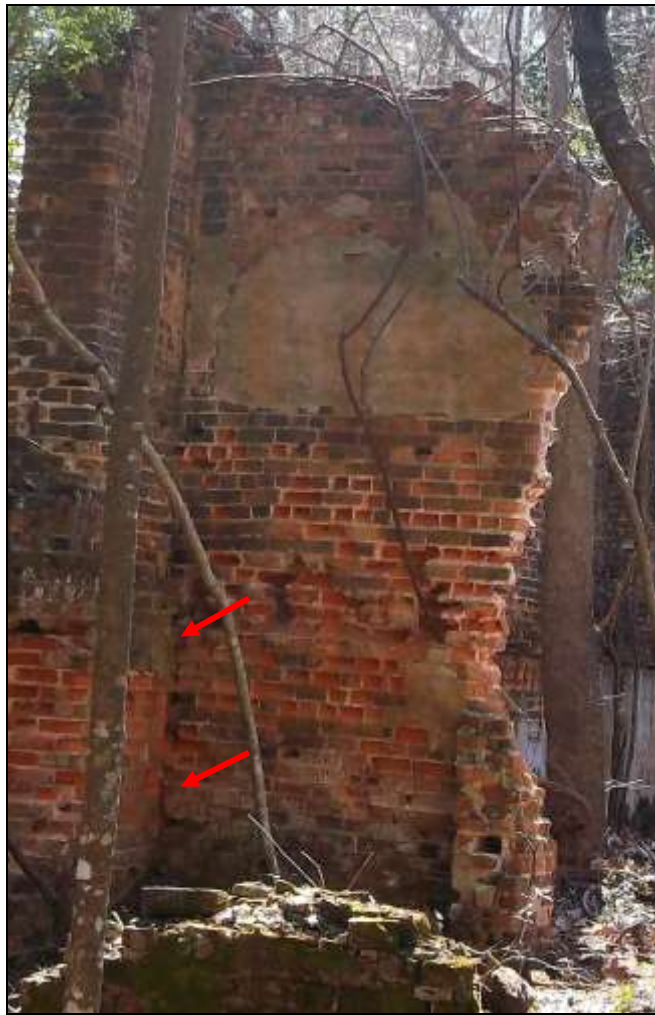
**Figure 118. East elevation interior T-wall remnant, showing structural cracking near intersection of walls.**

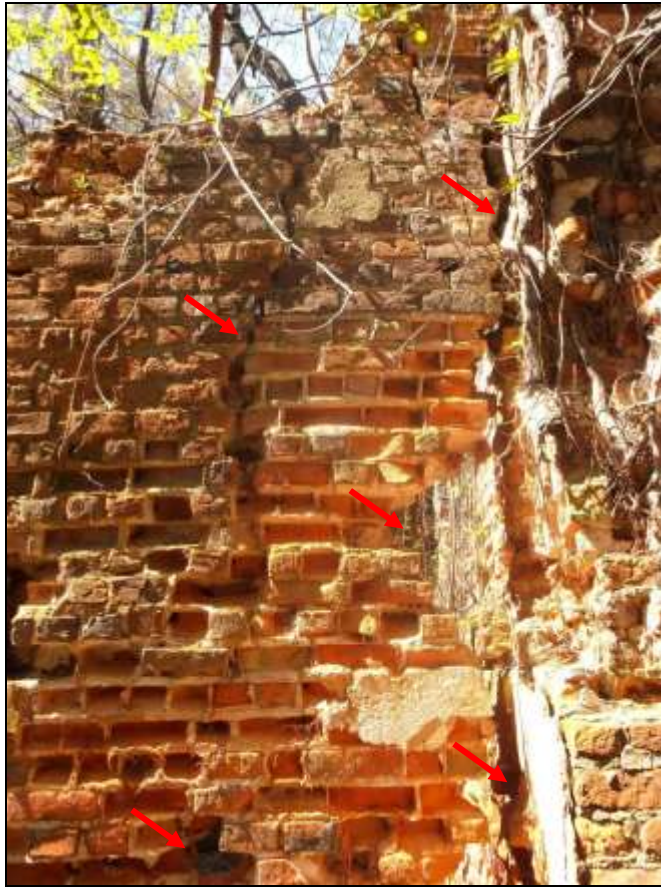
**Figure 119. West elevation, southern interior wall, showing erosion and broken tie-in; view southwest.**

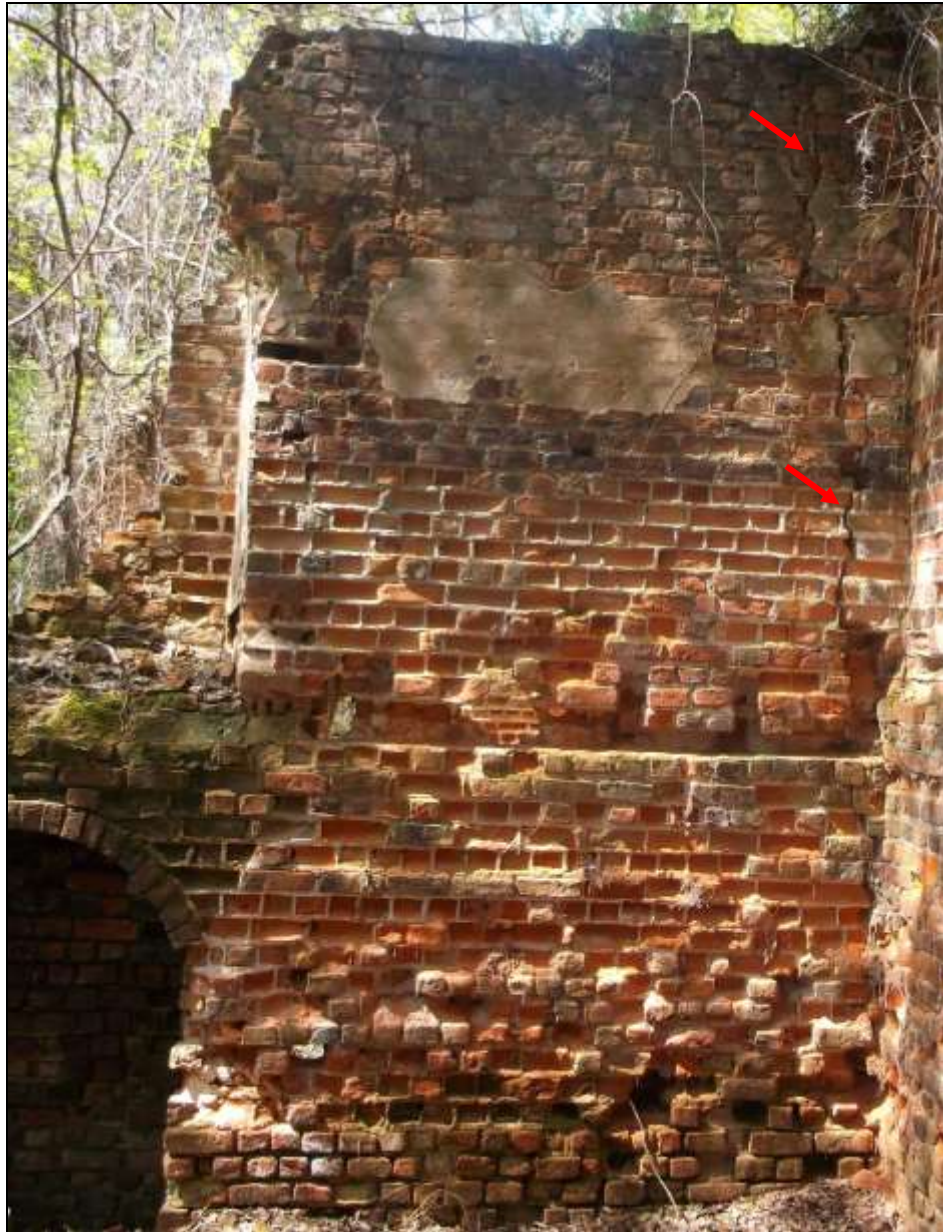
**Figure 120. West elevation, northern interior wall showing structural cracking near the tie-in and eroded brick and mortar.**

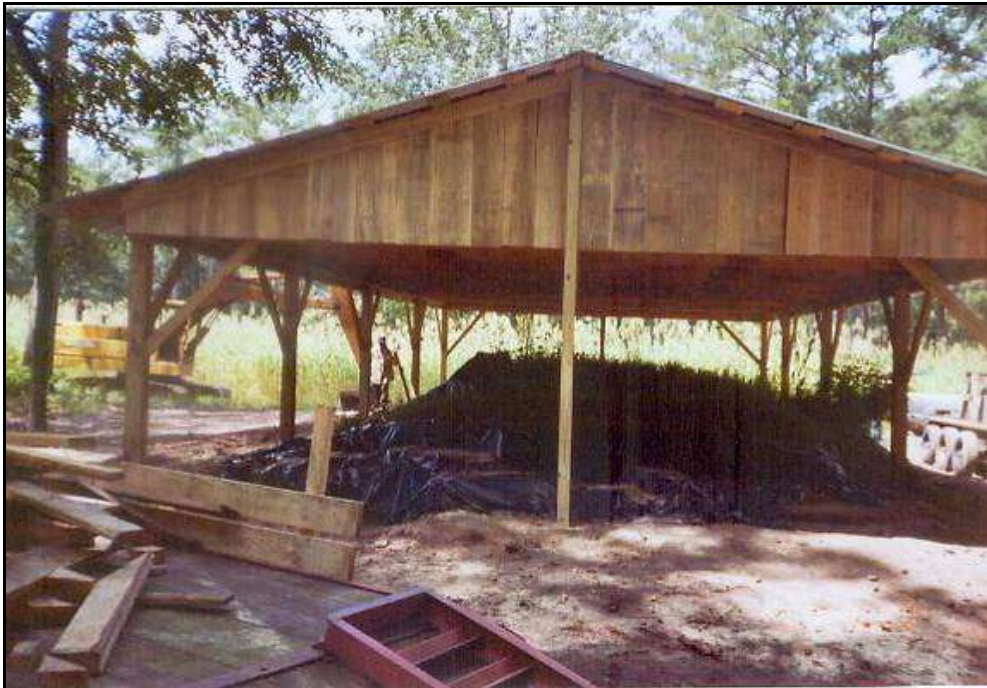
**Figure 121. Wooden structure covering the Willtown parsonage foundation and archaeological excavations.**
