AN EARLY WARNING MONITORING SYSTEM FOR CNC SPINDLE BEARING
FAILURE

A Thesis
Presented to
the Graduate School of
Clemson University

In Partial Fulfillment
of the Requirements for the Degree
Master of Science
Mechanical Engineering

by
Andrew F. Werner
December 2011

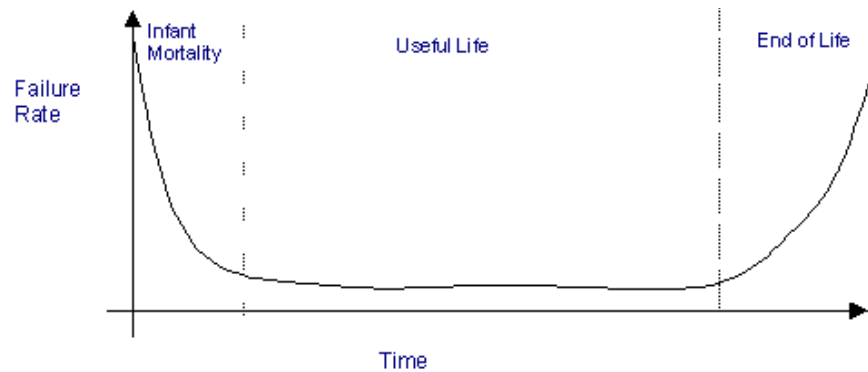
Figure 2: A Bathtub Curve [10].

A model representative of a component's life with respect to its failure rate can be seen in Figure 2. This particular model is known as the "bathtub curve" and provides a good general concept for the lifetime of machine components.

As indicated on the curve, components have a high rate of failure, known as the “infant mortality”, at the beginning of their life. This type of failure is usually due to manufacturing defects and causes a component to fail prematurely. As the lifetime of a component progresses out of its infant mortality period, it enters its normal operation mode. This time period is known as the equipment’s “useful life”. Its failure rate is somewhat constant; as the component was designed operate properly for its given application. As time continues, and the component starts to show signs of age and wear, it enters its “end of life” phase [10], [11], [12]. This is the time when the catastrophic failures start to take place.

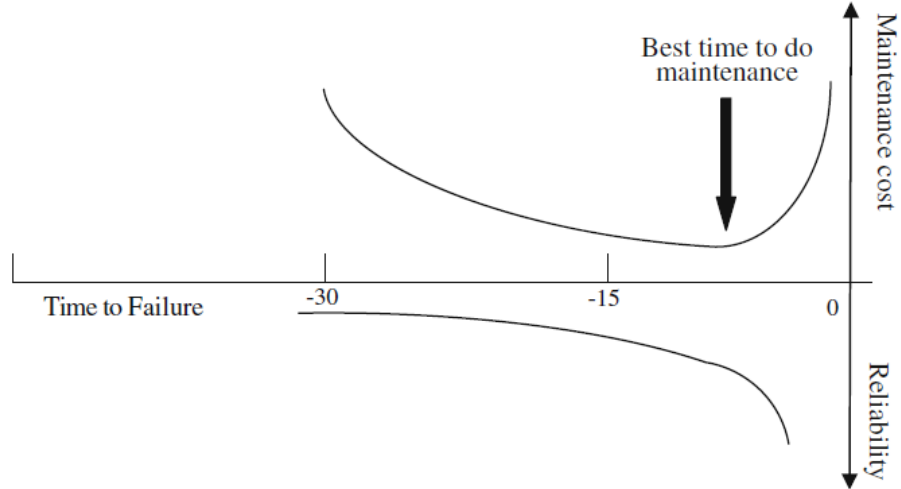
Figure 3: Relationship Between Maintenance Costs and Component Reliability [14].

Predictive maintenance, often referred to as condition-based maintenance (CBM) [13], is a maintenance strategy that uses a combination of predictive monitoring tools to determine the condition of equipment. These tools range from thermal imaging and ultrasonics to vibration monitoring and oil analysis. Utilization of these tools provides a better understanding of components' health, therefore allowing a better prediction of when failure will occur. Mathematical and physical models have also been developed to aid in this prediction based on the past and current circumstances. Due to this ability to now predict a failure, maintenance can be scheduled on an "as needed" basis rather than being based on specific MTTF intervals [2]. This strategy helps to maximize a component's life cycle while reducing the maintenance costs associated with its replacement. Machine uptime is also increased as maintenance work can be scheduled and planned to be performed when the machine is not being utilized. The relationship between maintenance costs and reliability with respect to how much component life remains is represented graphically in Figure 3.

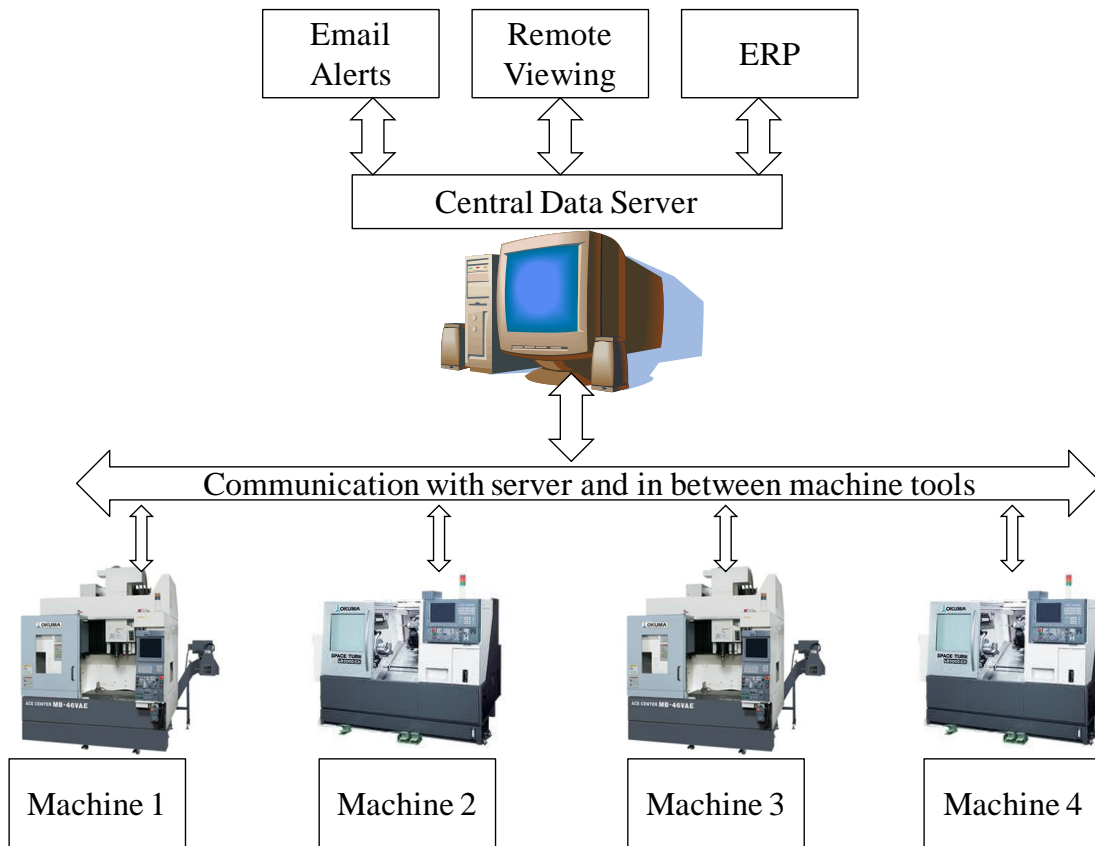
Figure 8: CBM System Extension to Multiple Machine Environments with Integration of other Features.

The system previously described can be extended to multiple machines as well, as shown in Figure 8. Individual machines are at the bottom-most level, containing either an individual CBM system for each machine or a central server to monitor all machines at once. Both of the approaches have their own advantages and disadvantages. Separate systems for machines induce greater hardware costs; however they ensure reliability of the total connected system should one of the CBM systems fail. This inherent redundancy allows for monitoring of the other machines to continue despite one system failing.

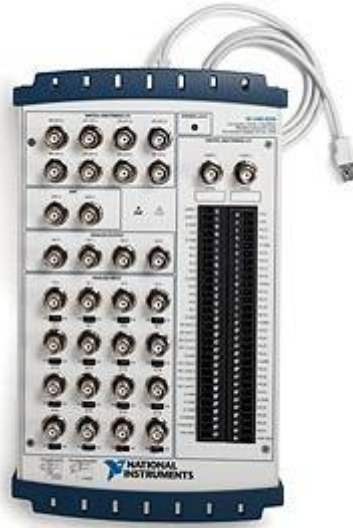
Figure 9: Example of Possible Compact Monitoring System Hardware [26].

There are a variety of techniques currently being employed today to help monitor equipment conditions and aid in maintenance planning and execution. All CBM systems are of two basic configurations, compact (all-in-one) or modular [23]. An example of the hardware used for each system can be seen in Figure 9 and Figure 10 respectively. The advantage of an all-in-one system is that only one unit is needed, however the unit may be limited by the different types of inputs it can receive, thus limiting the types of sensors that can be used. The advantage of having a modular system allows for a variety of multiple sensors to be utilized, but may have a higher cost associated with it as each module needs to be purchased separately.

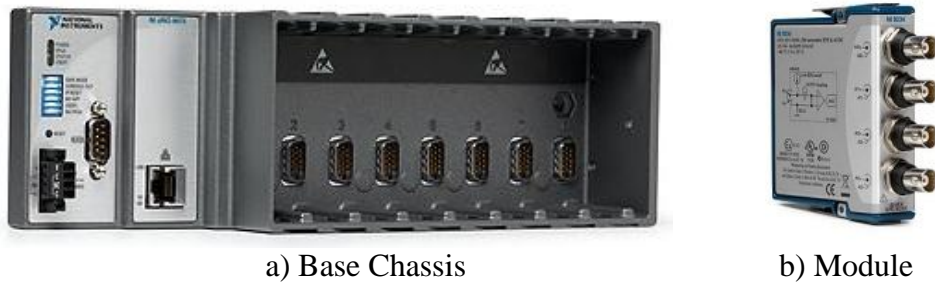
Figure 10: Example of Modular Monitoring System Hardware [27], [28].

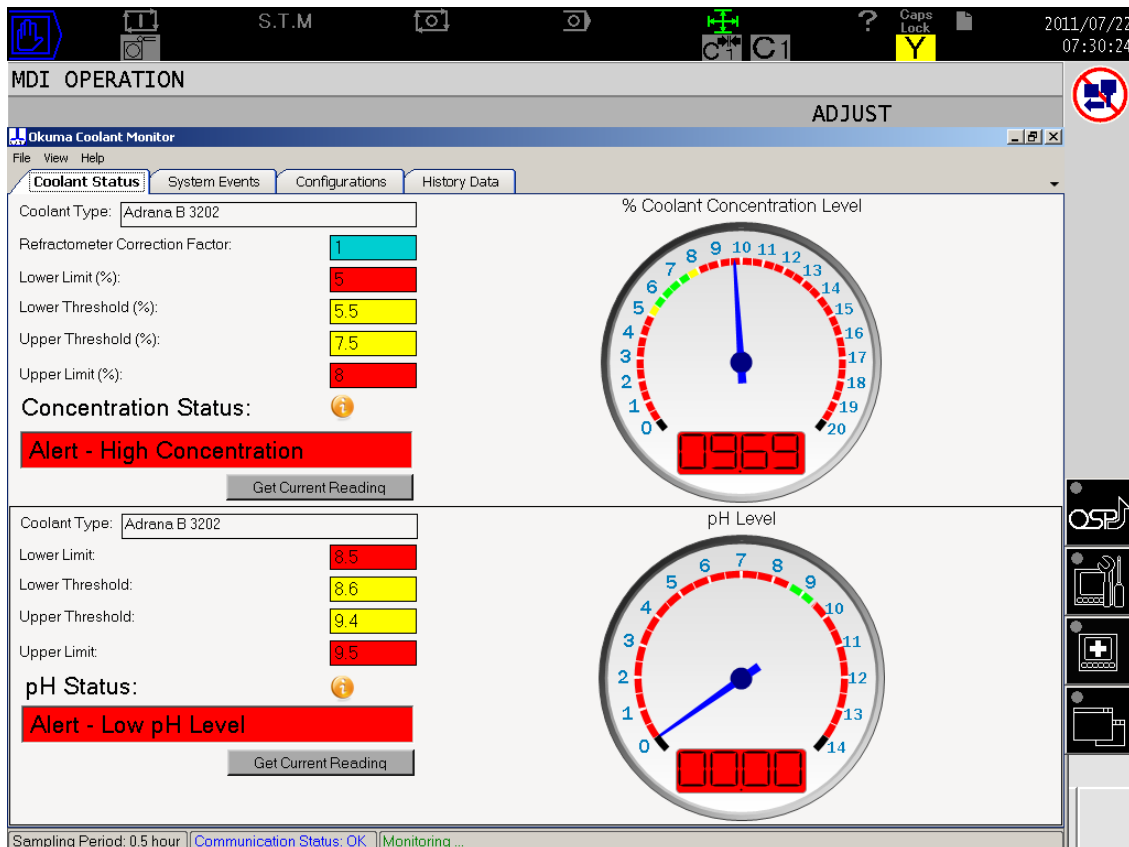
Figure 17: Okuma Coolant Monitor – Main Page.

The application, shown in Figure 17, monitors both the machine's coolant concentration and pH from the machine control simultaneously as the machine is operating. It is an interactive CBM program and is flexible to allow for the program to be adjusted based on the specific coolant type the machine tool is using. The application provides both the current health of the coolant, Figure 17, as well as a past history, Figure 18, allowing for any historical patterns to be noticed. The program even has an "events" page that allows the user to know of any changes that have occurred. As an example, Figure 19 shows that at 7:29 am on July 22,2011, both the concentration and pH were at alarm levels.

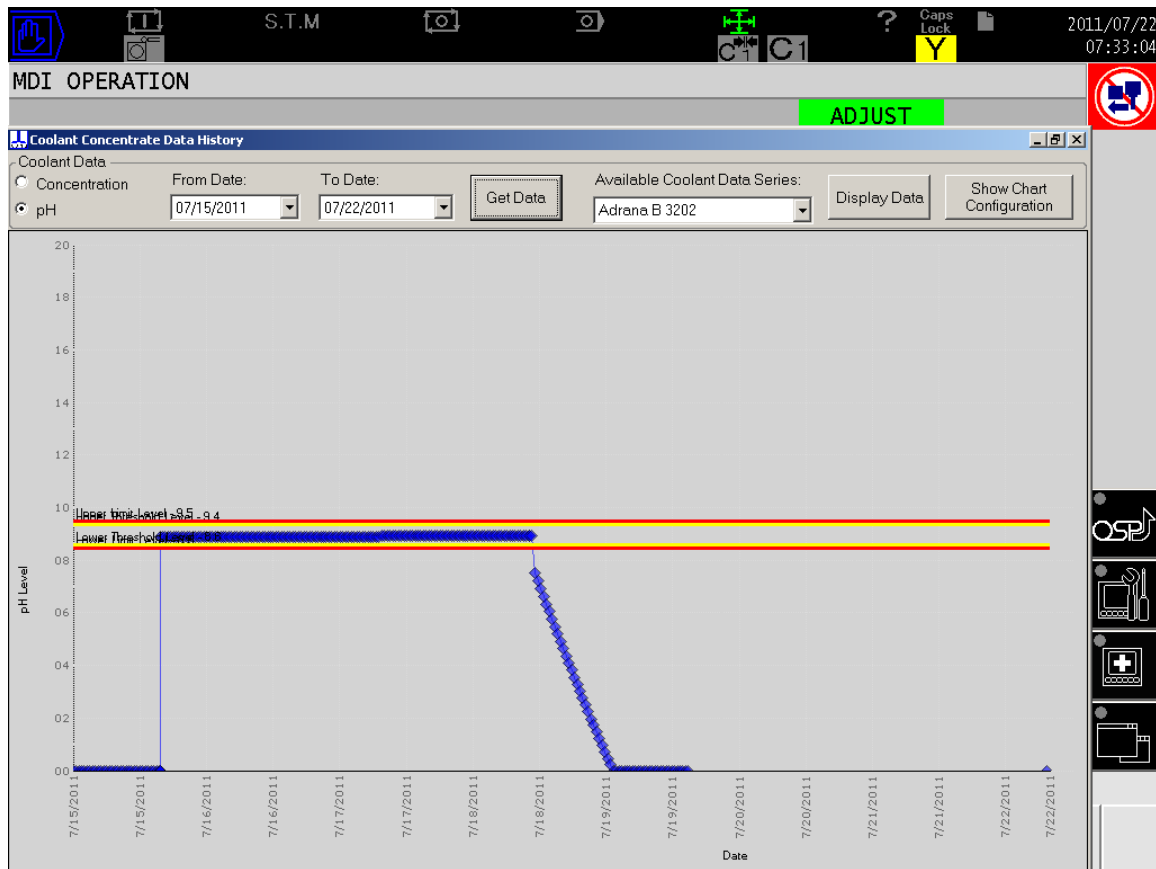
Figure 18: Okuma Coolant Monitor - History Trending.

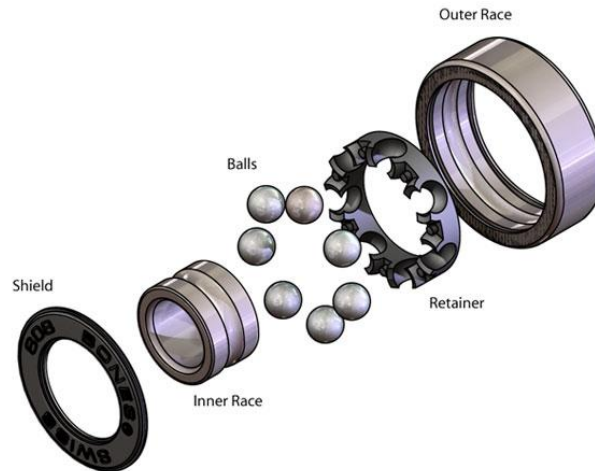
Figure 21: An Exploded View of a Ball Bearing [48].

Rolling element bearings are comprised of the rolling elements, an inner race, an outer race, and a cage or retainer to hold the rolling elements. An exploded view can be seen in Figure 21.

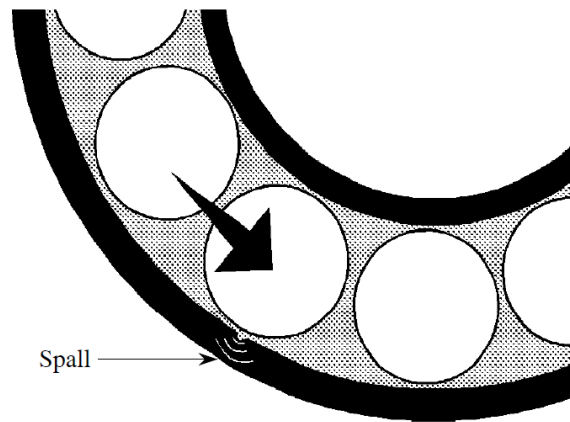
Figure 22: Example of a Bearing Spall Defect [53].

Local defects are those that include cracking, spalling, and pitting on the rolling surfaces. Spalling is most frequent defect seen in rolling element bearings. This happens when a micro-crack, due to fatigue, occurs below the component surface. The crack then propagates to the surface until a fragment of metal breaks away. The cavity left behind is known as the spall and can occur on both the races of the bearing or the rolling element itself [52].

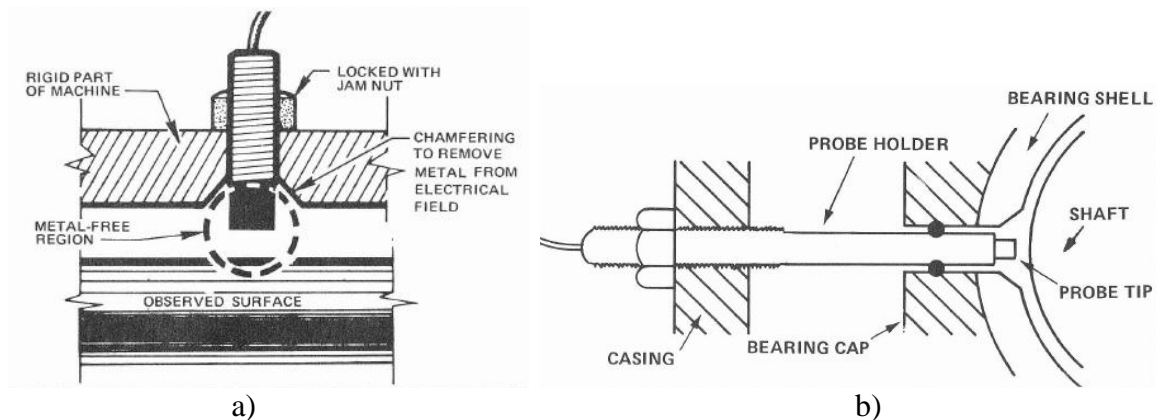
Figure 23: Mounting of a Non-contact Displacement Transducer [54].

probe and when the tip is placed close to a conductive material, eddy currents are created. These currents remove energy from the probe, allowing for a change in voltage to be measured. This voltage change can then be related to the change in displacement of the conductive material from the probe. The main limitation with this transducer is that it cannot distinguish between shaft motion and material defects (scratches, dents, conductivity variations). This causes the output to include both shaft vibration as well as material defects, so the response seen is not necessarily the true vibration. This limits the sensor to frequency ranges between 1,000 Hz to 1,500 Hz. Another limitation for this type of transducer is that it only measures relative position and may not indicate a shaft's true movement. True movement can be measured by velocity pickups and accelerometers, both discussed in the next several pages.

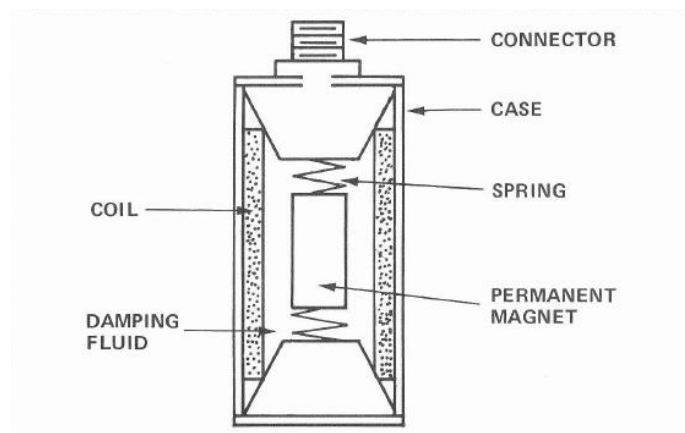
Figure 24: Diagram of a Velocity Pickup [54].

vibrates, causing a magnetic flux to come through the coil. This induces a voltage that is proportional to the vibration the sensor is experiencing. As an example, electric guitars use velocity pickups to convert the string vibration into sound through amplification. The main limitation of this transducer is that it is an electromechanical device with moving parts. In aggressive environments, these parts can fail. Thus, these transducers should be used in applications where the frequencies are between 10 Hz to 1,500 Hz.

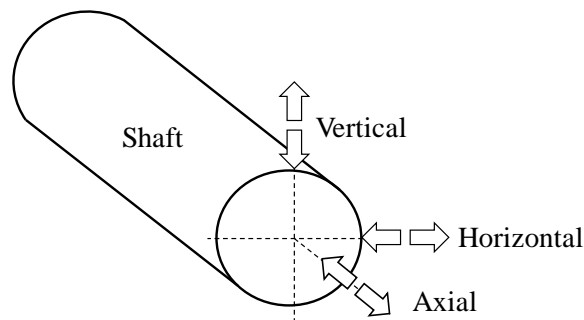
Figure 27: Directions of Movement in which Vibration is Measured.

Vibration is considered one of the best measurements to judge low frequency dynamic conditions such as mechanical looseness, imbalance, misalignment, or excessive bearing wear [53]. It can be measured in one or more of the following directions: horizontal, vertical, or axial. Each direction is represented in Figure 27.

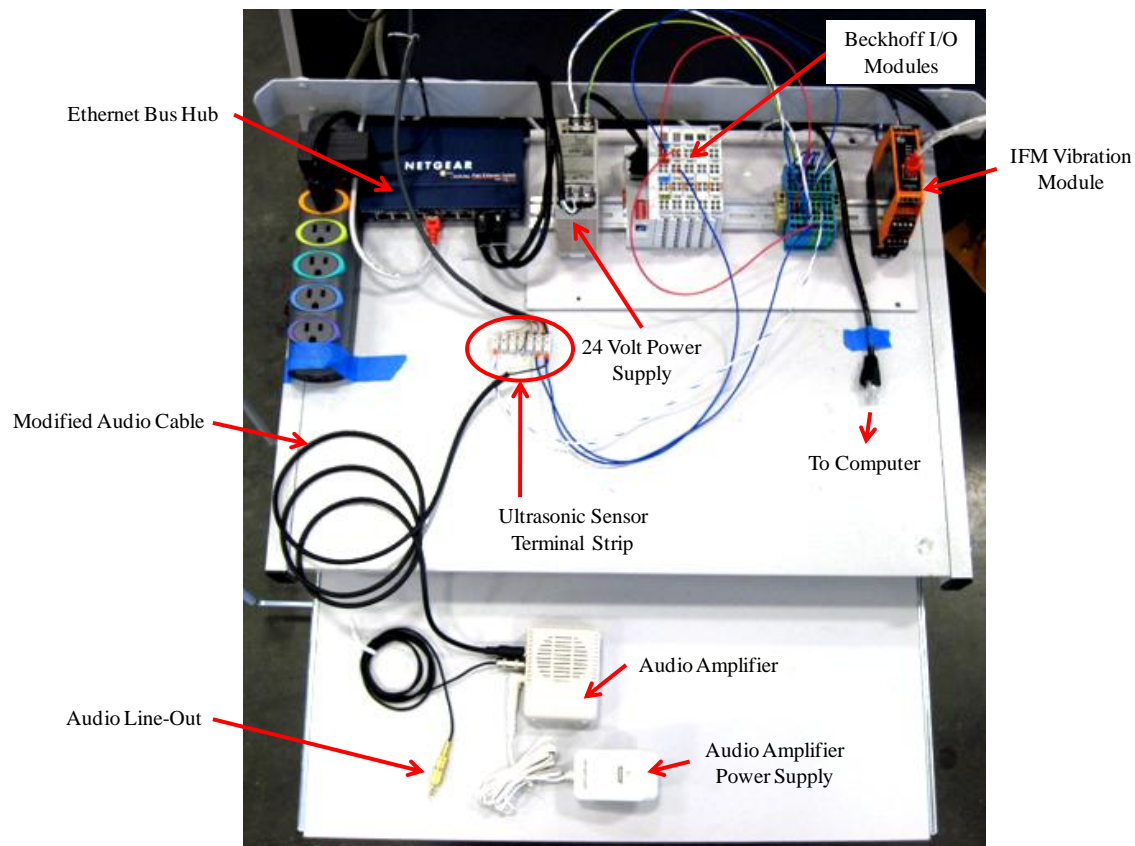
Figure 33: Hardware Layout During System Development.

Figure 33 shows an overview of the hardware used in the development and testing of this system. It is mainly comprised of a data acquisition programmable logic controller (PLC), a 24 volt power supply, an Ethernet bus hub, as well as the optional IFM Efector vibration module and ultrasonic audio amplifier. A breakdown of each component and its respective cost can be found in Appendix B.

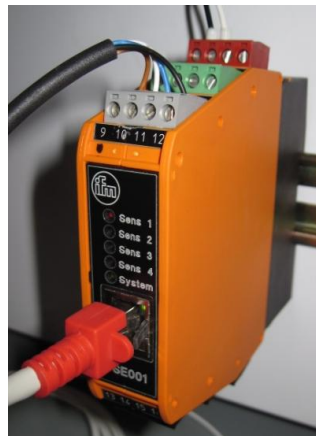
The IFM Efector vibration module, allows for vibration to be measured and recorded. The model used was the VSE001 (the newer model is now named VSE002). A close up picture can be seen in Figure 35. The module can support up to four accelerometers and measure acceleration, both RMS and peak levels in g's, as well as an RMS velocity in mm/s. It has a sampling rate of 100 kHz and has an exceptional frequency spectrum display (FFT chart) with zooming capabilities. This will allow for even better pinpointing of the bearing fault frequencies. The device settings are configured and set by accessing its own software program, called Octavis VES003. This software can be run on the machine control as well, as it is a Windows based program.

Figure 35: IFM Efector Vibration Module

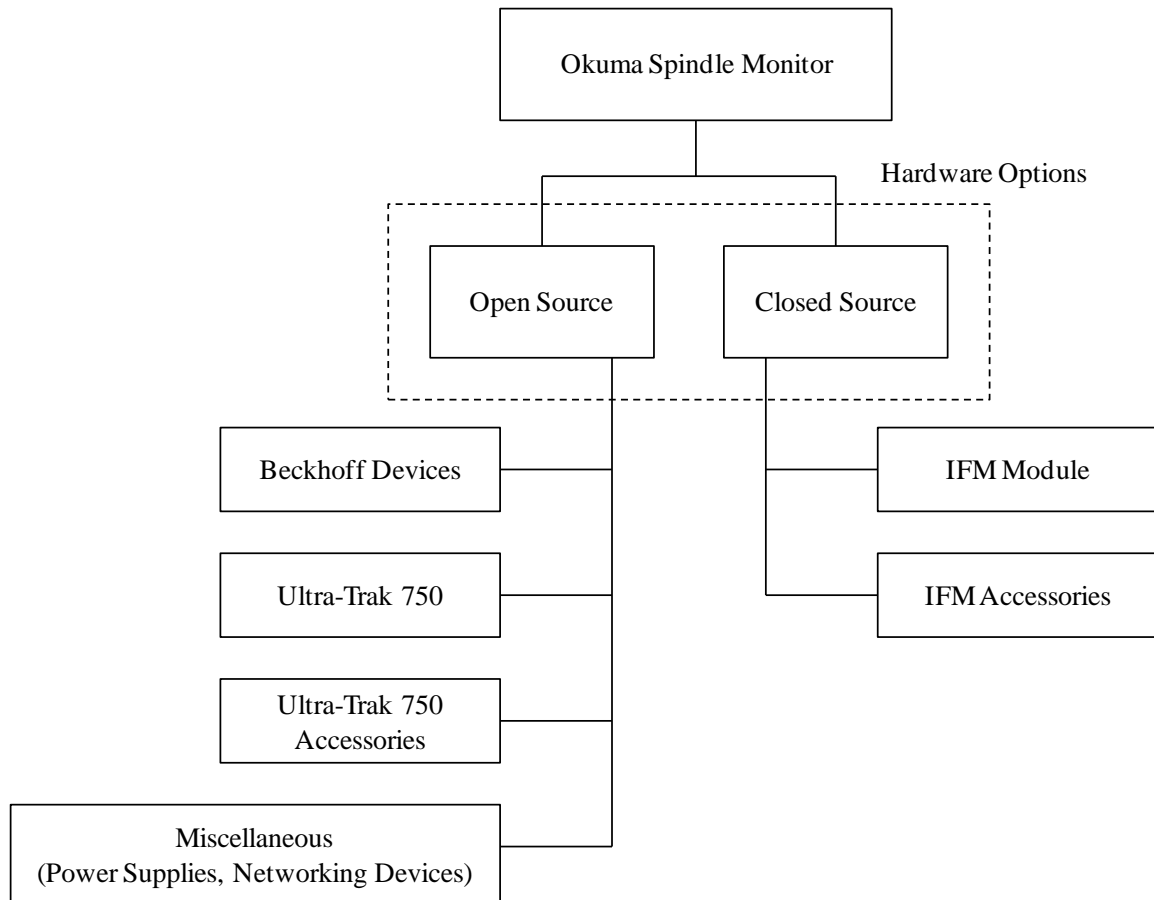
Figure 37: Visual Representation of the Open and Closed Source Hardware the System Employs.

The hardware used in this monitoring system can be broken up into two categories: *Open Source* and *Closed Source*. The *Open Source* devices are those that allow for an open source architecture and software programming to be performed by anyone with a software background. This provides the application developer with complete control of how these devices function. The *Closed Source* devices are those that the developer has no control over device function. Figure 37 provides a system architecture to allow for better device clarification for this monitoring system. The *Closed Source* devices can be removed from the system and the monitoring system will still function the way it was intended, however certain information will not be obtainable.

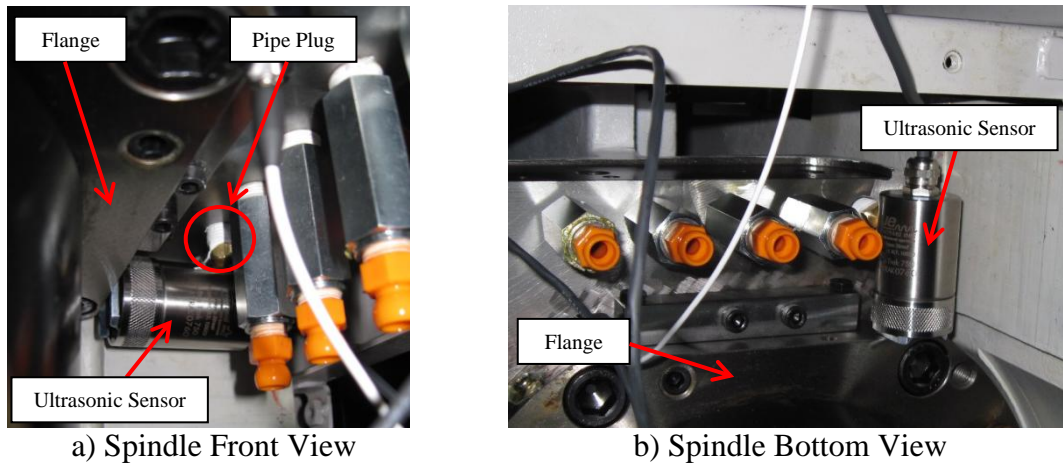
Figure 41: Ultrasonic Sensor Placement on the MU-500VA.

column assembly. This is shown in Figure 41. Mounting the ultrasonic sensor on the flange provides a good material route straight to the bearings (the ultrasonic sounds can emanate from the bearings and be transferred through only one medium, metal). Placing the sensor on the black spindle cover does not provide as good of a route as it has the spindle chilling fluid behind it (as does the lathe casting).

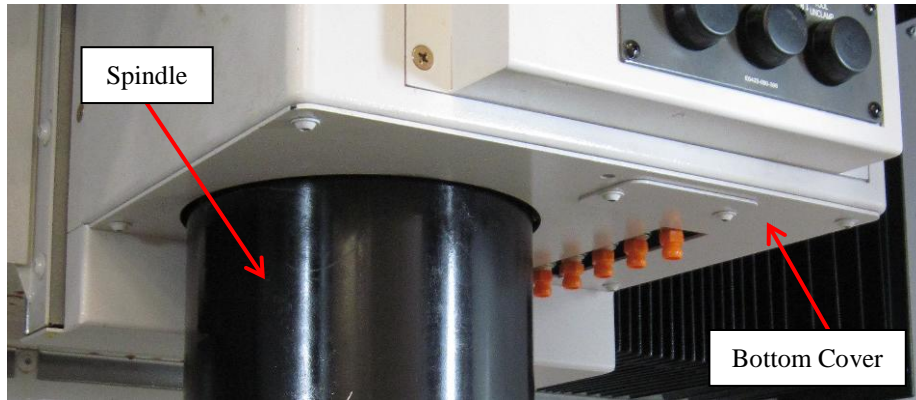
Figure 42: Bottom Cover for the MU-500VA.

The last coolant nozzle was removed and plugged to ensure the upper ultrasonic sensor had a solid mounting foundation. A pipe plug was put in the nozzle's place to prevent coolant from splashing the sensor. The pipe plug was used as a mock-up piece; however, a set-screw should be used in this hole to allow for the sensor to be mounted higher on the spindle flange, preventing the bottom cover from being modified. This bottom cover is shown in Figure 42.

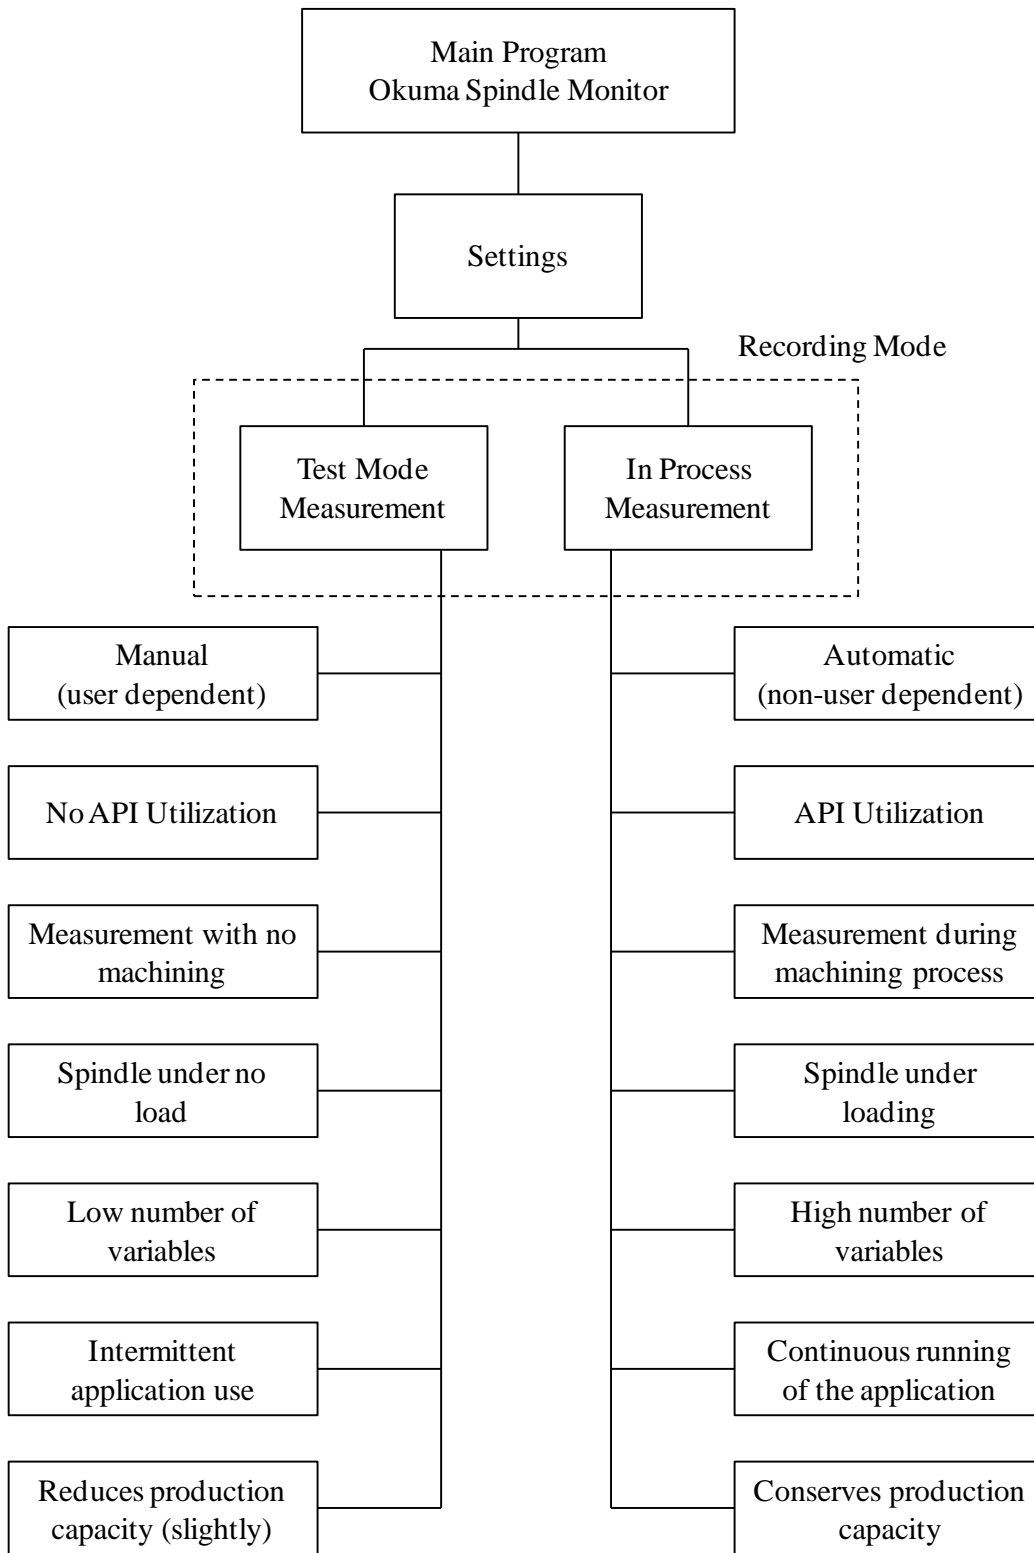
Figure 44: Recording Mode Differences.

Before the program is discussed any further, it must be made clear that the program has two distinct recording modes, *Test Mode* and *In Process Mode*. This gives the machine tool owner the ability to select how the measurements are to be performed. There are various advantages and disadvantages for each mode. These can be seen in Figure 44.

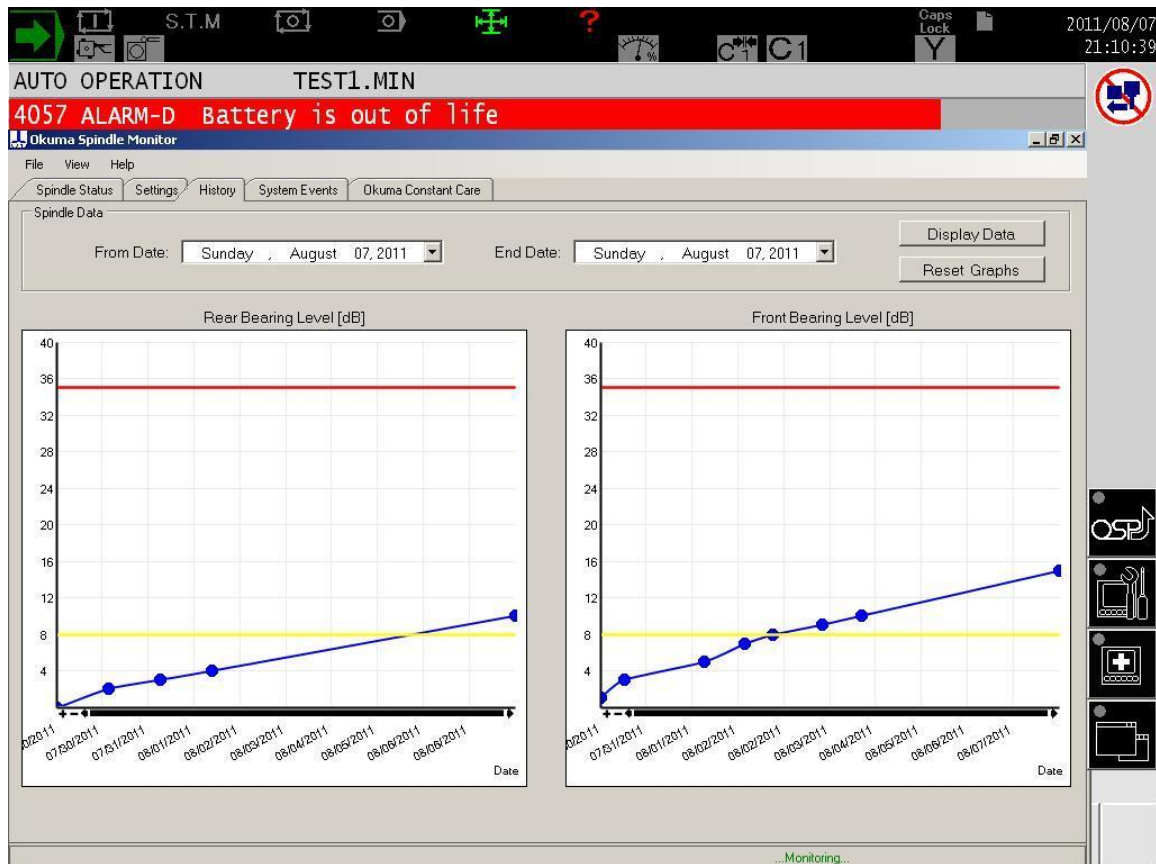
The *History* tab allows for the previously recorded data to be viewed. Each time a measurement is taken, the graphs, shown in Figure 58, are updated to reflect that new record. The user has the ability to zoom in manually on each graph by clicking the + symbol on the x-axis scroll. Additionally, DateTimePickers for the exact start and end dates to be zoomed in on has also been included. The x-axis on the charts is scaled with respect to time so that an accurate representation of the time between readings can be seen.

Figure 58: History Tab.

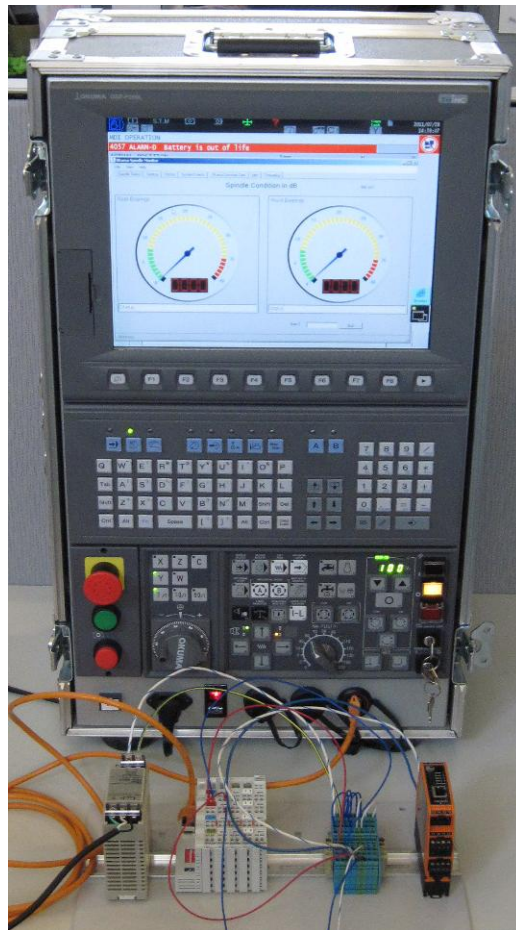
Figure 66: Validation Test Setup on Simulator

To ensure that the system was fully functional, an Okuma Machine Simulator was utilized. This allowed for the application to be run on the same computer that a machine would have on it; however there is no machine attached. The validation test setup can be seen in Figure 66. The Beckhoff PLC device was connected directly with the simulator (rather than a bus hub) as this device is the one that communicates with the *Okuma Spindle Monitor* program.

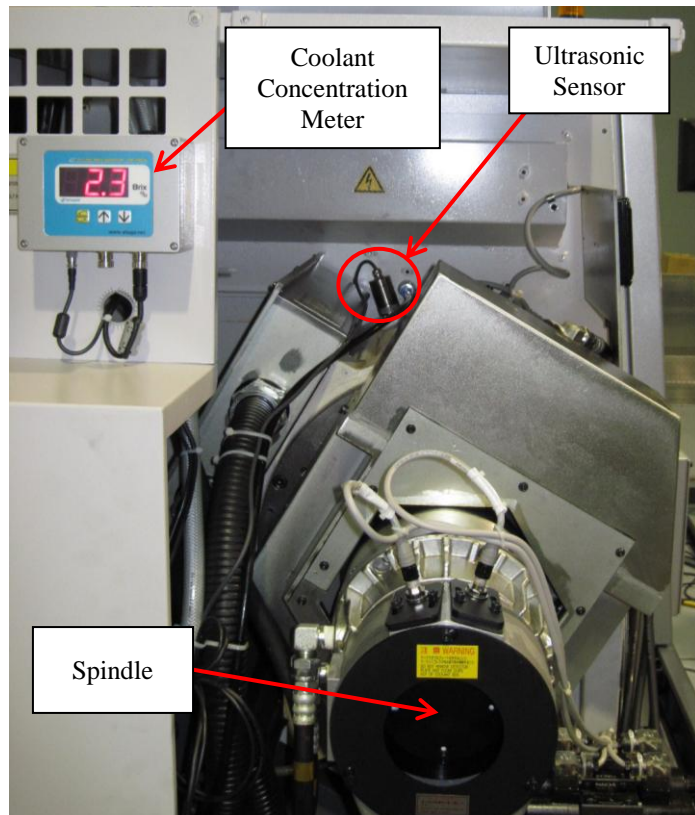
Figure 67: Ultrasonic Sensor Placement.

The next validation step was to take the program to an actual machine and test it out under actual conditions. This was performed on an LB3000EX lathe at Okuma's Partners in THINC building, the manufacturer's partner teaming facility. This particular machine was sent to the Interactive Manufacturing Experience (imX) 2011 machine tool show [69] in Las Vegas to debut the developed system. Figure 67, Figure 68, and Figure 69 show the system setup on the machine. To allow for the same data acquisition hardware to employ both the *Okuma Coolant Monitor* as well as the *Okuma Spindle Monitor*, an additional analog current module was added and the software program was modified. This served as a verification that both systems could be run from one PLC.

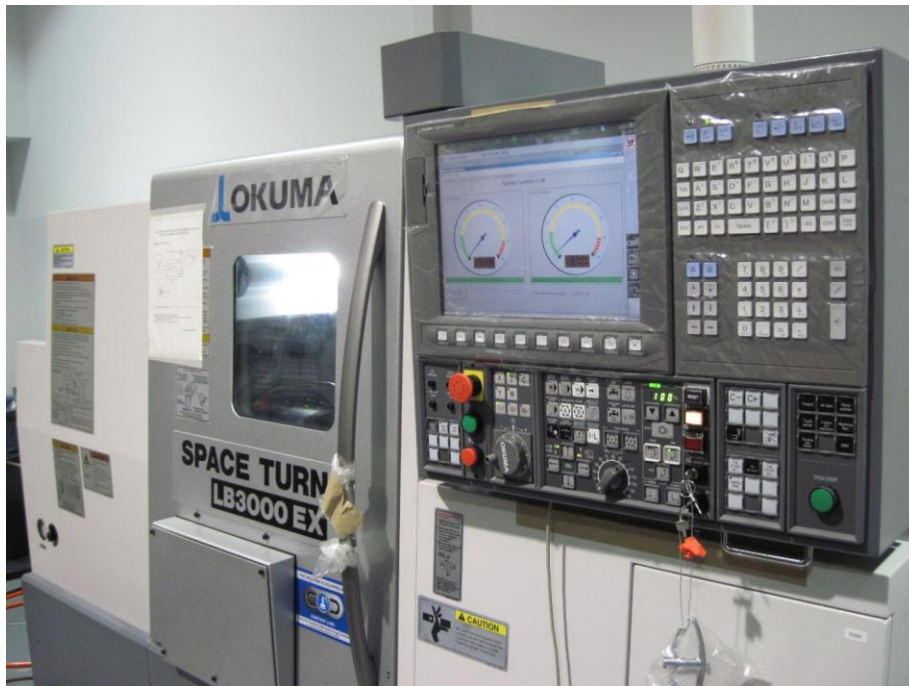
Figure 68: Software Loaded onto the Machine Control.

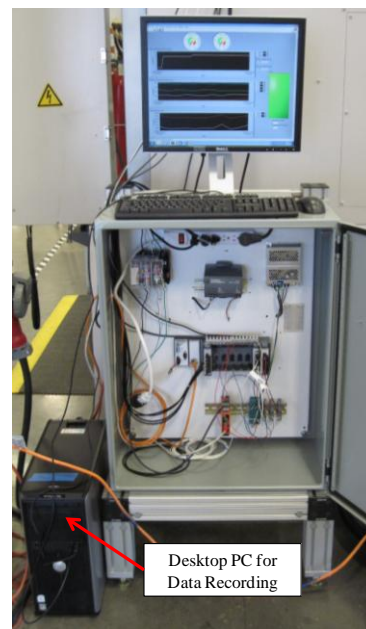
b) Total Recording System

Figure 91 shows the data acquisition setup. All electrical components were set up inside an electrical cabinet and placed next to the machine. All data recording was performed on the desktop PC, next to the electrical cabinet.

Figure 91: Recording System.

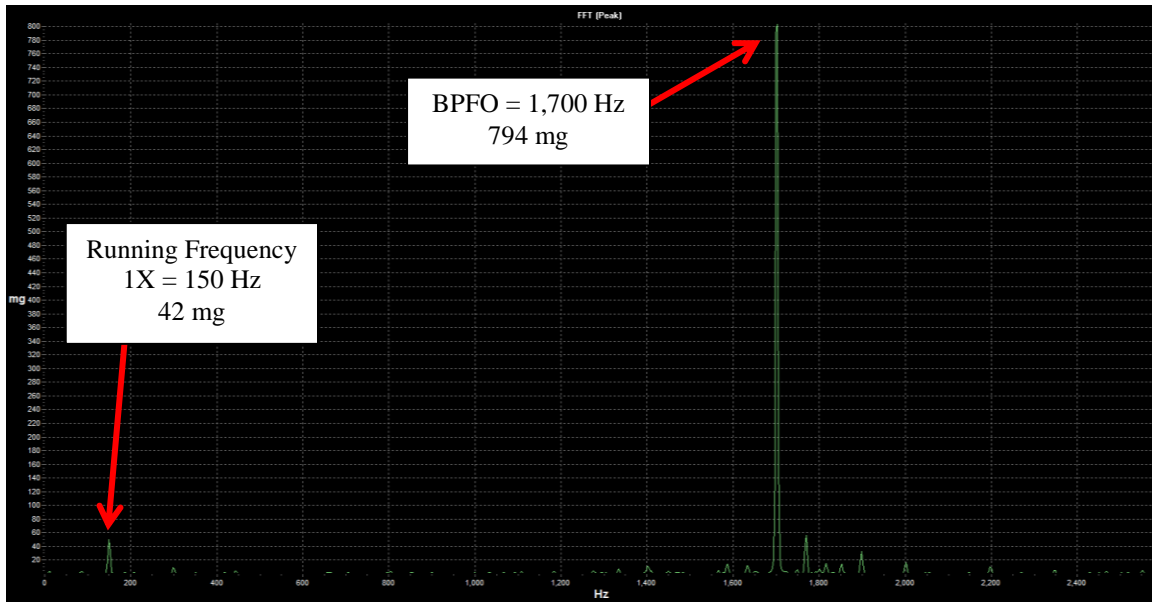
An FFT reading was recorded at the point where a maximum 4.2 dB was read, shown in Figure 101. The running frequency had no change, however the BPFO was even higher than that of the previous lack of lubrication test, reaching 794 mg (a 148 mg increase).

Figure 101: Frequency Spectrum at the 4.2 max dB Reading.

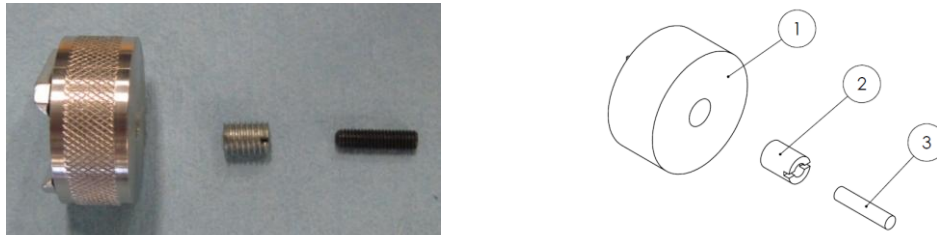
Figure F-1: Magnet Adapter Exploded Views.

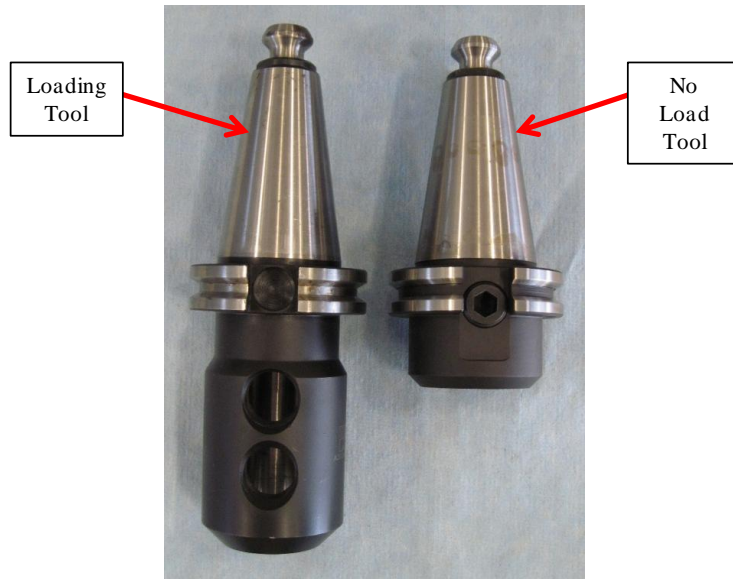
OEM: Sandvik
Model: A392-4025-40 25 101
Serial Number: 28472
Tool Length: 3.25 inches
Weight: 3.38 lbs

Figure G-1: Tool Holders used in the Destructive Bearing Test.

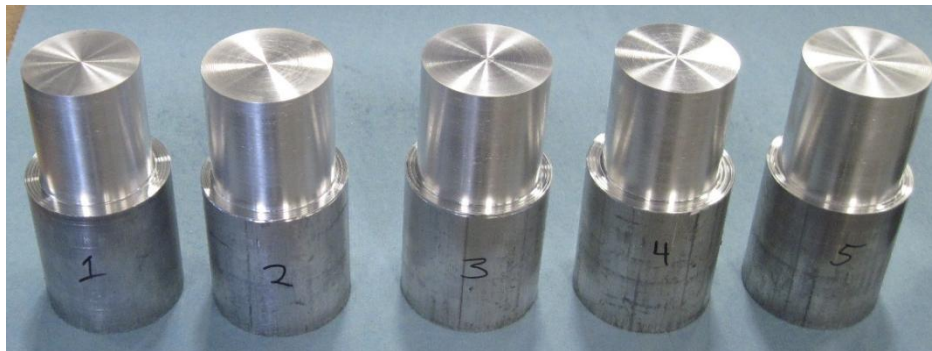
Figure J-1: Aluminum Specimens (6061 Aluminum)

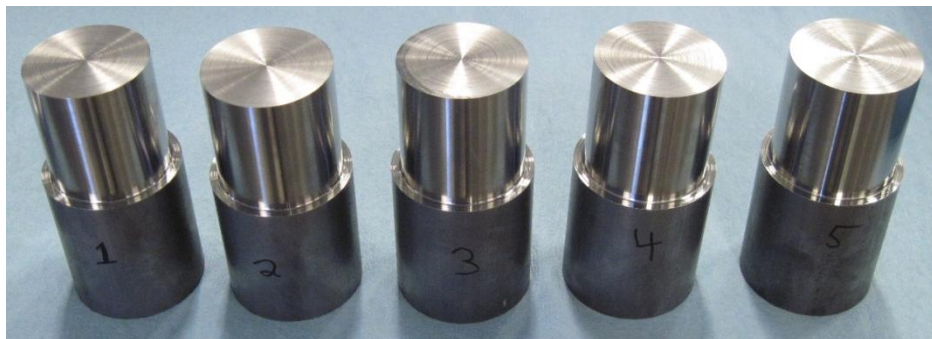
Figure J-2: Steel Specimens (Cold Roll - C-1018)
