RAMMED EARTH ARCHITECTURE'S JOURNEY TO THE HIGH HILLS OF THE
SANTÉE AND ITS ROLE AS AN EARLY CONCRETE

A Thesis
Presented to
the Graduate Schools of
Clemson University & The College of Charleston

In South Carolina, Dr. William Wallace Anderson of Stateburg built wings on his house out of pisé, seven outbuildings, and a nearby church of the material. These rammed earth structures in the High Hills of the Santee, the Borough House (c. 1821) and the Church of

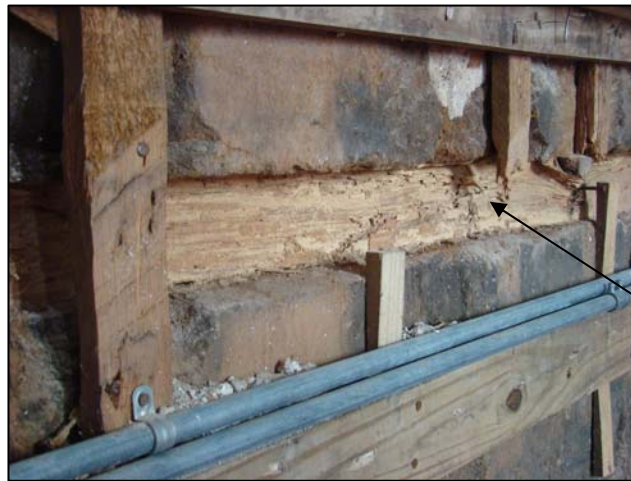
Figure 4. Arrow points to the original bond timbers at the Church of the Holy Cross in Stateburg, South Carolina. (Photo: Author)

Wood is used in pisé construction for framing and for window and door headers. Thin boards are used to brace the building and are placed at each story for extra supports. These boards are placed in the pisé walls as bond timbers.²³ Traditional lime and sand mortar should be placed in the notch for the beams and all around them once they are placed in order to securely hold them in place. Any wood used as window or door headers should be put in place angled towards the ground so that water can run off them and not collect in the wall.²⁴

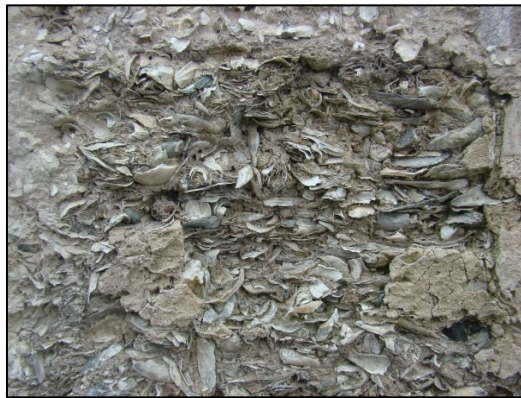
Figure 11. Close view of a tabby wall in Beaufort, South Carolina. (Photo: Author)

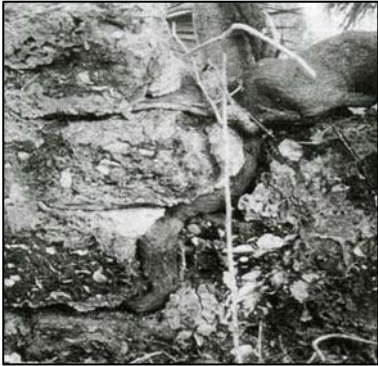
Figure 13. Vine damage in a tabby wall. (Photo: Lauren B. Sickels – Taves.)

Tabby is durable and strong, but the biggest threat to its survival is water. Capillary action causes water to rise into the material, which causes erosion and spalling of the exterior render. Also, any water that enters tabby can break down the lime's strength, which leads to weakening of the structure. Another threat to tabby is plant growth, especially with vines and roots. As with pisé, the best way to protect tabby is to maintain its traditional render, either stucco or whitewash. This helps to decrease the chance for water infiltration as well as slowing any capillary action from the ground.

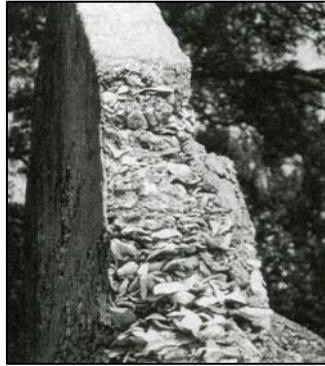
Figure 14. Damaged tabby wall with previous cement repairs at top. (Photo: Lauren B. Sickels- Taves)

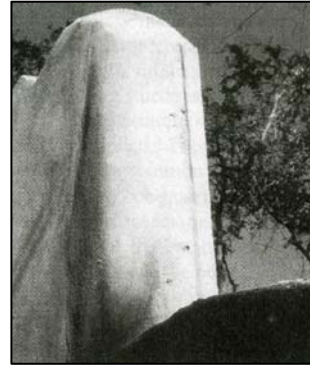
Figure 15. Same wall as in Plate 7 repaired with a new compatible stucco. (Photo: Lauren B. Sickels – Taves)

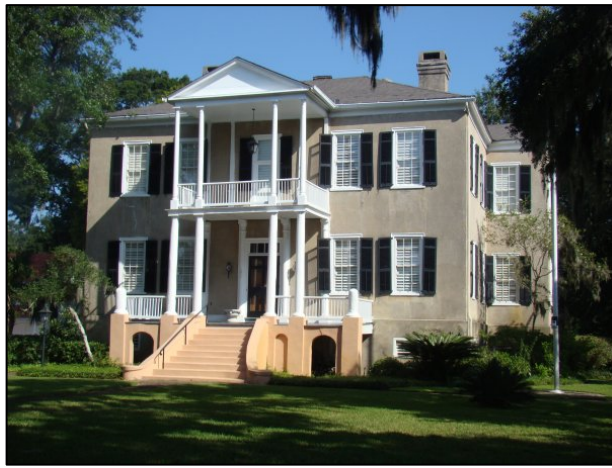
Figure 18. Tabby Manse, c. 1786, in Beaufort, South Carolina, which is built of Oglethorpe tabby. (Photo: Author)

Tabby that is determined to have been built between 1703 and the 1790s is often referred to as Oglethorpe tabby, as after 1790 there is not much new tabby construction seen in Georgia or South Carolina.⁷⁰ Oglethorpe tabby is differentiated from the other eras of tabby by its pour height of twenty to twenty-two inches, visible marks left by the cradle, and by the irregularity of pinhole placement that helped to hold the cradle together.⁷¹

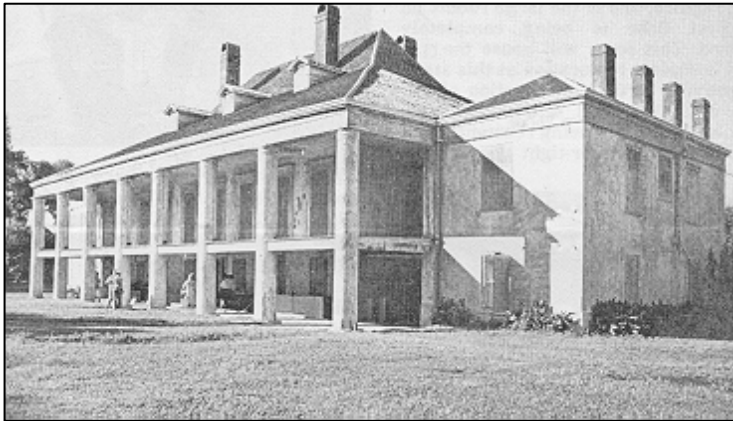
Figure 20. Destrehan Plantation in Destrehan, Louisiana, was built out of poteaux en terre bousillage construction. (Photo: National Parks Service)

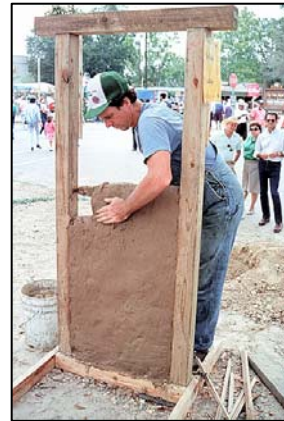
Figure 21. A man demonstrating how a bousillage wall is made. (Photo: www.laheritage.org)

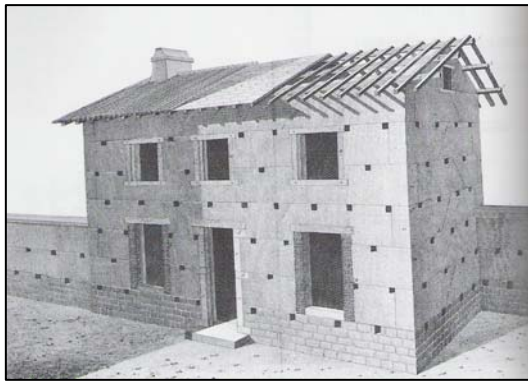
Figure 24. Rondelet’s sketch of a pisé house and wall. (Image: Louis Cellauro and Gilbert Richaud)

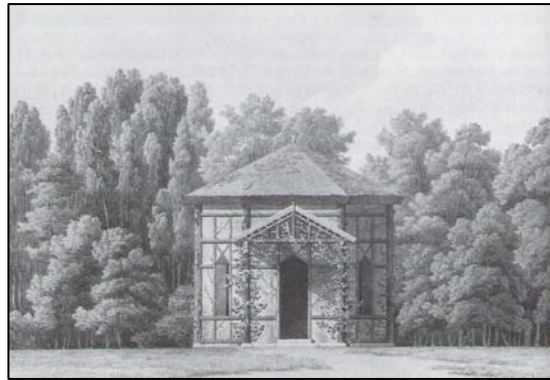
Figure 28. A watercolor painting of Cointeraux's Pavillon de l'Empereur built in 1791. (Image: Louis Cellauro and Gilbert Richaud)

In December of 1789, Cointeraux won another design competition for a large pisé farm. Two years later, he built the Pavillon de l'Empereur, which was an octagonal shape on the exterior, but circular on the inside. During his years in Paris, Cointeraux was consistently producing designs for houses, schools, and other buildings.⁹²

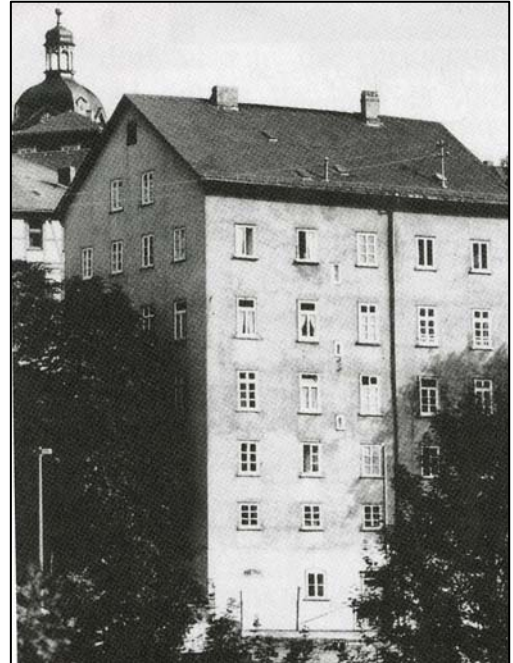
Figure 43. A seven story apartment building of pisé on a hillside built by Wimpf. (Image: Louis Cellauro and Gilbert Richaud)

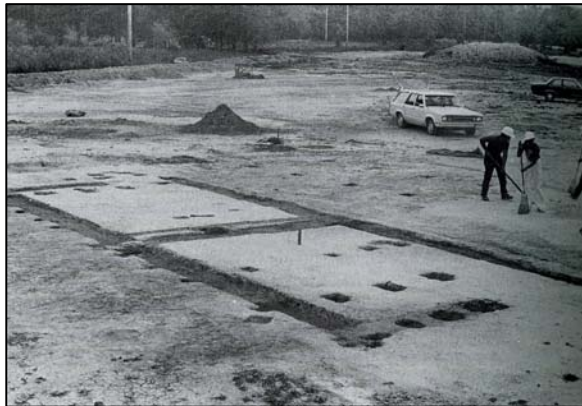
Figure 59. View of archaeological remains of an earth walled house at Curriboo Plantation. (Photo: Leland Ferguson)

Patrick Garrow and Thomas Wheaton discovered slave houses in an African style on the Santee River in Berkeley County, South Carolina, at two neighboring French Huguenot plantations called Yaughan and Curriboo. Two slave quarters were found at Yaughan dating from the 1780s to the 1820s and the 1740s to the 1790s while one structure was found at Curriboo dating from the 1740s to 1800. In all, Garrow and Wheaton found 26 structures, most of which were identified as slave houses and outbuildings.¹⁴⁷ Most African style houses were built with post in ground construction and clay infill and the quarters at Yaughan and Curriboo were found to have post in ground construction tying these buildings to an African origin.

The structures had wall trenches comparable to clay and cob buildings in West Africa.¹⁴⁸

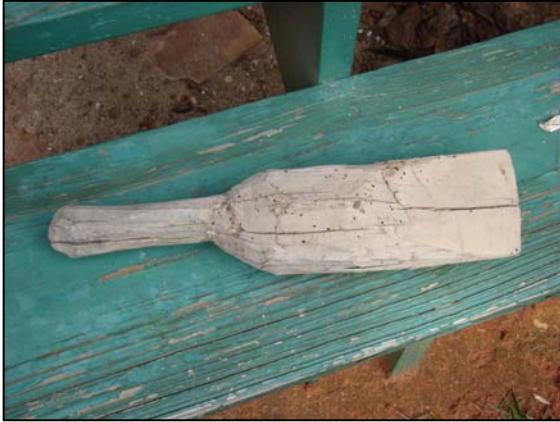
Figure 66. One of the original pisoirs used by Dr. Anderson's slaves to construct the pisé buildings on site. (Photo: Author)

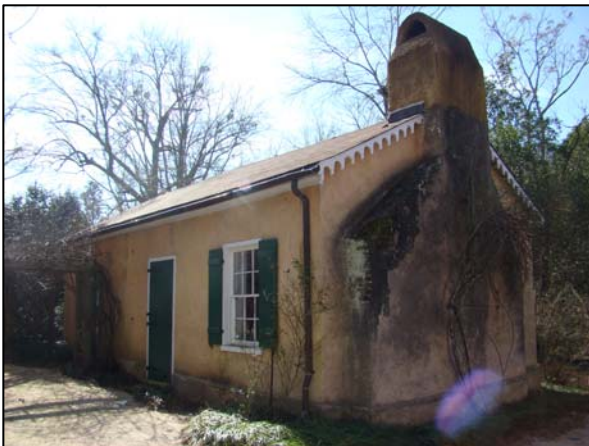
Figure 78. The east façade of the dairy/kitchen building. (Photo: Author)

Of all the pisé buildings on site, the dairy has been most significantly altered. The right half was destroyed by a falling tree and rebuilt. Today, the dairy is in good condition with some minor plaster cracking due to moisture that was continually on the west side of the building as wood was stacked on the opposite side of the wall for many years. The original pisé wall can be seen inside the dairy as well as a previous render of tar and sand.

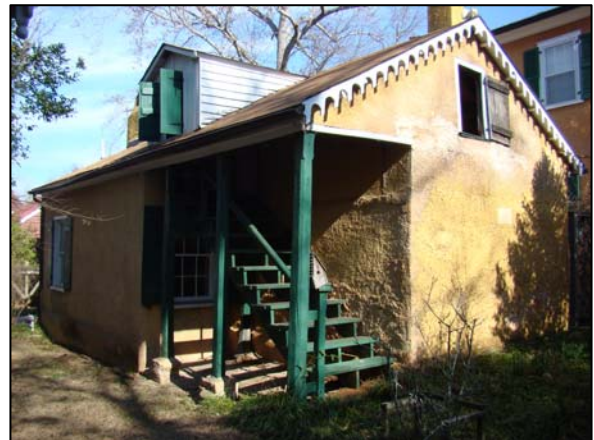
Plate 79. The west and south facades of the dairy/kitchen. (Photo: Author)

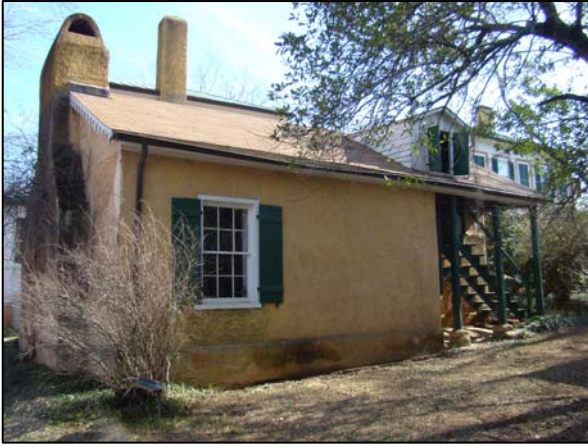
Figure 80. The west façade of the dairy/kitchen building. (Photo: Author)

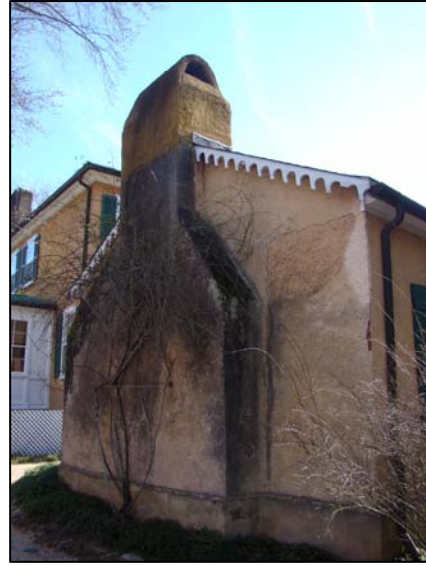
Plate 81. The north façade of the dairy/kitchen building. (Photo: Author)

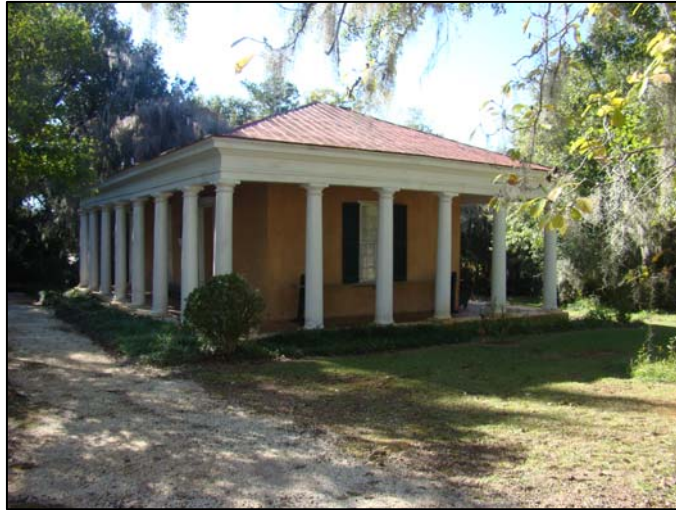
Figure 82. The library in 2009. (Photo: Author)

The library, which formerly served as a school, is in excellent condition. The pisé walls are protected by a peristyle around the entire building and the only repairs that have had to be made were because of risks taken during construction and later human intervention. Originally, the foundation of the library was also built out of pisé, while the majority of pisé buildings employ masonry foundations. The pisé foundation was replaced in the middle of the 20th century because moisture caused it to deteriorate. It was replaced with a concrete foundation and has had no major problems since. The other issue with the library is that in order to protect the books, which date all the way back to the 1790s, a humidifier was installed inside during the middle of the 20th century. A drain hose was run from the inside of the library under the building and stopped just short of the original pisé foundation. This was an important error as all the excess water from the humidifier was pooling up at the base of the foundation. Fortunately, this is no longer an issue as the drain was removed and the caretaker empties the humidifier a few times a week by hand.

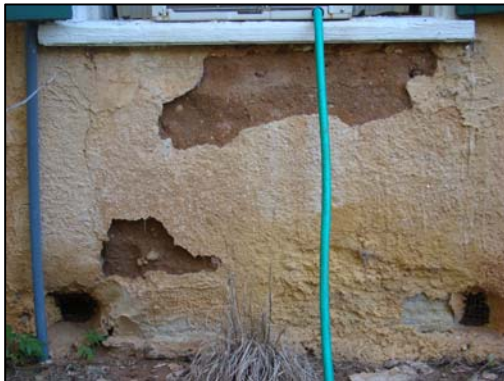
Figure 83. Loss of pebble dash on the eastern wall of the doctor's office due to water leaking from the air conditioning unit. (Photo: Author)

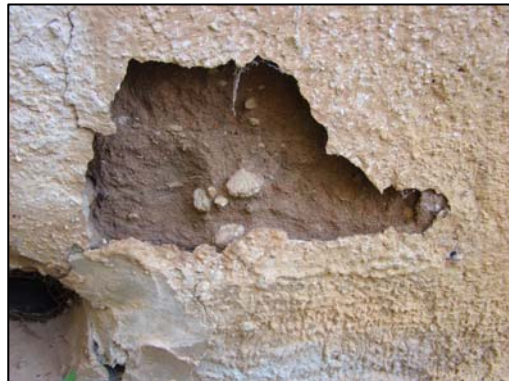
Figure 84. A closer view of the pebble dash loss where some of the earth has also deteriorated. (Photo: Authot)

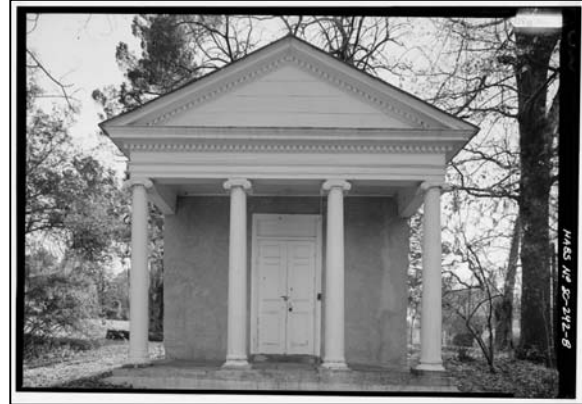
Figure 86. The doctor's office at the Borough House based on the design of the Temple of Aesculapius. (Photo: Library of Congress)

Dr. Anderson's office, situated at the end of the main drive, is in good condition. It was built to resemble the temple of Aesculapius and looks like a small Greek temple. The only deterioration on the structure is underneath an air conditioning unit where water has continually dripped down and eroded the pebble dash finish. Even with the erosion, the pisé is still sound and has not deteriorated much.

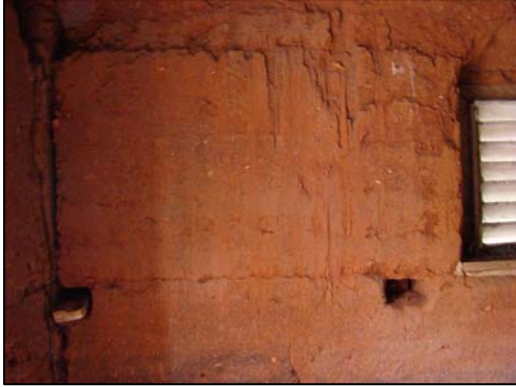
Figure 87. The original pisé walls of the dry well, which were left unfinished. (Photo: Author)

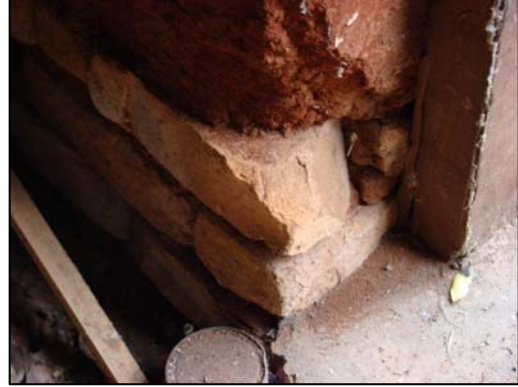
Figure 88. The visible foundation of the dry well constructed of locally made bricks. (Photo: Author)

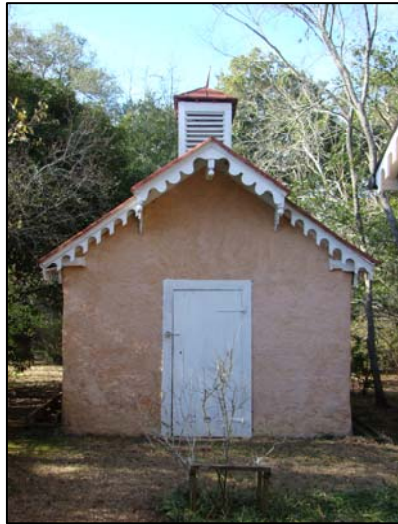
Figure 89. The exterior of the dry well with decorative barge boards added in the 1880s. (Photo: Author)

The dry well exposes unfinished pisé walls offering a glimpse at the building's masonry foundation and putlog holes as well. The other pisé buildings on site have interior walls with plastered or whitewashed walls. The dry well's pisé walls are in good condition while the wooden staircase, in poor condition, is not structurally sound. The stairs lead down to the well, which is one of the only ones left in the Stateburg area, and is about twenty feet below the surface.

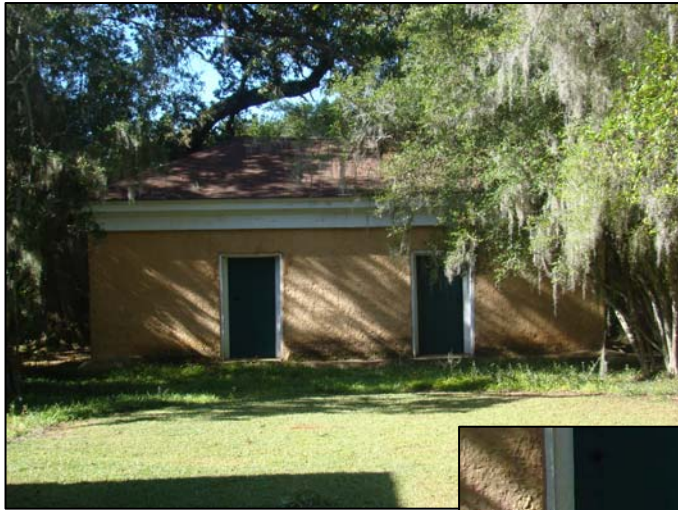
Figure 92. The loom house with dark staining along the base of the building due to rain and dirt splash. (Photo: Author)

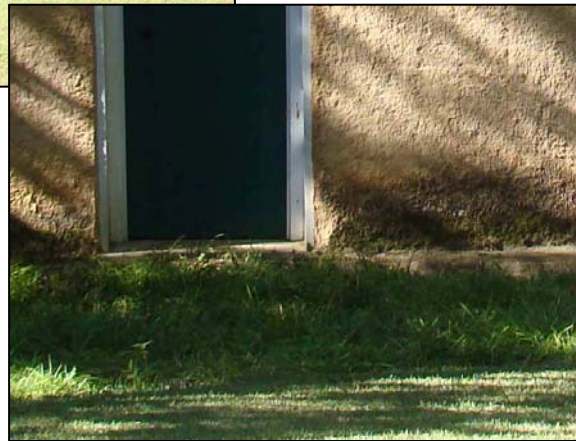
Figure 93. Closer view of the staining. (Photo: Author)

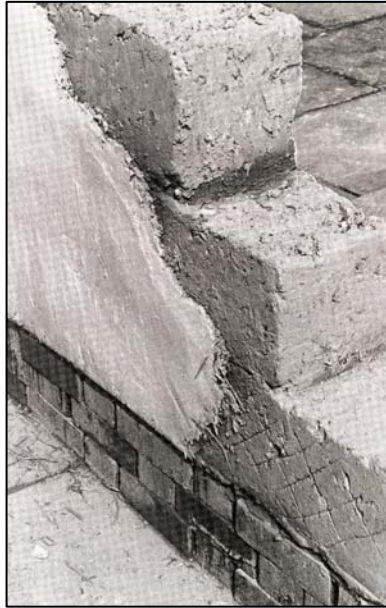
Figure 94. The layers of stucco on pisé walls are similar to this photograph of an exterior render on a clay lump wall. (Photo: John and Nicola Ashurst)

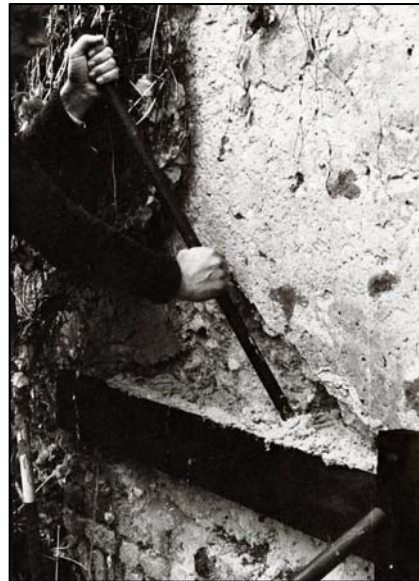
Figure 96. A cob wall being repaired and filled in with temporary shuttering. (Photo: John and Nicola Ashurst)

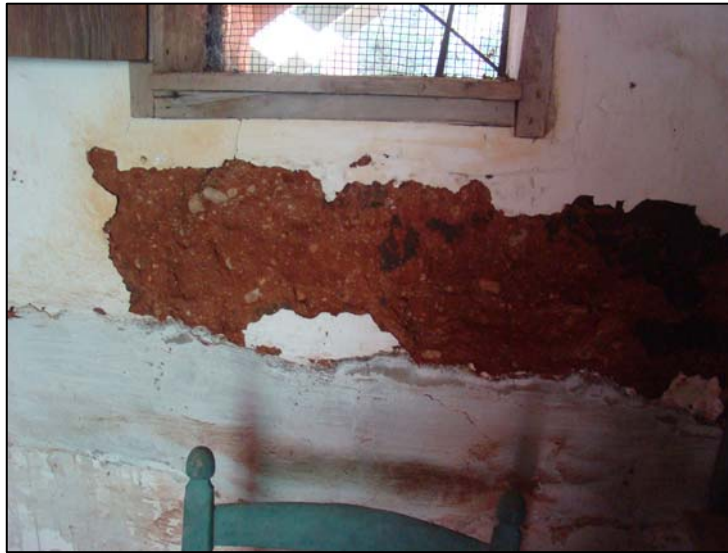
Figure 98. Interior wall showing some plaster loss inside the dairy/kitchen. (Photo: Author)

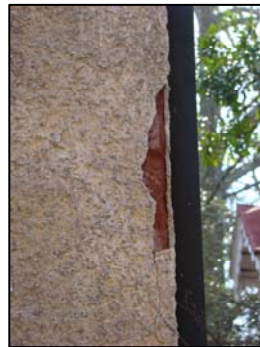
Figure 100. Closer view of area of pebble dash loss (about six inches in length) (Photo: Author)

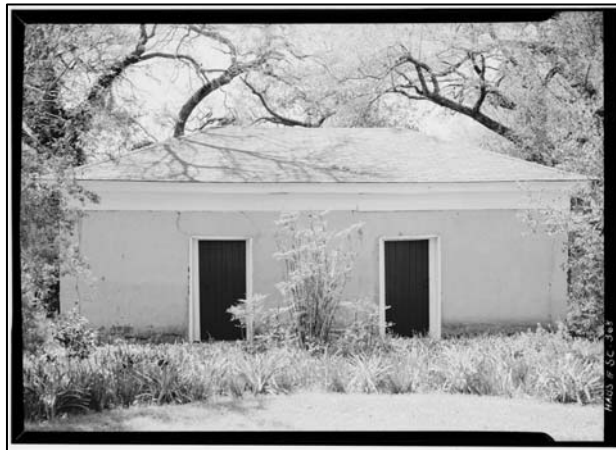
Figure 101. The loomhouse in a 1980 HABS photograph when the earth walls did not have an exterior render on them. (Photo: Library of Congress)

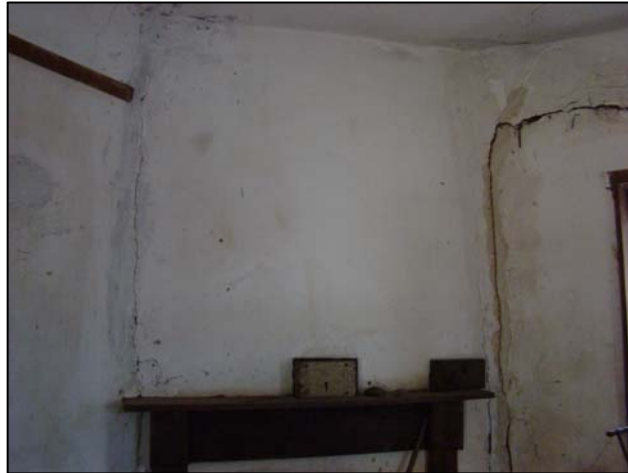
Figure 103. Large crack in the plaster of the loom house where a live oak's roots have disrupted the eastern wall of the structure.
(Photo: Author)

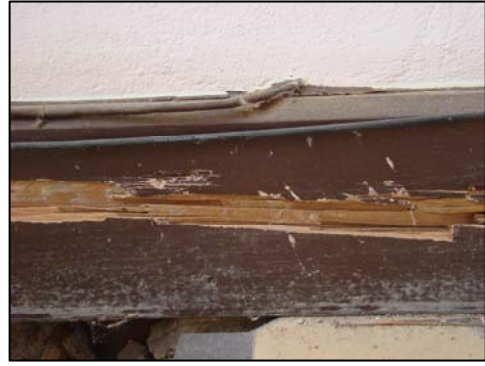
Figure 113. Termite trails on the baseboard in the Chancel. (Photo: Author)

The following photographs illustrate termite damage currently in the church on a mantelpiece in the sacristy, floorboards under the choir area, wood supports in the pisé walls, and areas where the termite damage is being monitored. Also, there are several photos of cracking due to the weakening of the structure because of termites.

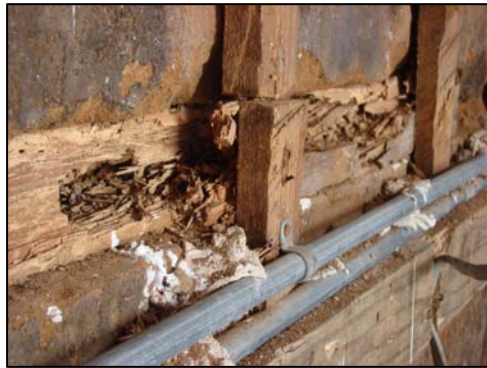
Figure 114. Termite trails on original support beams in the pisé wall. (Photo: Author)

The focus material, rammed earth, is in good condition. Currently, the pisé portions of the walls are exposed as all the wainscoting has been removed to look for and treat termite damage. There are some loose bits that have fallen out of the wall or have just been loosened in place, but overall the pisé is stable and firm. The portions that failed in the past have been replaced with concrete and concrete block and as all of the walls are removed, it is easy to see where these repairs are. There are some areas of concern especially where the original bond timbers have extensive termite damage and this

weakening of the wood support could cause portions of the pisé to fail. This has not been observed as happening yet, but it is possible. The damaged bond timbers will have to be replaced and a compatible wood will need to be used as the expansion and contraction rates of new wood are different from old wood and rammed earth.

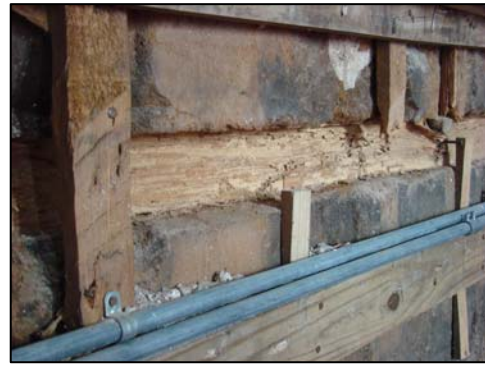
Figure 115. Termite trails on original support beams in the pisé wall. (Photo: Author)

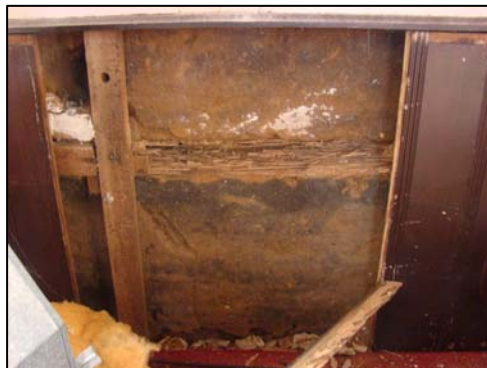
Figure 116. Termite trails on original support beams in the pisé wall. (Photo: Author)

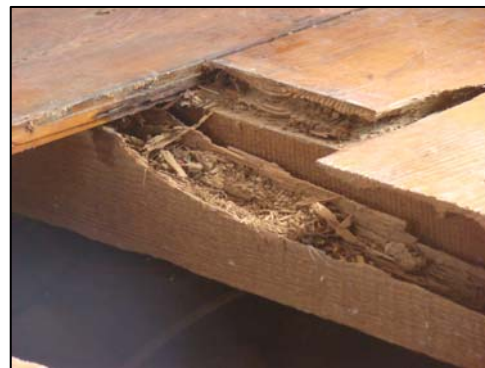
Figure 117. Severe termite damage on floorboards under choir area. (Photo: Author)

The extensive termite damage today includes roof trusses, floor boards, wood used in the original pisé walls, the modern wainscoting, and all other locations where wood was used, such as the mantelpiece in the sacristy. The heavy cement roofing tiles exacerbate the weakened structure with their weight. However, the cost to remove the tiles and replace them is significant. Similarly, the incompatible render on the exterior will be left in place since it is not in the budget to remove it at this time.

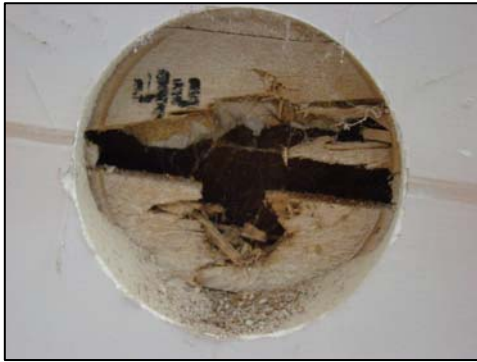
Figure 118. Holes cut in plaster to monitor termite damage. (Photo: Author)

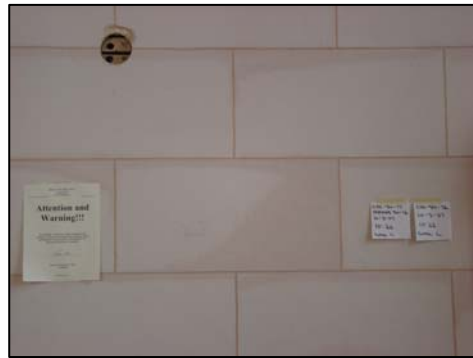
Figure 119. Holes cut in plaster to monitor termite damage. (Photo: Author)

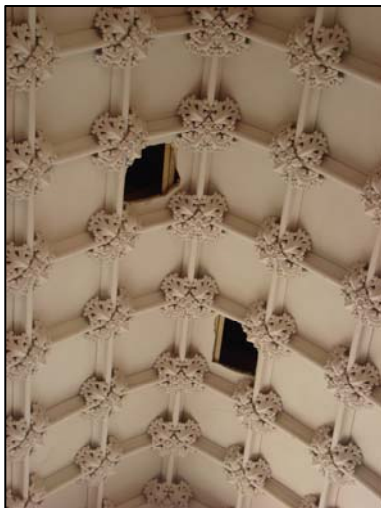
Figure 122. Holes cut in the Chancel ceiling to inspect and monitor termite damage. (Photo: Author)

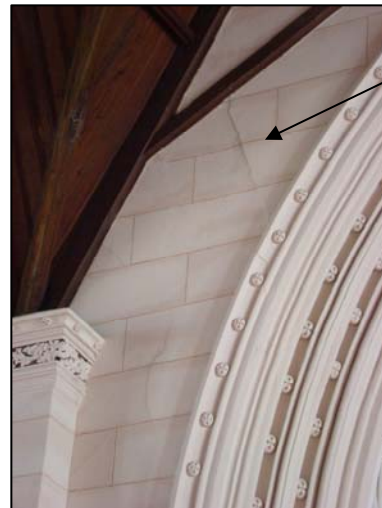
Figure 123. Arrows point to cracks due to weakened structure. (Photo: Author)

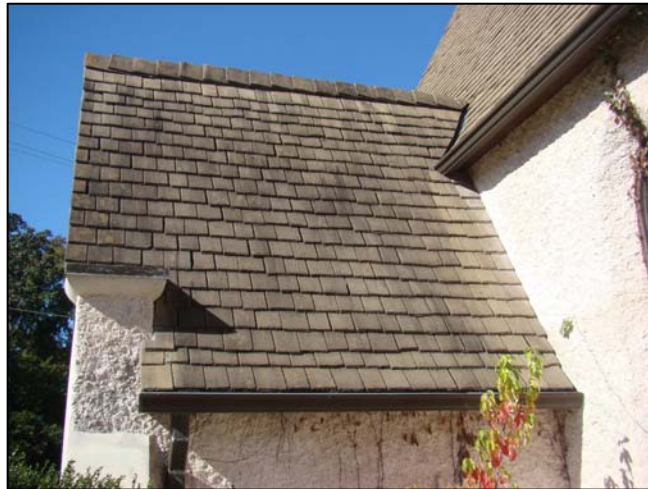
Figure 124. View of the current cement tile roof on the northern transept. (Photo: Author)

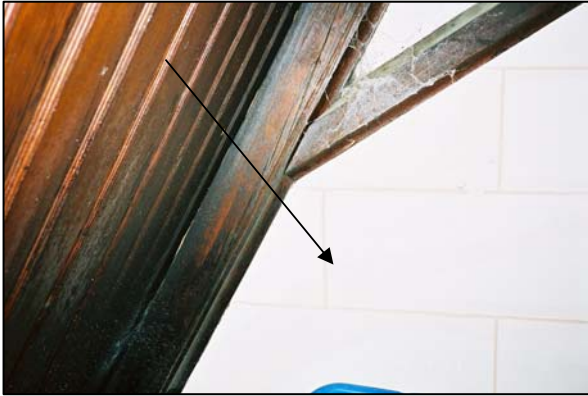
Figure 125. Arrow points to cracking in roof truss due to termite damage and weakened strength. (Photo: Cummings and McCrady Architects)

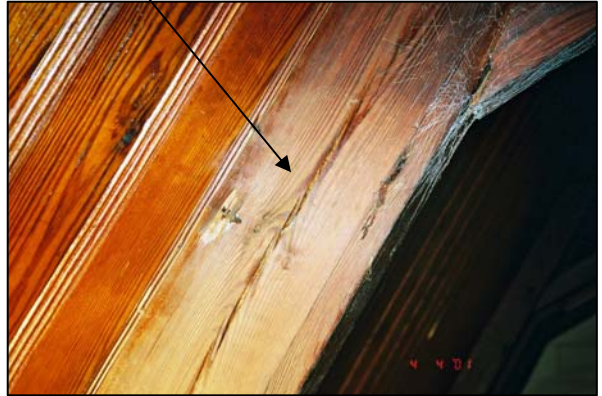
Figure 126. Cracking and separation of wood in roof truss due to termite damage. (Photo: Cummings and McCrady Architects)

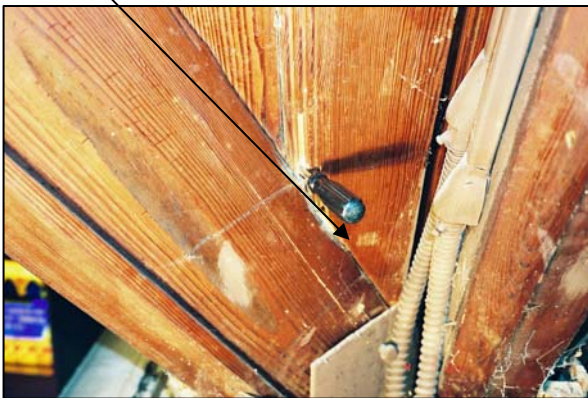
Figure 127. The screwdriver illustrates how soft the wooden roof trusses had become due to extensive termite damage. (Photo: Cummings and McCrady Architects)

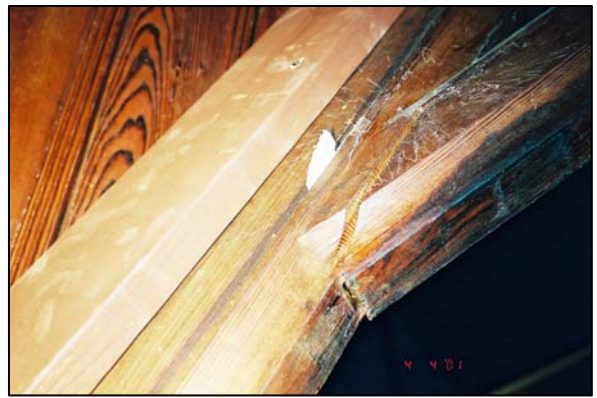
Figure 128. The arrow points to the area where the roof truss has pulled away from other wooden members because of weakened structure. (Photo: Cummings and McCrady Architects)

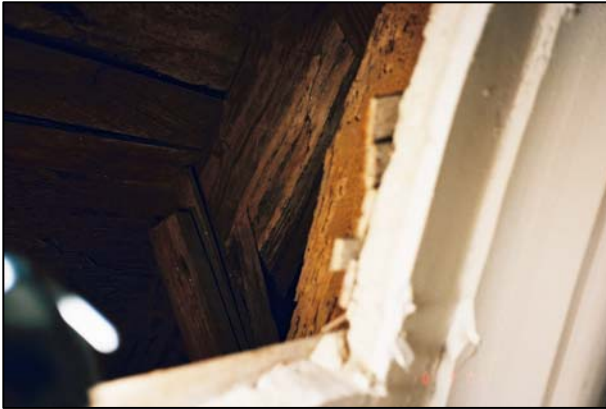
Figure 129. This is a view through a hole cut in the Chancel ceiling showing extensive termite damage in the roof structure. (Photo: Cummings and McCrady Architects)

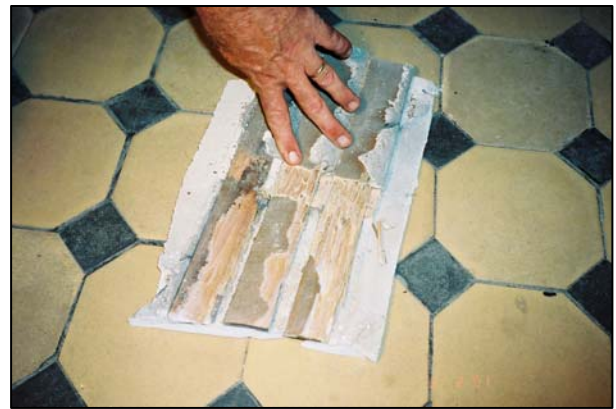
Figure 130. The piece that was cut from the Chancel ceiling shows termite trails on the wooden lath. (Photo: Cummings and McCrady Architects)

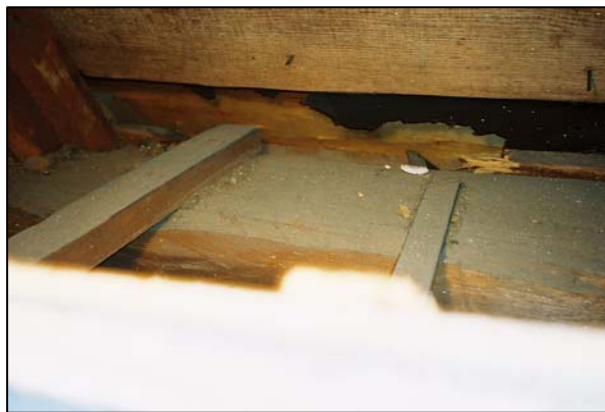
Figure 131. Another view through the hole cut in the Chancel ceiling reveals a wooden member that used to be a solid piece of wood. (Photo: Cummings and McCrady Architects)

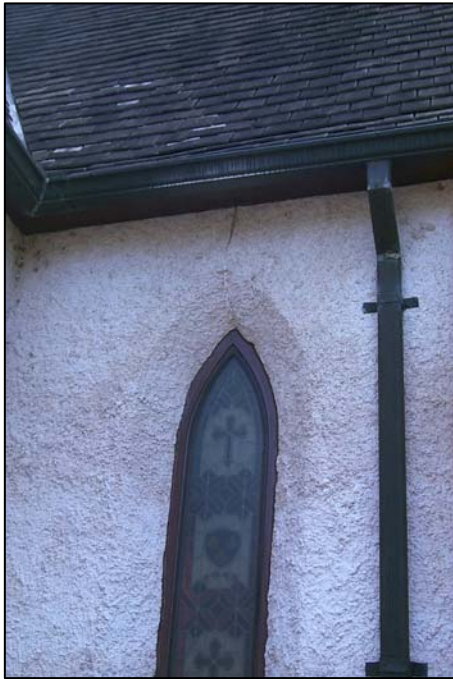
Figure 132. Cracking on the exterior render due to excess stresses from termite damage. (Photo: Cummings and McCrady Architects)

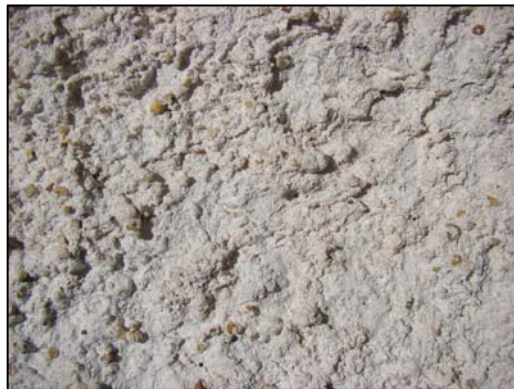
Figure 134. View of the current cementitious exterior pebble dash render. (Photo: Author)

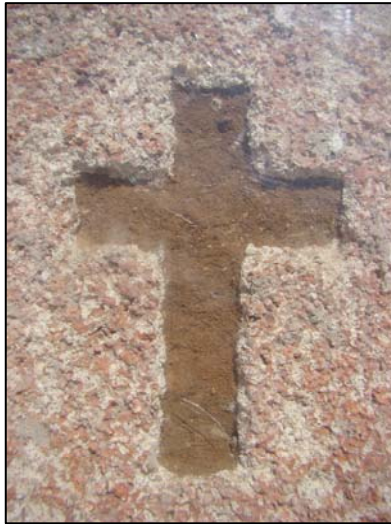
Figure 135. The original render on the Church of the Holy Cross. (Photo: Author)

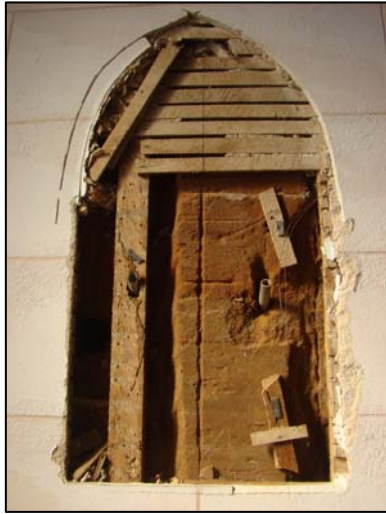
Figure 136. Area on north wall where a plaque used to be showing how modern conveniences have been installed through the pisé walls. (Photo: Author)

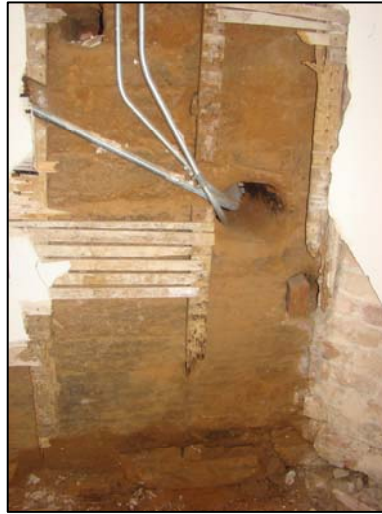
Figure 137. View of eastern pisé wall from inside the Sacristy. The hole that the metal pipes are going through goes all the way through the wall. (Photo: Author)

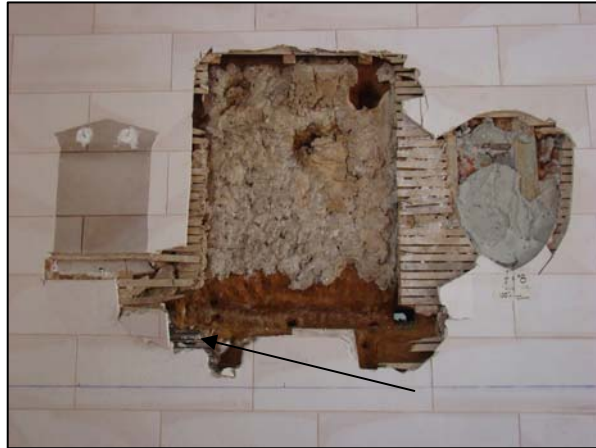
Figure 138. Area where the memorial plaques to Dr. Anderson and his two sons were previously located. Arrow points to the hole seen in plate 104. (Photo: Author)

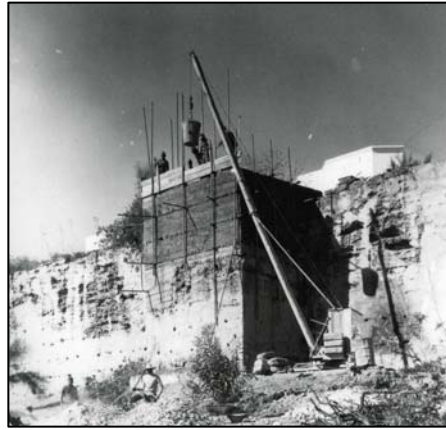
Figure 139. The Almohad walls in Tarifa, Morocco. (Photo: David Cornelius)

periods, when repairs are made or entire new walls built in Morocco, some Portland cement is incorporated into the mixture to provide extra strength.

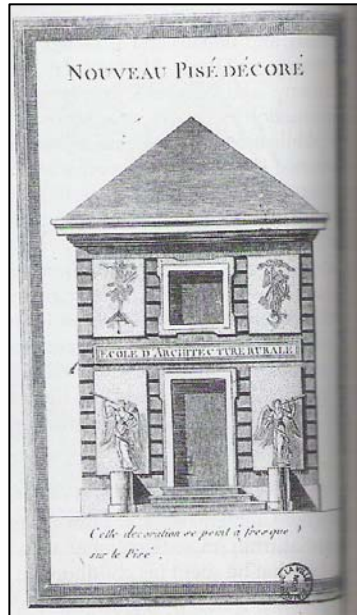
Figure A1. A design for a house to be finished with pisé décorée. (Image: Louis Cellauro and Gilbert Richaud)

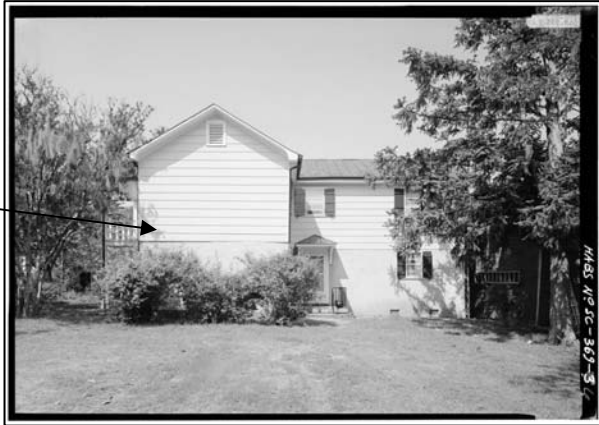
Plate A4. The addition made to the cook's house in the 1970s. Arrow points to the original portion of the cook's house. (Photo: Library of Congress)

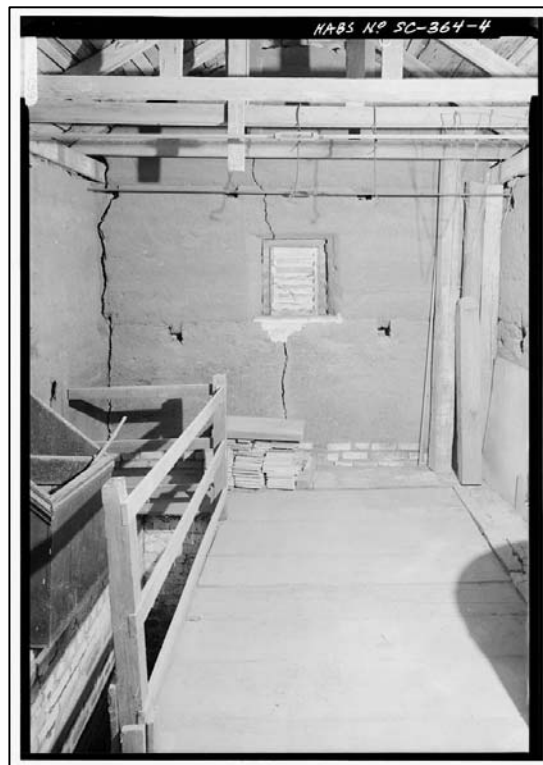
Plate A8. Interior of the dry well building with unfinished pisé walls. The stair to the left goes down to the well. (Photo: Library of Congress)

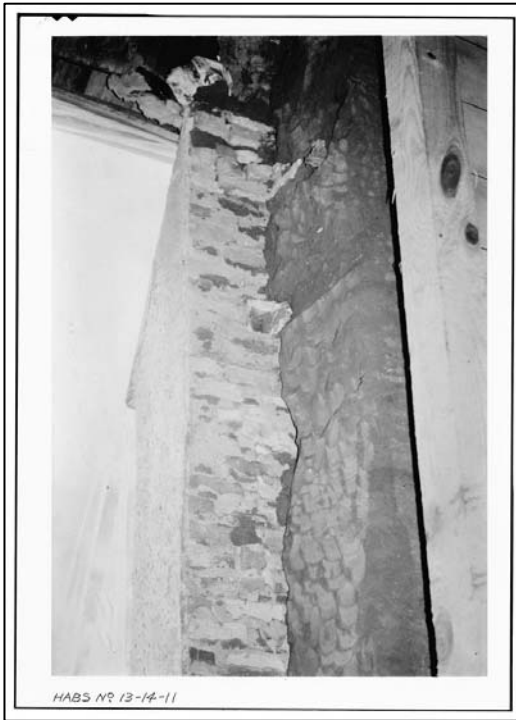
Plate A15. Original pisé walls and brick buttress exposed during the 1974 restoration. (Photo: Library of Congress)

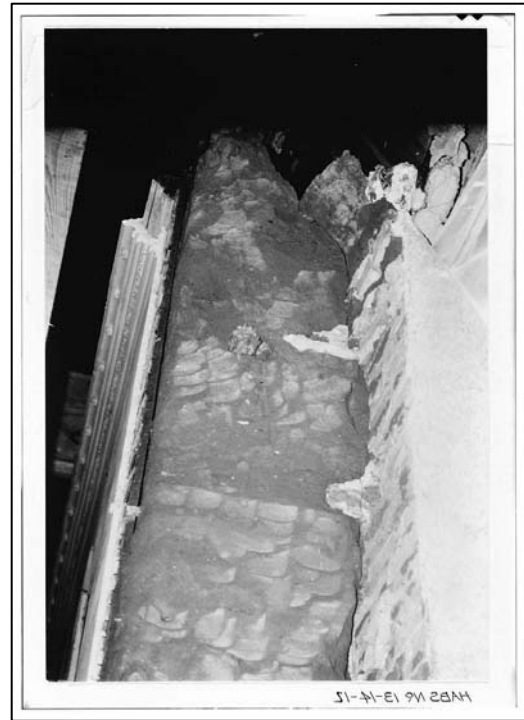
Plate A16. Original pisé walls and plaster cornice exposed during the 1974 restoration. (Photo: Library of Congress)

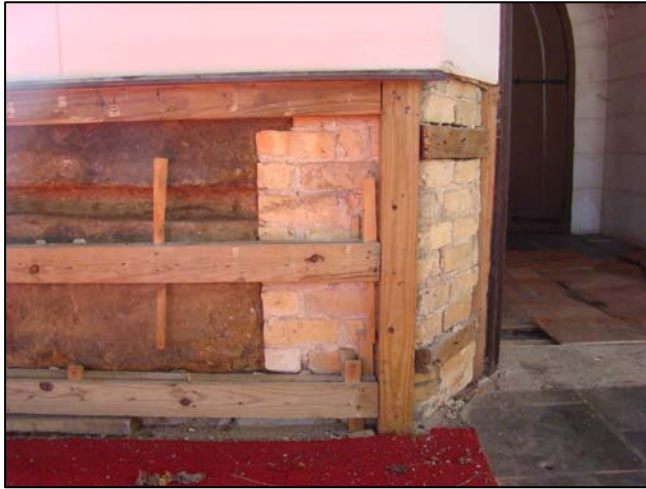
Plate A21. Brick repair made near the porch entrance on the south elevation. (Photo: Author)

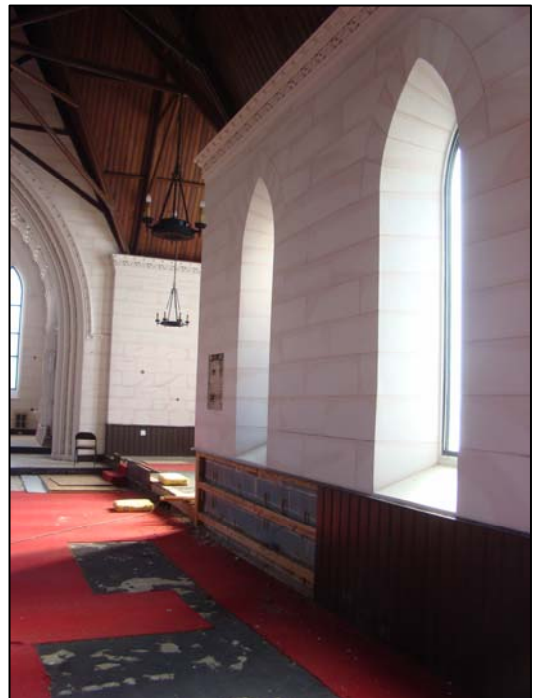
Plate A22. Concrete block repair made after the collapse of a portion of the south wall in 1974. (Photo: Author)
