# Choices of Contention: Decision Making Factors Leading to the Substitute Method Over In-Kind Repairs and Their Effectiveness at Lyndhurst Estate

CHOICES OF CONTENTION: DECISION MAKING FACTORS LEADING TO THE  
SUBSTITUTE METHOD OVER IN-KIND REPAIRS AND THEIR  
EFFECTIVENESS AT LYNDHURST ESTATE

A Thesis  
Presented to  
the Graduate School of  
Clemson University and College of Charleston

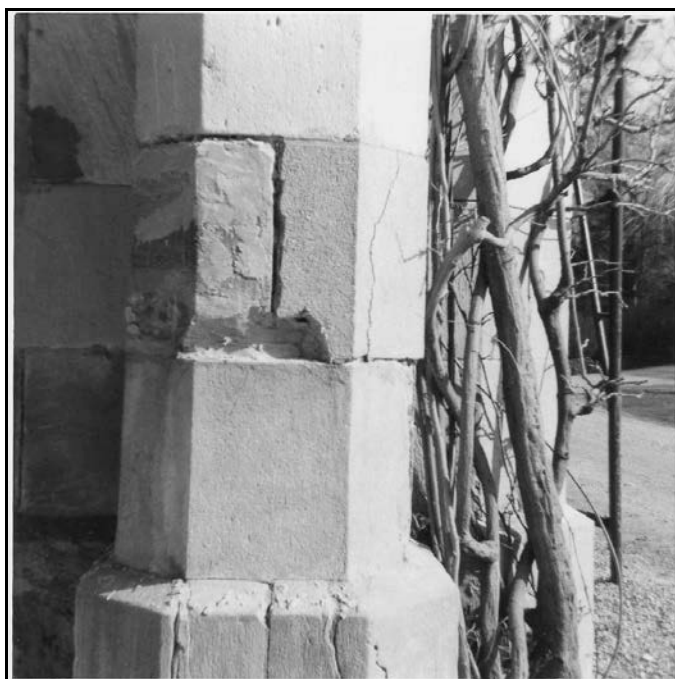
Figure 4.2: Condition of joints, 1965 (Lyndhurst Archives).

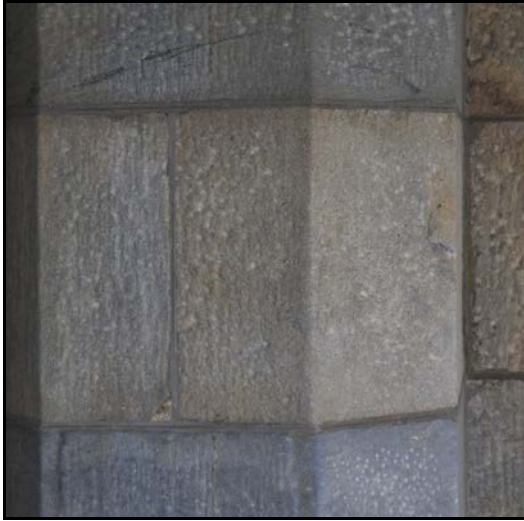
Figure 4.3: Original mortar (Photograph by author).

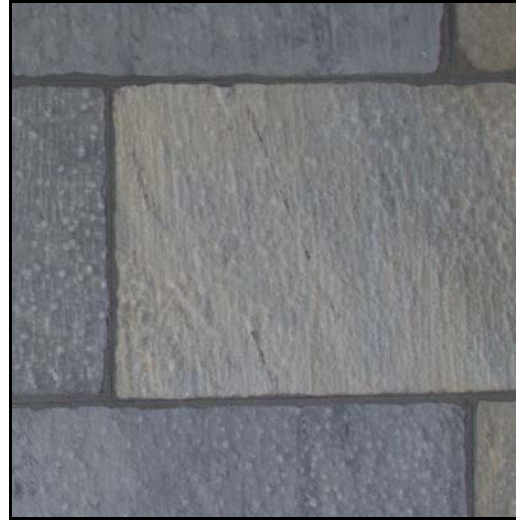
Figure 4.4: Portland cement (Photograph by author).

replacement of historic mortar (See Figure 4.4) and for the cast concrete replacement of marble repair projects.

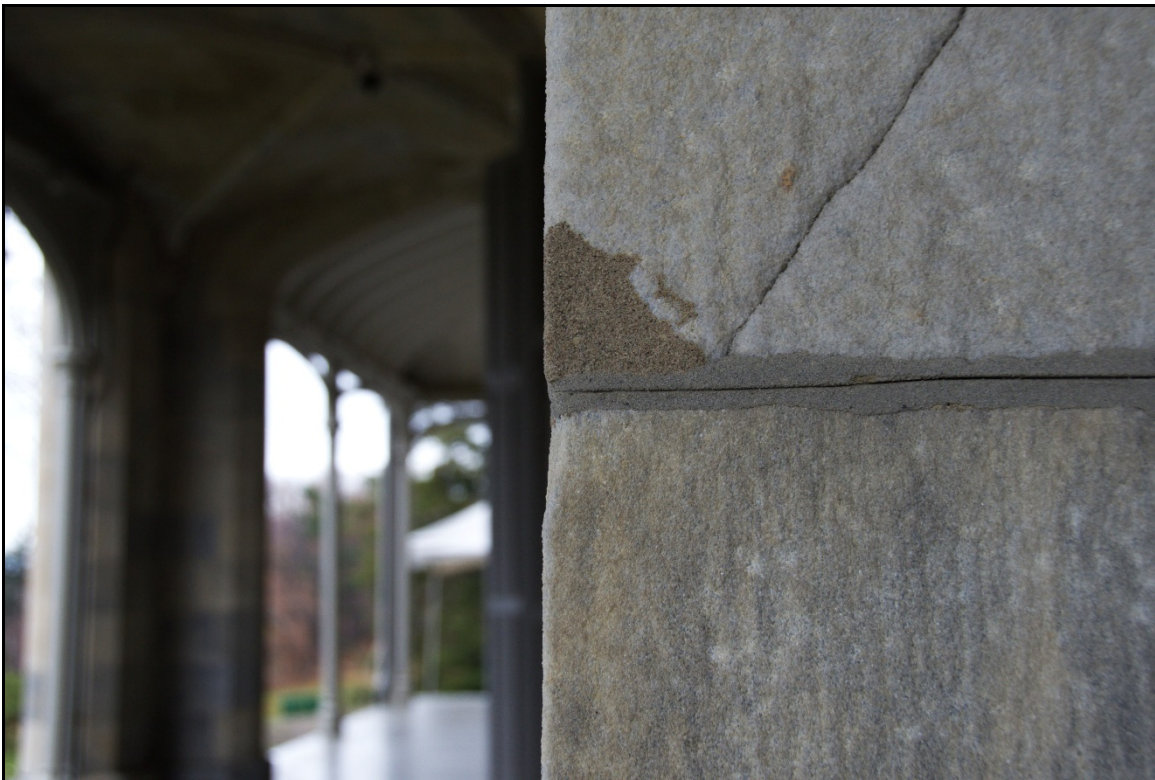
rating of 'poor' is due to cracking that was evident in some areas (See Figure 4.5). The cracking is most likely a result of the conflicting thermal expansion and contraction of the different materials and perhaps also the moisture that may be getting in. Lastly, under the subcategory of anthropogenic the rating was 'poor.' This rating is low because of the fact that portland cement was chosen for repointing. Because something softer and closer to the original mortar was not chosen, a negative impact inflicted by humans is evident.

Figure 4. 5: Detail of portland cement and resulting material loss and cracking (Photo by author).

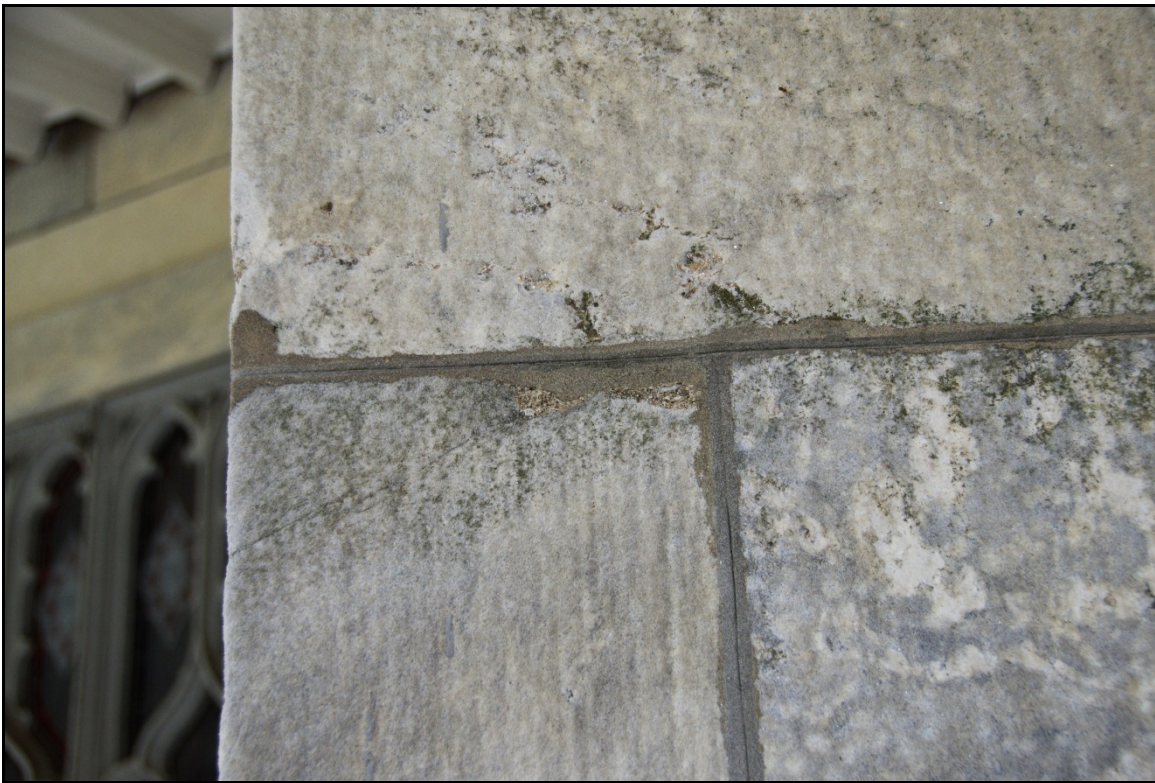
weathering. This category required a comparison of the original material to the replacement material. Under this category, the ratings again ranged from 'good' to 'poor.' The only subcategory given the rating of 'good' under weathering was biological growth. Although there was biological growth present in the form of a brown or green mold or algae (See Figure 4.6), this could be seen on areas of both the historic mortar and the portland cement. The subcategory of surface texture's rating of 'fair,' was higher because both mortars were finely grained and similar in feel when touched. However, the portland cement was noticeably harder than the original. Under the subcategory of coloring, the repair received a rating of 'poor.' The original mortar is light gray, while the portland cement is much darker and stands out from the original.

Figure 4. 6: Portland cement with surrounding patching of material loss and biological growth (Photograph by author).

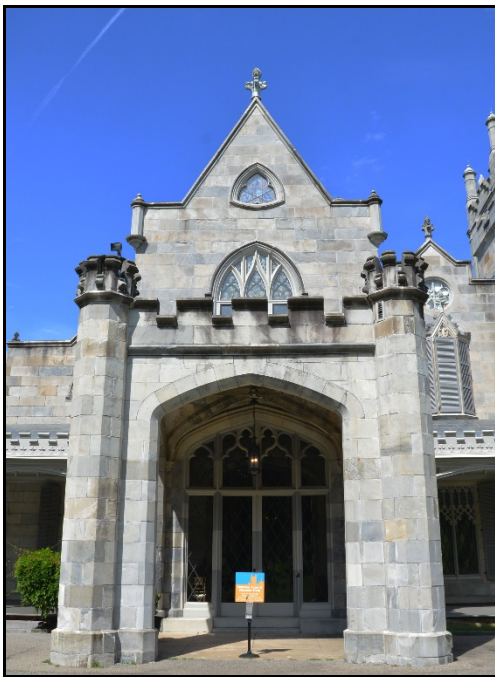
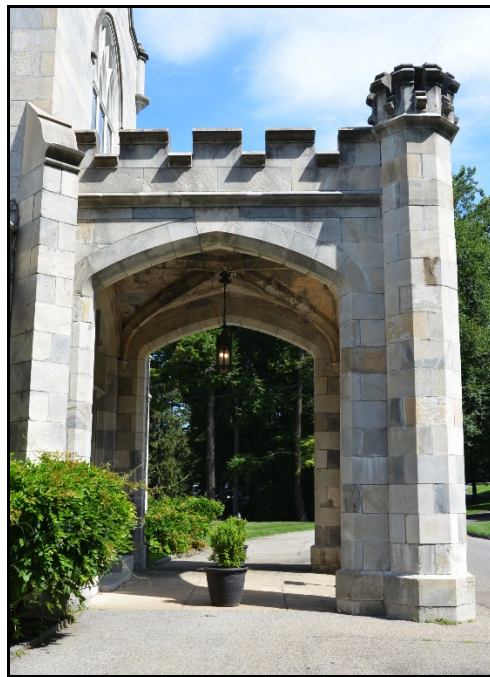
Figure 4. 7: Front of porte-cochère (Photo by author). Figure 4.8: Side of porte-cochère (Photograph by author).

A porte-cochère is defined as a, “porch large enough to admit wheeled vehicles,” in *Pevsner’s Architectural Glossary*.<sup>89</sup> Additionally, a porte-cochère is a partial enclosure functioning to provide shelter for people exiting a wheeled vehicle or a carriage which can be accommodated through its large opening. A porte-cochère was part of the initial design of the building dating back to 1838, but was later enclosed and made into a vestibule.

In order to remedy the problems with the exterior, replacement needed to be done for some and patching for the other stones in salvageable condition. Another decision dictated that the replacement units and patching repairs would use concrete, instead of original or comparable materials. The Restoration Workshop, now established at Lyndhurst for ten years, would take on the project. A master mason and a small team of Workshop participants gathered together to complete the job. There were many areas on the exterior in need of repair, but the porte-cochère was the first area the Restoration Workshop worked on.

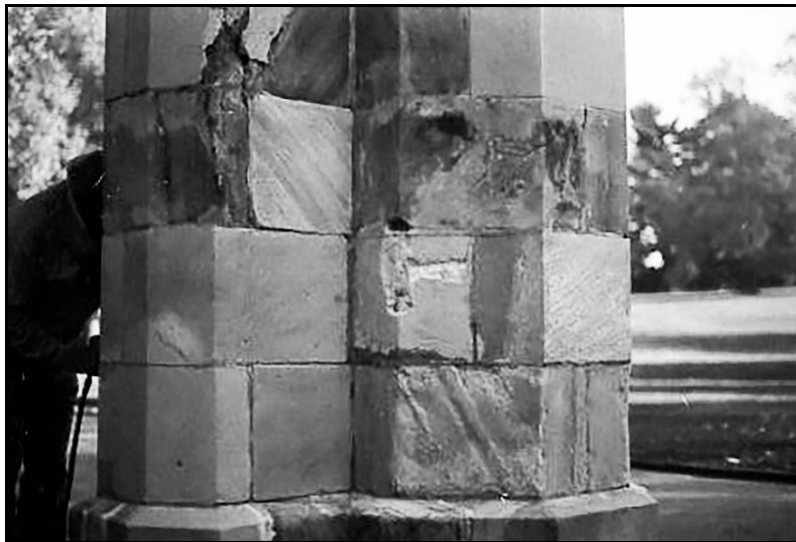
Figure 4.9: State of porte-cochère marble, 1984 (Lyndhurst Archives).

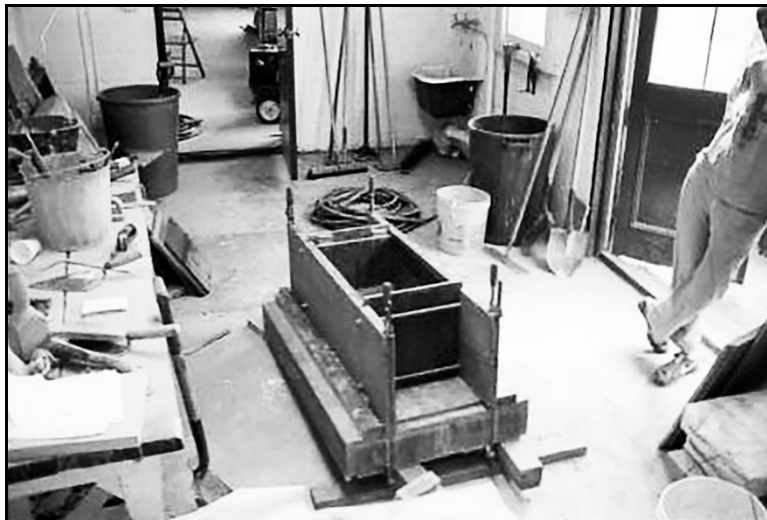
Figure 4.11: Wooden mold for casting concrete, 1984 (Lyndhurst Archives).

This decision was probably a mistake according to Workshop participant Eric Clingen, who says it would have been a better idea to start in, “the most inconspicuous areas.” It is in the porte-cochère where he feels that the worst work occurred, due to the fact that the concrete stands out from the stone. For the participants of the project it was the first time doing work such as this, so they became better as they progressed. The process for the replacement stones consisted of casting the replica’s form by pouring the concrete mixture into a wooden form (See Figure 4.11) with the aid of clay and sand. After becoming more comfortable with the process, the Workshop began experimenting with mason’s coloring and swirling techniques to recreate the details found in the marble.

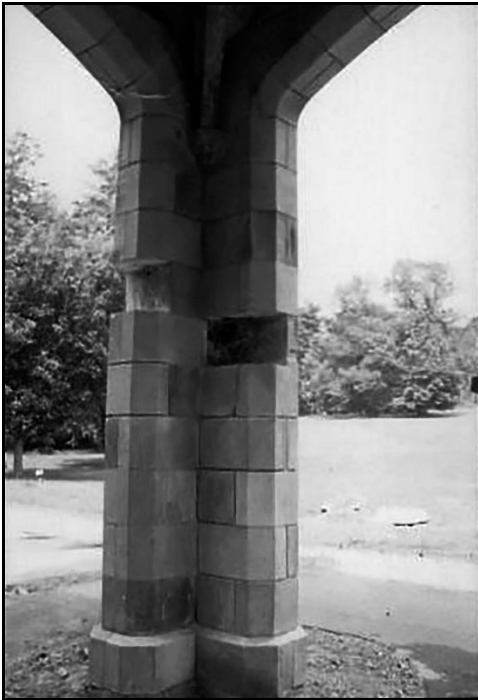
Figure 4.12: Removed Stone (Lyndhurst Archives).

place. Eric estimates that the Workshop replaced about a third of the porte-cochere's stones. The stones that were in poor shape, but not deteriorated enough for replacement, received patching on the surface. The same mixture employed for the cast units served for patching the stones. A masonry drill used on the surface of the stone made it more irregular for better adherence of the patching material. Once this was done and somewhat dry, the newly applied surface received tooling using a float or trowel to make faint striations to the surface.<sup>100</sup>

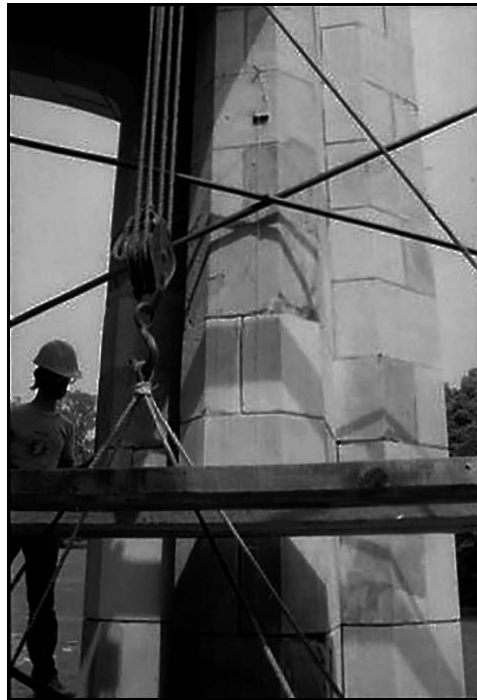
Figure 4.13: Installation of concrete (Lyndhurst Archives).

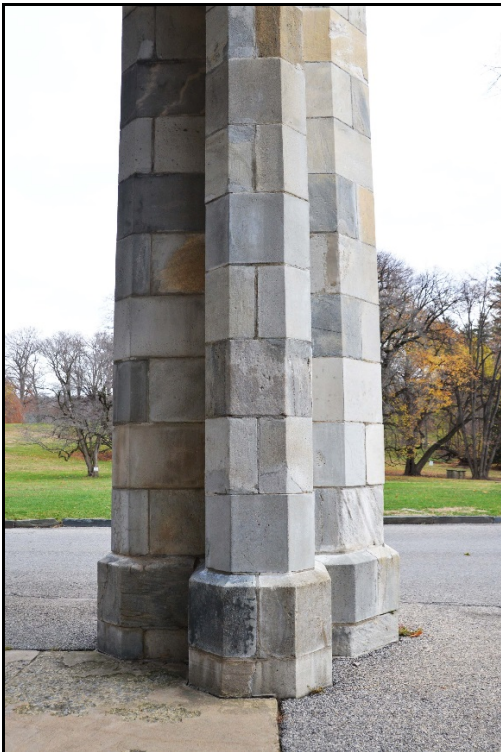
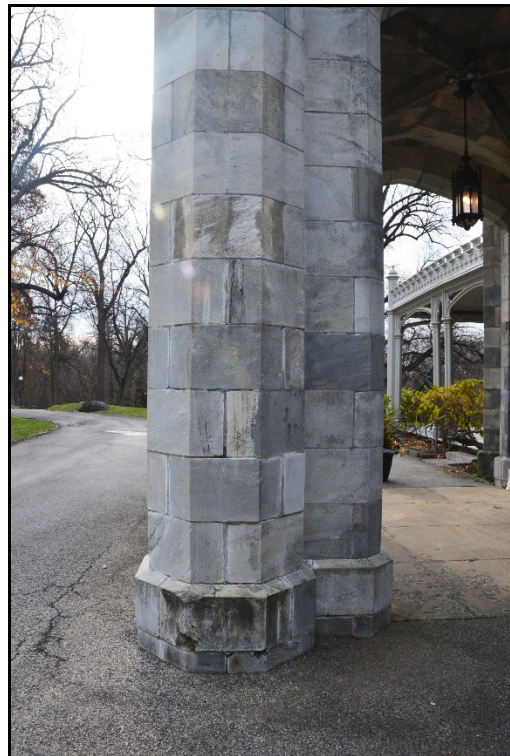
in the replacement the rating was 'poor.' This rating points to the construction techniques, because these were totally different between the stone and process for casting the concrete. In terms of details between materials the color, texture and luster found in the original stone are incomparable in the cast concrete replacements. Last, under the craftsmanship category only the question of: Are the basic dimensions the same as the original received a rating of 'good,' because the units were cast to be the exact dimensions needed to fit the area where the failing stones were removed.

Figure 4.15: West side of south porte-cochère column (Photo by author).

Figure 4.16: North side of south porte-cochère column (Photo by author).

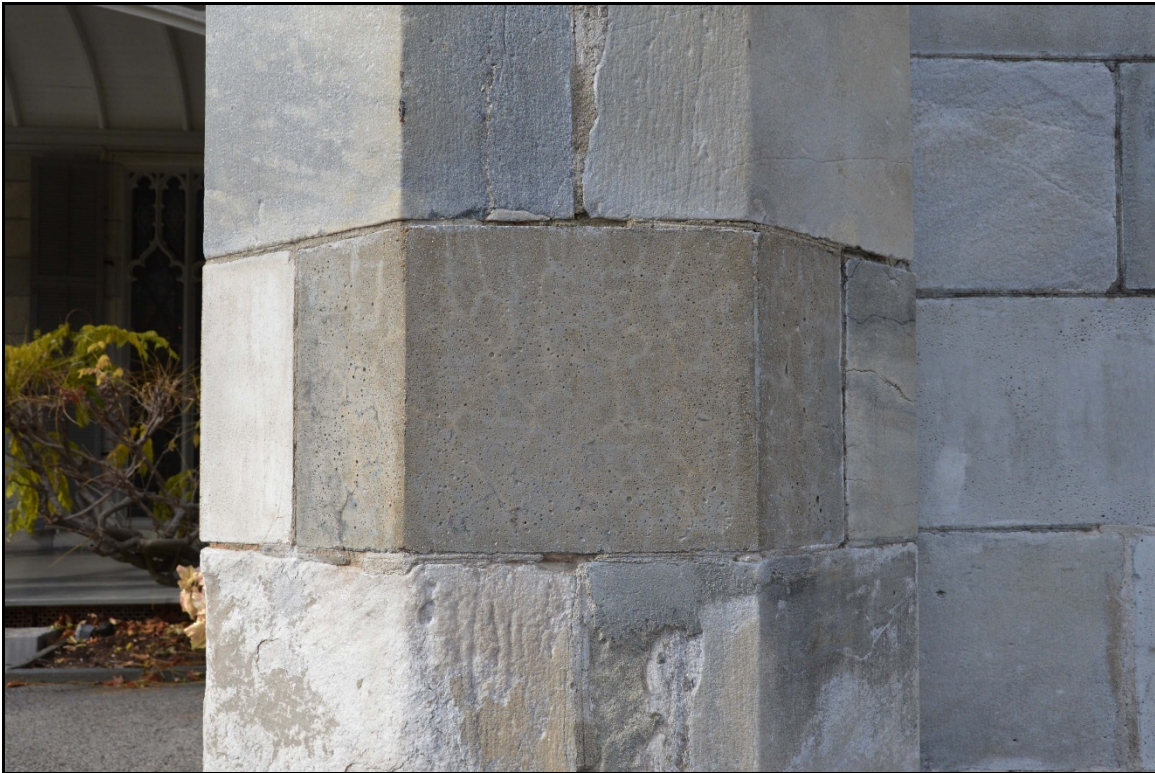
The next criteria category for the cast concrete stones was impact on surrounding materials. The deterioration and wear present on surrounding materials needed division into the subcategories of: biological, chemical, mechanical and anthropogenic. The subcategory of biological received a rating of 'good,' as there were very few signs that the cast concrete was causing any biological growth on the surrounding stone. There were areas of biological growth present on the stone, but it was on both areas next to cast concrete and areas surrounded by the original stone. This finding prevents any definite conclusion about the correlation of the cast concrete and biological growth. No signs of deterioration from chemical factors are evident, so the rating given was 'good'. The mechanical category under impact on surrounding materials received a 'poor' rating, as many areas show stone loss has occurred where the stone is adjacent to the cast concrete. Parging is evident on some of these areas, which was probably as past effort to prevent further deterioration of the area (See Figure 4.17). In the category of anthropogenic the rating was 'fair,' due to the fact that the decision to use cast concrete next to stone was not the best decision in the first place.

Figure 4.17: Detail of cast concrete and surrounding marble (Photo by author).

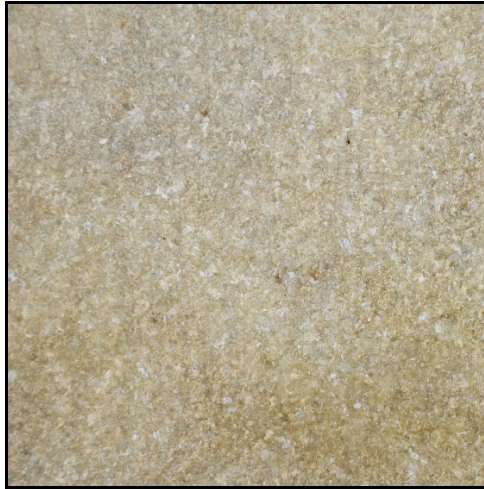
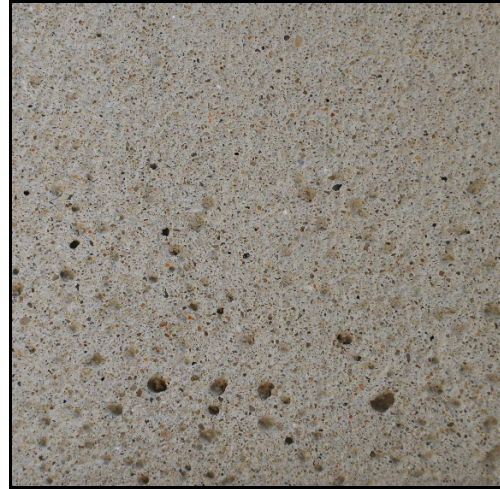
rating was low because many of the original stones have small amounts of moss or algae, none of the cast concrete units present biological growth, which further illustrates the noticeable differences in the weathering of both materials.

Figure 4.18: Detail of marble texture  
(Photograph by author).

Figure 4.19: Detail of concrete texture  
(Photograph by author).

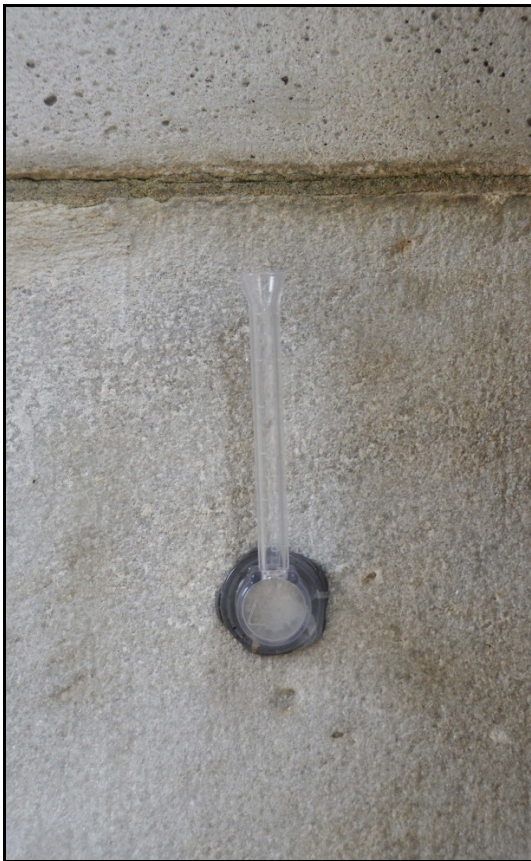
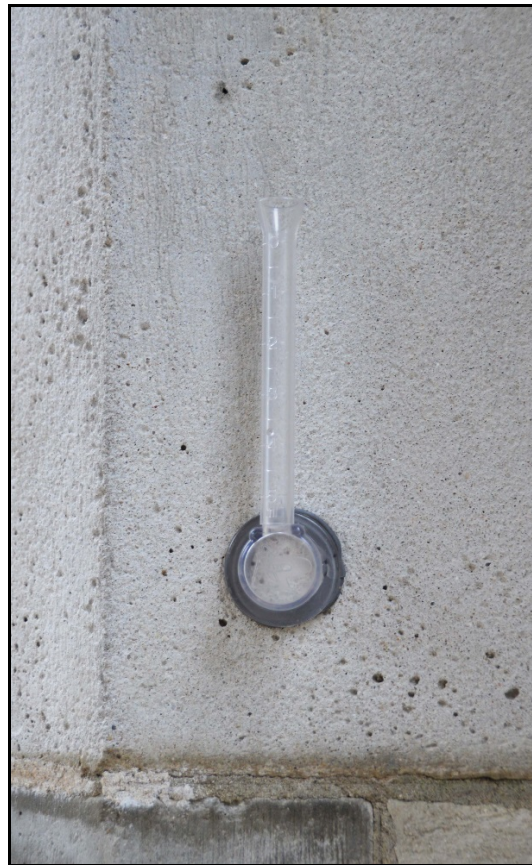
Once the completion of the project assessments and the RILEM water penetration test occurred, clear conclusions about the success of the repair project emerged (See Figures 4.20 and 4.21). For the overall score the project received three ratings of 'good,' four ratings of 'fair' and nine ratings of 'poor.' Therefore, although there were successful parts of the repair project, overall the project was unsuccessful.

Figure 4.20: RILEM permeability testing of marble (Photograph by author).

Figure 4.21: RILEM permeability testing of concrete (Photograph by author).

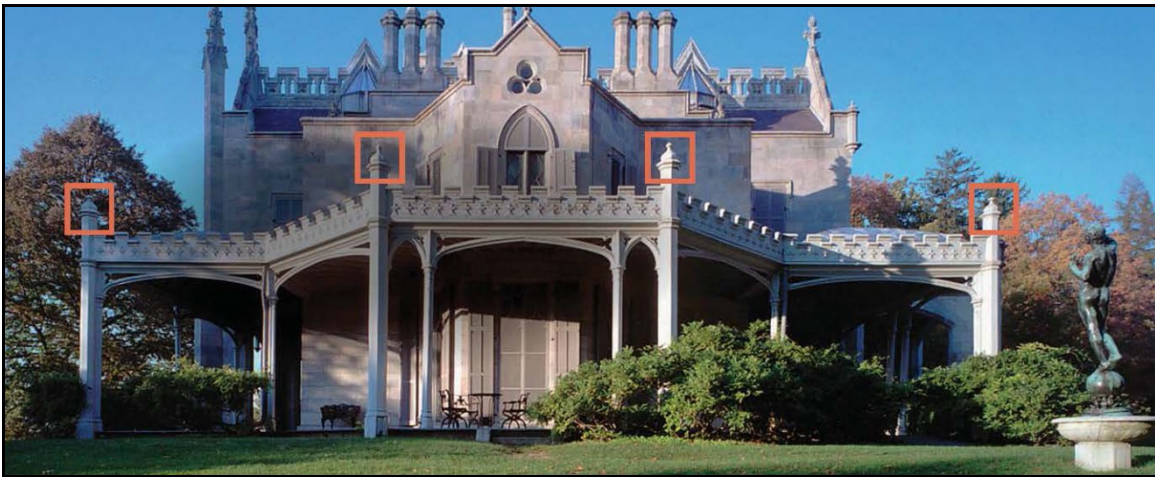
Figure 4.22: Location of mansion roof finials on south elevation (Photograph courtesy of Lyndhurst website and altered by author).

Nine finials border the roof line of the veranda on the south side of the mansion wrapping onto part of the east and west sides (See Figure 4.22). The shape is often described by Lyndhurst staff as being similar to a Hershey Kiss candy. Original colorplates provide evidence and point to installation in 1864, when the building addition occurred. A color plate from 1838 depicting the original cottage known as “Knoll” includes the veranda, but ornamentation is minimal compared to what is present on the building today (See Figure 4.23).

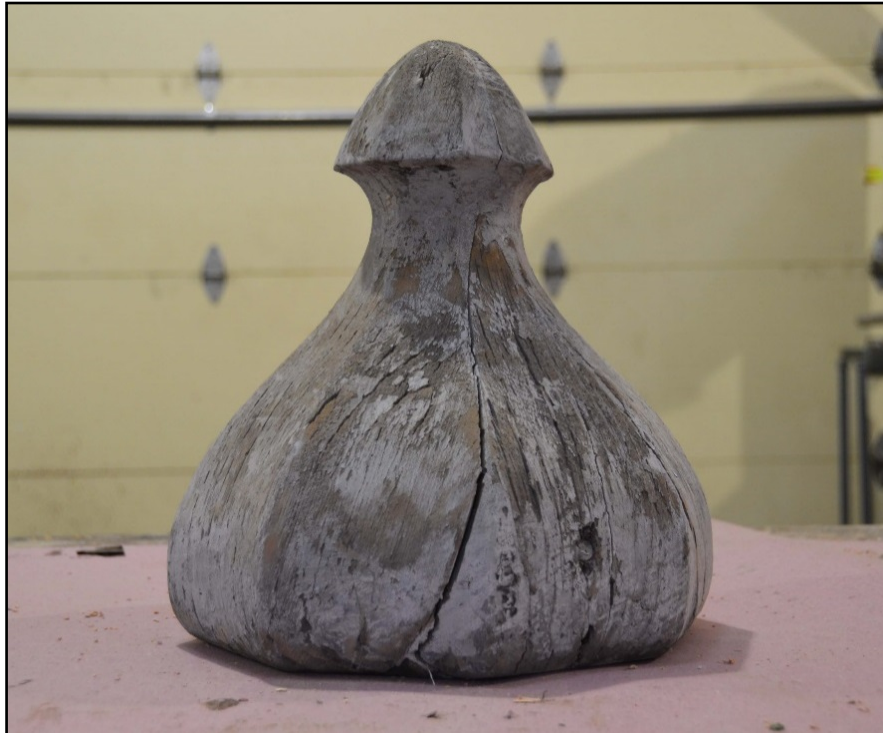
Figure 4.25: Original mansion roof finial (Photograph by author).

Although the staff at Lyndhurst initially wished to replace the deteriorated finials with replicas made from the same material, carved finials proved to be very expensive.

of the casting process, no documentation provides information on this repair to the mansion. An interview conducted with the current Assistant Director of Lyndhurst, Krystyn Hastings-Silver provided insight into the project. Ms. Silver took part in the staff decision to install the cast replicas. She stated that although the intention was to create a report detailing the process after completion, understaffing and lack of time to devote to the document lead to the delay of a report again and again.

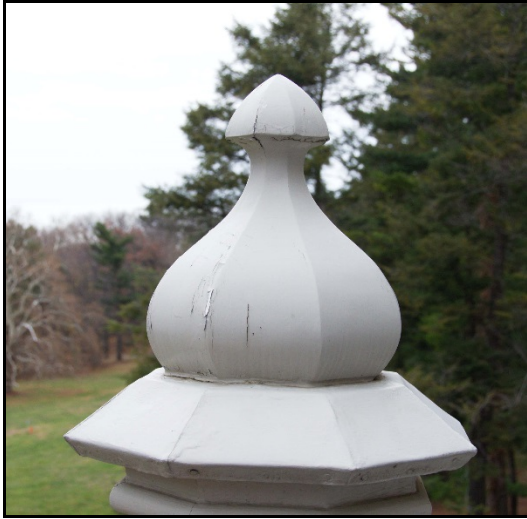
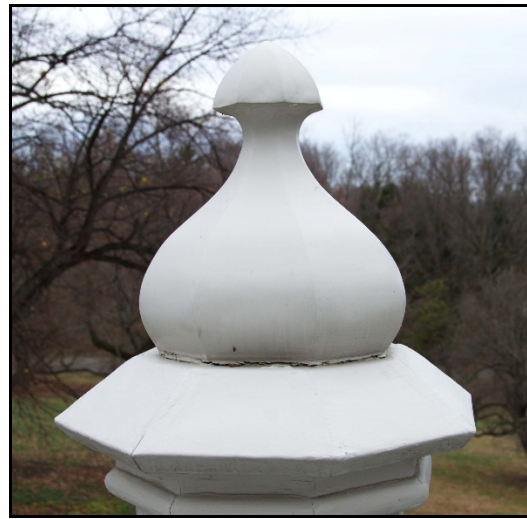
receiving little sunlight, but nothing significant. In the category of mechanical, the fasteners offered no indication of harmful impacts on the surrounding materials.

Figure 4.26: Wooden roof finial (Photography by author). Figure 4.27: Polyurethane finial (Photograph by author).

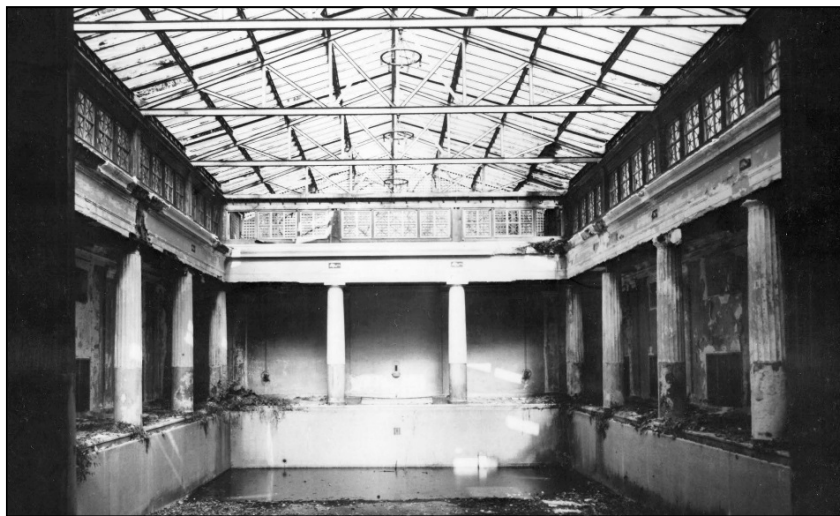
Figure 4.31: Interior of swimming pool building, 1970 (Lyndhurst Archives).

When the National Trust acquired the property in 1961, the swimming pool was in fairly good condition.<sup>112</sup> The original plan for the building was to implement an adaptive reuse and several potential plans were drawn. The unused structure deteriorated rapidly after this reuse never happened due to unknown reasons. Photos taken eight years after acquisition by the National Trust in 1970 show the fragile state of the building (See Figure 4.31). Highlighted problems mentioned in a 1979 property

development plan included, “a leaking roof, broken skylight glass, water damage to the walls and floors, unusable mechanical systems and rusted steel beams.”<sup>113</sup> The National Trust considered demolition of the building, but ultimately decided instead to save and stabilize it. In 1984, the Planned Parenthood of Westchester and Rockland donated fifteen thousand dollars to stabilize the building. Planned Parenthood leased the building for five years, in exchange for this monetary support.<sup>114</sup> The work on the building consisted of a demolition of the interior and the restoration of the flooring and roof. The roof restoration was not true however, the repair was not back to any specific time period before, which would have meant installing a glass roof. Instead, corrugated aluminum panels were installed as a cover.

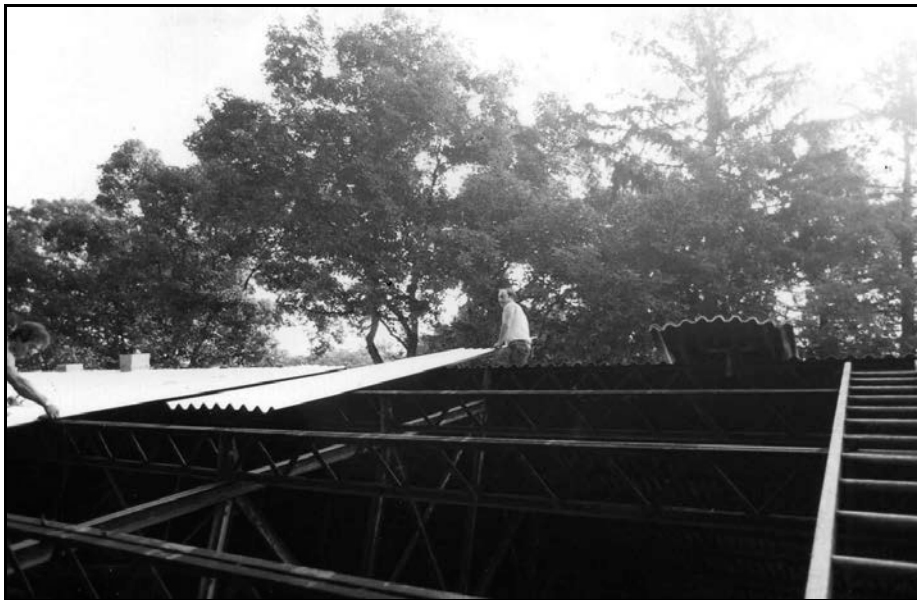
The corrugated aluminum roof cost \$23,400 and in August of 1984 installation took place (See Figure 4.32).<sup>115</sup> According to David Overholt who was the Restoration Project Manager for Lyndhurst from the years 1987 to 2003, the roof had little to no maintenance during that time and was never in need of replacement. The aluminum roof was not a permanent solution according to him, but a measure to stabilize the building to prevent further damage and water from getting inside.<sup>116</sup> A Historic Structure Report done in 1988 of the Swimming Pool Building pointed to the intention of starting the process of restoring the exterior of the building seven years later, but does not mention the roof specifically.<sup>117</sup>

Figure 4.32: Corrugated aluminum roofing installation, 1984 (Lyndhurst Archives).

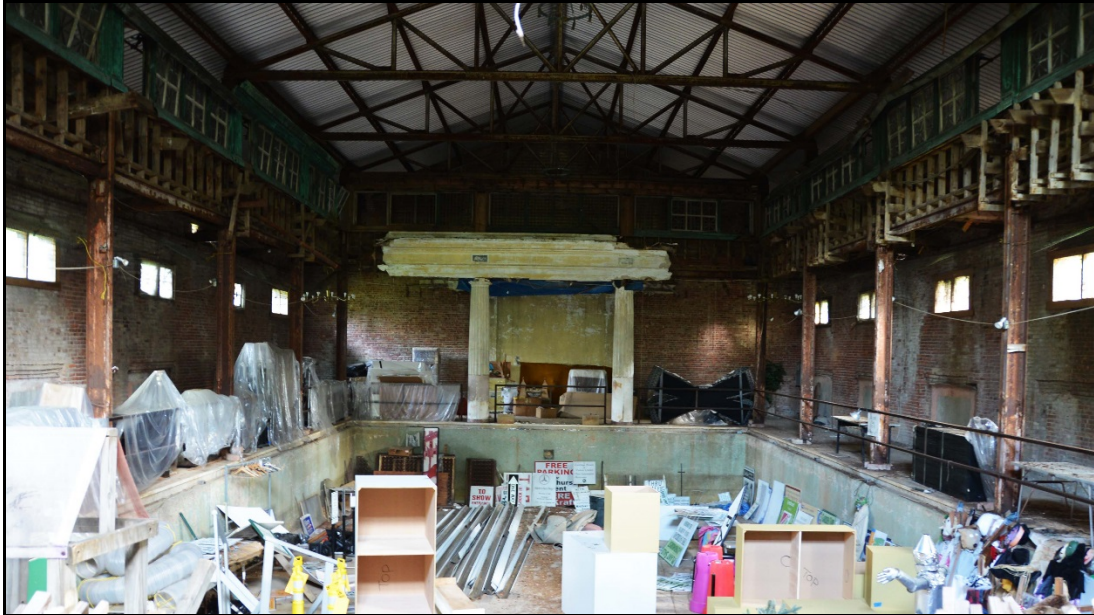
Figure 4.33: Interior of swimming pool building, 2016 (Photograph by author).

In the category of craftsmanship, the results for the roof ranged from ‘good’ to ‘poor.’ The replacement was rated as ‘good’ under the question of: Are the basic dimensions the same as the original? Although examination up close was limited due to safety, this conclusion could be made because the roof dimensions are most likely the same. The roof rating of ‘fair’ was applied to the question: Was the process labor intensive? The only somewhat laborious component related to the roof was the installation of the paneling, while the material itself was machine made. The project received ‘poor’ ratings under the following questions related to craftsmanship: 1) is it aesthetically pleasing; 2) was skill required to make it; 3) were similar construction

Under the category of impact on surrounding materials the ratings given were 'fair' and 'poor.' The deterioration and wear subcategories are: biological, chemical and anthropogenic. The fourth category of mechanical was not included due to the inaccessibility of the roofing and surrounding materials for close examination. Only the biological subcategory received the rating of 'fair.' The last two subcategories of chemical and anthropogenic received the rating of 'poor.' Biological factors affecting the materials are the access points in which plants and animals are able to enter the building. In several areas where the metal paneling reaches the plywood exterior supports or brick of the original structure, openings can be found. Plants and vines can clearly be seen on some areas of the interior, while the openings also suggest the straightforward entry inside for small animals such as squirrels and birds (See Figure 4.35).

The final category of weathering was ultimately left out of the scoring of the project, as again, the roof and surrounding materials could not safely be accessed for close inspection. After adding up the overall rating numbers, the project received three ratings of 'good,' two ratings of 'fair' and five ratings of 'poor.' The scoring clearly indicates that this project cannot be considered successful. It should be noted however, that it was meant to be a temporary solution and remains unchanged due to unavailable funding which would provide the appropriate replacement of the corrugated metal roof paneling with glass or at least a more protective option.

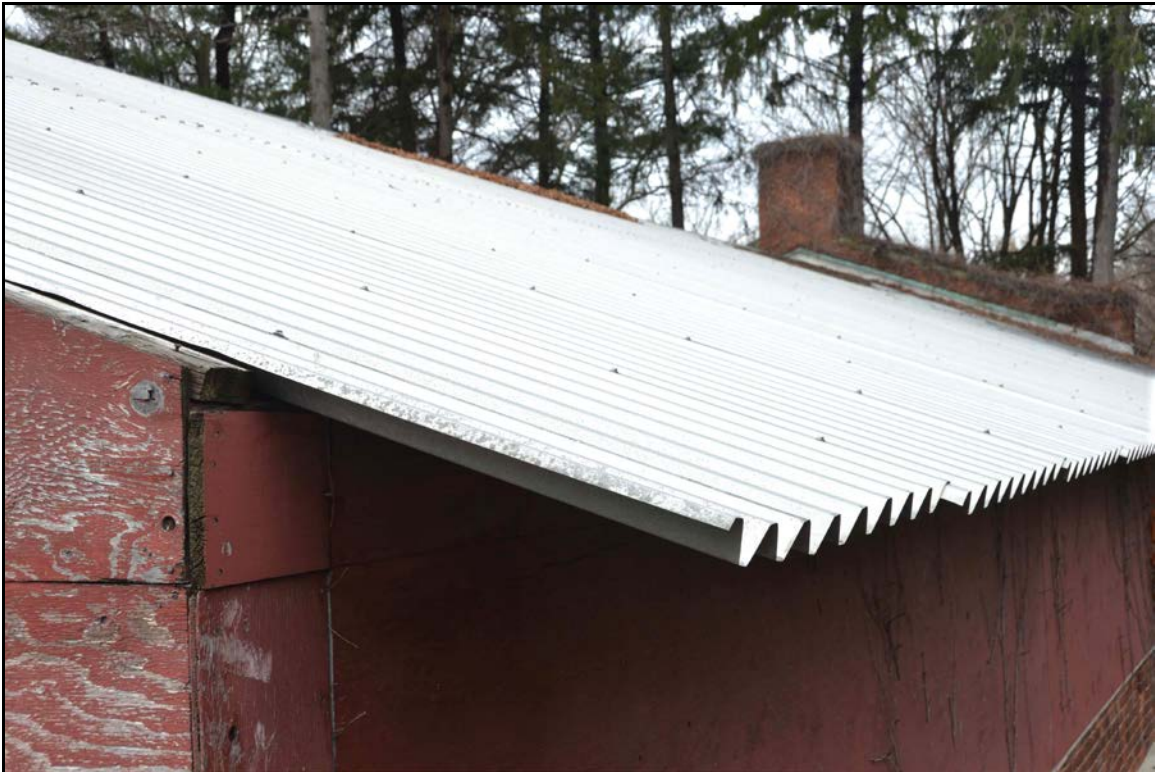
techniques used; and 4) are the details of the original present in the replacement? The metal paneling is clearly not an aesthetically pleasing choice and glass and metal are two totally different and incomparable materials. Construction and skill behind the materials is also very different. Similar details cannot be considered, because of the transparent properties of the glass and the undulating characteristics of the metal paneling (See Figure 4.34).

Figure 4.34: Detail illustrating condition of corrugated aluminum roofing, 2016 (Photograph by author).

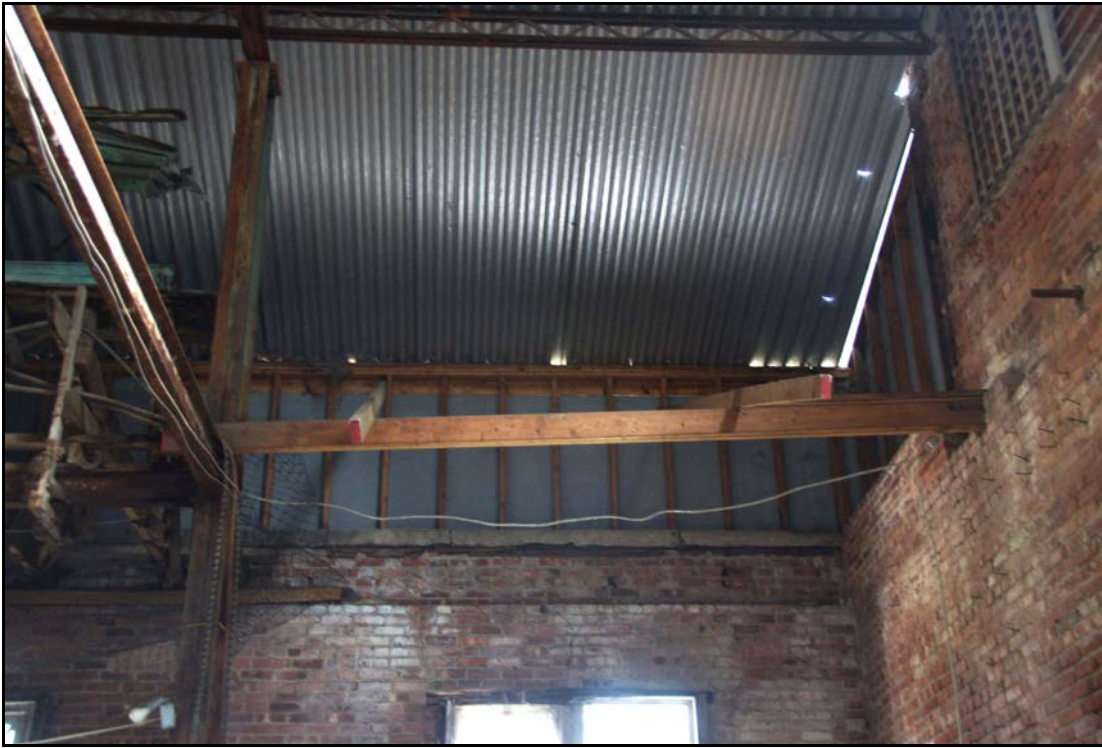
Figure 4.35: Detail of openings present in roofing, 2016 (Photo by author).

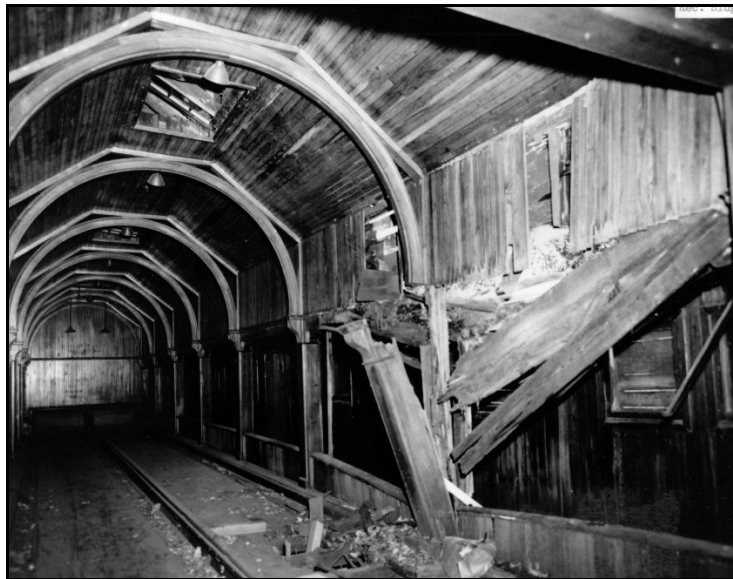
Figure 4.39: Interior of bowling alley before restoration (Lyndhurst Archives).

When the Trust took over the Estate in the 1960s, the bowling alley was already in bad shape (See Figure 4.39). Time and money dictated when the completion of repairs occurred during this period. The restoration of the bowling alley started in the mid 1990's. The efforts of research, investigation and documentation took precedent

during this time in preparation for the repairs to the building.<sup>124</sup> A new shingle cedar roof was among the first of the priorities, which happened in 1995.<sup>125</sup> It was not until 2009 however that other priorities were addressed when limited funding provided a chance to start on the restoration.<sup>126</sup> The second phase of the restoration received funding from a combination of sources. According to Thomas Richmond, the current Restoration Project Manager, a combination of private donors and state grants funded the last phases. Mr. Richmond oversaw the final phases of the building restoration, which started during the summer of 2014 and was finally completed in July of 2016 with the help of interns (See Figure 4.40).<sup>127</sup>

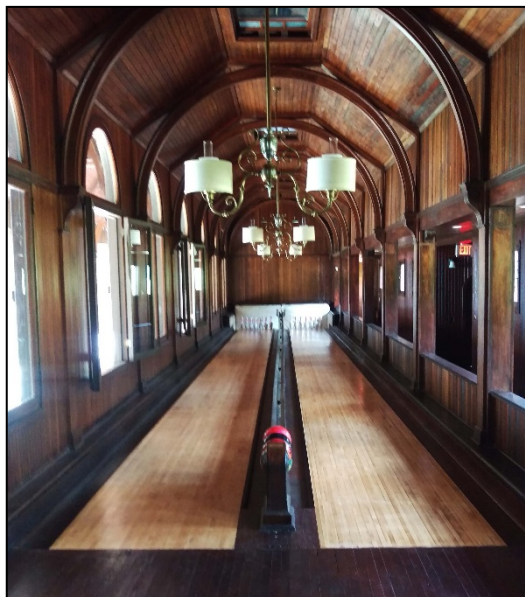
Figure 4.40: Interior of bowling alley, 2016  
(Photograph by author).

Two sizes of decorative brackets are part of the original features adorning the inside of the bowling alley. Of these, two large and seven small brackets were missing or in an unusable condition. The large brackets sit at the ends of large wooden arches equally spaced, framing the two bowling lanes from start to end. The arches ended at a column on their east side which contains two smaller brackets attached to the columns on each side. These small brackets frame the column in the top corner of the north and south ends. Both of the bracket types are hand-carved and incorporate a spiral design. The wood type of the brackets is poplar, according to Thomas Richmond. The brackets are fairly simple, but charming and add to the overall aesthetic quality of the bowling alley interior. Because of this, the brackets are character defining features of the building.

The decision to replicate the brackets by casting them came only after receiving a quote on the pricing to replicate them in wood. Initially, Lyndhurst approached the same person who recreated the mantel piece in the north parlor about replicating the missing brackets. According to the quote given, the small brackets would cost eight-hundred and fifty dollars, while the large brackets would cost one-thousand, one-hundred and fifty dollars each to replicate in wood. Since this was a large expense for Lyndhurst, the staff decided to try replicating them in a different material by casting.<sup>128</sup> The product Smooth-On 300 was already on hand at Lyndhurst, because of its use previously for the mansion finials located on the mansion veranda's roof. In the summer of 2016, Thomas Richmond and four summer interns took on the replication of the brackets using this product. The effort resulted in two large and seven small polyurethane replicas of the brackets.

alley. The use of stainless steel screws to attach the brackets to the interior of the bowling alley marked the completion of the project in July of 2016 with the help of summer interns.

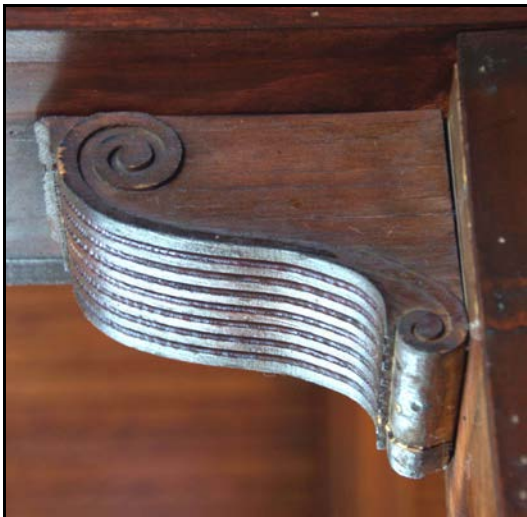
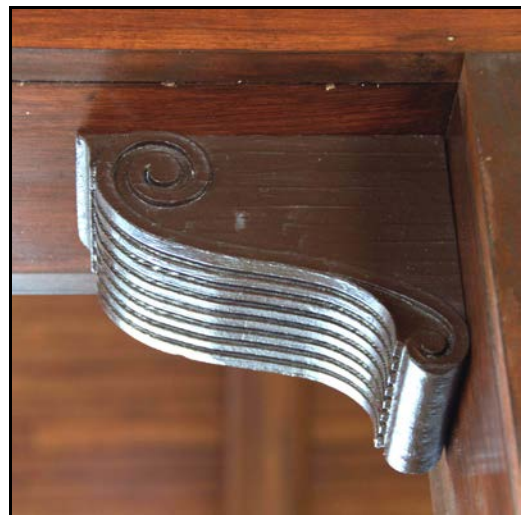
in the replacement? The replacement brackets are exact replicas of the original bracket form and therefore are nearly as aesthetically pleasing as the originals in wood (See Figures 4.43 and 4.44). The dimensions and details of the replica and original are the same because of the precision that casting allows. The rating of 'fair' applied only to the question: Was skill required to make it? Although casting requires skill and a certain amount of work and practice to master, it is a very different skill set than wood working. The last rating of 'poor' applied to the questions of: 1) was the process of producing labor intensive; 2) and were similar construction techniques used? Because this question required comparison to the original it can be concluded that the process is not as laborious as carving the bracket from wood. Similarly, construction techniques used are very different.

Figure 4.43: Original wooden bracket (Photo by author).

Figure 4.44: Polyurethane bracket (Photo by author).

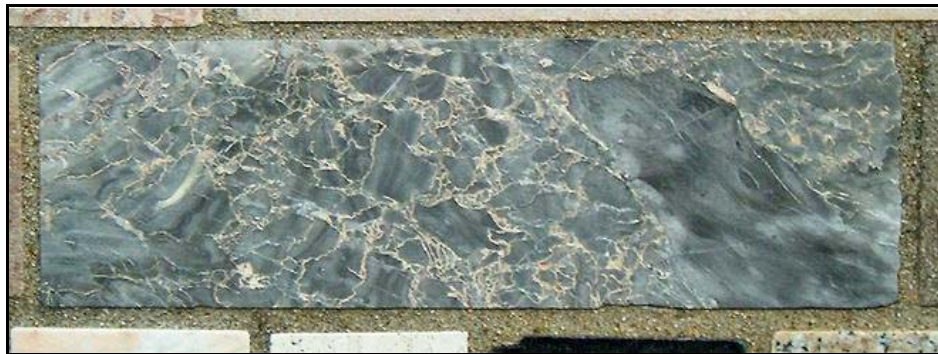
Figure 4.48: NIST Test Wall entry photo for Sing Sing marble (Courtesy of NIST website).

Upon inspection of the online database, the same marble used on the portecochere of the mansion of Lyndhurst was found. The Sing Sing marble entry, wall specimen number 11B24, contains a picture of the stone located on the wall, however the website states that a picture of the archival stone is unavailable. Both pictures would be helpful for comparison and drawing conclusions, unfortunately the indoor sample is not accessible. The photo of the Sing Sing marble on the wall seems to be different in appearance in terms of color and veining than the mansion marble. It does appear to be in fairly good condition after seventy years, however (See Figure 4.48).<sup>174</sup>
