Mission (66) Accomplished: The Cost of Retaining Historic Integrity in a Mission 66 National Park Service Visitor Center

A Thesis
Presented to
the Graduate School of
Clemson University
and
The College of Charleston

In Partial Fulfillment
of the Requirements for the Degree
Master of Science
HISTORIC PRESERVATION

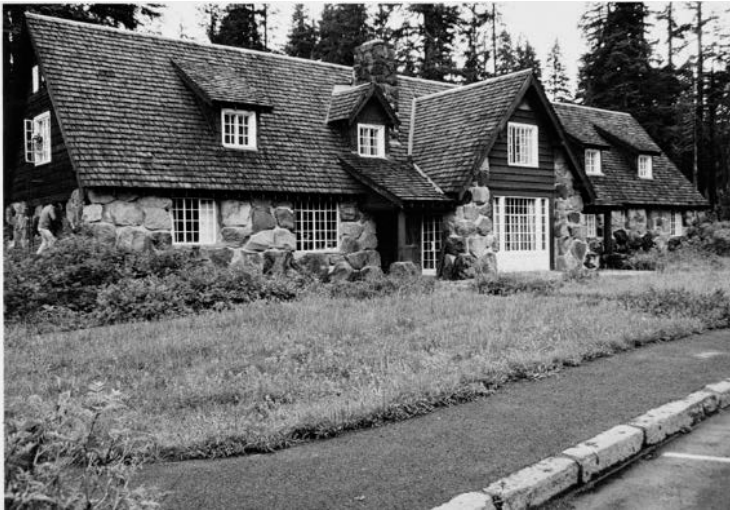
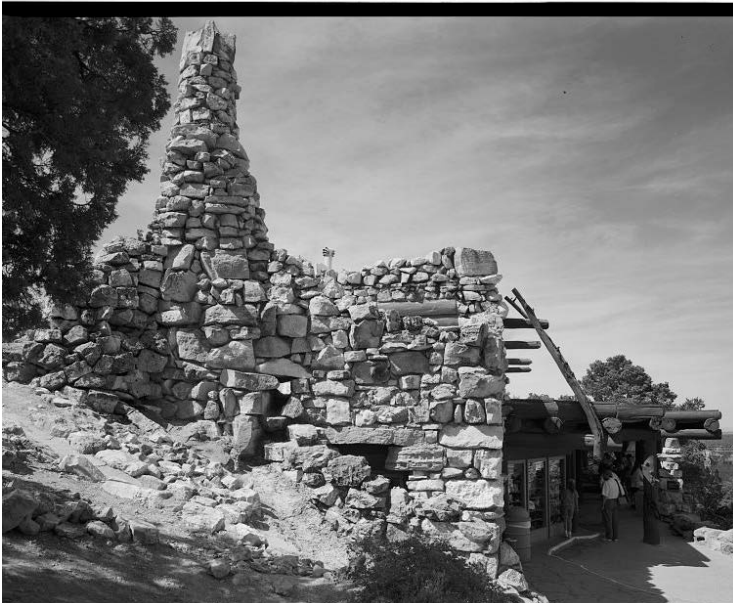
Figure 3.1 Examples of Parkitecture at Crater Lake (top) and Grand Canyon (bottom). Two different environments, yet easily identifiable as Parkitecture. Courtesy of the Library of Congress HABS Collection.

majority of early National Parks were out West, buildings evoked images of life on the frontier. Early examples of buildings in Parks relied on the use of natural materials such as heavy timbers or rocks to blended in as much as possible with the surrounding landscape. Initially this was unplanned, as “government buildings usually were limited to primitive, vernacular expressions of facility need. Crude frame shacks, log cabins, or tent

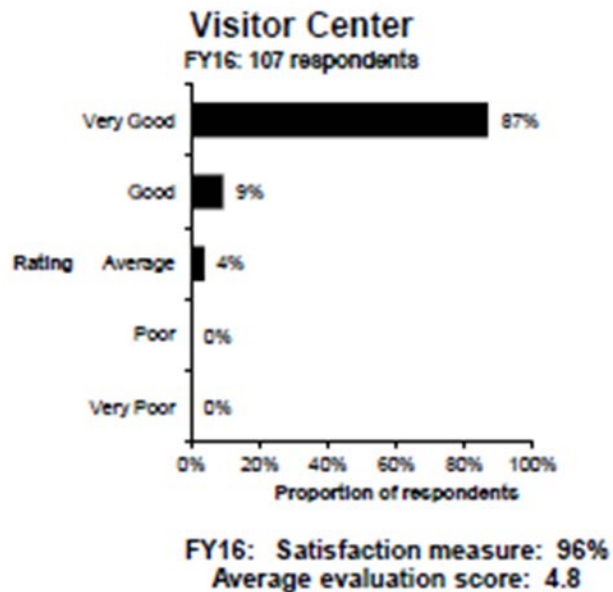
Figure 4. 1.. Portion of Visitor Survey Card with Visitor Center response data.

Customer satisfaction surveys were all drawn from the NPS's Integrated Resource Management Application's (IRMA) Data Store.²⁴ Customer surveys from 1998-2017 are available for all units. Of special significance in the surveys is a portion where visitors

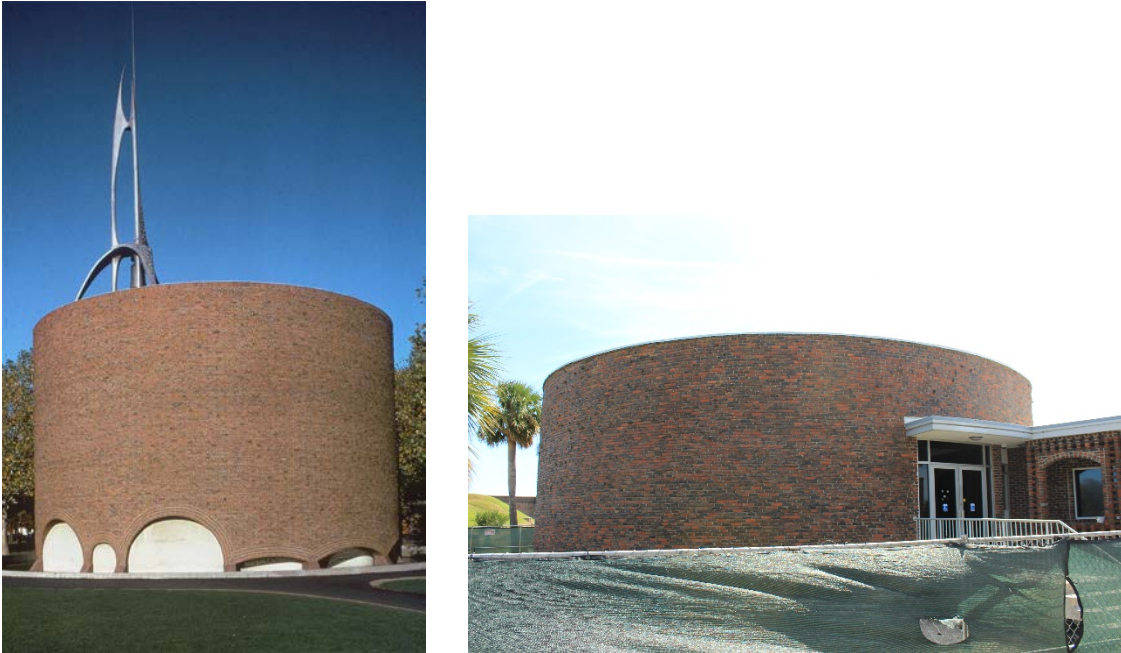
Figure 5.3 Kresge Chapel (L) and Ft. Pulaski visitor center (R). The visitor center is fenced off to assess and repair damage suffered during a tornado. Kresge Chapel photo courtesy of the Library of Congress, Visitor Center is author photo.

The Fort Pulaski visitor center is a cylindrical brick building with a flat roof which drew inspiration from Eero Saarinen's³⁶ Kresge Chapel at the Massachusetts Institute of Technology.³⁷ In keeping with the aspirational goals of Mission 66 design, the use of brick is a strong tie-in to the massive brick structure that is the fort. To more

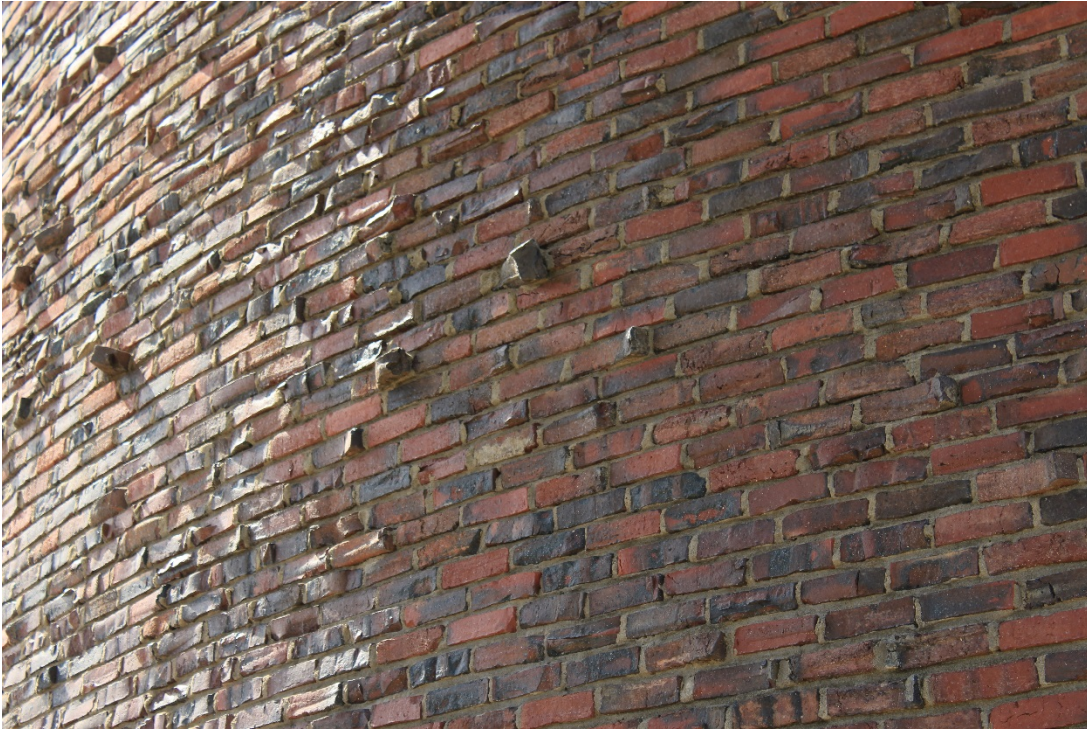
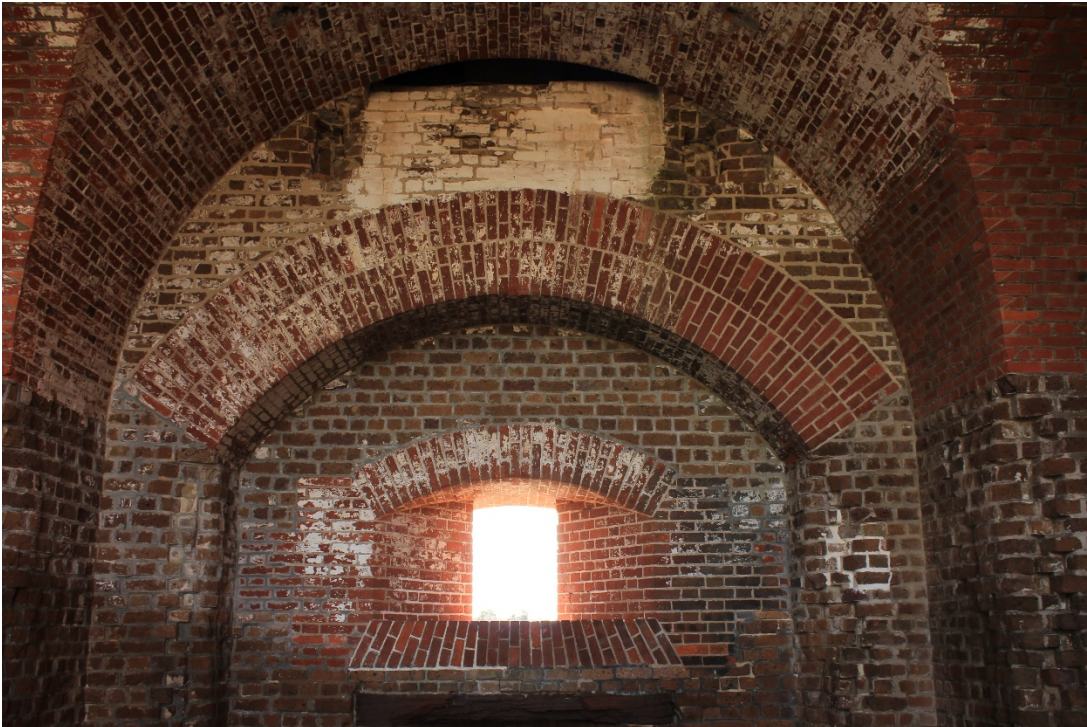
Figure 5.4 Comparison of brickwork at Ft. Pulaski. Visitor Center (top), and inside one of the fort's casements. (bottom). Author photos.

closely resemble the site it represents, initial color and texture specifications of the bricks were created from one of the fort's bricks taken from the foundation.³⁸ Further color selections during correspondence in the initial planning stages make references to the color of the women's dormitory at the University of Pennsylvania in Philadelphia which was another of Saarinen's buildings.³⁹ The only external feature (originally) which was non-brick was the use of angular metal sunshades on the rear of the building, relative to the entrance.

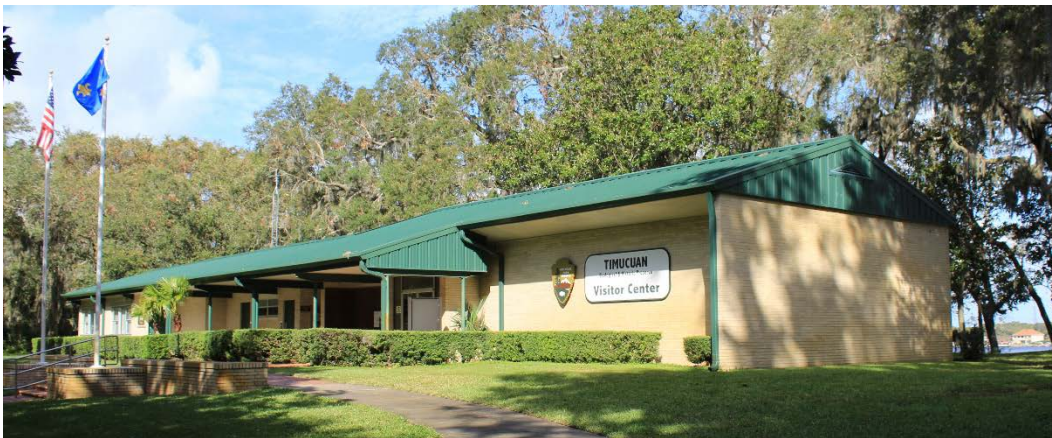
Figure 6.3 Timucuan Visitor Center as it currently looks.

At the time of the first renovation campaign, the building had a flat roof with was a visual characteristic of many of the Mission 66 visitor centers in the region. An addition was built onto the west end of the building for greater square footage for work areas and visitor services. This initial campaign did match the original building stylistically, matching the brickwork and flat roof. The second campaign however, did not. Because of leaks in the roof, it was replaced in 2002 with an angled roof. Because the visitor center was still less than the fifty-year threshold for National Register eligibility this design change was made.

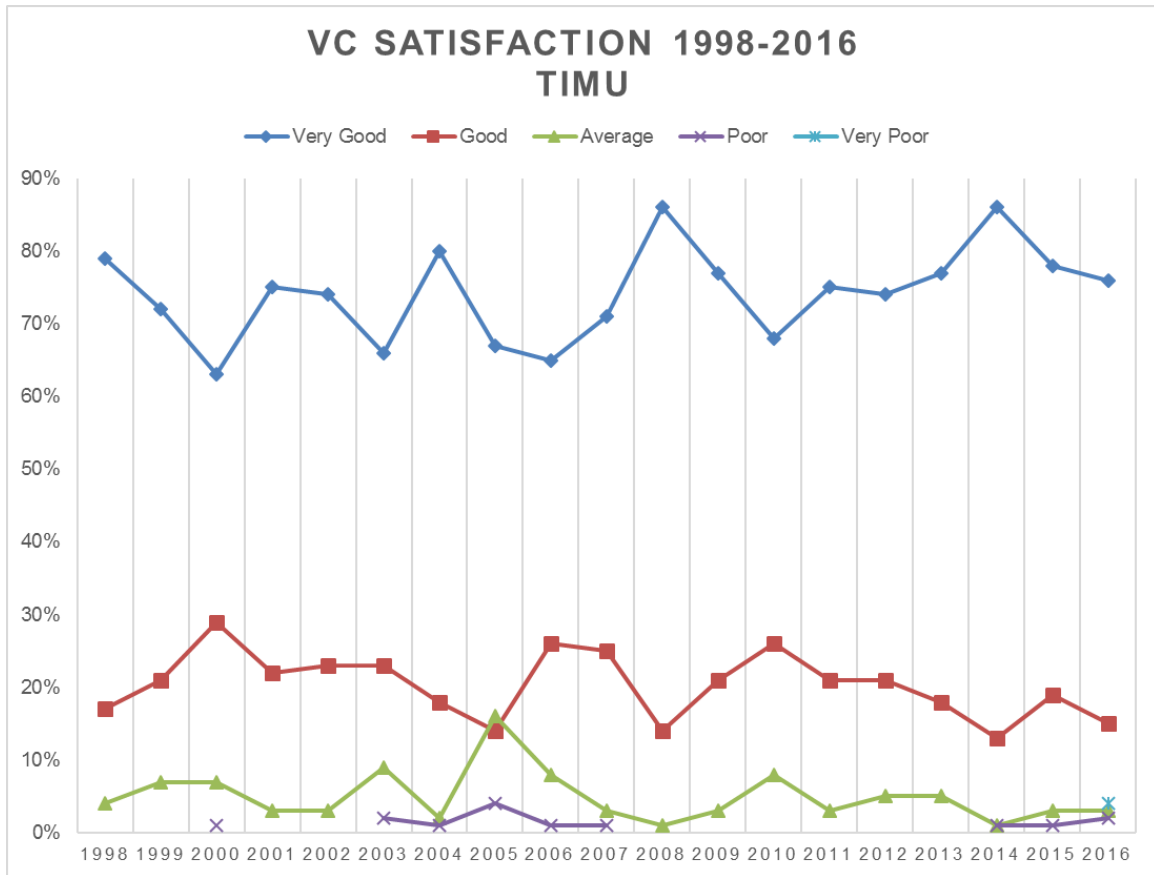
Table 6.4 Timucuan Visitor Survey Card data responses when asked to rate the visitor center.

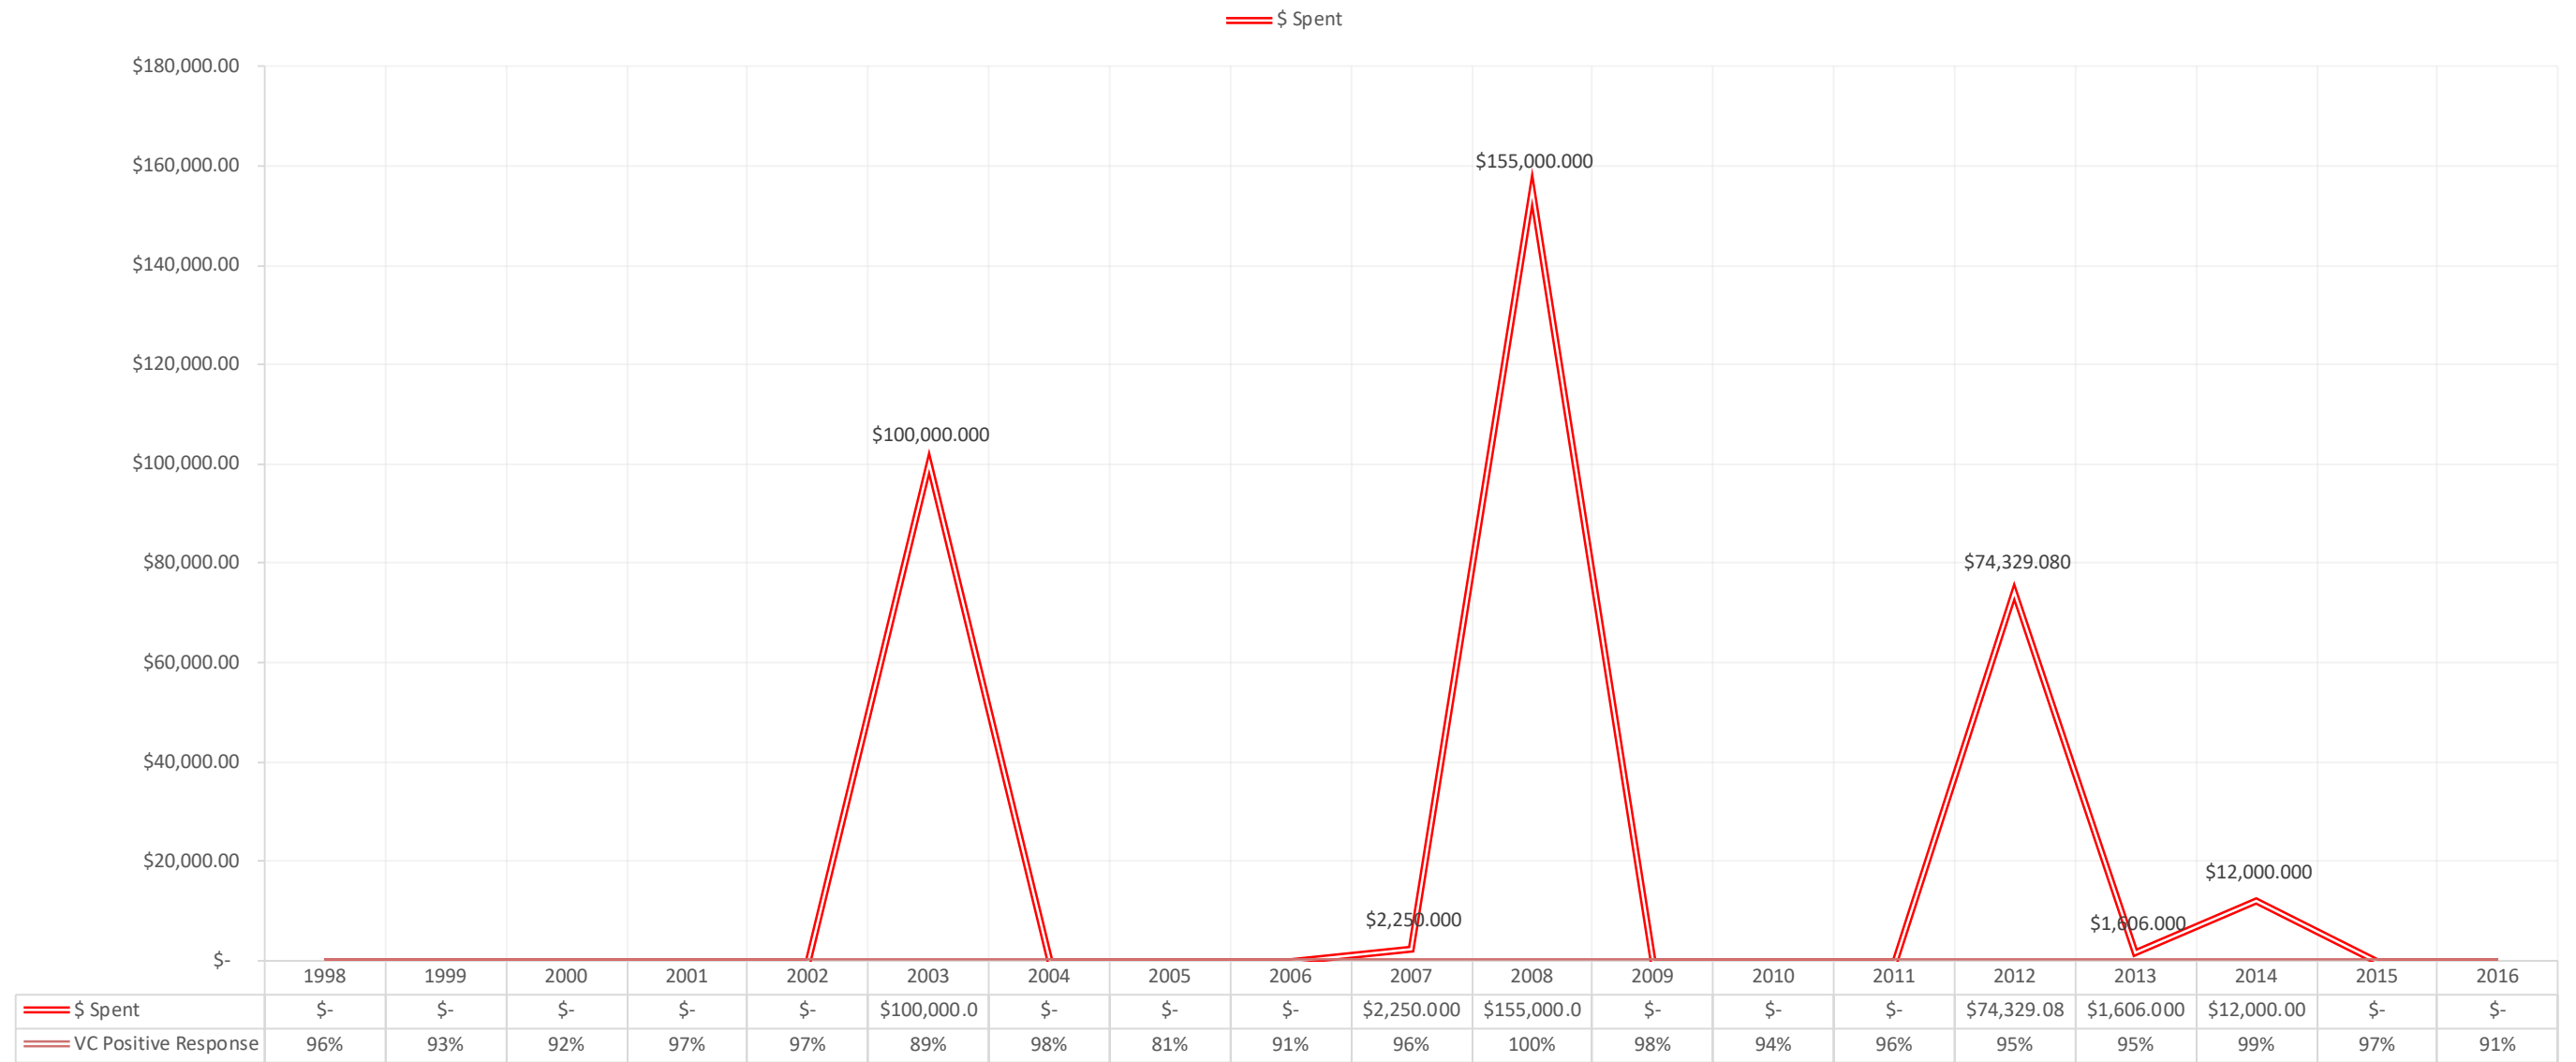
Table 6.5 Timucuan Composite.

As with Pulaski, the final part of data analysis was to examine whether or not there was any correlation between renovation work and the level of satisfaction visitors have with visitor centers. Visitor responses on survey cards are available on the IRMA website (<https://irma.nps.gov/Portal>), and data was tallied from each card. Because of rounding in the original surveys, all totals may not add up to 100%. The same standard of determination was made that any responses that were a “Very Good” or “Good” would be combined to create a category called “Positive Response”.

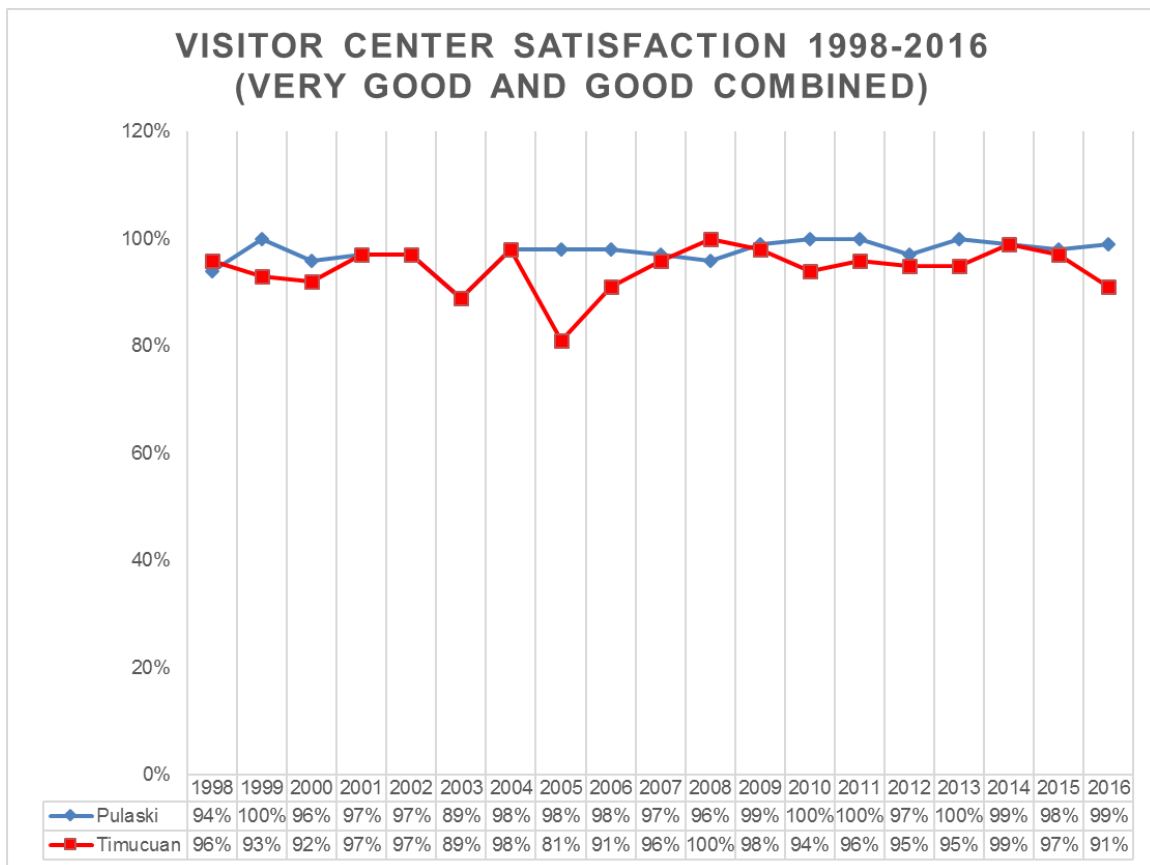
Table 7.2 Satisfaction Comparison.

Neither park saw a significant spike in visitor center satisfaction ratings, nor attendance figures which can be directly attributable to improvements carried out. What is interesting is how well visitors responded to the Mission 66 Visitor Center overall in comparison (Table 7.2). Whether or not this is a reflection of stylistic preferences is hard to determine, but does provide a little evidence that the Modernist style can still be
