4-2018

Simulation of the Behavior of Corrosion Damaged Reinforced Concrete Beams with/without CFRP Retrofit

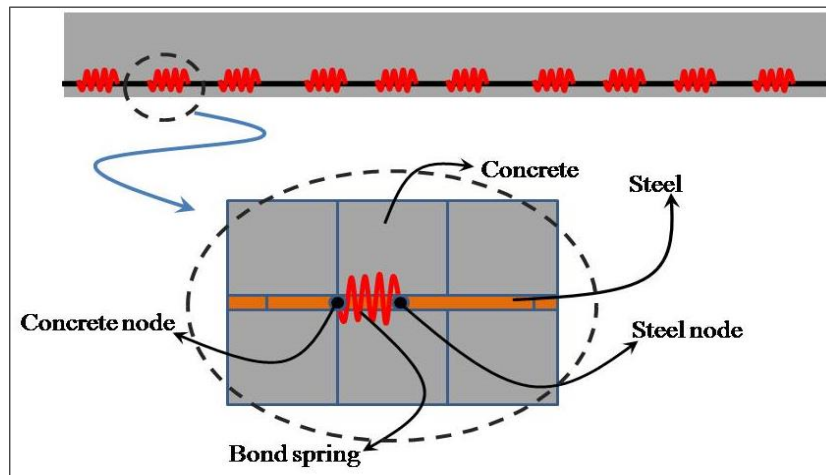
Figure 1. Simulation of the bond of steel reinforcement to concrete using bond spring

In this study, ABAQUS is employed to handle nonlinear simulations in the current study [15]. Concrete is modeled using 'solid element,' while steel reinforcements are modeled using 'wire element.' Nonlinear behavior of concrete is captured by using 'damaged plasticity concrete,' and nonlinear behavior of steel reinforcement is modeled in trilinear fashion using 'plastic/isotropic' model. Corrosion deteriorative effects are concentrated into a reduction of reinforcement cross-sectional area and decline in the bond between steel reinforcement and concrete. It is practical to use a specific constraint available by ABAQUS known as 'embedded region to simulate slips between steel reinforcement and concrete. It is assumed that there is strain compatibility or perfect bond between steel and concrete. Although this approach works well for intact steel reinforcements, however, it is unable to mimic critical decline of the bond between steel reinforcement and concrete. Therefore, a different method should be devised to simulate the interface between steel reinforcement and concrete. The bond between corroded steel reinforcement and concrete is modeled using springs shown on Figure 1. Bond spring is a spring in which all degrees of freedom are constrained except the axial translational degree of freedom. One end of bond spring is connected to reinforcement node, and the other end is connected to the concrete node. Slip between concrete and steel can be simulated by defining slip-bond behavior in the axial direction of the spring [16]. It is required to maintain the necessary accuracy of the simulation by choosing small enough intervals between bond springs. The accuracy of this approach has been extensively verified by several researchers [17]. The behavior of bond spring resembling bond to intact steel reinforcement can be defined as shown in Figure 2 [18]. Parameters of bonding strengths condition between concrete and steel of the beam is expressed in the Table 1.

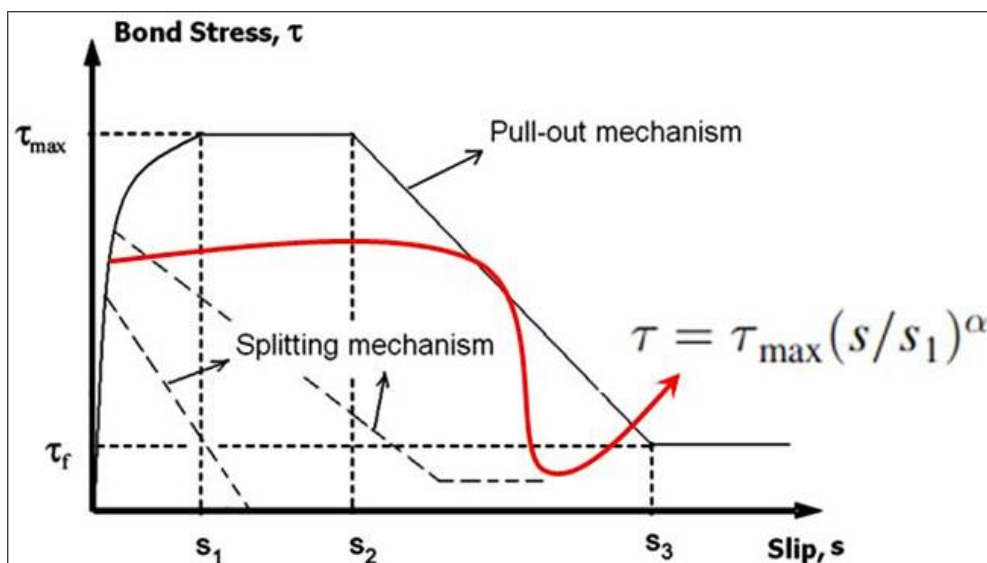
Figure 2. Spring behaviour of intact steel reinforcement and concrete

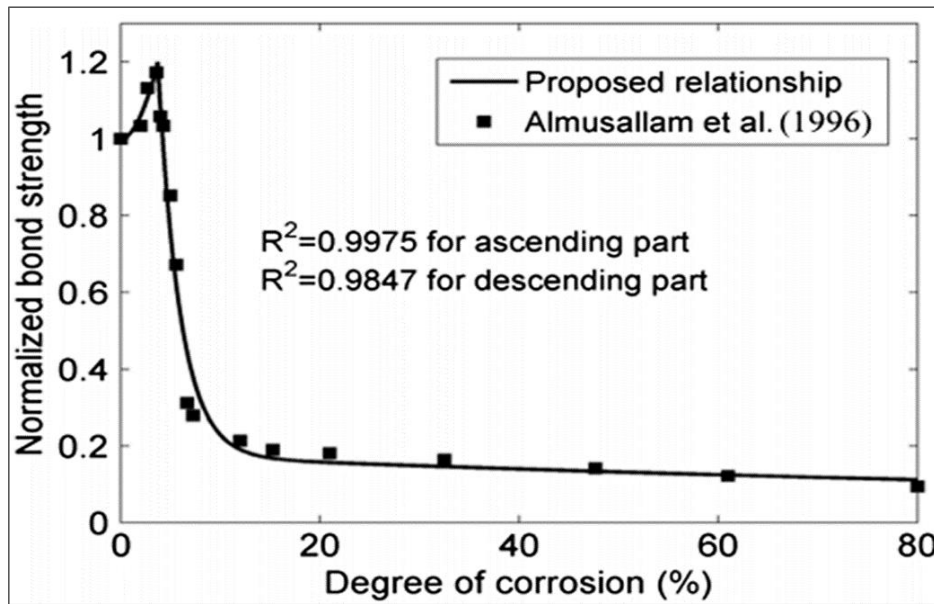
Figure 3. Corrosion influence on the ultimate bond between steel reinforcement and concrete

- The ultimate bond strength (T_{max}^c) needs to be modified by the corrosion level as illustrated on Figure 3.
- The residual bond is set to be 15% of the ultimate bond strength.
- The failure mode is assumed to be splitting mechanism.

The ratio of the ultimate bond strength (T_{max}^c) to developed bond strength (T^c) can be obtained for each corrosion degree based on the above assumptions and using Figure 3 [19]. In this study, the bond behavior is idealized as plotted in Figure 4.

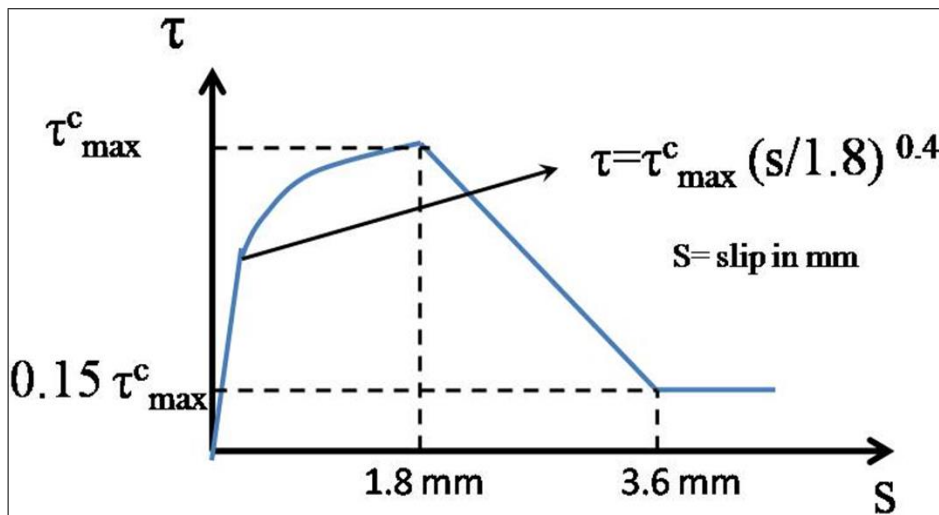
Figure 4. Bond spring behaviour used for corroded specimens

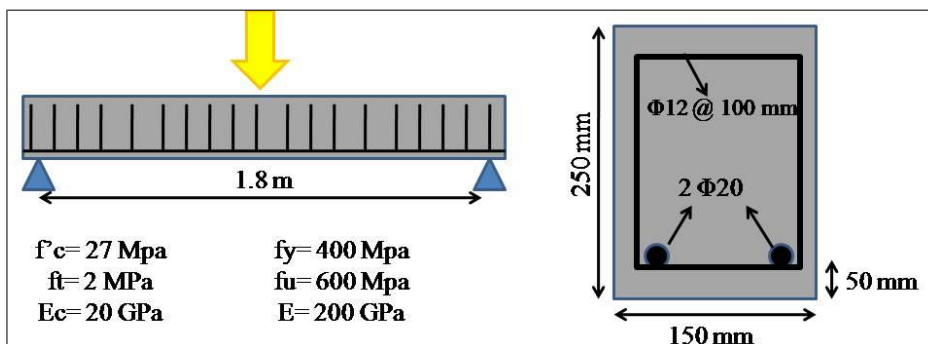
Figure 5. Beam specimen undertaken to study bond effects on the beam structural behaviour

A beam is investigated to verify the adopted approach in handling simulation of the bond between steel and concrete (Figure 5). The capacity of the beam is predicted for different cases as explained in Table 2.

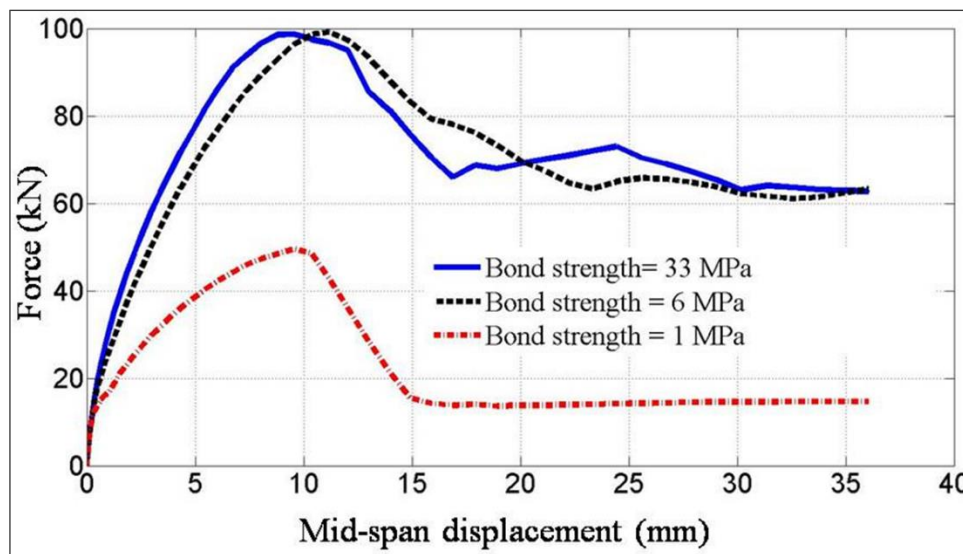
Figure 6. Beam specimen undertaken to study bond effects on the beam structural behaviour

Reinforcement cross-sectional area is assumed to be constant for all cases. Moreover, the perfect bond is assumed between steel stirrups and concrete. Force mid-span curve of the specimen is predicted using the embedded region as well as bond spring modelling approach as presented on Figure 6. This reveals the significant influence of bond between steel and concrete on the strength and stiffness of the specimen.

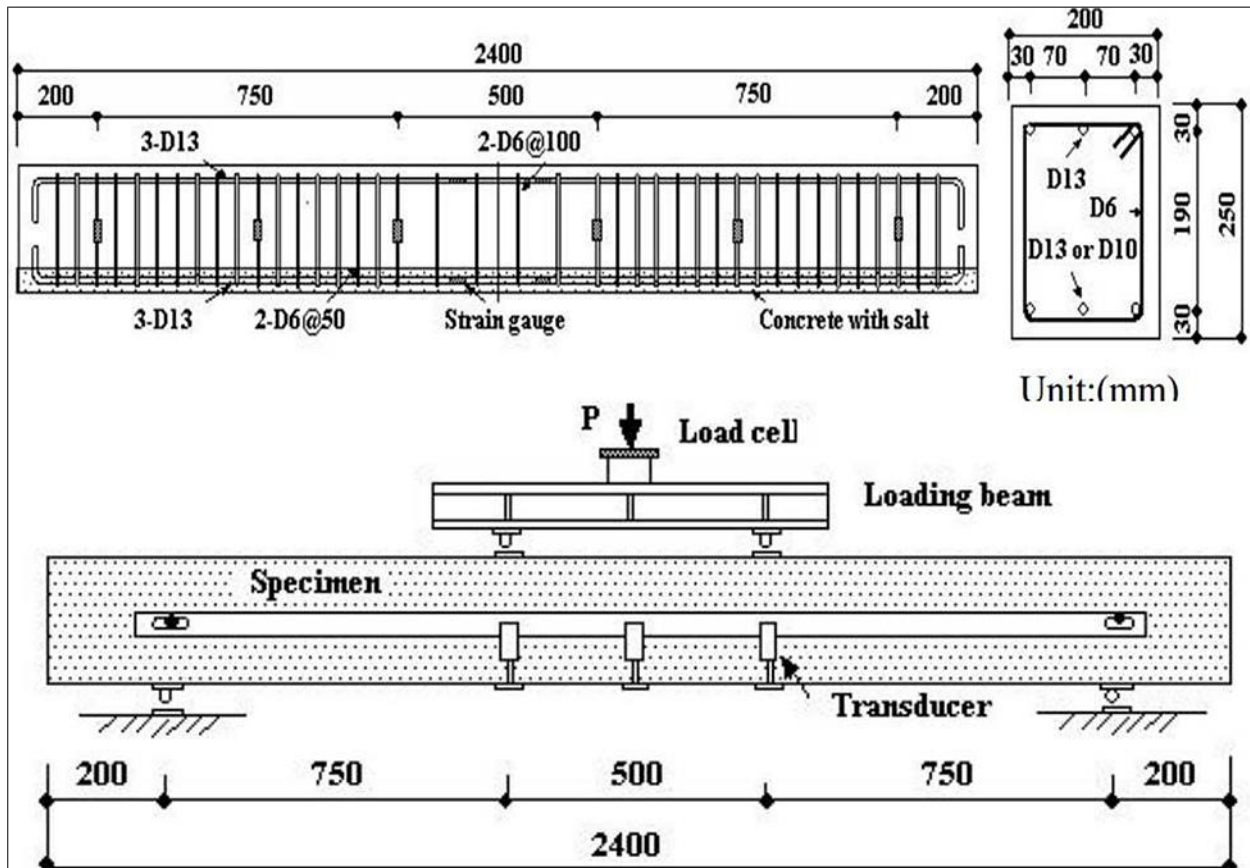
Figure 7. Beam specimen adopted for validation of the numerical procedure [4]

The experimental result [4] and numerical findings on structural behavior of the beam are compared in Figure 7 to validate the results of numerical simulations. Beam cross section includes a depth of 250 mm and width of 200 mm with six rebars with an intact diameter of 13 mm were used. Stirrups with the size of 6 mm spaced at 50 mm in two ends of the beam and 100 mm in the middle of the beam were utilized. Tensile reinforcement was exposed to accelerated corrosion using electrical currency to achieve different levels of corrosion. After that, specimens are tested under two concentrated loads. Test specimens consist of an intact specimen and two corroded specimens with 7.9% and 25.3% degrees of corrosion. The degree of corrosion is obtained based on weight loss of rebars in the corrosion process. Mechanical properties of the specimens are demonstrated in Table 3.

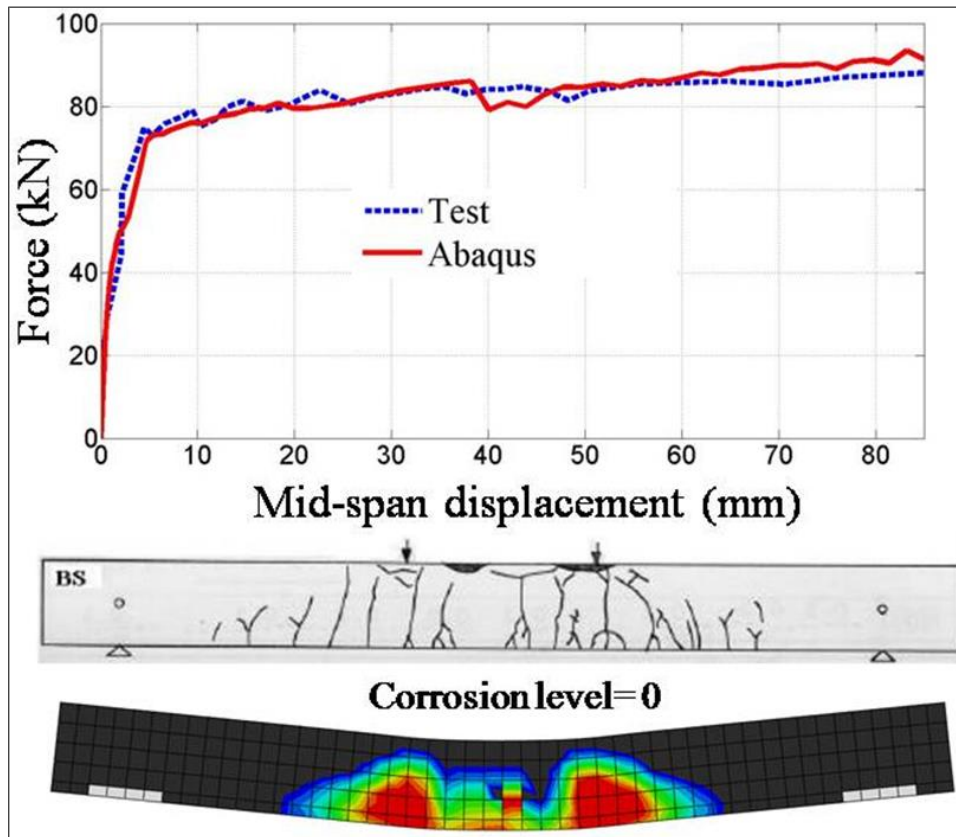
Figure 9. Comparison between analytical and experimental load-deformation response and crack pattern of intact beam specimen

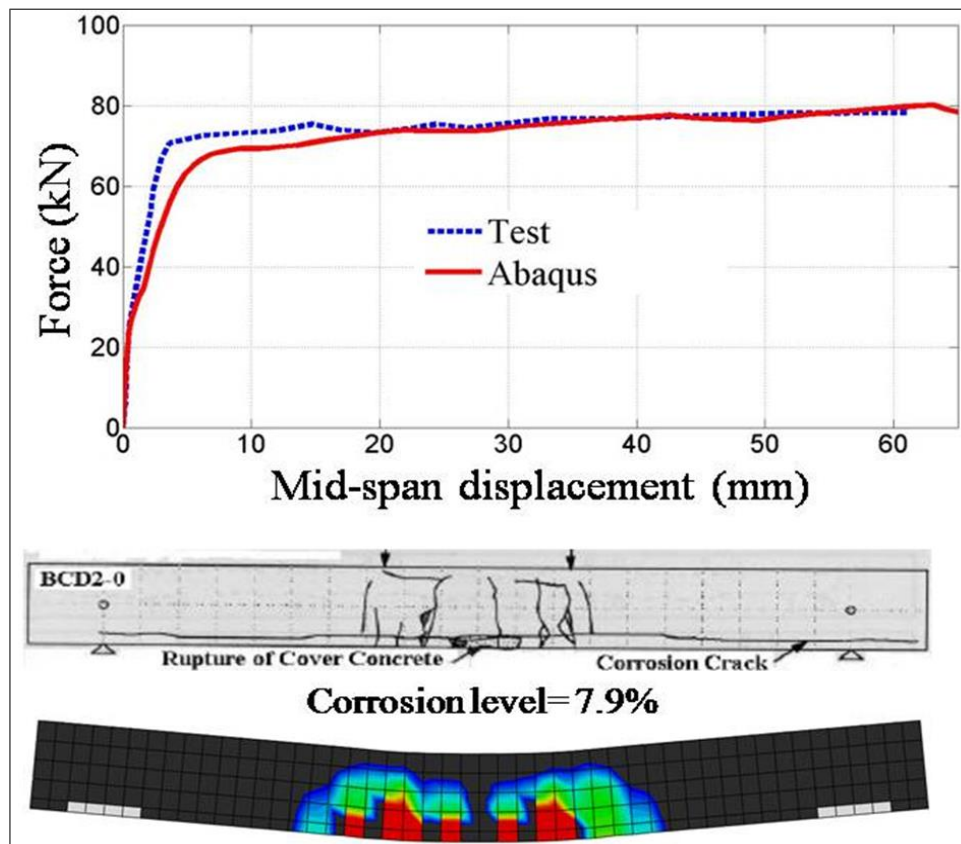
Figure 10. Comparison between analytical and experimental load-deformation response and crack pattern of beam specimen with 7.9% degree of corrosion

In other words, corrosion to some extent precludes propagation of flexural cracks along the length of the beam, which can be attributed to the decline of the bond between steel reinforcement and concrete as well as reinforcement cross-sectional area.

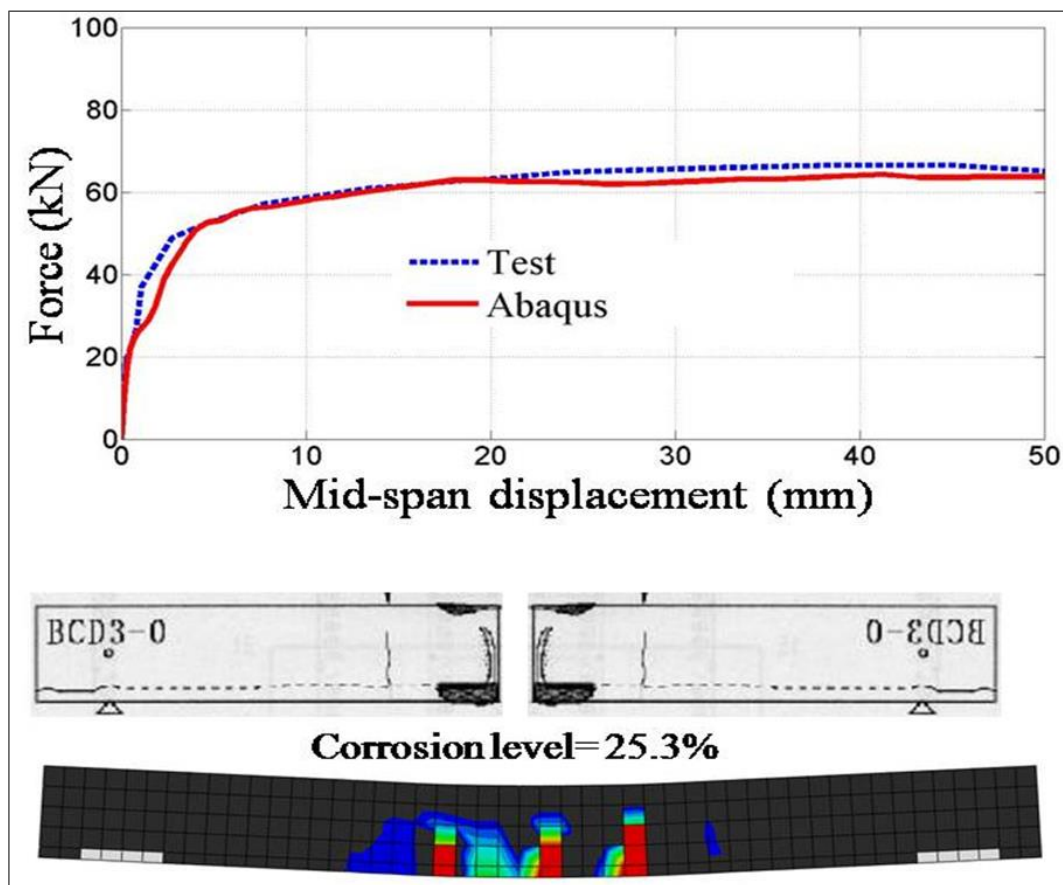
Figure 11. Comparison between analytical and experimental load-deformation response and crack pattern of beam specimen with 25.3% degree of corrosion

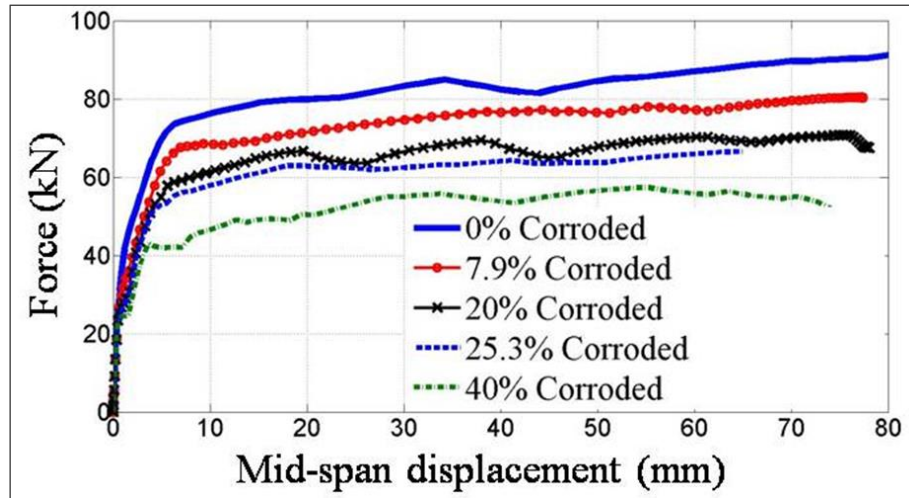
Figure 12. Comparison between the load-deformation responses of beams at different levels of corrosion

Two corrosion levels of 20% and 40% are chosen for beam specimens. The modeling approach is similar to validation part of the study. However, the cross-sectional area reduction is taken into account for stirrups and bond decline is neglected. One reason is the observation made in the validation phase of the study, which proves for stirrups cross-sectional area reduction is greatly more influential than bond decline. Secondly, stirrups transfer loads to the surrounding concrete by ‘bearing mechanism’ rather than ‘bond mechanism’ due to their short lengths and 90° bending. Figure 12 compares the structural behavior of intact specimen and corroded specimens with different degrees of corrosion. Results demonstrated that specimens with 7.9% and 25.3% degrees of corrosion are the same of the beam as discussed in the previous section except stirrups are intact. Specimens with 20% and 40% degrees of corrosion adopted for the current section including both tensile longitudinal and transverse reinforcements corrosion. Compressive reinforcements are intact in all cases. This assumption matches well with the real construction practice: typically there is a slab resting on top of the beam protecting it against corrosion. Figure 12 reveals an increase of the degree of corrosion leads to beam moment capacity reduction. This reduction can be more attributed to the reduction of the area of reinforcements than the decline in the bond due to the fine sizing of bars. Moment-curvature of the beams are constructed using SAP 2000 to prove this argument further, [20]. Strain compatibility is assumed which neglects any slip between steel and concrete. Table 4 summarizes beam moment capacity for different degrees of corrosion.

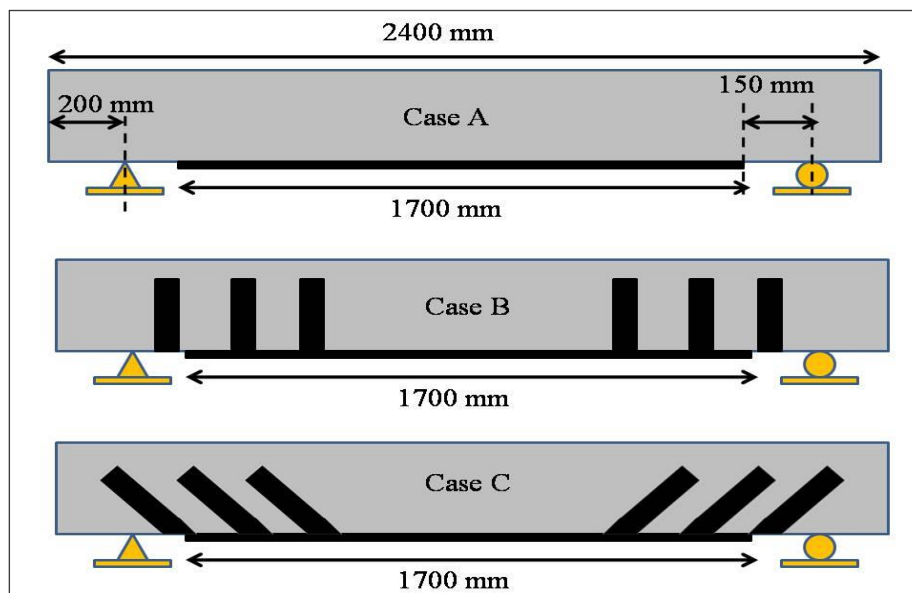
Figure 13. Different retrofit variants

Retrofit variant A, consists of inclusion of a CFRP strip with thickness and width given in Table 5 and constant length of 1700 mm to the soffit of the beam. Retrofit variant B in addition to variant A includes three CFRP plates on both sides with a thickness of 1 mm and width of 100 mm for shear strengthening. Shear CFRP plates center to center spacing is 150 mm. Retrofit variant C is similar to variant B except vertical shear CFRP plates is substituted by inclined shear CFRP plates to an angle of 45°. Thickness, width and spacing of shear plates of variant C are same as variant B. Figure 13 presents detailing of each variant of retrofit. Width and number of strip layers are designed using SAP 2000 software package.

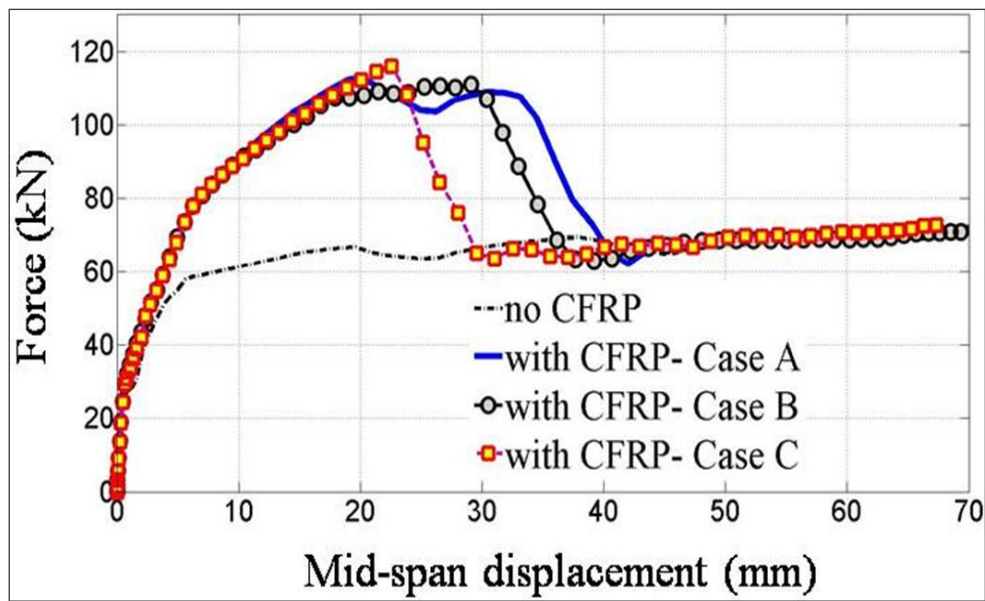
Figure 14. Behavior of the beam with 20% degree of corrosion using different corrosion variants

Figure 14 provides a comparison between the load-deflection curve of the beam specimen with 20% degree of corrosion before and after the retrofit. This plot reveals an anticipatable insignificant increase of initial stiffness due to small contribution of CFRP strips to the total moment of inertia of the section. All retrofit variants lead to more or less the same ultimate capacity. Moreover, shear retrofit causes more brittle behavior. However, this conclusion should not be generalized for all cases. Result demonstrated that beam did not require shear retrofit. CFRP strip de-bonds from concrete in higher deformation levels, which leads to decrease of the member strength to its preliminary before retrofitted strength. Similar to moment-curvature analyses, failure mechanism of retrofitted beams were recorded as failure of tensile reinforcements, followed by de-bonding of CFRP strips from the concrete (Table 6). Figure 15 shows the failure mechanism captured by numerical simulation for retrofit variant A.

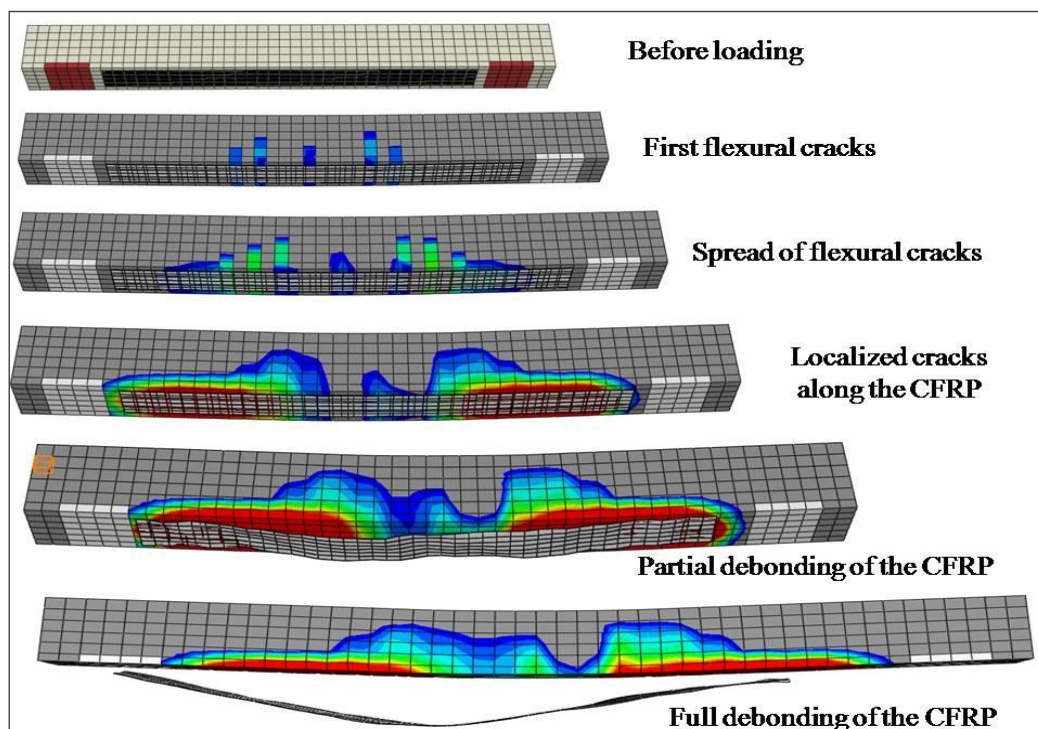
Figure 15. Crack propagation pattern and de-bonding of CFRP strip in the beam with 20% degree of corrosion using retrofit variant A

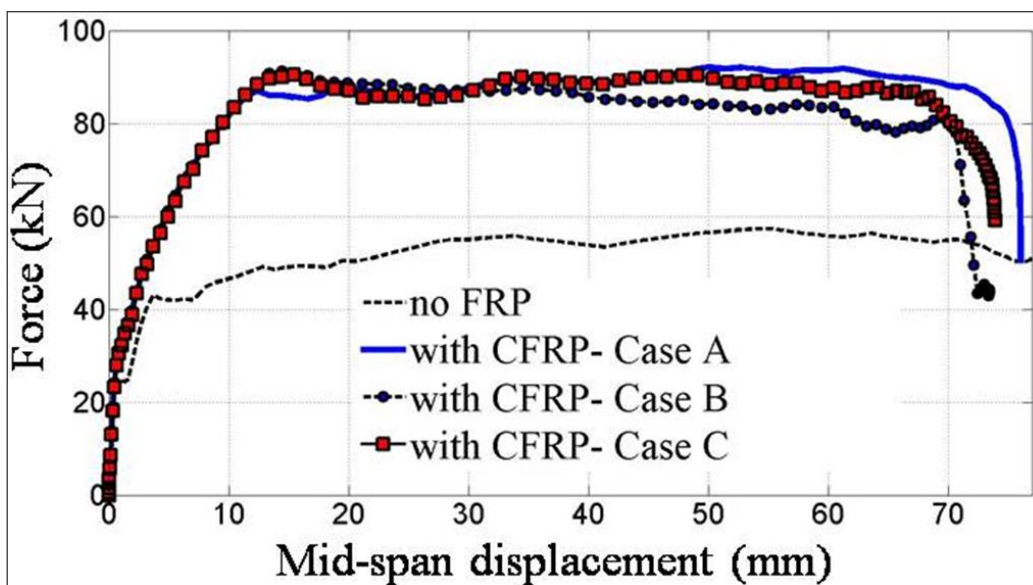
Figure 16. The behaviour of the beam with 40% degree of corrosion using different corrosion variants

Figure 16 provides a comparison between the load-deflection curve of the beam specimen with 40% degree of corrosion before and after the retrofit. In contrast to the beam with 20% corrosion degree, the ductility of the beam remains unchanged after the retrofit. It can be attributed to the lesser ratio of CFRP strip width to the beam width resulting in higher bond strength and fracture energy between CFRP strip and concrete. In other words, the specimen with 40% corrosion ratio compared with the specimen with 20% corrosion ratio requires more excessive slips between concrete and CFRP strip to have CFRP strip de-bonded from concrete. As a result, CFRP strip is de-bonded in higher deformations. Moreover, the presence of shear CFRP strips does not contribute significantly to the beam behavior. This conclusion should be limited to this specific case and not generalized to other cases. Table 7 shows slight variations in the retrofitted beam moment and load capacity for different retrofit variants. Results demonstrated that retrofit design carried out by SAP 2000 targeted at a moment capacity of 32.8 kN.m, which is maintained in any of retrofit variants.
