# Quantification and Standardization of Pattern Properties for control of the Lost Foam Metal Casting Process

Maurice I. Iwunze

# **QUANTIFICATION AND STANDARDIZATION OF PATTERN PROPERTIES FOR CONTROL OF THE LOST FOAM METAL CASTING PROCESS**

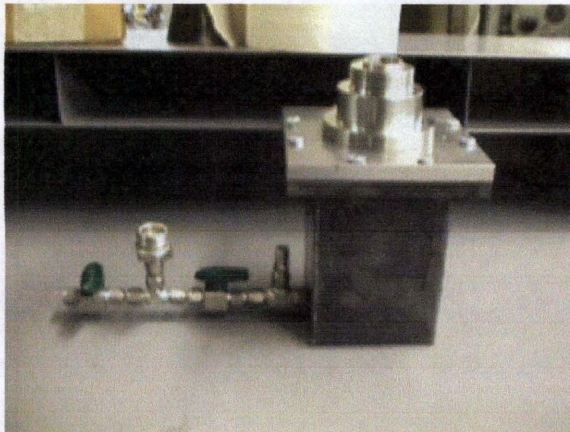
**Figure 1. Picture of the chamber and valve attachments**

In order to simulate the LFC process, a system had to be built that could accurately duplicate the procedure. The system consists of a chamber built to hold the sand and the EPS foam. The chamber was designed to be hermetically sealed in order to prevent gas to escape during the degradation process. The dimensions of the chamber are 4x4x6 inches. The chamber is displayed in the following figures.

The chamber was equipped with two valves. Valve 1 was closed initially to measure the temperature of the exiting gas prior to pressure readings to ensure that the gas temperature was less than  $70^{\circ}\text{C}$  ( $158^{\circ}\text{F}$ ). The temperature was determined using a thermocouple that was affixed to the chamber outlet. The thermocouple was also used to determine the temperature changes during the degradation process. Valve 2 remained close until the completion of the test, when it was opened to release the gas. To measure the changes in pressure of the system during the degradation process, a pressure transducer was attached to the system as shown below in Figure 3.

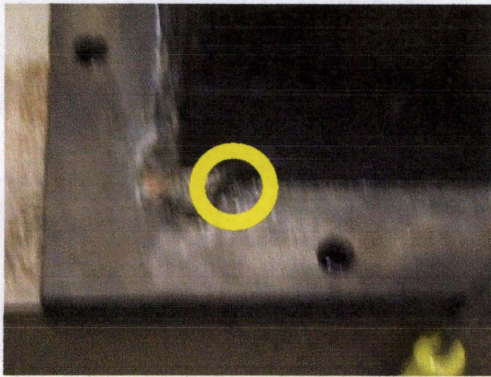
**Figure 13. Leakage area**

Now if the chamber had leaks the soap water would start bubbling and get sucked inside the chamber. And this is what exactly occurred. Water leakage was noticed in two specific areas of the chamber as shown in the figures below.
