# Corrosion Resistant Surface Finish by Chemical Browning

Final Report

MSE 489 Project 3  
May 11, 2010

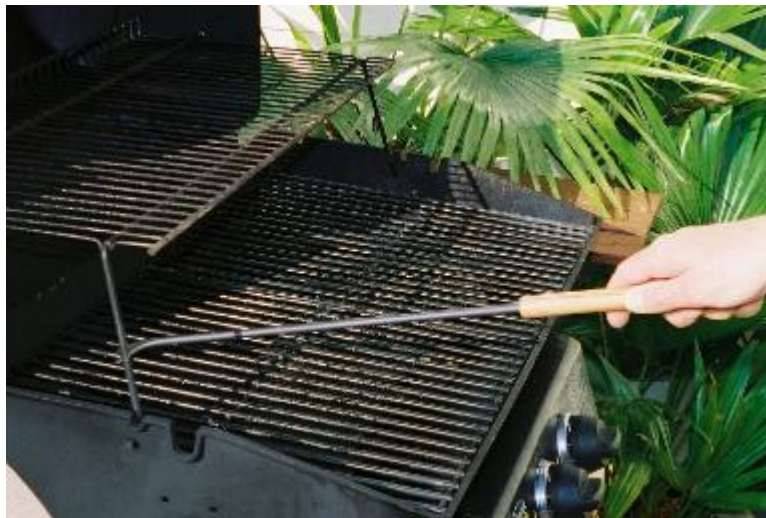
Figure 1: Product image of the Billy Bar barbeque grill cleaner.<sup>1</sup>

The Billy Bar is a revolutionary barbeque grill cleaning product made of AISI 1018 steel. The manufacturer has contacted us to develop an attractive, uniform, corrosion resistant coating. Two methods were put forth, one being a heat treatment in a fluidized bed to create a black coating, and the other a chemical means of applying a brownish coating. Our group was responsible for the chemically applied brown coating.

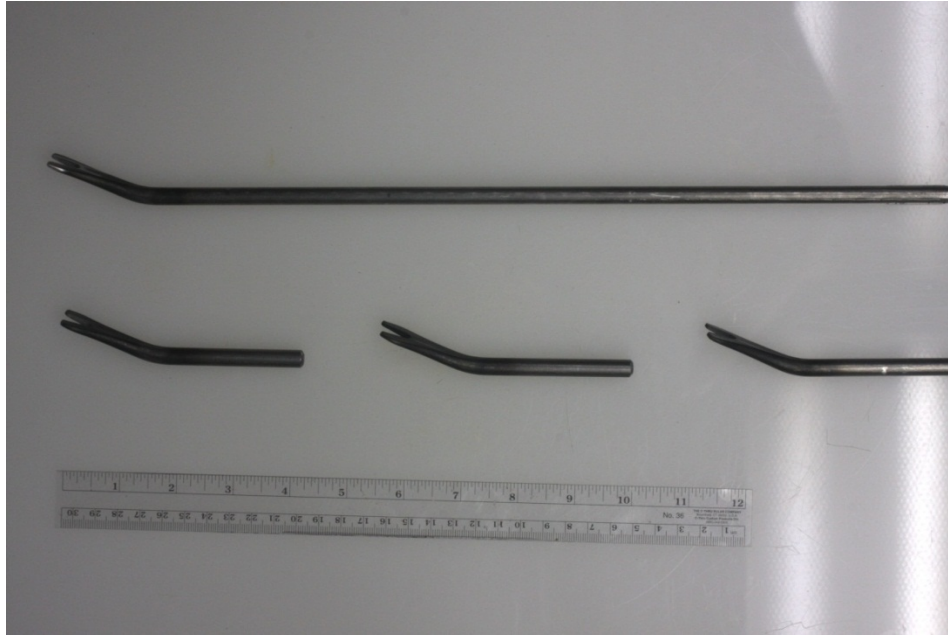
Figure 2: Macrograph showing the two sample sizes which will be used for creating a brown surface finish.

Each solution was applied to 3 Billy Bar samples. Two of the samples were 3 inches in length and the other was the full 16 inch length; the two sample sizes are shown in Figure 2. The smaller samples are being used in order to save raw material and space while still being able to see the effect of the browning solution. The smaller samples were prepared in two ways. One sample was sandblasted to remove any coating on the surface and create a clean, uniform surface for the browning to take place. The other 3 inch sample and the full length sample did not receive this treatment. The two small samples were boiled to remove grease and other contaminants while all of the samples were rubbed down with acetone and methanol. Once this surface preparation was complete, the browning process was undertaken.

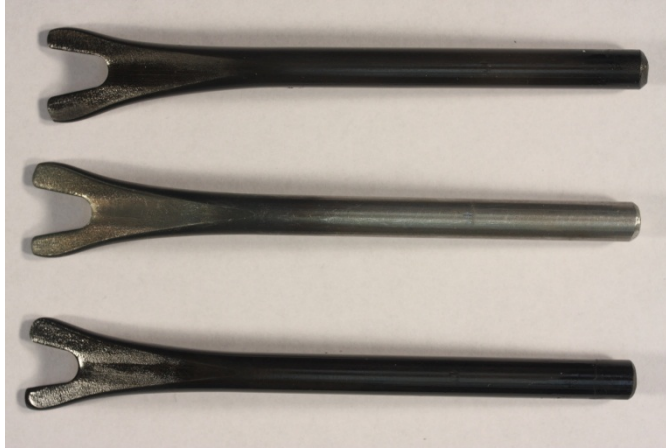
**Figure 3: Samples coated with solution 1 have a thick consistent layer.**

The results from the browning process are shown in the following images. Figures 3-5 show the sand blasted, original, and boiled samples for each solution. The sand blasted samples are in the top of the images and the boiled on the bottom. An untreated sample is in the middle of the images to show the change that the browning procedure made on the surface of the samples.

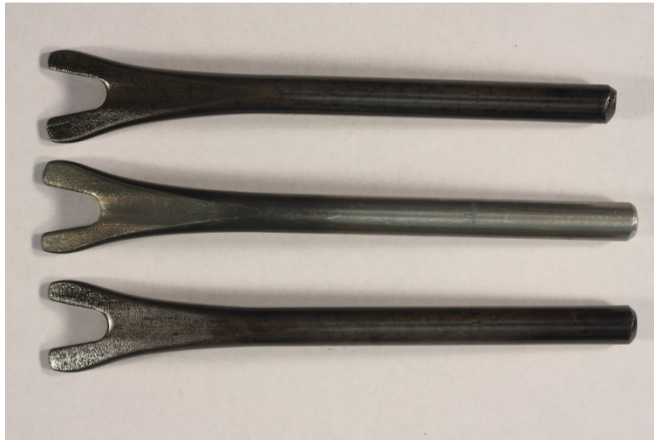
**Figure 4: Samples coated using solution 2 resulted in an inconsistent layer**

There did not appear to be a difference between samples that had been sandblasted and those that had been boiled. Solution 2 provided a blotchy layer on the sample and

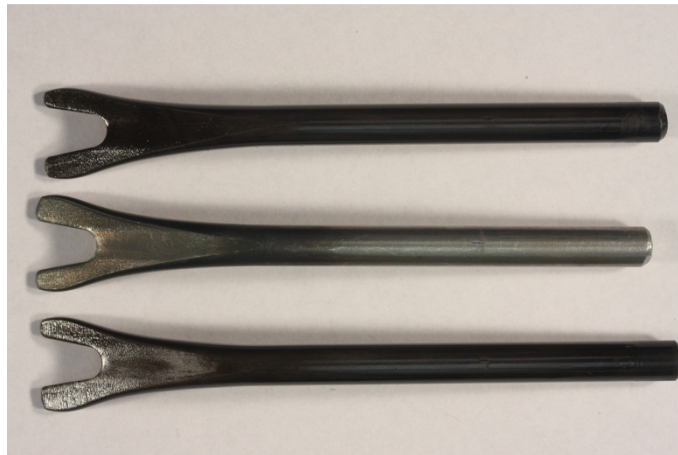
**Figure 5: Solution 3 samples have a thin but consistent layer**

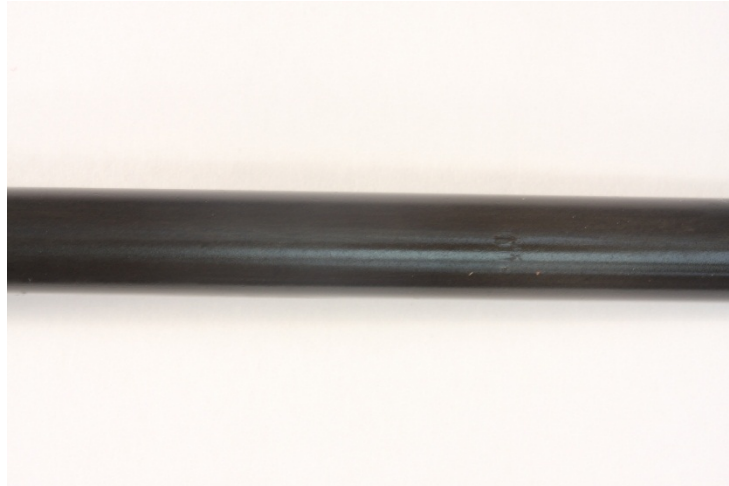
**Figure 6: Solution 1, good layer consistency**

therefore is not an option for the tool. Solution 1 and 3 both created consistent finishes that met the requirements. The following images are close-up shots taken for each of the sand blasted samples. These show in better detail the coating placed on the surface.

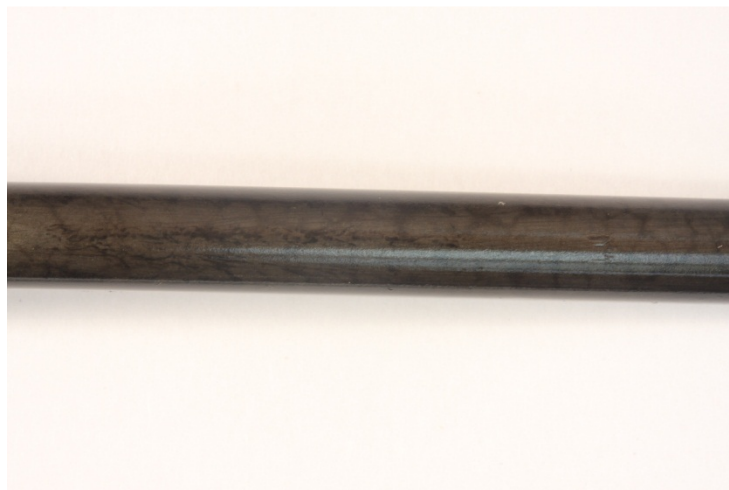
**Figure 7: Solution 2, very blotchy thin layer, not a good choice**

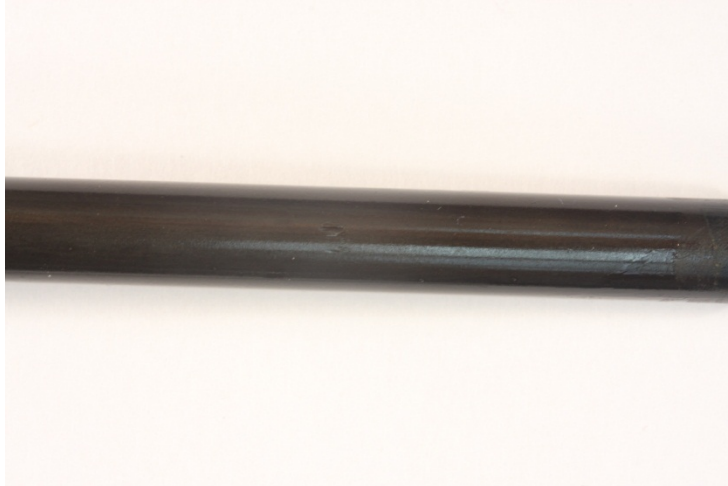
**Figure 8: Solution 3, thin but consistent layer**

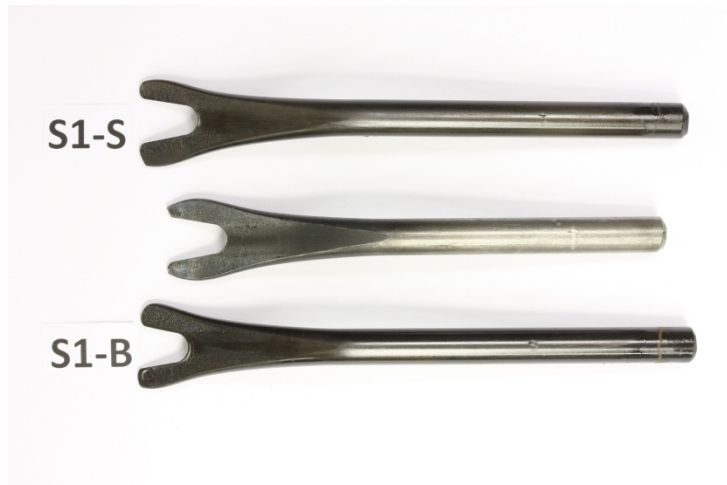
**Figure 9: Solution 1 samples showing no rust formation except the lower ring.**

Following browning, the samples were placed into a humidity chamber for atmospheric corrosion testing. The images in Figures 9-12 show the results of this test. The following abbreviations were used for labeling the samples: S# indicates which solution was used followed by a suffix to indicate surface preparation (S-sandblasted, B-boiled). For the untreated samples the prefix U was used while the suffix referred to finishing (U-uncoiled, O-oiled).

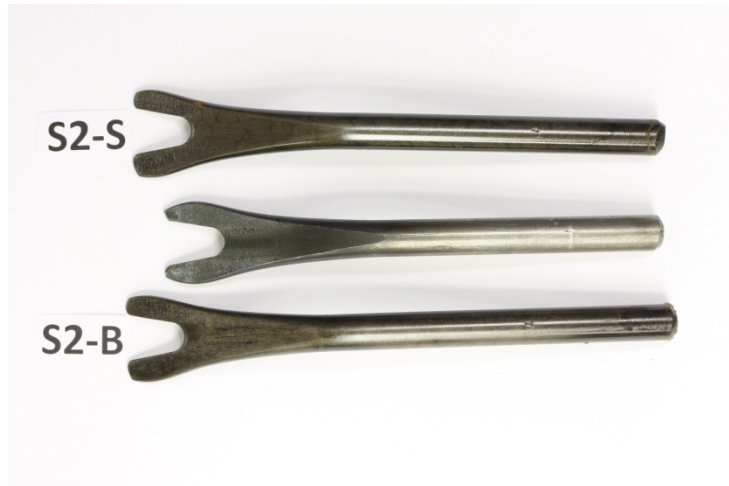
Figure 10: Solution 2 samples showed no rust except on the bottom of S2-B

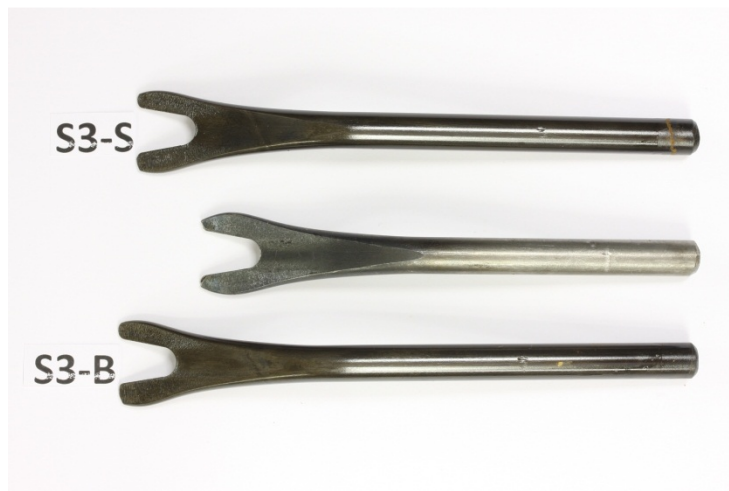
Figure 11: Solution 3 samples have no rust except the ring near the bottom.

All of the samples were placed into an atmospheric testing chamber with ~65% humidity for two weeks following coating. All of the solutions showed little to no corrosion. Several of the samples showed a thin ring of rust around the bottom of the shaft which can easily be seen in the S3-S sample of Figure 11. These rings were not exclusive to one solution and were not specific to one pretreatment. They were not found on both of the uncoated samples. The tung oil did not seem to affect whether or not this ring formed. We do not know what caused this ring to form or why its choice of sample substrate was unspecific. The U-U sample showed a small amount of rust formation near the neck in Figure 12.

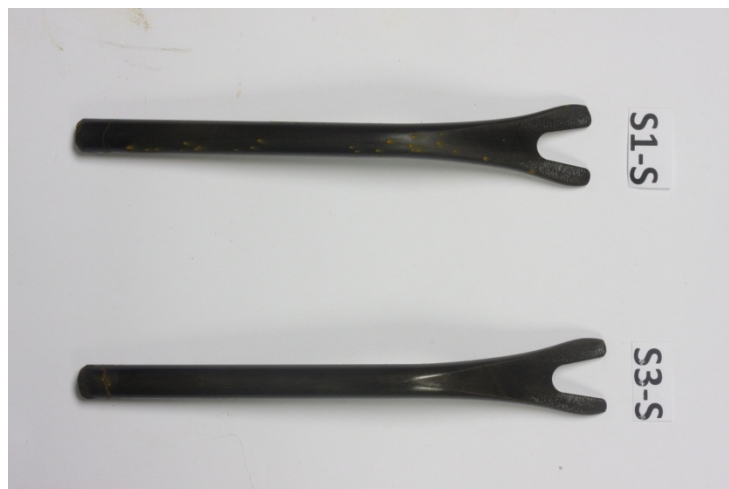
**Figure 13: S1-S sample shows many rust spots. S3-S sample has no rust formation on the head and shaft except the unexplained ring located near the bottom**

Following the atmospheric corrosion testing, sandblasted samples from solution 1 and 3 along with an oiled and unoiled untreated sample were immersed in oxygenated water. The results from this test can be seen in Figures 13-15.

The samples of solution 1 and 3 along with the uncoated samples were placed into the immersion chamber. Solution 1 and 3 sandblasted samples showed little to no rust as seen in Figure 13. Solution 1 was the worst of the two which formed small specks of rust randomly around the sample. Solution 3 had no rust formation and consequently is the number one choice because of its corrosion resistant uniform layer. The two uncoated samples showed significant amounts of rust formation which can be seen in Figure 14 and 15. The uncoated-unoiled sample had the greatest amount of rust which was to be expected. The tung oil alone prevented a large portion of the rust from forming.

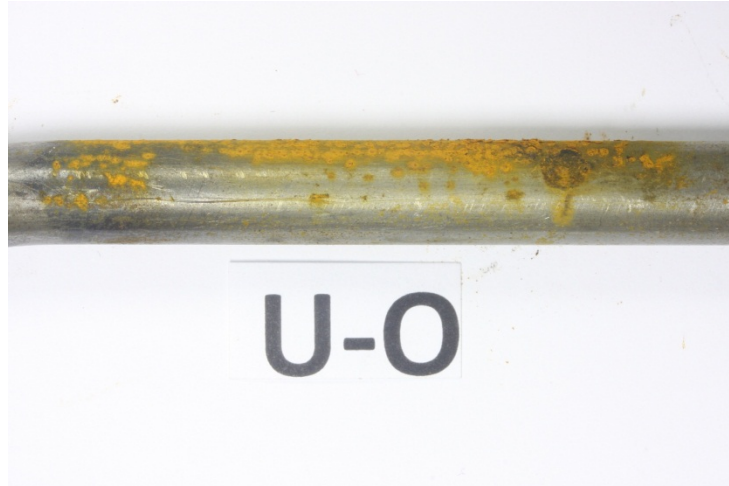
**Figure 14: U-O sample shows some rust prevention from the tung oil.**

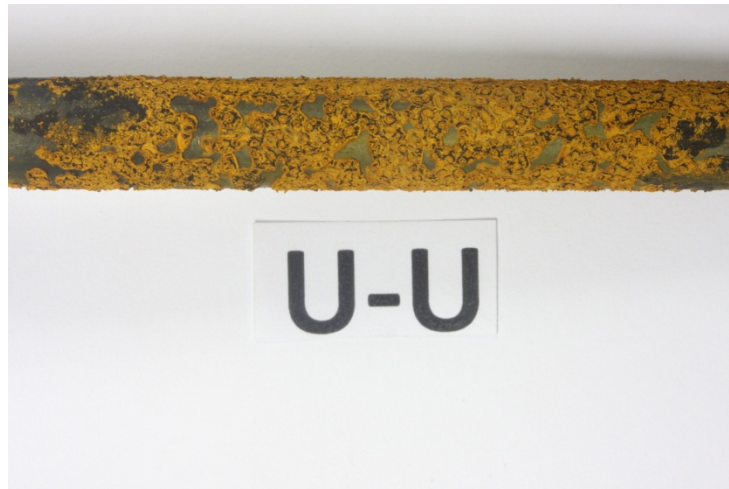
**Figure 15: U-U sample has significant rust formation.**
