Innovation of Driving Gear Train System for Developer Unit of Lexmark Home Printers

Final Report

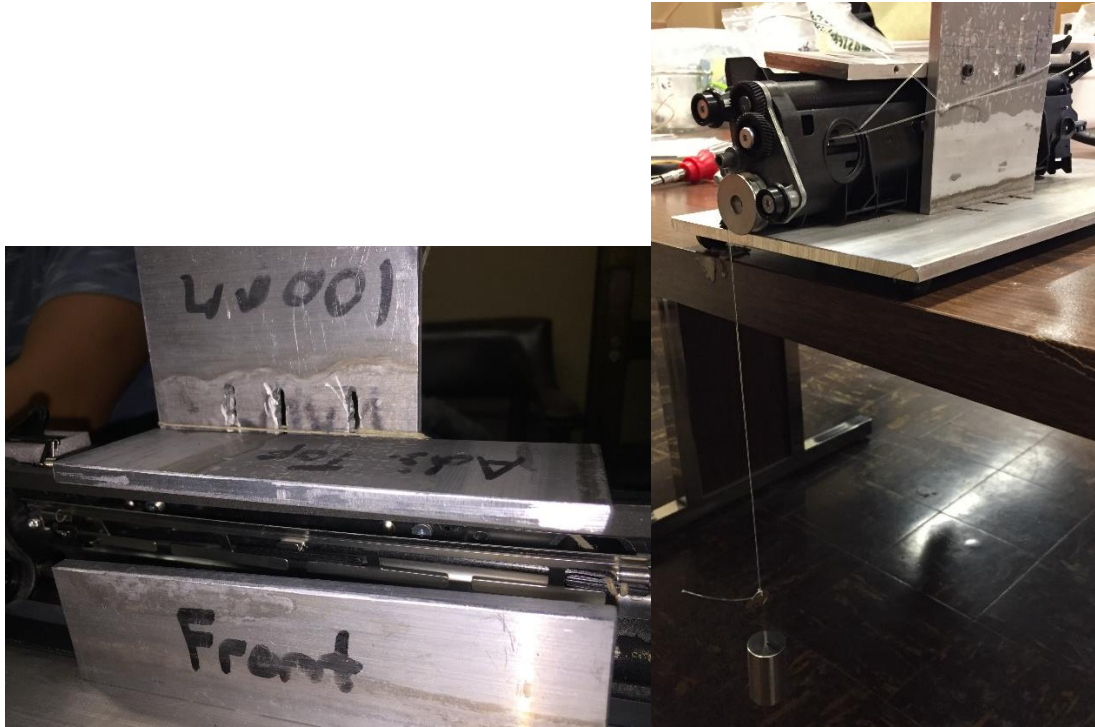
Figure 5. Gear Failure Test Apparatus and Loading Flywheel

The second test conducted was designed to determine the actual impact the change in gear face width had on the system by independently testing the gears. The paddle farthest from the gear train was tied with high strength twine to fix the agitator shaft, as can be seen in **Figure 5**. The developer unit without the front plate was used to represent the real system and allow for the assembly of the gear train. The developer unit was locked into place with a fixture designed to prohibit any movement or rotation of the housing. This fixture was stabilized by rubber feet to reduce any vibrations in the system. Similar to the first test, a flywheel was designed with a radius of 9.5 mm to attach to the input shaft with an insert made by Lexmark. Since the angle of the flywheel was irrelevant, the insert was glued in for more security than a set screw. Weights were tied to the flywheel with fishing line locked into the flywheel by a small hole. A 0.932 mN-m torque was incrementally loaded using the flywheel until failure occurred. A camera was set up to record the gears to attempt to measure the deflection in the system based on known measurements at different weights.

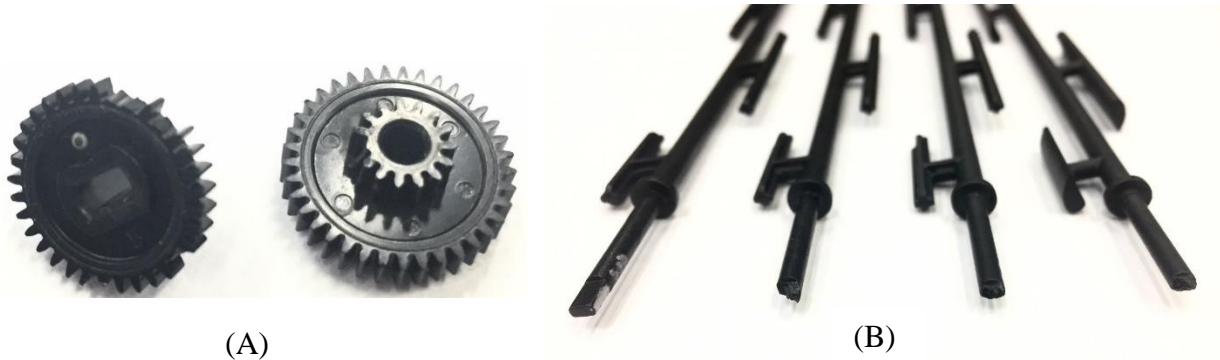
Figure 9. Gear Failure Test Failure Modes with (A) Molded Gear Failure and (B) Molded, Old Design Machined, and New Design Machined Agitator Shaft Failure

First, the molded gears were found to fail under the original setup at about 98 mN-m which was 26 mN-m more than predicted; this failure is depicted in **Figure 9**. Second, both systems with machined gears and shafts were found to exhibit a preloading phenomenon that manifested itself as a 90° to 120° visible rotation of the end of the agitator shaft that engaged with the agitator gear, along with a large vertical deformation of the central portion of the agitator shaft of about roughly 3.5 mm, calculated from images. Furthermore, the first new failure mode was discovered: shearing of the ends of the agitator shaft at the point of stress concentration where the shaft engages with the gear. This failure was found to occur in other tests and was explored further when combining all the shaft failures at the end of the final test. The second new failure mode was also discovered: shearing of the idler post from the gear face plate. This failure was found to occur more often in other tests and was explored further later.

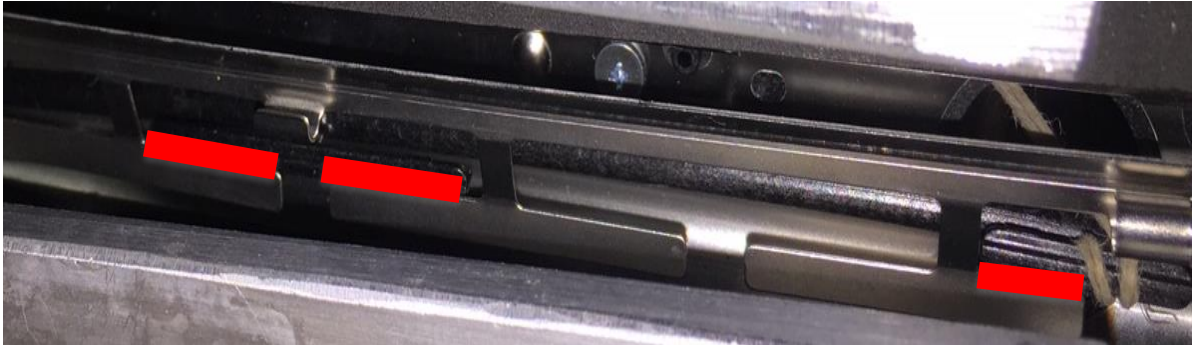
Figure 10. Additional Problem: Interference with Metal “T’s” Due to Extreme Deflection of Agitator Shaft (Marked by Red Zones)

Next, the agitator shaft deflection led to another unforeseen problem in the interaction of the system: after a load of 23 mN-m was applied to the system, at least one of the five agitator paddles became engaged with the metal “T’s” fixture within the system. By 46 mN-m, all of the paddles facing toward the front of the agitator shaft had engaged with the metal “T’s” fixture, depending on starting orientation. This provided a significant new problem because interference with this metal fixture drastically increased the torque required to turn the agitator shaft because

the shaft would not be able to rotate through this metal fixture. In fact, it was predicted that the agitator shaft would have to deflect away from this fixture to be able to move past it, which would require a load much higher than was capable before reaching the new failure mode of the shaft failure.

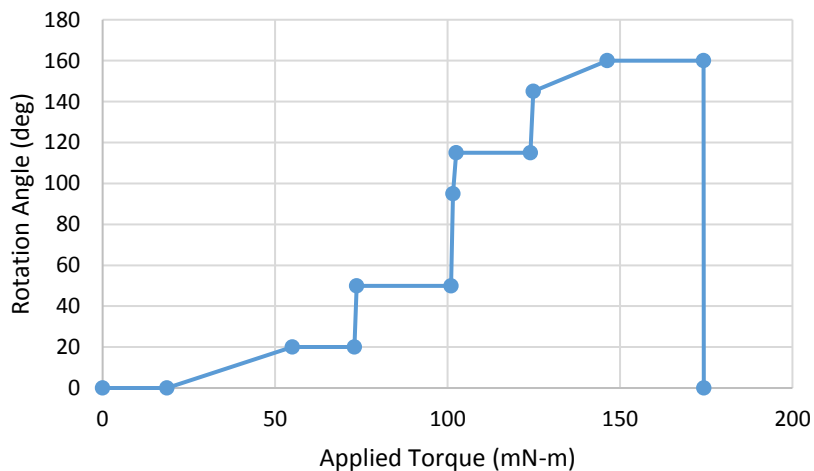
Figure 14. Example Rotational Loading Increments Used to Understand Preloading that Failed at 174 mN-m

Another observation made was in the described preloading of the system. As the load incrementally increased in the system, the visible end of the agitator shaft visibly engaged with the output gear would rotate along with the each of the gears within the gear train; a depiction of a load and angle measurement comparison can be seen in **Figure 14**. Similar to the second test, a rotation of between 90° and 150° was found to be a maximum rotation before shaft failure. However, this preloading rotation occurred incrementally and at higher loads compared to the second test. In attempting to understand this loading, the system was compared to a mass-spring system with multiple springs connected in parallel. A specific load, for example about 50 mN-m, was required to load the first spring to the point where the second spring would become loaded, and so on, leading to tiers of movement at higher loads. Different parts of the system that could be understood as spring resistances in the system were the rotation of the input shaft through the toner, the rotation of the paddle closest to the gear train, the rotation of the second paddle, and so on. This theory would need to be further tested in future work to determine its validity.
