Doctoral Dissertations

Fatigue Behavior of a Zirconium-Based Bulk Metallic Glass

William Hutchison Peter
University of Tennessee, Knoxville

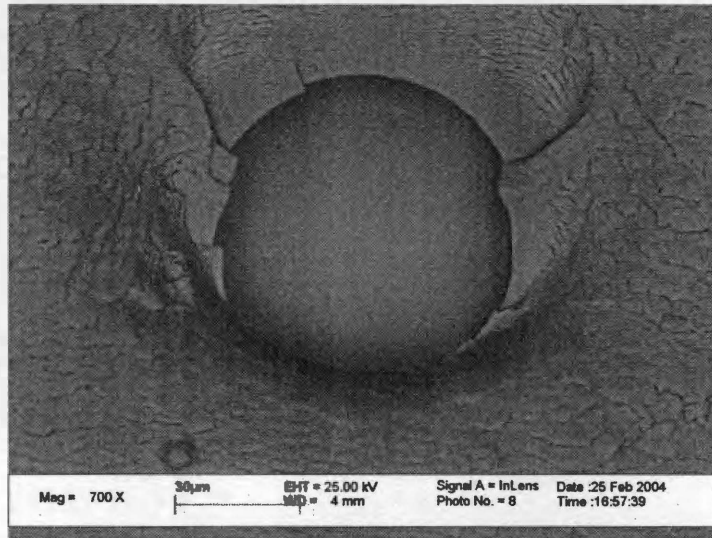
Figure A-11: SEM Image of Porosity on the Fracture Surface of a Fatigue Specimen Caused by Trapped Inert Gas During the Drop-Casting of a Zr-Based BMG.

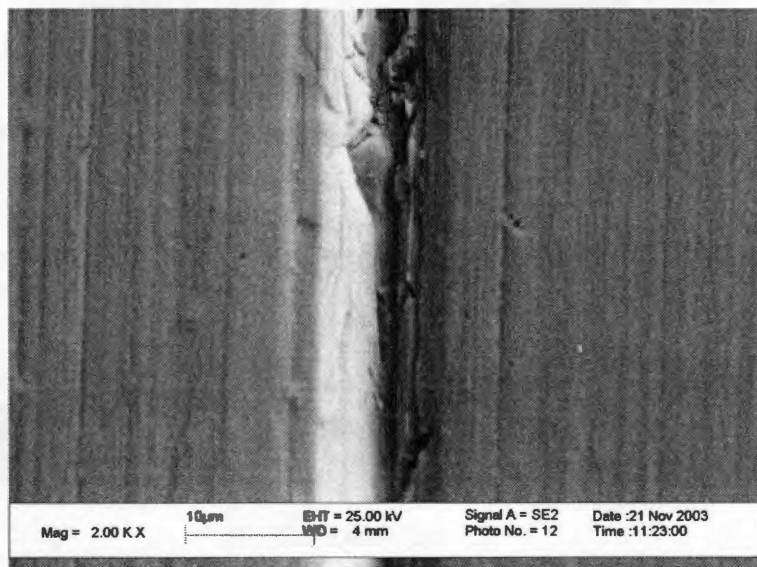
Figure A-12: SE Image of Radial Machine Marks And a Large Geometric Defect on the Outside Surface of a Round Bar Fatigue Specimen.

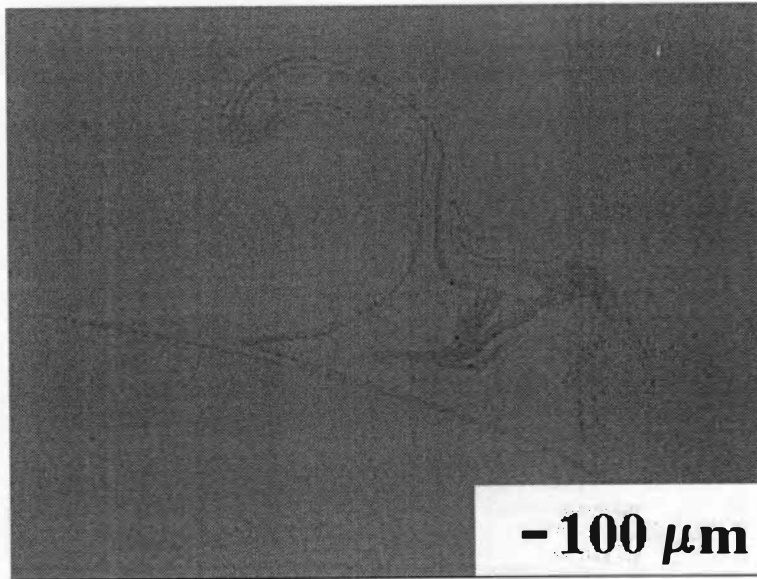
Figure A-13: Optical Micrograph Image of Etched BMG-11 As-Cast 6.4 mm Diameter Specimen Illustrating Small Bands of Crystallinity.

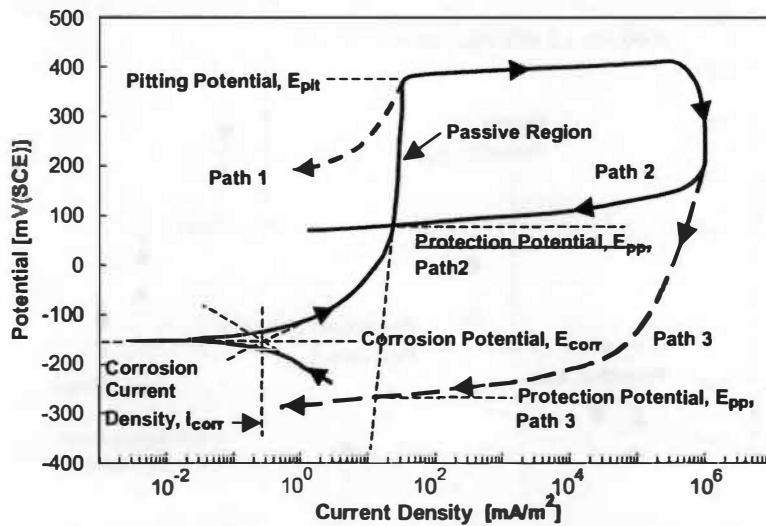
Figure A-19: Schematic Cyclic-Anodic-Polarization Curves. Reprinted from Intermetallics, Volume 10, W.H. Peter et al., Localized Corrosion Behavior of a Zirconium-Based Bulk Metallic Glass Relative to Its Crystalline State, pp. 1125-1130, 2002, with Permission from Elsevier.

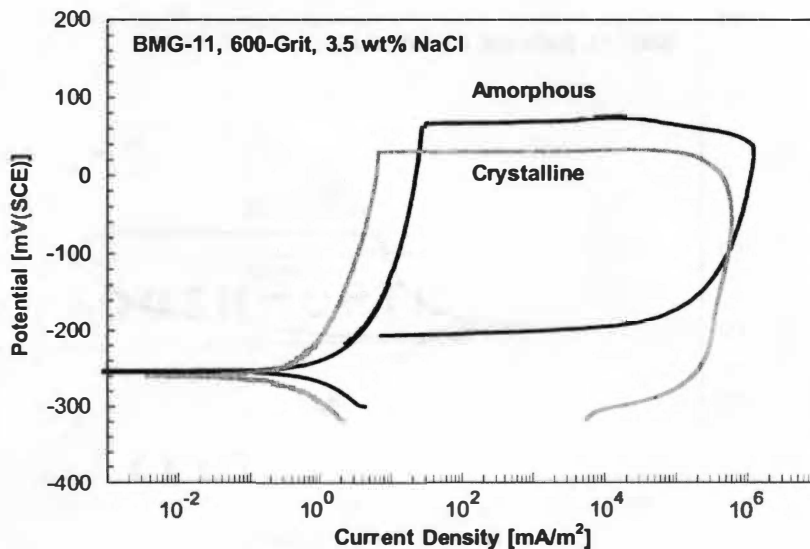
Figure A-20: Average Cyclic-Anodic-Polarization Behaviors of Amorphous and Crystalline BMG-11 with 600-Grit Surface Finish in Aerated 0.6 M NaCl Solution at Room Temperature. Reprinted from Intermetallics, Volume 10, W.H. Peter et al., Localized Corrosion Behavior of a Zirconium-Based Bulk Metallic Glass Relative to Its Crystalline State, pp. 1125-1130, 2002, with Permission from Elsevier.

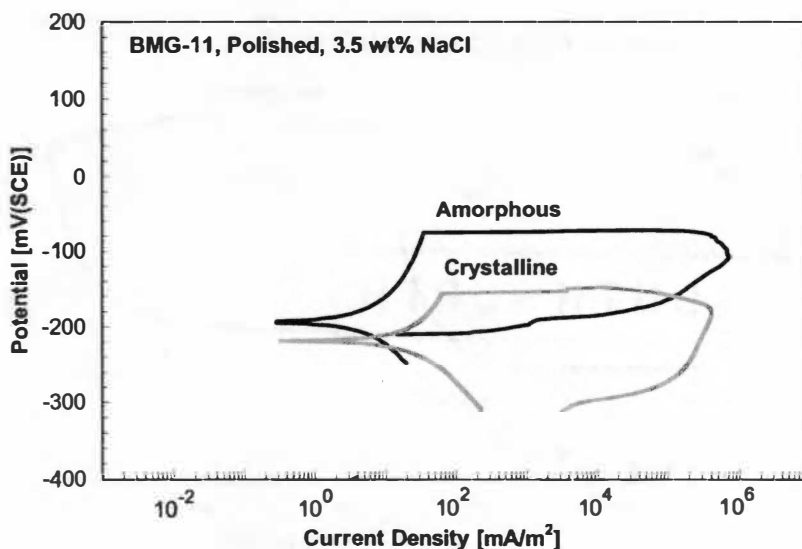
Figure A-22: Average Cyclic-Anodic-Polarization Behaviors of Amorphous and Crystalline BMG-11 with Metallographically-Polished Surface Finish in Aerated 0.6 M NaCl Solution at Room Temperature. Reprinted from Intermetallics, Volume 10, W.H. Peter et al., Localized Corrosion Behavior of a Zirconium-Based Bulk Metallic Glass Relative to Its Crystalline State, pp. 1125-1130, 2002, with Permission from Elsevier.

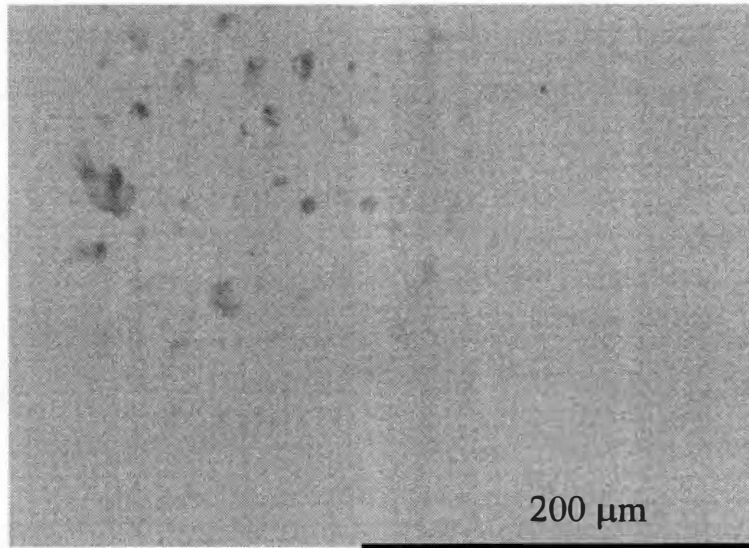
Figure A-25: Secondary Electron Image of the Porosity in the Amorphous Corrosion Sample After Being Tested in 0.6 M NaCl Solution.

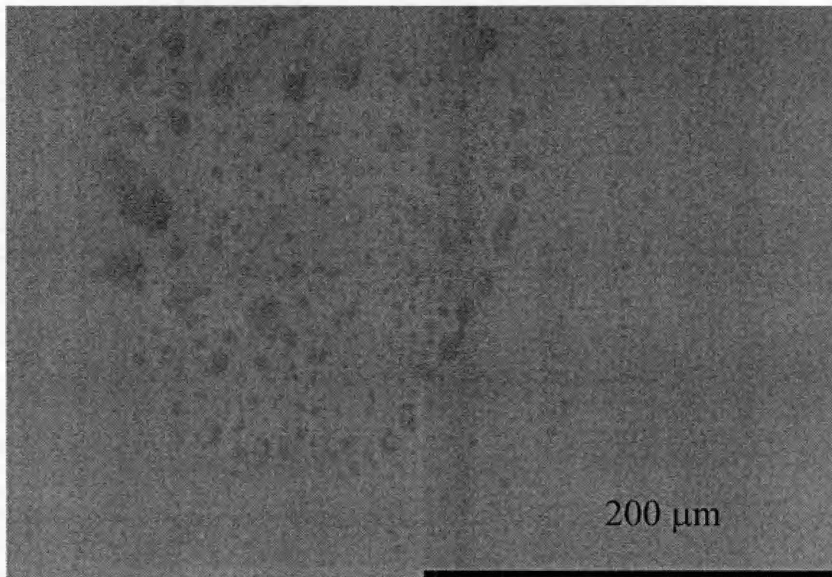
Figure A-26: Back-Scattered Electron Image of Porosity in the Amorphous Corrosion Sample After Being Tested in 0.6 M NaCl Solution.

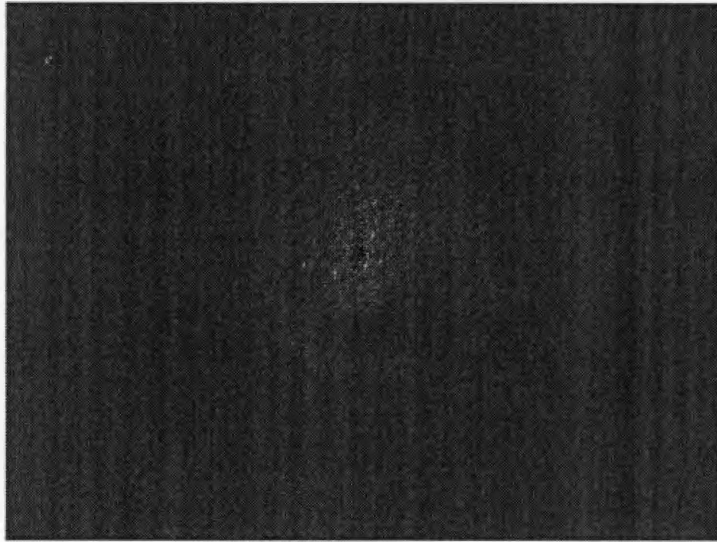
Figure A-27: Secondary Electron Image of a Pit in a Crystalline Corrosion Sample After Being Tested in 0.6 M NaCl Solution (Same Scale as A-28).

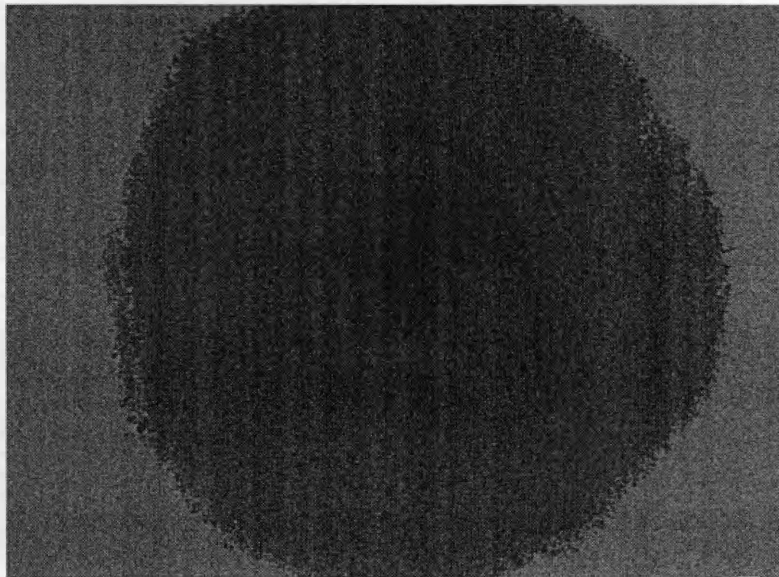
Figure A-28: Back-Scattered Electron Image of a Pit in a Crystalline Corrosion Sample After Being Tested in 0.6 M NaCl Solution (Same Scale as A-27).

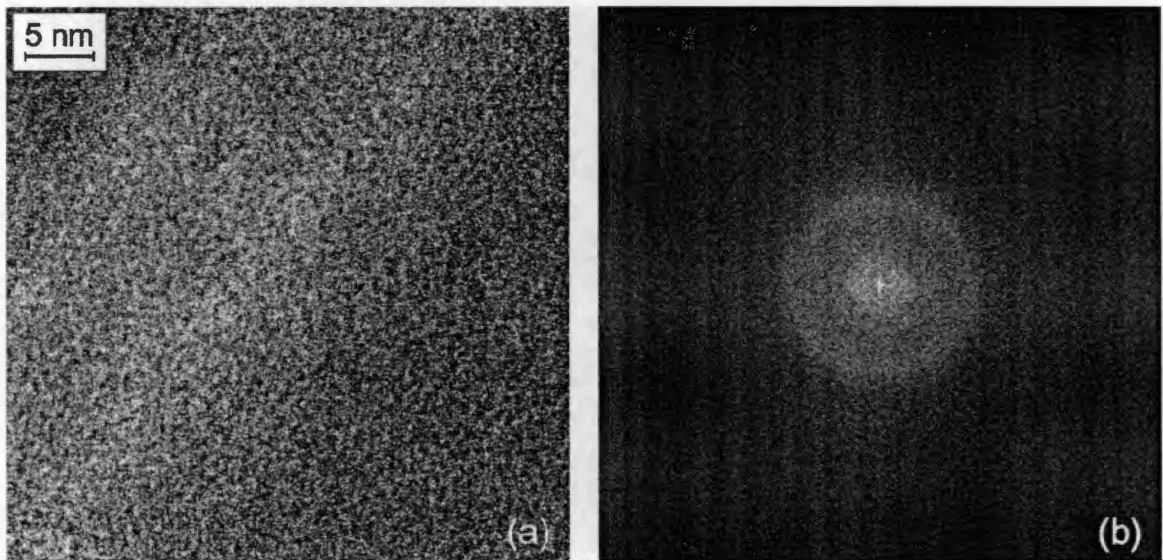
Figure A-30: Shear Band Near Crack Tip. HRTEM Image (a) and Fourier Transform (b) of a Shear Band Near a Crack Tip. Reprinted Figure with Permission from J Li et al., Physical Review B, Volume 65, pp 144201-1-144201-6, 2002. Copyright 2002 by the American Physical Society.

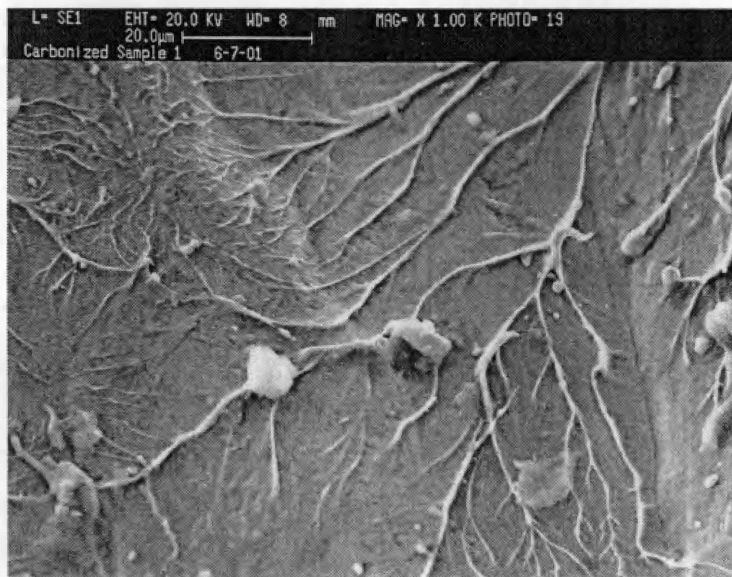
Figure A-32: Secondary Electron Image of the Overload Fracture Surface of a Zr-Based Metallic Glass.

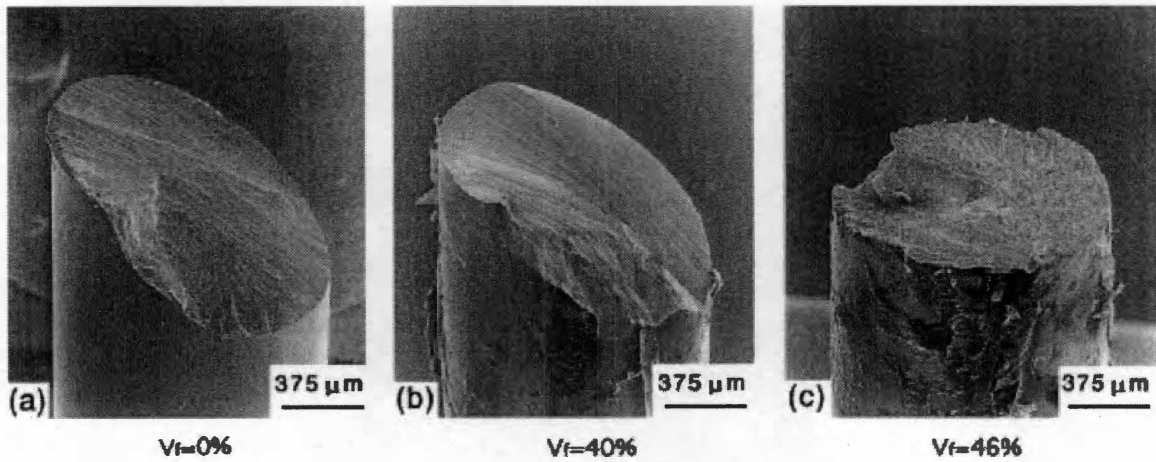
Figure A-33: Tensile Fracture Surface of Amorphous ZrAlCuPd Alloy with Varying Percents of Volume Fraction (V_f) of Nanocrystallization (a=0%, b=40%, c=46%). Reprinted from *Intermetallics*, Volume 8, A. Inoue, *Mechanical Properties of Zr-based Glassy Alloys Containing Nanoscale Compound Particles*, pp. 469-475, 2000, with Permission from Elsevier.

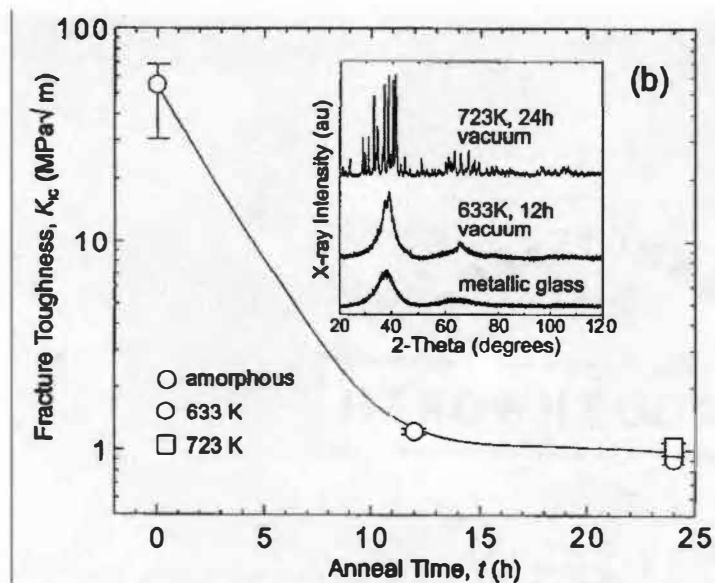
Figure A-34: Fracture Toughness Versus Anneal Time. Reprinted from *Materials Research Society: Bulk Metallic Glasses*, Volume 554, C.J. Gilbert et al., *Fracture and Fatigue in a Zr-Based Bulk Metallic Glass*, pp. 343-354, 1999, with Permission from Materials Research Society.

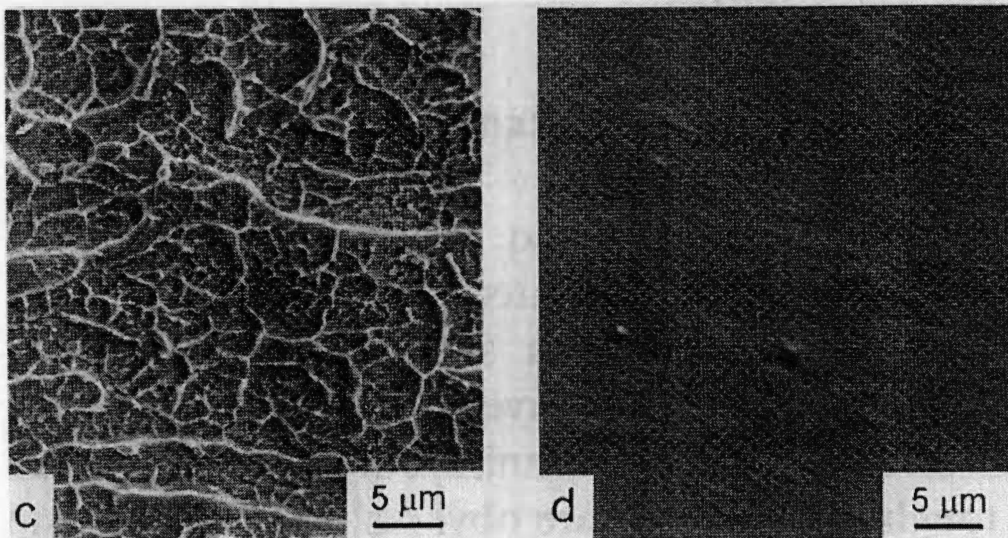
Figure A-35: SEMs of an Overload Fracture Surface for a Metallic Glass (Left) and 5% Crystallized Sample (Right). Reprinted from *Intermetallics*, Volume 8, R.O. Ritchie et al., *Fracture, Fatigue and Environmentally-Assisted Failure of a Zr-Based Bulk Amorphous Metal*, pp. 469-475, 2000 with Permission from Elsevier Science.

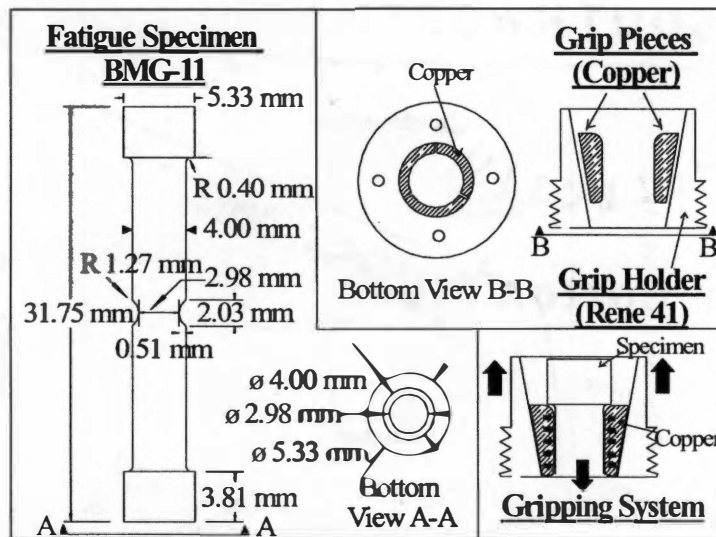
Figure A-38: BMG-11 Specimen Geometry for Fatigue Testing in Air and Vacuum.

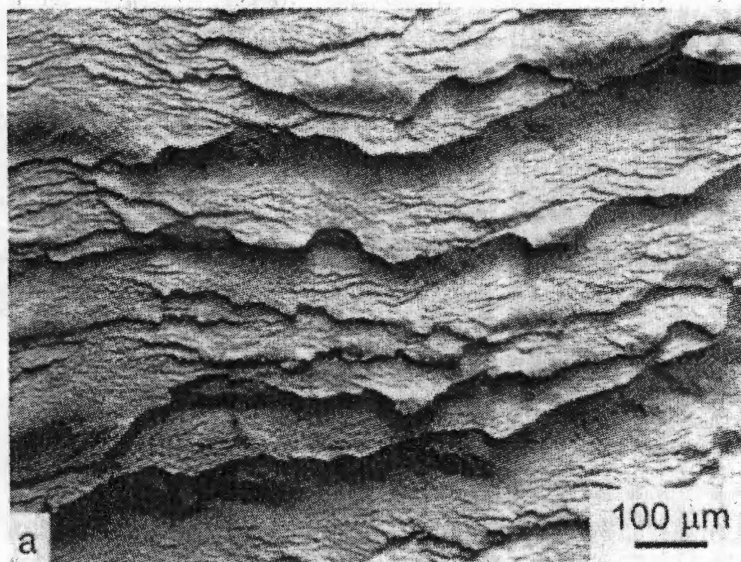
Figure A-42: Secondary Electron Image of Shear Steps in an Overload Fracture Surface. Reprinted from Materials Research Society: Bulk Metallic Glasses, Volume 554, C.J. Gilbert et al., Fracture and Fatigue in a Zr-Based Bulk Metallic Glass, pp. 343-354, 1999, with Permission from Materials Research Society.

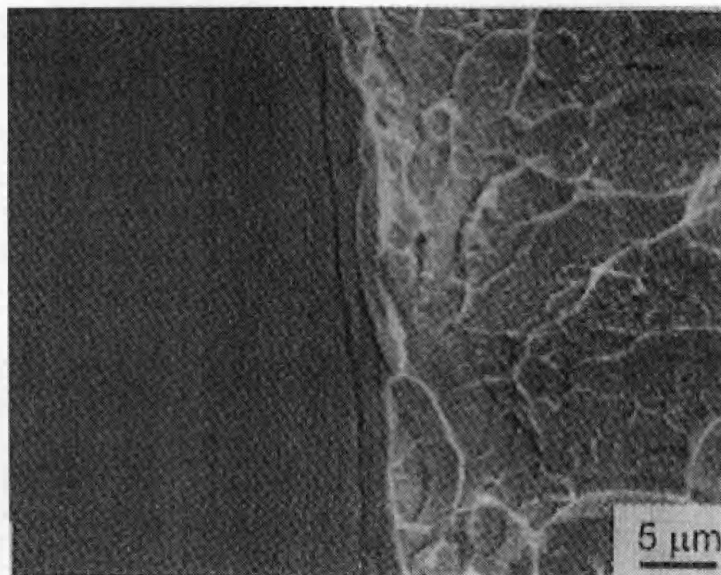
Figure A-44: Secondary Electron Image of the Division Between the Fatigue (Left) and Overload (Right) Fracture Surfaces. Reprinted from Materials Research Society: Bulk Metallic Glasses, Volume 554, C.J. Gilbert et al., Fracture and Fatigue in a Zr-Based Bulk Metallic Glass, pp. 343-354, 1999, with Permission from Materials Research Society.

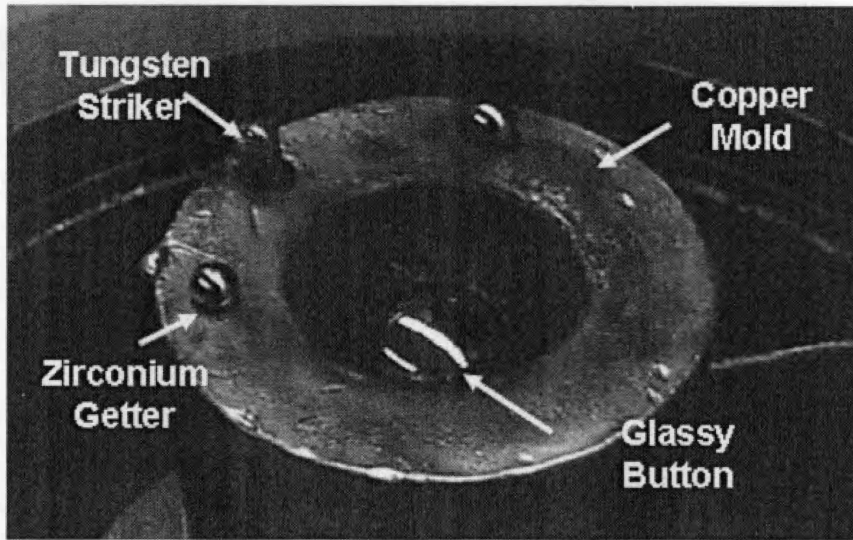
Figure A-47: BMG-11 Sample After Mixing by Arc Melting, but Before Drop Casting.

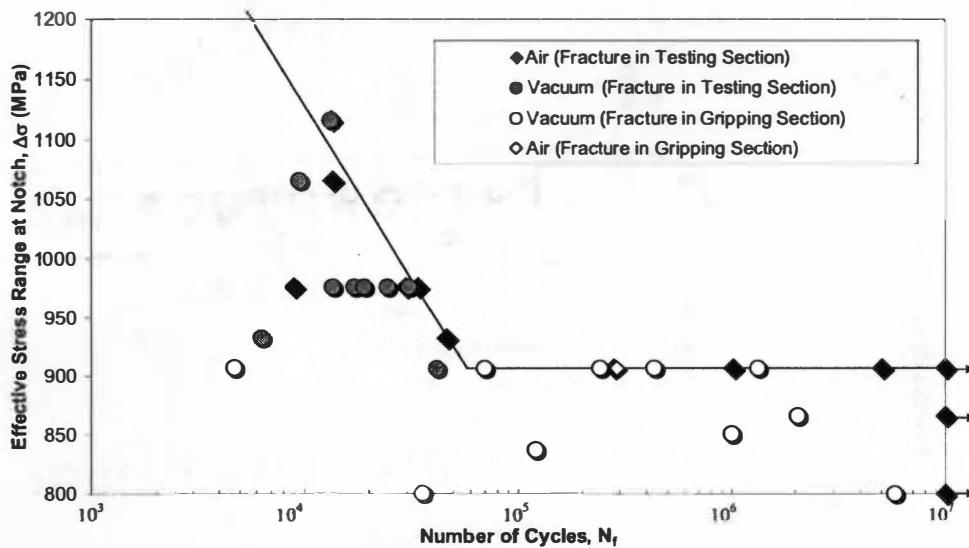
Figure A-60: Stress-Range / Fatigue-Life Data of Notched BMG-11 Specimens Tested in Air and Vacuum With the Results of the Fracture Location (Gripping Section Versus Testing Section). The R Ratio Was 0.1 and the Frequency Was 10 Hz.

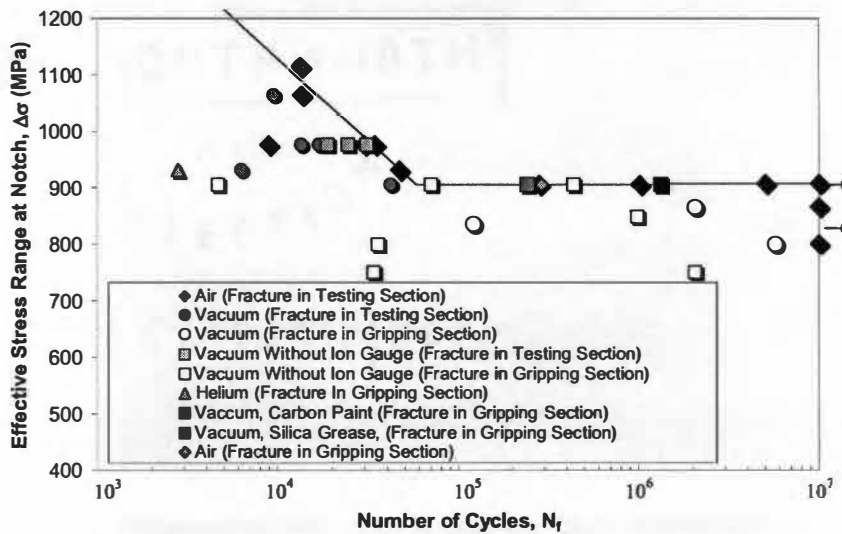
Figure A-63: Stress-Range / Fatigue-Life Data of Notched BMG-11 Specimens Tested in Air and Vacuum with All the Present Diversifications. The R Ratio Was 0.1 and the Frequency Was 10 Hz.

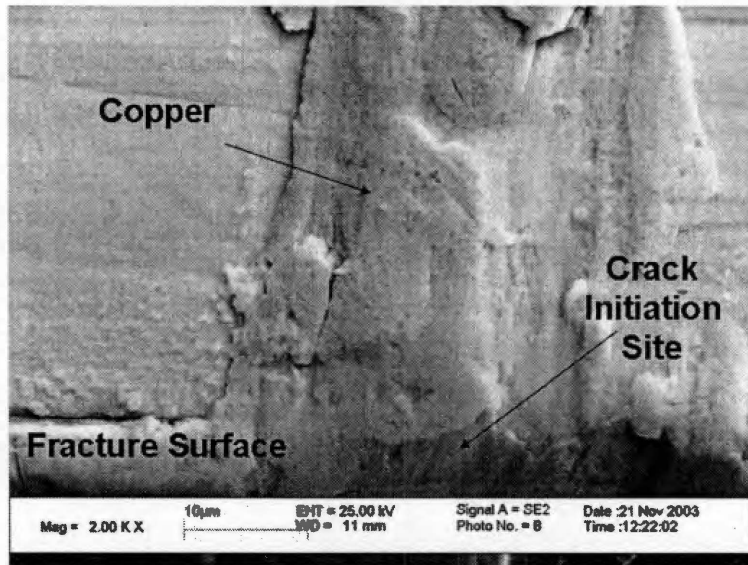
Figure A-65: Secondary Electron Image of Copper Smear Near the Crack Initiation Site.

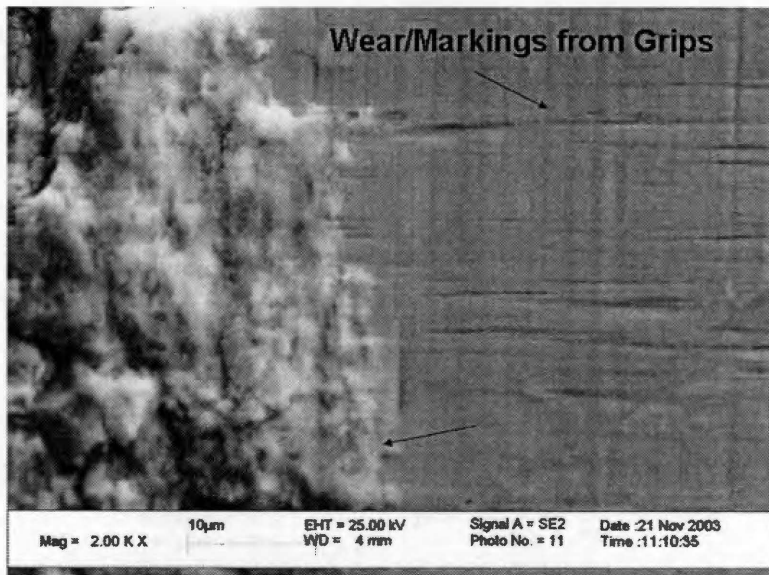
Figure A-66: Secondary Electron Image of Oxide Near Copper Grip Location of Sample Tested in Air.

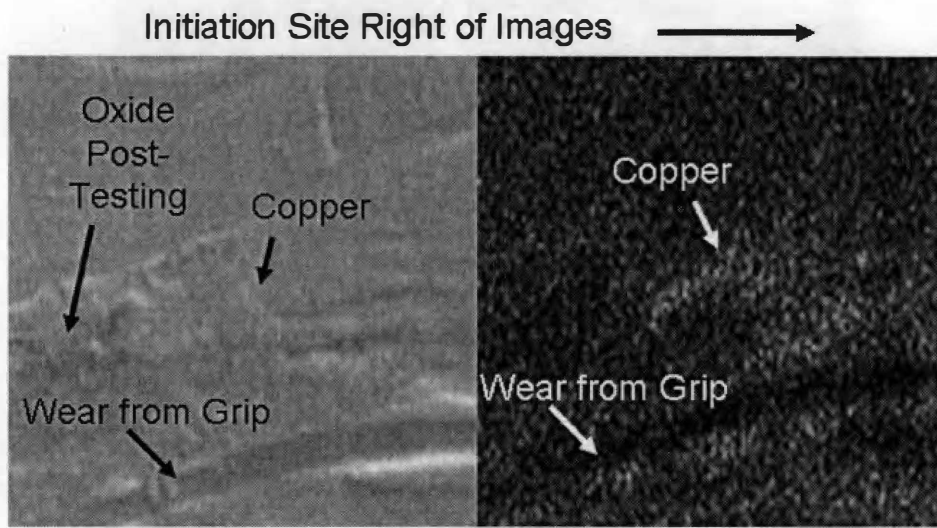
Figure A-67: Energy Dispersive Spectrum Map for K_{α} Copper Energy Level of the Outside Surface of the Round Bar Specimen. This Image Is Located at the Crack Initiation Site.

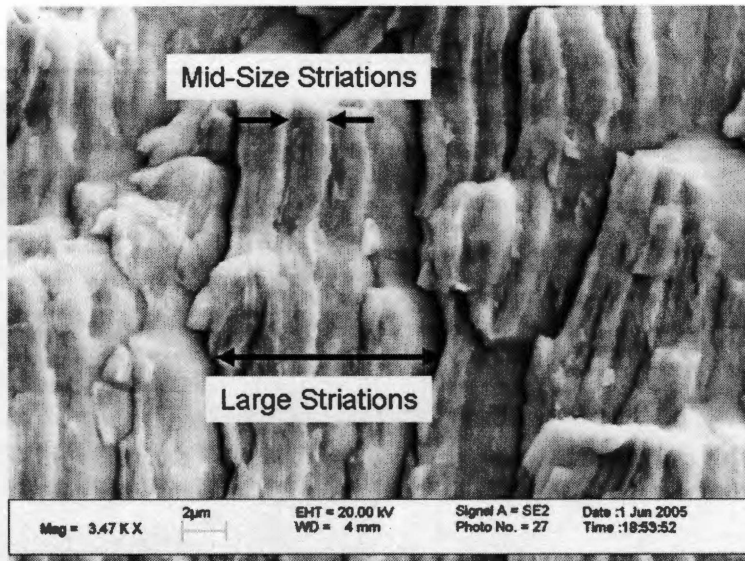
Figure A-69: Secondary Electron Image Illustrating Large and Mid-Size Striations. Small Striations Associated with Individual Cycles Are Not Labeled, But Are Visible as Well.

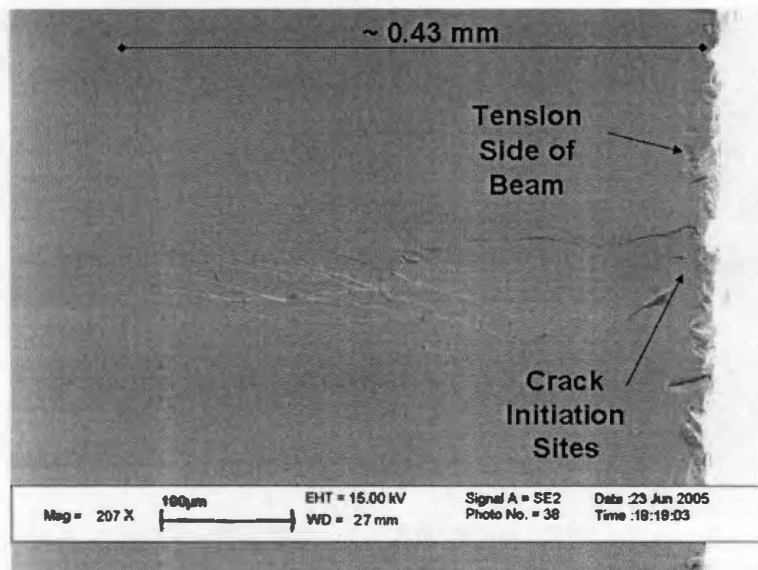
Figure A-70: Secondary Electron Image of Side Profile of Beam Specimen (The Right Side of the Image is the Tension Edge). Note the Angle of Most of the Micro-Cracks and Shear Bands.

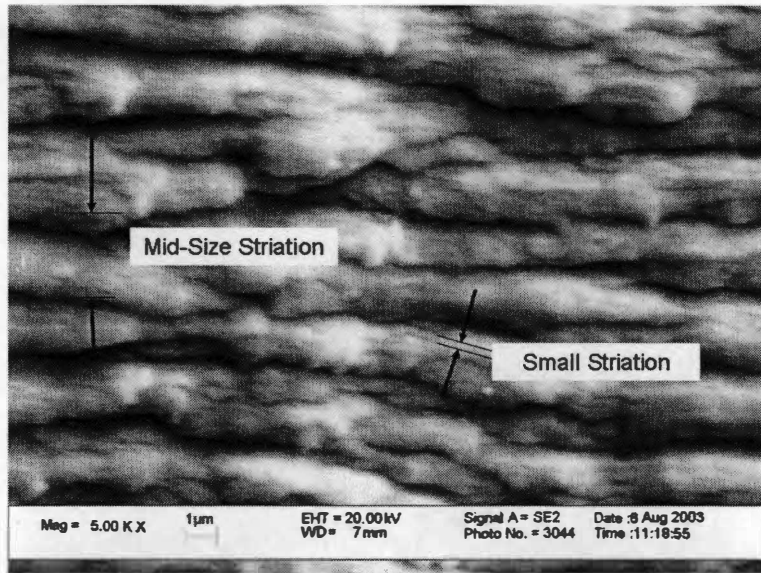
Figure A-71: Secondary Electron Image Illustrating Mid-Size and Small Striations. The Small Striations Are Associated with Individual Cycles.

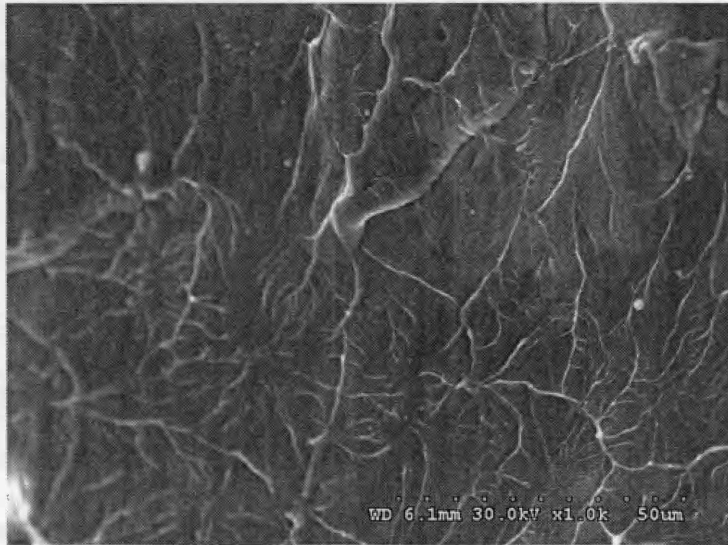
Figure A-73: Secondary Electron Image of the Vein Morphology Present in the Overload Fracture Surface of Sample 1 After Fatigue Test at 698 MPa.

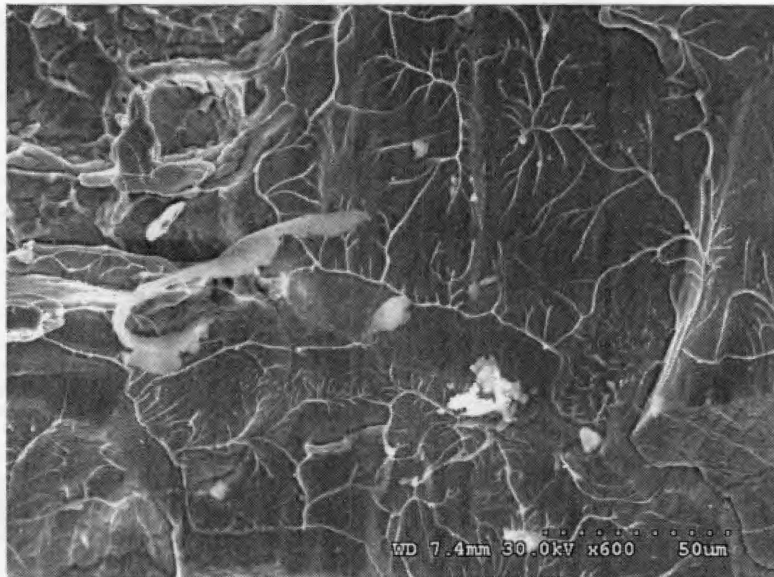
Figure A-74: Secondary Electron Image of the Vein Morphology Present in the Overload Fracture Surface of Sample 1 After Fatigue Test at 698 MPa.

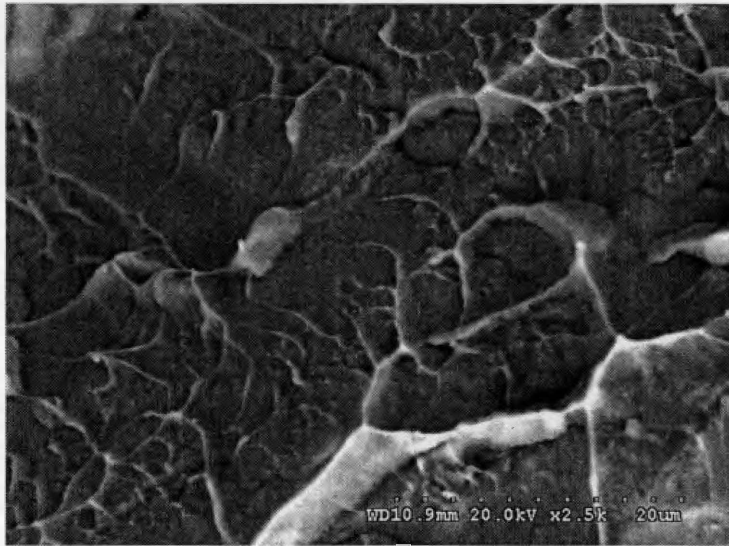
Figure A-75: Backscattered Electron Image of the Overload Fracture Surface of Sample 2 After Fatigue Test at 977 MPa.

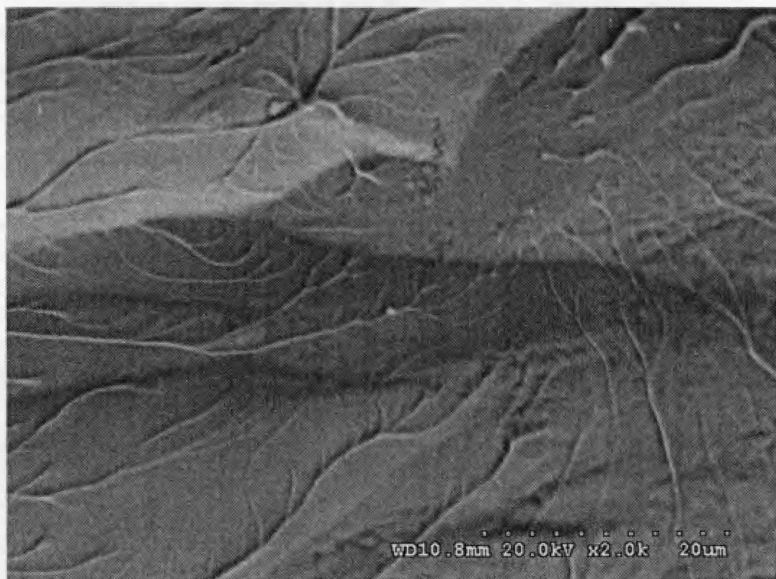
Figure A-76: Backscattered Electron Image of the Vein Morphology on the Shear Lip of Sample 2 After Fatigue Test at 977 MPa.

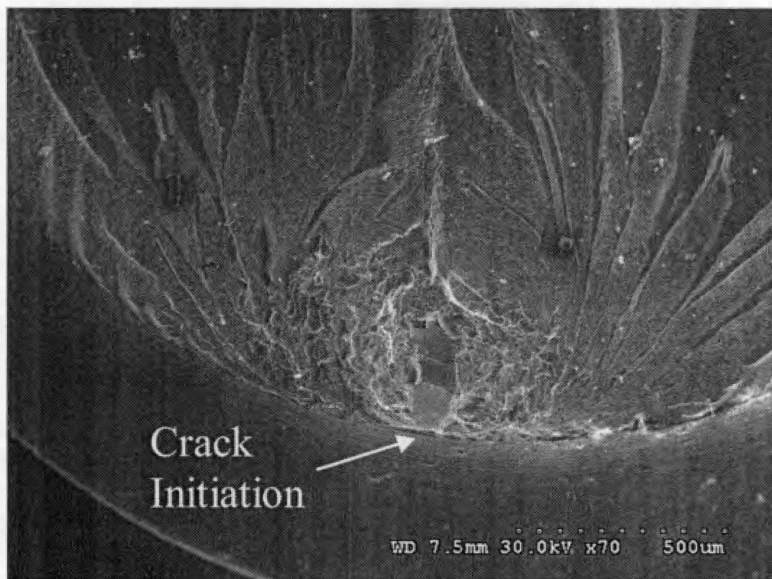
Figure A-78: Secondary Electron Image of the Fatigue Fracture Surface Around the Crack Initiation Site of Sample 1 After Fatigue Test at 698 MPa.

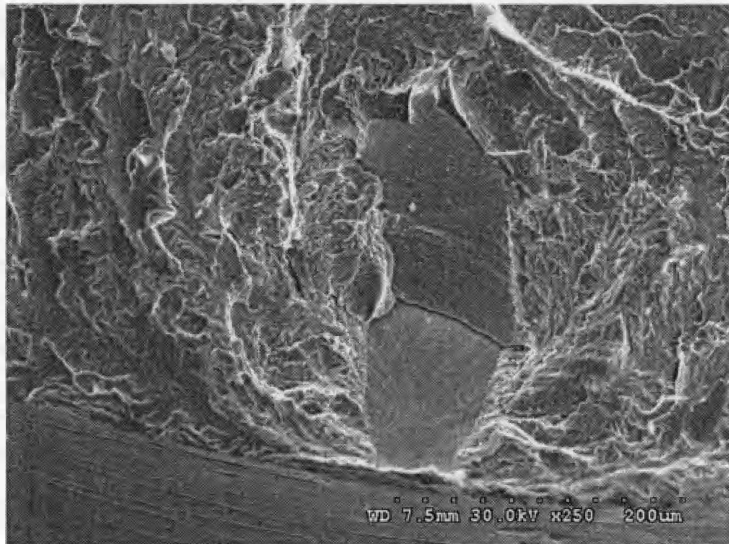
Figure A-79: Secondary Electron Image of the Crack Initiation Site of Sample 1 After Fatigue Test at 698 MPa.

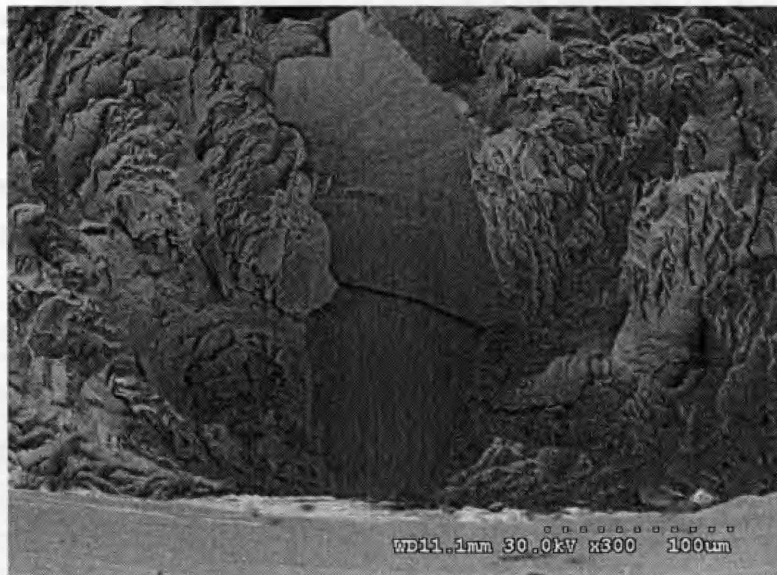
Figure A-80: Backscattered Electron Image of the Crack Initiation Site of Sample 1 After Fatigue Test at 698 MPa.

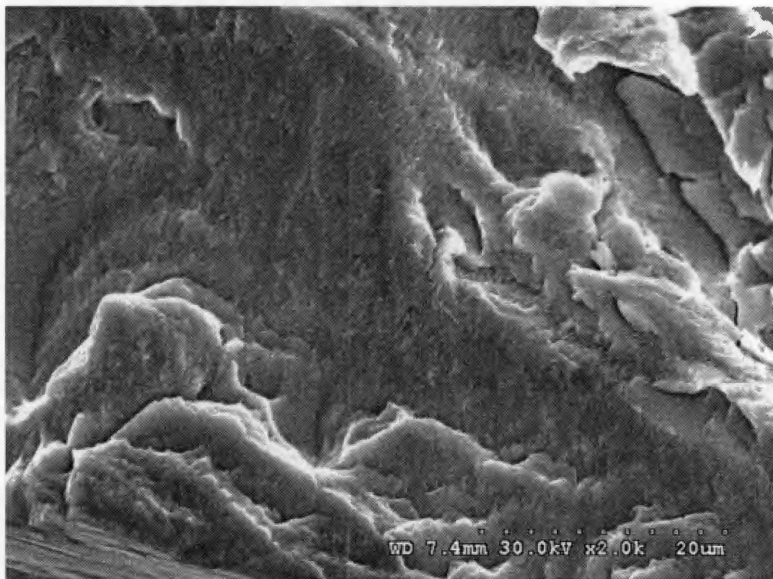
Figure A-82: Secondary Electron Image of the Area Surrounding the Crack Initiation Site (Left of the Site) of Sample 1 After Fatigue Test at 698 MPa.

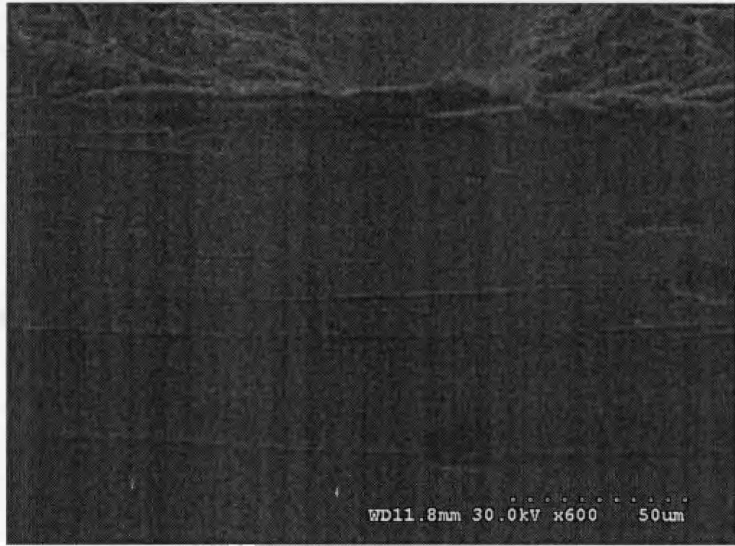
Figure A-83: Secondary Electron Image of the Outer Surface of the Crack Initiation Site at a 10° Tilt of Sample 1 After Fatigue Test at 698 MPa.

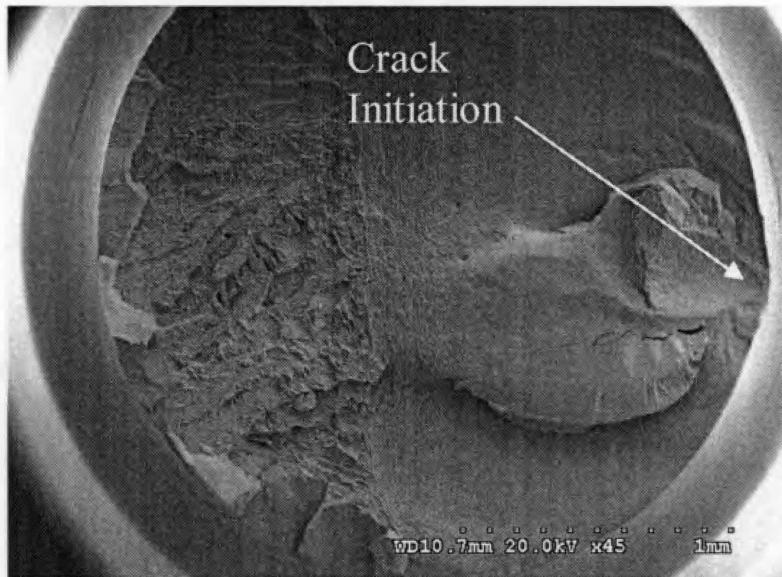
Figure A-84: Secondary Electron Image of the Fracture Surface of Sample 2 at Low Magnification After Fatigue Test at 977 MPa.

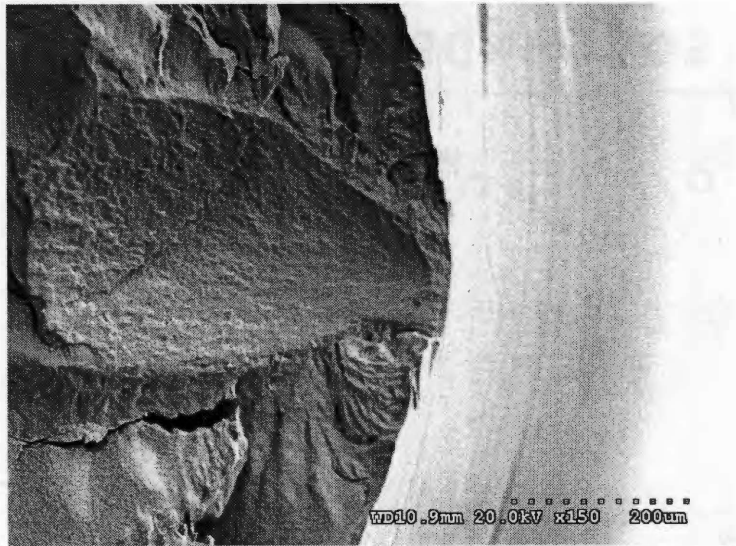
Figure A-85: Secondary Electron Image of the Crack Initiation Site of Sample 2 After Fatigue Test at 977 MPa.

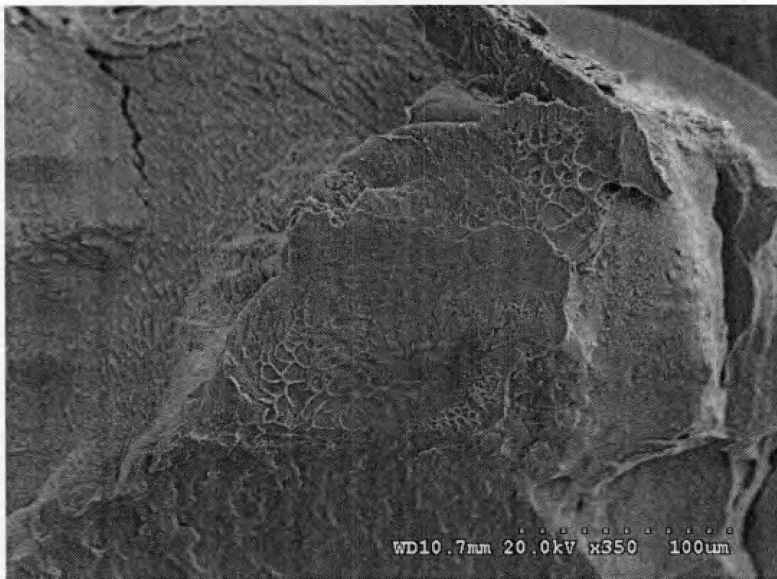
Figure A-86: Secondary Electron Image of the Protrusion in Proximity of the Crack Initiation Site (Right of Protrusion) of Sample 2 After Fatigue Test at 977 MPa.

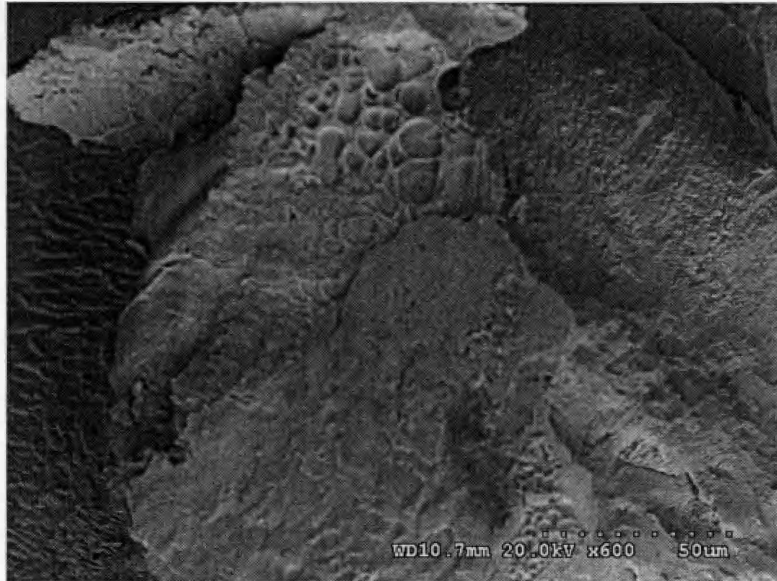
Figure A-87: Backscattered Electron Image of the Plateau of the Protrusion of Sample 2 After Fatigue Test at 977 MPa.

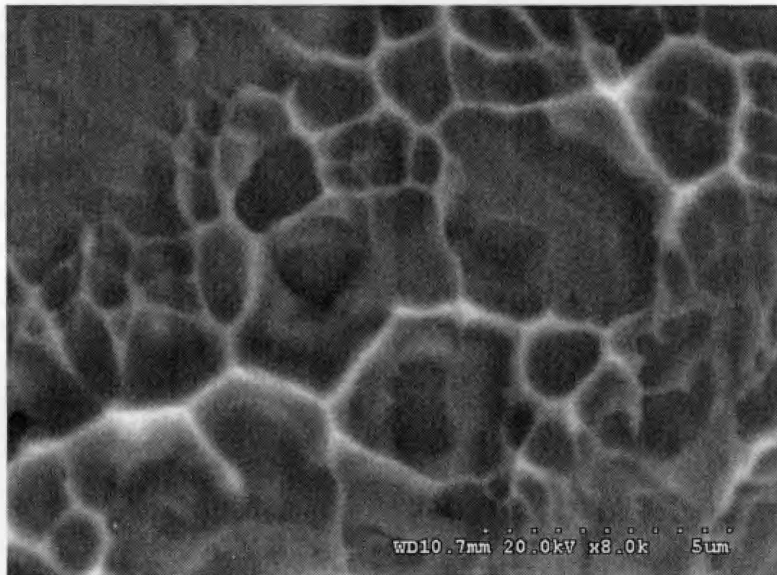
Figure A-88: Backscattered Electron Image of the Dimpling Found on the Top of the Plateau of Sample 2 After Fatigue Test at 977 MPa.

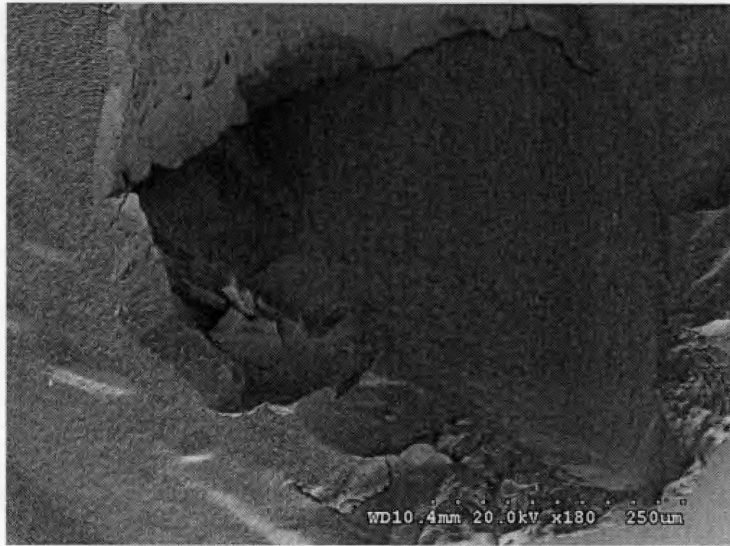
Figure A-91: Backscattered Electron Image of the Crack Initiation Site (Opposite Half) of Sample 2 After Fatigue Test at 977 MPa.

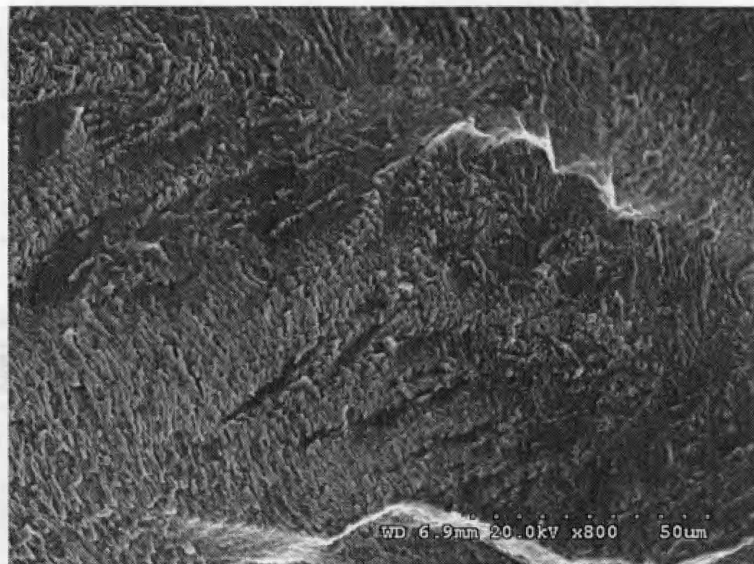
Figure A-92: Secondary Electron Image of the Depression of Sample 2 After Fatigue Test at 977 MPa.

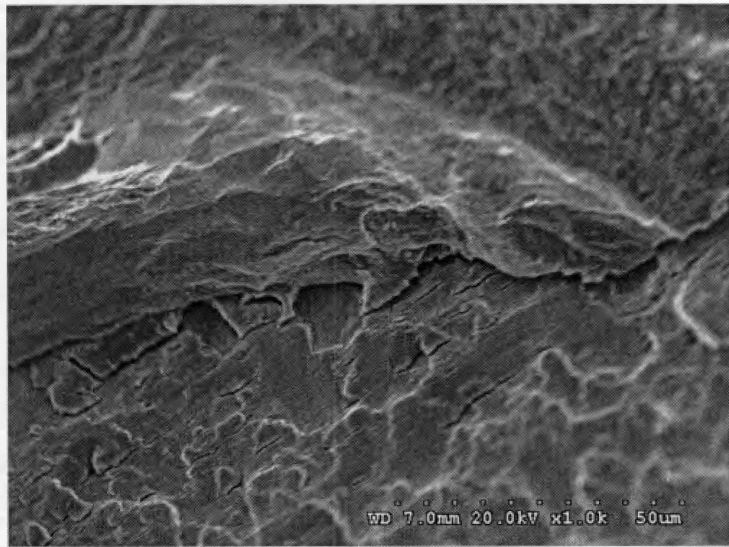
Figure A-93: Secondary Electron Image of Crack Branching at Bottom of Depression (Opposite Half) of Sample 2 After Fatigue Test at 977 MPa.

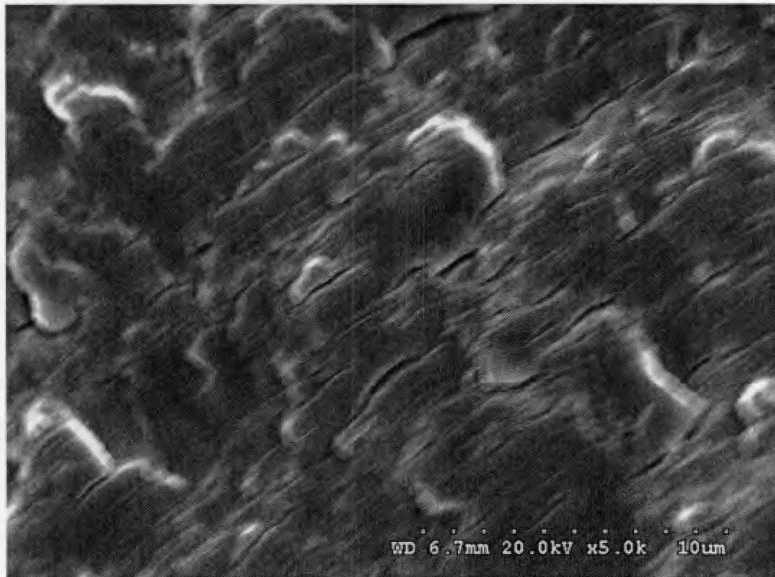
Figure A-94: Secondary Electron Image of Crack Branching of Sample 2 After Fatigue Test at 977 MPa.

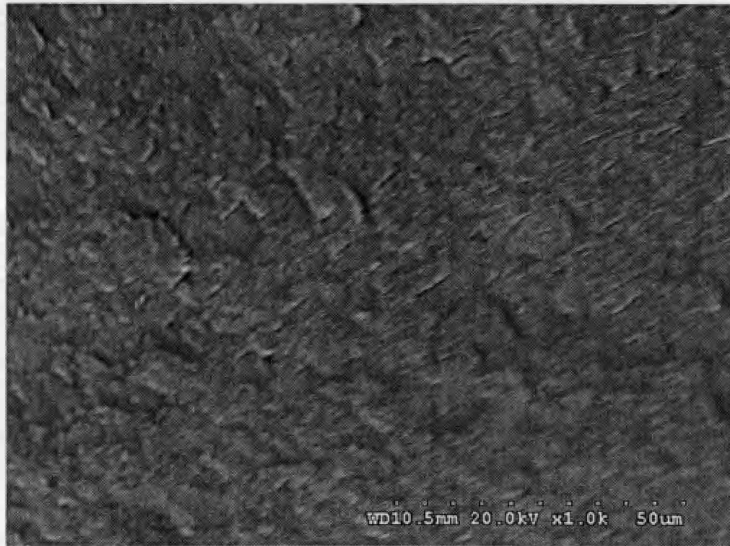
Figure A-95: Backscattered Electron Image of Crack Branching (Estimated Location of Dimpling) of Sample 2 After Fatigue Test at 977 MPa.

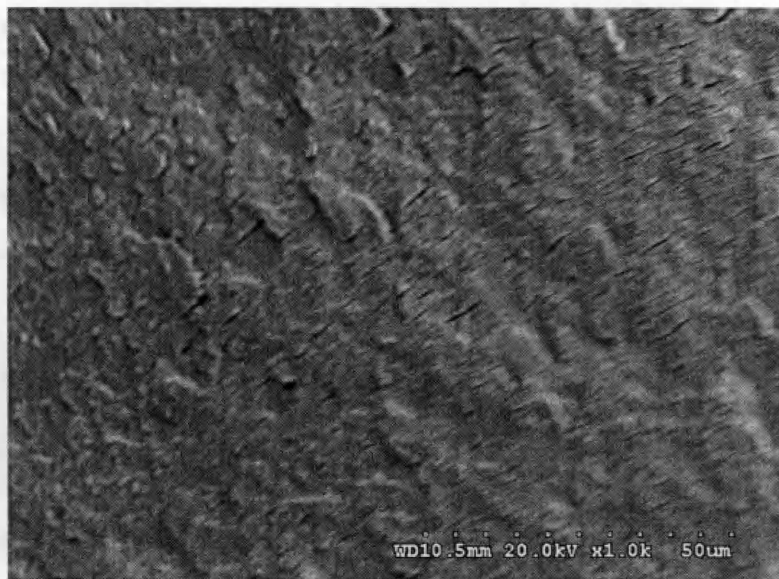
Figure A-96: Secondary Electron Image of Crack Branching (Estimated Location of Dimpling) of Sample 2 After Fatigue Test at 977 MPa.
