Doctoral Dissertations

Fatigue Behavior of a Zirconium-Based Bulk Metallic Glass

William Hutchison Peter
University of Tennessee, Knoxville

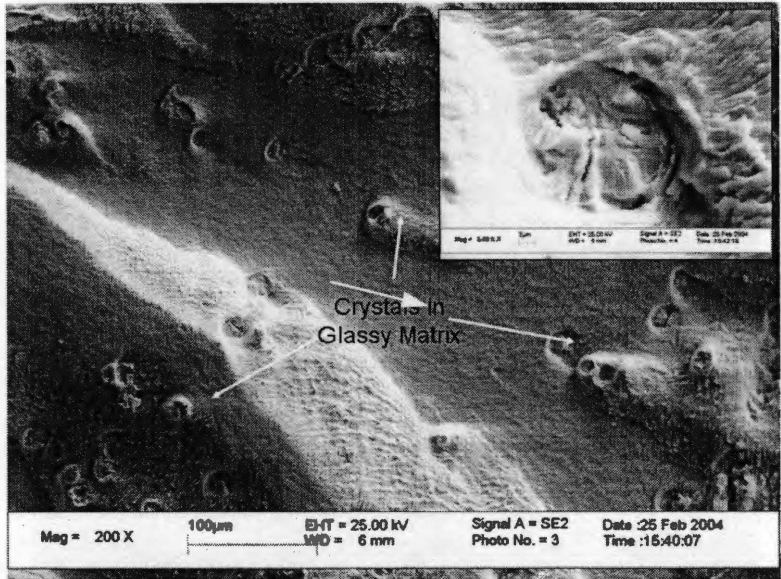
Figure A-97: Secondary Electron Images of Crystals in an As-Cast Amorphous Alloy. Crystals Are Either Protrusions Or Depressions. Higher Magnification of a Depression Is Inset.

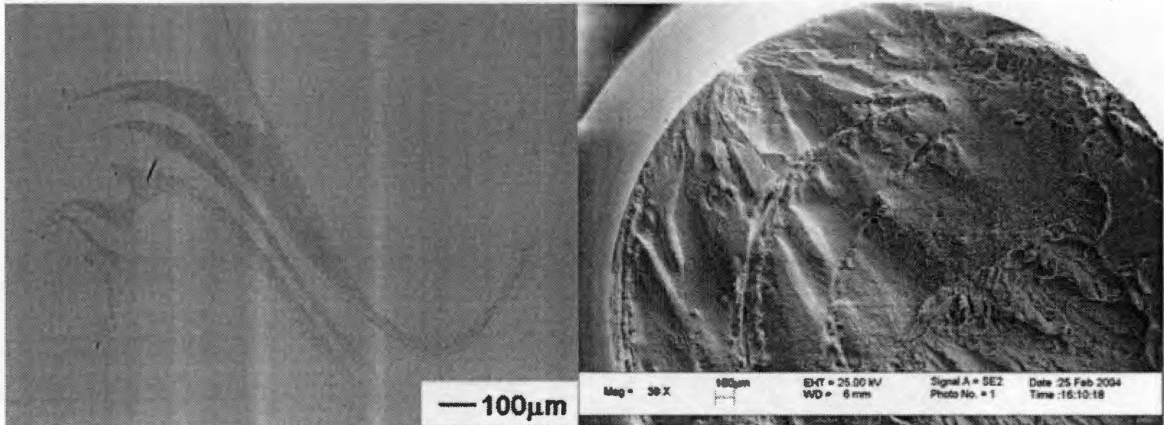
Figure A-98: Optical Microscopy Image of Crystalline Band in Polished and Etched BMG-11 Sample (Left) And Secondary Electron Image of Fracture Surface of Fatigue Sample Tested in Air (Right).

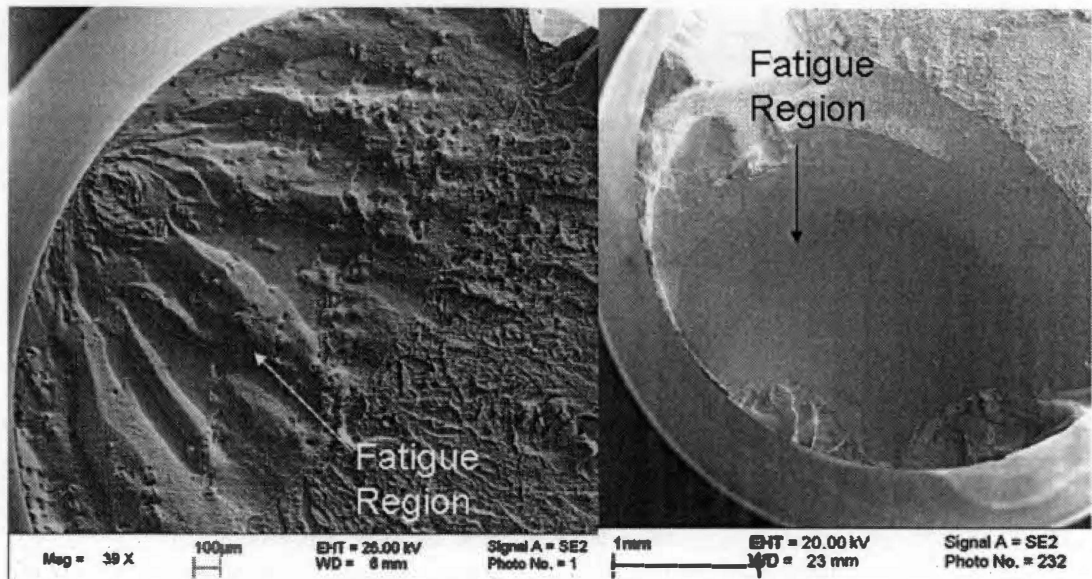
Figure A-99: Secondary Electron Images of Air Sample Tested at 907 MPa for $N_f = 282,785$ Cycles (Left), and Vacuum Sample Tested at 750 MPa for $N_f = 5.8$ Million Cycles (Right).

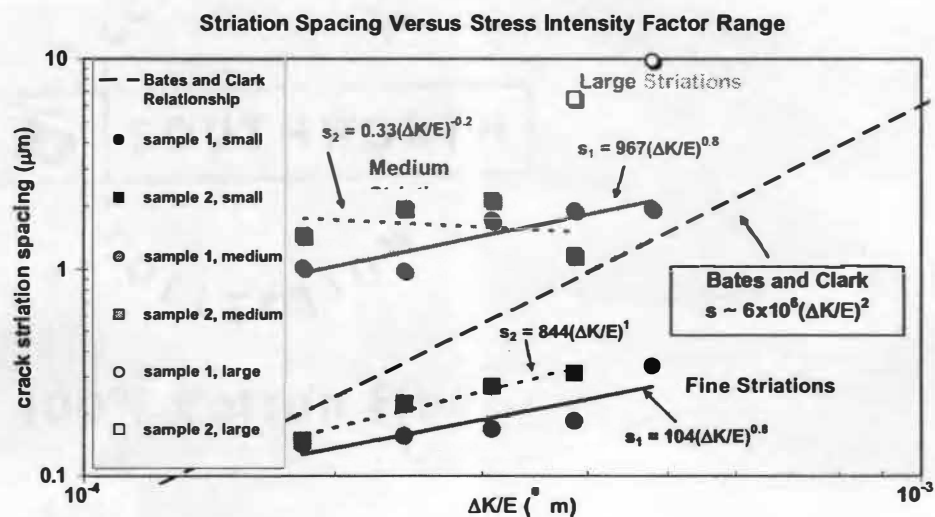
Figure A-100: Crack Striation Spacings for Small, Medium, and Large Striations of Two Samples Tested in Air Versus the Stress Intensity Range Divided by Young's Modulus. Results Are Displayed with the Bates and Clark Relationship [96] for Conventional Crystalline Materials.

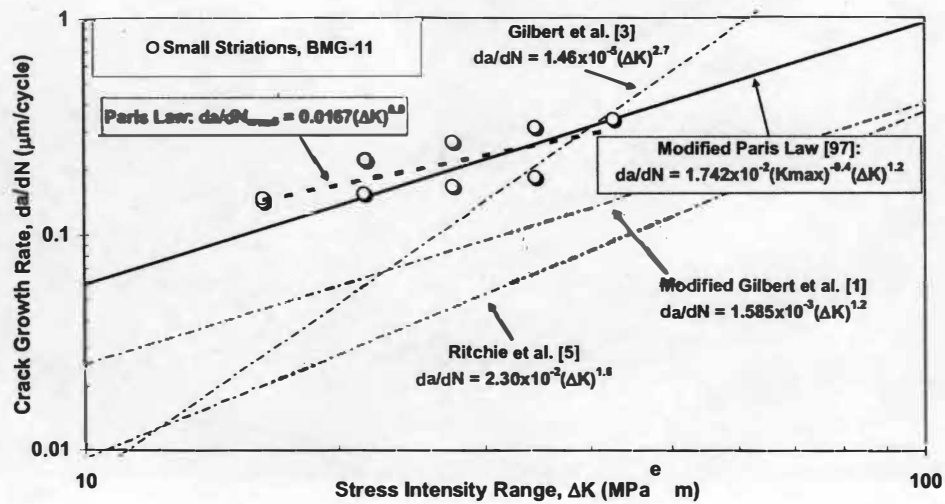
Figure A-101: Crack Growth Rates for Small Striations of Two Samples Tested in Air Versus the Stress Intensity Range. Results Are Compared with Gilbert et al. [1,3] and Ritchie et al. [5].

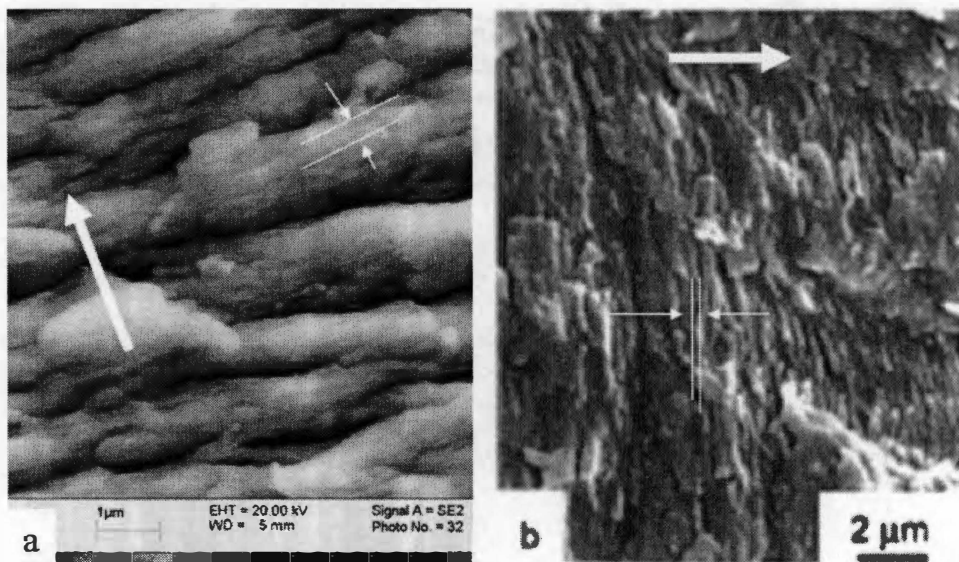
Figure A-102: Secondary Electron Images of Fatigue Striations. Striations Seem to Be Associated with Individual Cycles in BMG-11 on the Left (a), and Viterloy 1 [5] on the Right (b). Modified from Intermetallics, Volume 8, RO Ritchie et al., Fracture, Fatigue and Environmentally-Assisted Failure of a Zr-Based Bulk Amorphous Metal, p. 471, with Permission from Elsevier.

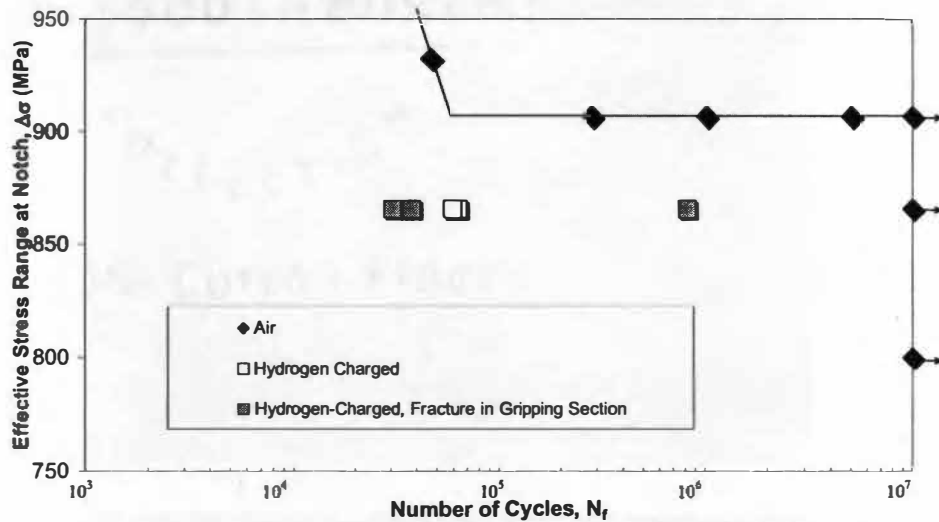
Figure A-103: Stress-Range / Fatigue-Life Data of Notched BMG-11 Specimens Tested in Air, but Cathodically-Charged with Hydrogen. The R Ratio Was 0.1 and the Frequency Was 10 Hz.

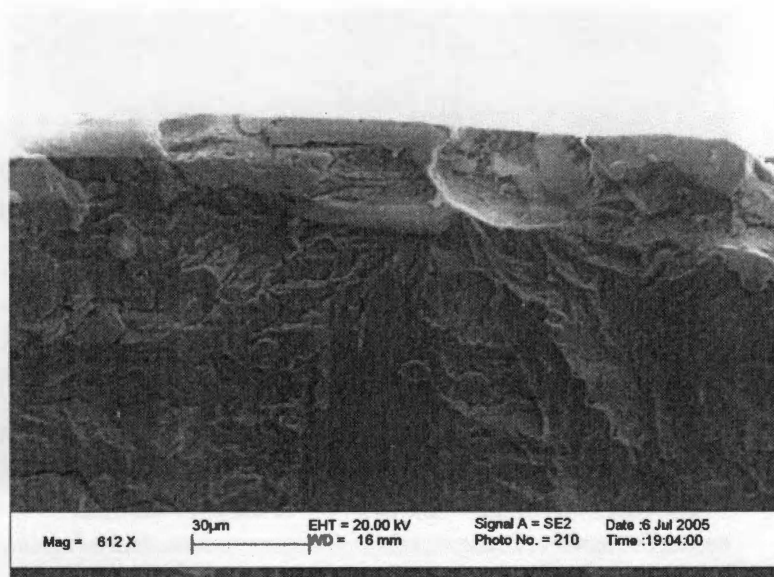
Figure A-104: Secondary Electron Image of Crack Initiation Surface of a Specimen Tested in Air, but Cathodically-Charged with Hydrogen.

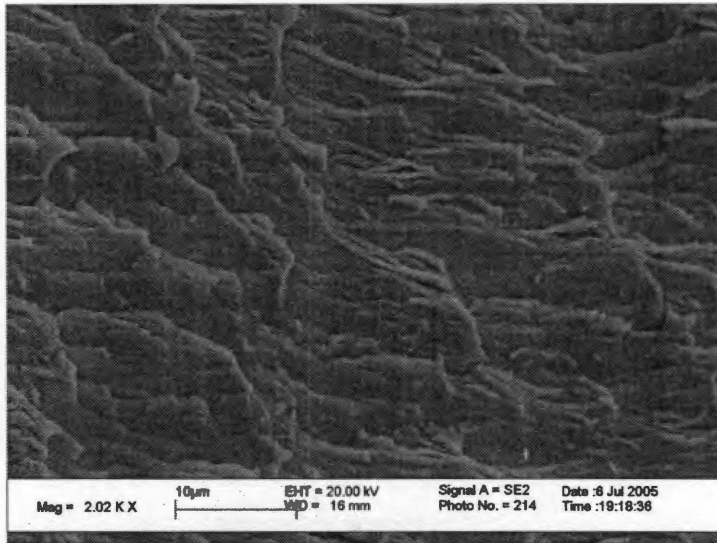
Figure A-105: Secondary Electron Image of the Fatigue Surface of a Specimen Tested in Air, but Cathodically-Charged with Hydrogen.

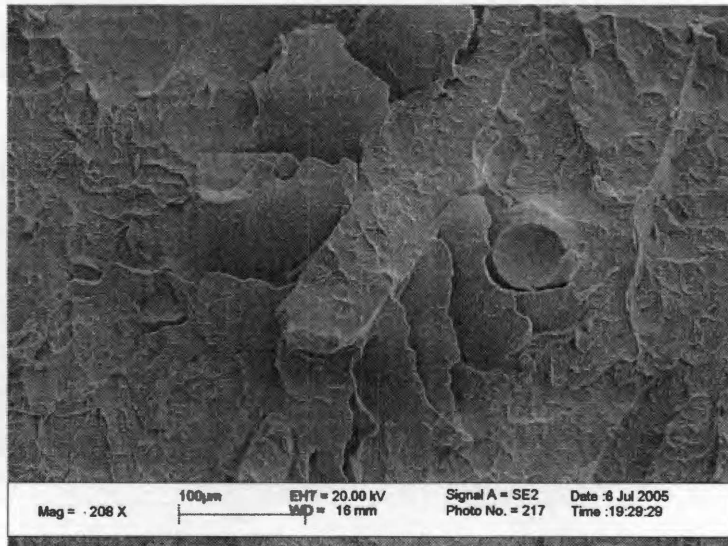
Figure A-106: Secondary Electron Image of Overload Fracture Surface of a Specimen Tested in Air, but Cathodically-Charged with Hydrogen. Note Unusual Peeled-Like Morphology.

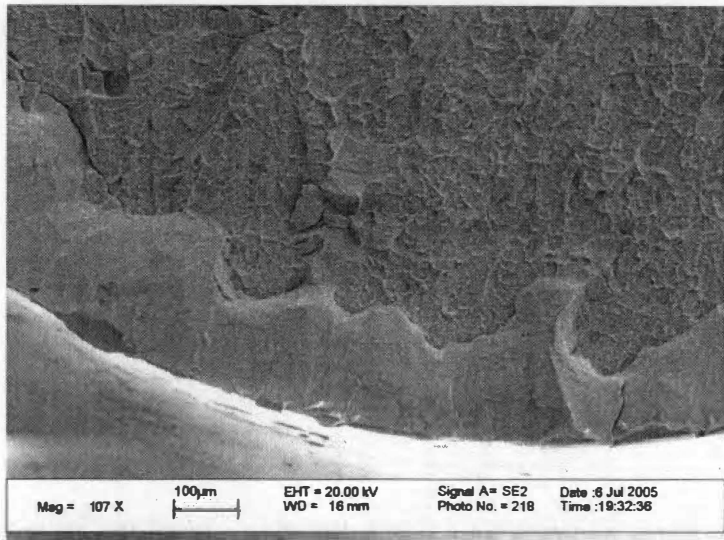
Figure A-107: Secondary Electron Image of a Shear Lip of a Specimen Tested in Air, but Cathodically-Charged with Hydrogen.

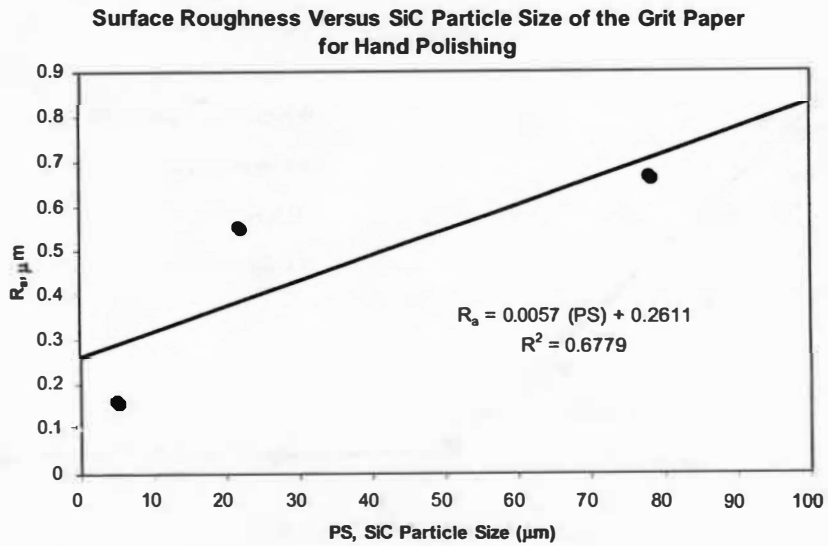
Figure A-110: Surface Roughness, R_a , Versus Particle Size of Silicon Carbide Grinding Paper for BMG-11.

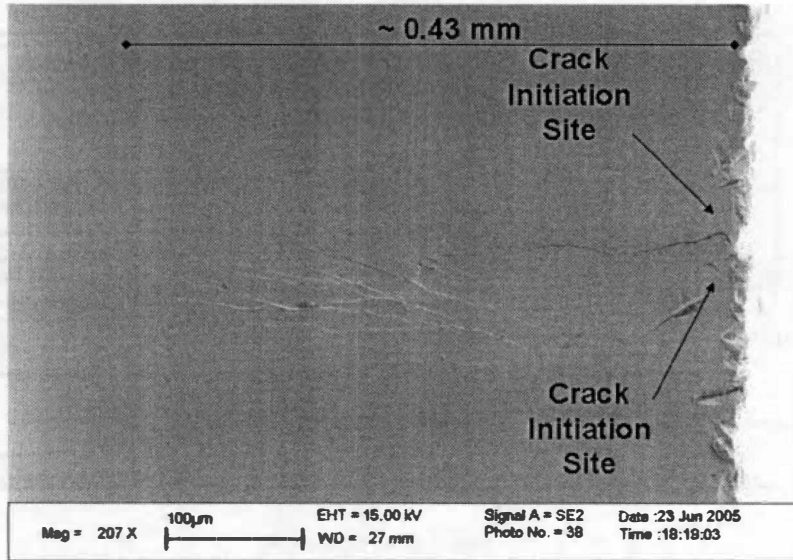
Figure A-114: Secondary Electron Image of Crack in a Square Beam, 3-Point Bend Specimen Finished with 180 Grit Paper.

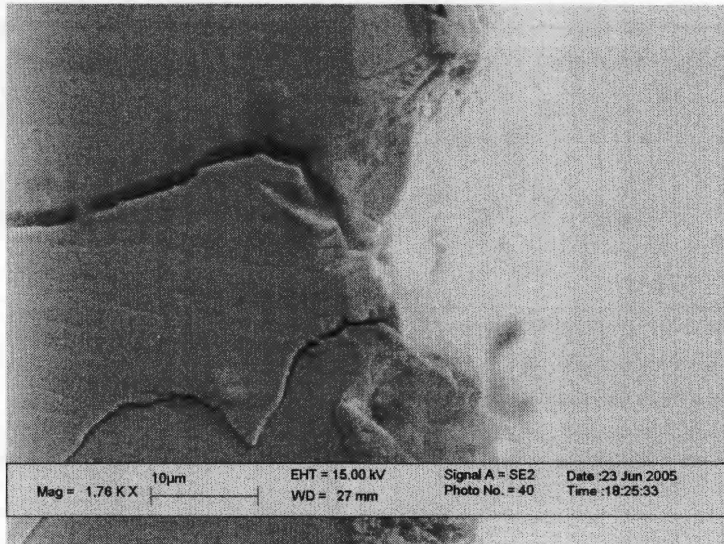
Figure A-115: Secondary Electron Image of the Two Crack Initiation Locations in a Square Beam, 3-Point Bend Specimen Finished with 180 Grit Paper.

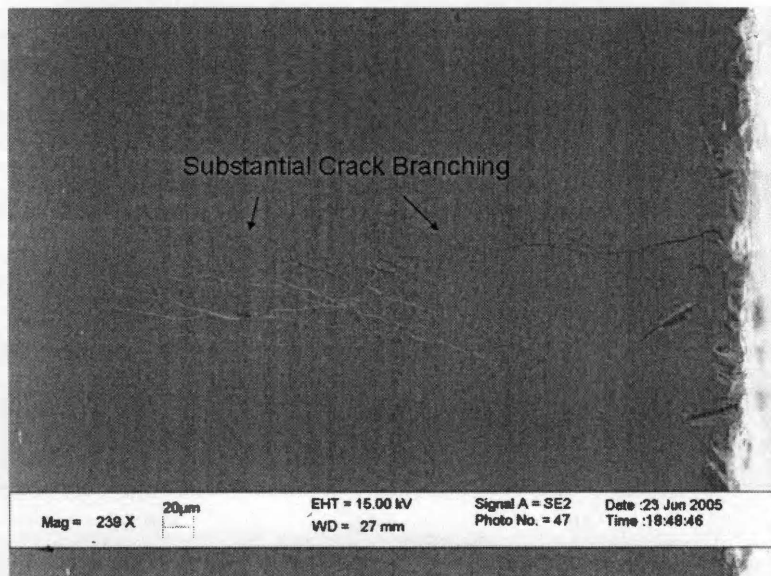
Figure A-116: Secondary Electron Image of the Severe Crack Branching that Occurs to a Square BMG-11 Beam Tested in 3-Point Bending with 180 Grit Paper Finish.

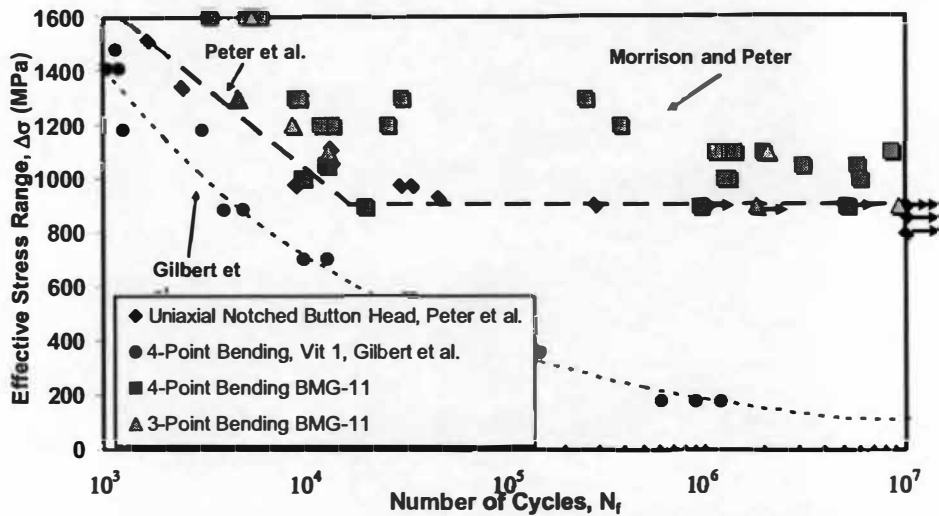
Figure A-117: Stress-Range / Fatigue-Life Data of 3-Point Bending [101], 4-Point Bending [100], and Uniaxial BAM-11 Specimens Tested in Air [6,7]. Gilbert et al.'s 4-Point Bending Results for Vit. 1 Are Included [1-5]. The R Ratio Was 0.1 and the Frequency Was 10 Hz.

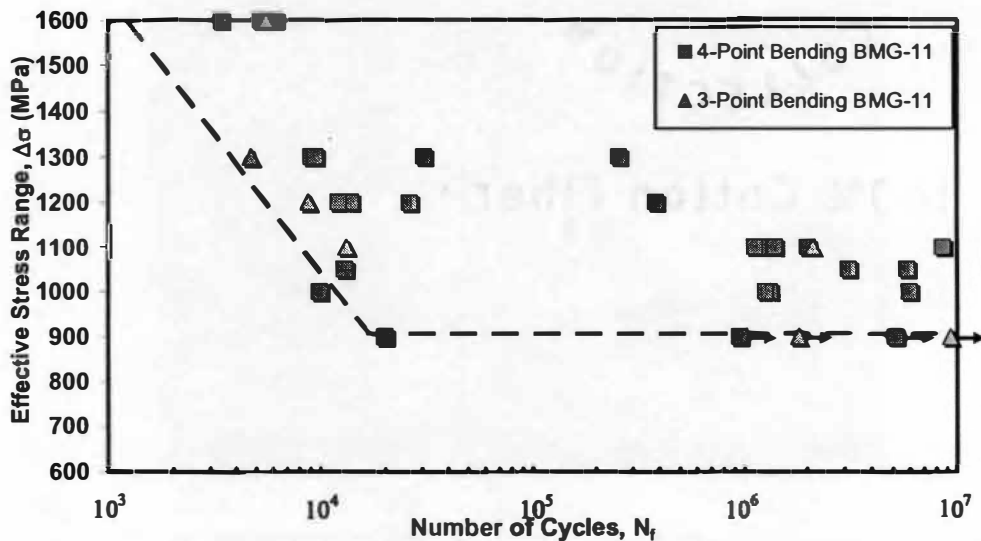
Figure A-118: Stress-Range / Fatigue-Life Data of 3-Point Bending [101] and, 4-Point Bending [100]. Arrows Indicate the Sample Did Not Fracture. The R Ratio Was 0.1 and the Frequency Was 10 Hz.

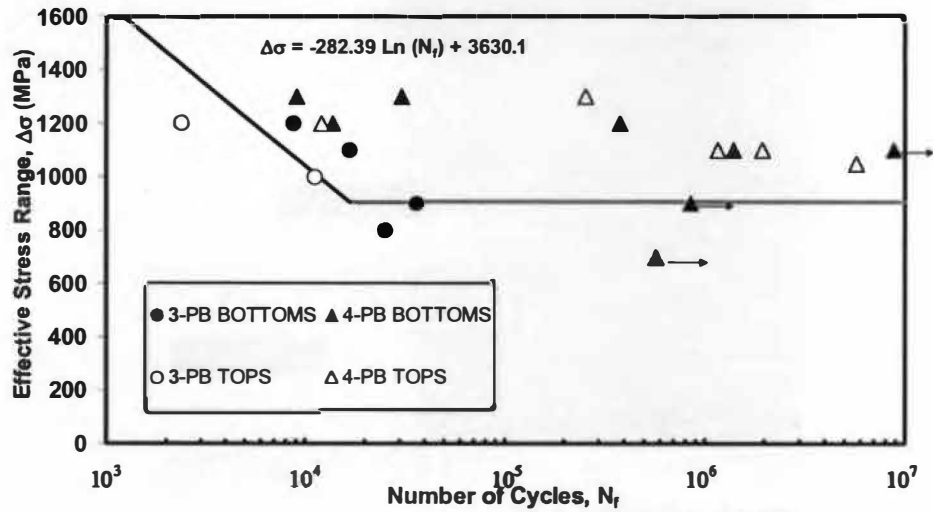
Figure A-119: Stress-Range / Fatigue-Life Data of 3-Point Bending and 4-Point Bending BMG Specimens Tested in Air Designating Whether the Sample Came from the Top or the Bottom of the Ingot. The R Ratio Was 0.1 and the Frequency Was 10 Hz.

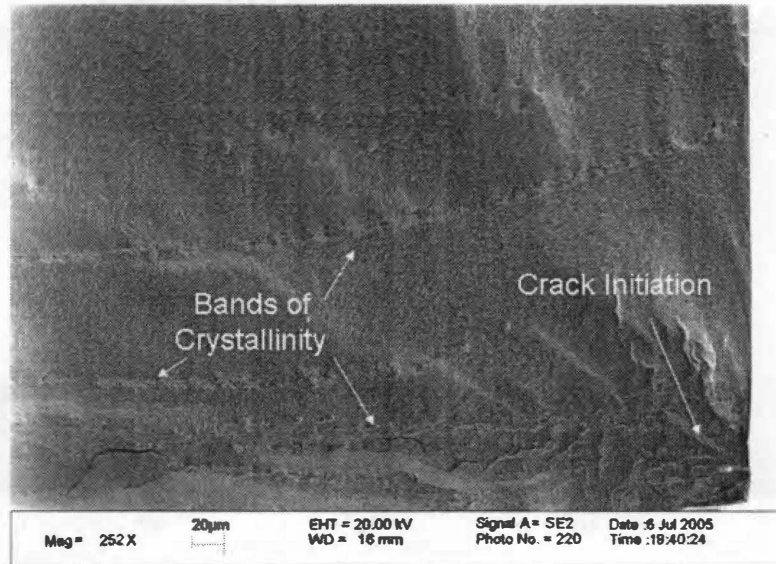
Figure A-120: Secondary Electron Image of Fracture Surface in the Fatigue Region of 3-Point Bend Specimen that Failed Near 13,000 Cycles. Notice Crystalline Band Running Near the Crack-Initiation Site. Another Sample from the Same Ingot Underwent Over 1 M Cycles.

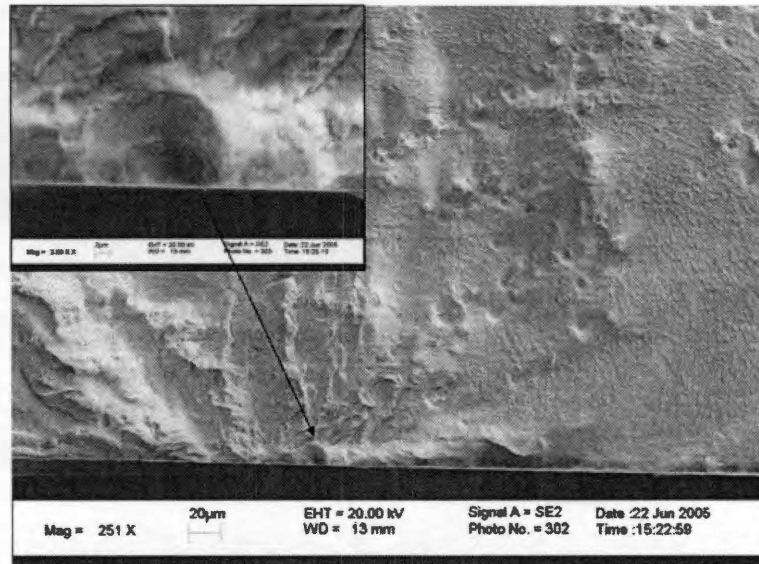
Figure A-126: Secondary Electron Images of Fatigue Area of Fracture Surface of Specimen T4. Crack Initiated at a Crystal.
