An Evaluation of the Design Requirements of the H-1 Upgrades Helicopter Blade Fold Racks

Matthew D. Funk

**AN EVALUATION OF THE DESIGN REQUIREMENTS OF THE
H-1 UPGRADES HELICOPTER BLADE FOLD RACKS**

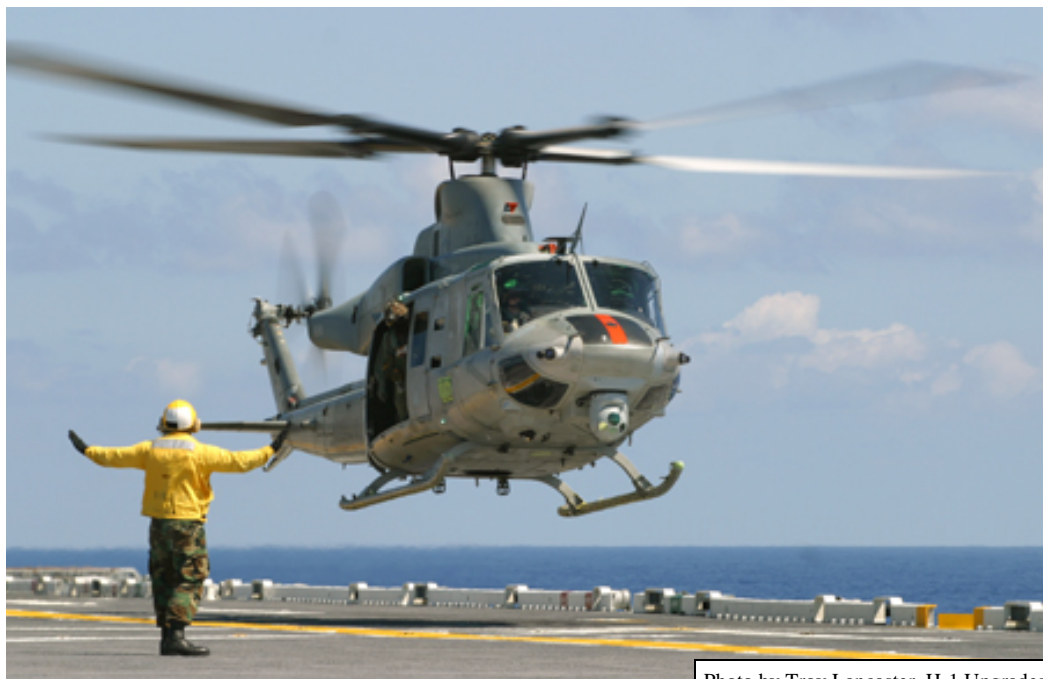
FIGURE 2: UH-1Y IROQUOIS

The UH-1Y Iroquois was a dual piloted utility helicopter with a 4-bladed single main rotor and an anti-torque tail rotor, powered by two T700-GE-401C turbo-shaft engines. The drive system of the UH-1Y was identical to the AH-1Z, which included the main rotor, transmission, tail rotor drive system, and tail boom. The UH-1Y also had a new fuel system with 380 gallons of internal fuel, provisions for 10 newly developed crashworthy troops seats, and a permanent fast rope installation. In addition, the UH-1Y was equipped with a new integrated cockpit that included upgrades to the communication, navigation, and electronic warfare systems. The UH-1Y also had a four axis stability and control augmentation system. The UH-1Y length with rotors turning was approximately 58 feet, and the height to the top of the main rotor hub was 13 feet 3 inches. Maximum gross weight, jacking weight, and towing weight was 18,500 pounds. Specification mission takeoff gross weights for the UH-1Y ranged from 17,603 pounds to 18,098 pounds. A complete description of the UH-1Y aircraft is contained references 1 and 3. One of the test aircraft, Bu No. 166476, is pictured in Figure 2.

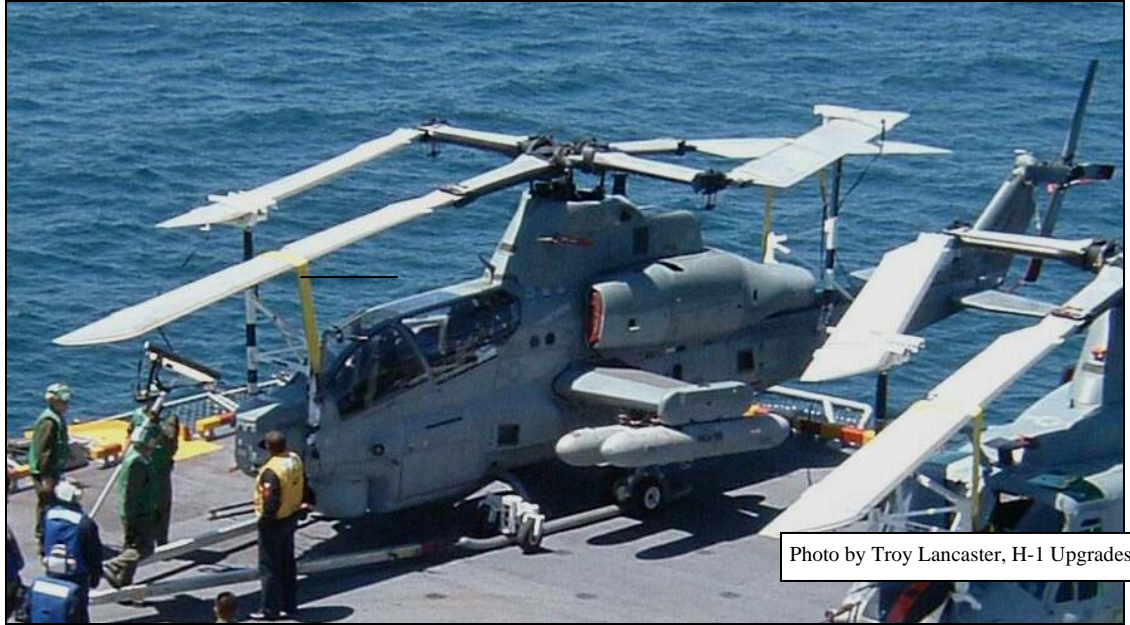
FIGURE 4: AH-1Z IN THE NORMAL WEATHER CONFIGURATION

The blade fold support equipment was designed to work with several configurations. The first, and most common configuration was the “normal weather” configuration. This was the fastest folded condition to apply and was versatile enough to suffice in nearly all weather conditions. In the normal weather configuration, the blue and red blades are folded and secured in the BFRs, while the orange and green blades remain unfolded and are secured by a large nylon strap to the BFR. The normal weather configuration was designed to restrain the rotor in winds up to 60 knots in any direction,

as well as during aircraft movement and elevator operations. The straps, used only in the normal weather configuration, were yellow, and are shown in Figure 4.

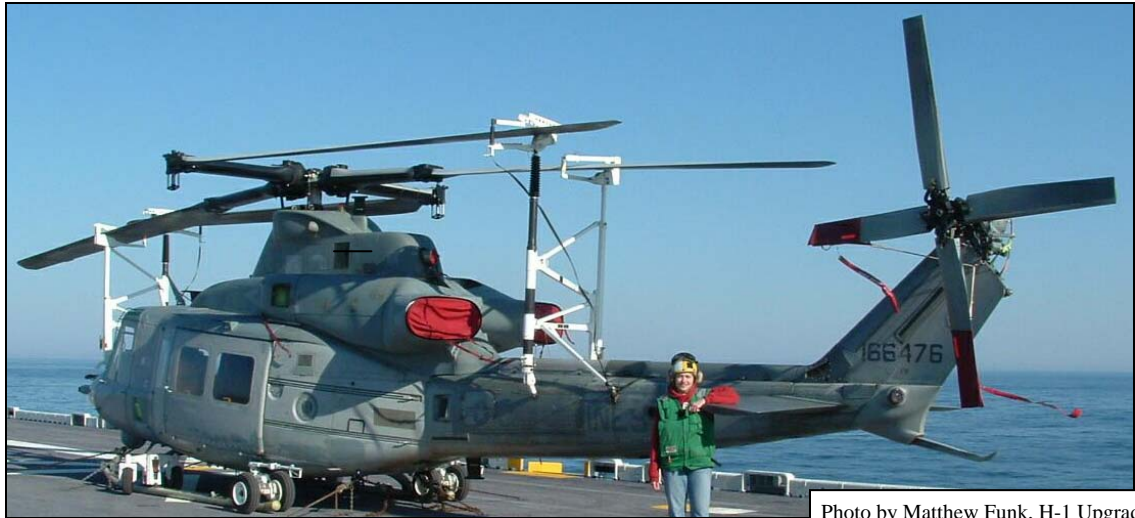
FIGURE 5: UH-1Y IN THE HEAVY WEATHER CONFIGURATION

The other configuration often used was the heavy weather configuration. In the heavy weather configuration, the blue and red blades are folded and secured by the BFRs, as in the normal weather configuration, but the orange and green blades are also secured by the secondary racks of the BFRs, which had to be added to the strongback. The orange and green blades remained unfolded and aligned fore and aft. This configuration of the SE was designed to withstand winds up to 100 knots in any direction. This required that in the heavy weather configuration, all four main rotor blades were secured by locking jaws on a rigid metal frame. In Figure 5, the heavy weather racks can be seen securing the unfolded blades of the main rotor. Because the heavy weather jaws were not

provided jacking, the orange and green blades had to be lifted into place using the blade support pole. The heavy weather jaws are the lower rack on both the front and rear BFR.

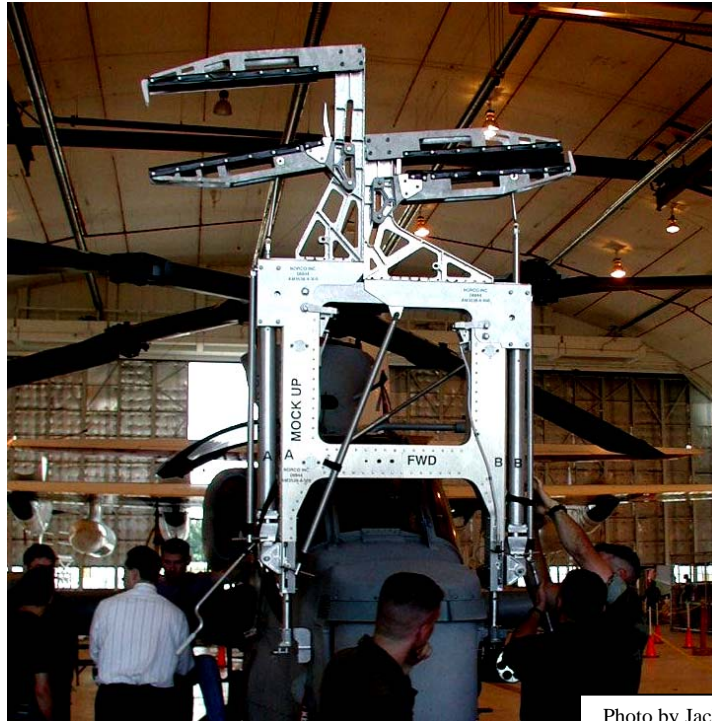
FIGURE 9: ORIGINAL BFR DESIGN

The initial design of the BFRs, shown in Figure 9, was created by Norco, Inc., and delivered in 2002. The racks did not meet the majority of the users' requirements and were too large and cumbersome for safe installation. This failure was the first sign of difficulty in development of a satisfactory BFR. The H-1 Upgrades team and BHTI collectively decided that not only were the racks too deficient for fielding, but that an entirely new design was required. In addition, a "tiger team" was assembled of senior government and contractor personnel that determined that the best course of action was for Bell Aero, a division of BHTI, to build the racks. Little space in this paper is devoted to the initial Norco design, because it was delivered and rejected before the author came aboard the program. Nevertheless, it is notable that the first attempt to design a set of blade fold racks with the given design requirements was a complete failure, and modification was not feasible. The first iteration was so bad that it was scrapped completely. It is also notable that the original design is similar in form to the final BFE.

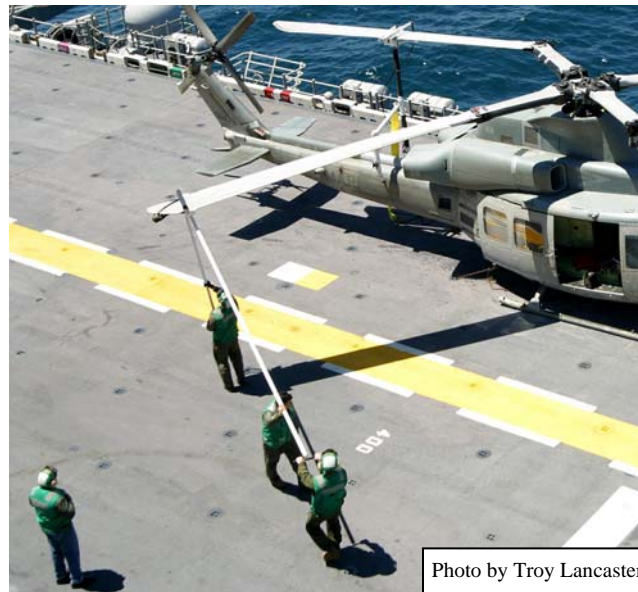
FIGURE 10: BLADE SUPPORT POLE AND BLADE HANDLING POLE IN USE

blade-handling pole applying the force. In addition, while aboard ship, the blades on one side of the aircraft are not over the flight deck so application of force on the outboard blades was impossible. The blade handling pole can be seen in use in Figure 10.

The results of this approach were that 1) an additional piece of equipment was required to the already cumbersome list of equipment, 2) an additional person was required to complete the blade fold procedure, and 3) the risk of damage to the aircraft still existed, if a deck crewman attempted to index the main rotor using the tail rotor. This approach, while functional, was a work around at best. It solved none of the problems and required a significant increase in effort and equipment.
