# Applying Human Factors Principles In Aviation Displays: A Transition From Analog to Digital Cockpit Displays In The CP140 Aurora Aircraft

**IMPLICATIONS OF VIOLATING HUMAN FACTORS  
DESIGN PRINCIPLES IN AVIATION DISPLAYS:  
*AN ANALYSIS OF FOUR MAJOR DEFICIENCIES IDENTIFIED DURING THE  
TEST AND EVALUATION OF A COCKPIT MODERNIZATION PROGRAM ON  
THE CP140 AURORA AIRCRAFT***

A flight test program that evaluated the results of a CP140 Aurora cockpit modernization project was conducted between May 2004 and October 2005. This paper uses the results of that test program to show how basic human factors principles were violated which led to the identification of multiple design deficiencies. This paper proposes that the failure to apply good human factors principles when designing aircraft displays can lead to unacceptable deficiencies. The result can be poor modal awareness, confusion in the cockpit, and often negative training for the pilots. In particular, four major deficiencies were analyzed to determine the specific human factors principles that were breached. The violations included a lack of concise and relevant feedback to the pilot, unclear and ambiguous annunciations, poor

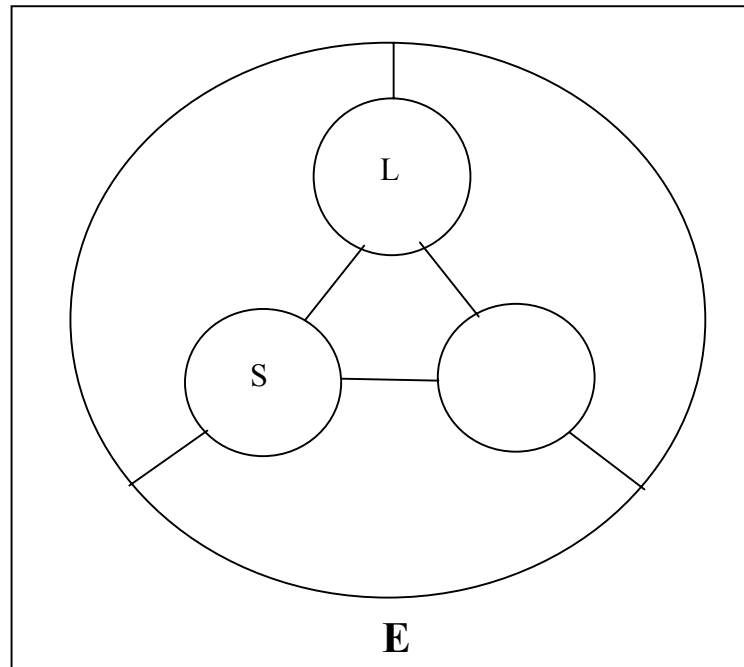
*Figure 2.1.* SHEL Model.

The SHEL model showing the relationships between the liveware (humans), the software (rules, regulations, standard operating procedures), hardware (panels, displays, levers) and the environment in which they all coexist. Human Factors is interested in optimizing the interaction of these components.

In 1972, Edwards published a conceptual model that is a useful tool in understanding the practical application of human factors’ principles. Edwards’ SHELL model (Figure 2.1) describes the interactions between software, hardware, and liveware, as well as the environment in which they all coexist. Software is identified as the rules, regulations, standard operating procedures, customs, practices and habits that guide the operation of the system and the way the human operator is expected to interact with it. The hardware comprises the physical components of a system, the displays, antennae, control panels, and may also include the building, aircraft, or any other physical material. Liveware is the term used to describe the human component, that which operates the system. The environment is the overall context in which the interactions take place, and may include such things as economic, political and social factors. Using this construct, it becomes easier to visualize and understand the interactions that represent the primary concern of the field of Human Factors Engineering.

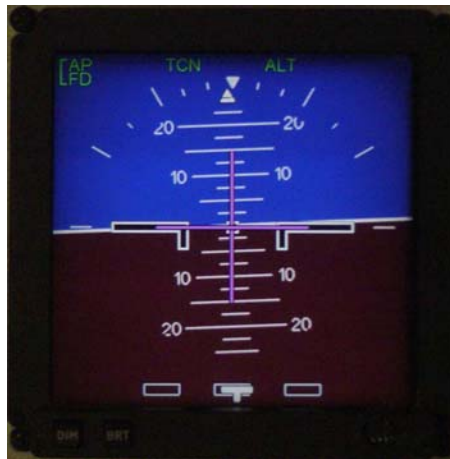
*Figure 3.2.* CP140 EFDI showing AFDS status combination 5 from Table 3.1.

In this screen capture the autopilot and FD are both engaged (green AP and FD annunciators in the top left hand corner of the display) and the AP is coupled to the flight guidance shown (green coupled bar). Two outer loop modes have been selected (TACAN navigation and altitude hold) and the FD is providing lateral and vertical guidance in the form of magenta flight director bars.

The EFDS consisted of three main interfaces: the EFDI, the electronic horizontal situation indicator (EHSI) and the DCP. The EFDI and EHSI were digital replacements of the CP140's analog Flight Director Indicator (FDI) and Horizontal Situation Indicator (HSI) and the DCP replaced the legacy HSI control panel. While the EFDS was only intended to be a functional replacement of the legacy systems, the new "glass" displays provided a significant increase in capability. The software, design philosophy and human factors considerations were the only constraints that limited the amount of information that was displayed on the electronic displays. The EFDI, EHSI and DCP are shown in Figures 3.2, 3.3 and 3.4, respectively.

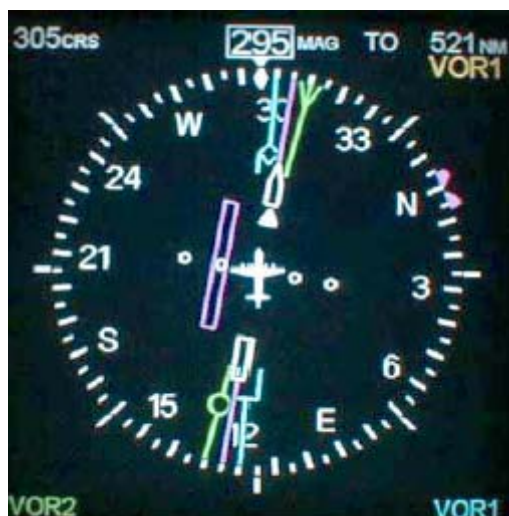
*Figure 3.3.* CP140 EHSI in the VOR navigation mode.

In this screen capture VOR1 is the selected source for lateral navigation and bearing pointers 1 and 2 are selected to VOR2 and VOR 1 respectively.

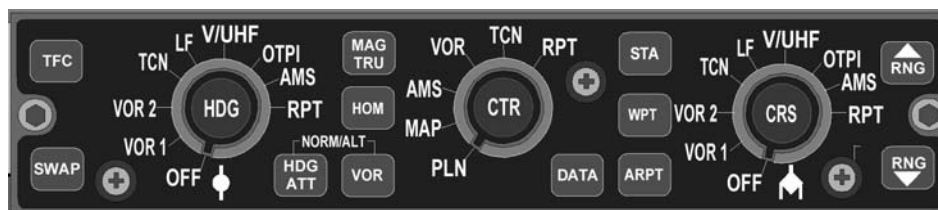
*Figure 3.4.* CP140 DCP.

This figure shows the arrangement of controls for selecting navigation sources and display information. The center knob controls the navigation source for the EHSI and also the AFDS. When engaged through the AFDS, guidance to the selected navigation source can be displayed on the EFDI.

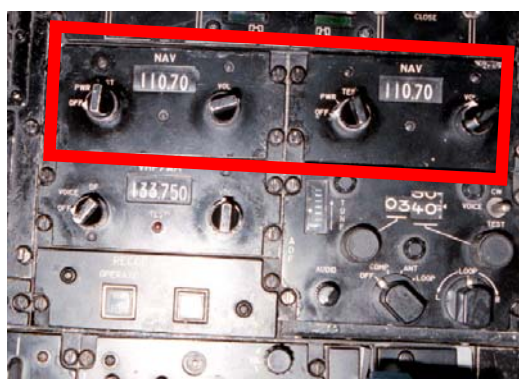
*Figure 3.5. CP140 VOR/ILS 1 and VOR/ILS 2*

These two receivers are independent but redundant systems. This control set can function as a VOR or as an ILS, depending on the frequency input into the control head.

Some of the legacy navigational aids on the CP140 included the VOR, ILS and TACAN systems. The VOR and TACAN systems were both radio navigation systems that could be used for enroute navigation or non-precision instrument approaches. The ILS was a precision approach system that guided the pilot to the landing runway. The VOR and ILS systems shared the same control head. As a result, the VOR and ILS systems were not individually selected but were differentiated by virtue of the frequency set into the control head by the pilot. The TACAN was an independent system with its own transmitter, receiver and antenna. These legacy systems were fully integrated with the new digital NFIMP components allowing the AFDS to fully couple to any of these systems through selections on the Display Control Panel and the AFDS Control Panel. The two VOR/ILS control heads are shown in Figure 3.5 and the TACAN can be seen in Figure 3.6.

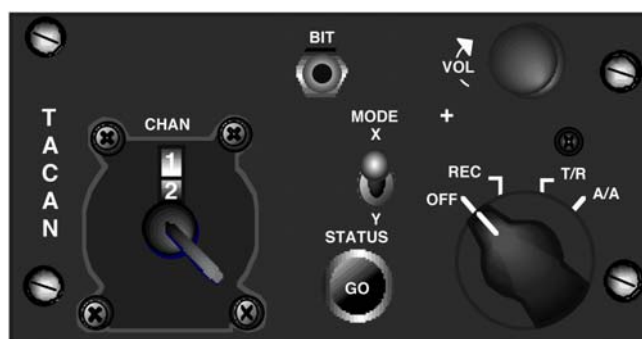
*Figure 3.6.* CP140 TACAN.

The TACAN receiver provides navigation guidance to military TACAN sites. It is an analog system that can be coupled to the new digital avionics of the NFIMP systems.

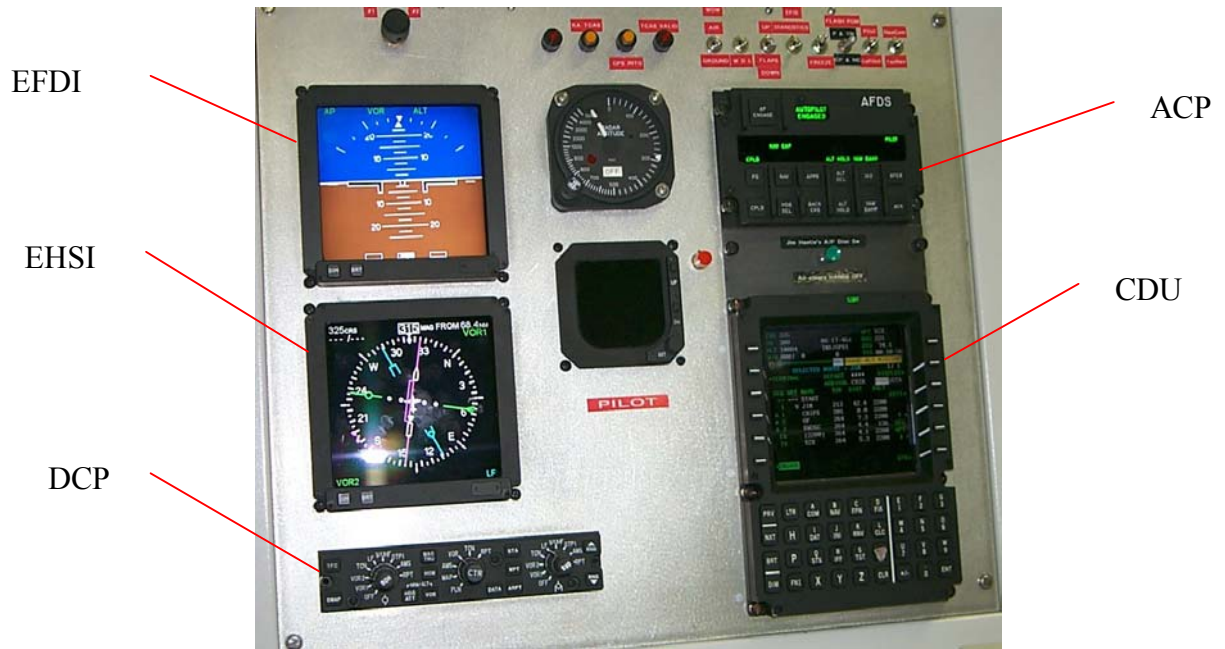
Figure 4.1. CP140 SIL.

A mock-up of the pilot's displays and controls to include the EFDI, EHSI, DCP, CDU and the ACP at the Systems Integration Laboratory. The layout of the SIL was not representative of the cockpit layout in the aircraft.

The SIL was a mock-up of the NFIMP systems for the pilot’s side of the CP140 flight deck and is shown in Fig. 4-1. The SIL included the EFDI, EHSD, DCP, Radar Altimeter (RADALT), TCAS, ACP and the Control Display Unit (CDU). The layout was not representative of the CP140 flight deck.

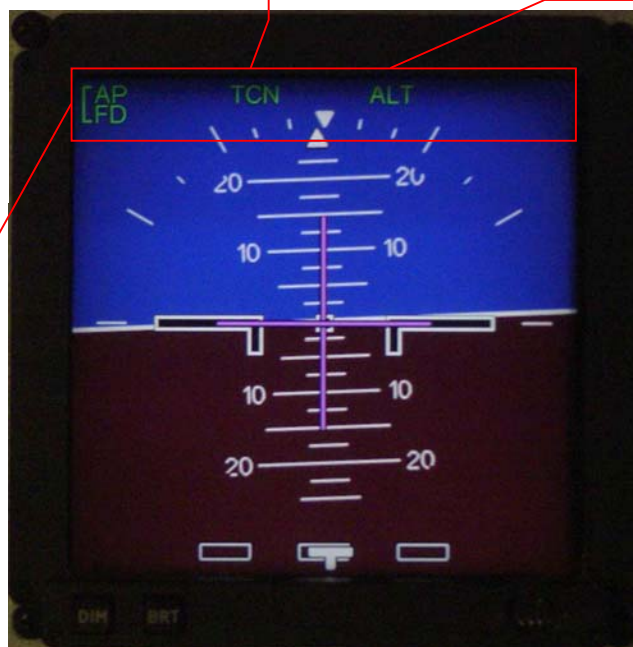
Roll mode engaged in navigation mode (coupled to the TACAN)

AFDS status showing autopilot and flight director engaged and coupled

Pitch mode engaged in altitude hold

Figure 5.1. CP140 EFDI showing the AP and FD System status.

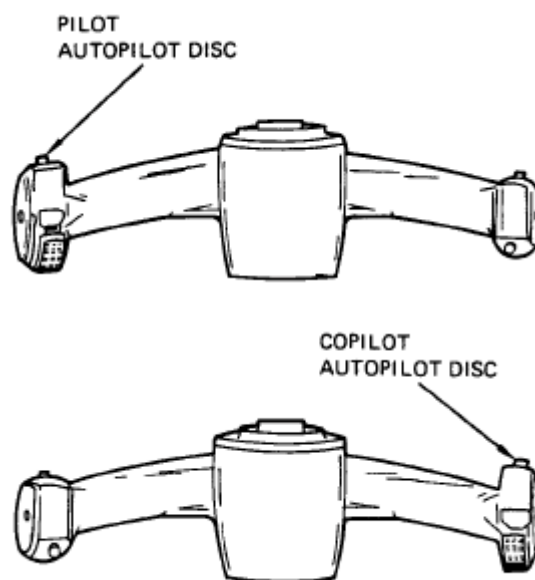
*Figure 5.2.* Automatic Flight Control System Disconnect Switches.

Top view of CP140 control wheels showing pilot and co-pilot autopilot disconnect switches.

normal disengagements. Recall that the only method of achieving a ‘normal’ disengagement of the AP was by depressing the autopilot disconnect switch on the outer horn of the pilot or co-pilot control wheel to the second detent (the first detent temporarily disengaged the altitude hold mode) as shown in Figure 5.2.

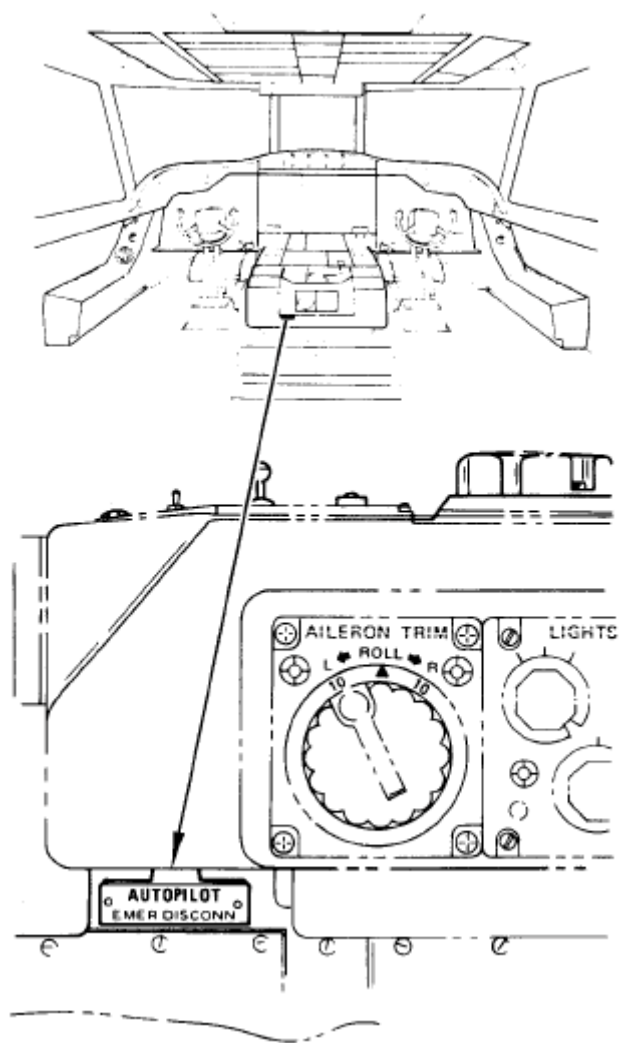
Figure 5.3. AP emergency disconnect handle.

A ‘non-normal,’ or ‘abnormal,’ disengagement was achieved by either depressing the AP engage pushbutton on the AFDS control panel (Figure 3.1), pulling the AP emergency disconnect handle (Figure 5.3) or by any number of system failures or malfunctions.

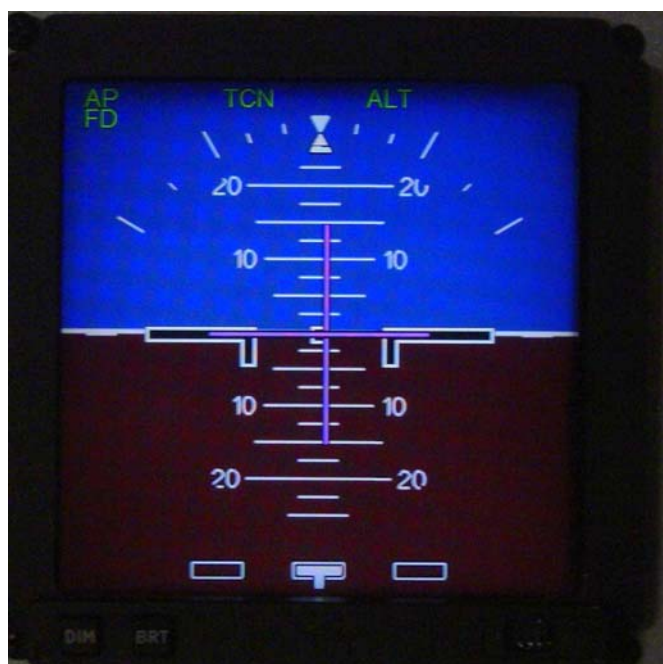
*Figure 5.4.* CP140 EFDI showing AFDS status prior to AP disengagement.

A normal disengagement was commanded by either the pilot or co-pilot through the disconnect switch on their respective control wheels. The only feedback to the pilot or co-pilot on the EFDI of a normal disengagement was the disappearance of the green AP symbol (Figure 5.4 and Figure 5.5).

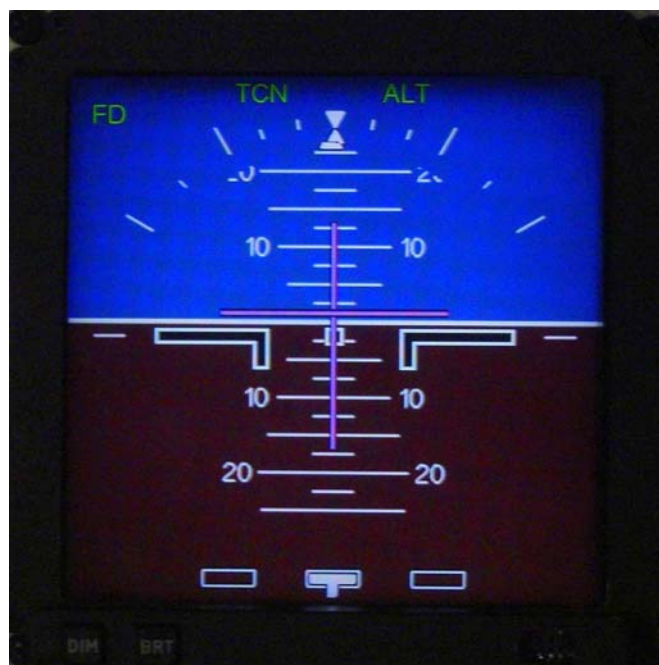
Figure 5.5. CP140 EFDI showing AFDS status following AP disengagement.

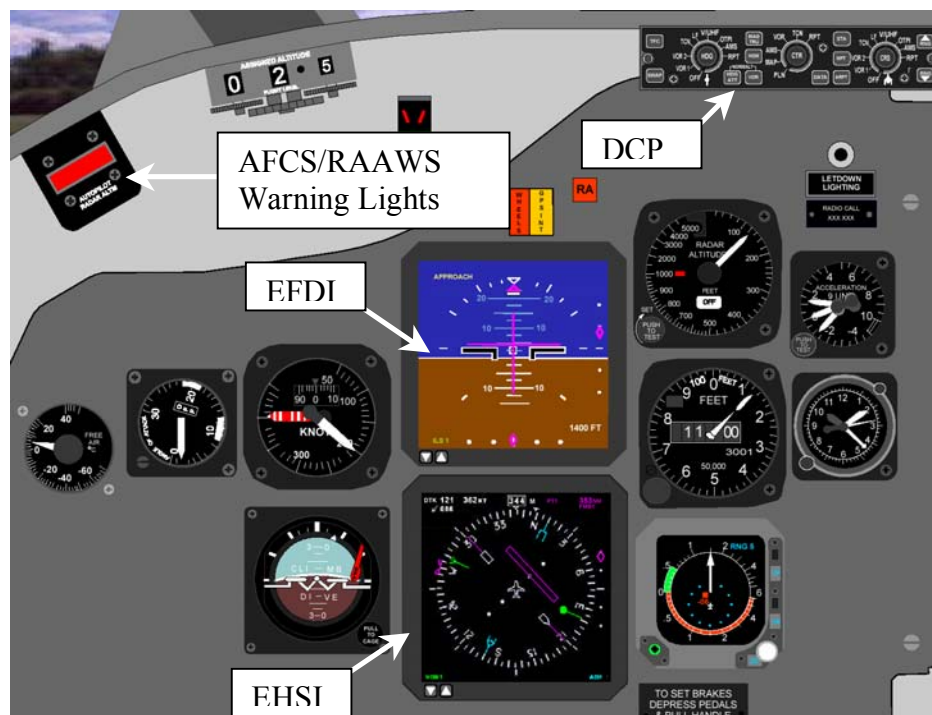
Figure 5.6. Pilot's instrument panel equipment layout showing the AFCS/RAAWS warning lights in the top left hand corner.

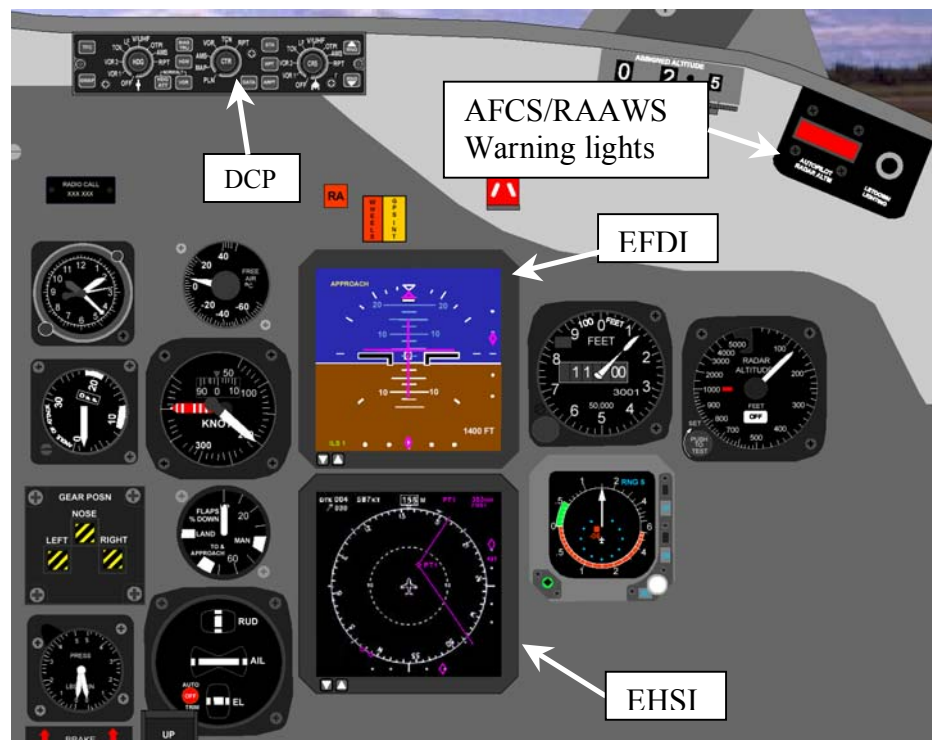
Figure 5.7. Co-pilot's instrument panel equipment layout showing the AFCS/RAAWS warning lights in the top right corner.

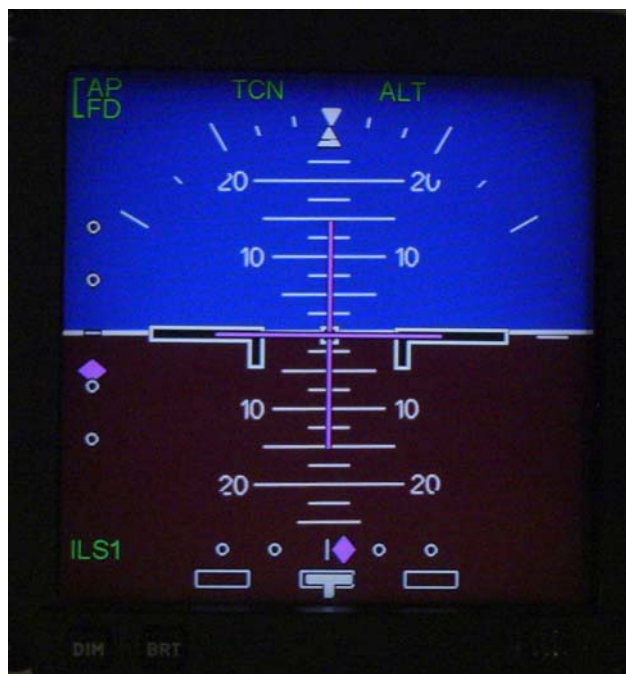
*Figure 5.8.* CP140 EFDI with approach course selected to TCN on the DCP.

In this screen capture the magenta flight director bars in the center of the EFDI show guidance to the TCN station while the magenta diamonds on the left side and bottom of the display show guidance to the ILS approach.

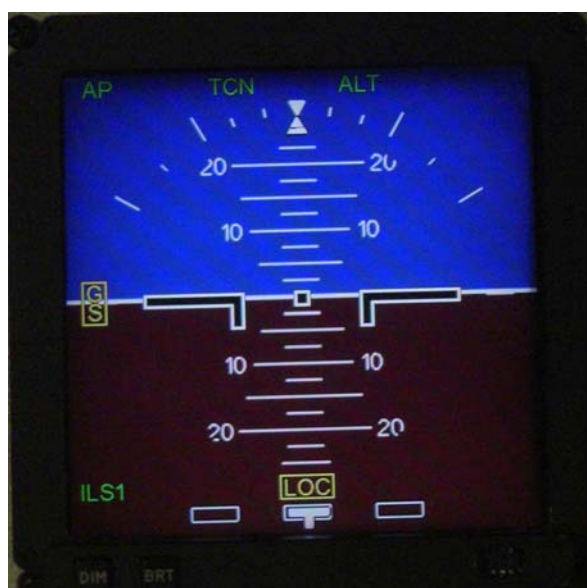
*Figure 5.9.* CP140 EFDI showing both TACAN and ILS approach symbology.

In this screen capture the TCN is selected for course guidance. The ILS is not selected but is displayed because there is an ILS frequency in the VOR/ILS control head (no valid signal).

There were two specific problems with this design. The first was that it contributed to display clutter, while the second, and more significant problem, was that it had the potential to provide confusing and misleading information to the pilots. In their chapter on Aviation Displays, Stokes et al. (1988) described in detail many of the problems that can arise from “information overload in the cockpit” (p. 387). There are limitations as to the amount of information that humans can process, and in data rich environments such as aviation, our visual systems can quickly become overwhelmed. In the transition to glass cockpits, designers sometimes go too far in saturating the visual

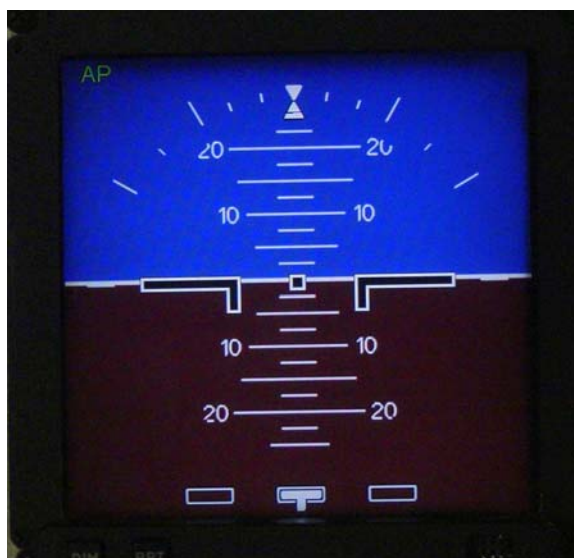
*Figure 5.10.* CP140 EFDI engaged in the basic AP mode.

In this screen capture, the autopilot is not coupled to any flight guidance and is simply maintaining the pilot's last input in pitch and roll attitude.

When the AP was first engaged, it activated in its most basic mode of heading and roll control (combination 1 from Table 3.1 and Figure 5.10). In this mode, the coupled bar was not illuminated on the pilot's primary flight display (PFD) but it was illuminated on the ACP (Figure 3.1). This was inconsistent and would have been more intuitive if both indications always reflected the same status. This was interpreted to mean that while it was not actively coupled to any outer loop flight guidance, it would couple to the flight guidance upon selection of an outer loop, or active guidance, mode.

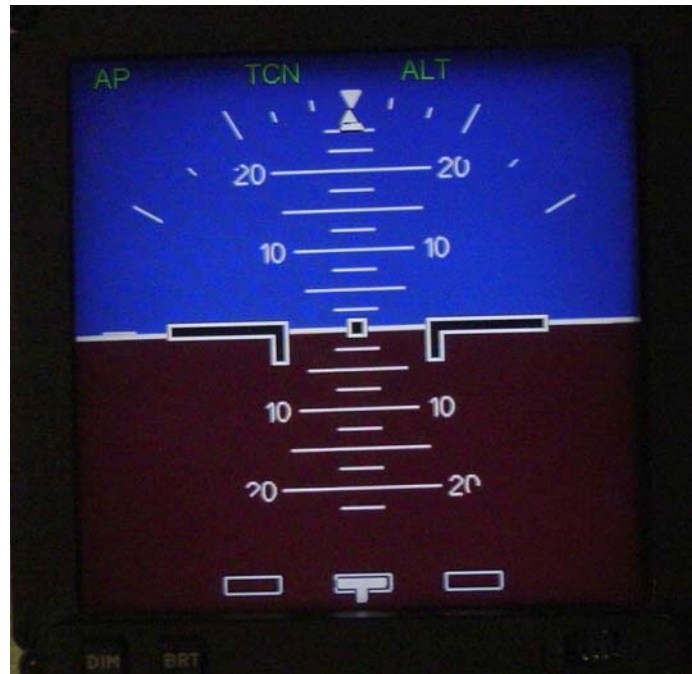
*Figure 5.11.* CP140 EFDI showing the AP engaged and coupled.

In this screen capture, the AP is engaged and coupled to the TACAN lateral guidance mode and the Altitude Hold vertical guidance mode. The AP is therefore steering the aircraft toward the TCN station, even though there is no couple bar. This is understood by the combination of an outer loop mode (TCN) with no FD cueing; which together indicates that the AP is coupled.

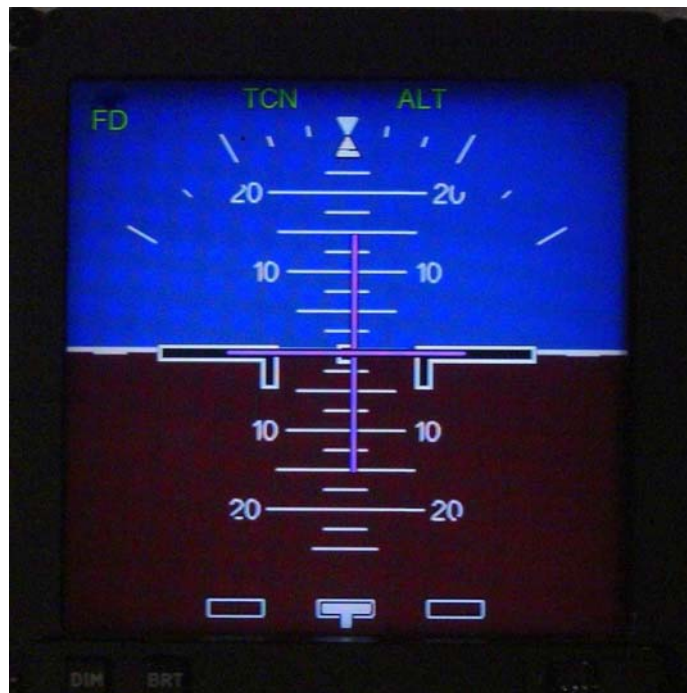
*Figure 5.12.* CP140 EFDI showing FD only.

In this screen capture, the autopilot is not engaged. When outer loop modes such as the TCN and altitude hold modes are selected without the AP, the flight director bars appear and provide steering guidance for the pilot to follow.

The third AFDS combination was the FD only (combination 3 from Table 3.1 and Figure 5.12). This mode was reasonably straight forward because the AP was not engaged and the AFDS was providing manual steering guidance only. The pilot was flying the airplane with no assistance from the AP and could follow the guidance of the FD bars. As well, the PFD and the ACP were consistent in that neither display showed a coupled indication, which made it easier to interpret.

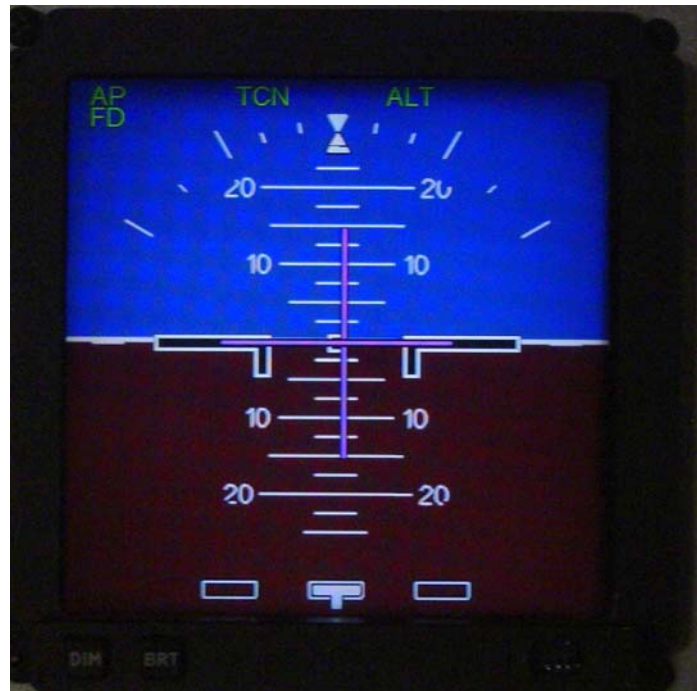
*Figure 5.13.* CP140 EFDI showing both the AP and FD in an uncoupled state.

In this screen capture, the AP is engaged but not coupled to the flight guidance, indicated by the absence of a couple bar linking the AP and FD symbols. The magenta flight director bars provide manual steering guidance to the TCN station (lateral mode) and to a defined altitude (vertical mode), but the AP will not command the aircraft to follow.

The fourth AFDS combination included both the AP and the FD in an uncoupled state (combination 3 from Table 3.1 and Figure 5.13). This mode also maintained consistency between the pilots' PFD and the ACP. The trend, however, was one in which the absence of the coupled bar sometimes correctly indicated an uncoupled AFDS state (combination 1 and 3 from Table 3.1) while at other times the absence of the coupled bar was meaningless and the AFDS was, in fact, coupled (combination 2 from Table 3.1). The only way to be sure was to check the ACP, which meant the pilot had to look to the side and backwards to read the display. This was a poor human factors design as it is never good for the pilot to look down and backwards while flying, especially in Instrument Meteorological Conditions, as the pilot can become prone to disorientation.
