The Relationships of Streambank Angles and Shapes to Streambank Erosion Rates in the Little River Watershed, TN

**The Relationships of Streambank Angles and Shapes to
Streambank Erosion Rates in the
Little River Watershed, TN**

A Thesis Presented for the Master of Science Degree
The University of Tennessee, Knoxville

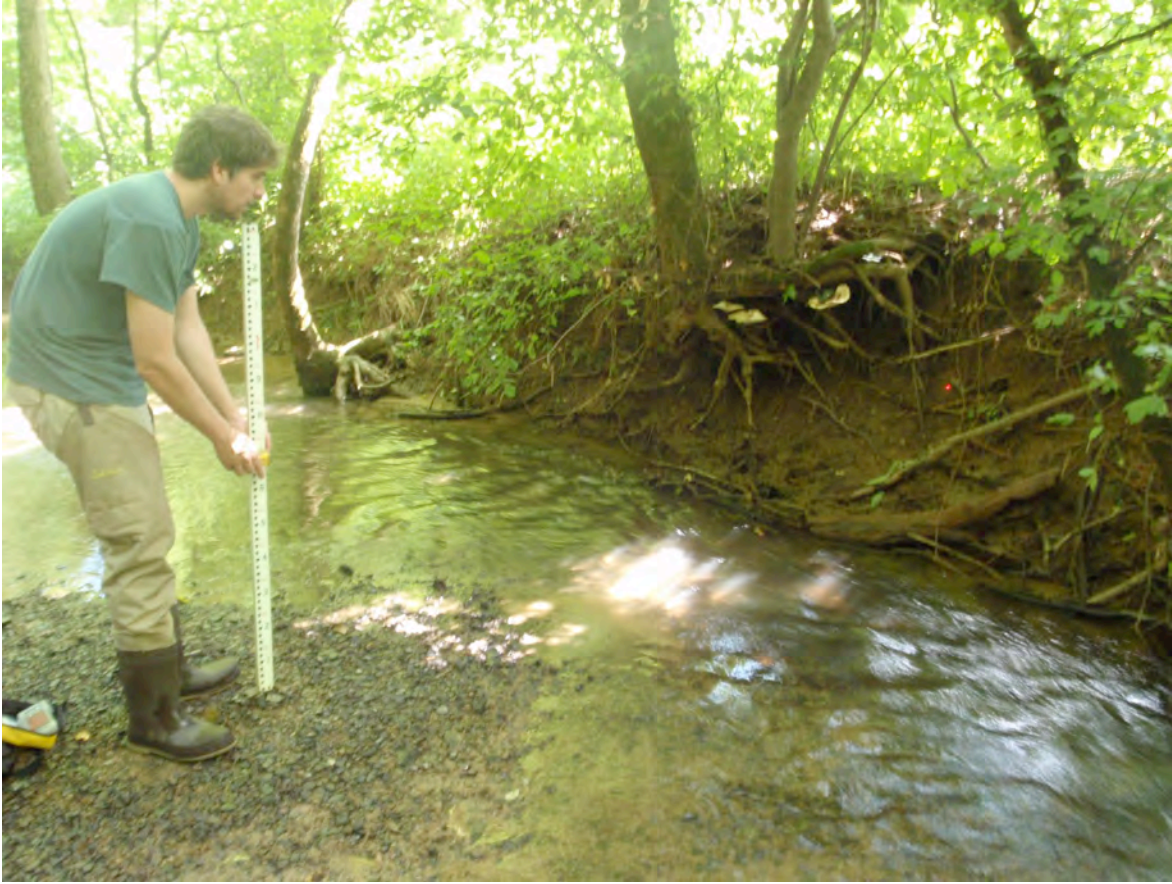
Figure 3.2 Profiling technique with laser point visible on bank of Nails Creek. Photo by Monica Rother.

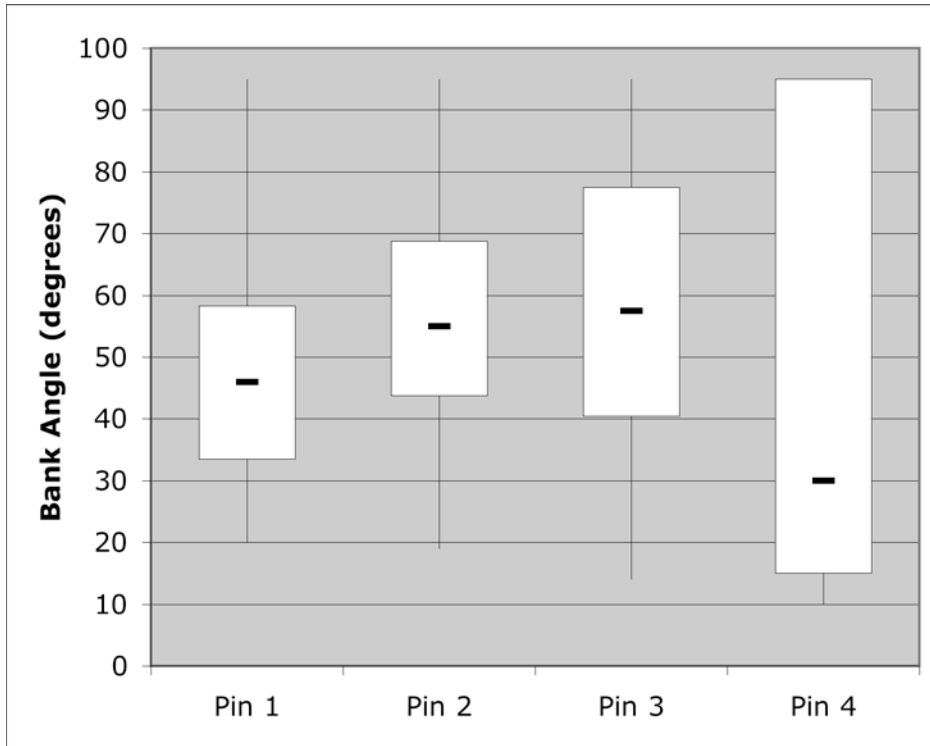
Figure 4.1 Variability of bank angle by pin position. The maximum, upper quartile, median, lower quartile, and minimum values are displayed for each pin.

Descriptive statistics indicated that angles varied by pin position (height on bank). The mean angle ranged approximately 50 to 60° between pins, with average angles greatest at pin #3. The median angle ranged approximately 30 to 58°, with angles again greatest at pin #3. At all four pin positions, a maximum angle of 95° was recorded, and the minimum angle ranged 10 to 20°. I found that angles were most variable at pin #4, which was located below the ordinary water line. This variability is reflected by the high standard deviation, widely spaced lower and upper quartiles, and large range (Table 4.1, Figure 4.1).

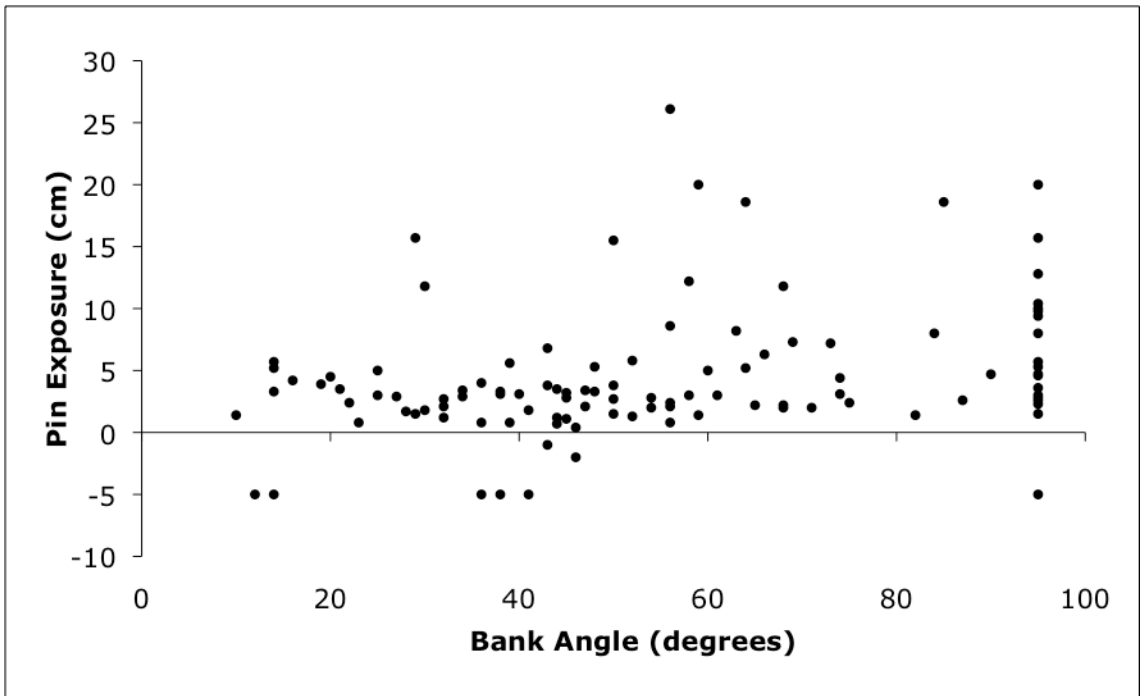
Figure 4.3 Relationship between bank angle and pin exposure.

I found a weak, positive relationship between local bank angle and pin exposure that was highly significant. This suggests that bank angle is one of many factors that contribute to streambank erosion on the studied tributaries in the Little River watershed. When considering only higher bank angles, those $\geq 30^\circ$, the relationship becomes stronger. This suggests that the association between bank angle and erosion is weakest where banks are gently sloped, and becomes stronger as banks steepen. Due to gravitational forces, an obvious assumption is that streambank particles are more likely to be detached from steeper slopes and deposited on gentler slopes. This agrees with Zonge *et al.* (1996), who studied streambanks in California during drought conditions. They found net erosion to be highest on steeper bank segments, while deposition occurred on more moderately sloped portions.

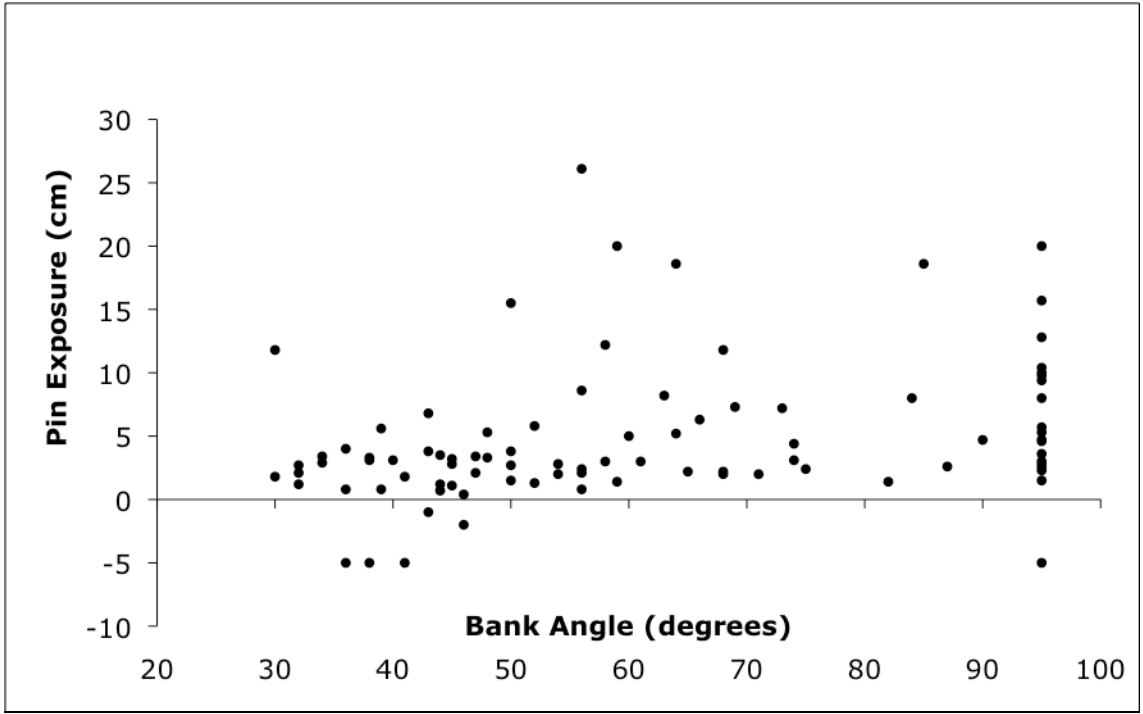
Figure 4.4 Relationship between bank angles $\geq 30^\circ$ and pin exposure.

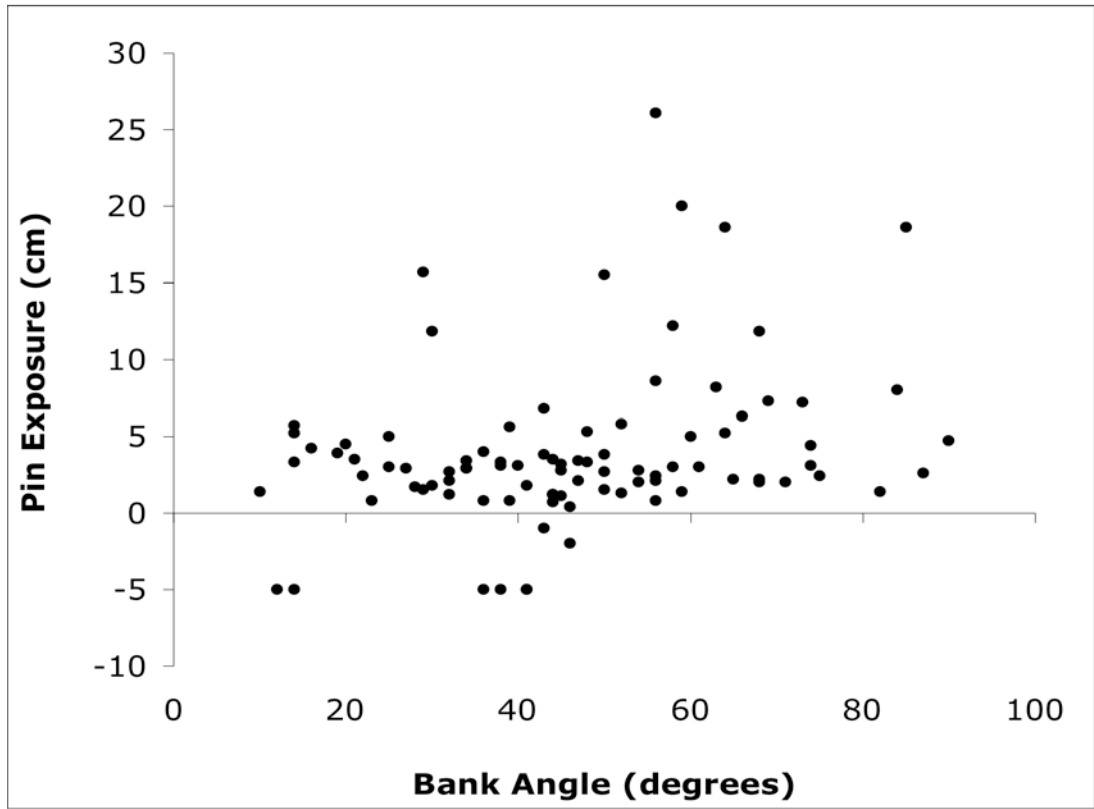
Figure 4.5 Relationship between bank angles $\leq 90^\circ$ and pin exposure.

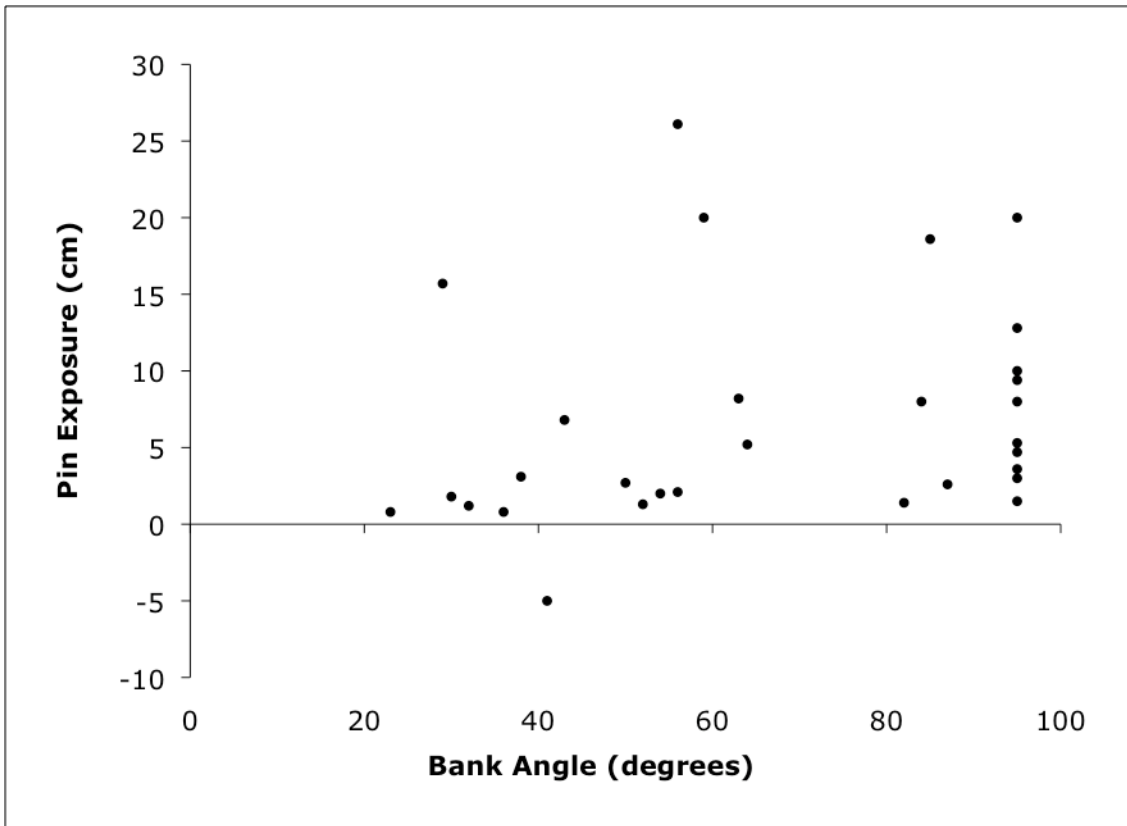
Figure 4.9 Relationship between bank angle and pin exposure on banks classified as undercut.

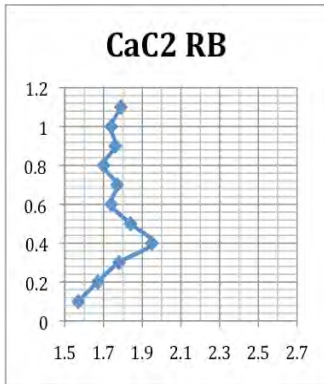
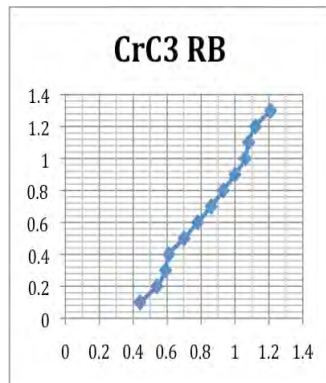
Appendix D Streambank profiles of erosion-pin monitoring sites. The vertical axes represent vertical distance (m) starting at 0.1 m above the water level (at the time of profiling) and extending to what was determined to be the break at the top of the bank. The horizontal axes represent the distance (m) from the stadia rod to the bank. Profiles of the right bank (RB) are viewed in the downstream direction, while profiles of the left bank are viewed in the upstream direction.
