## **Design and Construction Of a Full-Scale Lateral Impact Testing Facility**

A Thesis Presented for the  
Master of Science  
Degree  
The University of Tennessee, Knoxville

Cody Aaron Mitchell  
May 2015

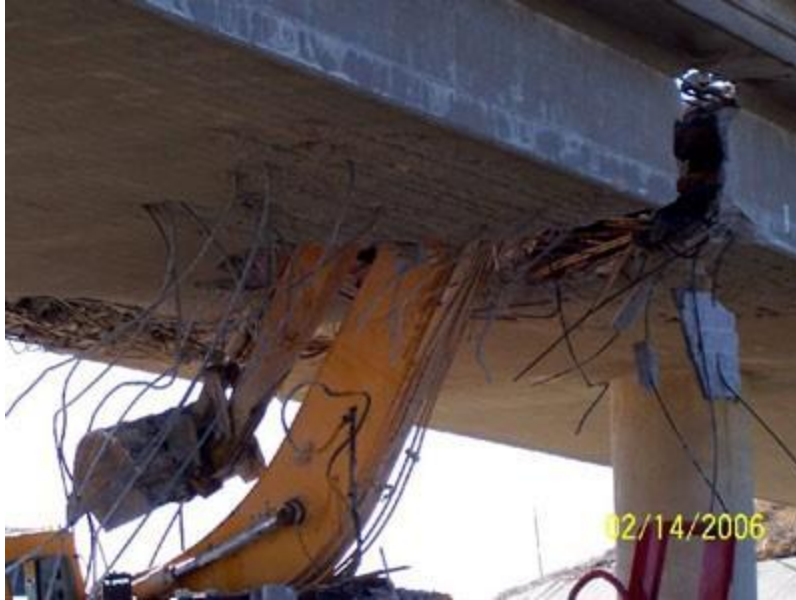
Figure 1. Excavator that has impacted the side of a bridge. (DailyCognition, 2013)

Based upon this information it was determined that the best way to simulate a worst case overheight impact would be to mimic a piece of heavy equipment improperly loaded on a flatbed. Example photos of the type of damage that can be caused by this type of collision are shown in Figures 1, 2.

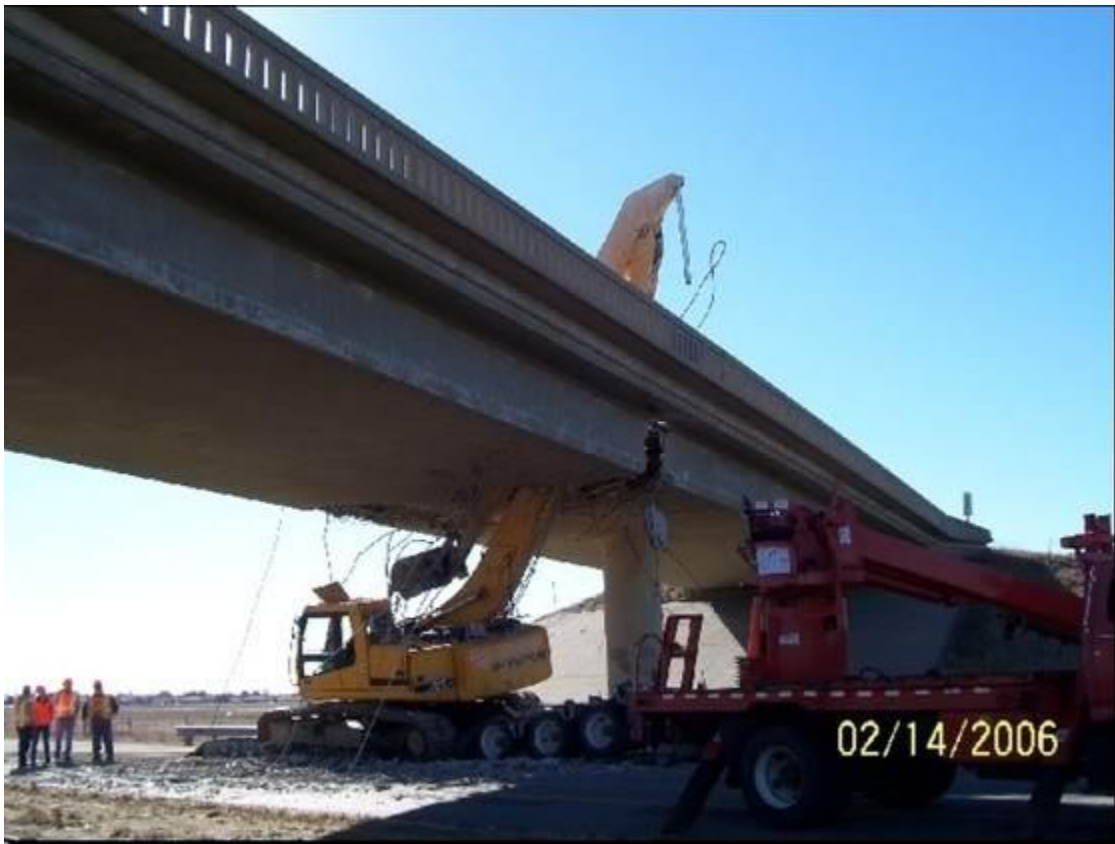
Figure 2. Damage caused by overhead collision. (DailyCognition, 2013)

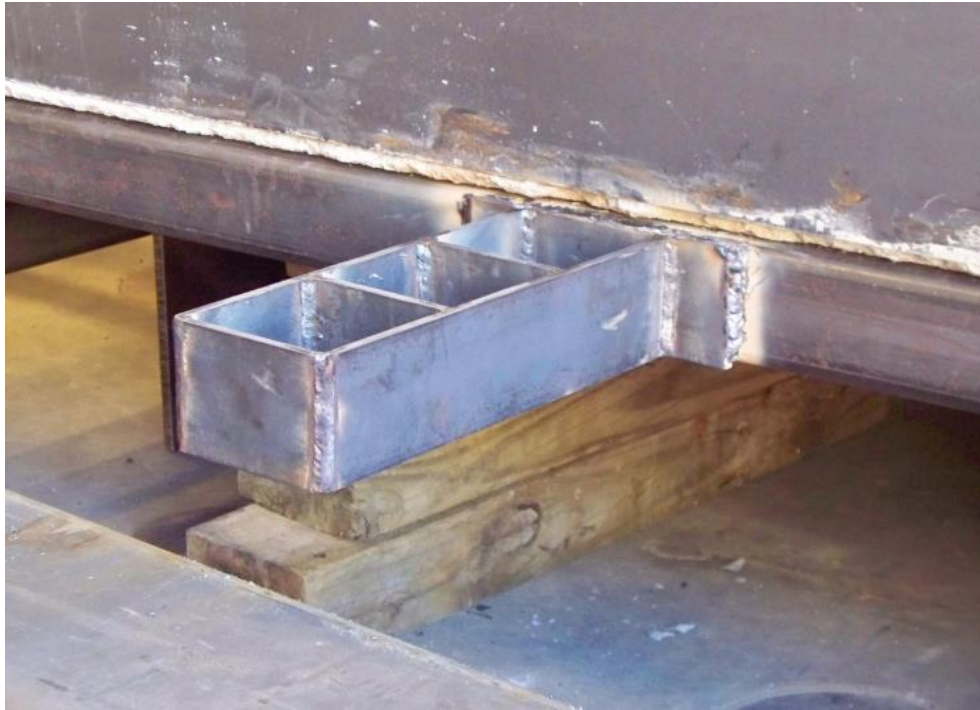
In order to be able to pull the impact cart up the slope of the track a hitch was fabricated. The hitch can be seen in Figure 4. The hitch is made of ¼ in. thick and 3 in. tall steel plates. These plates were welded together. The amount of weld provided more than enough strength to pull the 8000 lbs. impact cart. The strength of the weld was determined in accordance with AISC (American Institute of Steel Construction, 2011). The equation used is shown below (Eq. 4.1). The opening between the pieces of steel was made to allow a 1 ½ in. shackle to pass through. The hitch was fabricated and then was welded to the frame as one unit. The multiple openings on the hitch were meant to provide the option to attach more than one means of pulling the cart if needed. It also allows for a release system to be attached to the hitch while it is still hooked up to the pulling shackle.

The length of the weld group,  $l$ , is 6 in. and the weld size,  $D$ , was conservatively taken as 1/8 in. The capacity,  $\phi R_n$ , of the hitch was determined to be 16.7 k. This is well above the 8000 lbs. weight of the impact cart.

Figure 4. Pull hitch attached to cart frame.

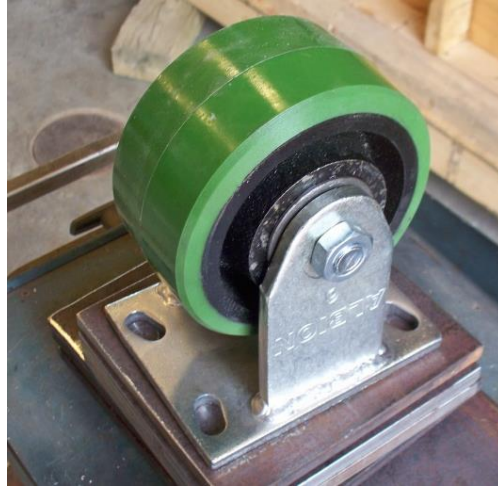
Eight casters of two different types were utilized in the design of the impact cart. Four casters were used as main bearing casters. These casters were standard rigid plate casters rated at a 2500 lbs. capacity per caster. The casters are 6 in. in diameter, have a tread width of 3 in, and a total height of 7-1/2 in. These casters were bolted onto bearing plates that were welded to the underside of the cart frame. The main bearing casters, shown in Figure 5, support the weight of the impact cart and allow for the motion and proper acceleration of the cart. Since the main bearing casters were not limited by any straight tracking mechanism four additional casters were added, two for each side of the cart. These casters ensured that the cart would maintain a straight line during travel. These casters are also 6 in. in diameter, but have a 2 in. tread width.

Figure 5. Example of main bearing caster.

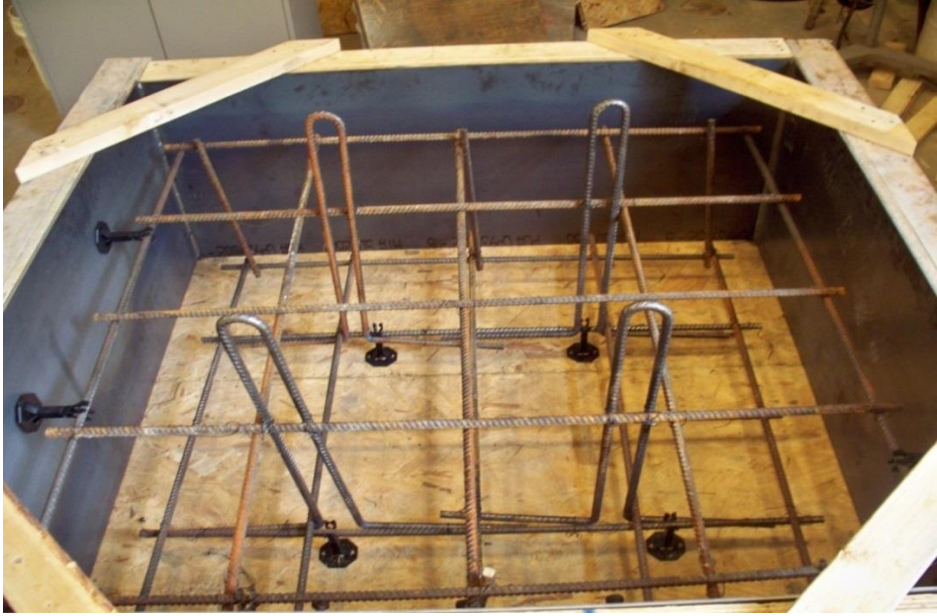
The concrete block makes up the largest portion of the weight of the impact cart. The block is 5x5x2 ft. and in total weighs 7500 lbs. The concrete block has two layers of #5 rebar placed in 4'6" x 4'6" mats with one foot spacing. The rebar was put in place to increase the reliability of the lifting hooks. Four lifting hooks were placed in the concrete block. The hooks are pieces of #5 rebar that are bent with a U on top and two 90° bends, one for each leg. The legs were placed underneath the bottom mat of rebar. This will insure that when the block is lifted the hooks will then pull on the rebar mats instead of simply pulling on the hooks. The four sides of the concrete block are wrapped in ¼ in. thick plate steel as seen in Figure 6. The plates were connected with seam welds on the inside and outside. These plates were added to help prevent punching shear from the impactor during testing. The connection between the concrete block and the impactor was provided by an imbed plate. The imbed plate was bolted to the formwork for the block and those bolts were then used to connect the impactor to the imbed plate. While casting the concrete for the block the bottom form dipped in between the studs and created humps on the bottom of the block. This meant that the block did not sit perfectly flat on the

Figure 6. Concrete Block formwork. Showing steel plates, rebar mats and lifting hooks.

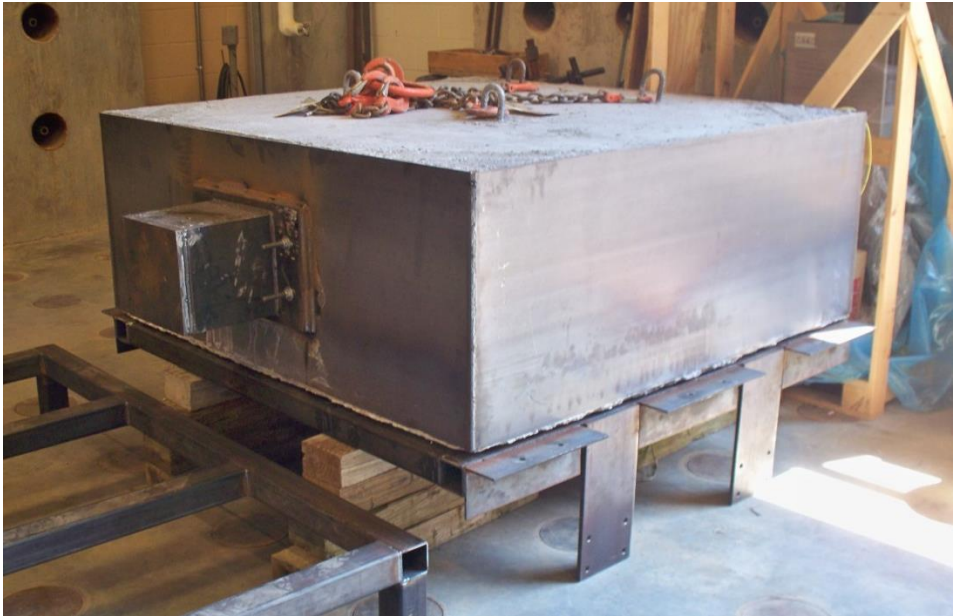
Figure 7. Finished concrete block with impactor.

frame. In order to counteract the gap between the frame and the block, metal shims were welded onto the cart frame at each corner. These shims allowed the block to remain level during testing and prevented the block from rocking during testing. The finished concrete block is show in Figure 7.

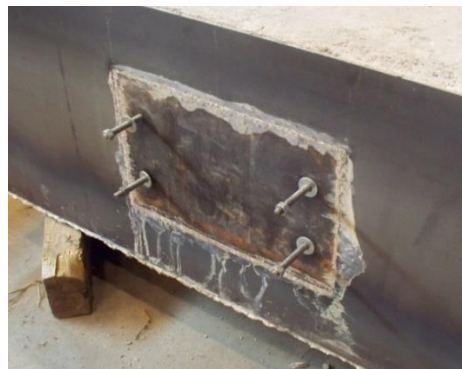
The dimensions of the impactor are 10"x10"x10" (EN 1991-1-7, 20006). The impactor was built with  $\frac{3}{4}$  in. thick steel plates that were welded together. These welds were different than all other welds for the impact cart in that the edges of the steel plates were first ground off to an angle to allow for a deeper penetration of the weld. This was done to insure that the impactor remained intact during testing. The impactor was also filled with concrete to prevent any bending of the plates and to insure that good contact was maintained throughout the actual impact. The impactor was welded to a base plate that was then bolted to the imbed plate on the concrete block. The bolts were threaded into the imbed plate and were used as the bolts for the impactor, as shown in Figures 8, 9. To insure that the impactor did not shift or come loose during testing the impactor was welded to the  $\frac{1}{4}$  in. steel plate.

Figure 8. Imbed plate and attachment bolts.

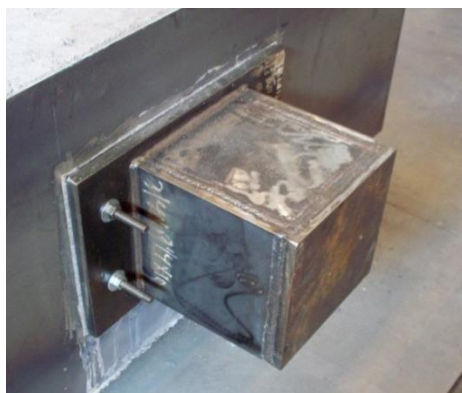
Figure 9. Impactor attached to the imbed plate.

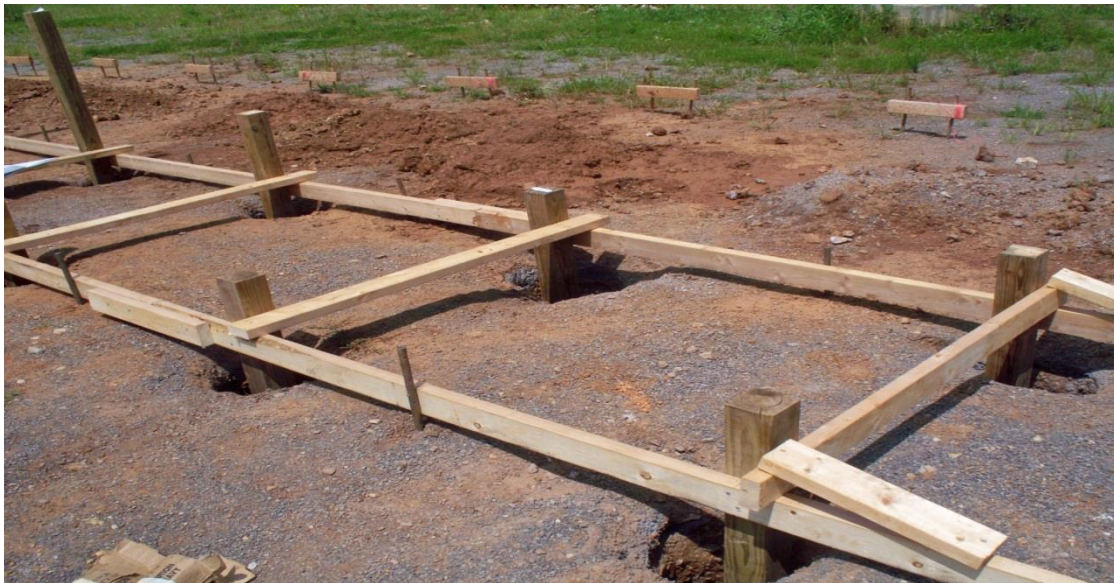
The initial trial size for the posts was a 4x4 wood post. The posts were designed from static loading when the impact cart is sitting between post lines. This means that at any given time a minimum of four posts will be taking the load of the impact cart. The limiting design criterion was compression loading with an applied load of 2000 lbs. per post. The capacity of an individual post in compression was determined to be 3000 lbs. Concrete was cast around and under the posts to insure that the posts did not shift during testing. This was achieved by slightly raising the posts and then screwing them into the guide boards so that the concrete could flow under the posts during the pour. The post positioning was laid out by having a 2x4 guide board that ran the length of the two post lines and a cross board that attached to the two post lines. These cross boards were placed every 5' to maintain post spacing. This created a 90 degree corner that the posts could be laid against, as seen in Figure 10. Once the concrete was cast the top of the posts were cut on the proper angle to insure that full contact between the top of the post and the track itself would be achieved.

Figure 10. Posts screwed into guide boards.

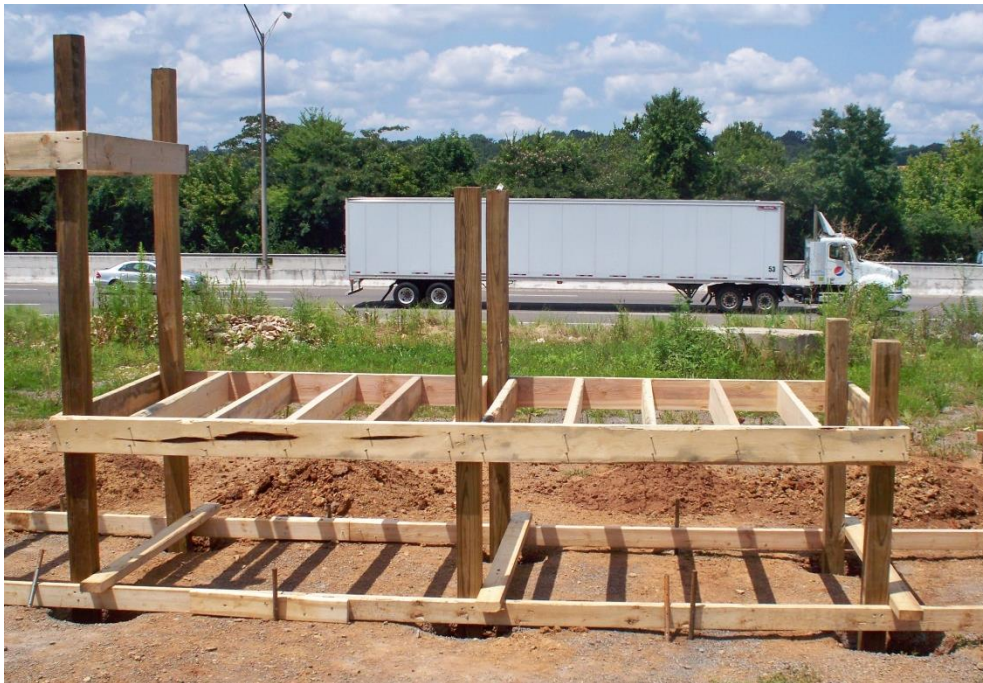
The work platforms consist of 2x6 boards that wrap around the outside of three lines of posts with joists spaced at one foot on centers as seen in Figure 11. The framework was then decked with 7/16 in. OSB plywood to provide a working surface. The work platforms served multiple purposes in the construction of the track. The main function was to provide a stable platform to stand upon for any work that could not be performed from the ground. Two platforms were built along the length of the track each spanning between three post lines. Since the elevation of the track changes along the length two platforms were placed at different heights with a built in ladder to connect them. Another purpose of the platforms was to tie the posts together while maintaining the desired spacing between the posts. The platforms were constructed prior to casting the concrete which allowed for the posts to be plumbed and spaced evenly with ease. With the posts connected together bracing for casting of concrete was minimized to only four temporary braces instead of needing two braces per post if the platforms were not present at the time of concrete casting.

Figure 11. Lower work platform without decking and before casting of concrete.

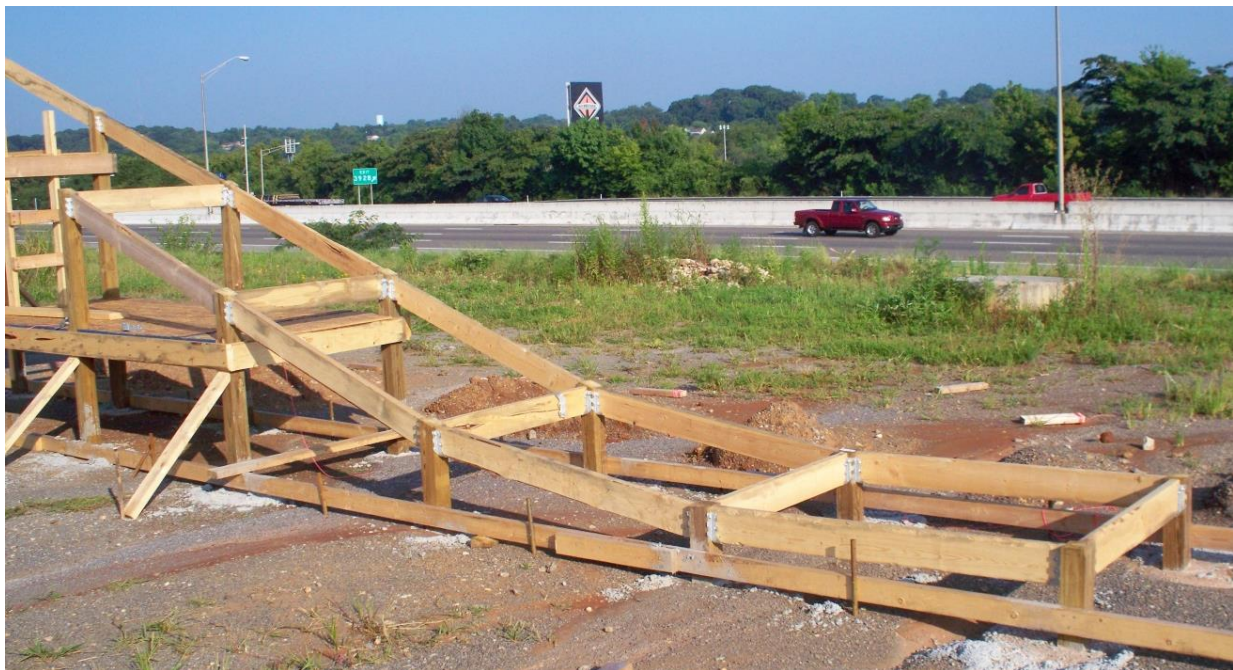
In order to maintain proper spacing at the top of the posts 2x6 joists were added. The joists that ran perpendicular to the length of the track were precut. This maintained the spacing at the top of the posts so that they would all be in line with each other. The joists that were placed along the length of the track were cut to match the existing spacing between the posts. This process was done to insure that full contact between the joists and the posts was achieved. Each joist was cut on an angle to match the slope of the track. The angle cut of the joist can be seen in Figure 12. The joists were connected to the posts at the very top of each post with joist hangers. Since the joists were angled instead of horizontal, notches had to be cut out of the bottom of the joists to create a horizontal surface for the joist to rest on the hangers. The hangers allowed the joists to be placed in the center of the posts with ease. This was necessary to maintain a straight line for which the rails could be attached. Once all joists were attached 2x4s were placed on top of and perpendicular to the joists. The 2x4's were nailed flatways spaced at one foot. on center in order to provide a stable platform of the rails to sit upon.

Figure 12. Lower portion of track with top joists prior to 2x4 decking.

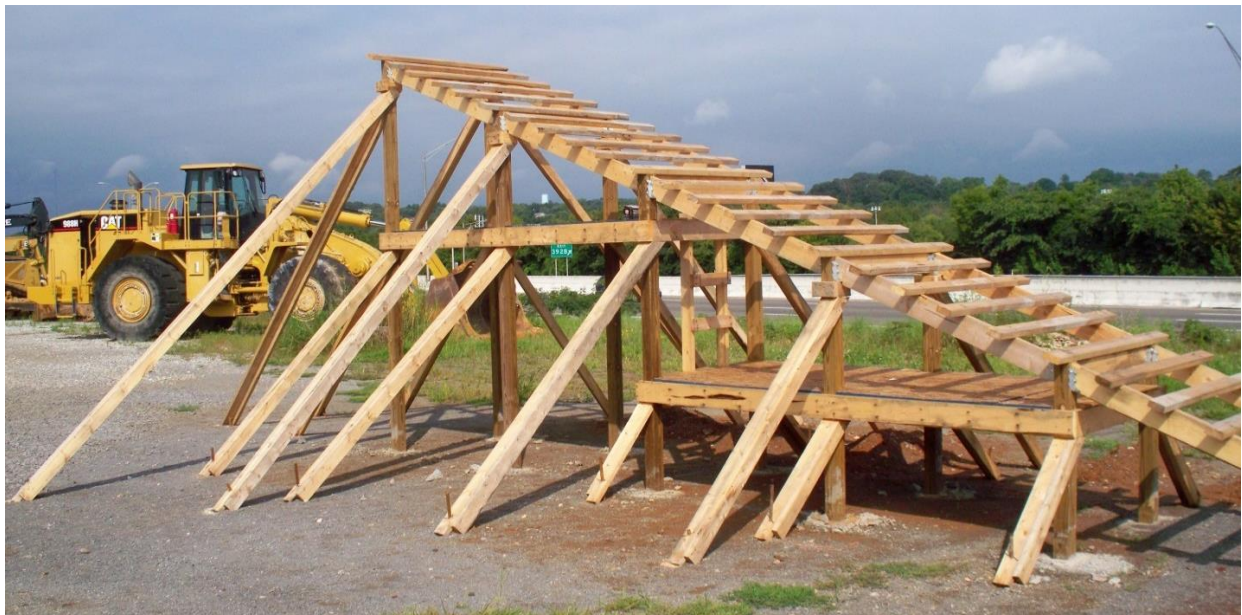
In order to prevent the track from swaying side to side during testing lateral bracing was added. Each brace consisted of 2 2x4's that were nailed together on edge. The braces were connected to the posts in two different locations. The lowest braces were placed directly underneath the work platforms to provide a solid contact surface. While the upper braces were placed directly underneath of a small 2x4 wrap that went around each post. These wraps were placed directly underneath the joist hangers to insure that gravity loads from the impact cart would be fully transferred into the braces without having to rely wholly on the connections. The braces were placed at a 45° angle from the posts as shown in Figure 13. This meant that all of the braces needed to be cut on 45° to insure complete contact with the wraps and work platforms. In order to secure the braces to the ground ¾ in diameter holes were drilled through the braces at the bottom and a nail pin was run through the hole as shown in Figure 14. Once driven sufficiently into the ground a nail was placed through the nail pin and the pin was then driven further into the ground until the nail compressed against the board. The process was necessary to insure that the braces had solid contact with the ground in the event that the track would try to shift.

Figure 13. Lateral bracing applied at multiple levels per post.

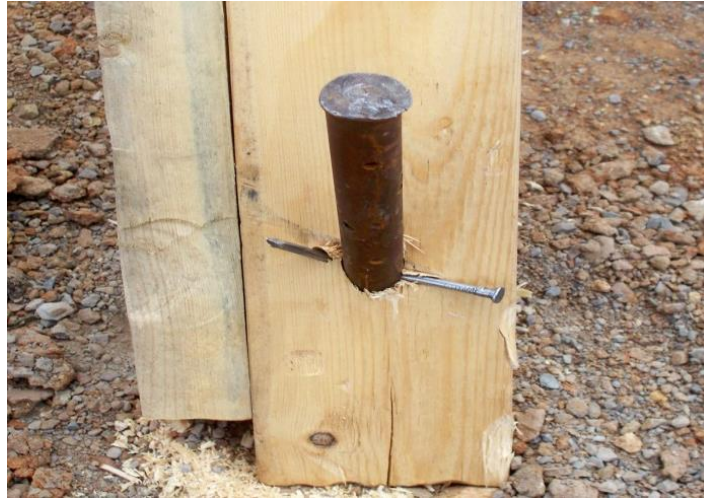
Figure 14. Nail through nail pin. Lateral bracing to ground connection.

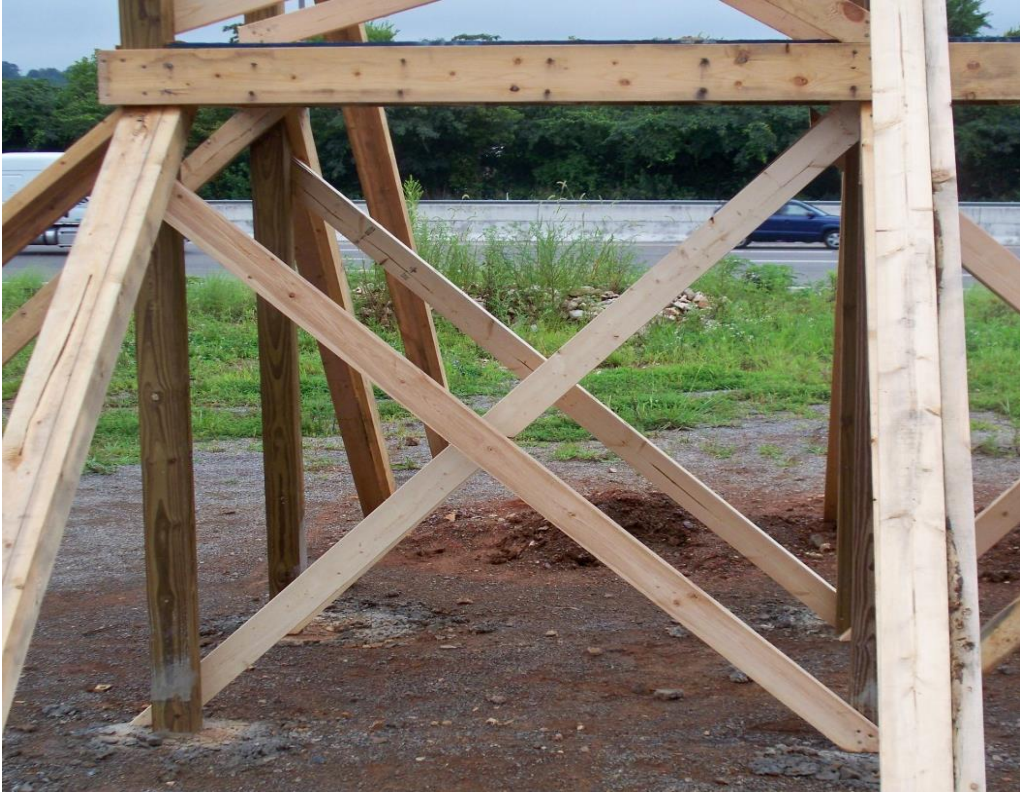
Figure 15. 2x4 X-Bracing

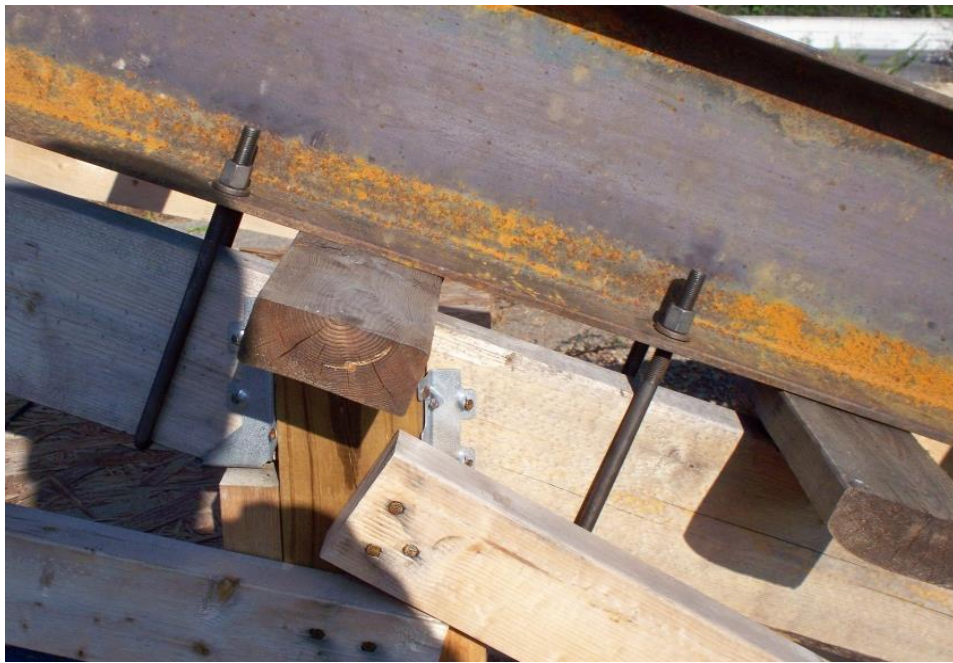
In order to create an effective impact with the specimen the impact cart needed to roll down a smooth surface. This surface was provided by rails that were attached to the top of the track. The rails were made of W8x13 steel sections. The rails were placed directly on top of the post lines to effectively transmit the load through the track to the ground. The rails were attached to the track by U-bolts as shown in Figure 16. The U-bolts wrapped around the 2x6 joists and were

Figure 16. Rails connected to joist by U-Bolts.

bolted to the rails on either side of the web. The U-bolts were placed on either side of each post in order to insure that the rails did not shift along the length of the track during testing.

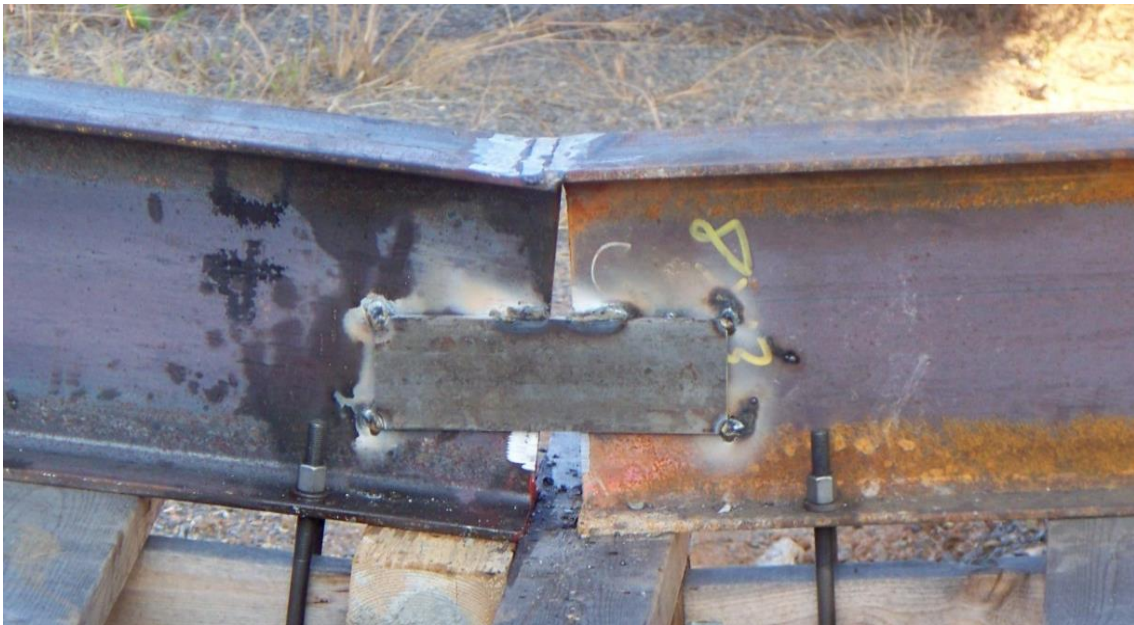
At the points along the track where the slope changes the rails were cut and the top flanges of the rails were butted up against one another. The tops of the rails were welded together to create a smoother transition between pieces as shown in Figure 17. The welds were also necessary to ensure that the pieces held together and acted as one cohesive unit. In addition to welding the top flanges splice plates were also welded on the inside of the web wherever pieces came together. These plates helped to tie the pieces together. Once the two rails were completed they were tied together with 2x2 in. HSS tubes as seen in Figure 18. The tubes were welded onto the inside of the web of each rail. In order to maintain a constant distance between the rails the tubes were all cut to an exact length and the rails were either pushed or pulled until the tube fit snugly on either side.

Figure 17. Welds connecting the top of the rails and splice plates.

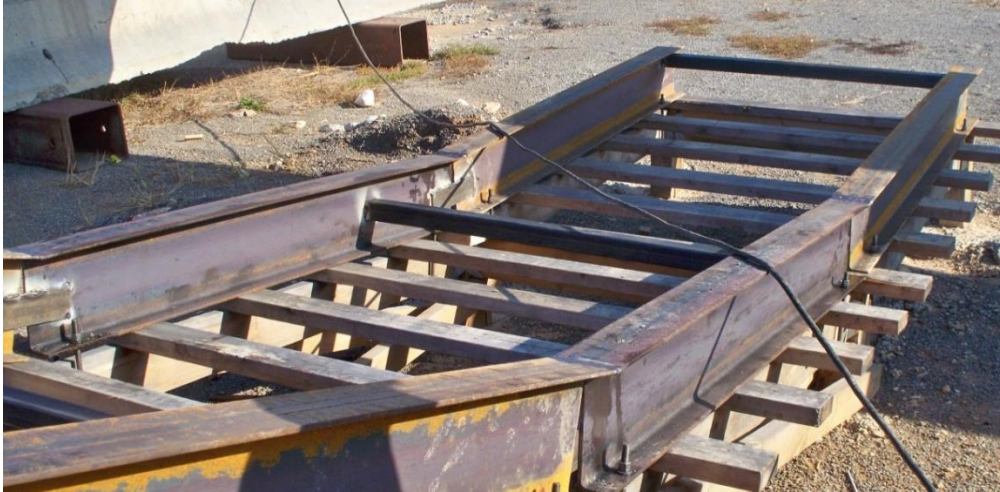
Figure 18. HSS tubes between rails.

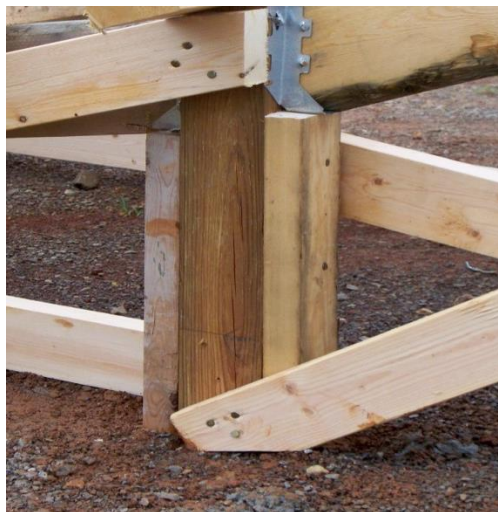
Extra compression reinforcement was added on either side of each post. This was achieved by nailed 2x4's against the posts. The 2x4's were wedged between the joist hangers and the concrete that was poured around the posts. These boards were installed to ensure that when the impact cart travelled over the top of the posts that the load would be carried from the rails through the joists to the 2x4's and into the posts. The added compression wood is shown in Figure 19.

Figure 19. Added 2x4's for extra compression reinforcement.

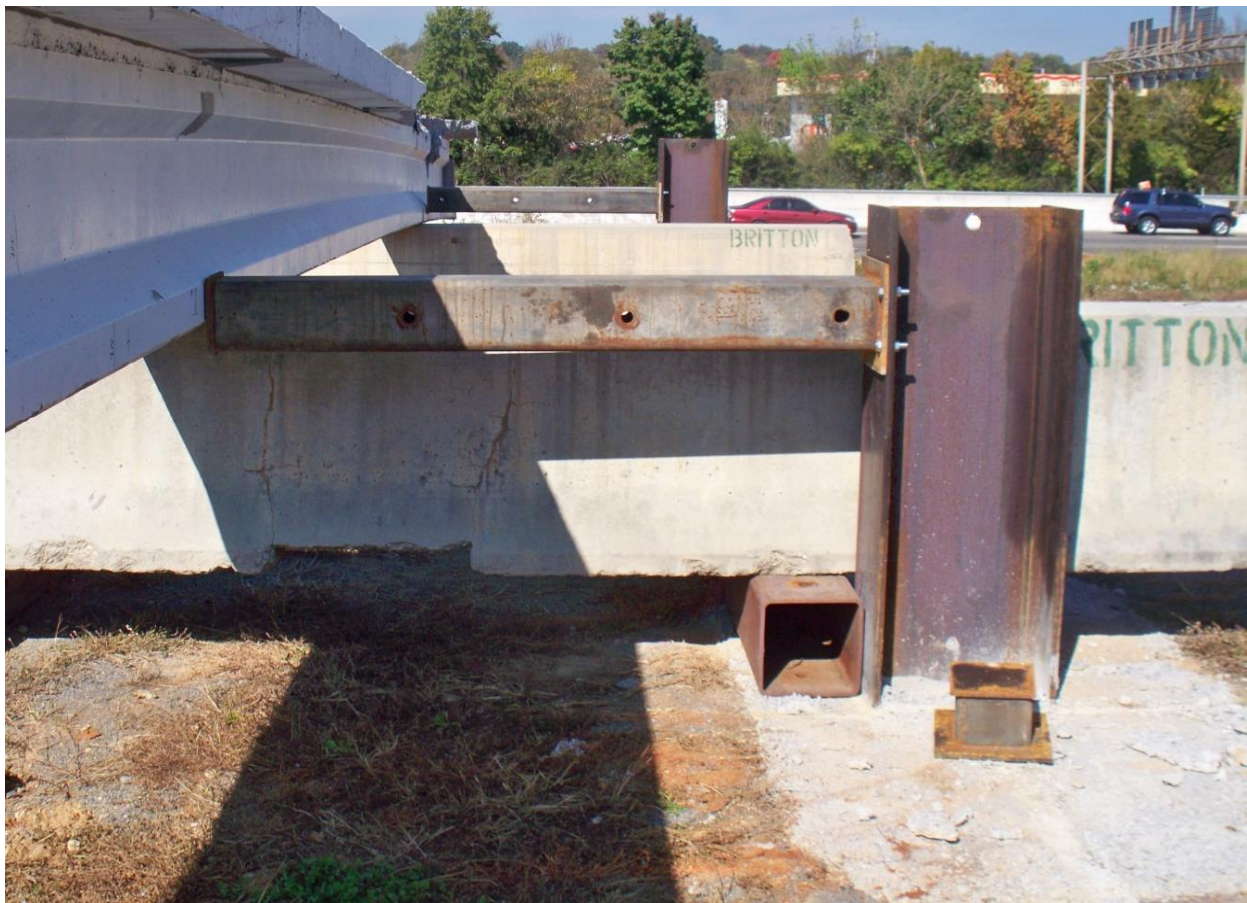
transferring the load from the test specimen to the steel beams. These tubes were oriented horizontally between the test specimen and the steel beams. Therefore the limiting design criterion was compression. Based upon an effective length of 7 ft. the minimum size for the HSS tubes was 3x3x1/4 in. This was not the ultimate section chosen since two 8x8x1/2 in. tubes were available at no cost. Therefore the size used was 8x8x1/2 in. In order to attach the tubes to the beams plates were welded onto the tubes with the same bolt hole pattern as that on the beams. A plate was also welded onto the front side of the tubes to insure full contact between the tubes and the test specimen. These details are shown in Figure 20.

Figure 20. Completed backstop with footing beam and tube.

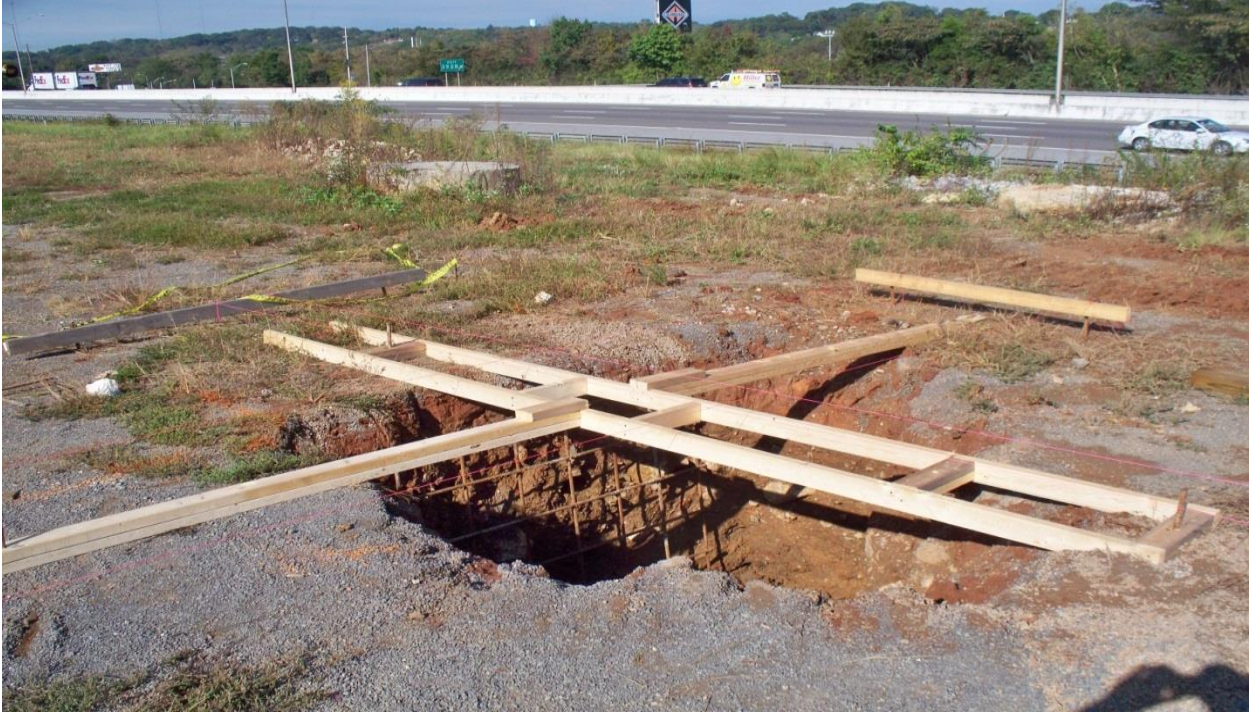
the guide system. The stacked boards were attached to the 14 ft. boards with a scab board to aid in ease of construction, and to insure that they did not come loose during steel erection. With all of the boards joined together the guide system was staked in place with nail pins as seen in Figure 23. This created a guide box for the steel beams to be placed in.

Figure 22. Guide system for steel beams.

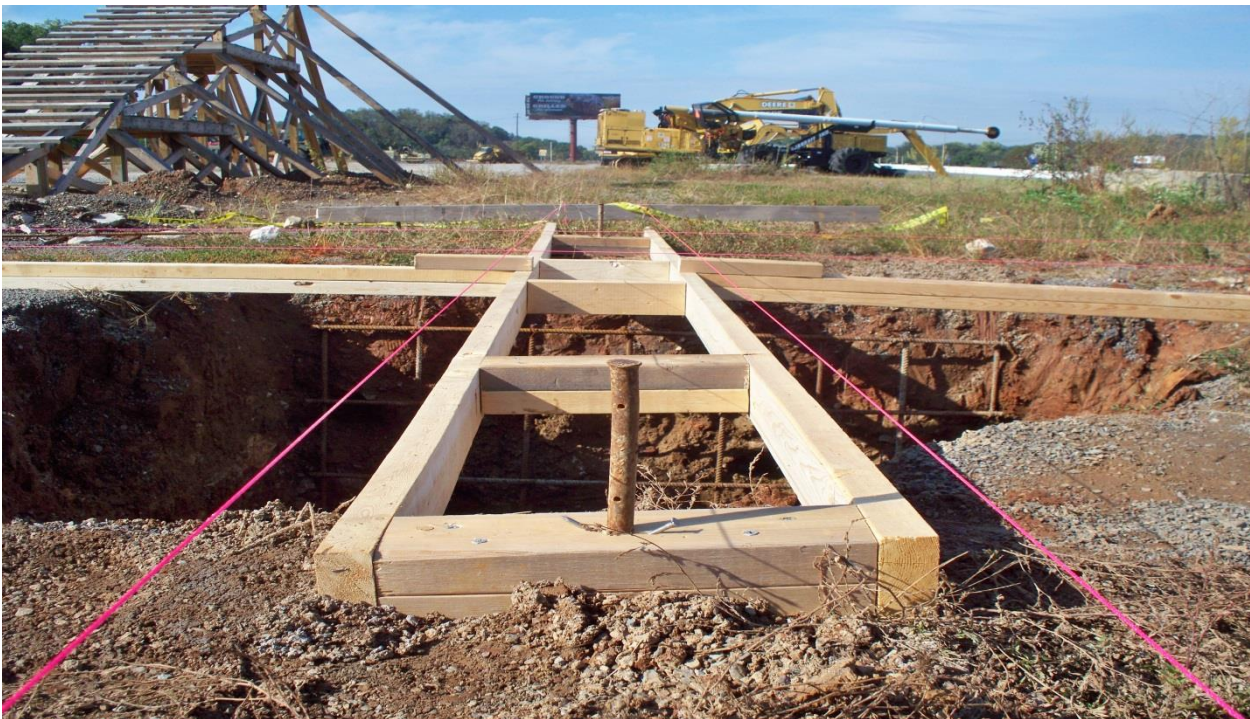
Figure 23. Nail pins securing the guide system to the ground.

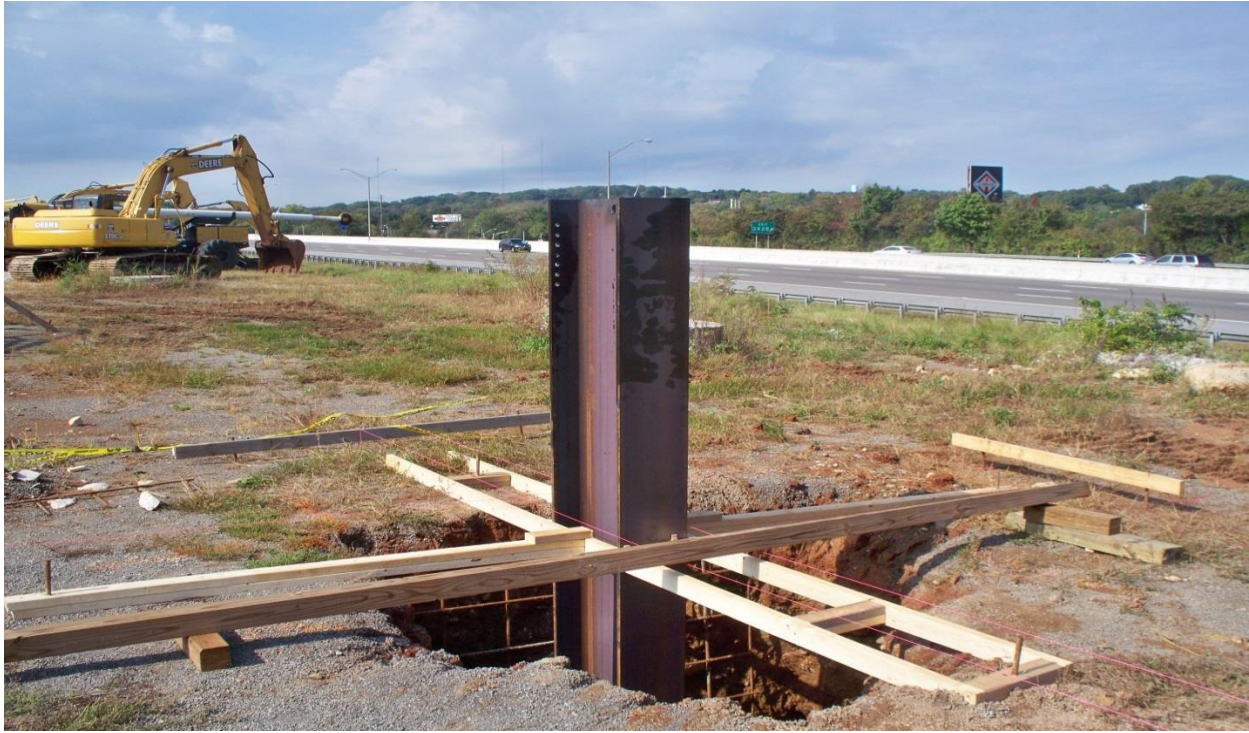
The steel beams were erected with a small crane, Caterpillar Galion 150FA. In order to slide the beams through the guide system they needed to be lowered straight down. This objective was accomplished by torch cutting a hole through the web of the steel at its balance point and running a shackle through the hole. The beams were slowly lowered through the guide system until they settled on the bottom of the footing. Once set the beams were plumbed by placing small wood shims between the beam itself and the guide system. A beam set in the guide system is shown in Figure 24.

Figure 24. Steel beam sitting within the guide system.

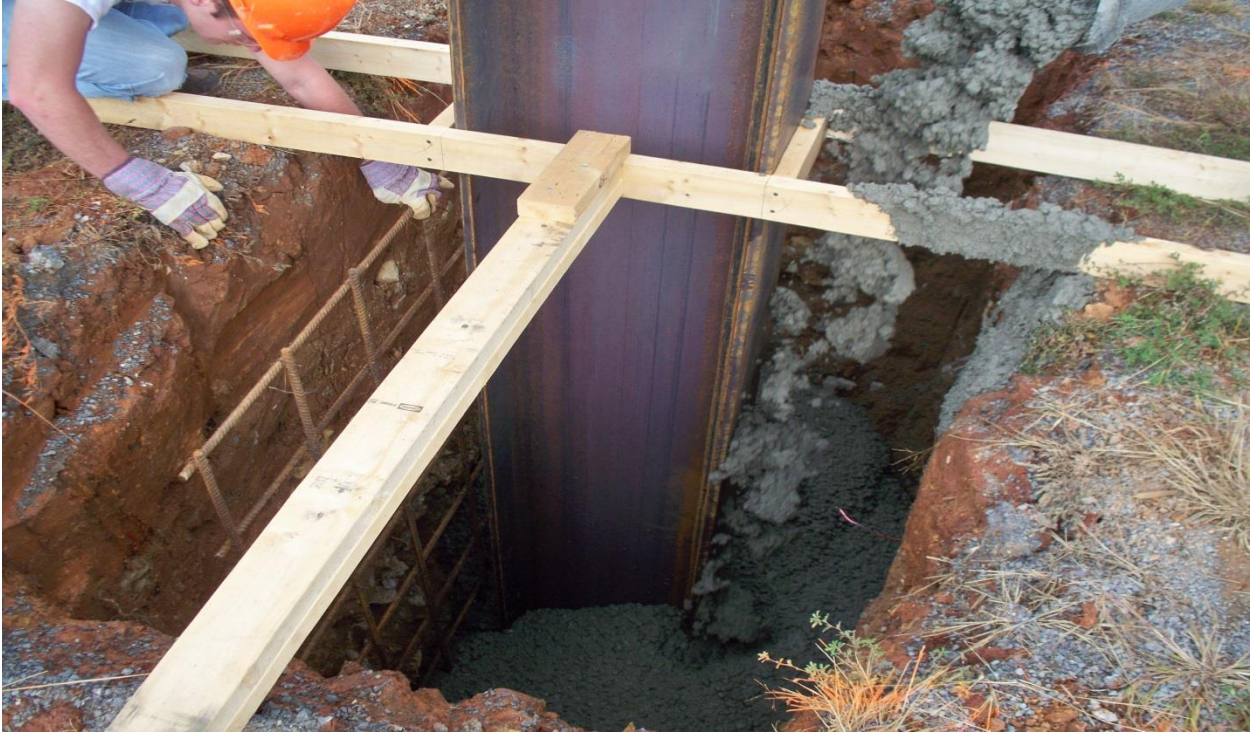
With the rebar mat and steel beams set in place concrete was poured in the open footings. The large volume of concrete needed for the footings required for the concrete to be poured out of ready mix trucks as seen in Figure 25. The concrete was poured in two foot lifts and was vibrated for consolidation after each lift was poured. The concrete was poured up to the existing ground elevation. Since nothing needed to be placed on top of the concrete no finishing was required. Therefore the only method of finishing was normal consolidation due to vibrating the concrete. One of the finished footings is shown in Figure 26.

Figure 25. Concrete being poured from a ready mix truck.

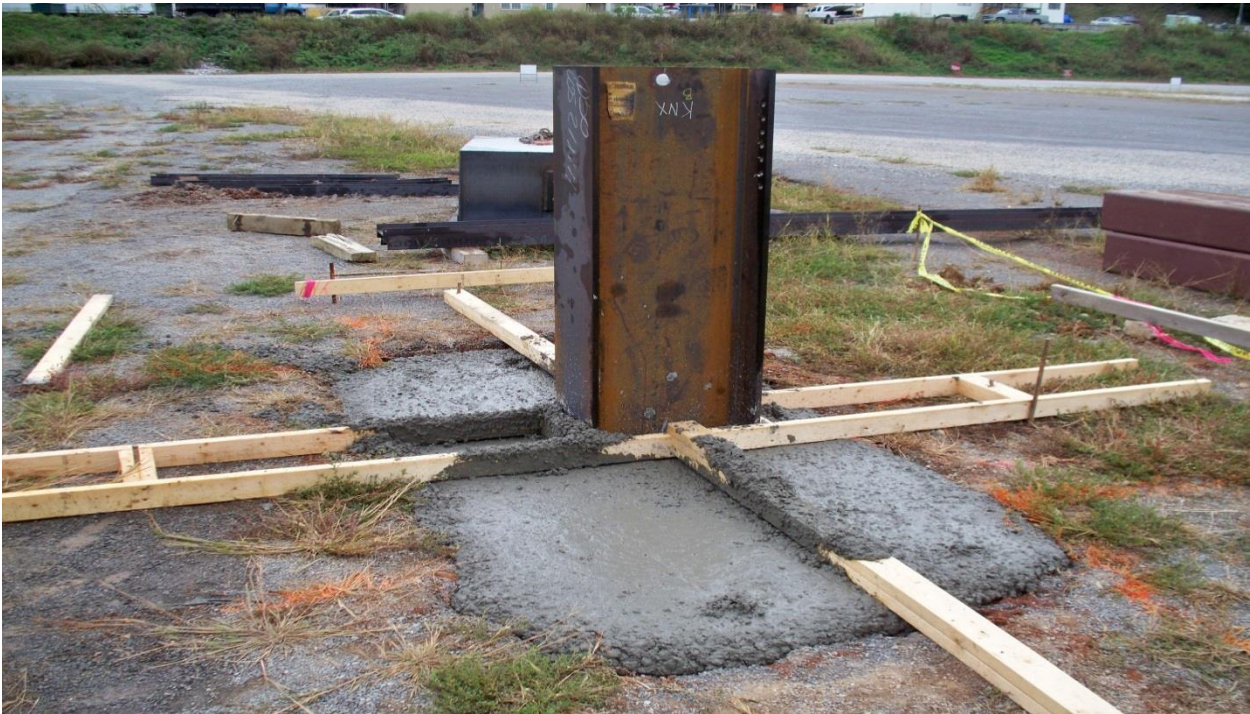
Figure 26. Finished concrete footing.

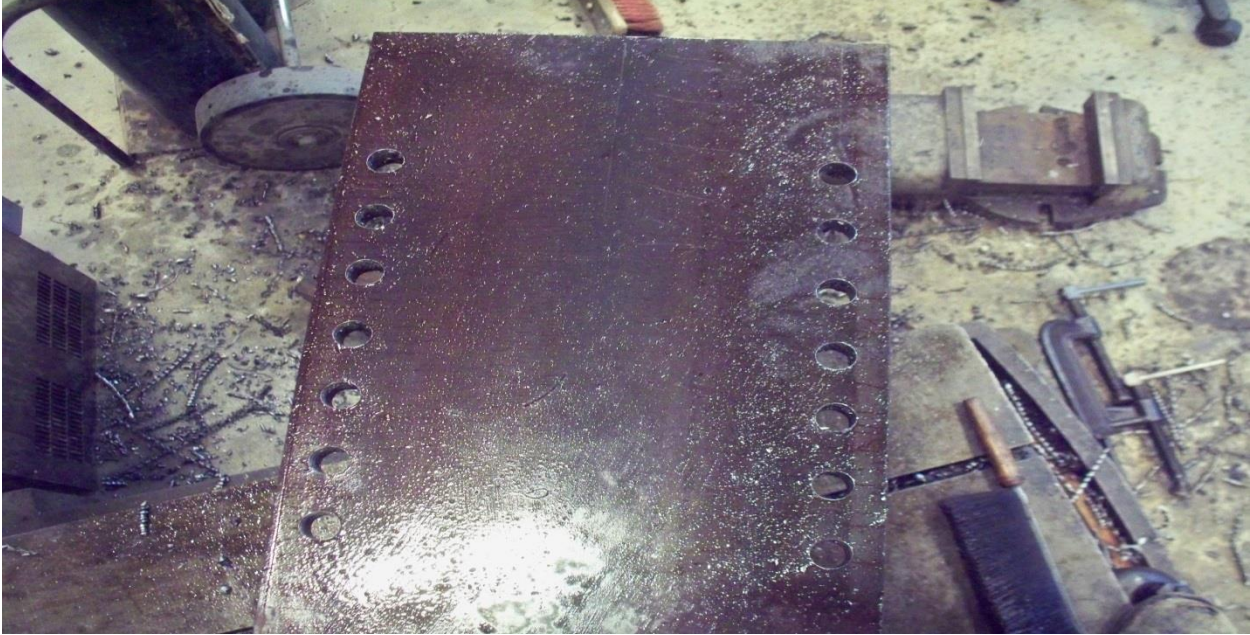
In order to make the tubes removable they needed to be bolted onto the vertical beams. Therefore the backplate that was welded to the HSS had four holes drilled through it with a spacing of 6 in. Matching holes were also drilled through the vertical beams prior to placement with spacing of 2 in, as seen in Figure 27. The smaller spacing was so that the tubes could be placed at multiple elevations. The tubes were installed by lowering them into place with a crane and then bolting them to the flange of the vertical beams. During installation it was discovered that the holes in the vertical beam did not match up with the holes in the tubes. The holes were

Figure 27. Vertical beams with predrilled holes at 2" spacing.

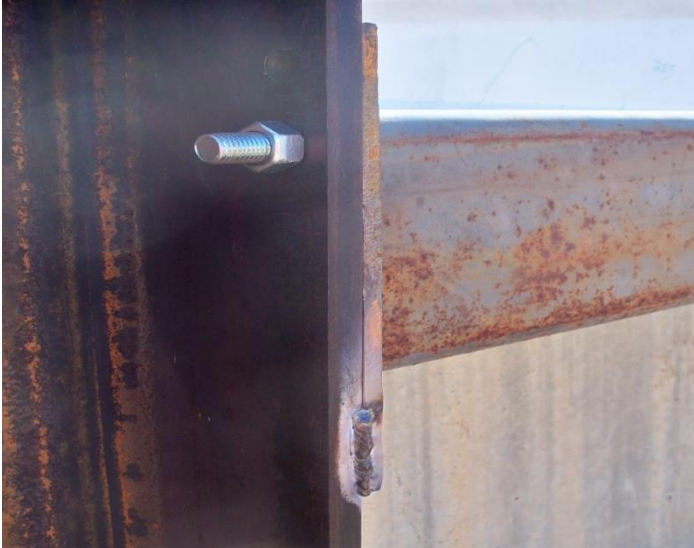
not off by much, however it was enough that only two bolts could be used for one of the tubes. As a substitute to bolts the backplate was connected to the beam by two small welds on either edge of the flange as seen in Figure 28. This connection held the tube in place during testing and the welds were ground off when the tubes needed to be taken down.

Figure 28. Connection of HSS tubes to vertical beams.

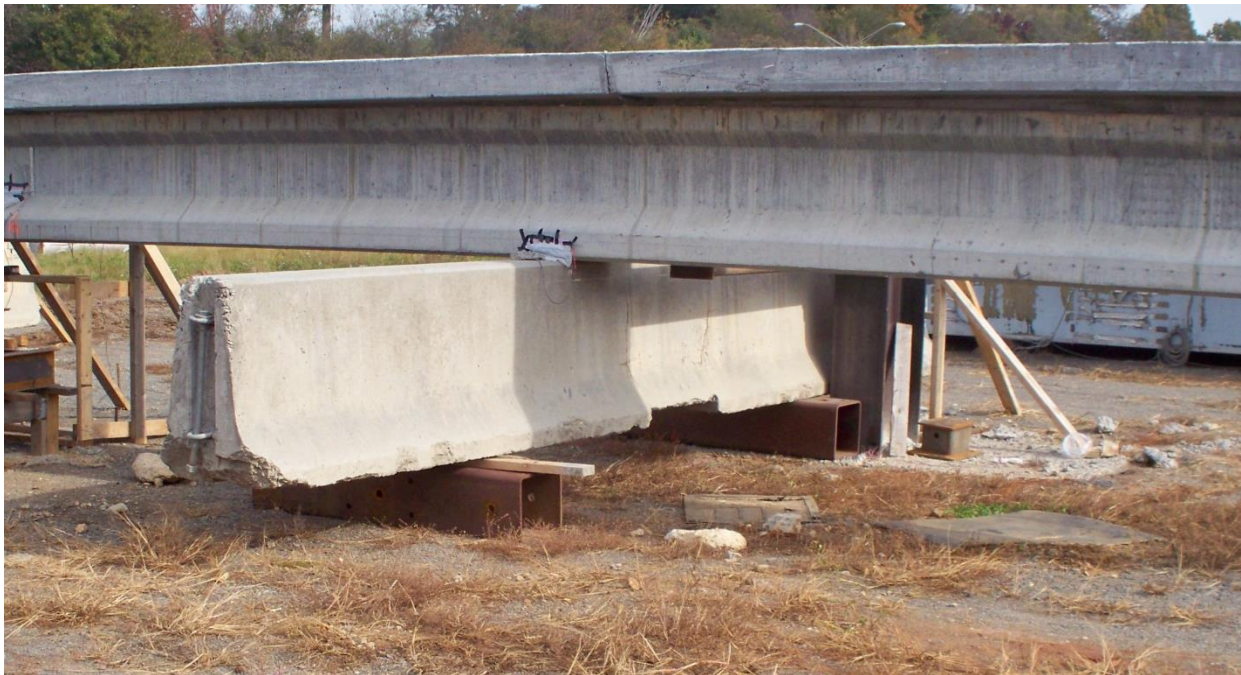
In order to have the maximum impact force possible the impact point must be at the center of gravity of the impactor. Since the target impact location off the test specimen was the bottom flange the specimen needed to be elevated to where the center of the bottom flange lined up with the center of the impactor. This was accomplished through the support system. The system consists of New Jersey Barriers and HSS tubes placed beneath the barrier. The choice of these materials was based on availability. The barriers were already on the testing site and were made available to use two of them for testing. The barriers were not tall enough on their own to properly elevate the test specimen. This problem meant that a secondary component was necessary. The height needed was determined to be roughly 12 in. Fortunately four 12"x12"x3/8" steel HSS tubes were available for use. Two tubes were placed underneath each of the barriers. The barriers were placed perpendicular to the direction of the test specimen and just to the inside of the backstop. This was done to create a support condition that was close to what the specimen would experience if it were being used in an actual bridge. The support system is shown in Figure 29.

Figure 29. One of the supports with test specimen sitting on top.
