## **Design and Construction Of a Full-Scale Lateral Impact Testing Facility**

A Thesis Presented for the  
Master of Science  
Degree  
The University of Tennessee, Knoxville

Cody Aaron Mitchell  
May 2015

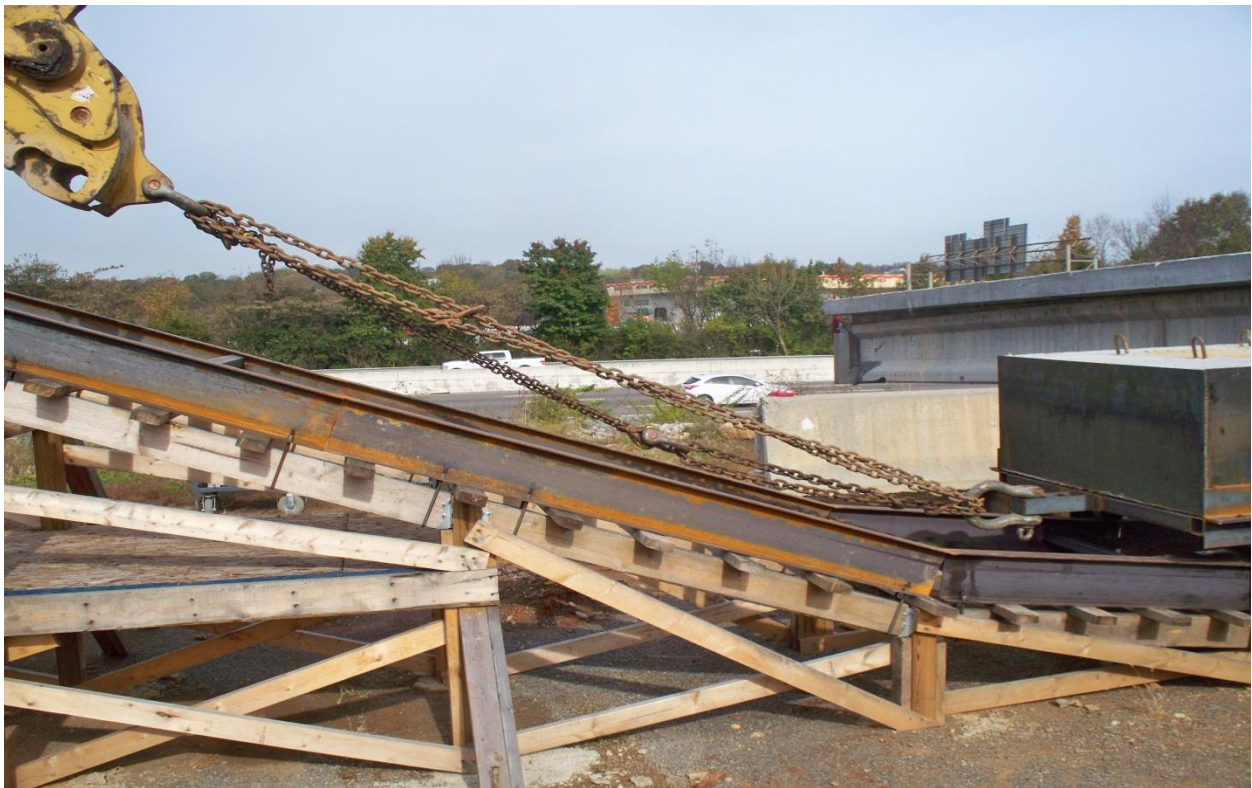
In order to operate the testing facility the impact cart must be pulled up the track, locked in place, and then released. This was accomplished by means of two large excavators. The first excavator pulls the impact cart up the slope. The impact cart is connected to the excavator by a chain and shackles that connect to the hitch on the cart itself as seen in Figure 30. Once the cart is pulled up the track a second excavator locks the impact cart in place. Meaning that the bucket of the second excavator is placed on the front side of the impact cart preventing it from rolling down the slope. Once the second excavator has secured the impact cart the chain is slacked and the shackle is unfastened from the hitch of the impact cart. Once the shackle is removed the bucket of the second excavator is raised and the impact cart is allowed to roll down the track. This method of release served as a type of quick release system, but was much safer than the alternatives. This method allowed for multiple redundancies and could be tested prior to the actual test without having the impact cart roll down the track.

Figure 30. Impact cart hooked up to excavator by shackles and chain.

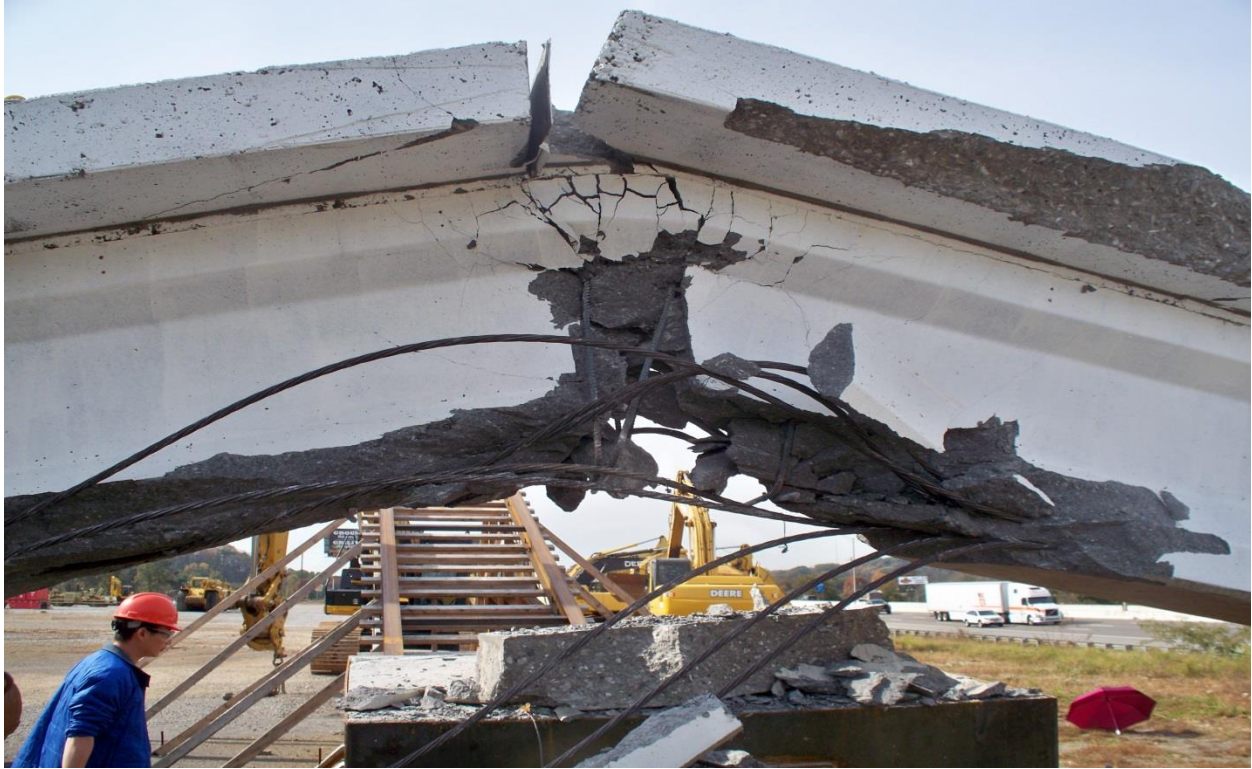
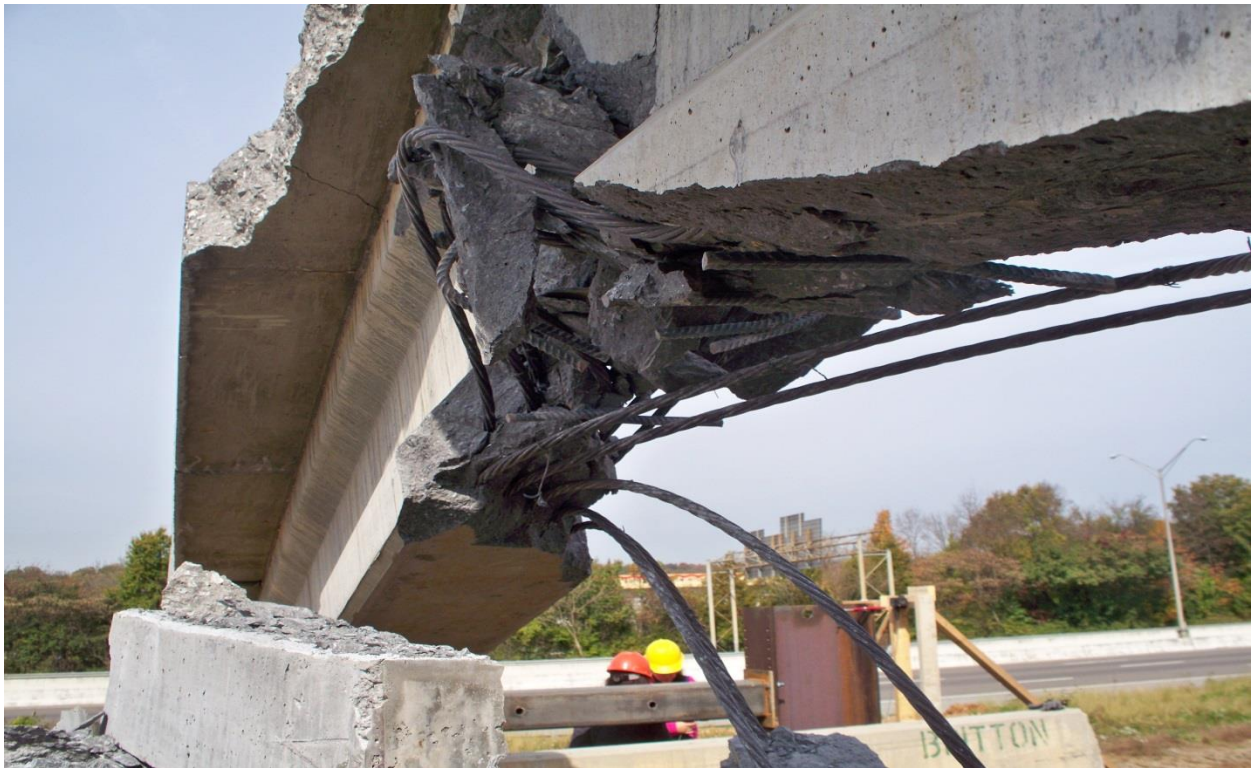
To verify all of the design assumptions described in Chapter 4 a single impact test was performed on a prestressed beam. The operation of the testing facility went smoothly and the impact cart collided with the beam as planned. The backstop also acted as planned and prevented the beam from sliding. The damage that occurred to the specimen can be classified as a catastrophic failure of the structural integrity of the beam. Upon impact the bottom flange of the beam crumbled and the beam twisted about the midpoint. Cracking was observed throughout the bottom flange of the beam and all the way through the cross section of the beam and into the top deck. The prestressing strands were all uncovered and the prestressing was released from all of the strands. The damage to the beam is shown in Figures 31, 32.

Figure 31. Prestressed beam after impact.

Figure 32. Prestressed beam after impact.

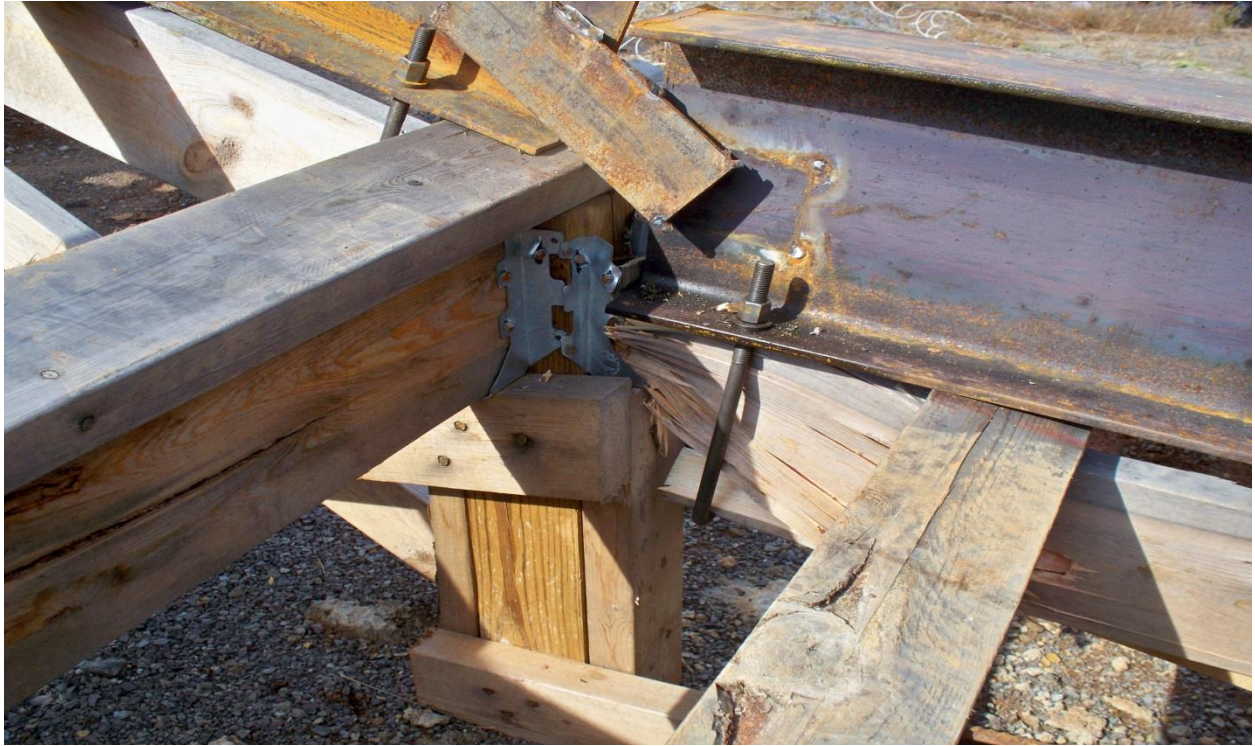
The impact testing facility itself performed well; however, when the impact cart hit the first angle change near the bottom of the ramp the structure failed. The joists nearly sheared completely in two and the welds on the rails broke. The failure was instantaneous, suggesting that the failure was due to vertical impact. The damage to the track is shown in Figures 33, 34. Despite this damage to the track the impact cart still collided with the beam with the expected force. This indicates that the facility as a whole worked for the intended purpose. However, modifications must be made so that this type of failure does not occur in future tests. In order to fix the broken section the initial design concept was scrapped in favor of an alternative that was more suited to withstand vertical impact.

Figure 33. Damage to joists after testing.

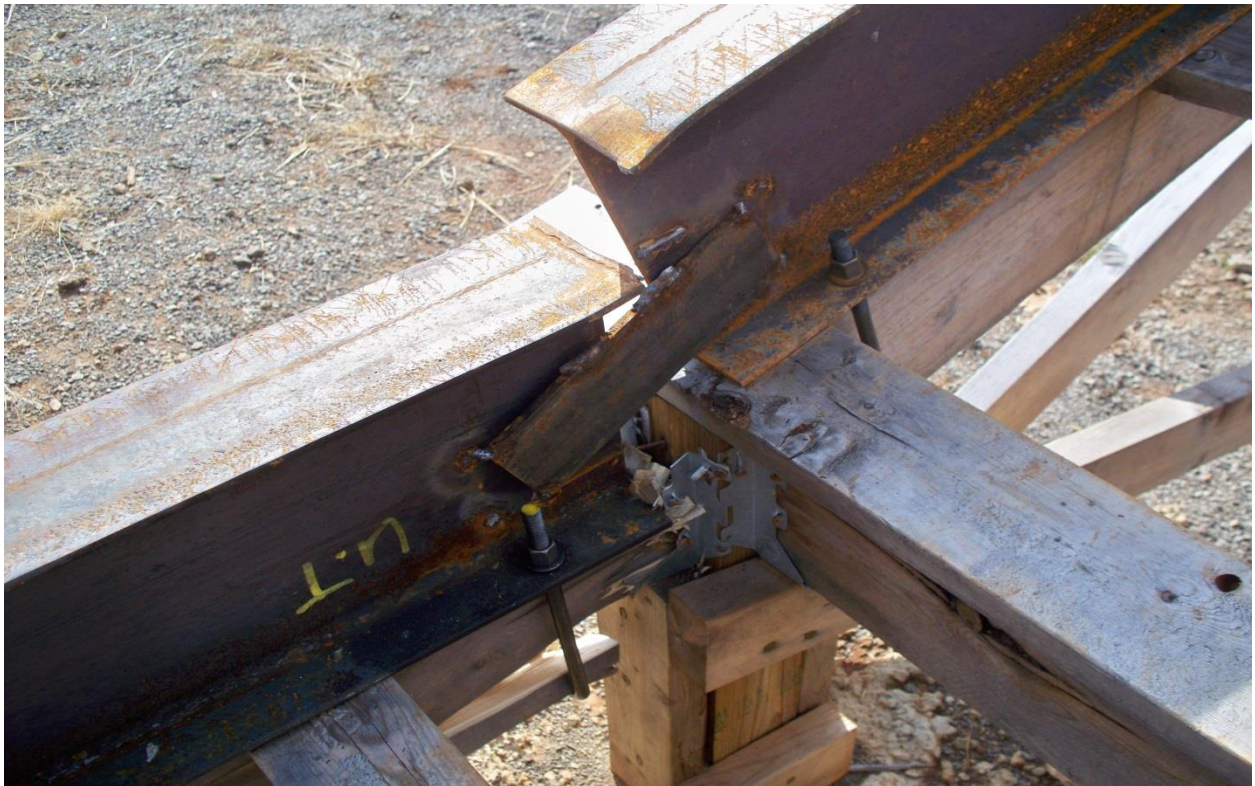
Figure 34. Damage to rails after testing.

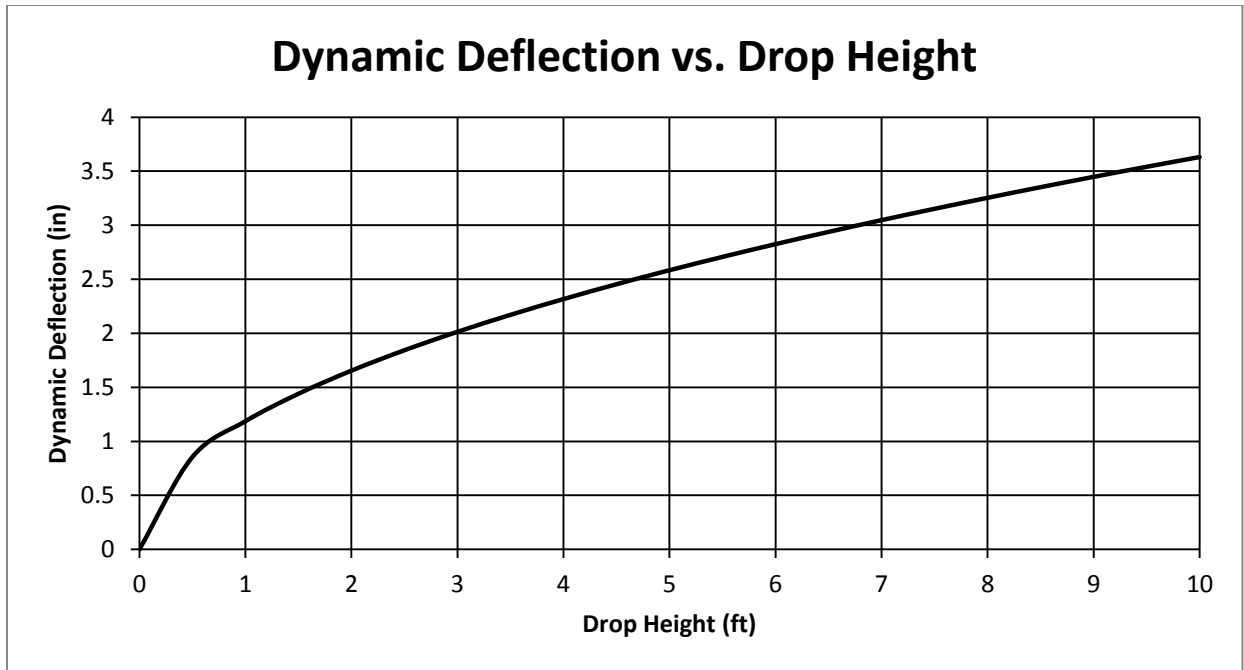
Equation 5.2 was rearranged to solve for the dynamic deflection. The drop height was varied and multiple values of the dynamic deflection were plotted in Figure 35. These values were then compared to the static deflection to determine an impact factor.

Based off of the maximum dynamic deflection of 3.63 in. from a drop height of 10 ft. the impact factor was determined to be 68.5. This is obviously unreasonably large and not a true representation of how much force is being transferred into the structure. Since this number was so large the worst case cannot be considered as the actual loading case.

Figure 35. Dynamic deflection vs. Drop Height.

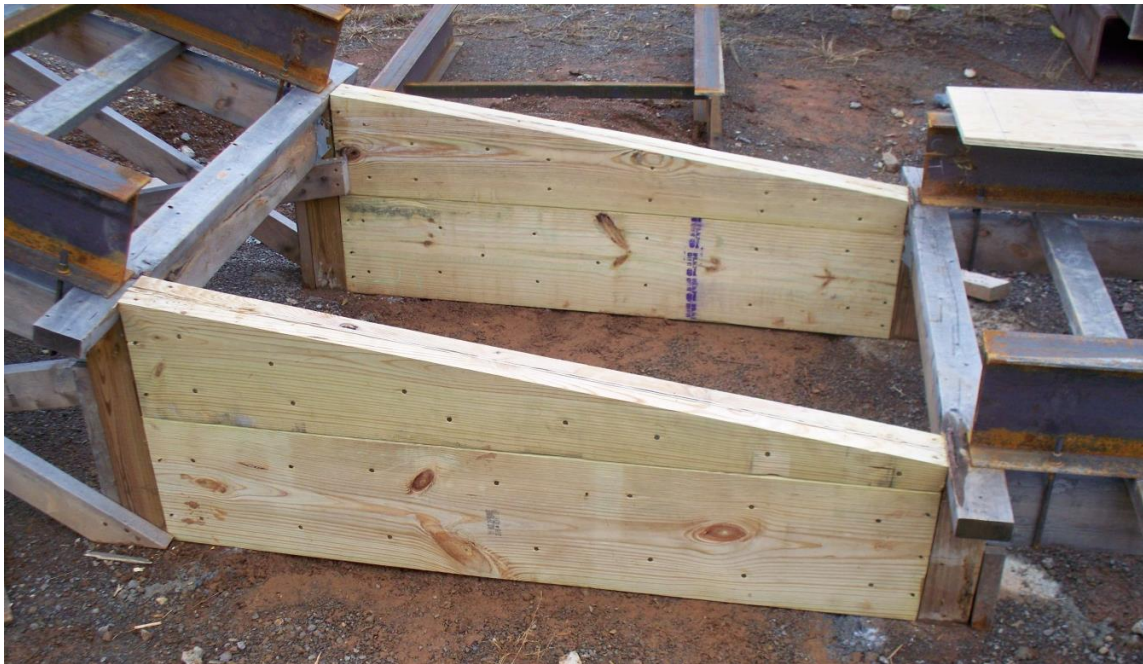
Only one section of the track needed to be redesigned. The rails were temporarily removed over the section while the joists and 2x4 decking were permanently removed. In place of the joist and decking system two walls were built and the rails were placed directly on top of them. The walls consist of 2x12's and ½ in. plywood. The 2x12's were placed in the horizontal direction and stacked on top of one another. The top board was cut on an angle that matched the slope of the track. There were two layers of 2x12 and one layer of plywood between the 2x12's. This is shown in Figure 36. The total thickness of this wall is 3 1/2 in. The entire system is then covered in ¾ in. plywood on either side of the wall. This plywood is screwed into the posts and then nailed onto the wall as shown in Figure 37. This creates a solid composite wood wall. This amount of wood is overkill, however it was desired to build a quick and easy solution that would ensure that the structure would not fail again.

Figure 36. Replacement 2x12 and plywood walls.

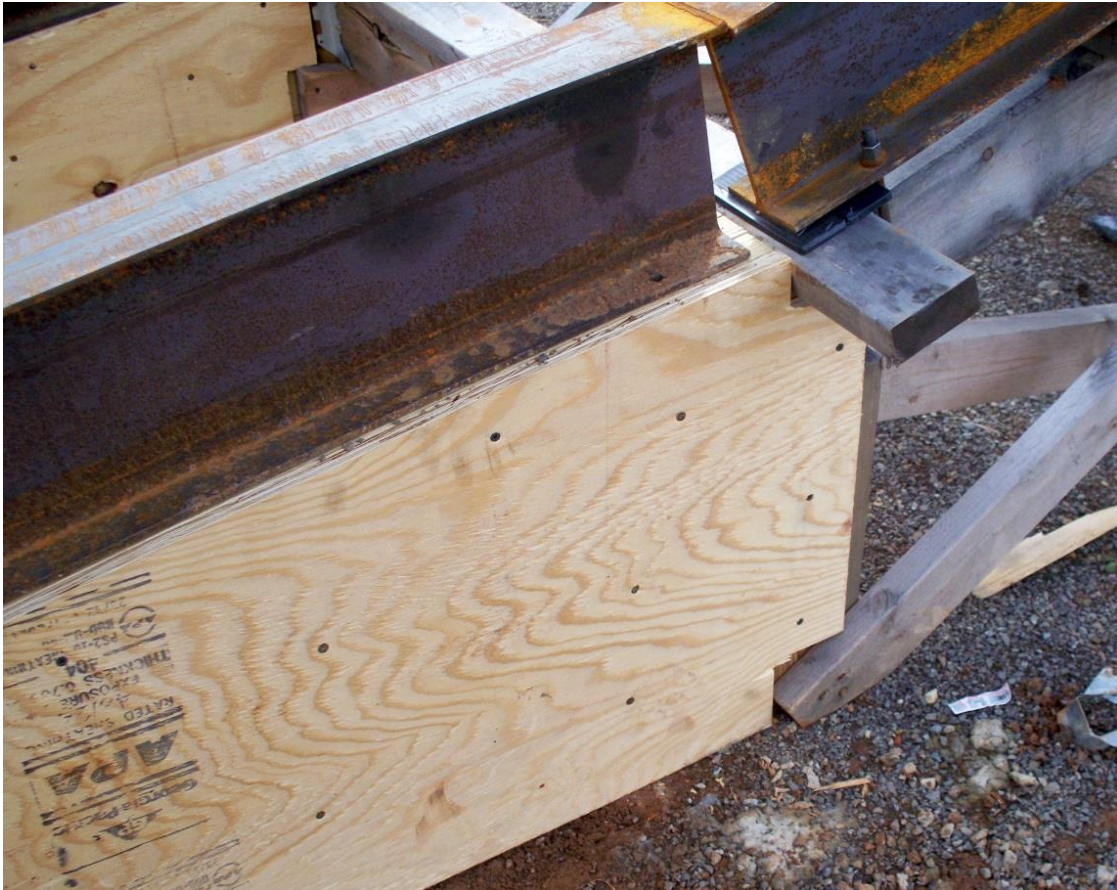
With the walls built the rails were then set directly on top of them. This section of rail was then welded to the other rails as previously described. Since the impact cart did not shift laterally during the first test it was determined that the rails did not need to be secured to the walls and rather only to the existing rails.

Figure 37. Plywood on the outside of the wall screwed into plywood.
