Conservation Handbook Al Zubarah Archaeological Site

Edited by
Moritz Kinzel

QIAH-01-02-HE-1000

First Edition January 2013

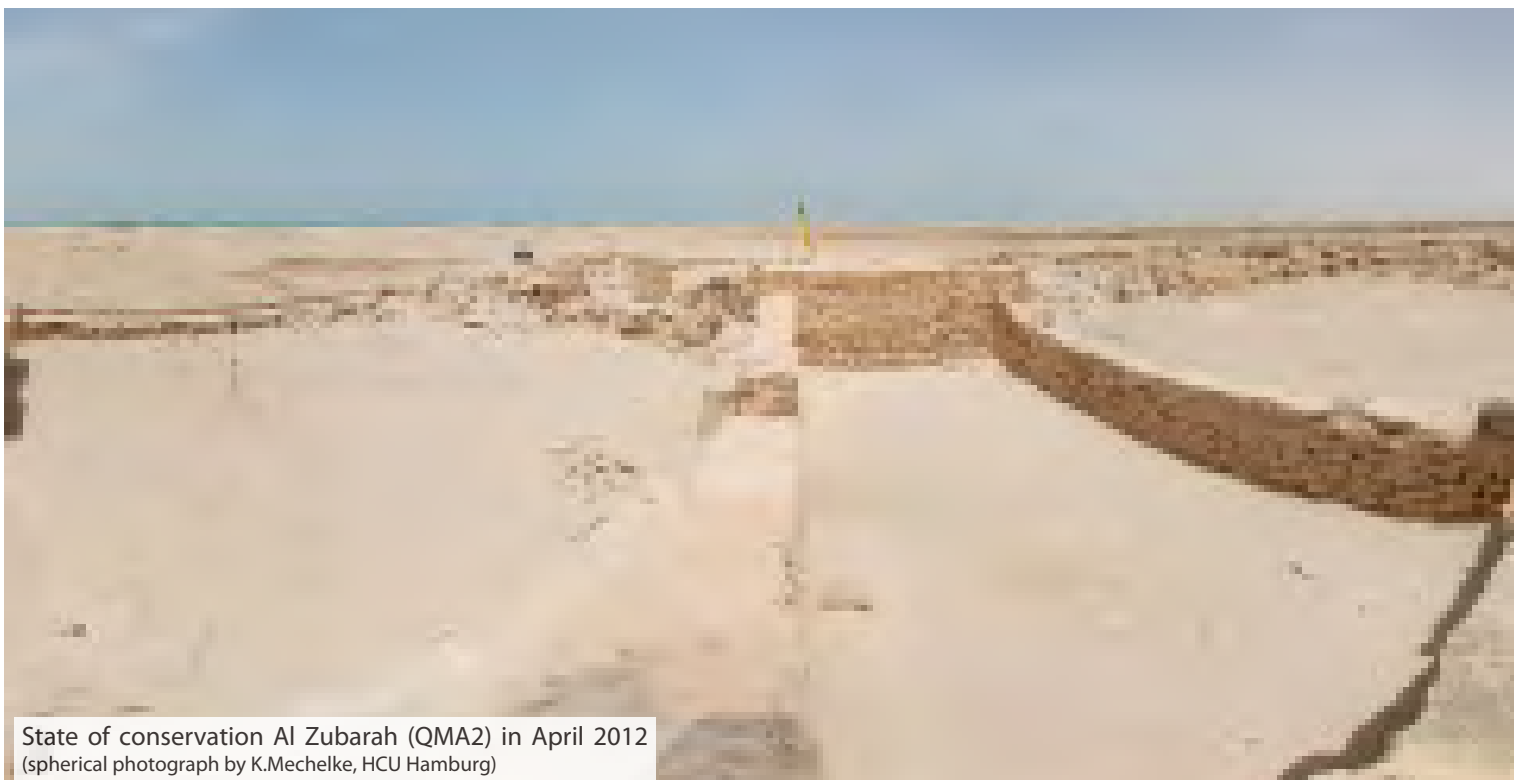
State of conservation Al Zubarah (QMA2) in April 2012
(spherical photograph by K.Mechelke, HCU Hamburg)

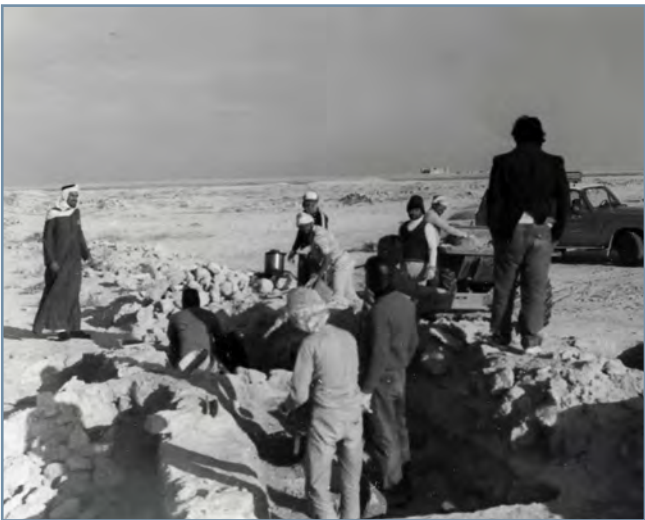
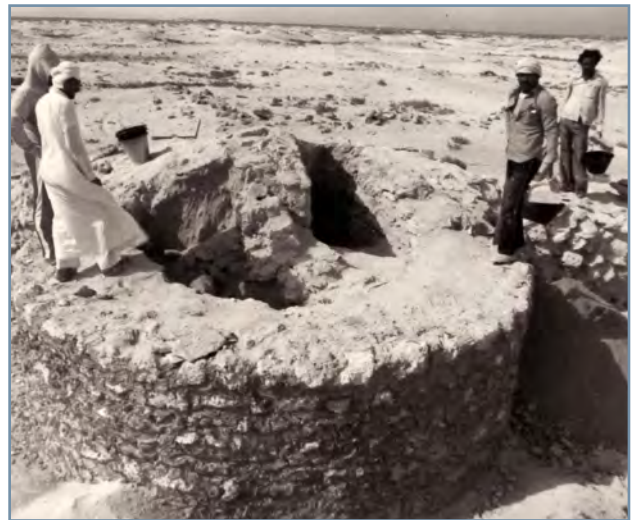
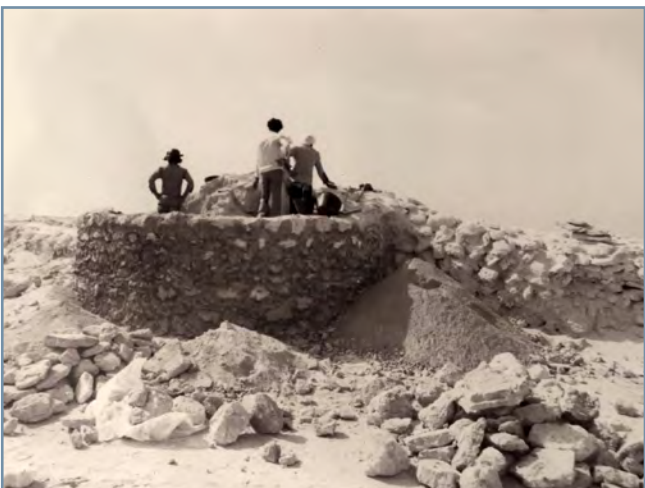
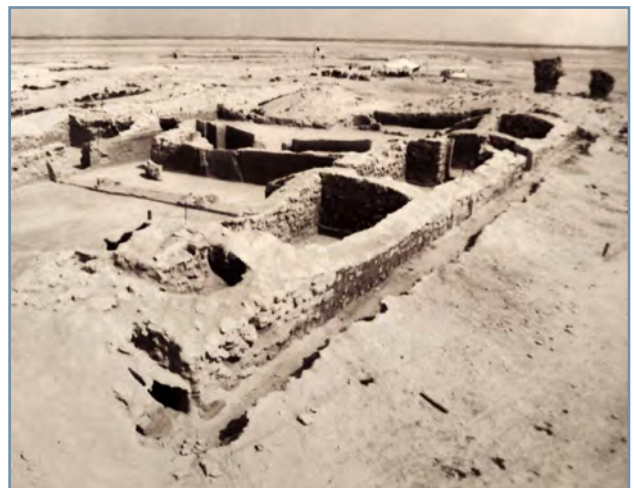
Excavation and Conservation work during the 1980s at Al Zubarah.

The driving concept of the conservation and presentation works was to present a regular plan of the ruined structures, to make the remains more easily "understandable" for the visitors. Therefore, original walls were "completed" with the addition of courses of stone to reach this abstract level, while higher standing walls were simply "capped" with a layer of hard impermeable cement-based mortar (upon which often was added a final course of stone capped with a more visually-neutral white cement mortar) to reach a regular level permitting the "reading" of the architecture.

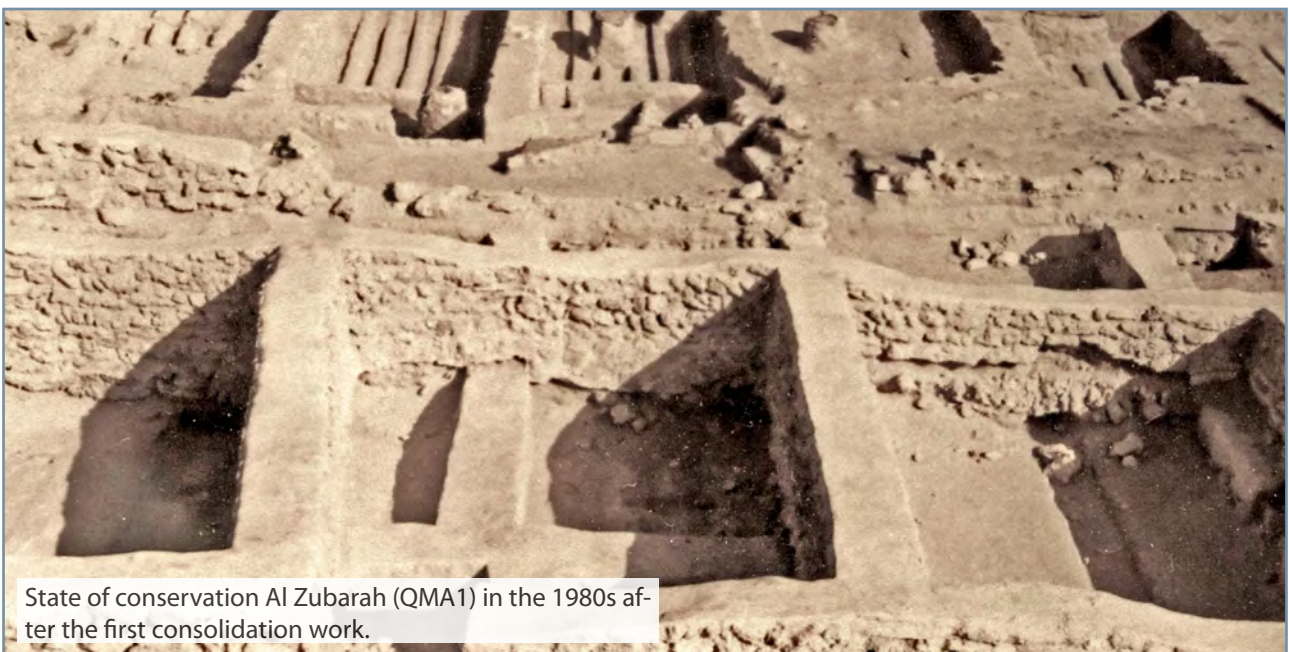
State of conservation Al Zubarah (QMA1) in the 1980s after the first consolidation work.

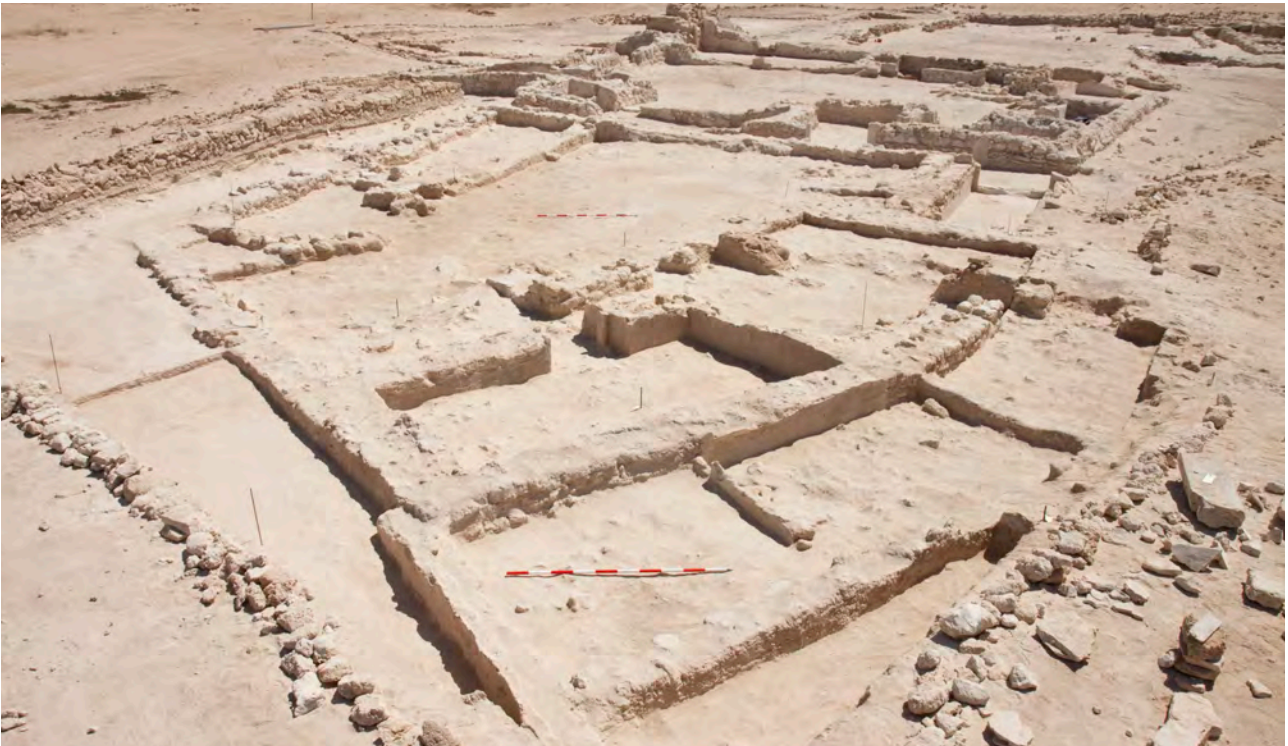
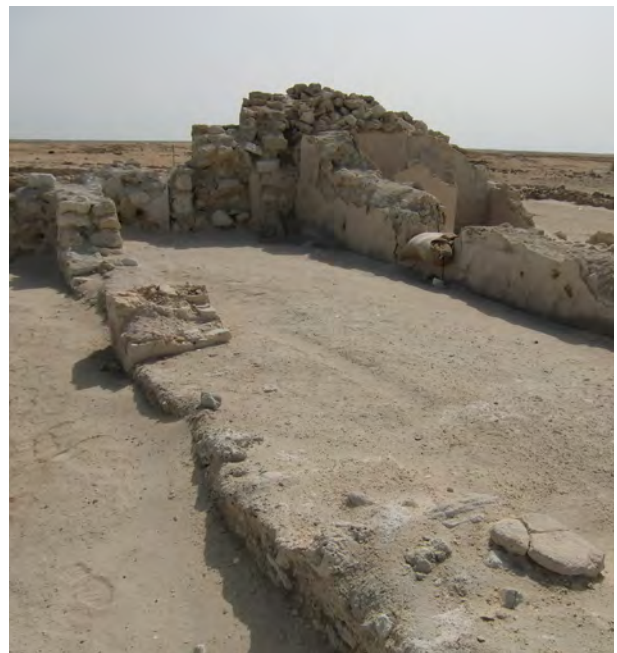
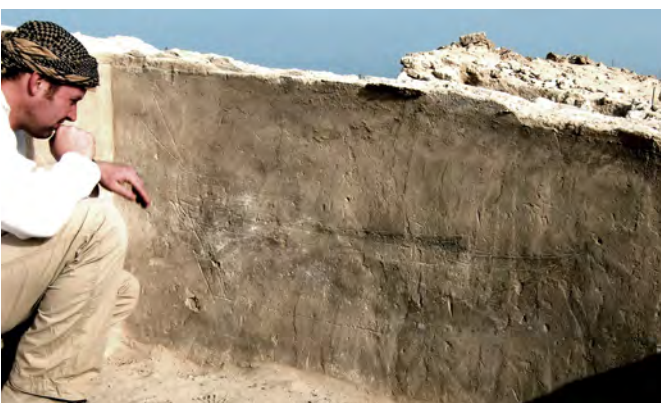
ZUEP01 - Courtyard houses

Excavation point 01 (ZUEP01): *Living quarter with courtyard houses.* In one of the houses a *dhow* was depicted in the wall plaster. This feature was documented carefully in different techniques. It was photographed, drawn, copied with a silicon moulding, scanned with a high-resolution scanner and with photogrammetric techniques. The courtyard houses show bended entrances, reception rooms (*majlis*), kitchen areas and an arcaded *Ivan*.

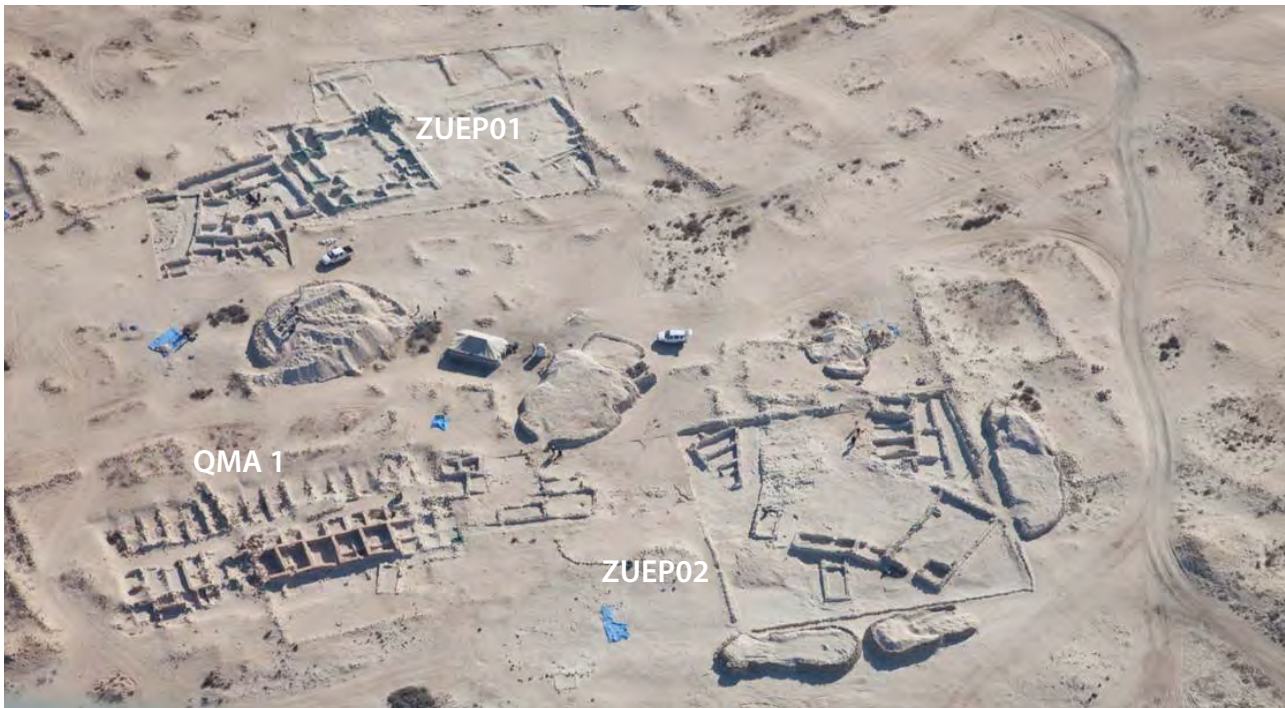
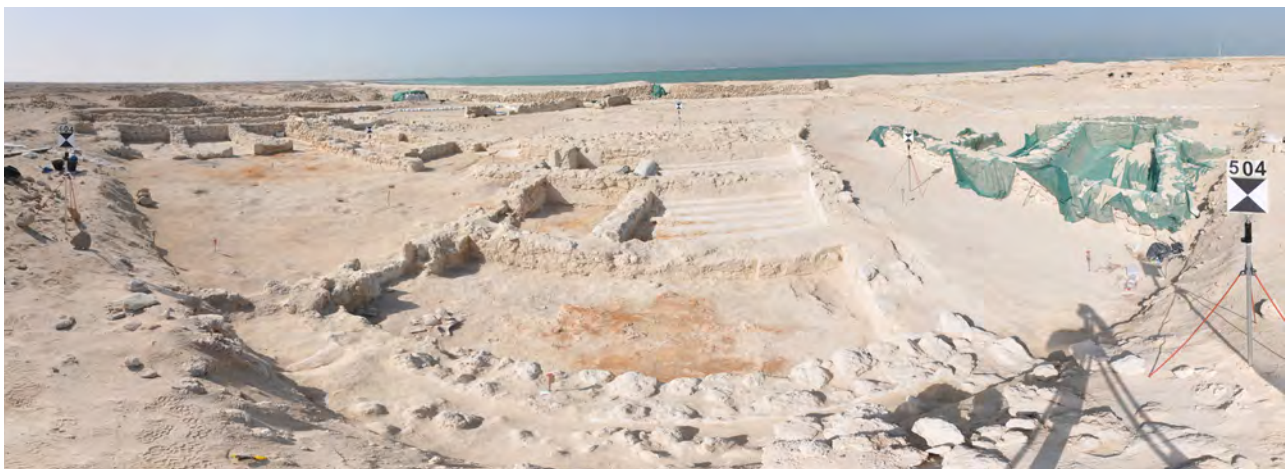
ZUEP02 - Commercial Centre (Souq)

Excavation point 02 (ZUEP02): *The Commercial complex of Al Zubarah is situated next to the harbour zone and includes warehouses, storage, and shops. The warehouse incorporates some date presses (*madbasah*) and a courtyard. The warehouse has a straight entrance to allow direct access to the central courtyard. The room cells of the suq are built in two rows and extend from the earlier excavations (QMA1) to the recently exposed areas (ZUEP02).*

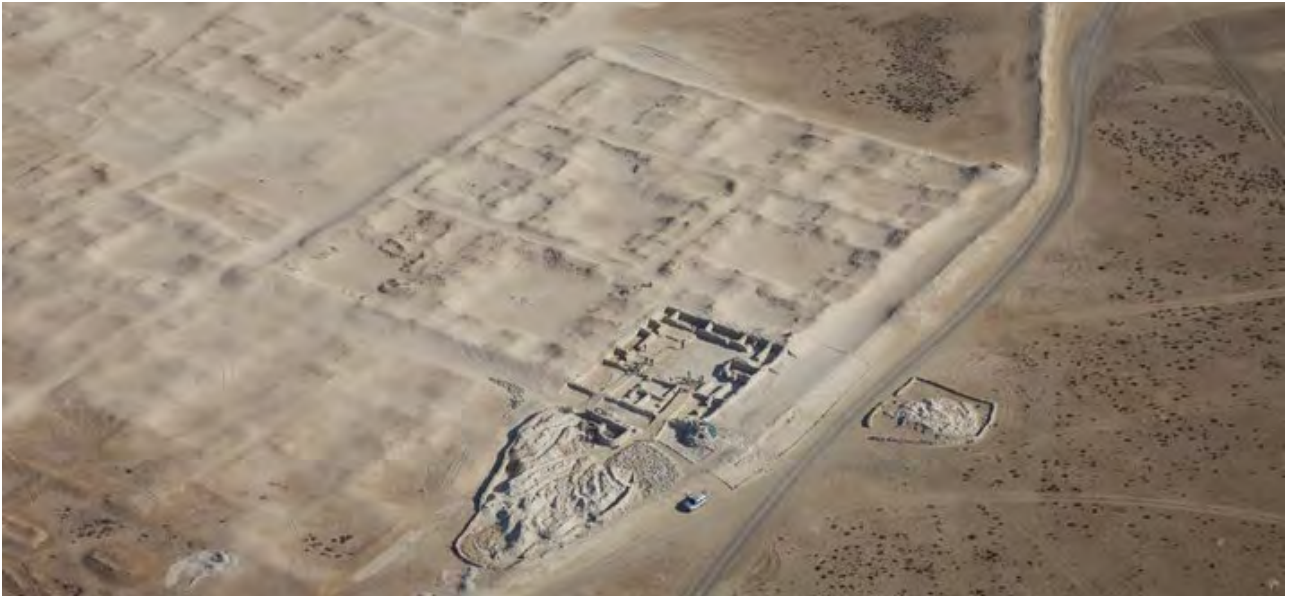
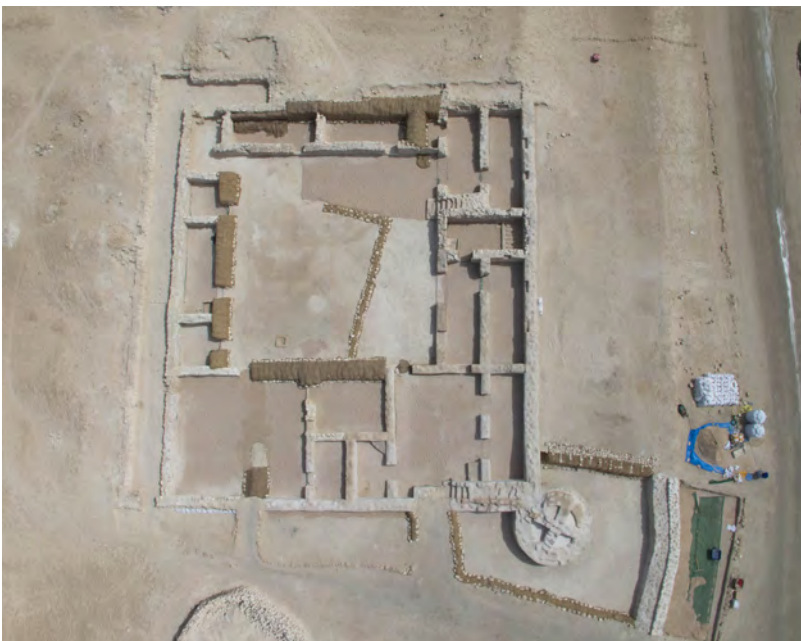
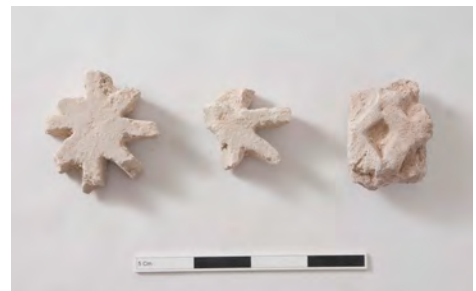
ZUEP04 - Palace

Excavation of the Palace started in early 2010 and has so far exposed one of the nine main courtyards. Decorated plaster and elaborate room arrangements were discovered. The walls are predominantly built from beach rock rendered with an anhydrite-based plaster.

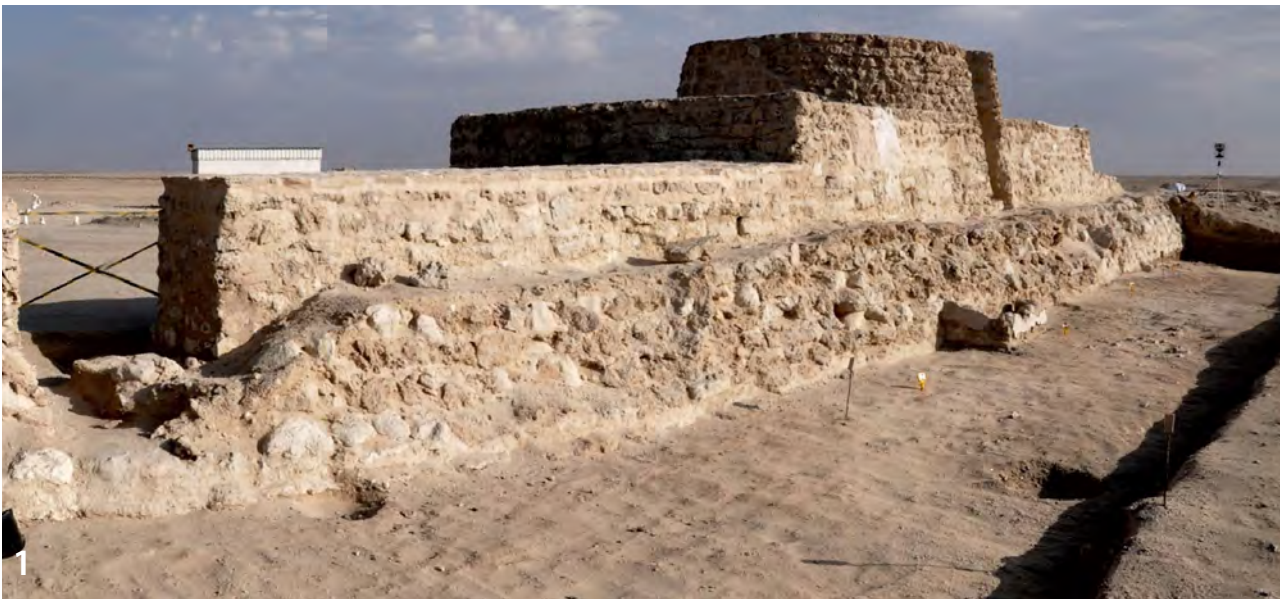
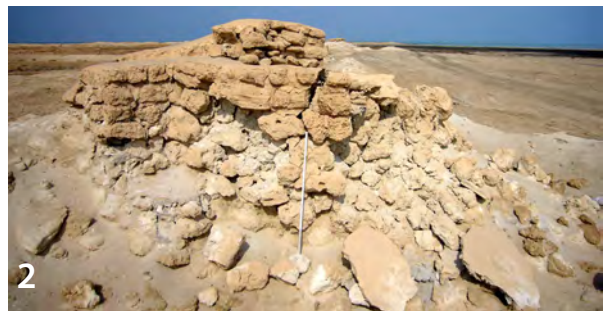
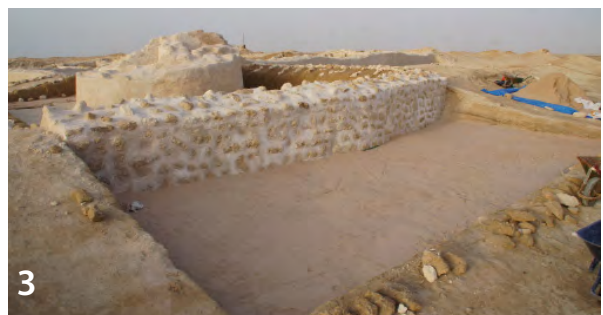
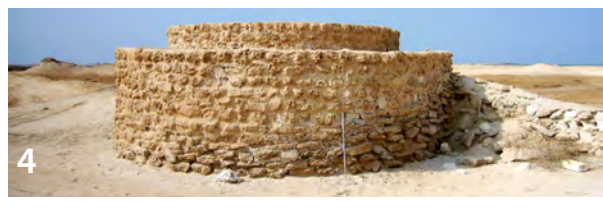
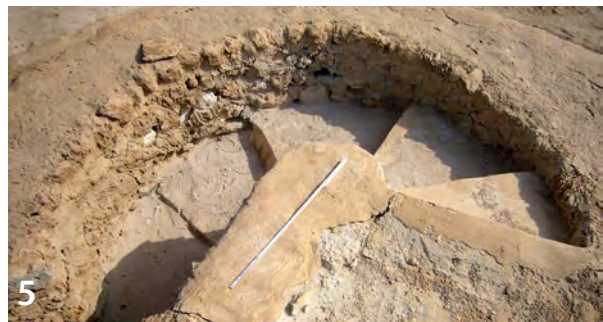
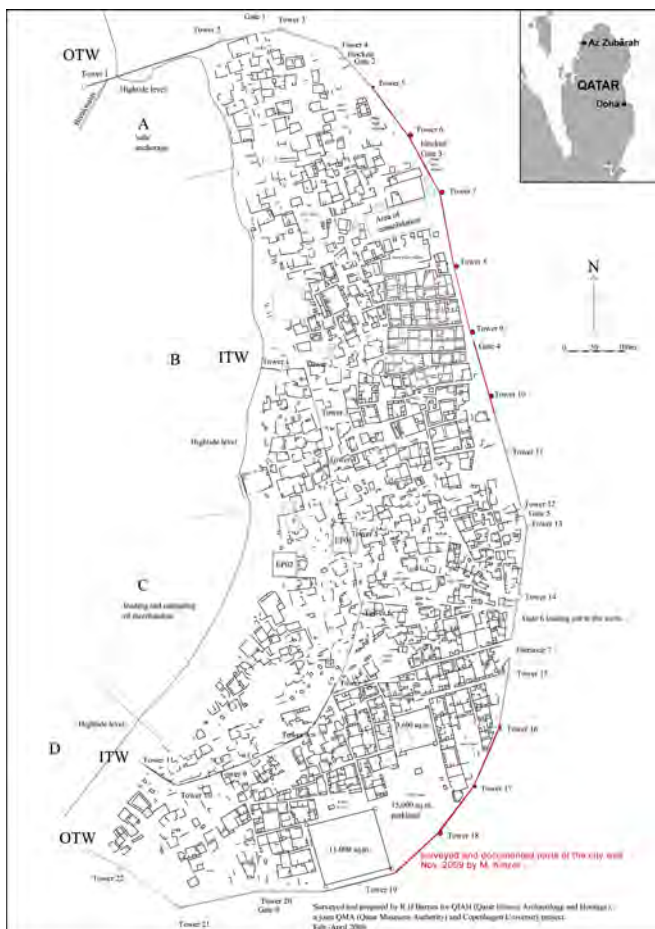
Town wall and Towers

1. Tower 8 and ZUEP10 (2012 before the consolidation).
2. Tower 7, collapsed outer wall face (2010).
3. Town wall at ZUEP04 (2012 after stabilisation).
4. Tower 18, seen from NE (2009).
5. Tower 18, Interior rebuilt in 1980s (2009).

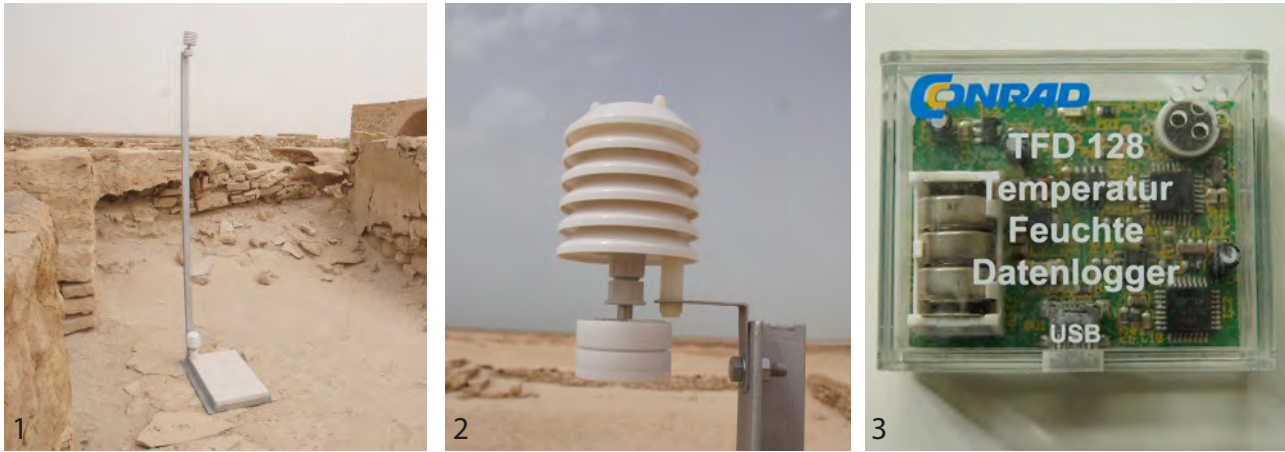
Fig.1, 2, 3: Temperature/humidity data loggers at QMA2 in Al Zubarah town (D1, D2) and HAB54506 at Al Zubarah Fort (indoor).

In order to gather detailed information on the climate of Al Zubarah, seven temperature/humidity data loggers were distributed over the town area, at the research station and inside a building of the fort (Fig.1 to 3). The localities are marked in Figure 4. The data loggers were distributed with respect to different geographical positions (close to the sea, more inland) and exposure situations (free exposure, protected position in a niche, wall crevice or under a stone, inside a building). One of the data loggers (D2) failed to record data over a longer period of time (more than several days). All data loggers are listed in Table 1 with their number, geographical position, exposure situation, and recording time.

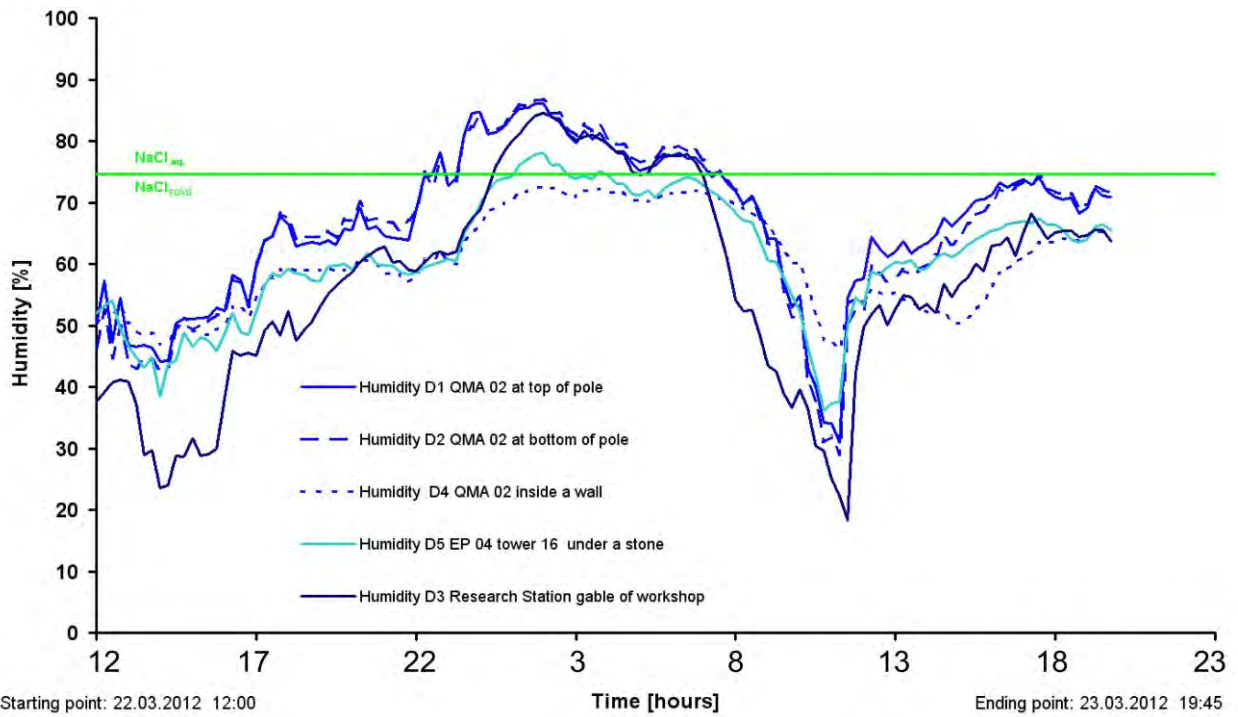
Fig.9: Humidity curves from data-logger D1 - D5 for the time period 22.03. - 23.03.2012

In Figure 9, the green horizontal line marks the deliquescence of sodium chloride. At 20°C and 74.6% relative humidity solid sodium chloride liquefies to a saturated brine. According to the humidity curve shown in Figure 9 this happens during the night hours when the temperature is close to the minimum. In the morning when the temperature rises and the humidity decreases and falls below the critical value of 74.6% sodium chloride crystallises again from the saturated brine. Deliquescence and crystallisation of sodium chloride takes place preferably in the colder winter period, as is shown in Figures 10 and 11.

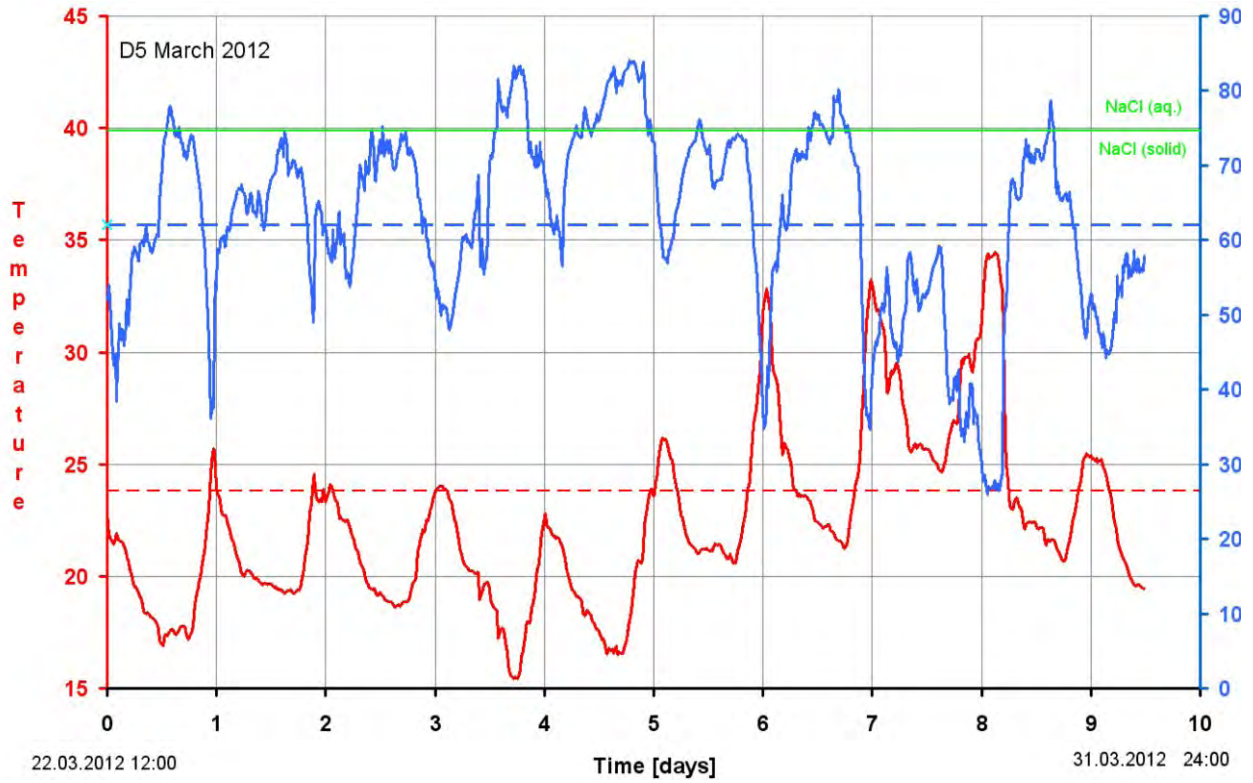
Fig.10: Temperature / Humidity curves from data-logger D5 for March 2012

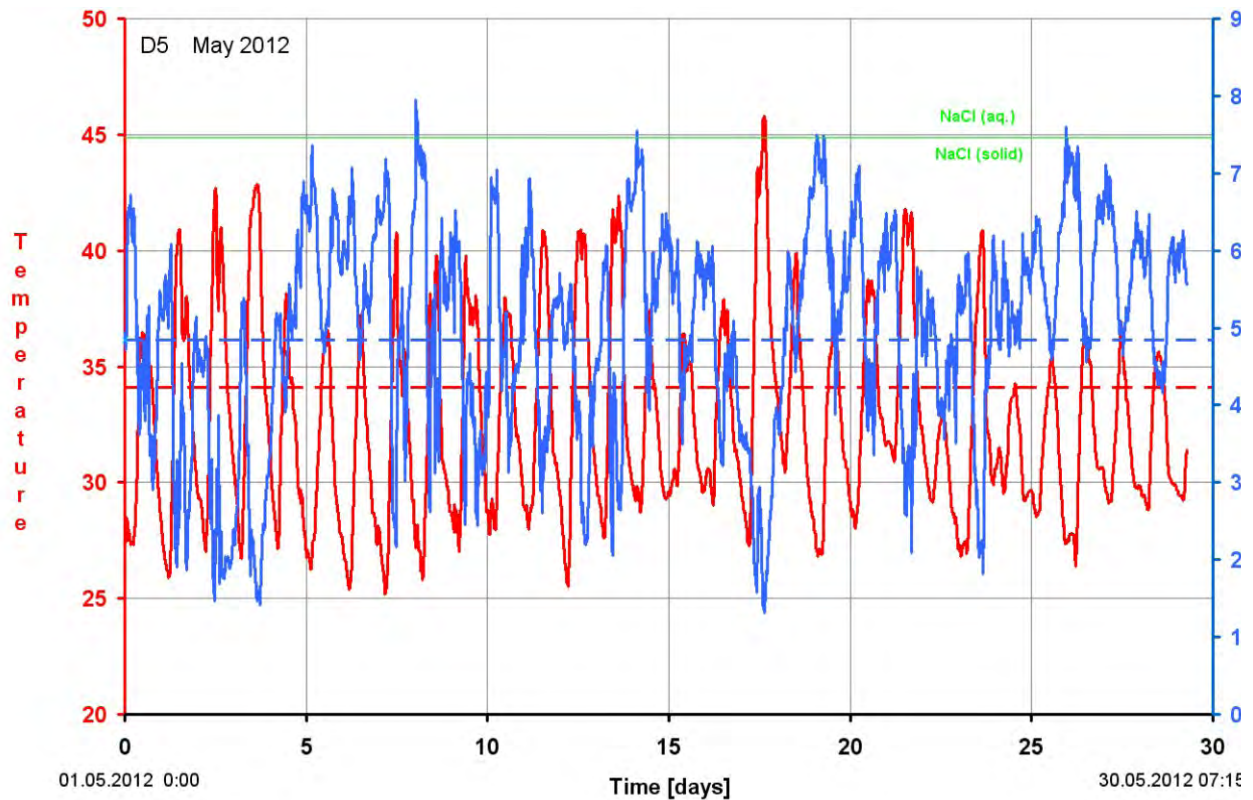
Fig.11: Temperature / Humidity curves from data-logger D5 for May 2012

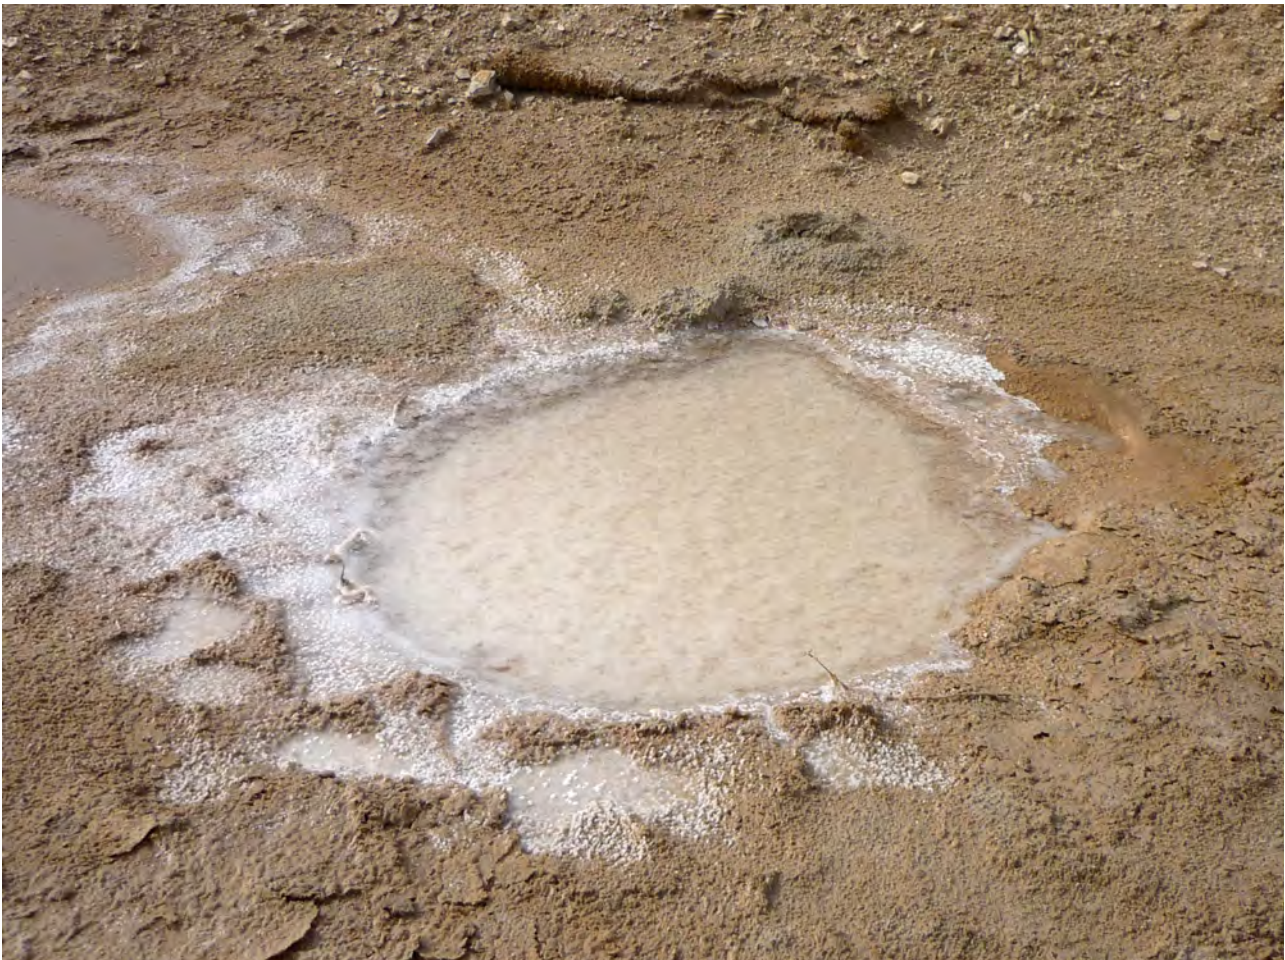
Fig. 1 a Crystallisation of sodium chloride (halite) on *sabkha* at Zubarah.

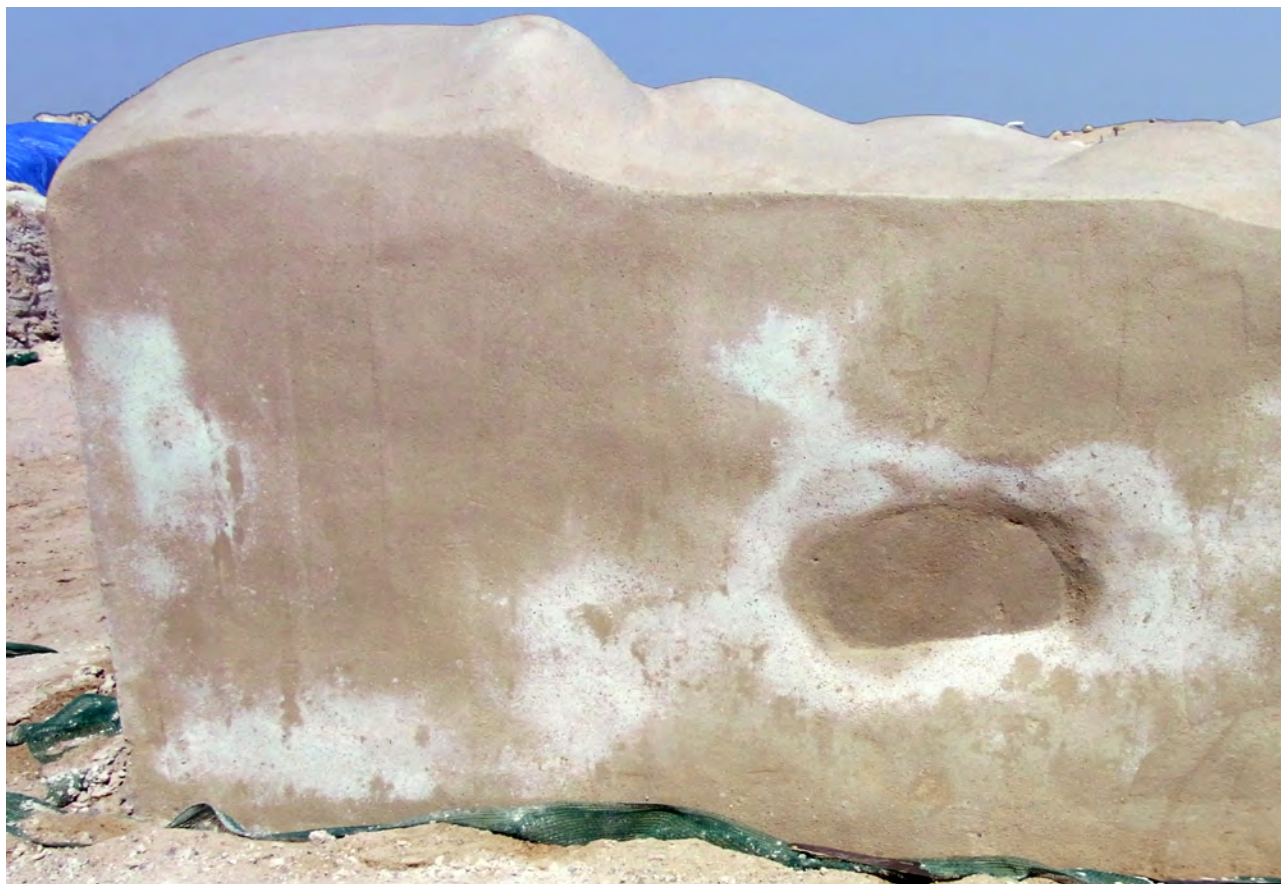
Fig. 1 b Crystallisation of sodium chloride (halite) on wall render at Al Zubarah.

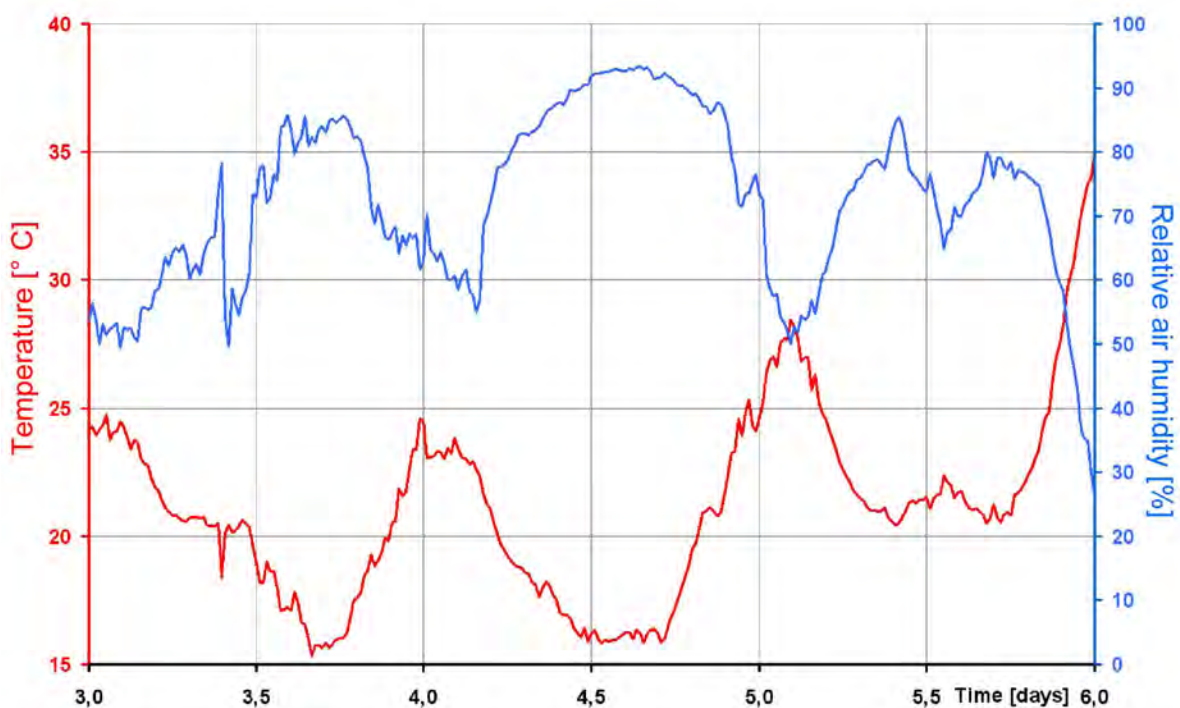
Fig. 2b : Temperature and relative air humidity data from 25.03.2012:12.00 to 28.03.2012:12.00.

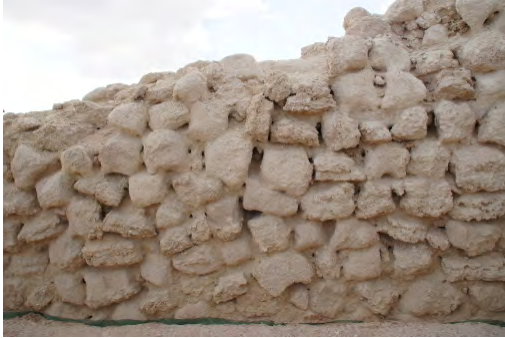
Open joints (e.g. ZUEP04, wall 4010)

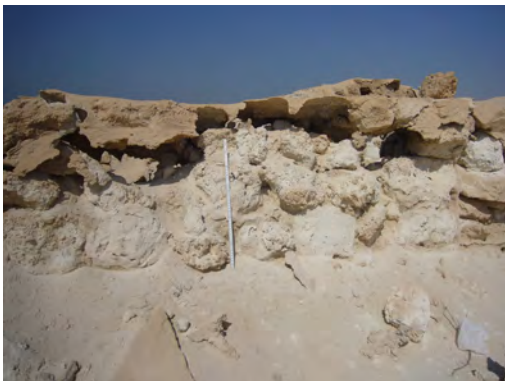
Eroded Beachrock (e.g. in QMA2)

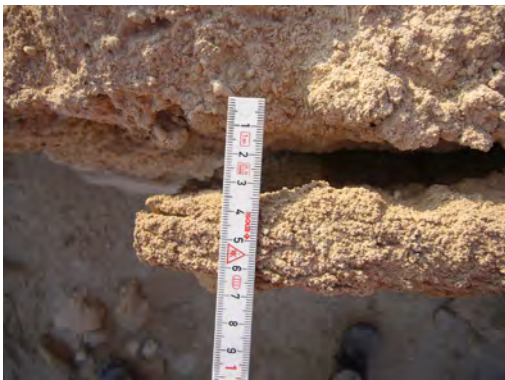
Poor bonding of plaster to wall structure (e.g. QMA4:5c)

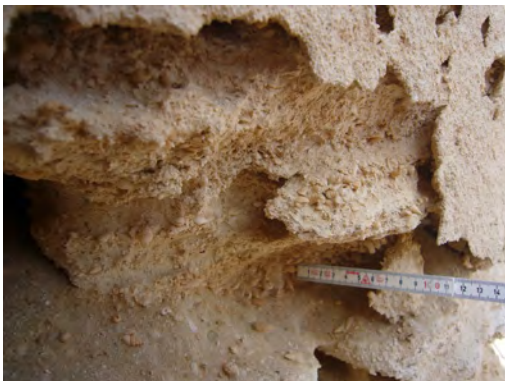
Voids in wall structures (e.g. QMA 4:4b)

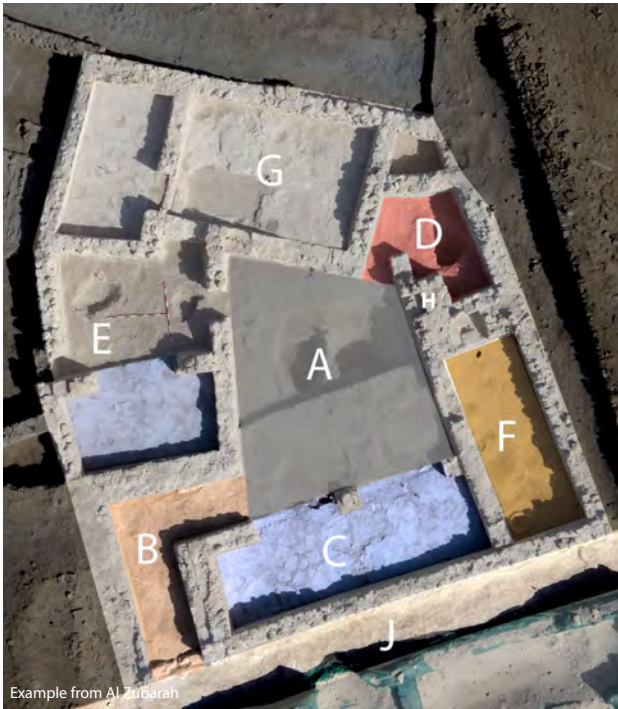
Example from Al Zubarah

- A - Courtyard
- B - Bended Entrance
- C - *Iwan* or *Majlis* (Reception hall)
- D - Kitchen area
- E - Private Courtyard with an *Iwan*.
- F - Storage Room
- G - Multipurpose room
- H - Stair to upper level (roof)
- J - Alley

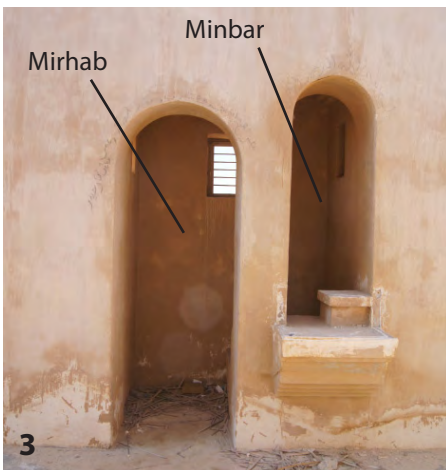
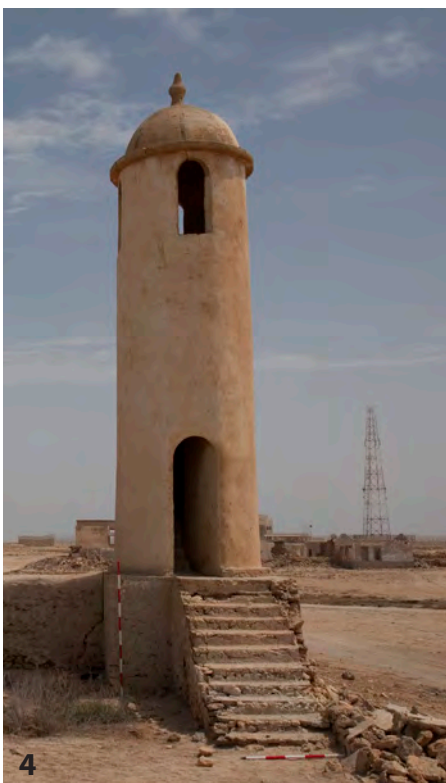
1. Jumail Mosque; A - Mirhab & Minbar in Qibla wall, B - Prayer hall, C - Riwaq (?) / Portico, D - Courtyard (Sahar), E - Ablution-Room, F - Minaret, G - Entrances.
2. Jumail Mosque -Isometry.
3. Jumail Mosque - Combined Mirhab and Minbar.
4. Minaret at Al Arish.
5. Historic Mosque at Freiha (dashed line in red indicates Qibla direction); Labels as above.

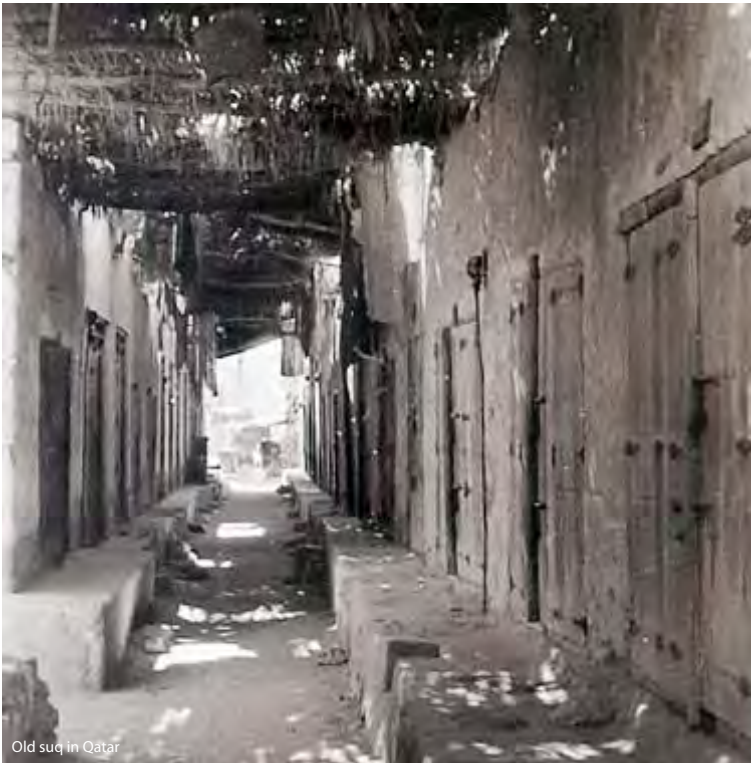
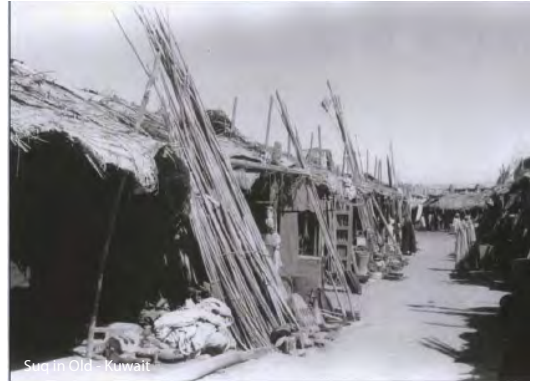
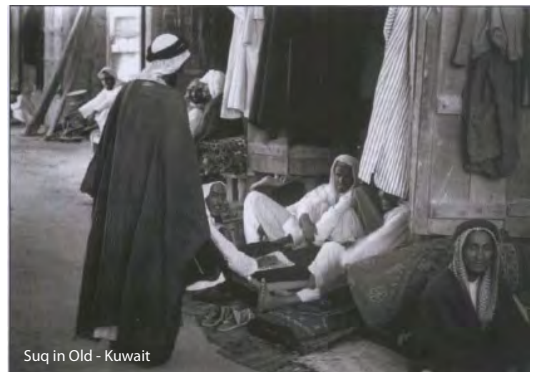
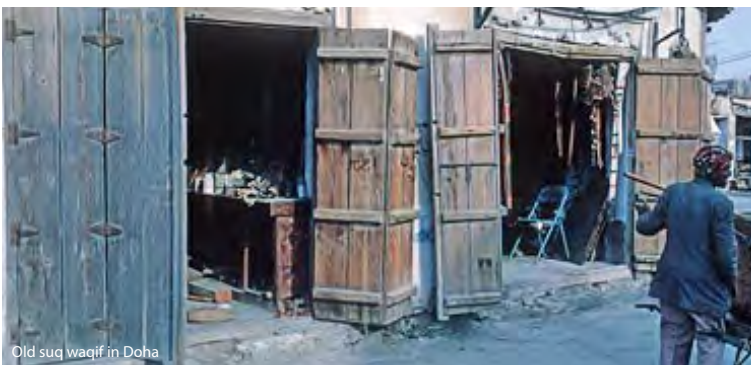
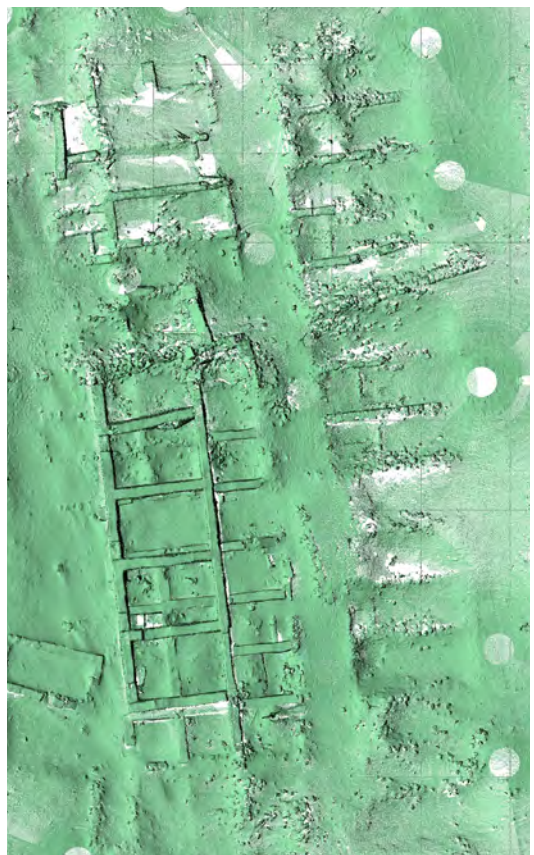
Suq

The *suq* is a commercial building complex characterised by rows of shop stalls in narrow alleys passable only for pedestrians and pack animals. Stores of the same industries are often grouped together. In general, shops, only a few metres wide, open onto the alley. They can have storage, warehouses and workshops out the back and upstairs.

At Al Zubarah's suq (QMA1 / ZUEP02) *madbasas* are a common feature in the back of the shops. Roofs over the alleys of the suq, covered with wood and mats, protected pedestrians and goods. The rows of shops are complemented by warehouses and other commercial facilities, such as *khans*.

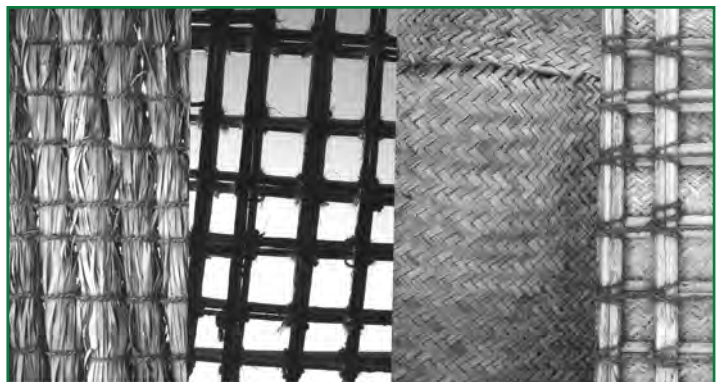
kuse
Palm frond (called zoof) with leaves intact

sarabic
Style of connecting palm-leaf fronds, usually into approximately 10 cm x 10 cm squares

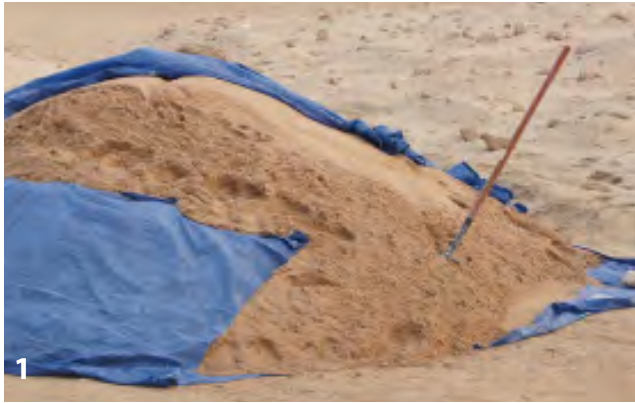
1 - (Quartz) sand

2 - Al Danshal timber from East Africa

6 - Soil/ Earth / Mud

7 - Plaster materials (Lime [A] & Gypsum [B]-based)

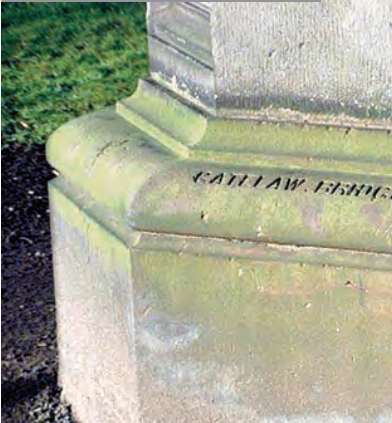
ALTERATION . MATERIALVERÄNDERUNG

Common **alteration** of architectural mouldings by algae.

Scotland, Edinburgh, Meadows Pillars, 1992. Height of vertical face approx. 300mm. Pers. Archive (ref. KP 22) / I. Maxwell

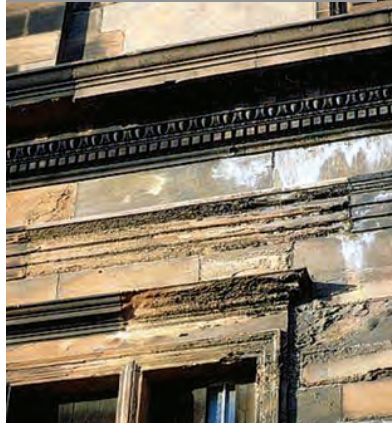
DEGRADATION . ABBAU / VERSCHLECHTERUNG

Degradation of red sandstone masonry due to defective rainwater gutter behind parapet.

Scotland, Edinburgh, Caledonian Hotel, 1991. Individual block heights approx. 300mm. Pers. Archive (ref. KD 30) / I. Maxwell

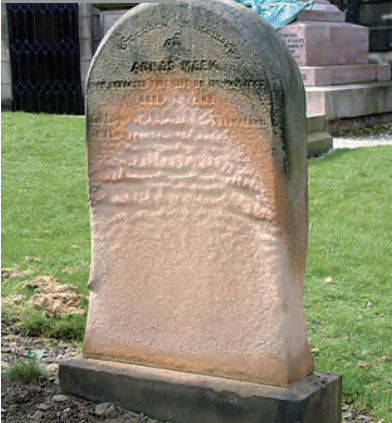
DAMAGE . SCHADEN

Damage to the lower part of a sandstone grave slab resulting in loss of value.

Scotland, Edinburgh, Old Calton Cemetery, 2002. British Geological Survey / E. Hyslop

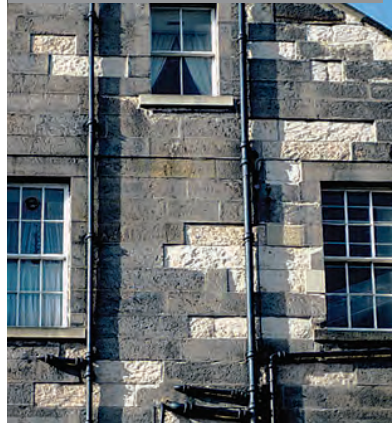
DETERIORATION . ZERSTÖRUNG / SCHÄDIGUNG

Deterioration of a Carboniferous sandstone masonry.

Scotland, Edinburgh, North Castle Street, 1993. Individual block heights approx. 30cm, Pers. Archive (ref. OU 13) / I. Maxwell
