Conservation Handbook Al Zubarah Archaeological Site

Edited by
Moritz Kinzel

QIAH-01-02-HE-1000

First Edition January 2013

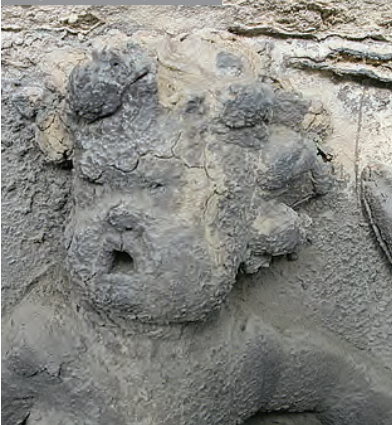
DECAY . ZERFALL / VERFALL

Limestone relief showing advanced **decay**.

France, Caen, Eglise Saint-Pierre, 2006. head ca.10 cm, LRMH / V. Vergès-Belmin

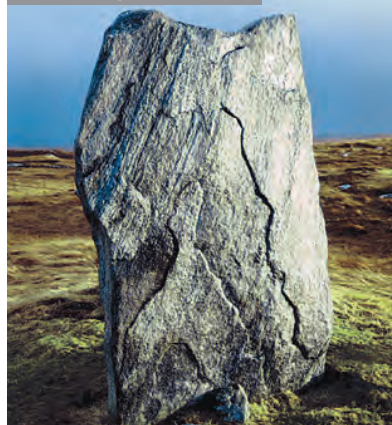
WEATHERING . VERWITTERUNG

Weathering of a Lewisian Gneiss monolith resulting from long term exposure to the elements.

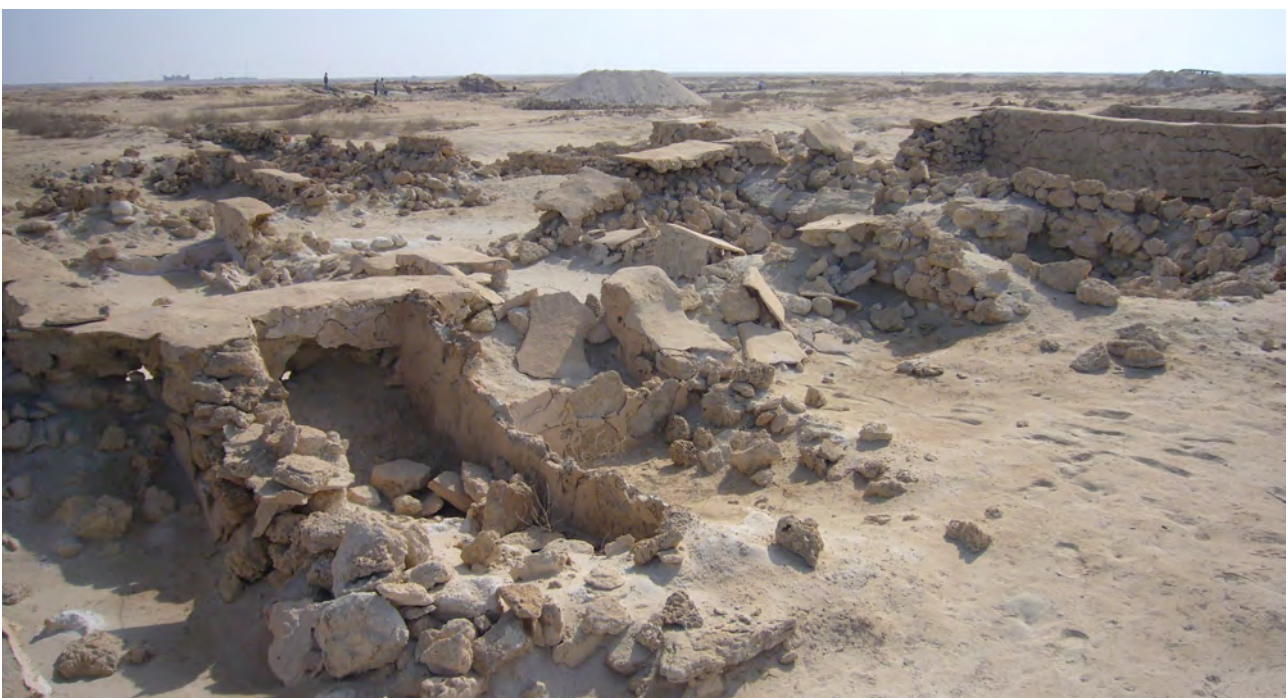
State of conservation of architectural remains restored in the 1980's in QMA1 (November 2009): Disintegration of building material; collapse of wall structures and cement capping.

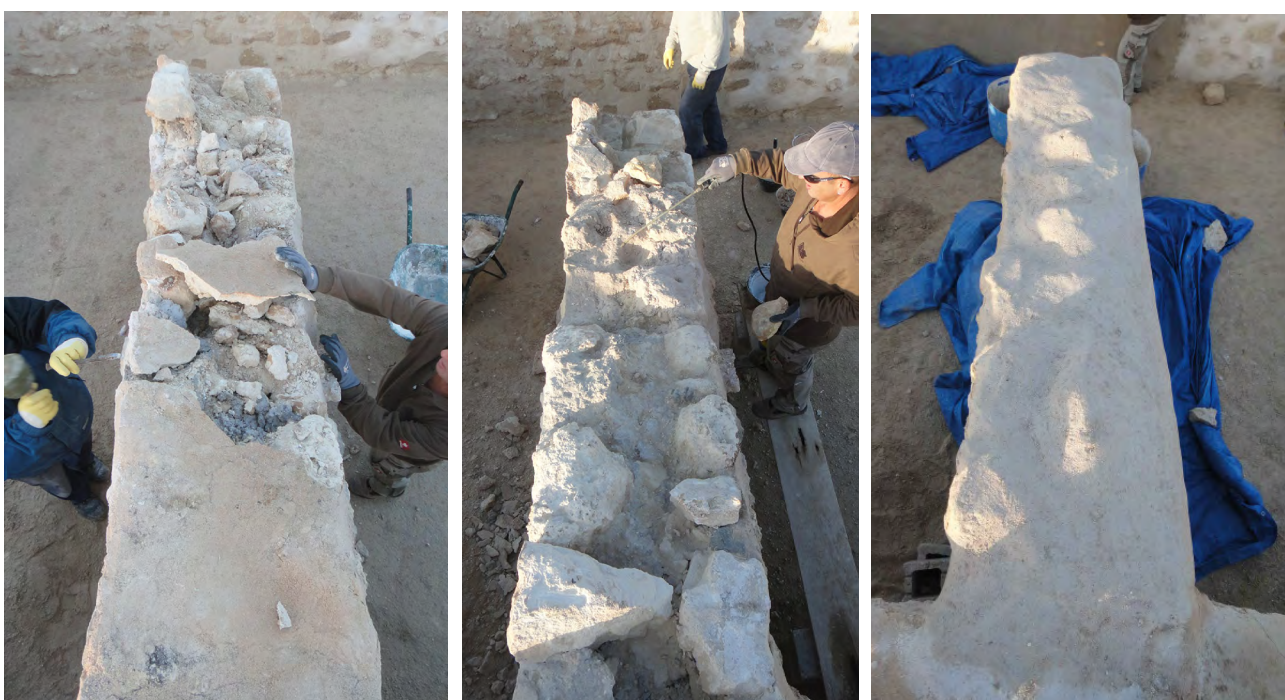
Consolidation of 1980s Restoration in QMA2: Taking off cement capping; Consolidation of wall structure, and re-shaping of wall top (2011/2012).

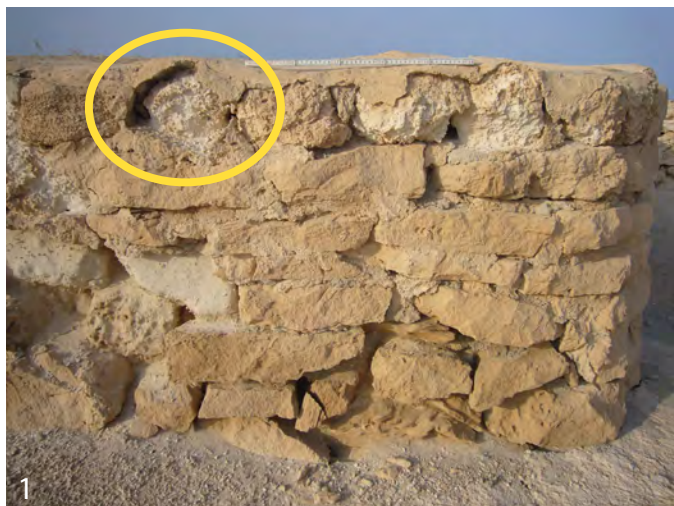
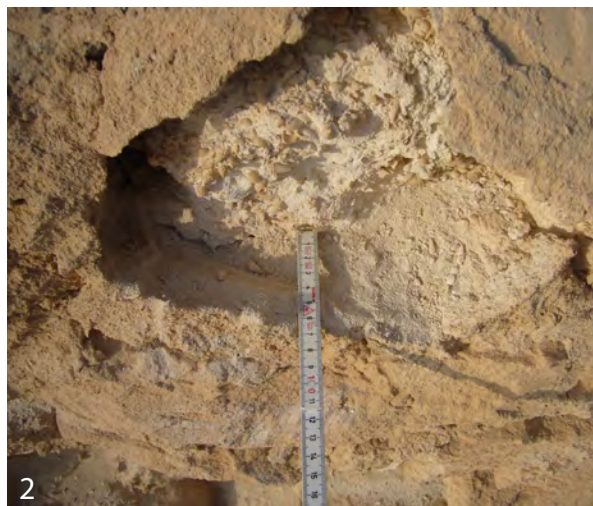
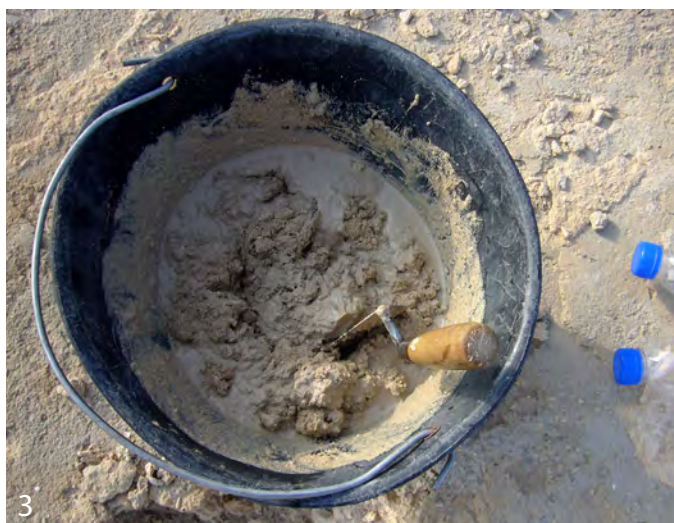
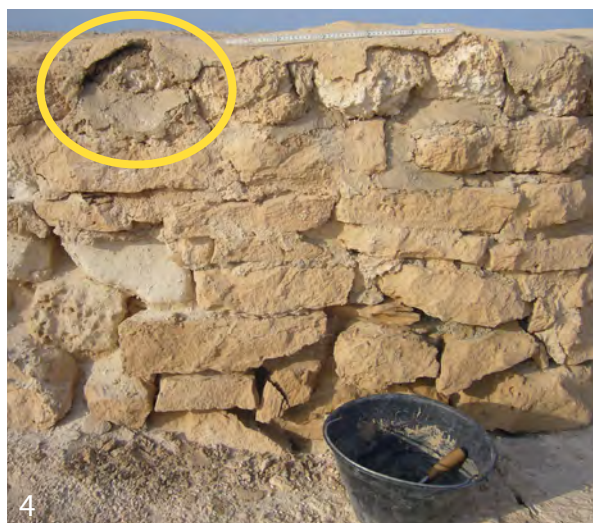
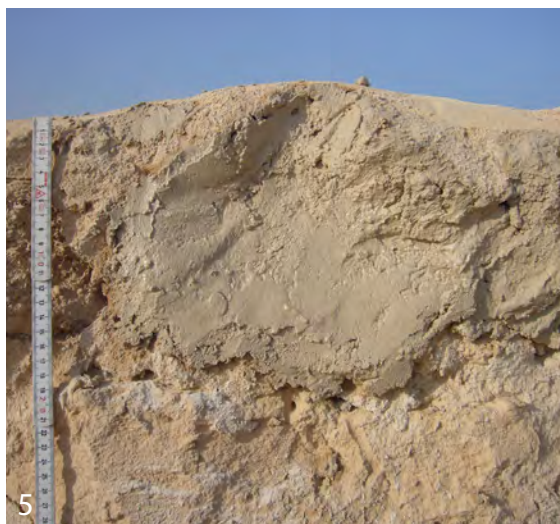
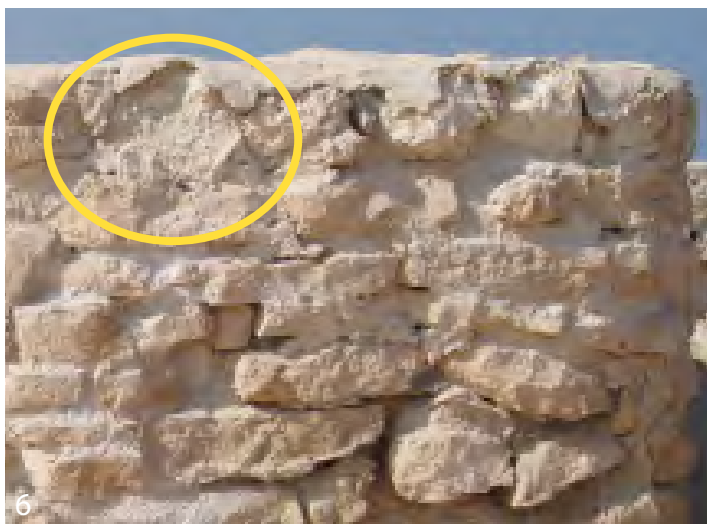
1ST TEST: soil mortar

First mortar tests at Al Zubarah in November 2009: Soil mortar mix with the soil from the site. 1. Wall in QMA2 before test; 2. Close up on wall; 3. Mixing soil mortar; 4. Re-pointing of joints and fill of voids; 5. Fill hole to stone surface; 6. Same situation in December 2010.

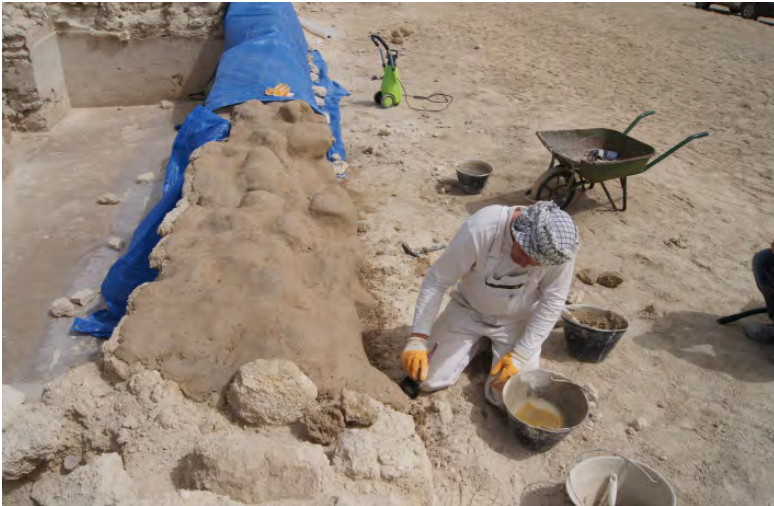
1ST APPROACH: protective lime slurry

To protect and stabilise the fragile wall structures built with beach rock a lime slurry is applied to the wall. No substantial rebuilding took place only water pockets were filled with smaller stones to eliminate these.

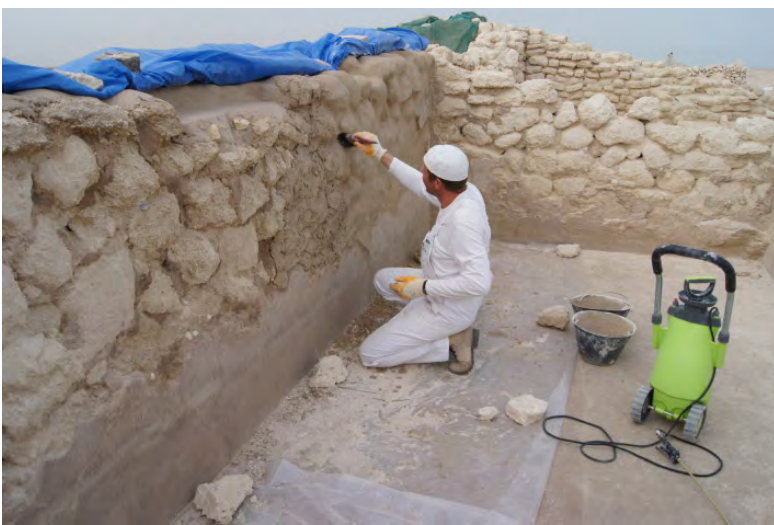
Wall top and wall face were treated the same way. Only a slightly different mortar mix was used. But surface followed the stone shapes as a protective layer. No plaster surfaces were reestablished.

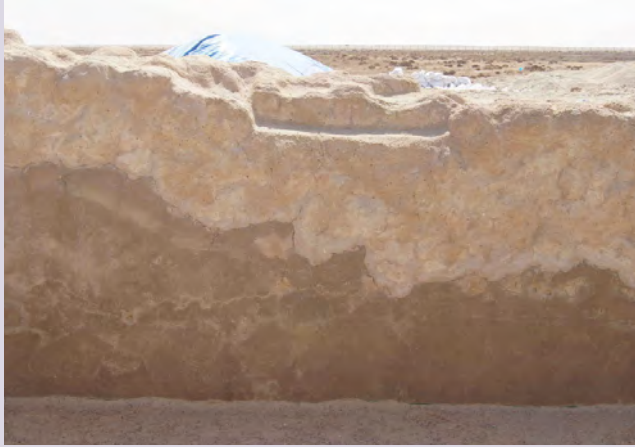
1. Conservation concept (in 2010/2011)

"Preserving and Protecting only"

- Lime slurry covering wall stones
- No differentiation between wall face and wall top
- No additions
- No levelling of uneven wall surfaces
- Lime slurry differs in colour and structure to the historic plaster surfaces.
- Based on conservation concepts for stone architecture.

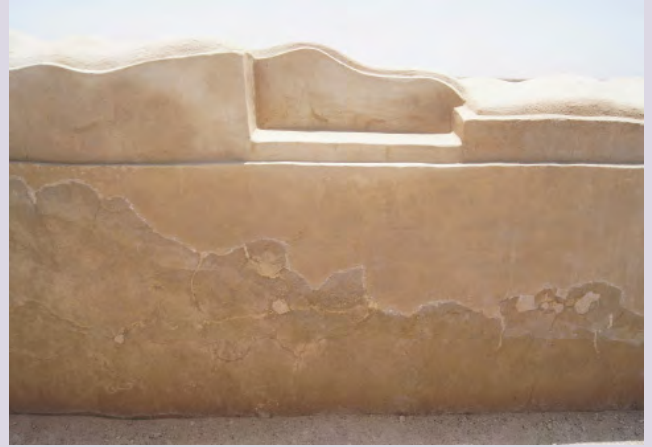
2. Conservation concept (since 2011/2012)

"Preserving remains, making the architecture understandable"

1. Remove of loose particles
2. pre-fixing of loose stones
3. Insert (new) mortar
4. Add Render/ plaster in layers
5. check for waterpockets on walltop

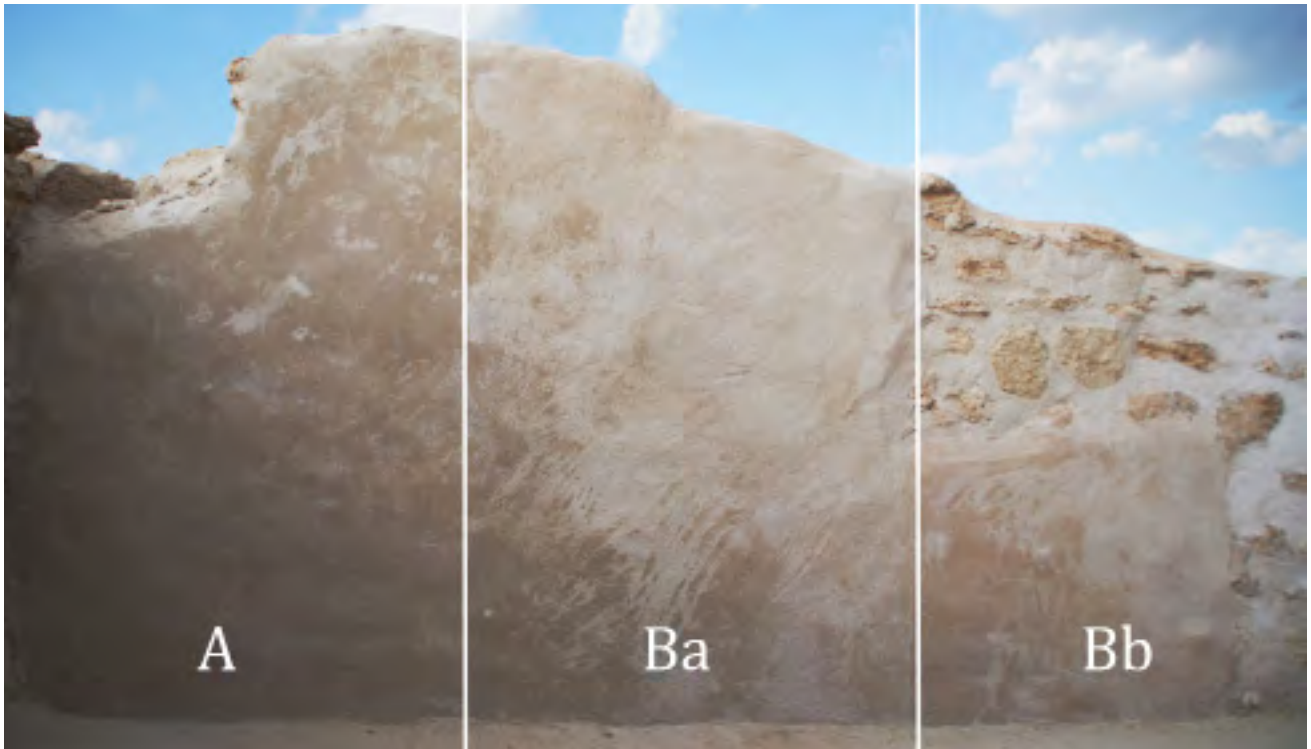
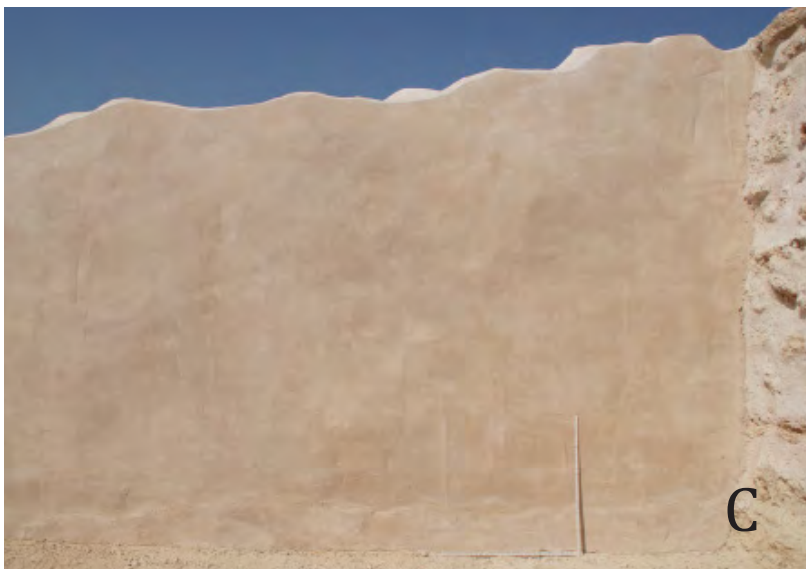
GENERAL PRINCIPLES AND CONSERVATION CONCEPTS PLASTER SURFACES AND TOOLING TRACES

QIAH- Tests:

A - very smooth, dense surface, almost no tooling visible

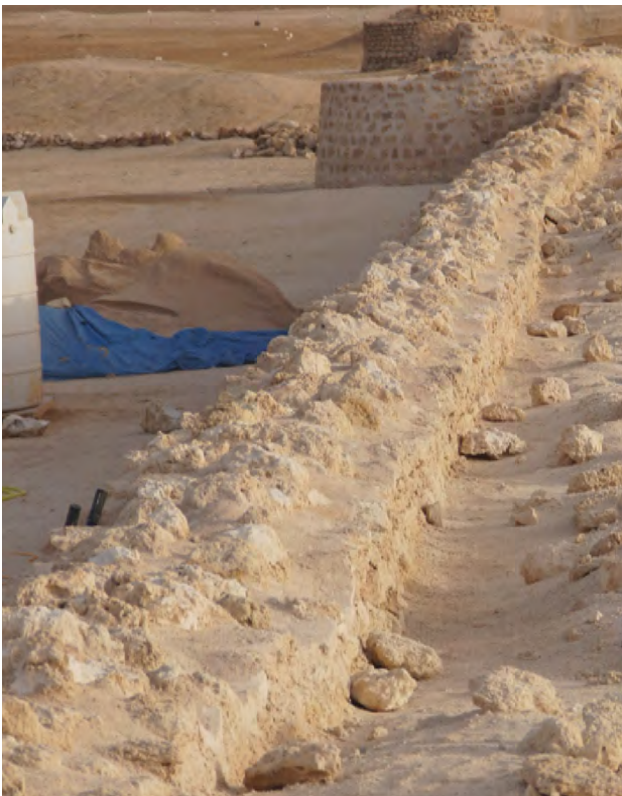
Town wall segment 8/9 with re-shaped crown in March 2012 (VAR. 1).

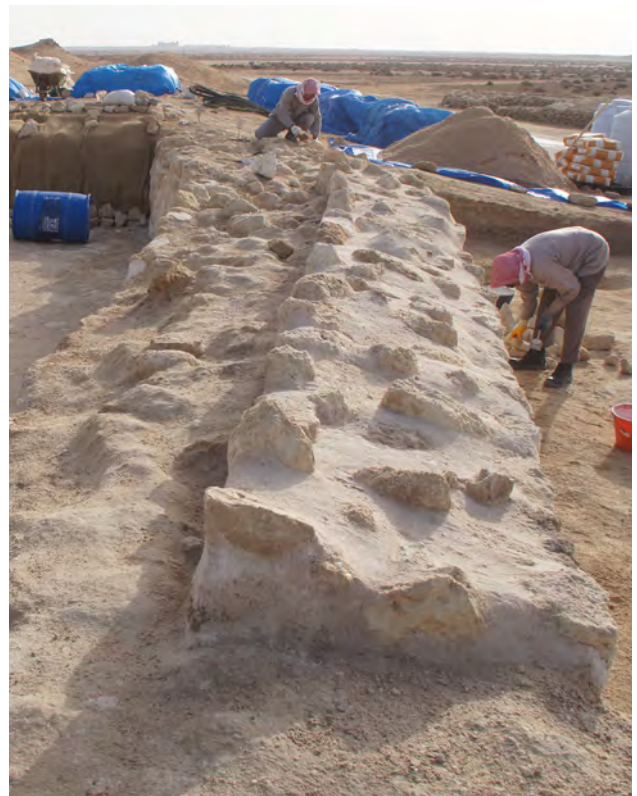
Town wall segment at tower 4012 (ZUEP04) in March 2012 (VAR. 2).

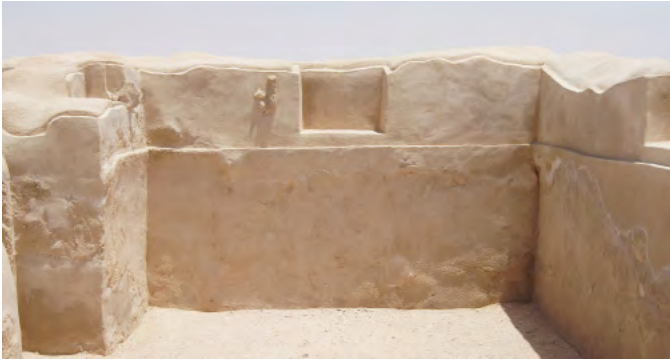
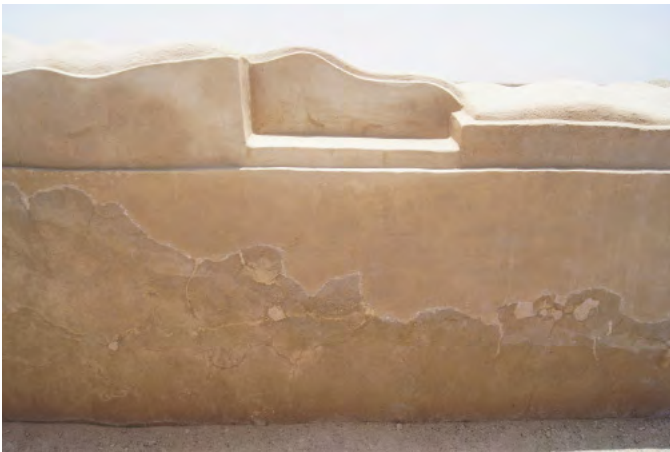
NICHES

Niches are a common feature throughout Zubarah's architecture. Situated above a plaster panel/socle, centred, or in regular intervals on the walls. Due to the state of conservation it cannot be stated if some of the niches exposed in the house walls are linked to wind catchers. Some niches seem to have had plaster decorations and decorated frames. Some were obviously arched, but no complete niches have so far been found.

1. keep things in
2. place a lamp onto it
3. point to *Qibla* direction
4. catch wind and direct it into the building.

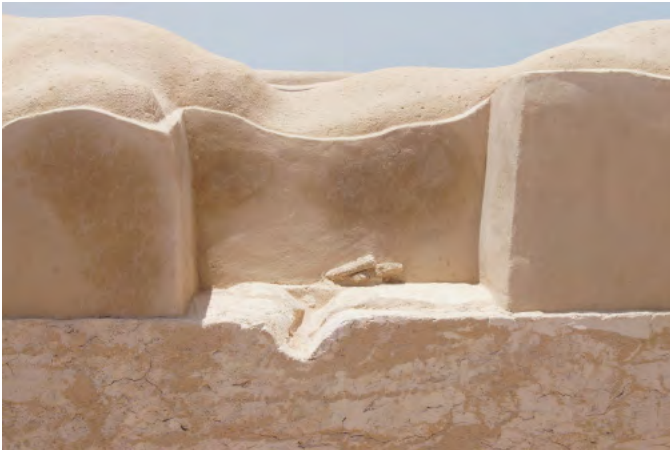
A) Restored example from Saudi Arabia (S. Ricca, 2008)
B) Historic example from Lamu /Somalia (S. Moriset 2009).

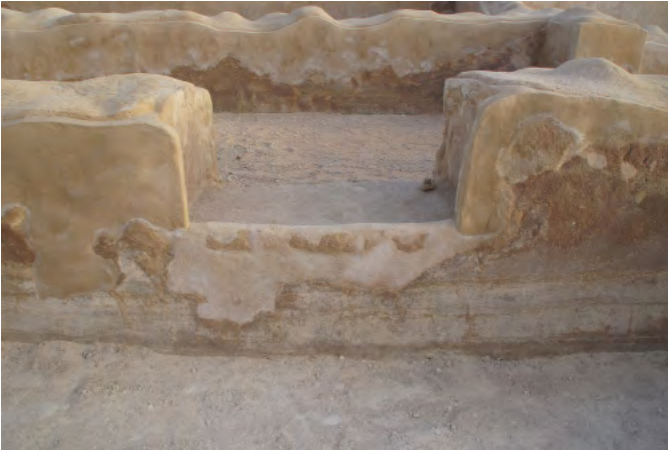
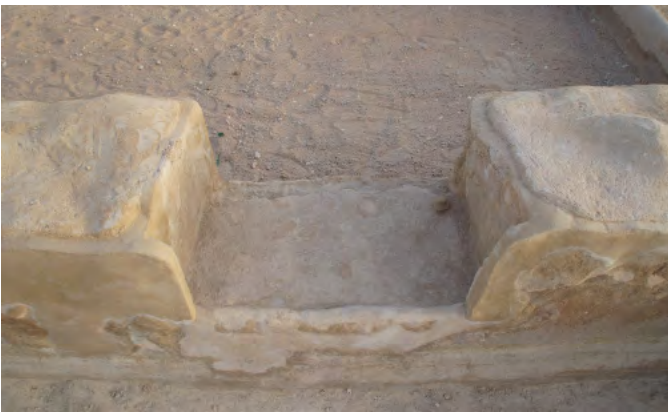
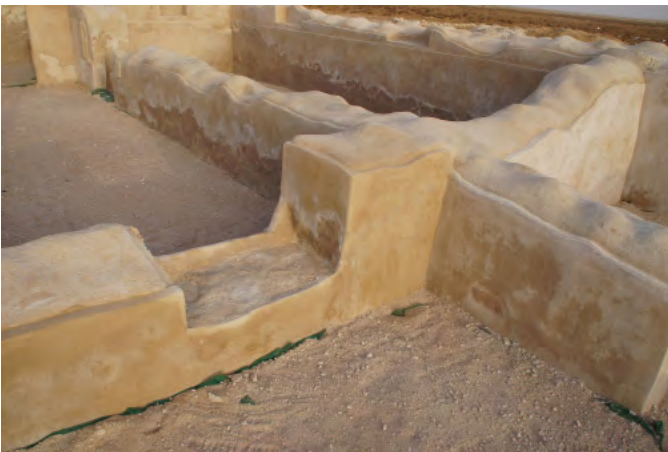
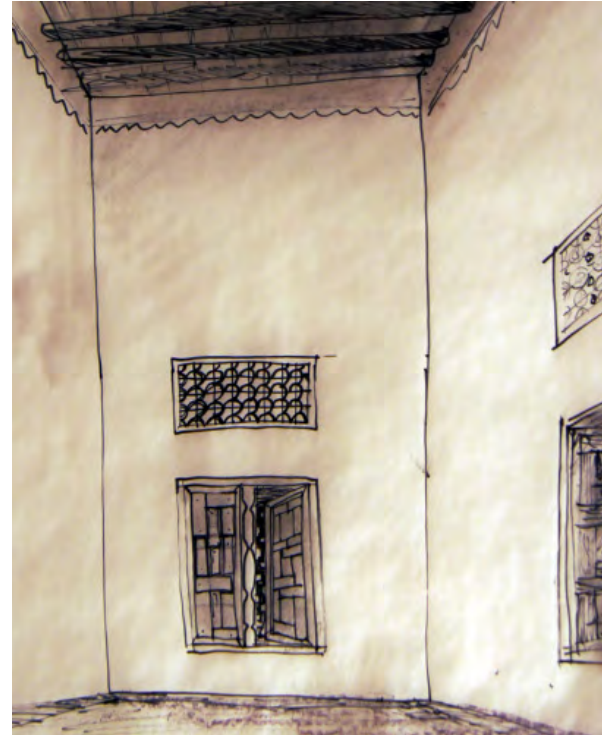
CONSERVATION CONCEPT FOR ARCHITECTURAL FEATURES WINDOWS

Windows are a common feature at Al Zubarah. The construction has an elaborated design. In several cases the window has a plaster frame on the exterior encircling a *mashrabiya* – Gypsum grill. In some cases (as shown here), there is a wooden frame on the interior where a shutter would be placed to regulate light and air flow. Often additional wall openings for air circulation were situated above the window. Windows are generally situated close to the floor for people sitting on floor mats.

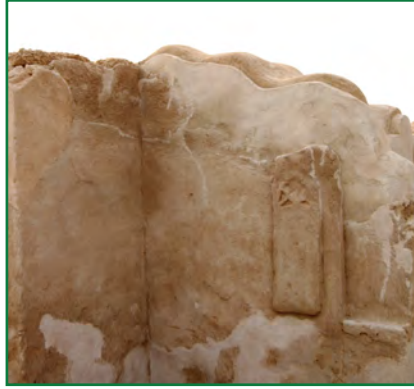
DOOR REVEALS

- AVOID plaster lines on different levels
- AVOID odd arrangements
- AVOID tilted geometry

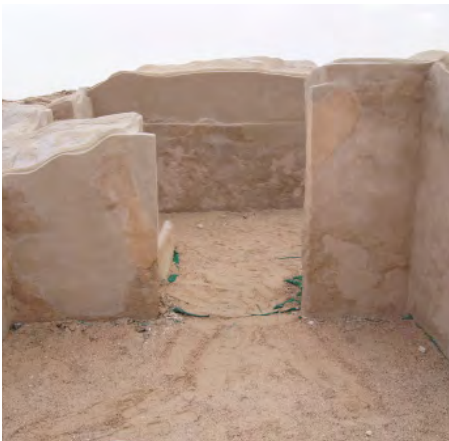
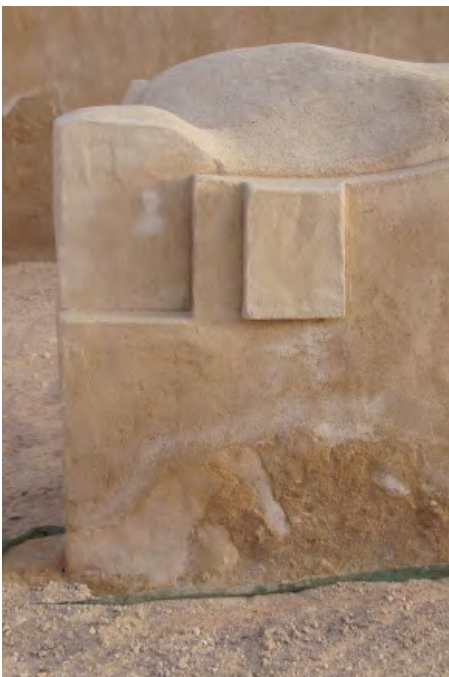
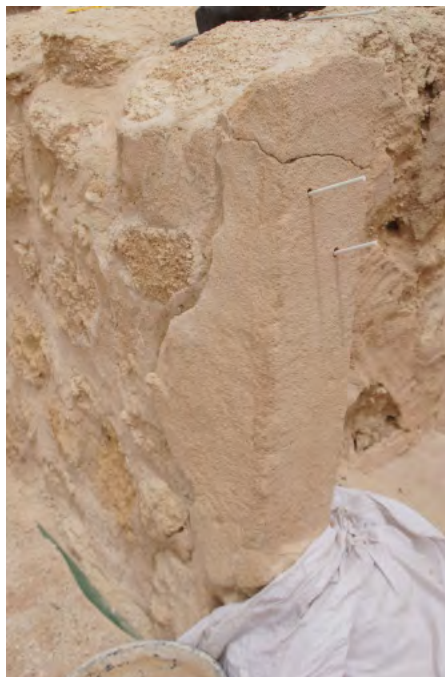
DO

- Keep it simple.
- Make the doorway recognisable.
- Stabilise fragile parts.
- Discuss detail on a case-by-case basis.

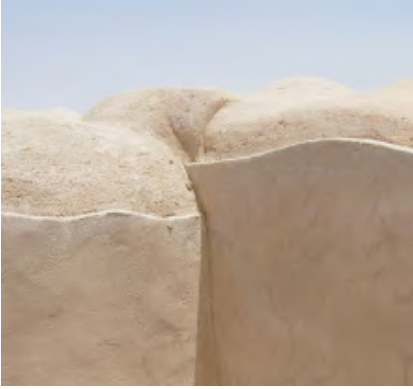
CONSERVATION CONCEPT FOR ARCHITECTURAL FEATURES **CORNERS**

- AVOID plaster lines on different levels
- AVOID odd arrangements and forms.
- AVOID artificial lines
- AVOID too extreme amplitudes

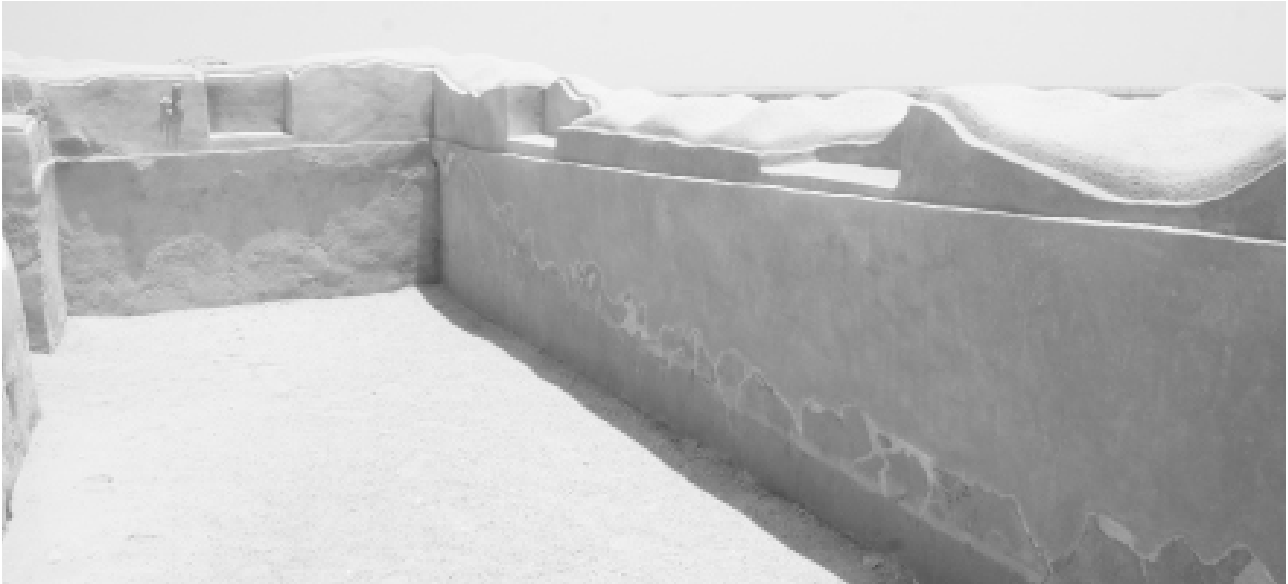
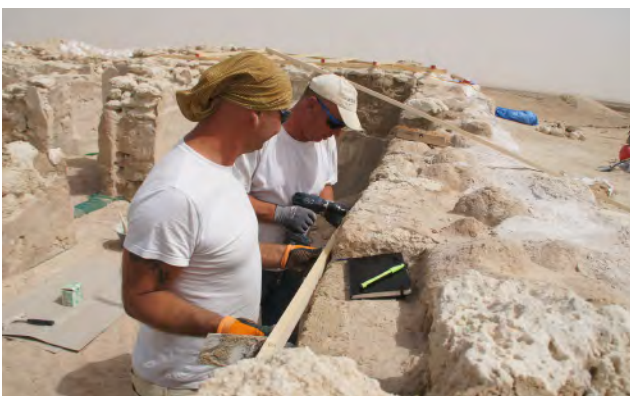
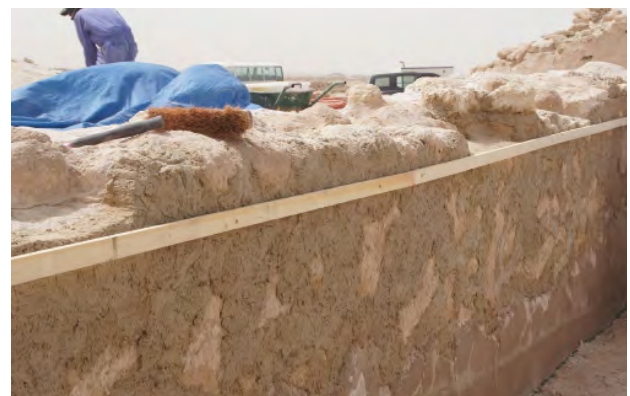
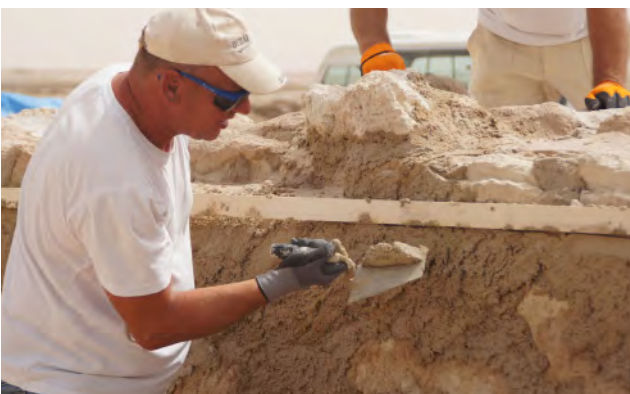
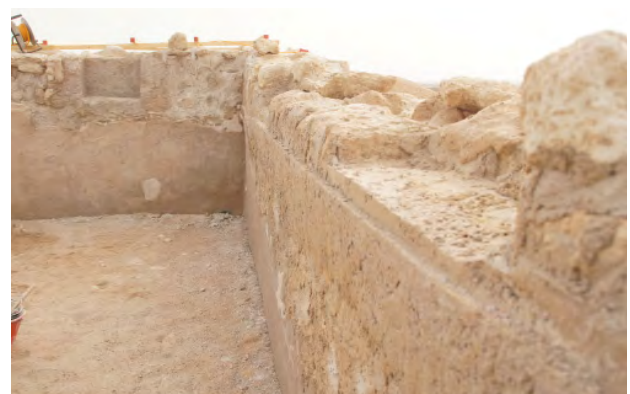
CONSERVATION CONCEPT FOR ARCHITECTURAL FEATURES **PLASTER LEDGE / PANEL**

Plaster panels and related ledges should be reconstructed where possible and where archaeological evidence is given. The reconstruction of these features will help to show the historic proportions, character and function of the rooms.

If no information is available **NO** reconstructions should take place. For interior plaster surfaces a “smooth” surface treatment with some traces of trowel tooling is recommended to reach a homogeneous image.

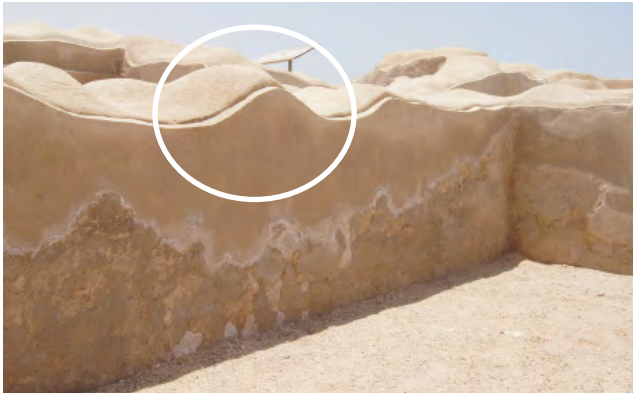
AVOID

- plaster lines joining on different levels.
- illogical arrangements and forms.
- artificial lines: do not follow every stone outline with the plaster line: keep it natural
- do not make the line too wide: max. 3 to 4 cm

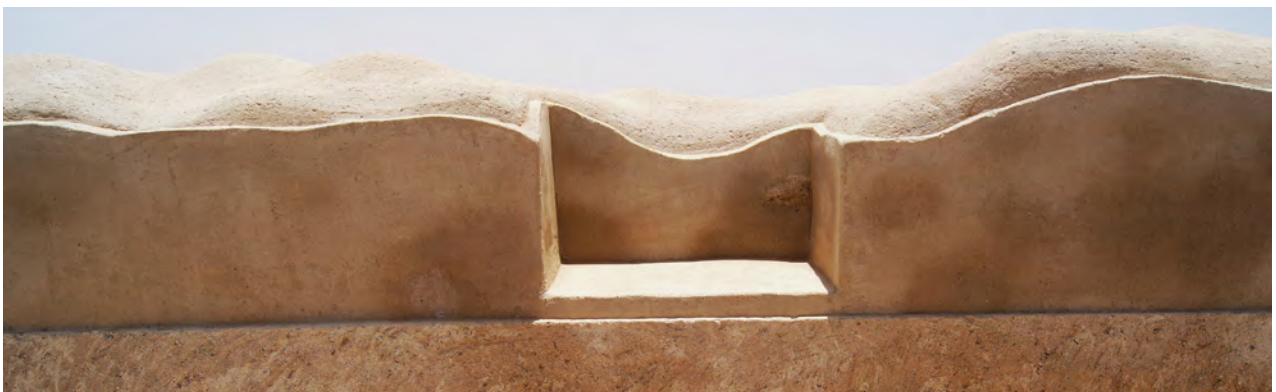
DO

- Create logical plaster connections.
- Try to keep levels straight and try to even out height differences.
- Keep the line running naturally.
- Do not follow every single stone outline.
- Keep the width of plaster line between 2 to 4 cm.

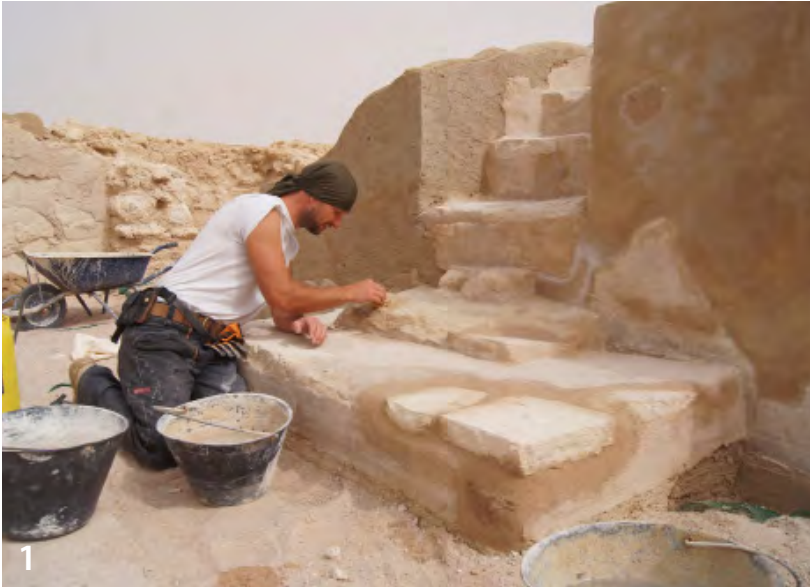
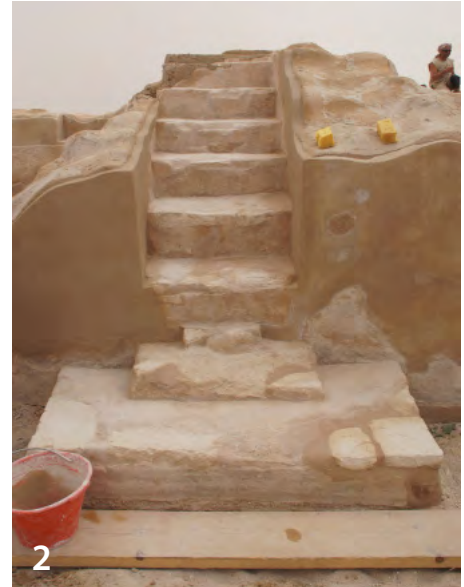
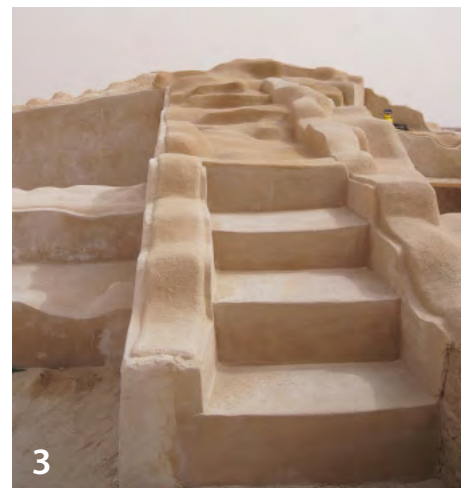
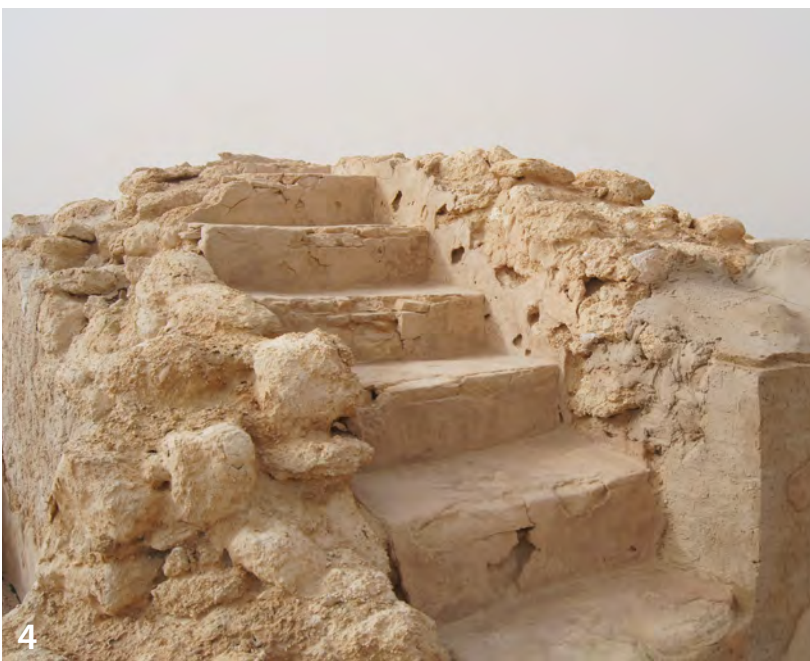
CONSERVATION CONCEPT FOR ARCHITECTURAL FEATURES STAIRS

The conservation solution for stairs and steps should be planned on a case-by-case basis. Stairs should be completed (Figs. 2 and 3) and stairwell walls should be rebuilt in keeping with the archaeological and architectural context (Figs. 3 and 5). Where a partly destroyed step can be understood as a step (Figs. 1 and 2), only the remains should be consolidated and conserved.

To stabilise, preserve, and consolidate historic plaster in situ, it might be necessary to complete a step or plaster surface (Fig. 4).

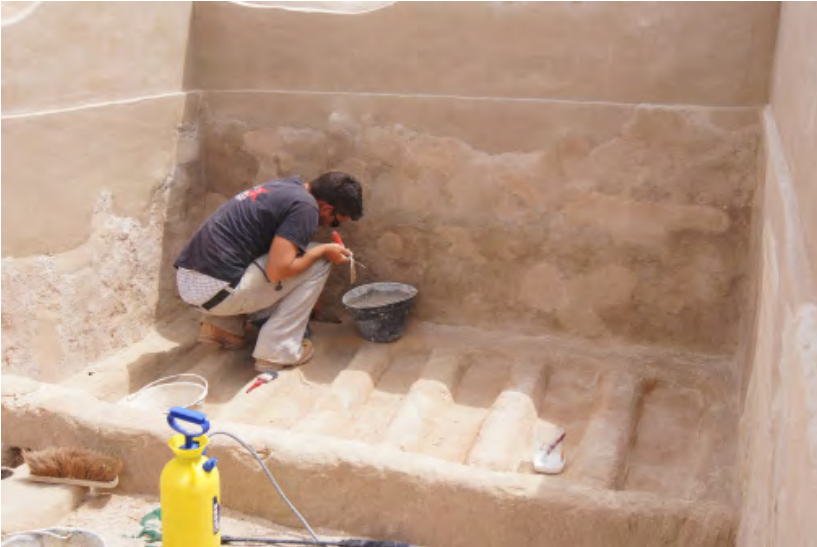
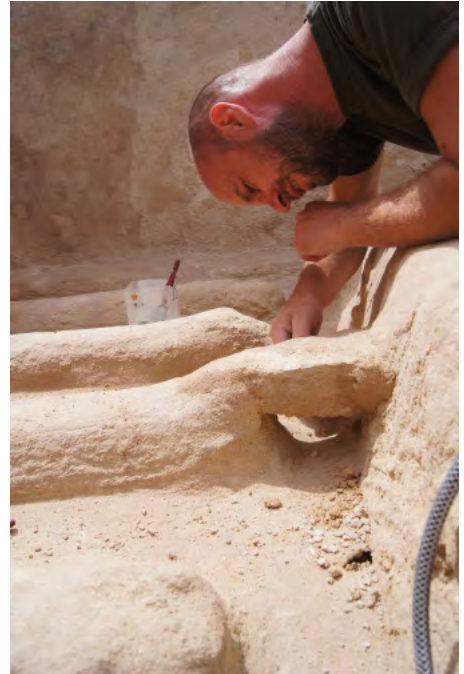
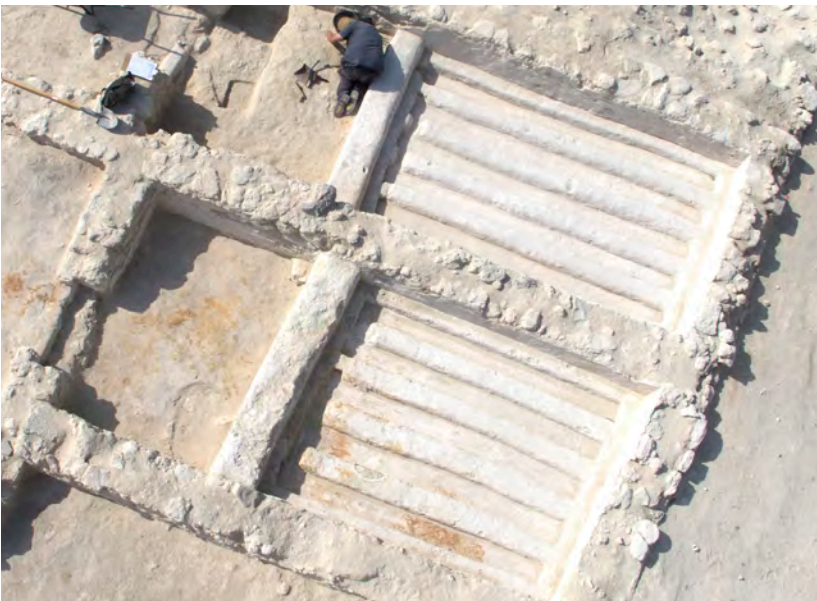
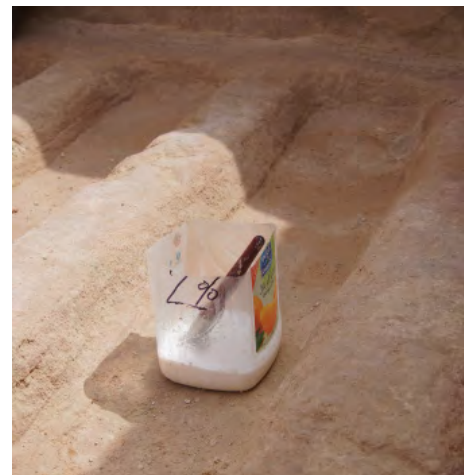
DATE PRESS

Sacks of dates piled on top of ridged floor

Over time the dates begin to release a sweet juice, and are „pressed“ by the weight from sacks above

A pot buried below floor level collects the dibs which is then ladelled out and used for food.

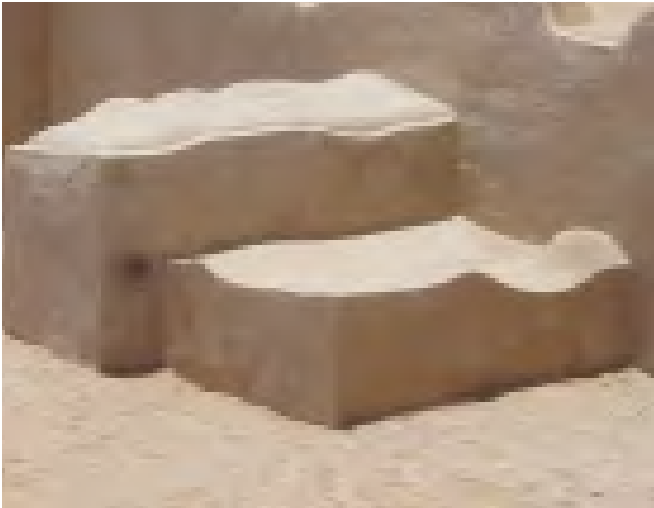
Surfaces of benches or platforms should be done with a smooth surface and a sharp plaster edge. NO double line! e.g. platforms in the Palace (ZUEP04). Same is true for benches, e.g. the reconstructed benches in QMA2.

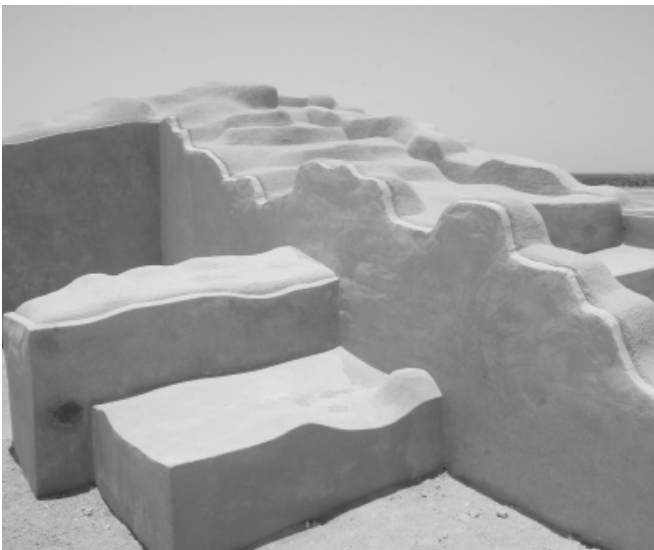
Platform in EP04 (2012 consolidation)

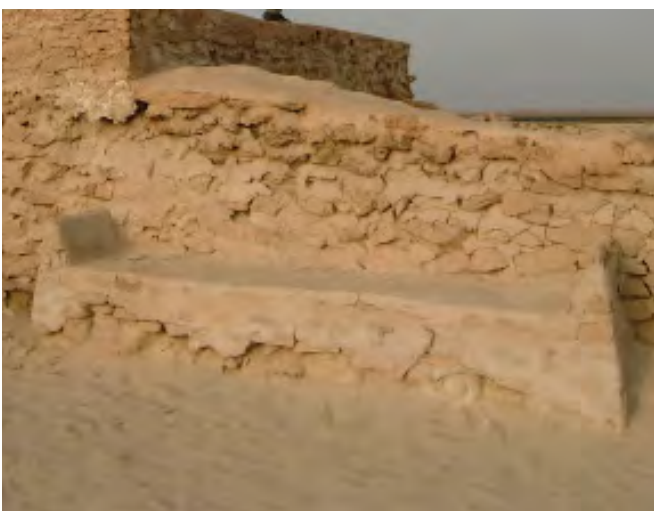
Bench in QMA2 (1980s reconstruction)

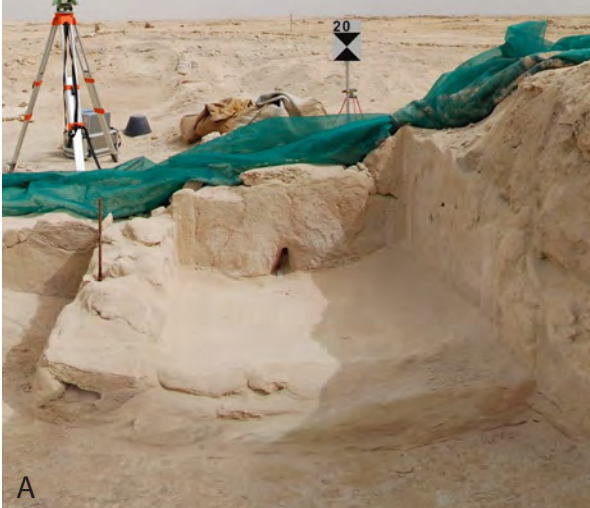
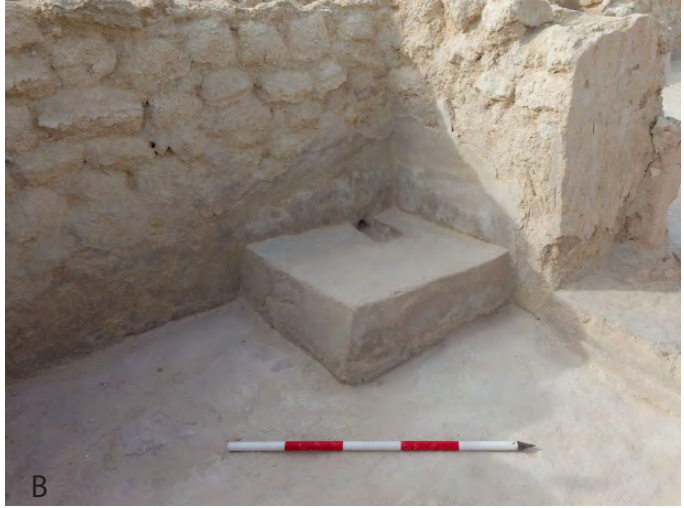
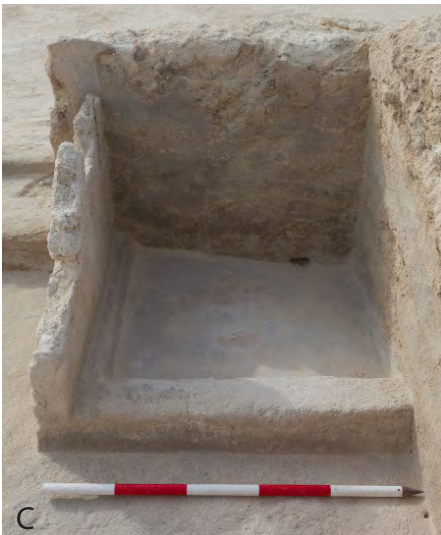
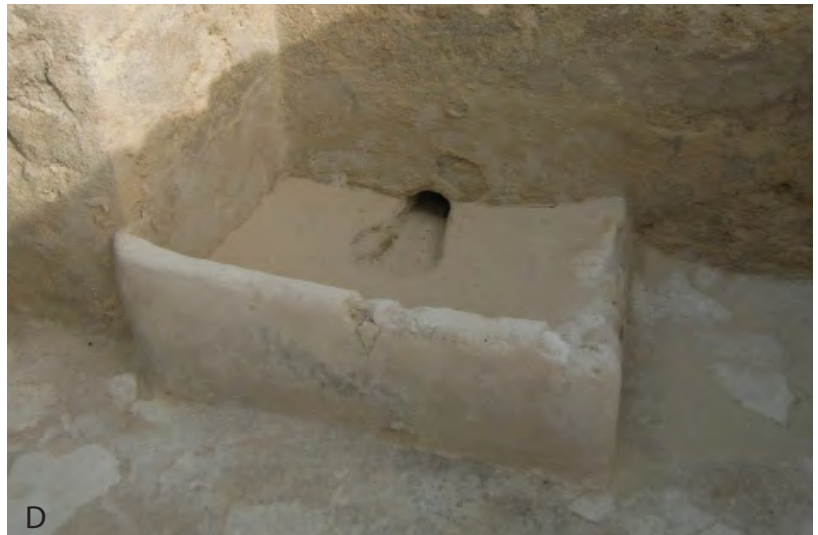
Hammams are common features throughout the settlement. Raised 10 to 30 cm above the floor level the platform shows a very smooth plaster surface. The Hammam installation drains through a sewer into an external, underground-placed sewage tank. Some hamams are showing elaborated plaster decorations (e.g. in ZUEP01 [A]), others are kept very basic and simple (e.g. in ZUEP04 [B to D]).

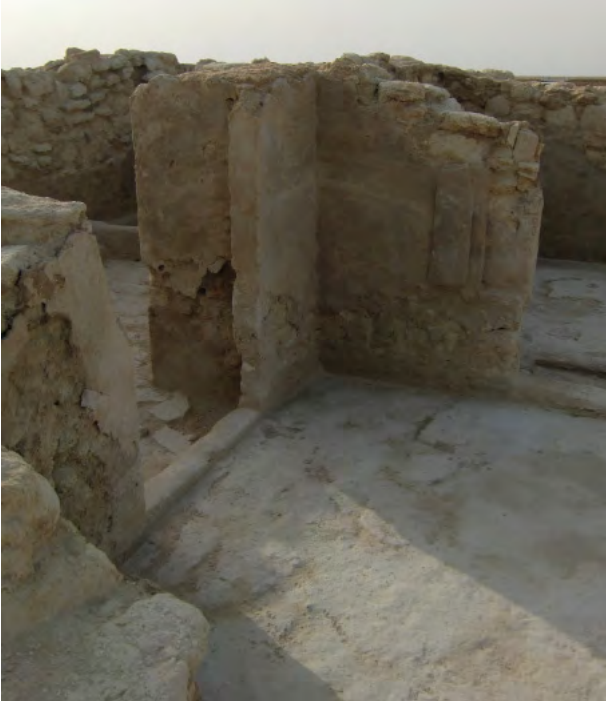
Historic (anhydrite) plaster floor at the palace; (03/2010).

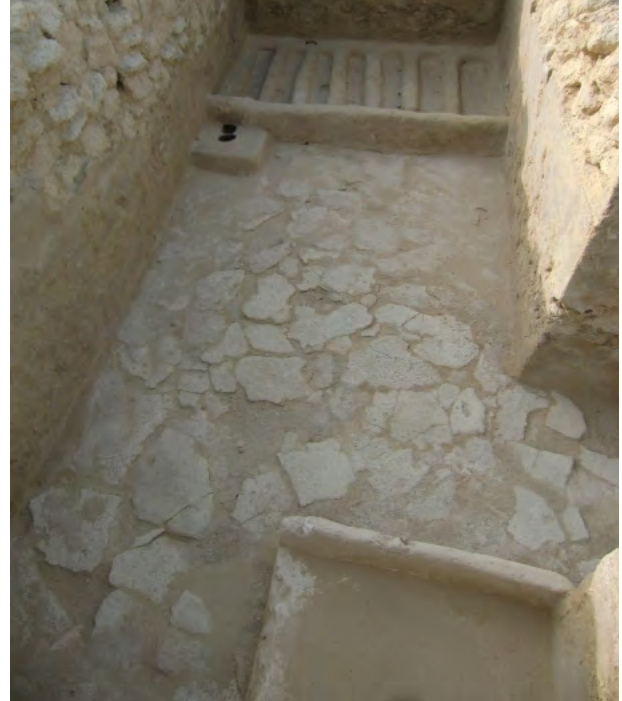
Pavement made of conglomerate stone slabs; This kind of pavement can also be found under the plaster floors as an underbed (03/2010).

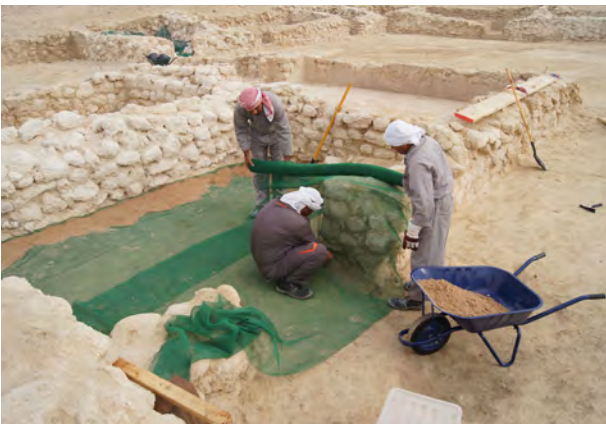
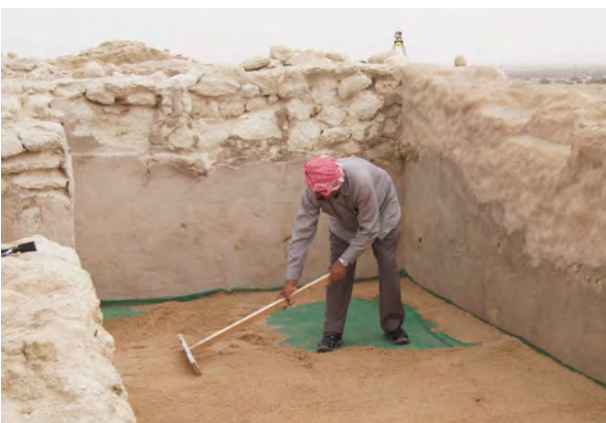
Cleaned floors should be covered by mesh or geotextile before a layer of fine sieved soil or better quartzsand is placed on. The layer of sand should be around 5 cm.
