Conservation Handbook Al Zubarah Archaeological Site

Edited by
Moritz Kinzel

QIAH-01-02-HE-1000

First Edition January 2013

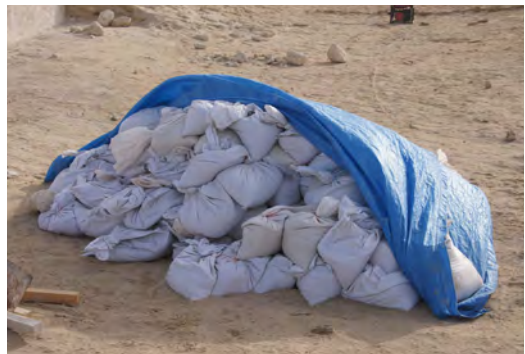
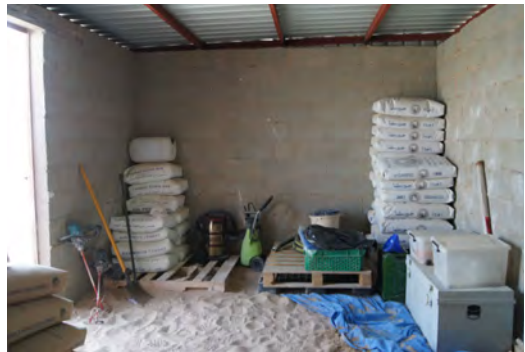
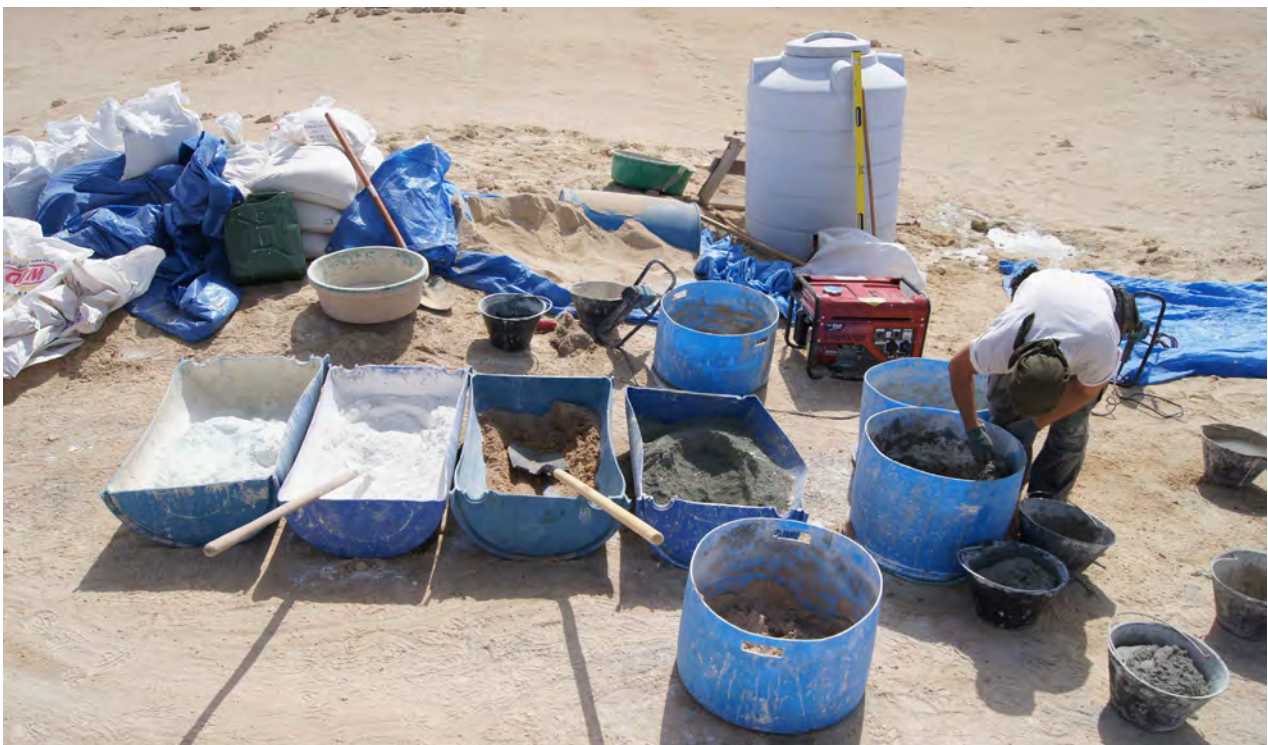
1. a secure storage and mixing areas; clear and well organised (see figure at the bottom),
2. separated the materials,
3. placed the water tanks on secure platforms to avoid cracks in the bottom.

Materials (especially Lime, Gypsum and Sand) should be covered with fabric to avoid direct sunlight. (pictures on the right: Sand bags covered with plastic fabric and building materials stored in house).

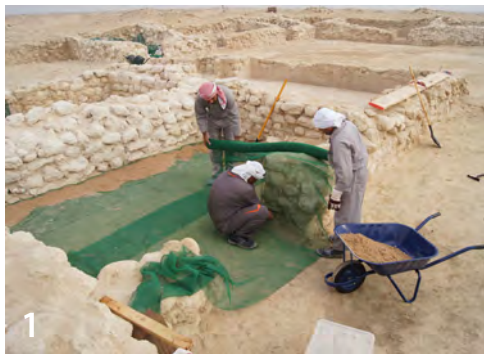
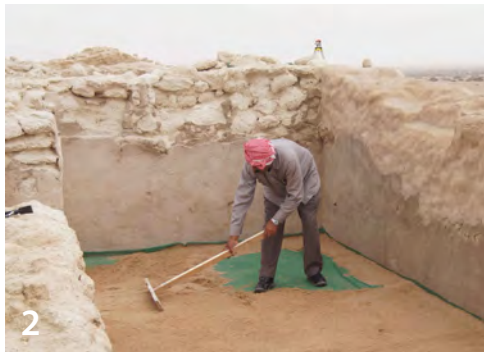
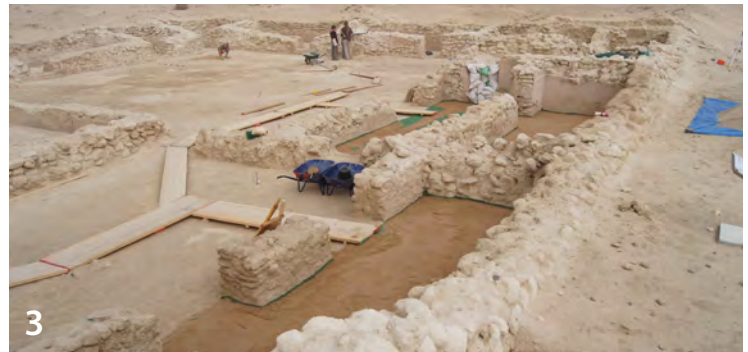
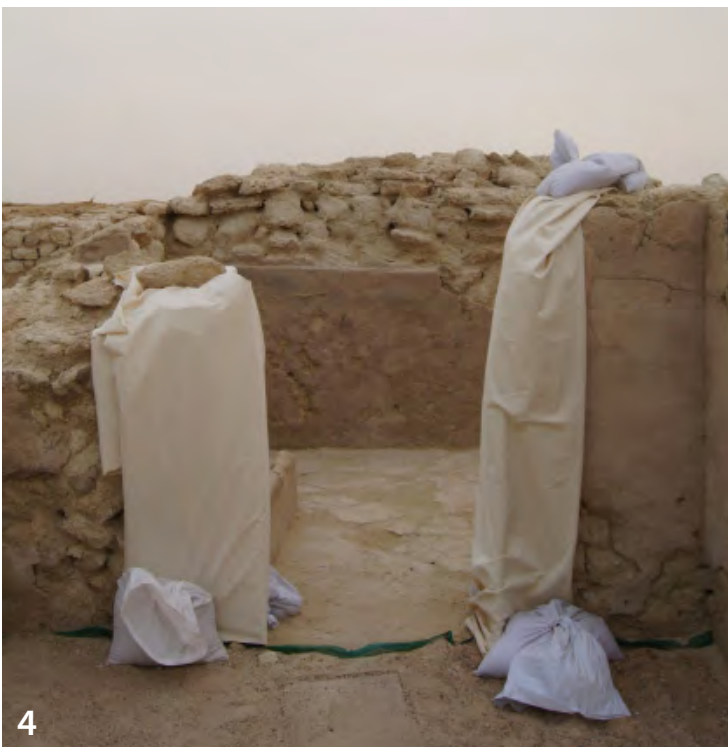
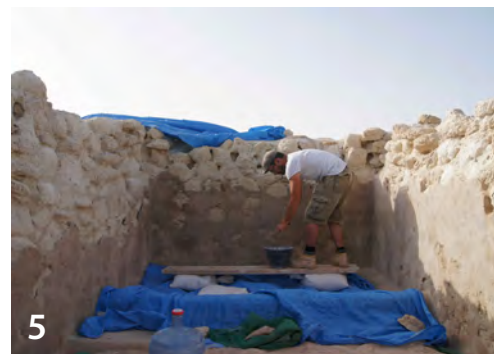
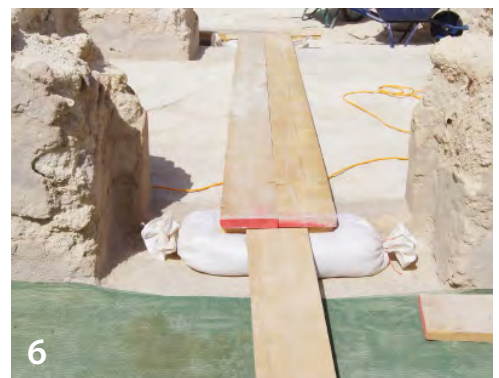
PROTECTION OF ARCHAEOLOGICAL REMAINS

Adjunctioned building elements should be protected, e.g. Floors, Doorways, etc. to avoid damages during the work process.

Building up protective layers: protective fabric, e.g. Mesh (Fig.1), 5 cm Sand layer (Fig.2) for walkway planks have to be added accordingly (Fig.3 & 6). In addition doorways, thresholds, recesses etc. have to be protected separately (Fig. 4 -6).

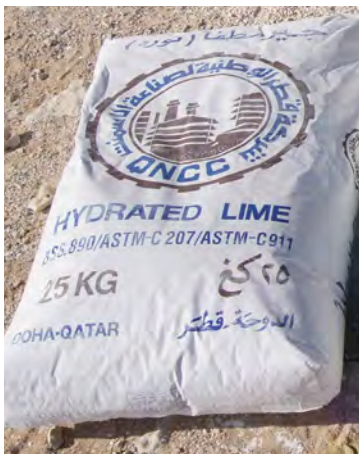
Hydrated lime produced by the QNCC

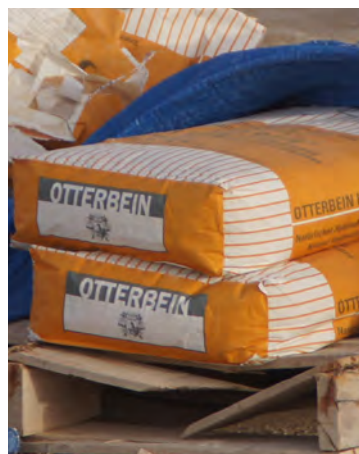
Natural Hydraulic Lime (NHL 5) produced by Otterbein

1 part NHL (Otterbein Hydradur) + 1,5 parts "desert" sand + 1,5 parts Quartz sand (0-3 mm); Ratio 1:4

Note: NHL should be used in the context with historic (gypsum-based) plasters; hydrated lime in combination with white cement should only be used were no gypsum-based plasters are preserved, due a possible reaction between the tricalciumaluminate (C3A) and the gypsum, which can result in the further disintegration of building materials.

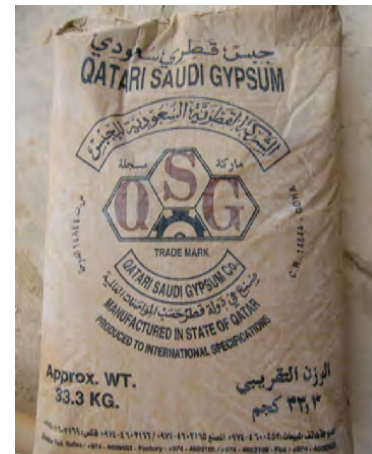
Gypsum produced by Qatari Saudi Gypsum

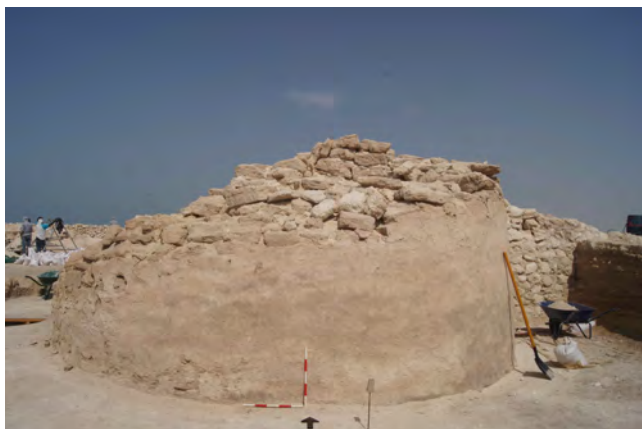
Tower (4012) at palace before consolidation (2011)

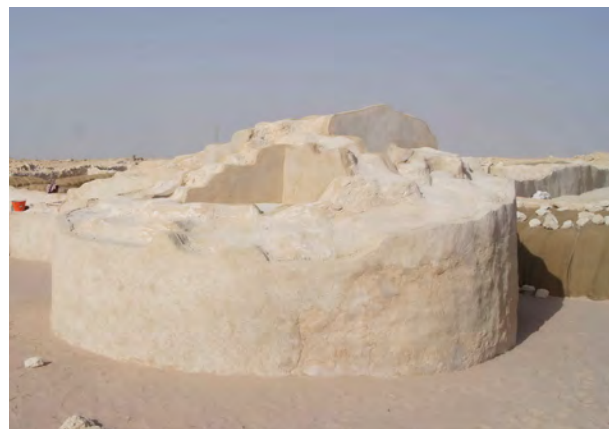
Tower (4012) at palace after consolidation (2012)

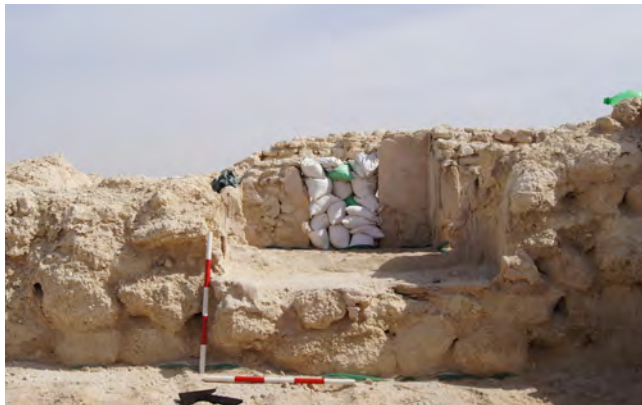
Window at palace before consolidation (01/2012)

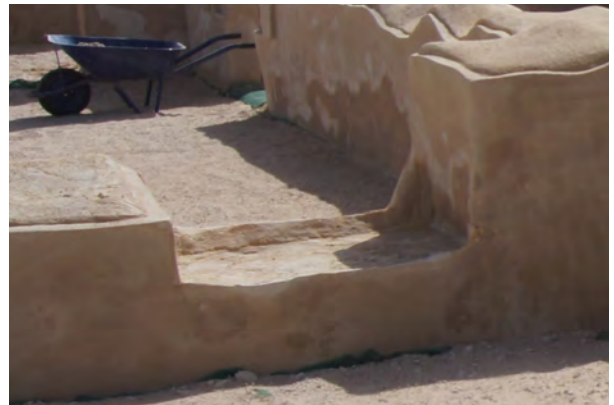
Window at palace after consolidation (03/2012)

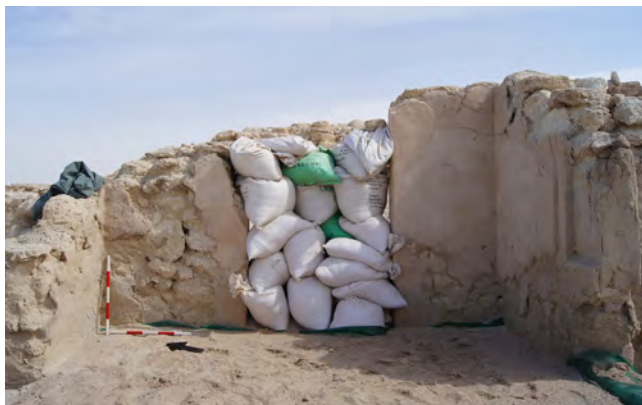
Doorway at palace before consolidation (01/2012)

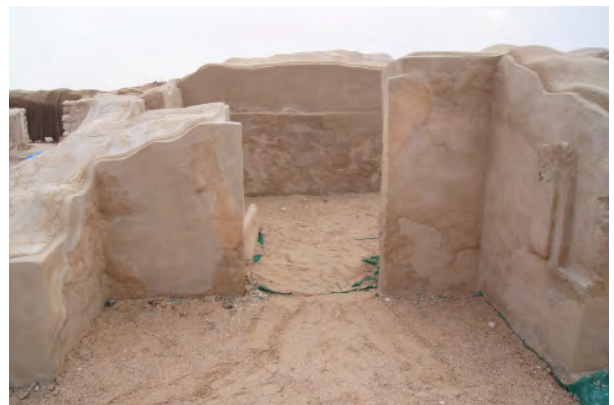
Doorway at palace after consolidation (03/2012)

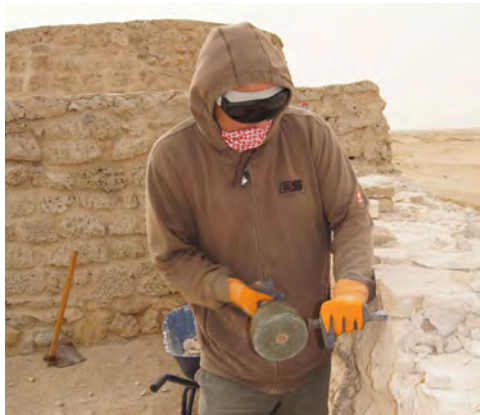
1. Hammer out and remove 1980s cement capping

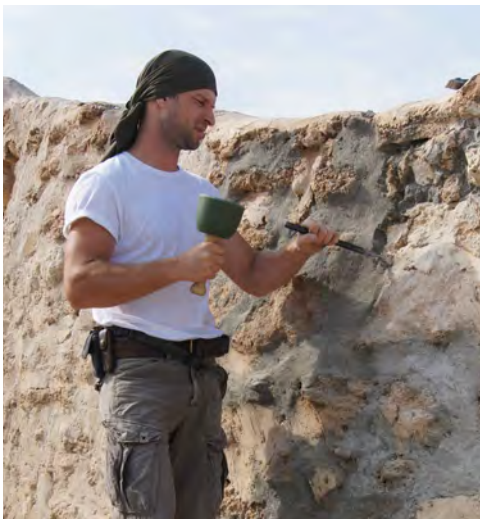
2. Hammer out and remove cement mortar remains in joints.

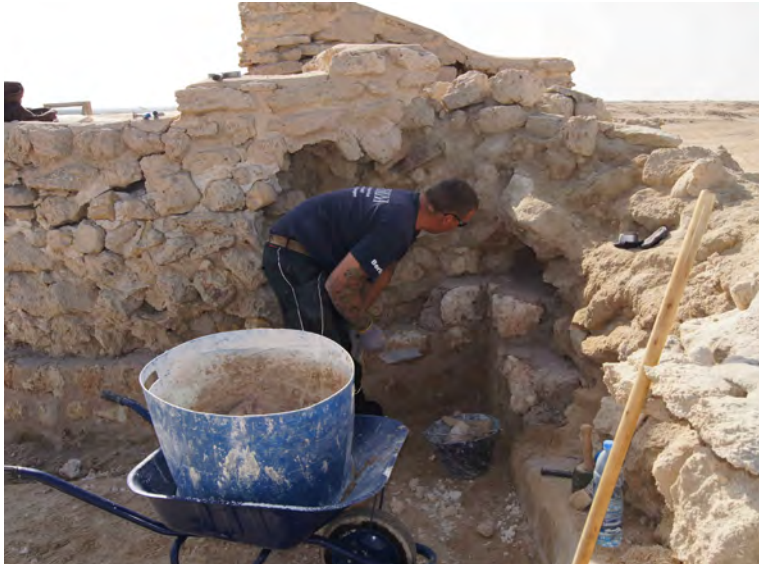
3. Expose, strip off and clean collapsed building parts.

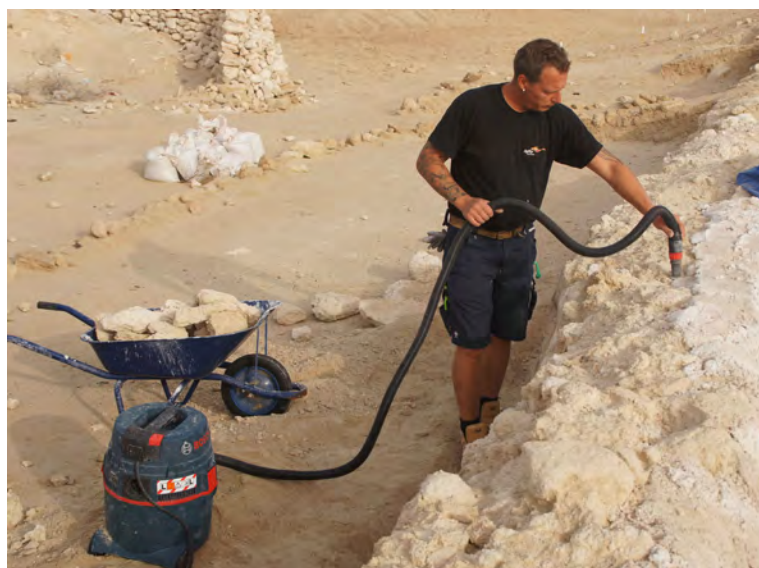
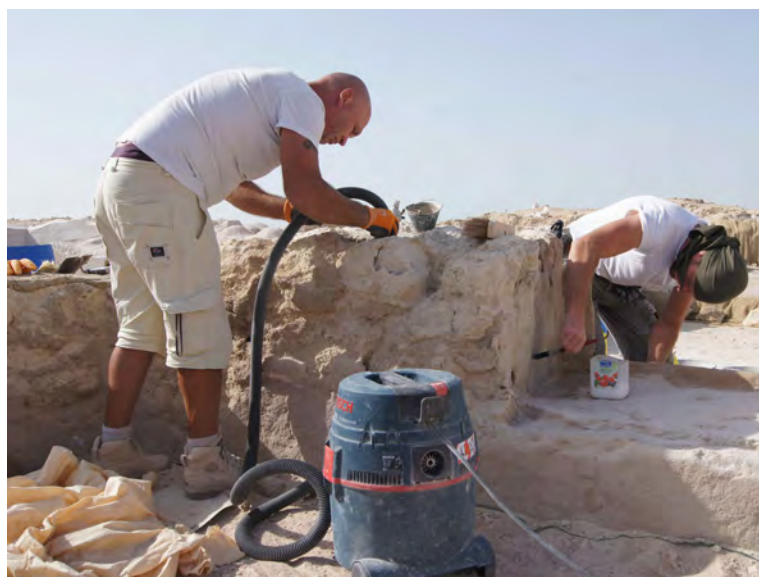
4. Remove loose materials and clean with an industrial hoover.

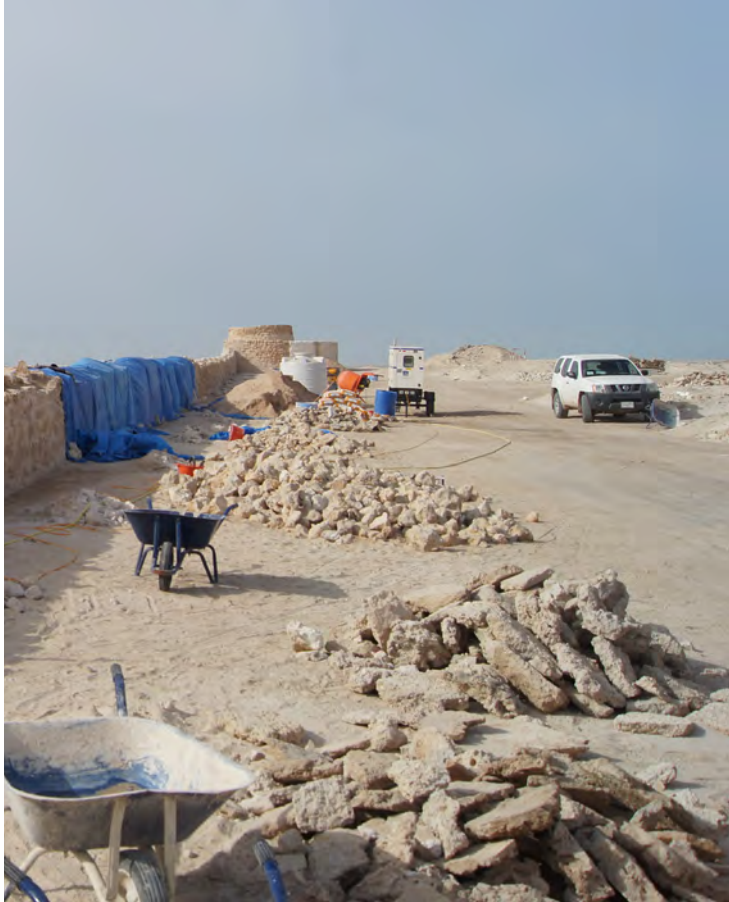
5. Pre-select stone material according to quality and (possibly) field of application

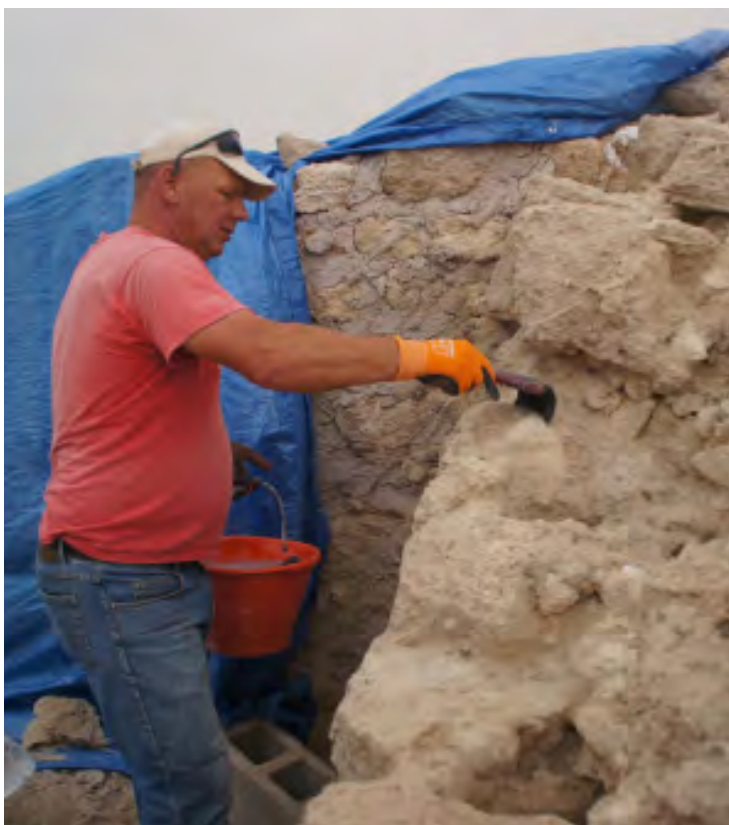
6. Pre-watering of wall stones before mortar is inserted.

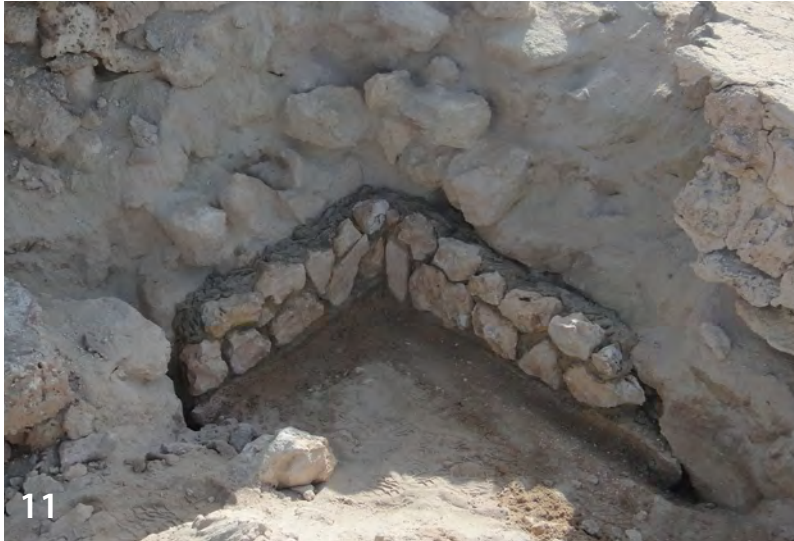
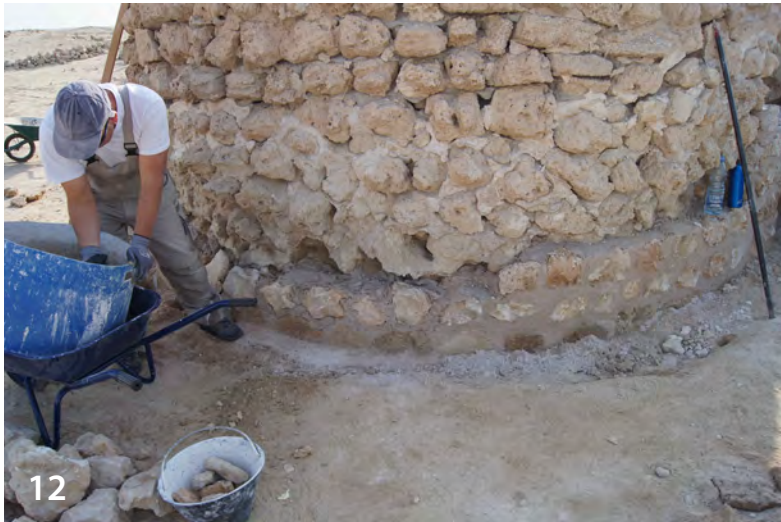
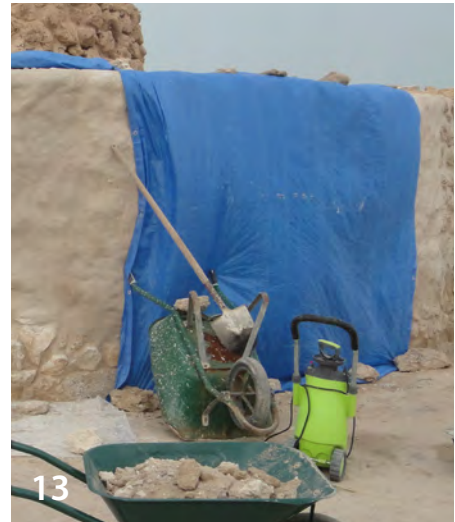
cross-section through consolidated town wall

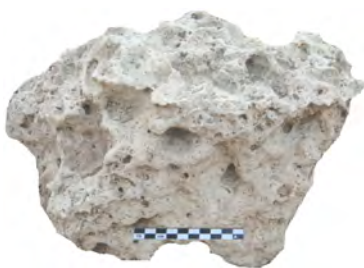
1. Selection of suitable stone material (Fig. 1 to 3).
2. Preparation of needed amounts of mortar mixtures (Fig.4).
3. preliminary dry-setting of wall stones of the area to be reconstructed; selection of stone curvature (Fig. 5).
4. After moistening of the wall structure and selected stones, build up prepared areas (Fig.6).
5. Raise wall-tops to ensure good surface-run off of water (e.g. rainfall). Set stones in mortar and re-pointing of joints (Fig.7 & 8).
6. Reconstruction and shaping of building features, e.g. steps, door recess according to approved planning documents (Fig.9, 10 and 11).
7. Protect your work segment at least for 12 hours against sun and wind (Fig.12). Keep it moist and re-moist it in regular intervals!

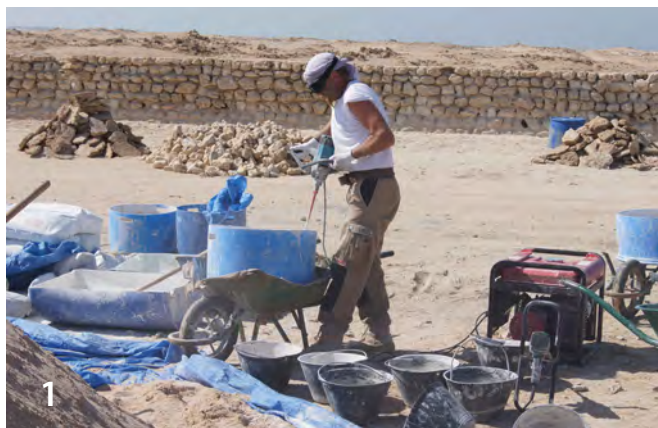
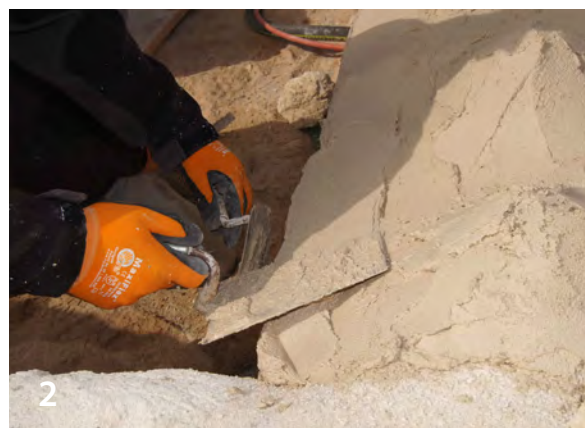
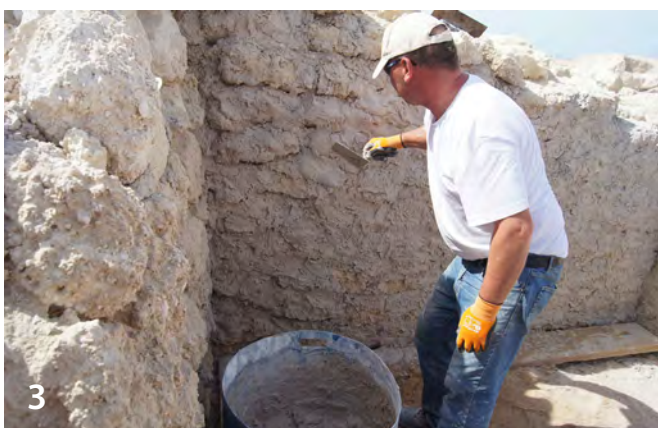
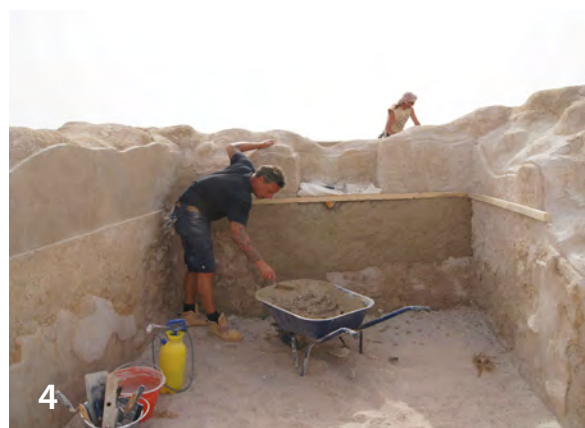
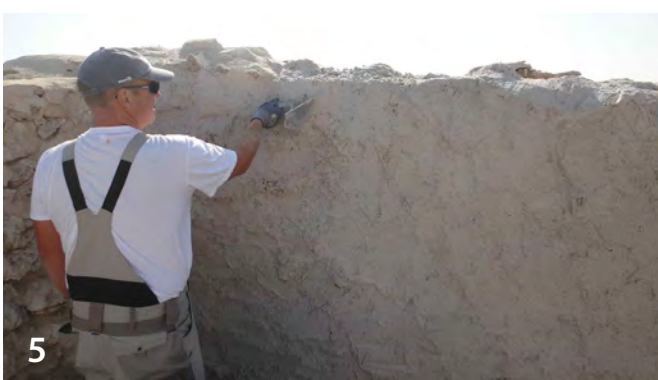
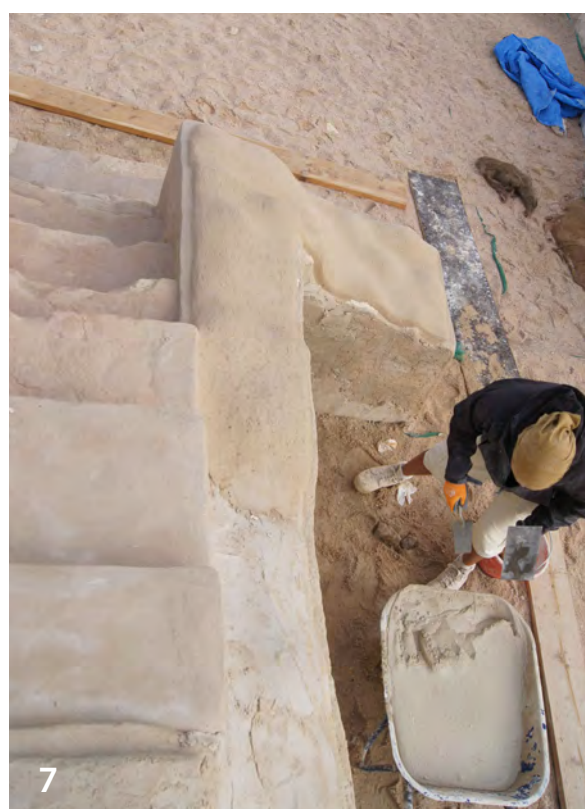
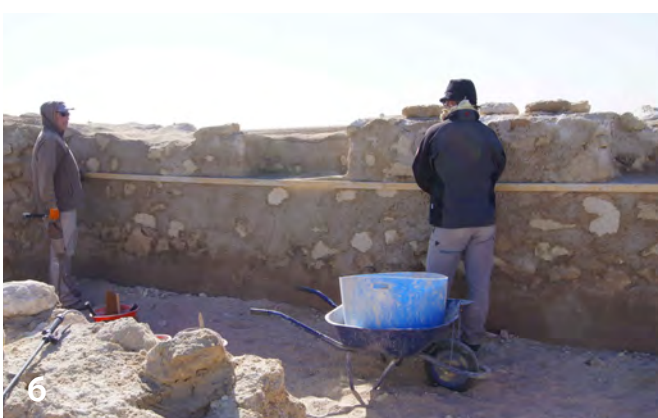
CONSOLIDATION OF WALLS PLASTER

1. Preparation and production of needed plaster mix (Fig.1)
2. **First application:** Even out irregularities, but follow the general form, keeping general unevenness. Plaster mortar should be inserted without smoothing. After ca. 2-3 hours scratch off peaks. This plaster layer can be 1 to 5 cm thick. Shrinkage cracks will appear. Design details have to be prepared and pre-shaped in this phase. Cover plaster with fabric! (Fig. 2, 3 & 4).

3. **Second application:** after approx. 6 -24 hours. The undercoat (1st application) can be partly dried. Pre-watering of wall segment. Apply plaster mortar and strip it off. Don't smoothen it. Plaster mortar application should not be more than 3 cm. There could still appear some shrinkage cracks. Design details have to be shaped. Plaster has to be covered with fabric (Fig. 5, 6, 7, 8 & 9).

5. Protect your work segment for at least 12 hours against sun and wind! Cover the surfaces with fabric (Fig. 14). Keep the plaster humid. (Fig.15).

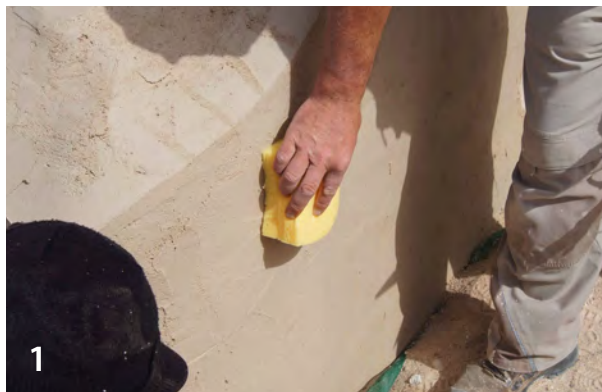
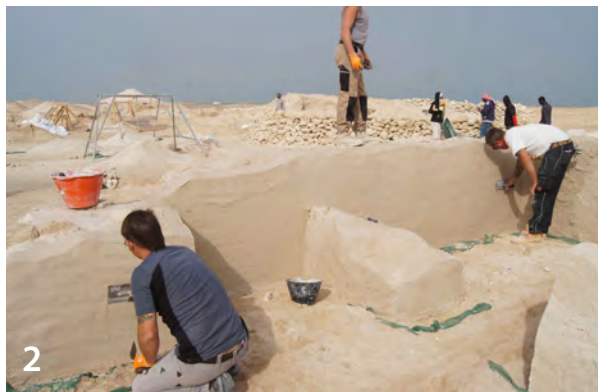
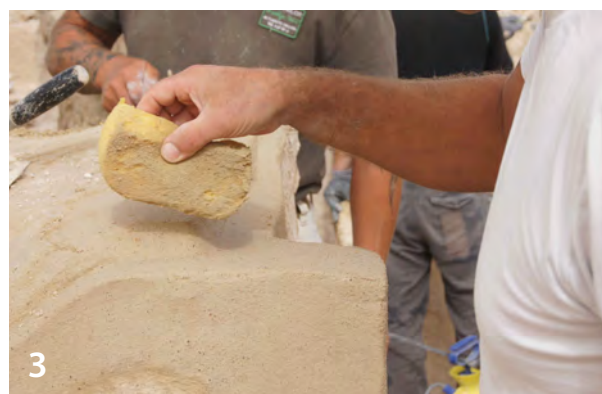
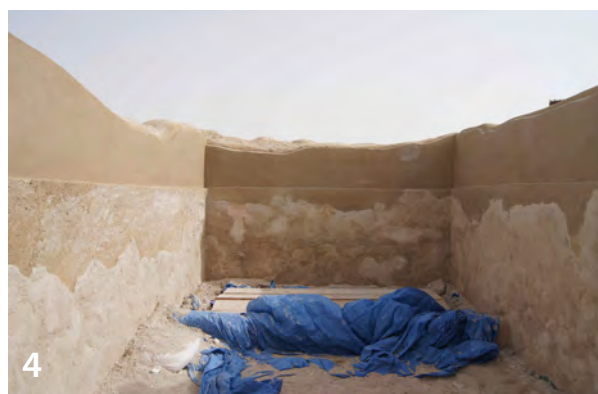
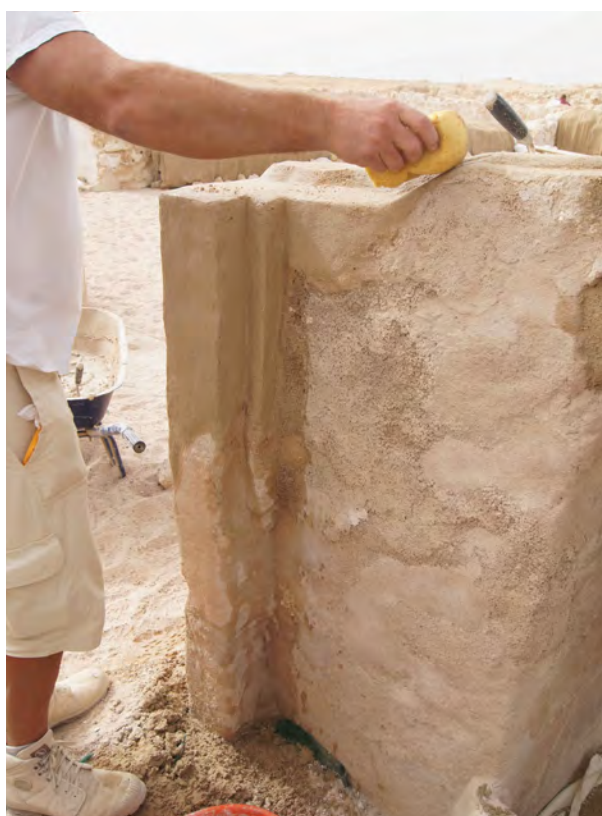
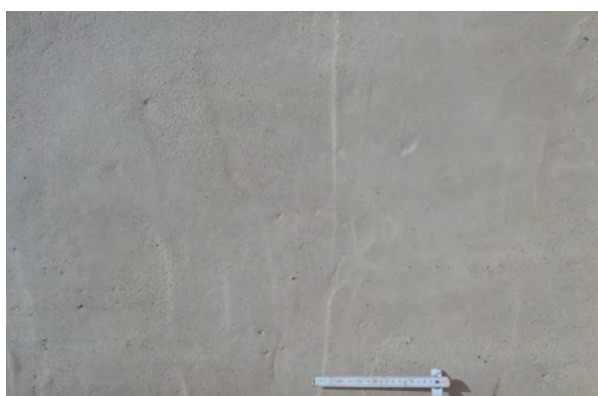
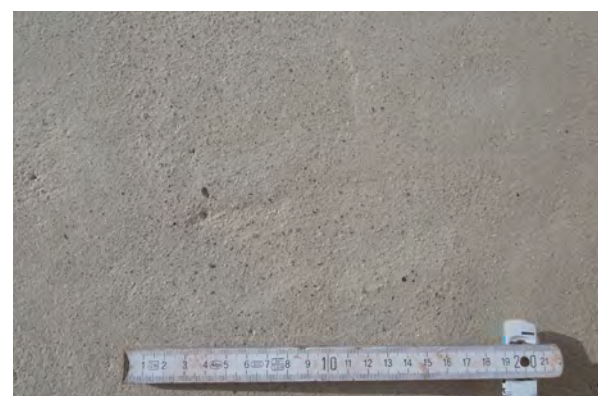
PLASTER DESIGN "Smooth surface"

1. After approx. 30mins. to 1.5hours the mortar should be not mouldable by thumb pressure.
2. Expose, carefully, quartz particles at the surface with sponge and water. Avoid sponge traces.
3. Afterwards, smooth surface with a small trowel. Traces of trowel tooling can stay visible.
4. Steps 2 and 3 (sponge/small trowel treatment) has to repeated over approx. 4hours with short breaks of approx. 15 to 45mins.
5. Surface should be kept humid over the entire work period.
6. Mortar has to be covered in between.

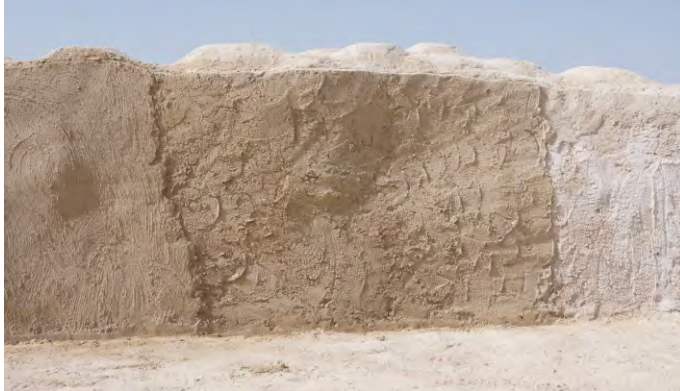
1. Treatment of mortar surface with gloves, hessian or linen-bales to create traces of hand tooling.
2. The surface appearance suggests that the plaster was applied entirely by hand.
3. Surface has to be kept humid during the entire work period.
4. Mortar should be covered with fabric in between.

1. Building up of mortar layers

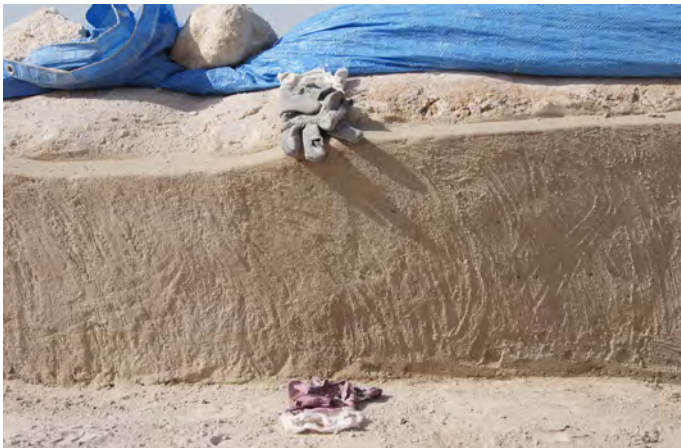
2. Applying final render by hand with gloves...

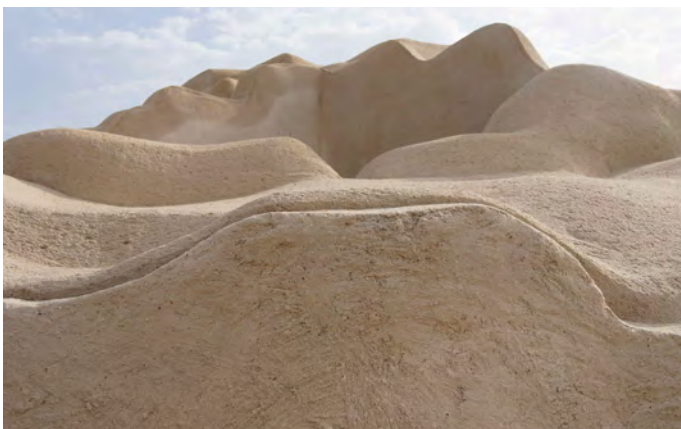
3. Final appearance with "tools".

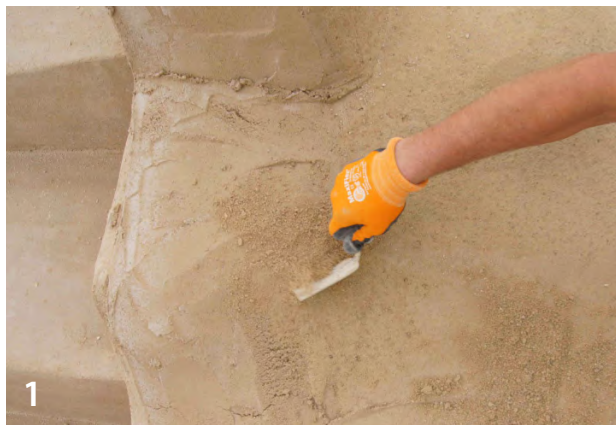
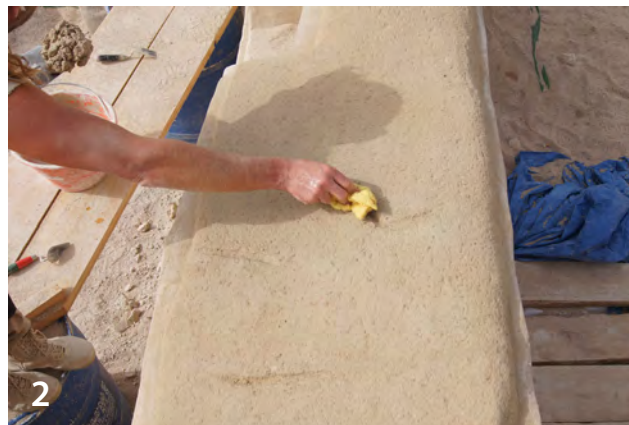
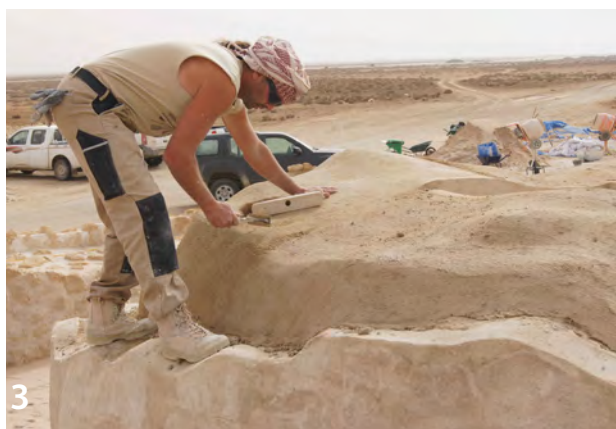
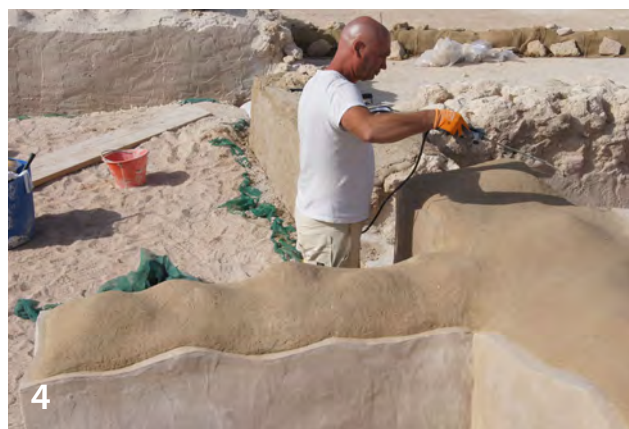
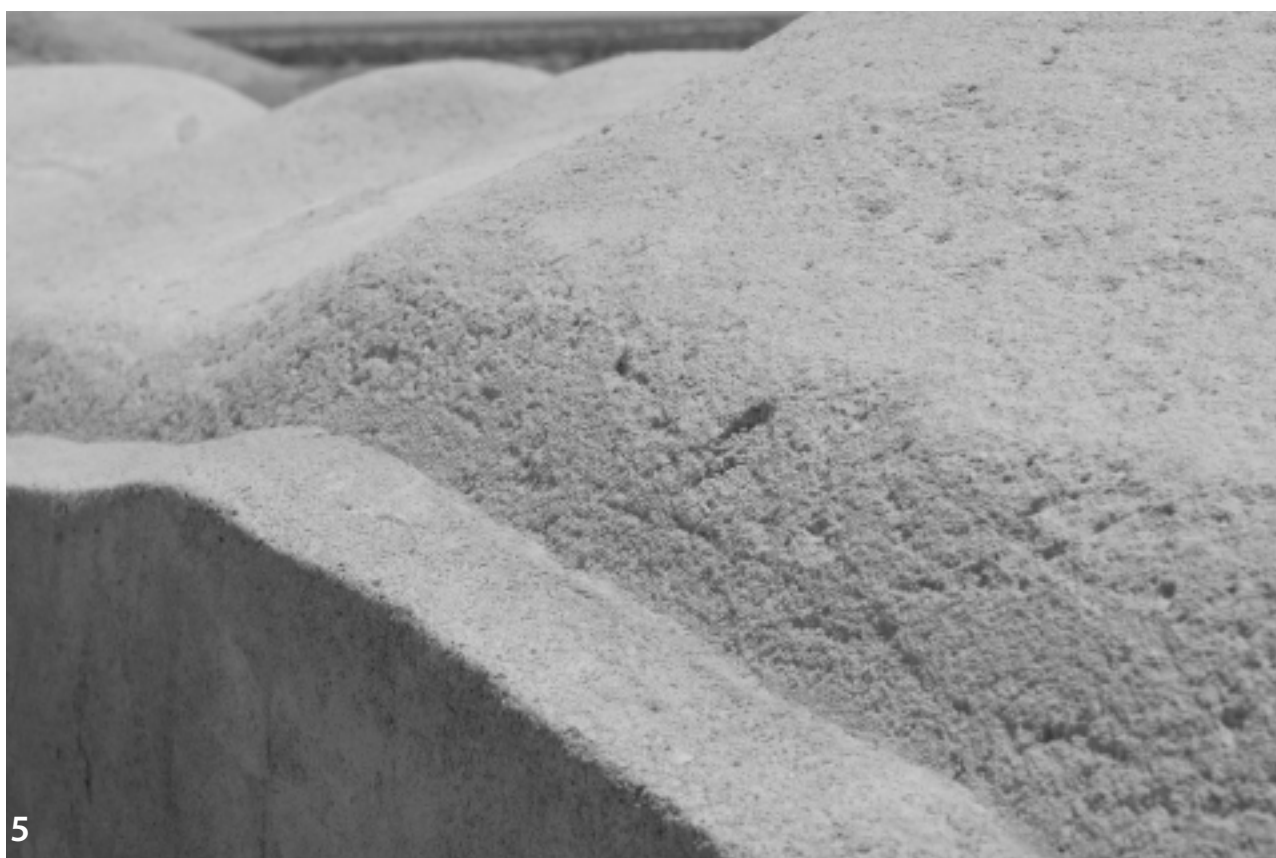
PLASTER DESIGN " Rough surface "

1. after 30 mins. to 1.5 hours the mortar should be not be mouldable by the thumb anymore.
2. Exposure of quartz particles at the surface by trowel, sponge and water; repeat procedure if necessary (Fig. 1 to 3).
3. This procedure applies a rough but regular appearance to the mortar surface (Fig.5).
4. Surfaces should be kept humid during the entire work period. (Fig.4)
5. Mortar should be covered with fabric in between the work steps.

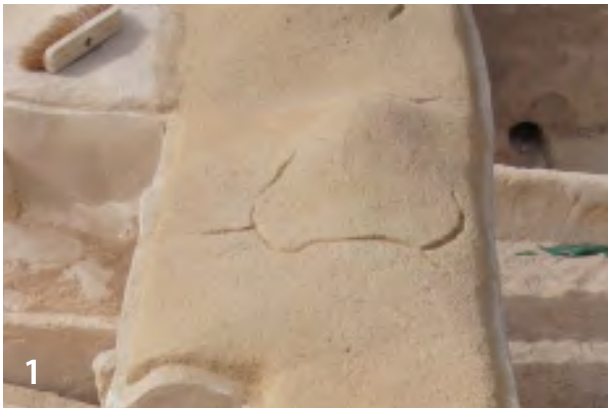
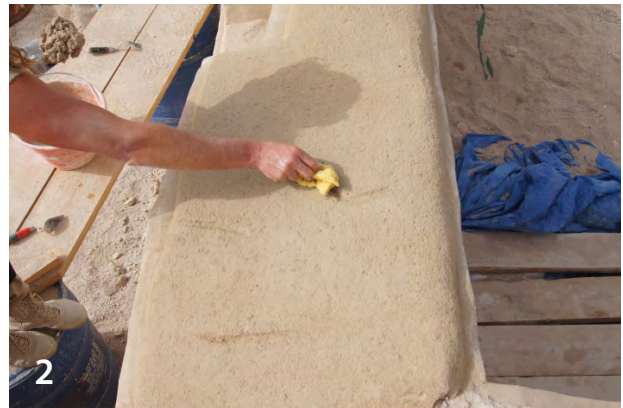
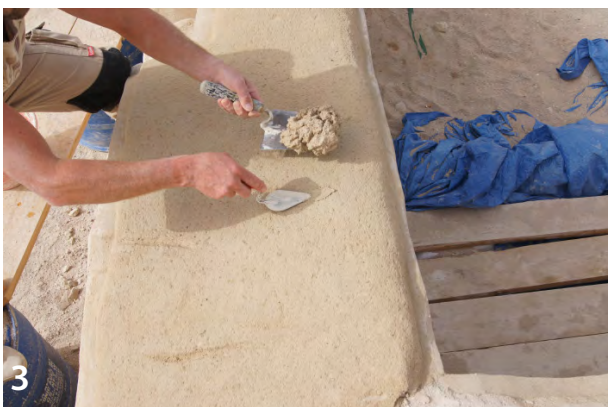
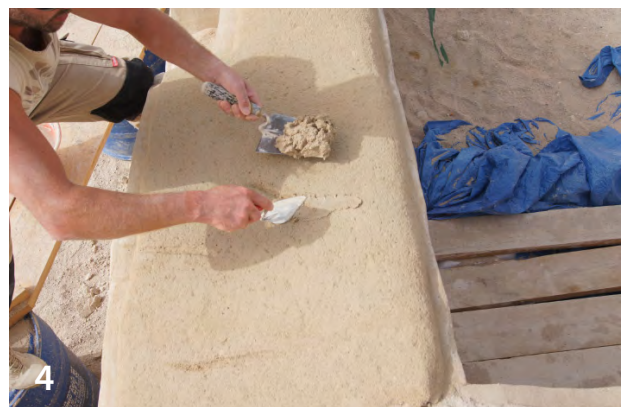
REPAIR OF CRACKS appearing in new plaster

1. Open surface cracks with trowel and clean the area with brush.
2. Water plaster / mortar and mix amounts of mortar required.
3. Fill opened crack with mortar.
4. Adjust mortar to surrounding surface.

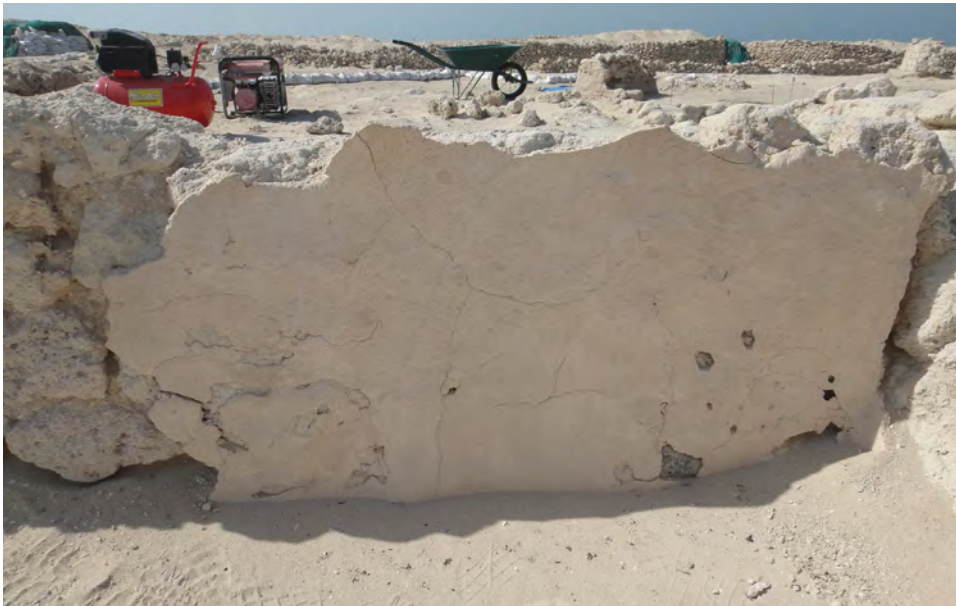
Before consolidation took place (ZUEP02)

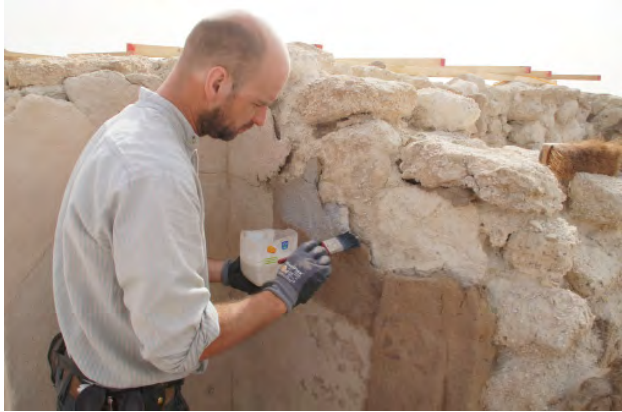
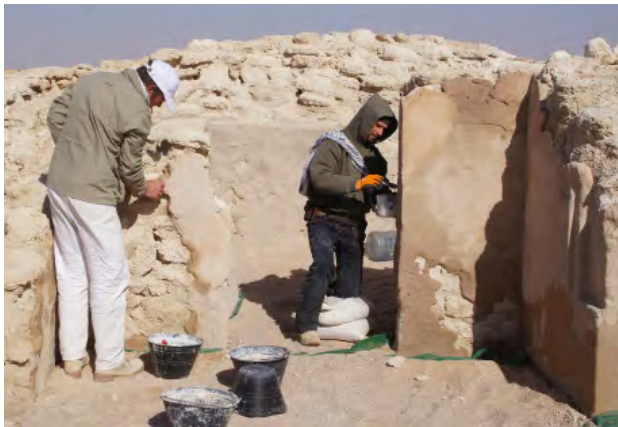
Consolidation of Plaster surfaces
see Fiche No. 4.1

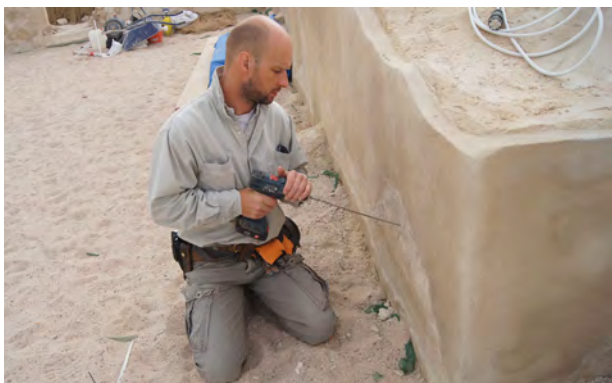
Fixing of loose plaster parts
see Fiche No. 4.2

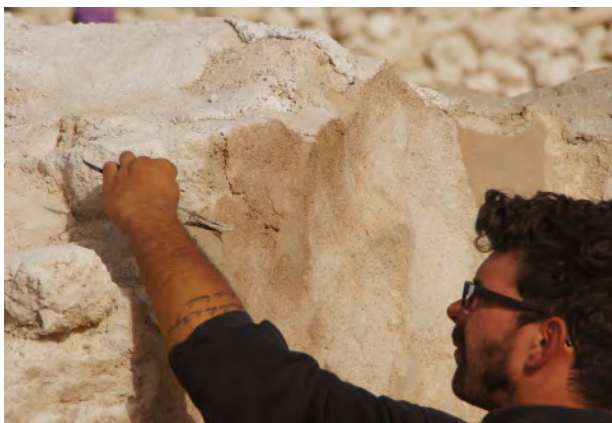
Cementing of Cracks
see Fiche No. 4.3

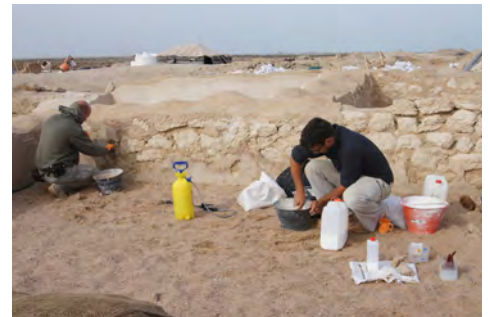
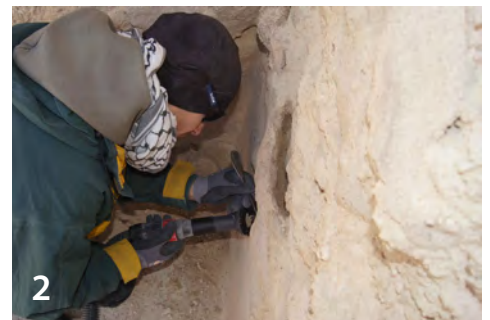
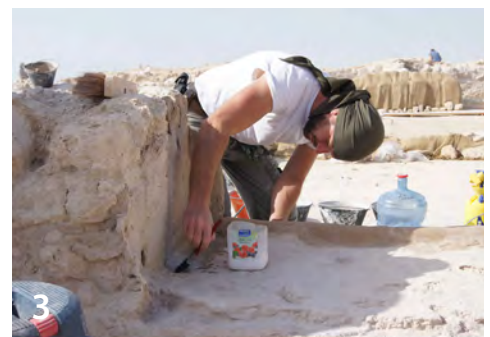
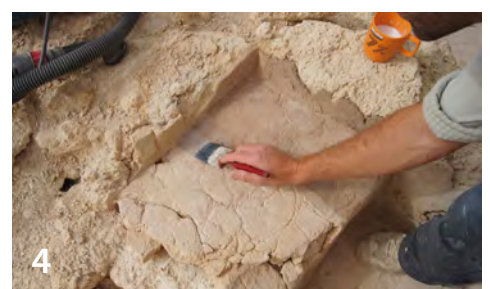
1. Preparation and mixing of Consolidation liquids (Acryl-dispersion SF016 7% in Water) (fig. is missing).
2. Cleaning of plaster surfaces with brushes and hoover (Fig.2).
3. regular application of consolidation liquid onto the plaster surface (Fig.3 & 4) .
4. repeat point 3 after 5 to 10 minutes according to absorbency of plaster subsurface. However additional application should be executed wet in wet (Fig.6).

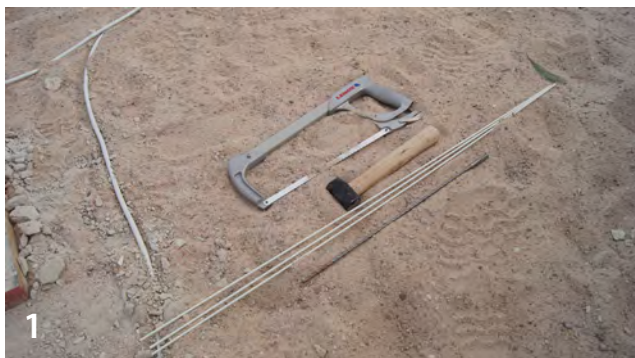
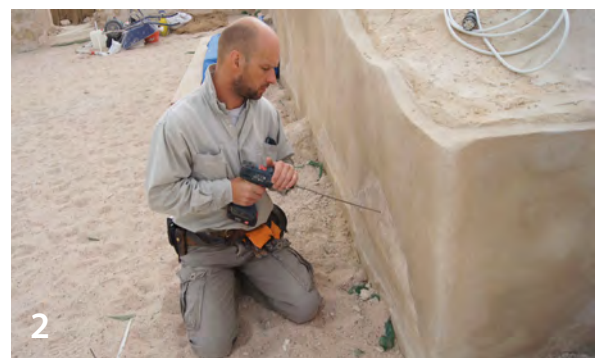
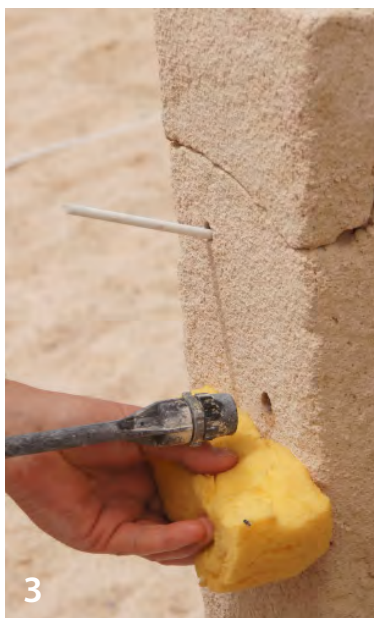
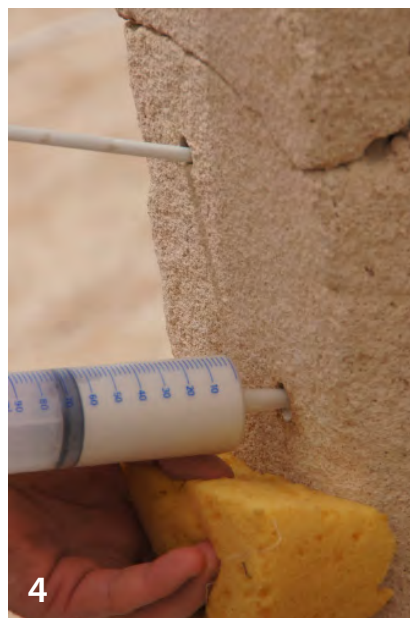
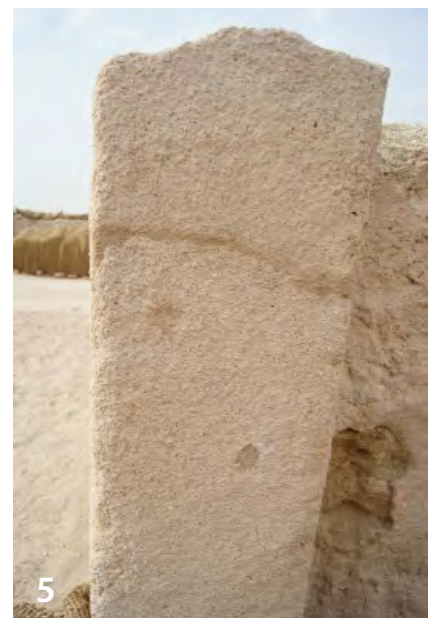
A - Securing detached plaster by needling

1. Prepare anchor material (fiberglass rods D 4-8 mm), define drilling range, quantity and length of needling and deployed anchors (Fig. 1).
2. Drilling holes with 2mm wider diameter than desired anchor material; make sure that the holes are pointing in different directions, but drilled slightly diagonally downward (Fig. 2)
3. Cleaning of the dowel hole and prewetting (Fig. 3)
4. Glue/Fixing of dowel rods. Glue: here Lime-Acryl milk (Fig.4)
5. Closure of the dowel holes with mortar (see Fiche 4.3), (Fig.5)
