Conservation Handbook Al Zubarah Archaeological Site

Edited by
Moritz Kinzel

QIAH-01-02-HE-1000

First Edition January 2013

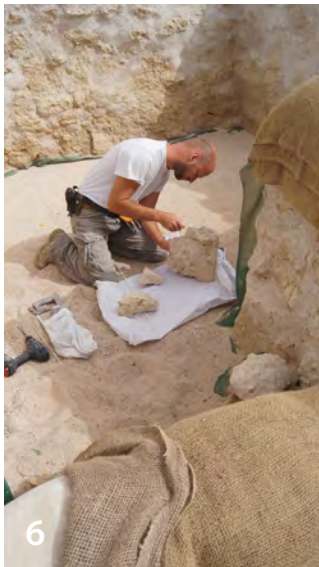
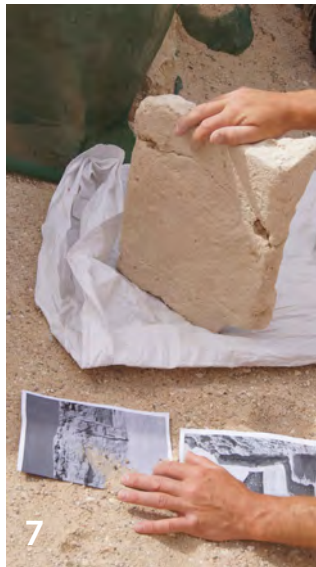
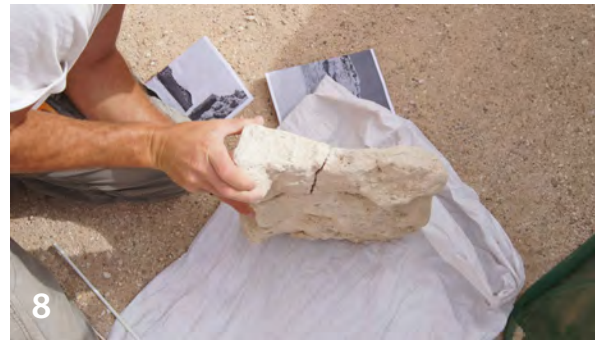
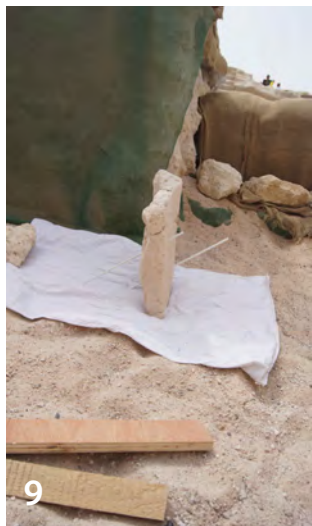
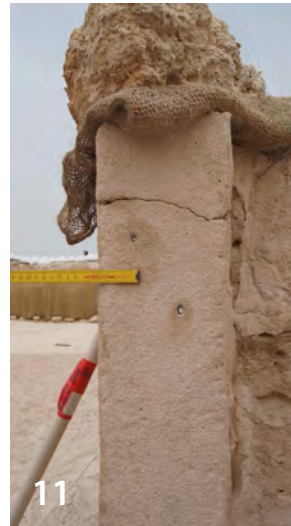
B - Re-attaching broken plaster parts by needling

6. Recover and securing fragments, Cleaning of fragments (Fig.6)
7. Mapping, sorting, and reconstruction of the original position (Fig.7).
8. Bonding of the fragments as required (Fig.8)
9. Preparation of needling (as described in paragraph A), (Fig.9)
10. Re-attachment and bonding of fragments in its historical position (Fig. 10 & 11).
11. Seal dowel holes and joints with mortar (Fig.12)

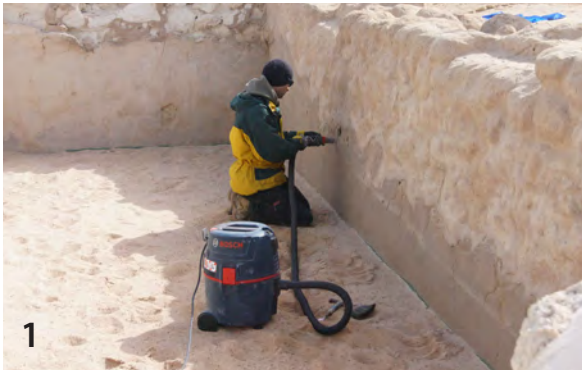
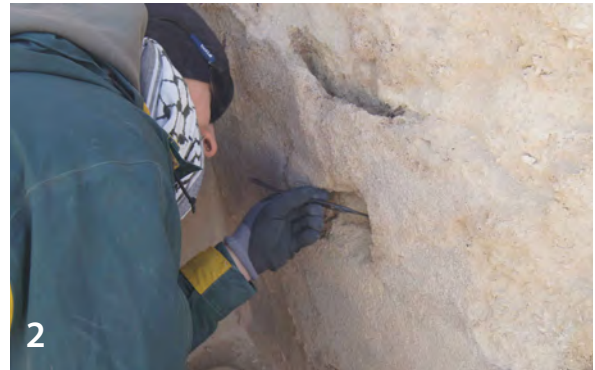
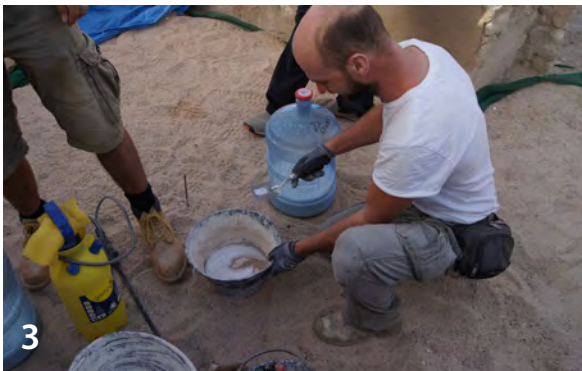
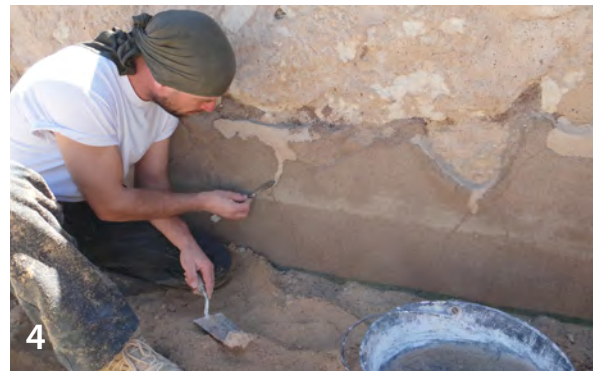
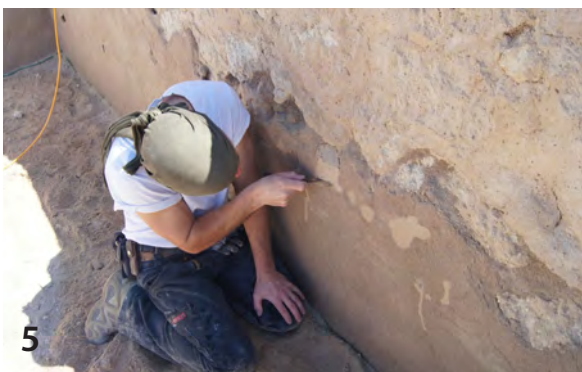
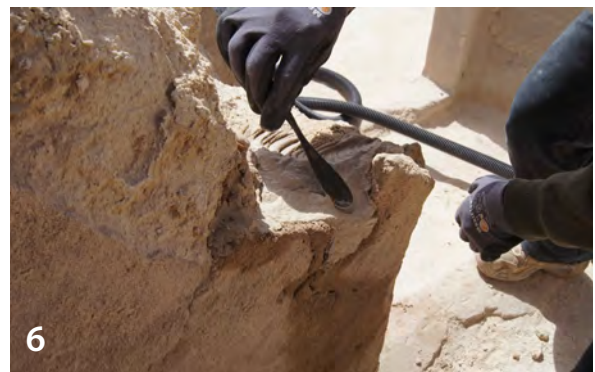
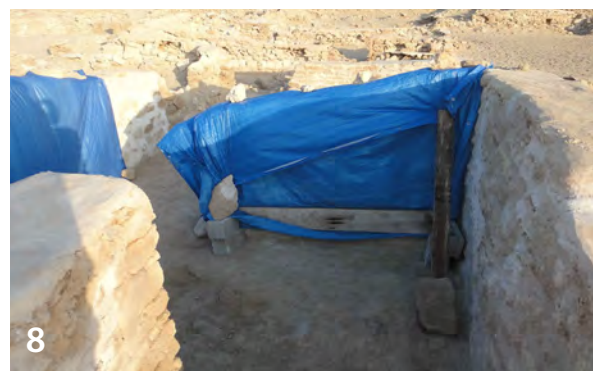
FICHE No.4.3

1. Cleaning of plaster borders with brush, hoover and lancettes (Fig. 1 & 2)
2. Mixing of repair plaster (1RT wLh, 4 RT ds, 2%SF016 in water) in an amount that can be used within 1 hour (Fig. 3)
3. Application of repair plaster after pre-watering to the level of the historic plaster surface: closing of holes and cracks, bridging areas to be prepared for later replastering (Fig. 4 to 6).
4. After 10 to 13 min.: Secondary- treatment with sponge, Exposure of granulation, smoothing and cleaning of plaster borders (Fig.7).
5. Protect your area of work for at least 12 hours against wind and sun (Fig.8). Keep it humid during period.

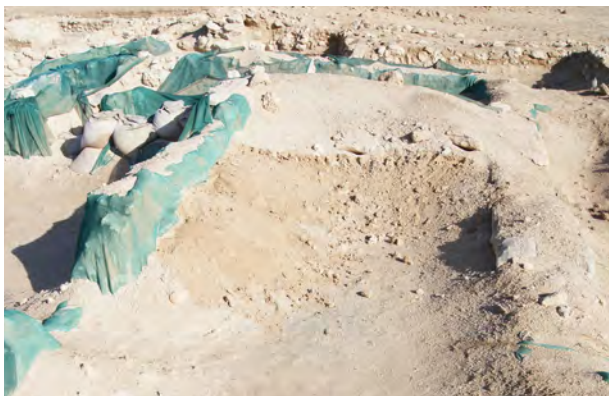
DO NOT

use unsieved soil from the spoil heaps mixed with stone material

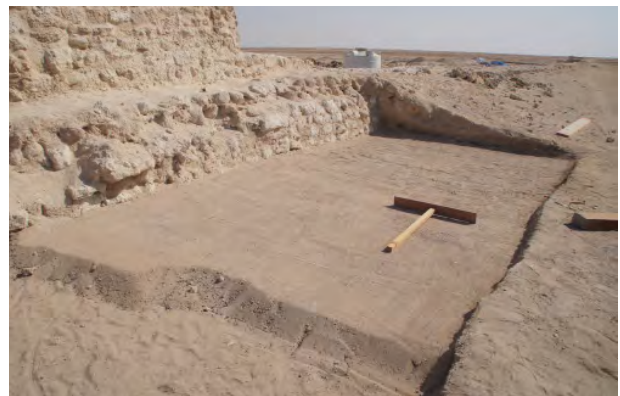
DO

only use sieved soil or quartz sand for backfill

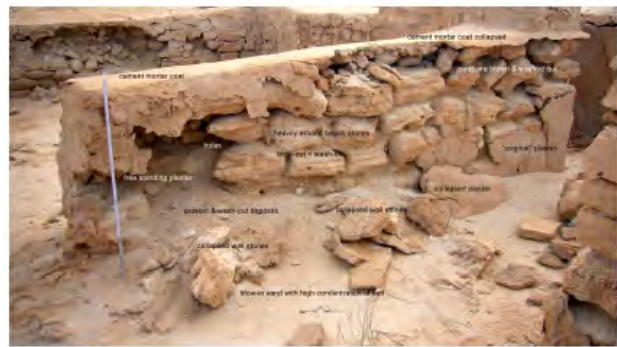
Az Zubarah	Documentation State of Preservation		2009
old excavation area	South field	Catalogue	
R.005	Wall d	Date: 18.11.2009

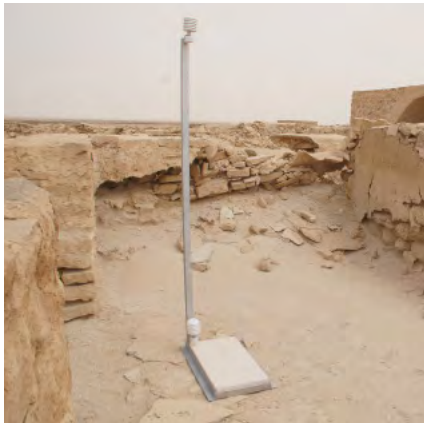
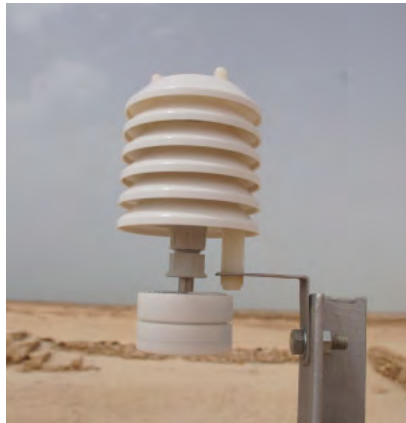
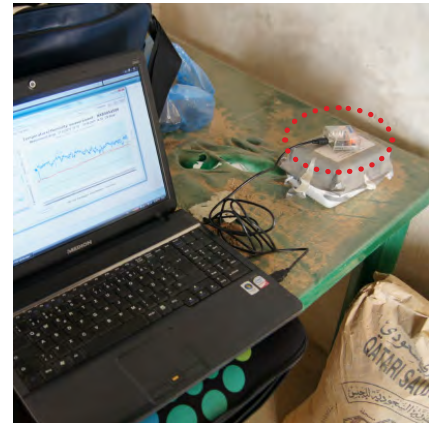
Temperature/humidity data loggers at QMA2 in Al Zubarah town (D1, D2) and HAB54506 at Al Zubarah Fort.

At Al Zubarah several data loggers are installed permanently (for locations see map below). The recorded data has to be downloaded from the single devices regularly, at intervals of three to six months. Data should be uploaded to the project server immediately.

Data loggers have to be reset according to the technical manual, before they are placed back. At the same time the batteries should be checked. **Make sure that the batteries are replaced in time!**

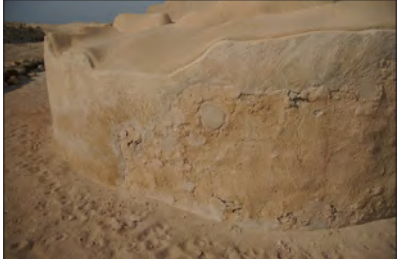
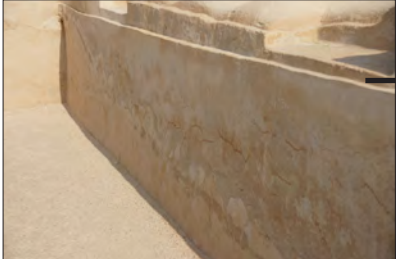
Tower 4012 - loss of historic plaster due to salt crystallization.	Wall 4010 - cracks in new wall plaster (sacrificial layer).				
SKETCH / COMMENTS					
Assessment should be done by experts when the season starts to execute repairs.

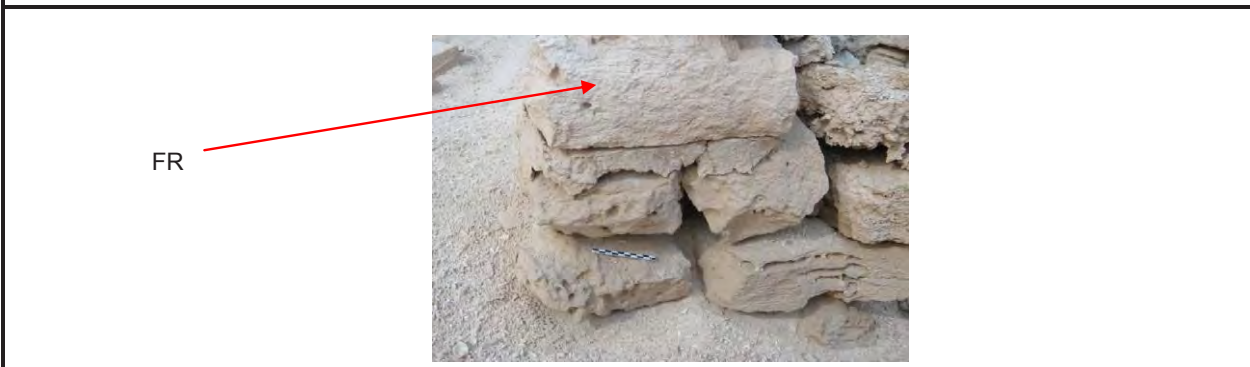
Appearance in wall structure

General description:	grain-supported, very porous fabric of biogenic detritus (forams, bryozoa, peloids) Cemented by granular calcite; homogeneous particle size distribution; maximum at 200 µm, medium compressive strength
Colour:	light yellow
Petrophysical properties:	porosity: ~40 Vol.%, bulk density: ~1,63 g/cm ³ , ultrasonic velocity: 3,1 km/s
Weathering characteristics:	good weathering resistance, best building stone of the Al Zubarah area
Bedding:	hardly recognisable
Occurrence in wall structures:	preferably in more important buildings, e. g. in walls of mosques; more frequent in Freiha than in Al Zubarah, because of greater proximity to the quarries

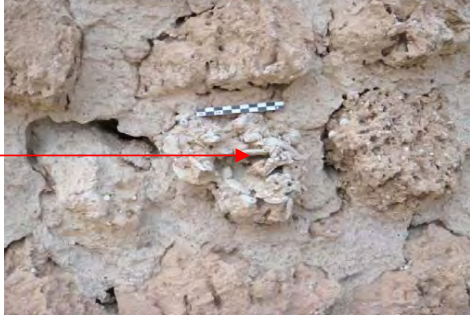
Appearance in wall structure

Characteristic features	
General description:	mixture of dolomite fragments and fossil debris (bivalves and gastropods) on a well cemented basal layer
Colour:	yellow grey
Petrophysical properties:	
Weathering characteristics:	good resistance to weathering due to good cementation of components
Bedding:	clearly marked by basal layer; rarely more than 2 or 3 layers
Occurrence in wall structures:	locally abundant

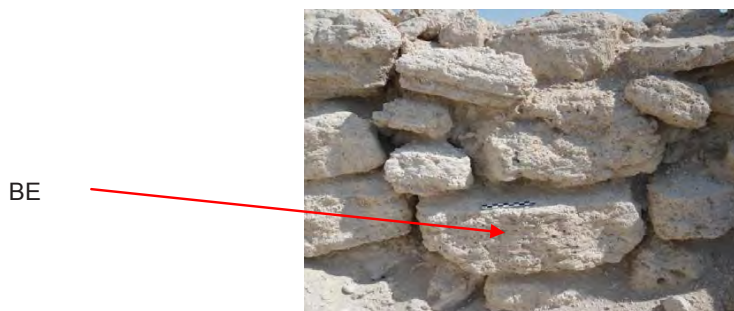
Appearance in wall structure

General description:	porous crypto-crystalline gypsum matrix with rock and mineral fragments and little fossil debris; low compressive strength due to the porous structure and low hardness of gypsum
Colour:	light yellow grey to white
Petrophysical properties:	porosity: ~39 Vol.%, bulk density: 1,5 g/cm ³ , ultrasonic velocity: 2,5 km/s
Weathering characteristics:	good weathering resistance
Bedding:	not recognisable
Occurrence in wall structures:	less frequent

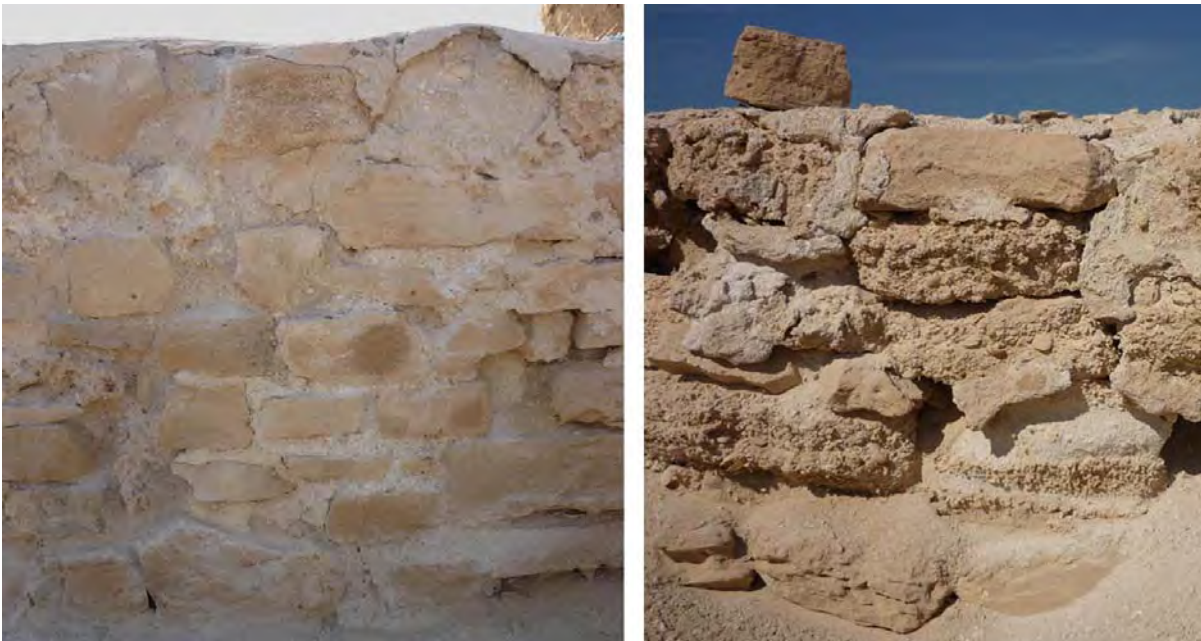
Figure 1: Preservation state of wall structures as a function of mortar and rock stability.

Left side: Homogeneous aeolianite building stones with good weathering stability and moderate mechanical strength. Right side: Beachrock type with poor weathering stability and mechanical strength.

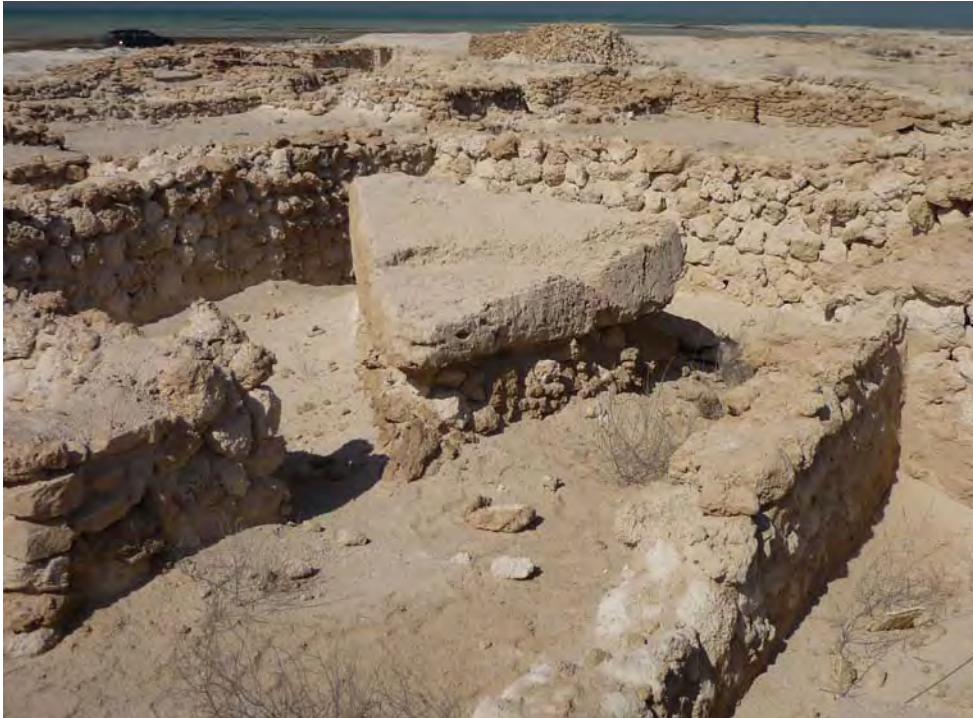
Figure 5: “Table stone” (beachrock) within the walls of a building, Al Zubarah

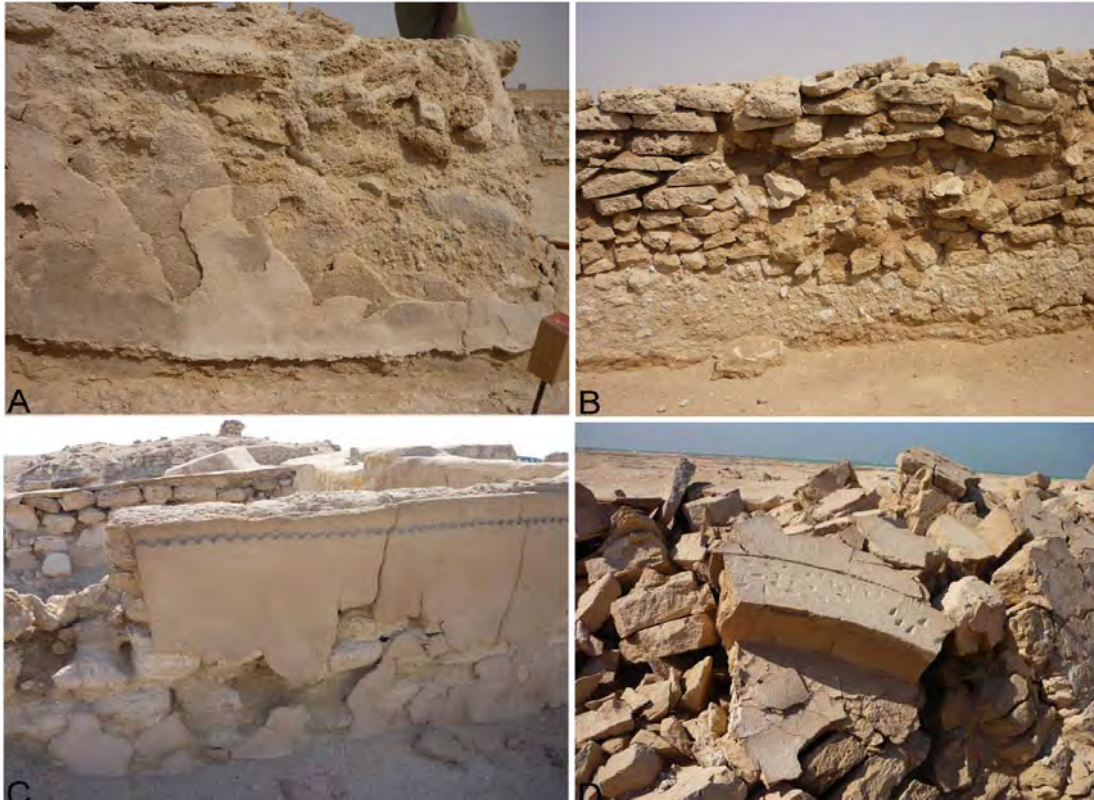
Figure 11: Sampling localities at Freha and at Al Zubarah. A. Double-layered wall plaster at Freha mosque, B. wall mortar at Freha mosque, wall plaster at Al Zubarah city, South field R.005, wall C (C) and Al Zubarah city area of consolidation (D)

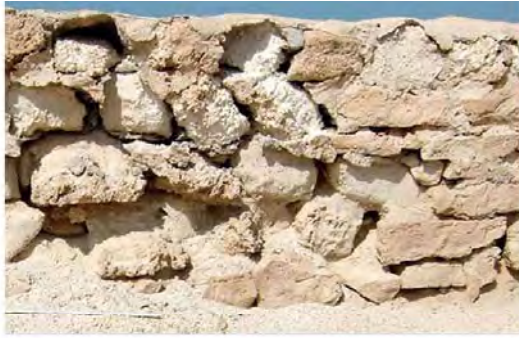
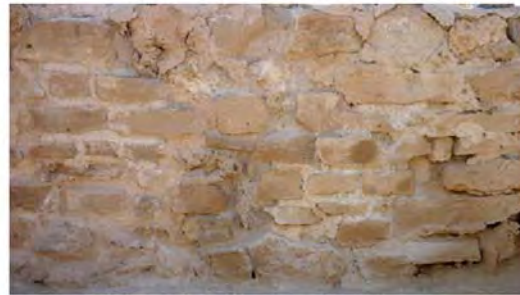
Figure 15: Test fields with NHL mortar at Eastern part of tower structure
(Roman numerals refer to sample numbers in table 6)

In the area of consolidation at the Northern end of Al Zubarah city several test fields were prepared with NHL mortar (figure 15) and the state of the mortar studied after a period of about six month. (The test fields at the wall of tower no. 8 which were carried out in February 2011 are not considered here because the time span between preparation and sampling would have been too short for the observation of noticeable effects.) The first test was scratching the mortar with a finger nail or the rubbing it between two fingers. Already this simple test showed that the NHL mortars had developed good strength and did not fail. Small samples were taken from the test fields and prepared for examination by X-ray diffractometry and optical microscopy.

X-ray diffractogram of hydraulic lime wall mortar, test area II, Eastern part of tower structure (figure 15)

X-ray diffractogram of hydraulic lime mortar from joint, test area XI, Eastern part of tower structure (figure 15)

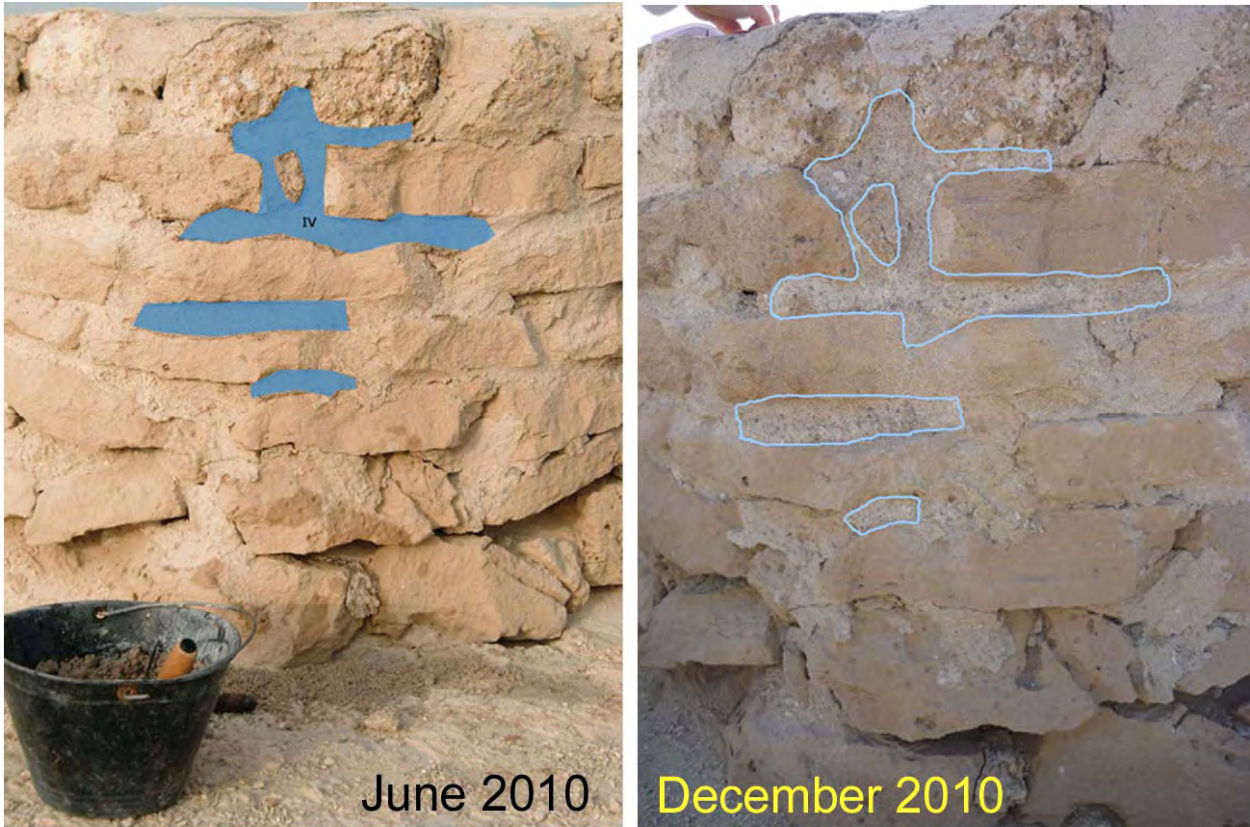
Figure 17: Test field IV with anhydrite mortar for jointing at NE corner of tower structure
 (Roman numeral refers to sample number in table 8)

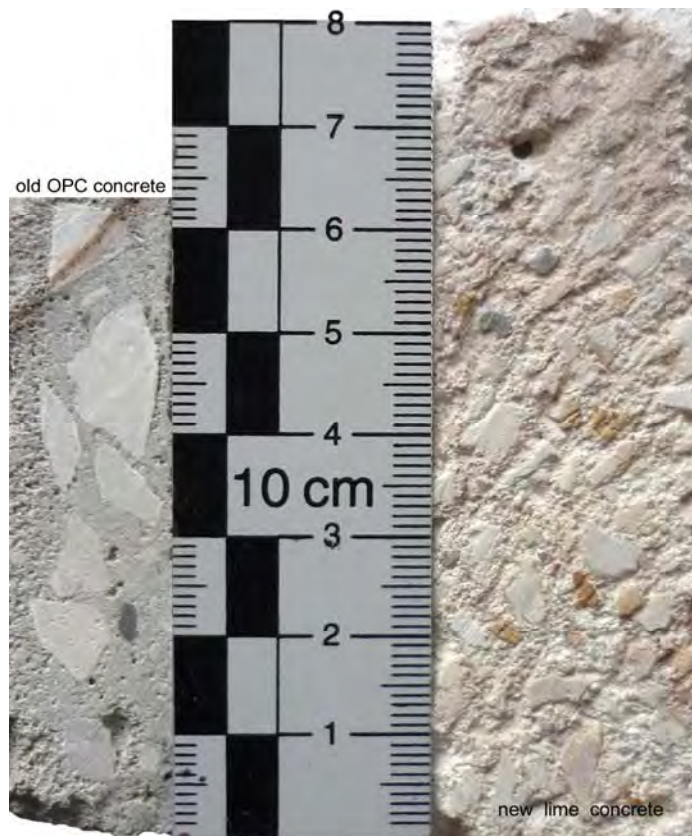
Figure 3: Old OPC (left side) and new lime concrete

Samples of the old OPC concrete and the new hardened lime concrete (**figure 3**) were taken for the determination of the bulk density, compressive strength, and Young's modulus. The results of the tests are summarized in **table 2**..

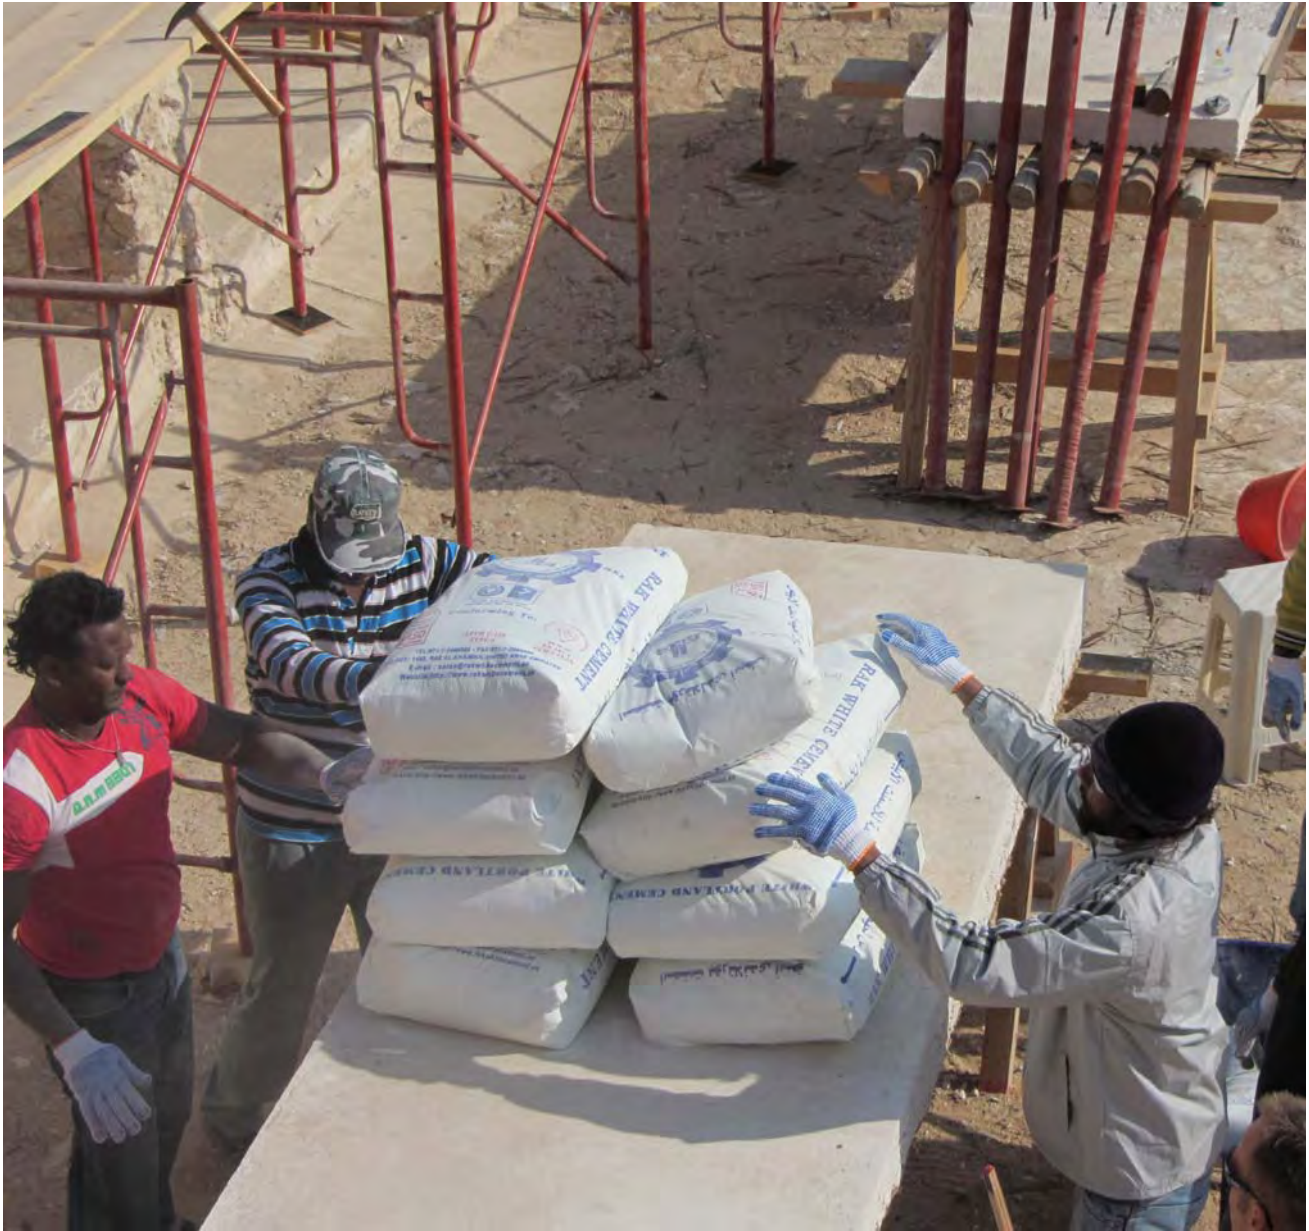
Figure 5: On-site bending tensile strength test

mass [kg]	no. of sacks	load [N]	area [mm ²]	force [N/mm ²]	flexure [mm]	
0	0	0			0	
100	2	981			0	
200	4	1962			0	
300	6	2943			0	
400	8	3924	480000	0,008	0	→ see figure 5
500	10	4905			0	
600	12	5886			5	
650	13	6377			5

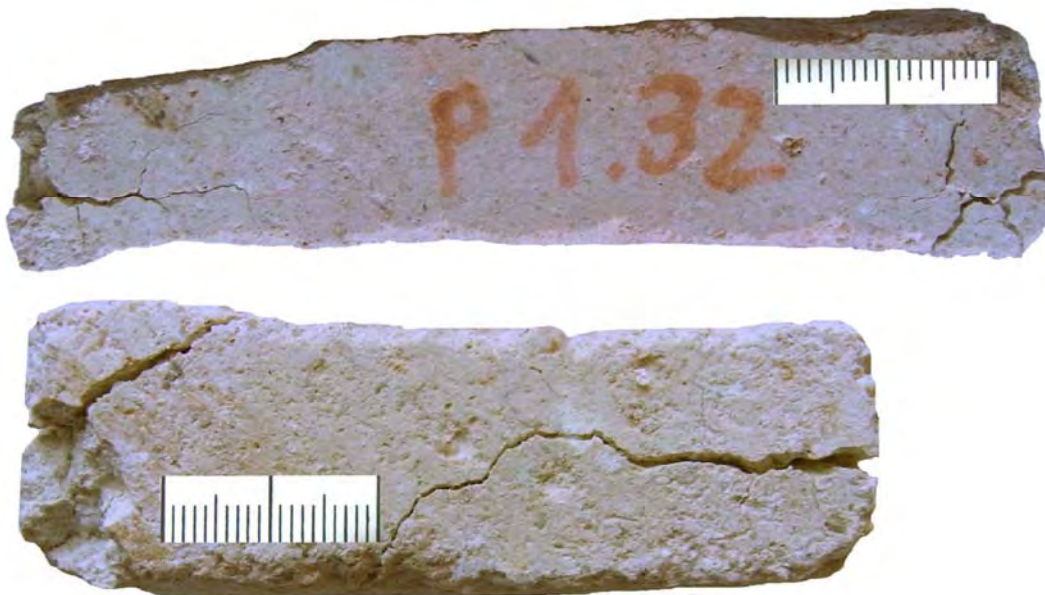
Figure 8: Sample “soil mortar” P 1.32 after 9 cycles in the water compatibility test

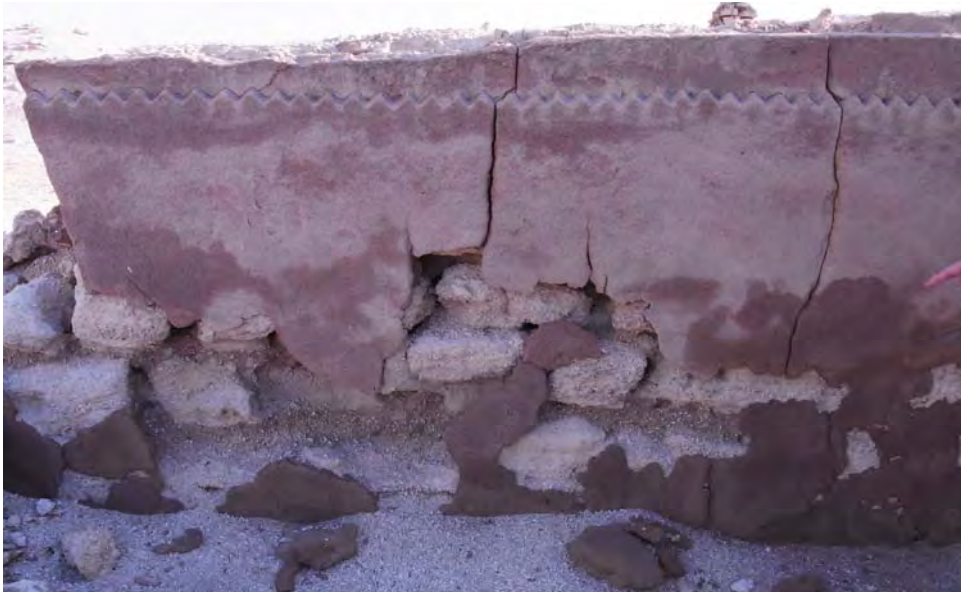
According to the local building tradition the walls of buildings at Al Zubarah were internally and externally coated with gypsum plaster (**figure 13**).

Figure 13: Decorated wall plaster, South Field, Room 005 Wall c

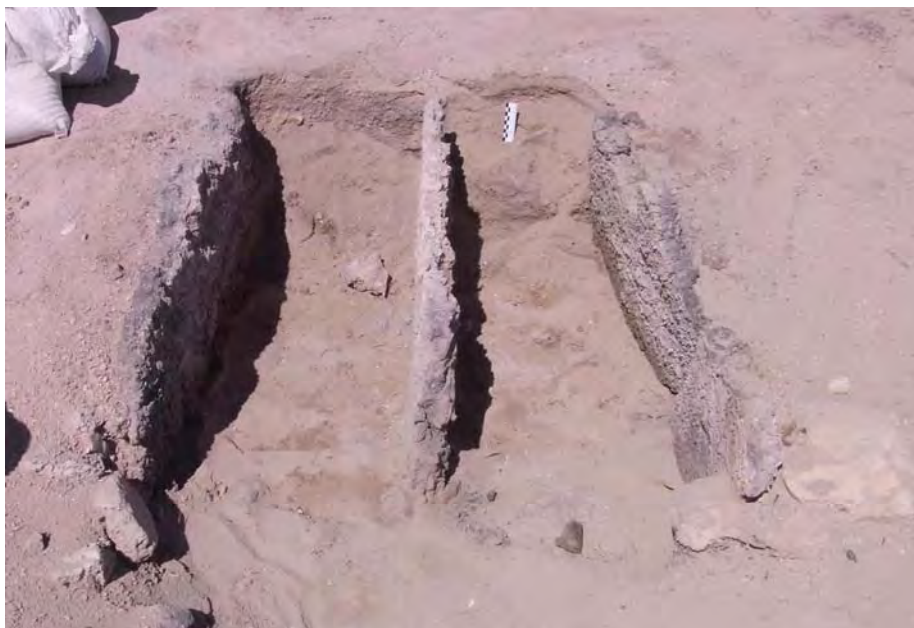
The raw material for the preparation of the plaster, namely gypsum, is ubiquitous on the peninsula of Qatar. Especially in the vicinity of Al Zubarah gypsum, related to the sabkha facies, can easily be collected. The excavations at Freyha led to the discovery of a double chamber construction which is regarded as a small kiln for the burning of gypsum (**figure 14**).

Figure 14: Double chamber construction at Freyha excavation site

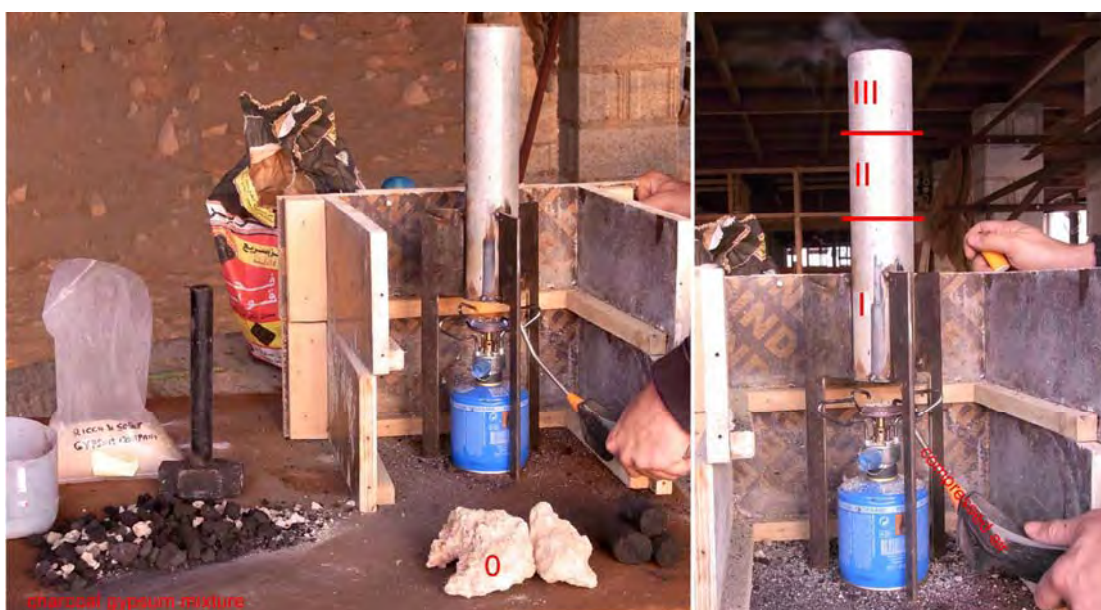
Figure 15: Tube-like experimental kiln for the burning of gypsum

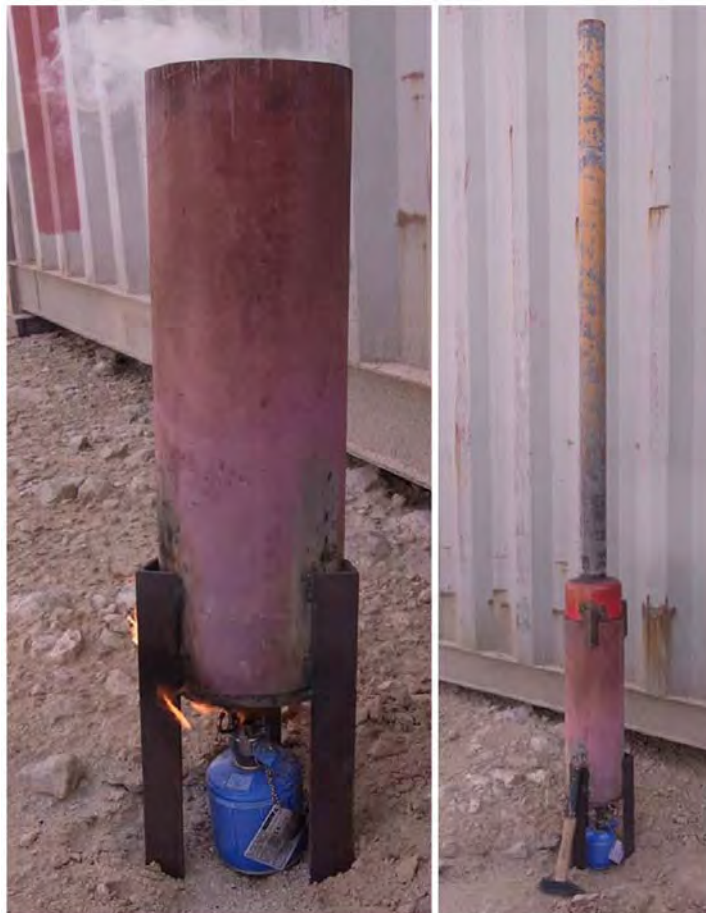
Figure 18: Large kiln with funnel mounted on top

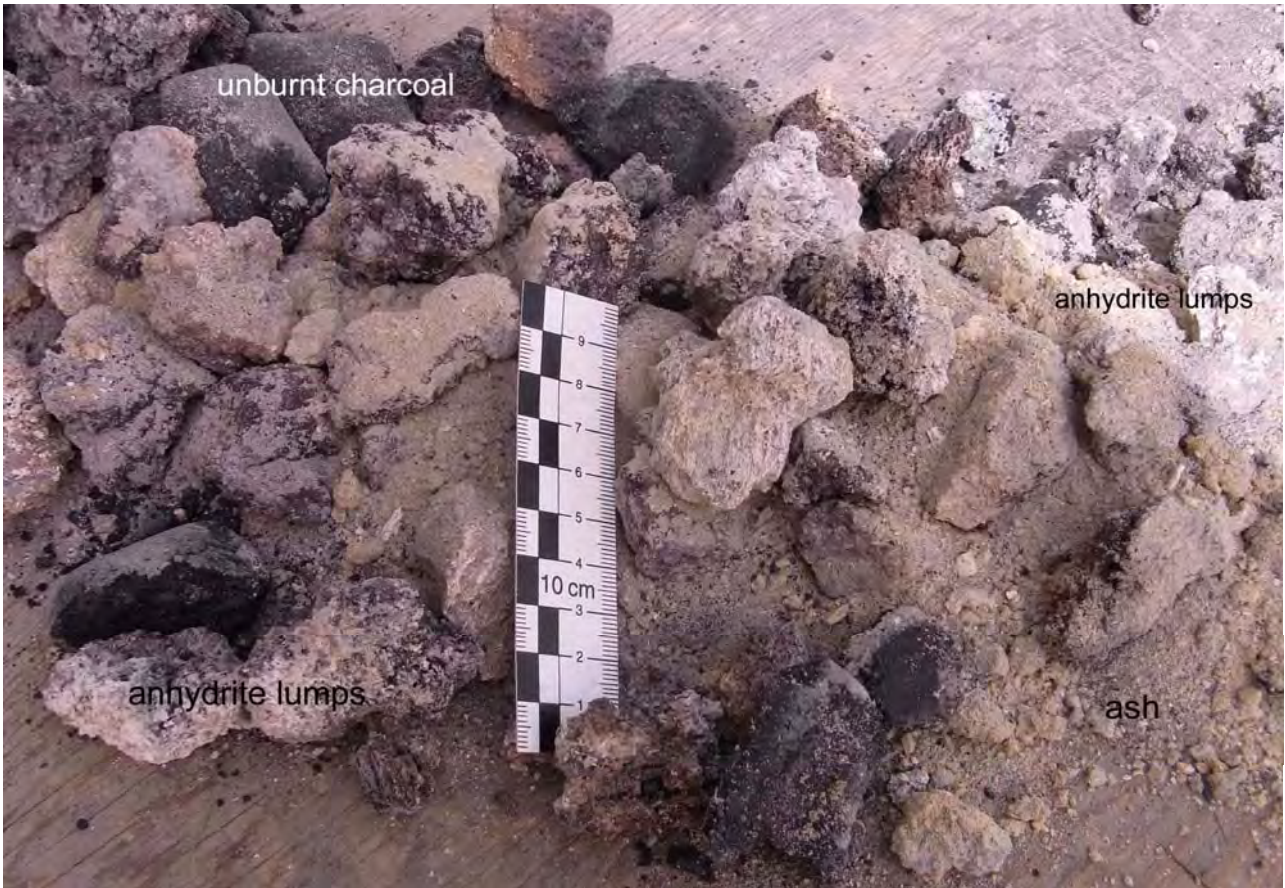
Figure 19: Kiln filling from the transition of zone III (left) to zone II

The experiments with the larger kiln were used for balancing the input and output of materials. The kiln was charged with 1547 g charcoal and 2243 g gypsum. After the burning a total of 1608 g burnt gypsum was handpicked from the filling which corresponds to 90,7 % of the theoretical yield (**figure 19**). However, it has to be remarked that this excellent result is due to the small scale operation of the gypsum burning with the raw material carefully selected by hand (**figure 20**).

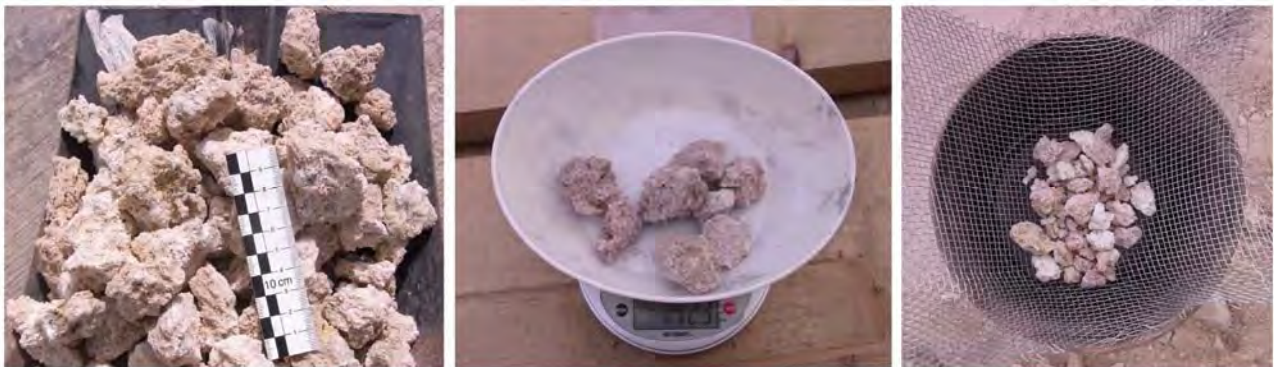
Figure 20: Selecting, weighing and sieving of raw material

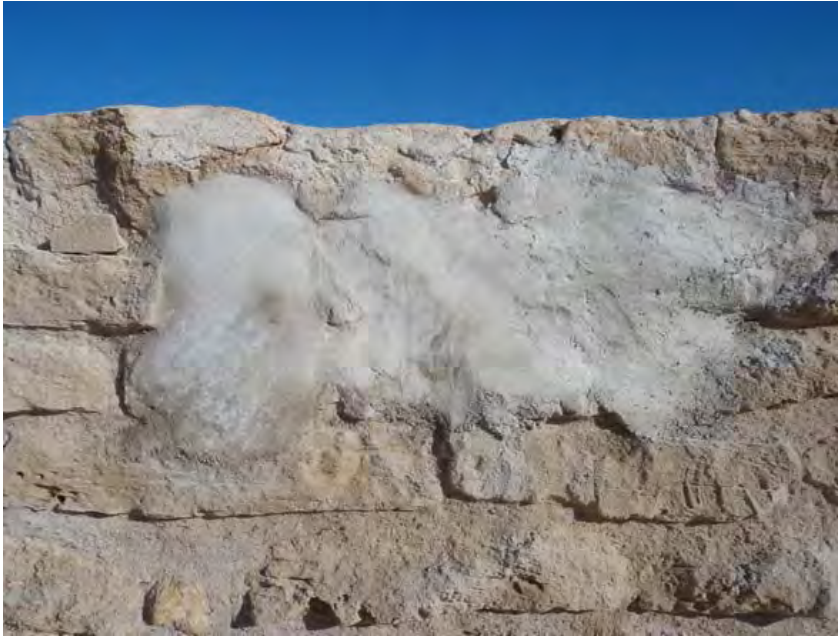
Figure 22: Gypsum plaster at test wall in the North Field

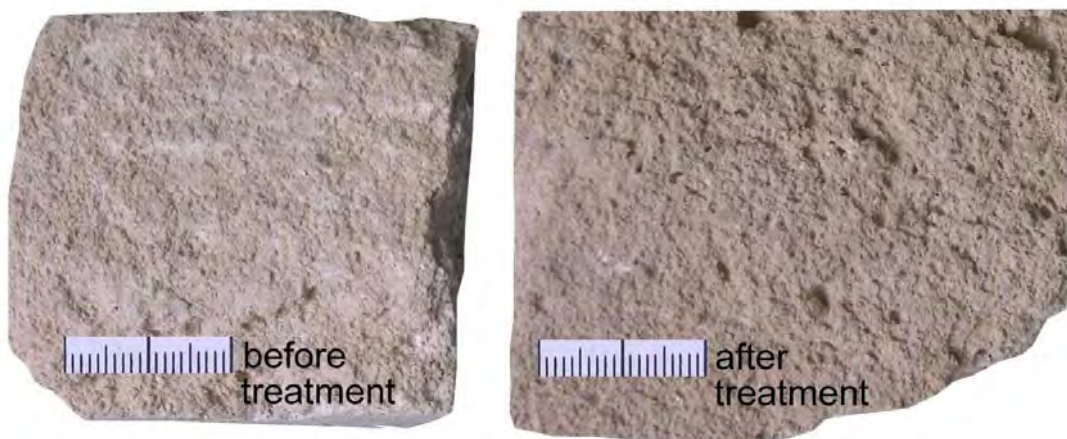
Figure 24: Gypsum plaster surface before (left) and after treatment with Xilan®. Note the slightly darker colour of the treated sample.

The colour of gypsum plaster surfaces treated with Xilan® is slightly darker than the original one (figure 23).

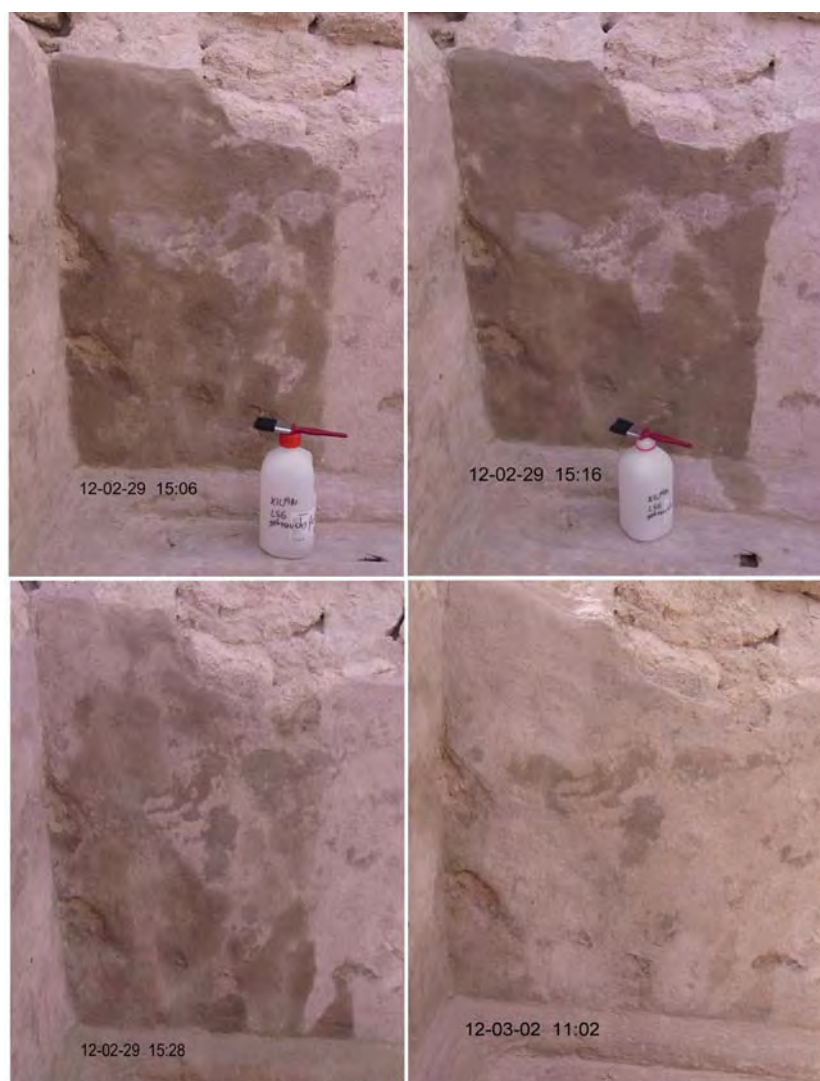
Figure 25: Consolidation test with Xilan® at wall plaster (gypsum) in room with mastaba at EP 04

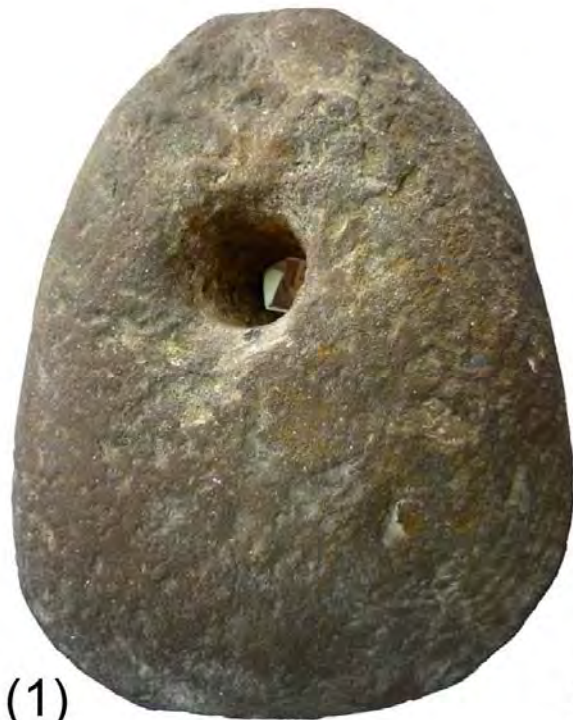
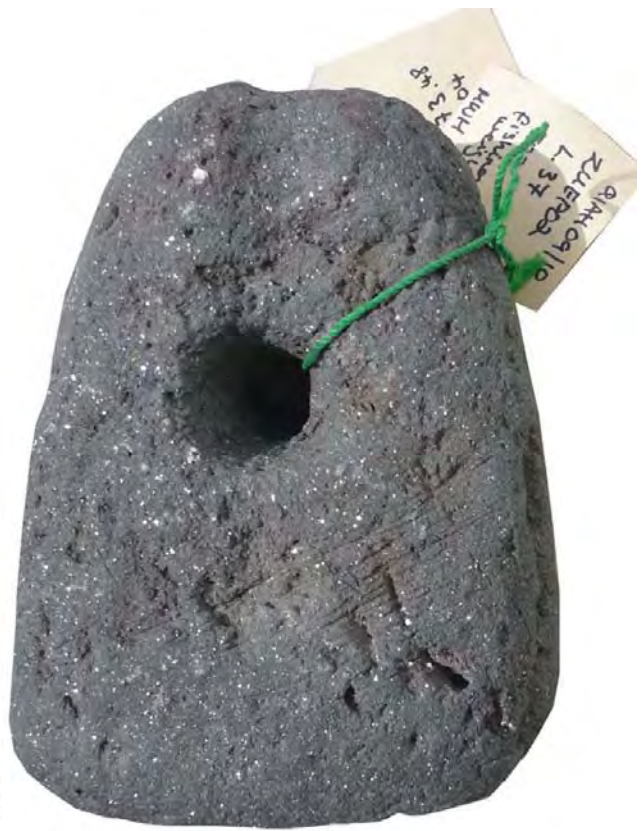
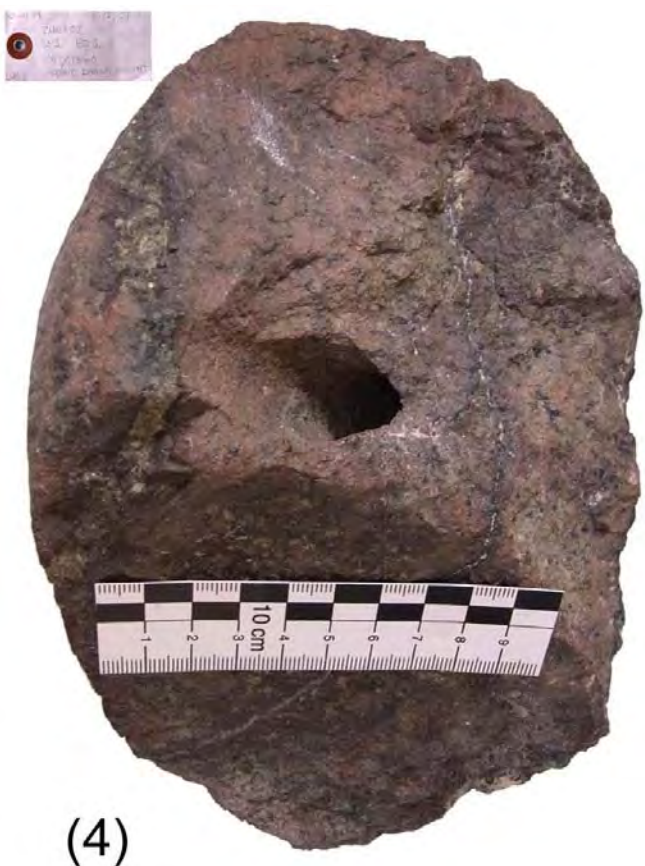
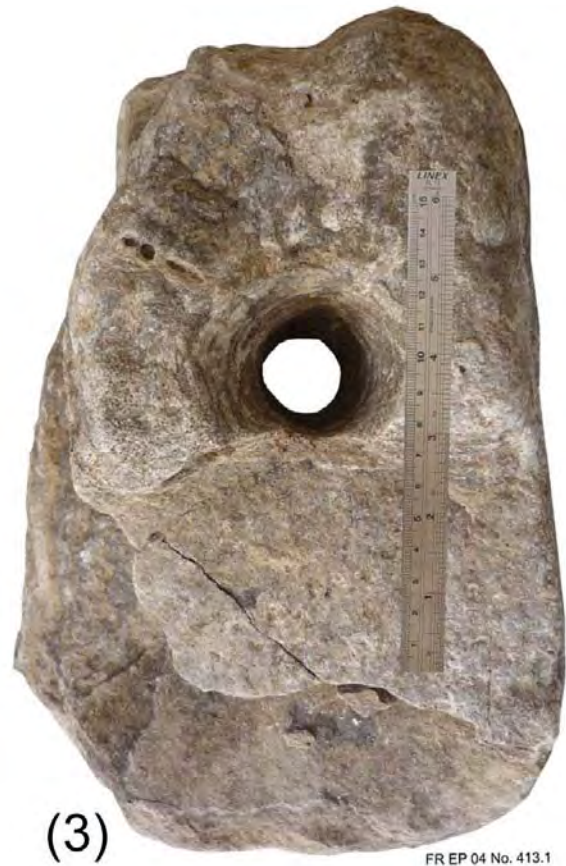
FR EP 04 No. 413.1

Figure 27: Stone diving weights made of different materials. From top left clockwise:
(1) unidentified rock material, (2) hematite-magnetite-(goethite), (3) barite-dolomite,
(4) partly metamorphosed peridotite (olivine, lizardite)

Among the many objects which were found at the various excavation places is a fairly large number of tools and commodities which were made of stones that are not to be found on the peninsular of Qatar. To these objects belong diving weights (**figure 27**) which are made of hematite-magnetite ore, metamorphosed peridotite, barite (**figure 28**), and other not yet identified stone materials. Since these rocks do not occur in Qatar they must have been imported to Al Zubarah. Potential sources from a petrographical-mineralogical point of view are Iran (barite, hematite-magnetite, ultrabasic rocks) and Oman (peridotite, ultrabasic rocks). The tracing of the points of origin of these special rocks would contribute to the understanding of trade routes and relations of the people of Al Zubarah with neighbouring countries.

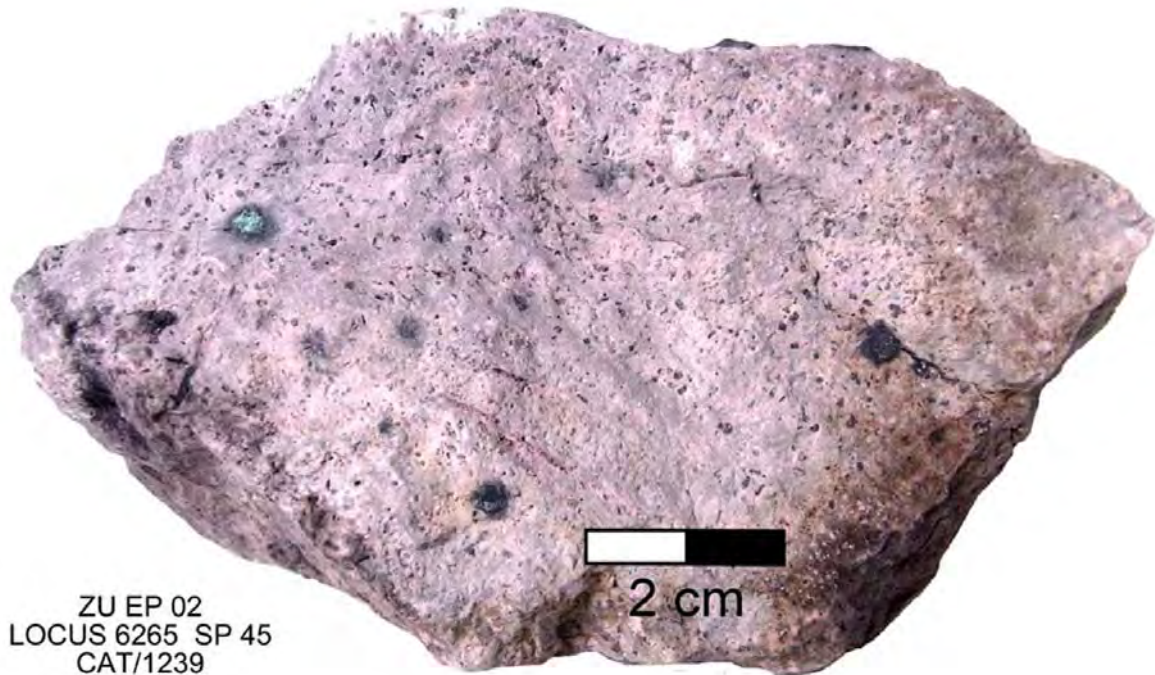
Figure 29: X-ray diffractogram (EU EP 02 Loc. 6285 SP 45 CAT 1239)

The collection of „odd stones“ also comprises a lump of dolomite (**figure 29**) which is speckled by black and green dots which turned out to be tenorite (black copper(II) oxide) and atacamite, $\text{Cu}_2(\text{OH})_3\text{Cl}$. The two copper minerals are oxidation minerals of primary copper (I) sulphide, chalcocite Cu_2S . The peculiar rock is nothing less than a low-grade copper ore ! And again, it would be most interesting to have an answer to the questions where does it come from and what was it used for?
