Conservation Handbook Al Zubarah Archaeological Site

Edited by
Moritz Kinzel

QIAH-01-02-HE-1000

First Edition January 2013

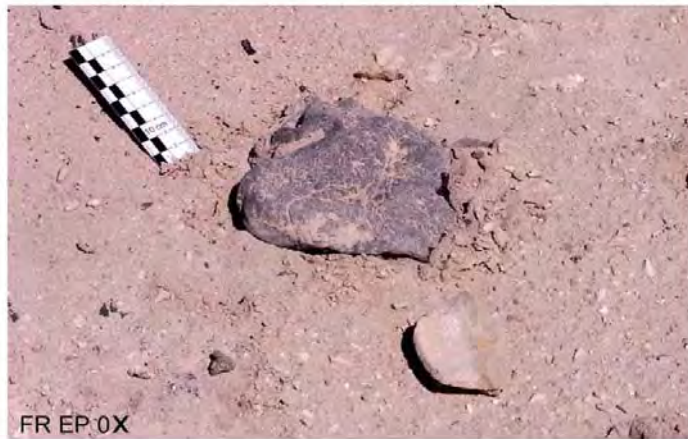
**Figure 32: Top: Different finds of bitumen from Freya.
Bottom: Distribution of aliphatic hydrocarbons**

In the collection of finds are vessels and vessel fragments which are partly coated with bitumen (**figure 32**). Parts of the Al Zubarah city area are littered with lumps of bitumen that were washed ashore in the wake of the Gulf War oil spill. Superficially looked at there is little difference in the appearance of archaeological bitumen and recent bitumen from the oil spill. Three archaeological bitumen samples from Freya (FR EP 04 585, FR EP 04 215, FR 0x) and a piece of recent bitumen (REF) from a spoil heap in the vicinity of Al Zubarah EP 04 were analysed by gas chromatography with respect to aliphatic (AH) and polycyclic aromatic hydrocarbons (PAH). It was expected that recent bitumen contains distinctly more and lighter AH and PAH than archaeological = old bitumen. However, as the results presented in **table 12** prove this was not the case: the fractions of lighter AH (C10 – C20) and the total amount of PAH were both higher in the archaeological samples. Obviously, the general idea that archaeological and recent bitumen could easily be distinguished by chemical analysis is too simple because it assumed that the starting material had the same or at least a very similar composition before the onset of degradation and that the degradation process took place under similar conditions.

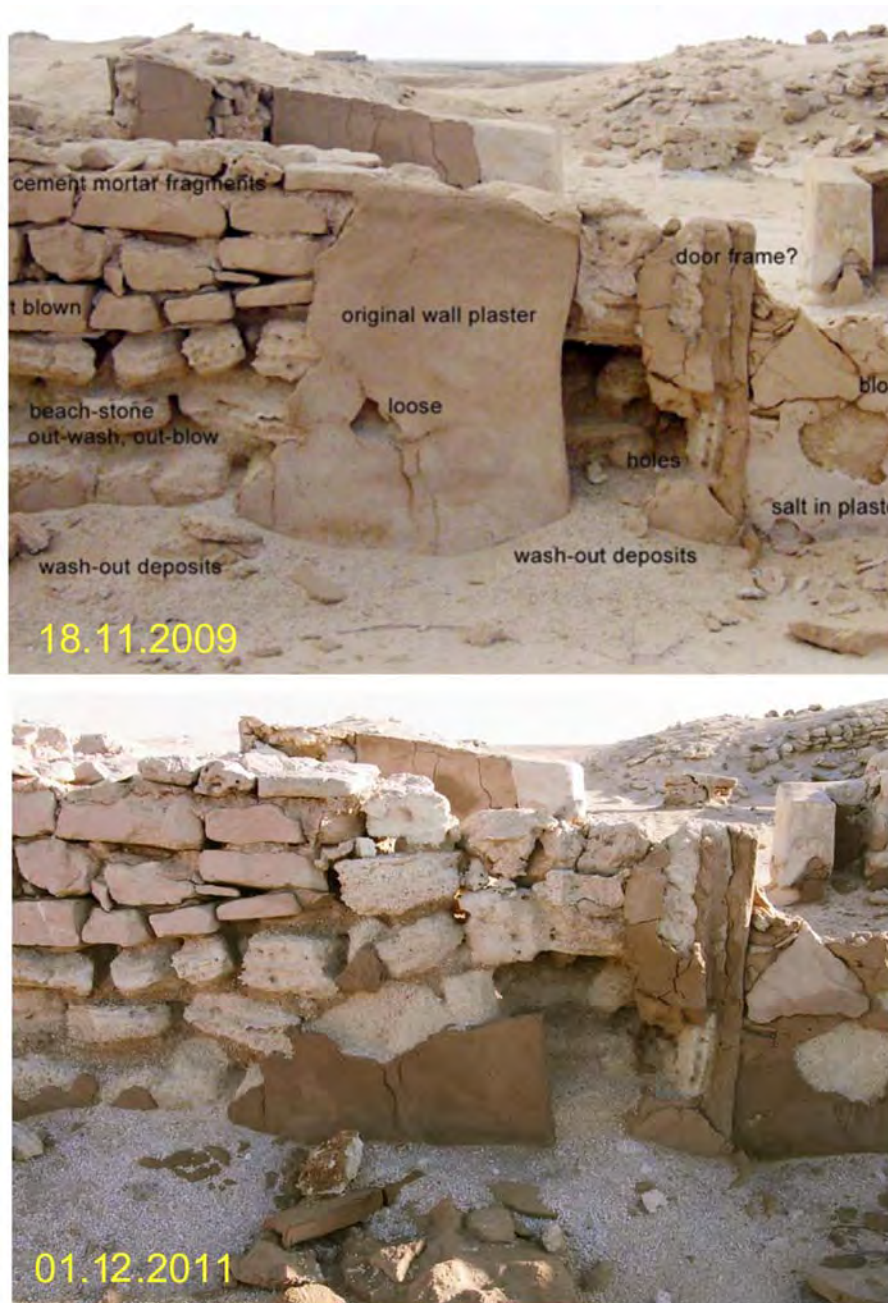
Figure 33: Loss of wall plaster at wall c, room 005, South Field

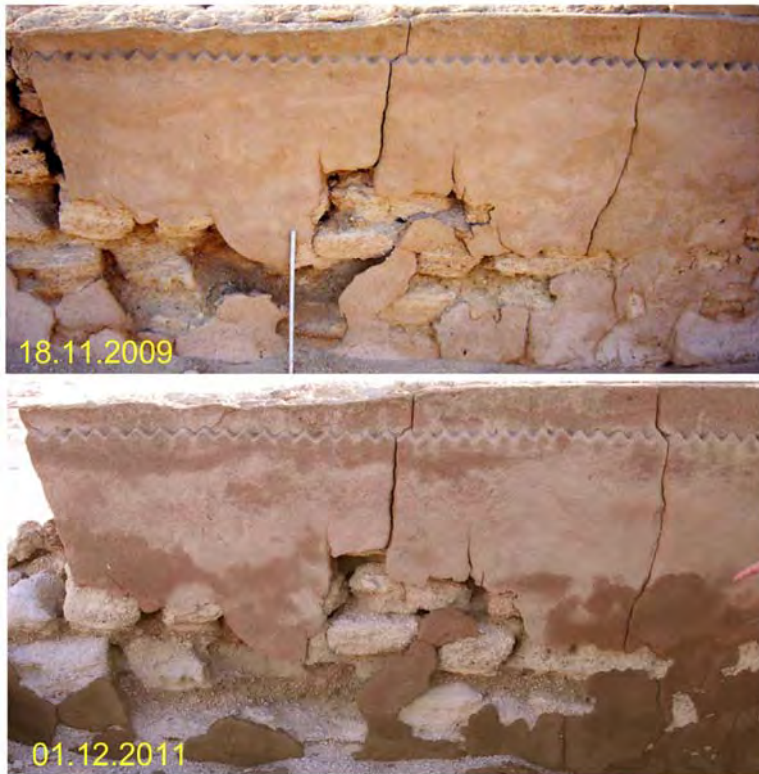
Figure 34: Loss of wall plaster at wall c, room 005, South Field

The photographic documentation of walls in different states of preservation and geographical orientation over time is a very effective method to get an idea about the rates and mechanisms of decay. **Figures 33 and 34** show that the collapse of wall plaster at different sections of wall c in room 5 depends very much on the state of the wall behind the plaster. If the substrate is no longer consolidated and if there is no more bonding between wall and plaster then there exists a state of metastable to instable equilibrium and the plaster may drop any moment. **Figure 35** demonstrates that a strongly decayed wall can persist in this state for a considerable time.

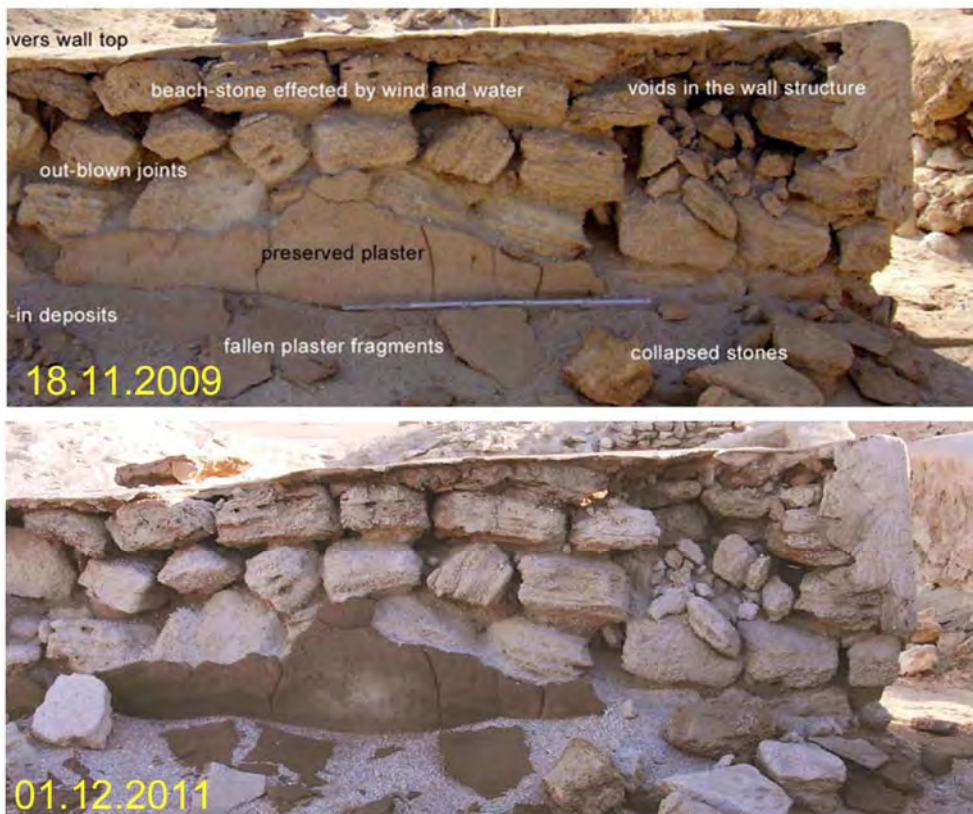
Figure 35: Loss of wall plaster at wall c, room 006, South Field

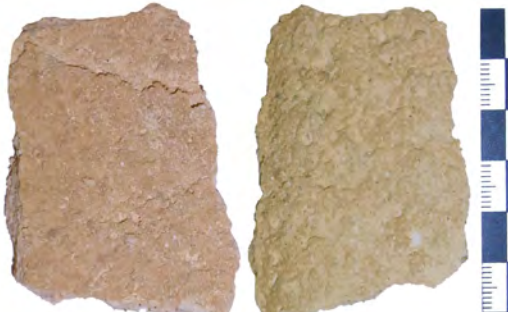
ZU 01
upper layer of gypsum plaster

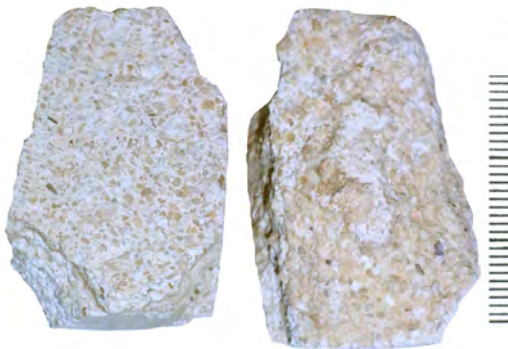
ZU 05
repair mortar from 1980

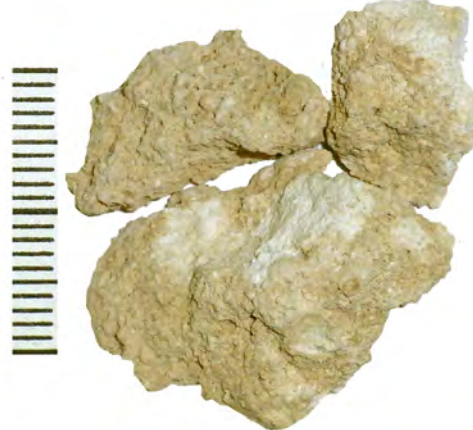
ZU 06 wall mortar

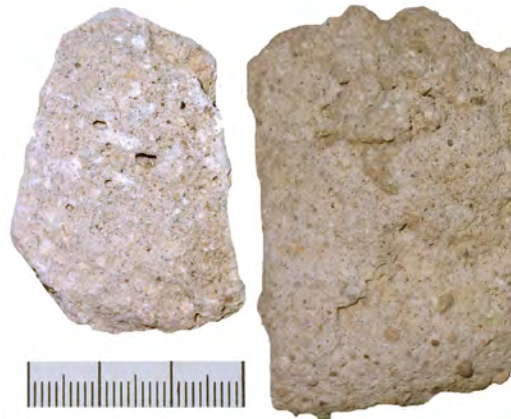
ZU 19 gypsum mortar QMA 02

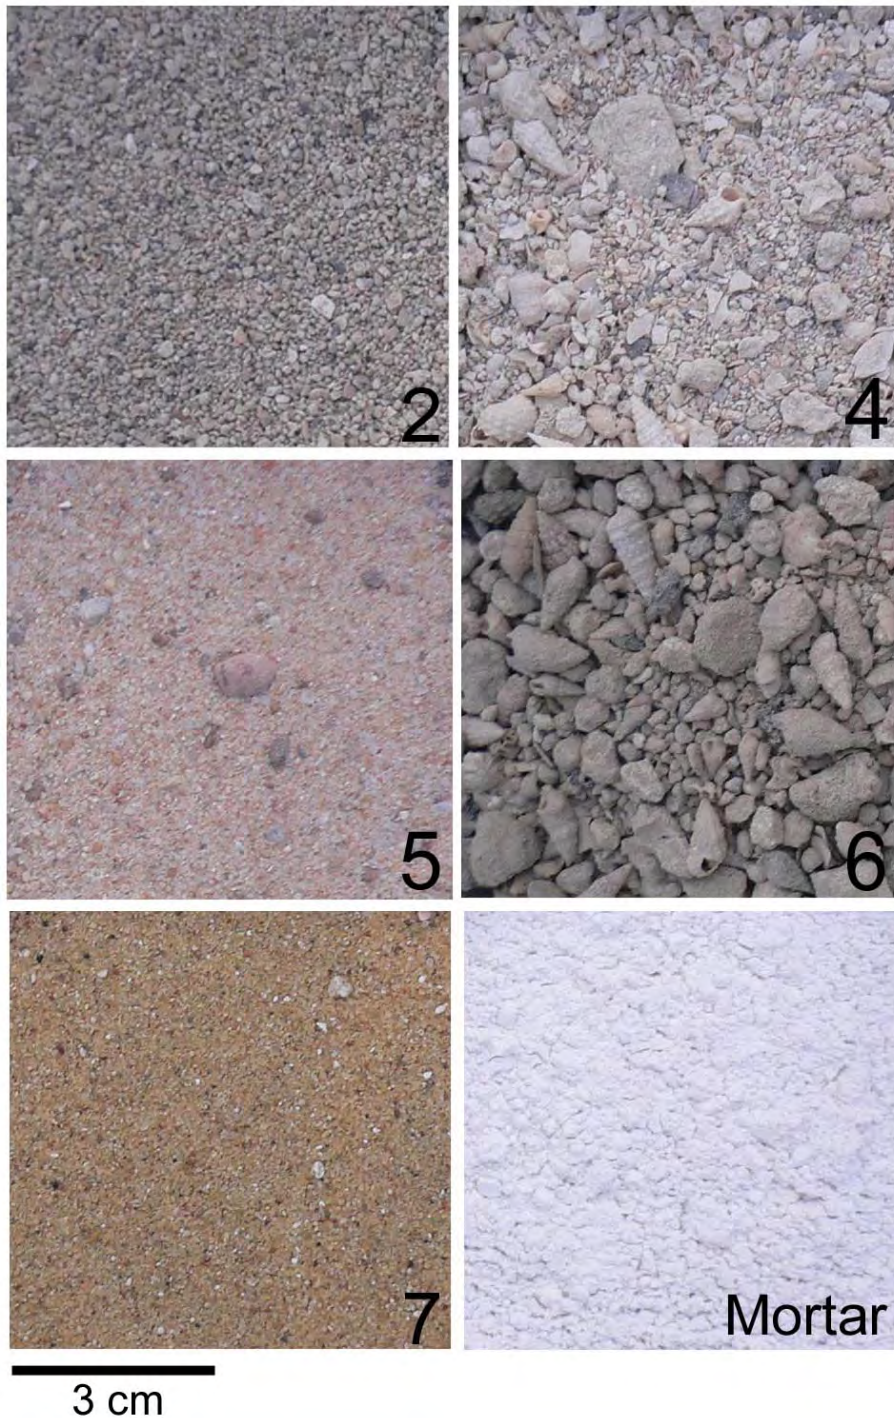
Figure 1: Sand and mortar samples

The Labor für Baudenkmalpflege Naumburg obtained a number of sand and mortar samples (figure 1) from the restorer Paul Hofmann in order to determine the chloride contents and phase composition, respectively. Two washed sand samples were used for the preparation of mortars with natural hydraulic lime as binder.

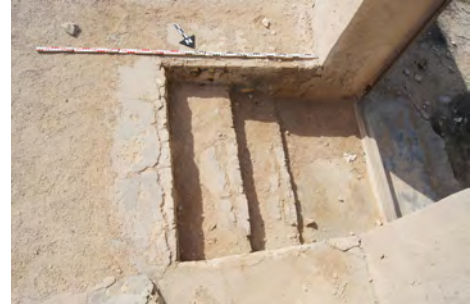
Al Jumail, S40 - mosque. Cracks on the steps leading to the courtyard of the mosque

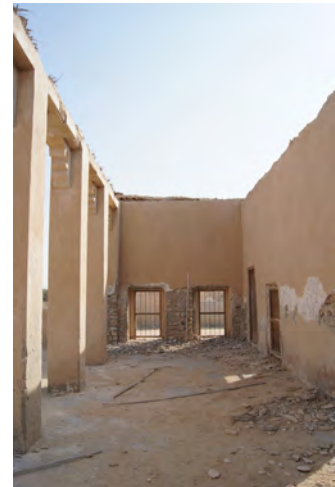
Al Jumail, S40 - mosque. Fragments of plaster, stones, blown-in sand deposits and litter visible on the floor

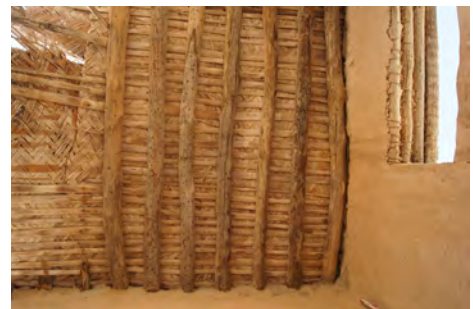
Round beams, Rectangular beams, Planks, Bamboo, Woven mats, Mud covering, Unknown - not visible, No ceiling/roof	The roofs are usually composed of round, rectangular beams or planks supporting splitted bamboo stems and woven mats. The top covering consists of mud layer and sometimes small gravel.
--	--

Al Jumail, S40, Roof of round beams, bamboo, woven mats and mud covering

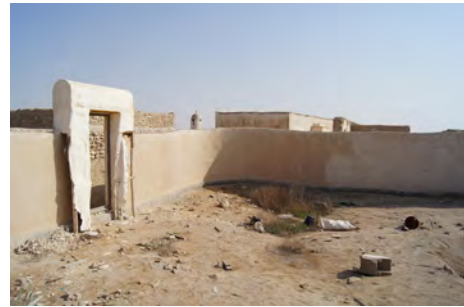
Constructions erected for a movie set in 2009 – walls of stone or cement blocks, mud/earth mortar of coarse grain and high amount of gravel, covered with mud slurry and/or shoddy plaster. Very often the proportion of mortar exceeds the proportion of stones in the stonework. Some parts of the structures may consist of provisional constructions made of wood, textile tissue and gypsum - e.g. portals or shelves.

Al Jumail, S42, courtyard walls erected in 2009; the gate made of textile and gypsum plaster

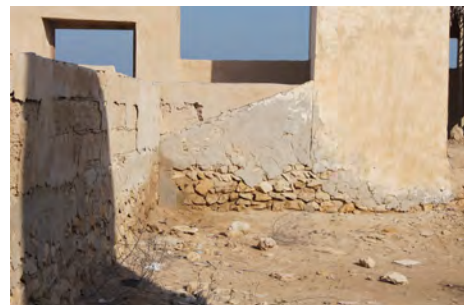
Al Jumail, mosque (S40). Masonry of cement blocks and stonework covered by cement plastering (left); the abluion room's wall has an additional layer of anhydrite finish (right)

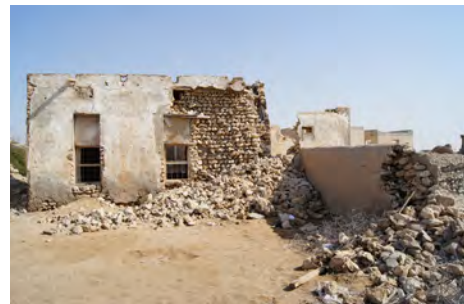
Al Jumail, S54, stonework with mud mortar and cement plastering. Anhydrite plaster finish on the façades, no anhydrite finish on the courtyard wall (right)

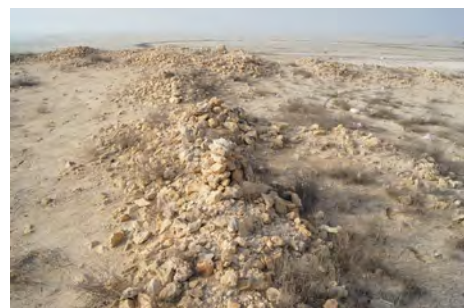
Al Jumail, compounds in the northern part of the village. Ruined walls made of stone and mud mortar

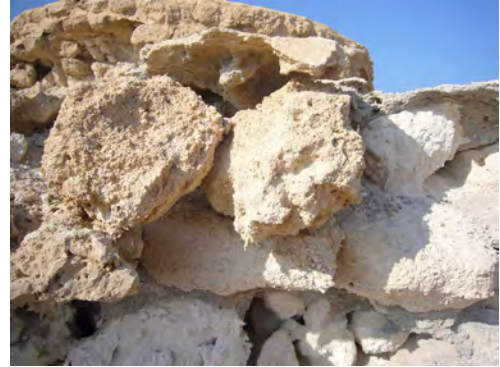
Colour: White to beige
Solidity: Very friable/brittle, loose components
Characteristics: Fine grained, high content of shells and gastropods, rough surface

White stones in the picture are Beachrock AG

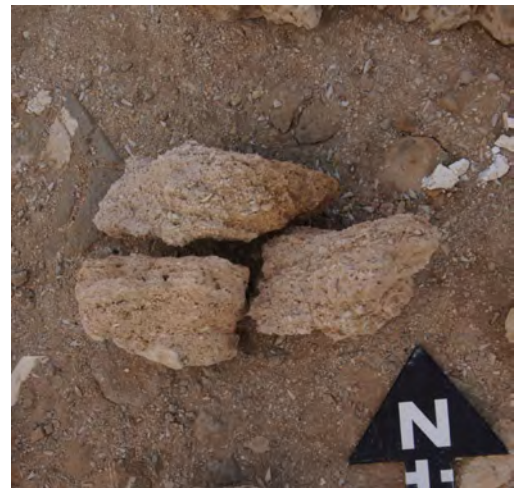
Beachrock BJ

Colour: Grey to light reddish
Solidity: Soft to medium hard
Characteristics: Recognizable stratification - gastropods and fine-grained sandy matrix, uniform ingredients, rough surface

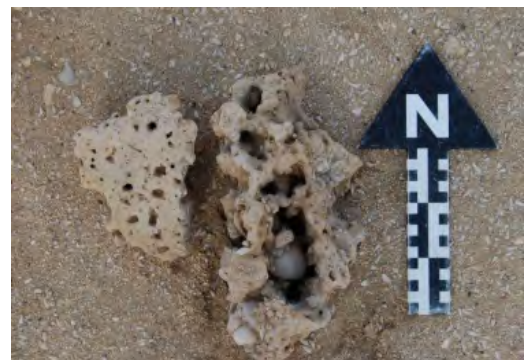
Beachrock LO

Colour: Reddish to brown, grey
Solidity: Medium to very hard
Characteristics: Rough surface, numerous cavities (holes), few gastropods and shells

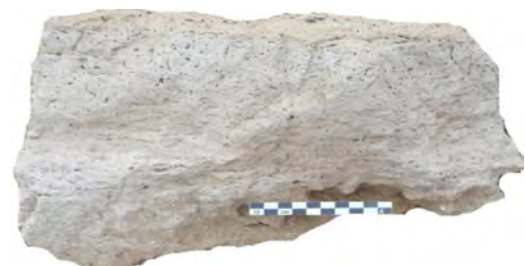
Gypsum BE

Colour: Yellow grey to white or bright grey
Solidity: Soft to medium hard (scratchable with fingernail)
Characteristics: Fine grained, no shells or gastropods, little holes, recognizable stratification and horizontal splits

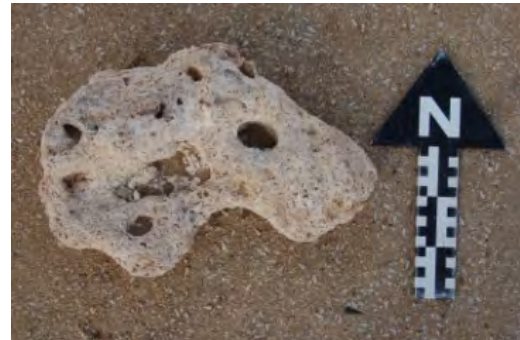
Fossiliferous limestone

Colour: White to bright beige
Solidity: Hard
Characteristics: A limestone that contains obvious fossils - normally shells, cavities

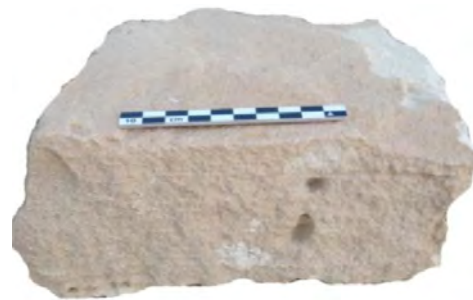
Aeolianite FR

Colour: Beige
Solidity: Fairly hard
Characteristics: Medium grained, even surface, no shells or gastropods, homogenous, looks similar to sandstone

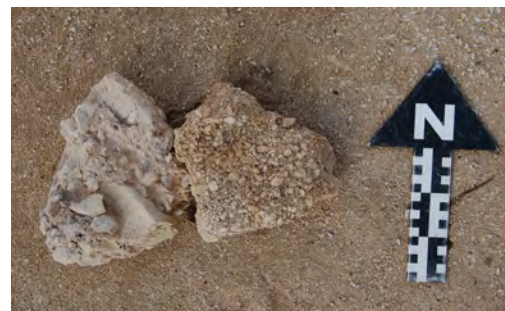
Conglomerate

Colour: Beige, grey
Solidity: Very hard
Characteristics: Mix of dolomite fragments and shells, extremely rough surface

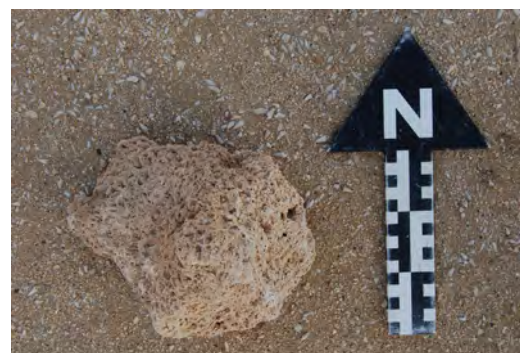
Coral

Colour: Brownish
Solidity: Hard
Characteristics: very rough surface, sharp edges, small cavities of organic origin

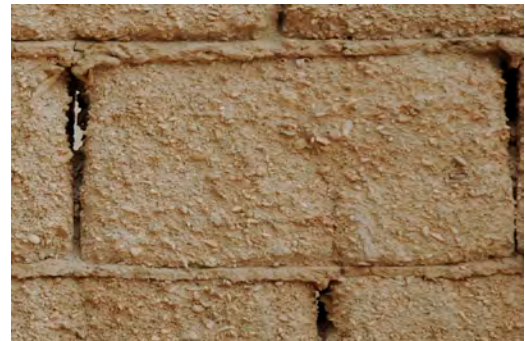
Concrete Block (old)

Colour: Brown, grey
Solidity: Two qualities: hard and soft (falls apart when touched)
Characteristics: Both types with a high proportion of small shells. Size: 20/20/40 cm, walls of about 3 cm thickness surround two square hollow spaces

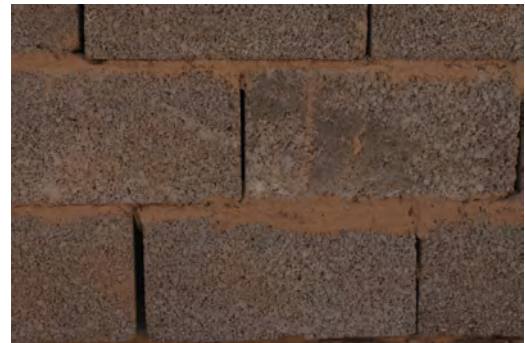
Concrete Block (new)

Colour: Grey-blue
Solidity: Very hard
Characteristics: No shells, round aggregate grains, porous. Size: 20/20/40 cm, walls of about 3 cm thickness surround two square hollow spaces

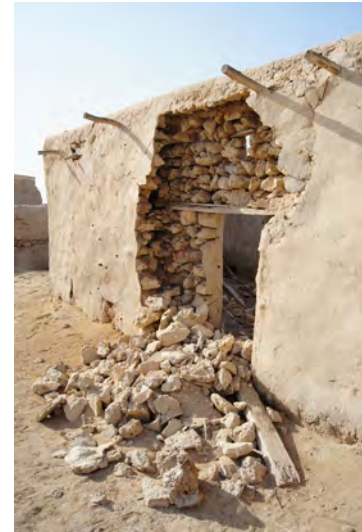
Mud, Fine Grain

Colour: Light brown to brown
Solidity: Very soft
Characteristics: Fine, extremely brittle and susceptible to wind erosion, joins stones in the cores of historic walls of stone masonry.

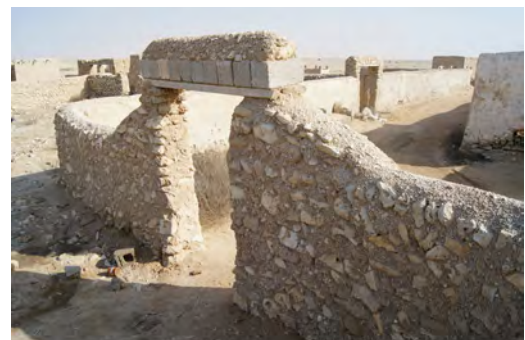
Mud, Coarse Grain

Colour: Brown
Solidity: Soft
Characteristics: High proportion of coarse aggregate, size reaching small gravel. In the stonework the proportion of the mortar often exceeds the proportion of stones

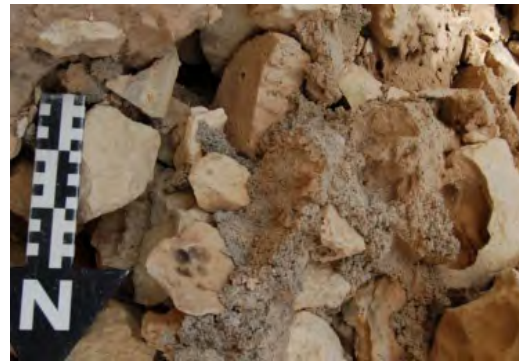
Cement

Colour: Grey, bluish-grey
Solidity: Very hard
Characteristics: Very fine aggregate, depending on the application technique smooth or rough surface

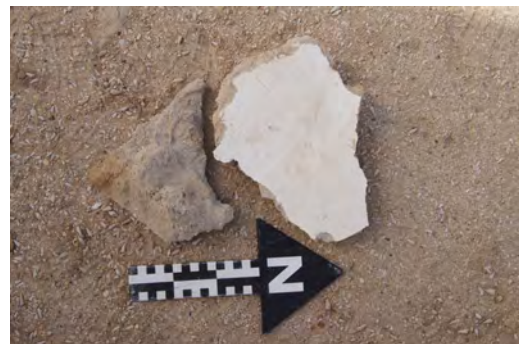
Anhydrite

Colour: White
Solidity: Soft
Characteristics: Fine, smooth surface, often applied as finish layer to cement plaster

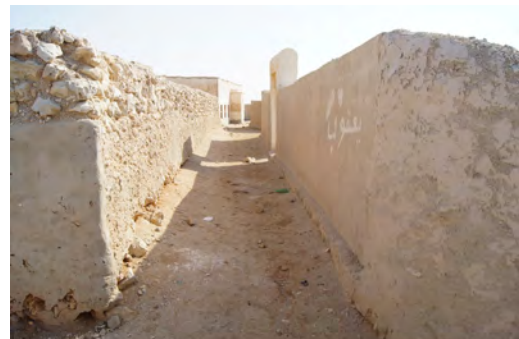
Mud, Fine Grain

Colour: Light Brown
Solidity: Medium
Characteristics: Relatively fine, fairly rough surface; mostly found on the wall faces of the buildings erected in 2009

Al Jumail, courtyard walls in the village erected partly in 2009. Left: top of the wall made of stones with earth mortar, no plastering at all. Right: the fine, thin layer of mud plaster covering the rounded wall.

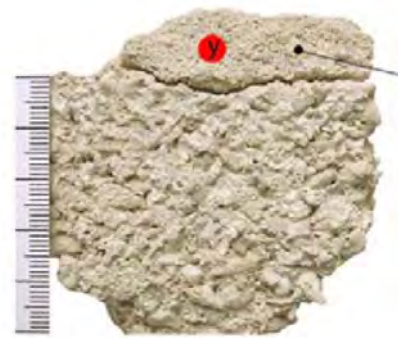
Lime

Color: Yellow grey
Solidity: Hard
Characteristics: Loose packing of aggregate grains stabilized by calcite cement and pores in between the matrix-forming particles. The pores have about the same size as the matrix particles and add up to 40 – 45 volume percent porosity. Often applied to the courtyard walls

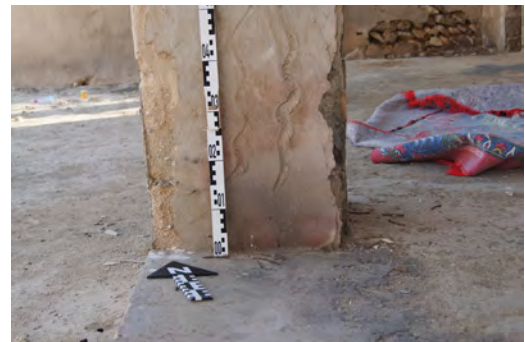
JU_S58

Cement

Colour: Grey
Solidity: Very Hard
Characteristics: Fairly rough surface, very often scratched (wavy lines) to increase the support for the following finish layer

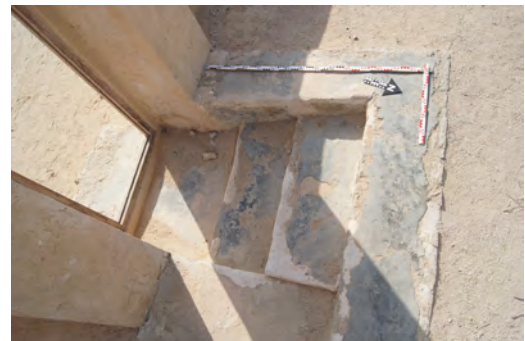
JU_S40

Fine Cement Finish

Colour: Grey to dark grey
Solidity: Very Hard
Characteristics: Very fine, polished, smooth surface, applied to lime or cement plaster

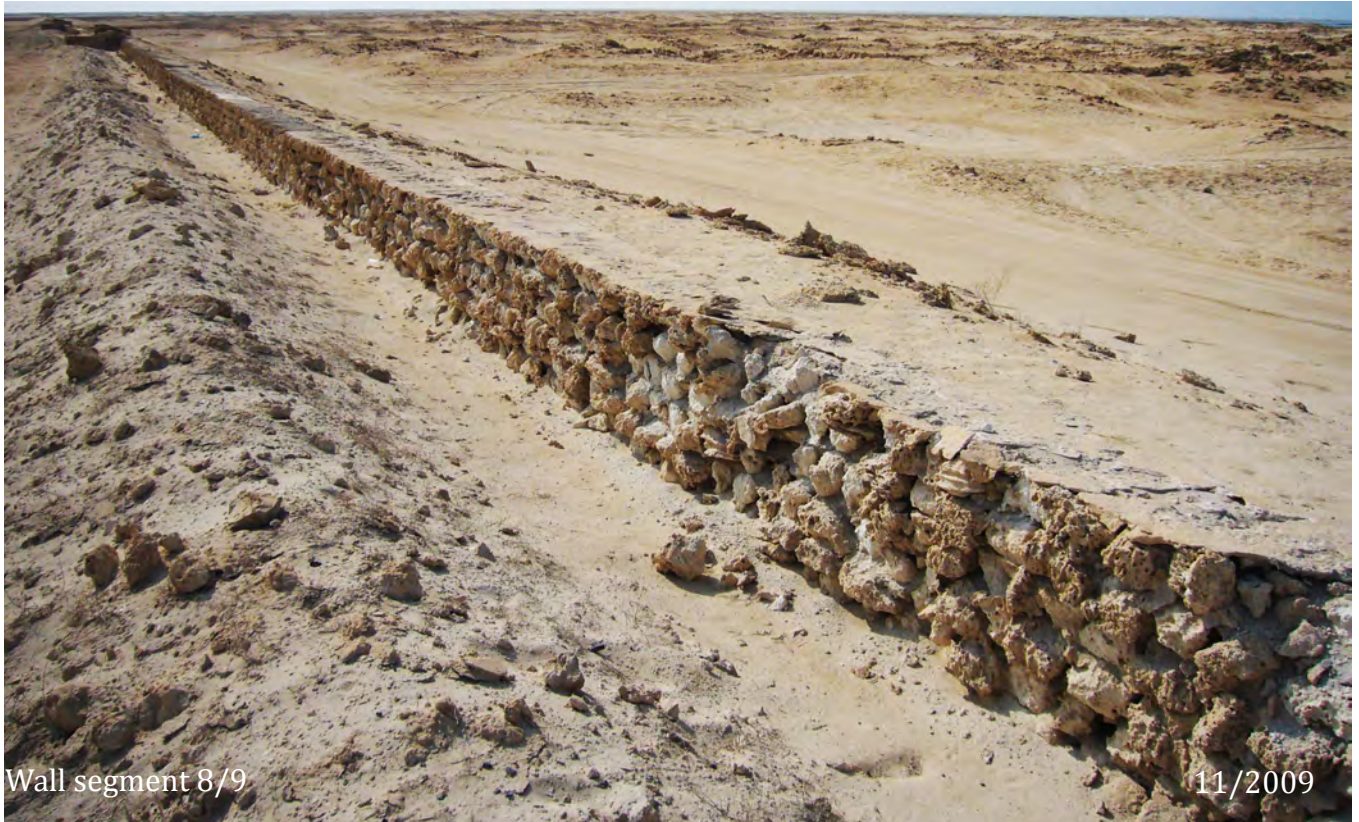
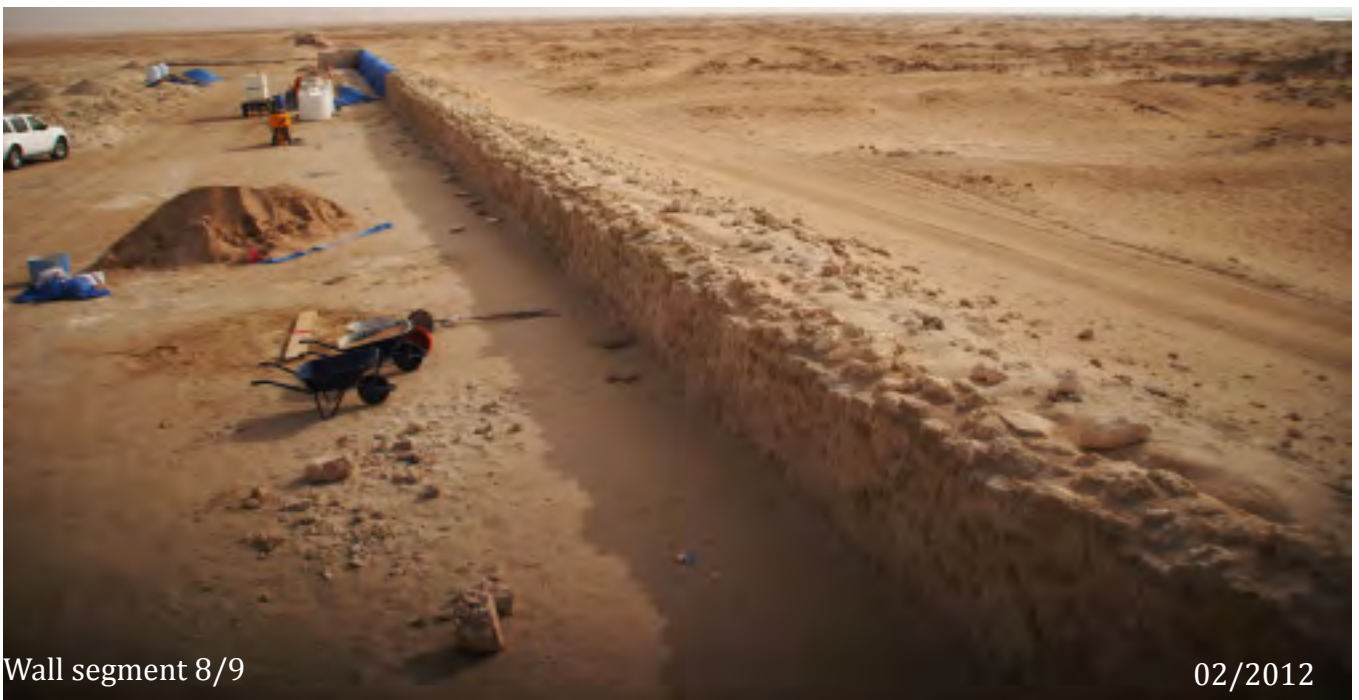
The outer town wall of Al Zubarah was excavated partly in the 1980s. The remains were consolidated then and capped with a flat cement layer. Over the past thirty years huge amounts of soil and sand deposit had accumulated on the exterior and the exposed wall segments were heavily effected by the harsh environmental conditions. When the QIAH-Project was initiated in 2009 it was decided to remove the accumulated deposits to make the town wall more visual for visitors and to gain a better understanding of its structural conditions. Based on the initial record of the state of conservation the conservation concept for the town wall was developed.

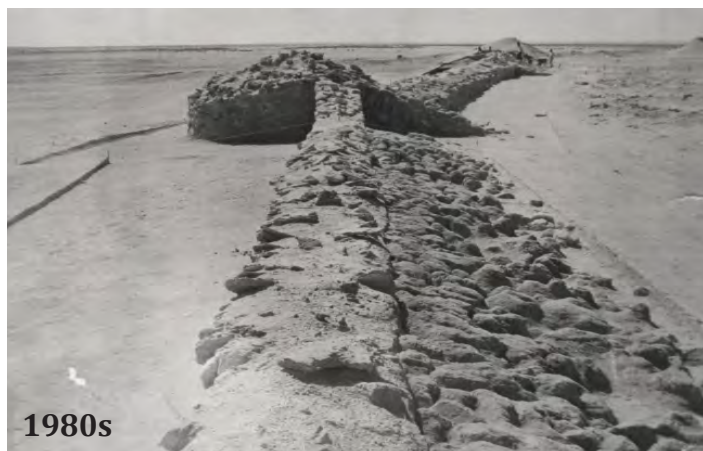
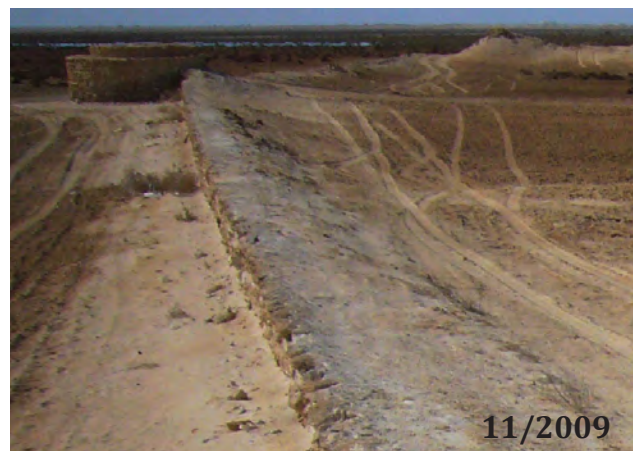
State of conservation
left: during 1980s excavation; right: in Nov. 2009

1. **Documentation** of State of Conservation / **Planning** of Measures
2. **Consolidation** outer wall face (Fiche 3 ; Fiche 3.1)
 - a) Re-placement of damaged wall stones

- b) Inserting new wall stones and new socle zone: up right standing conglomerate (La) stone slab and one course dolomite (Bl) to avoid damages caused by salt crystallisation (Fiche 3.2).

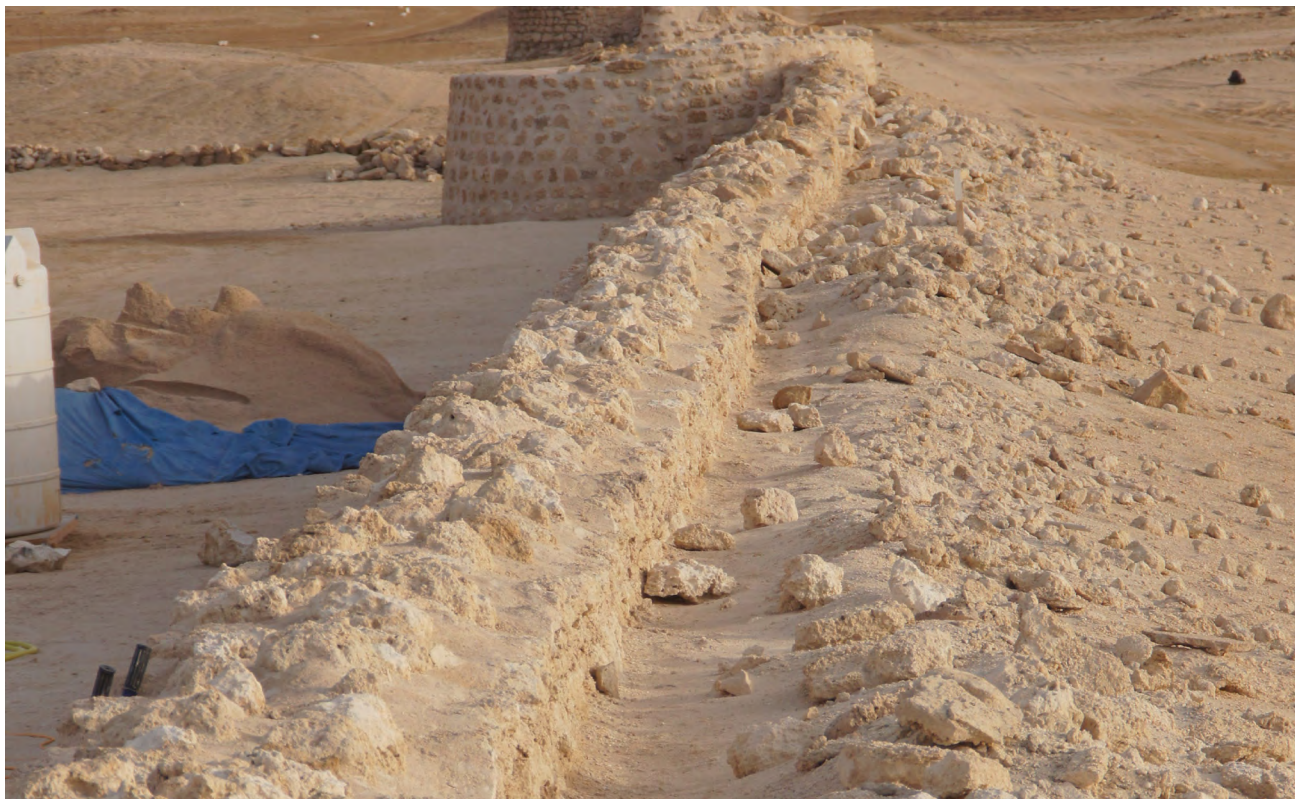
Town wall segment 8/9 with re-shaped crown in March 2012 (VAR. 1).

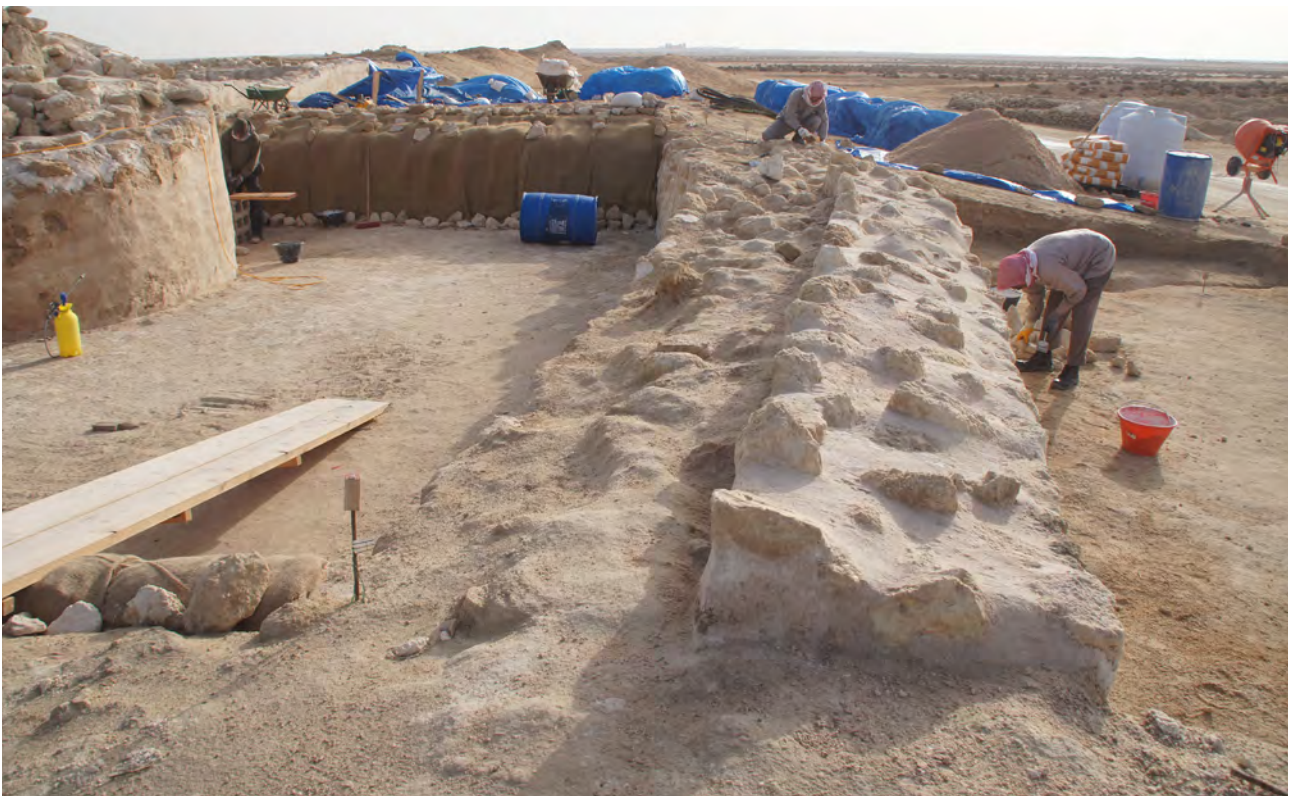
VAR. 2

Town wall segment at tower 4012 (ZUEP04) in March 2012 (VAR. 2).

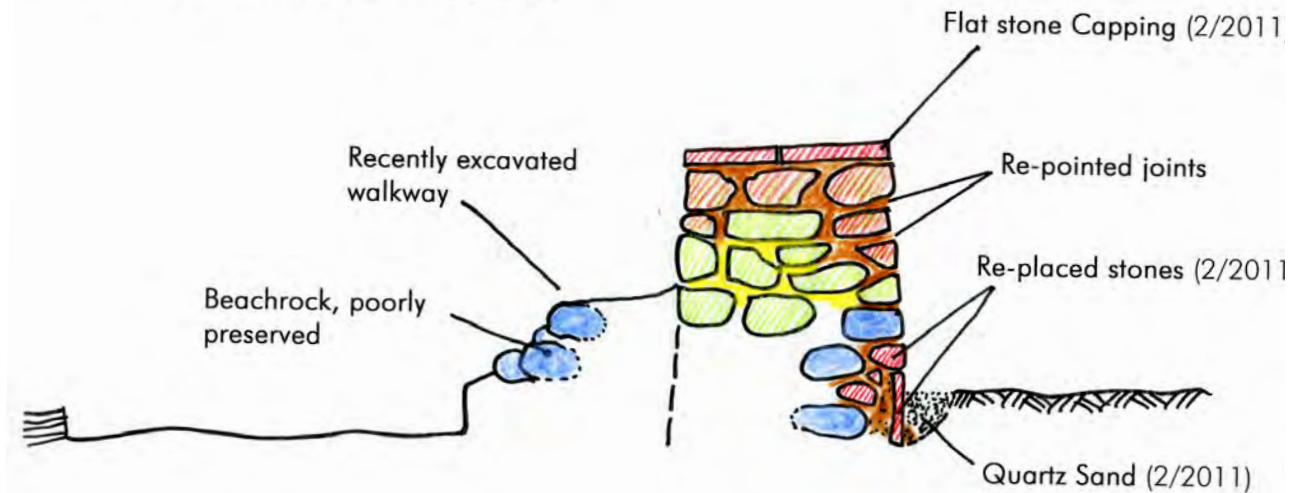
Section of wall segment North of tower 8

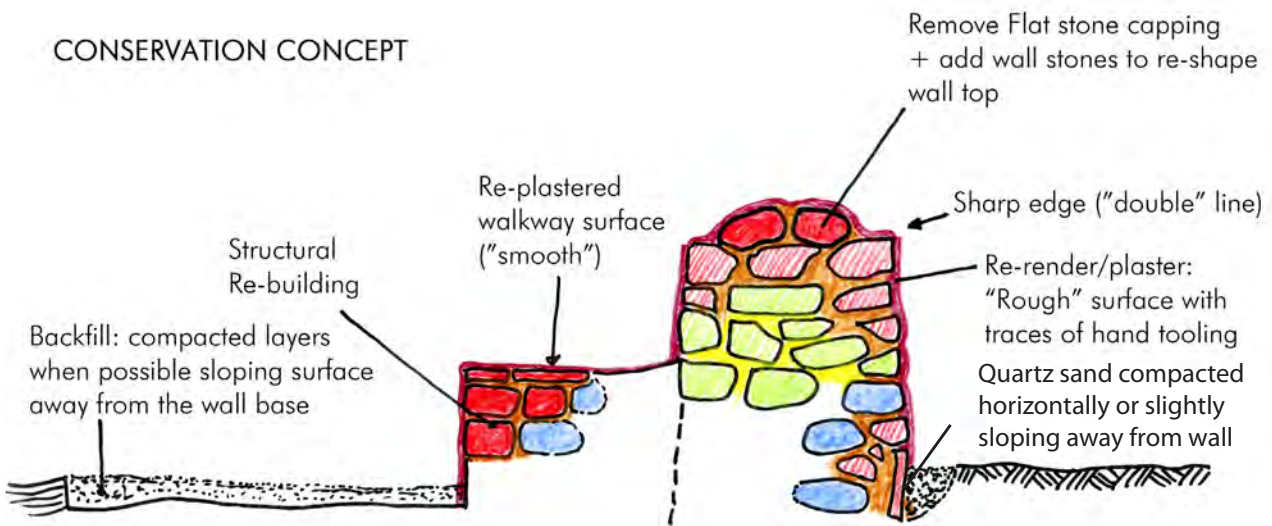
Re-plastering:
"Rough" surface (wall top) and with traces of hand tooling (wall face); sharp edge (double-line) between wall top and wall face; edged corners

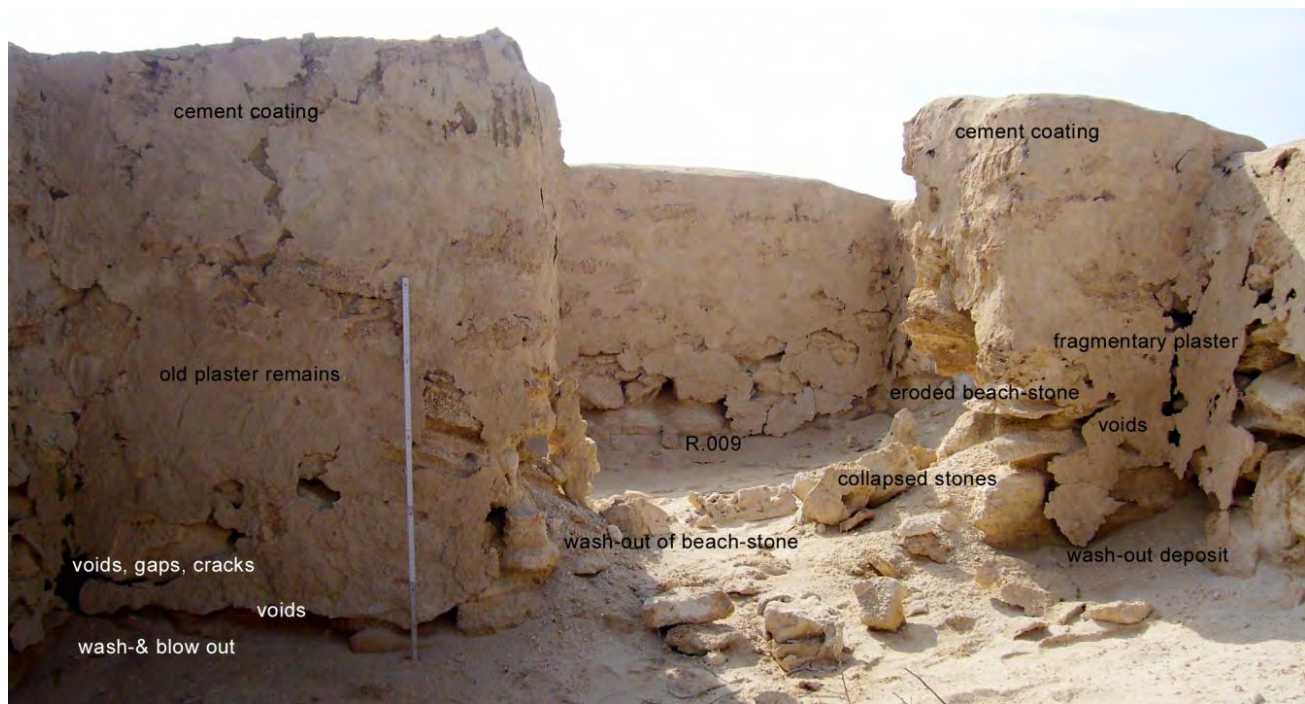
Wall c	
Description	Consolidation/Conservation suggestions
<p>Cement coat on wall top and upper 1/3 of wall face is crackling.</p> <p>Beach stone material is in a very poor state and heavily effected by aeolian and fluvial erosion processes. Wall structure starts to collapse.</p> <p>Massive deposits of disintegrated building material debris at wall base.</p> <p>In lower half of the wall historic plaster fragments preserved.</p> <p>It is unclear if the wall opening is a result of the 1980s excavation and consolidation work or if it is a historical context.</p>	<p>2012: Removal of deposits; Sorting of wall stones and plaster remains; Removal of cement capping and render; consolidation of wall structure; consolidation of historic plaster remains; re-plastering.</p>

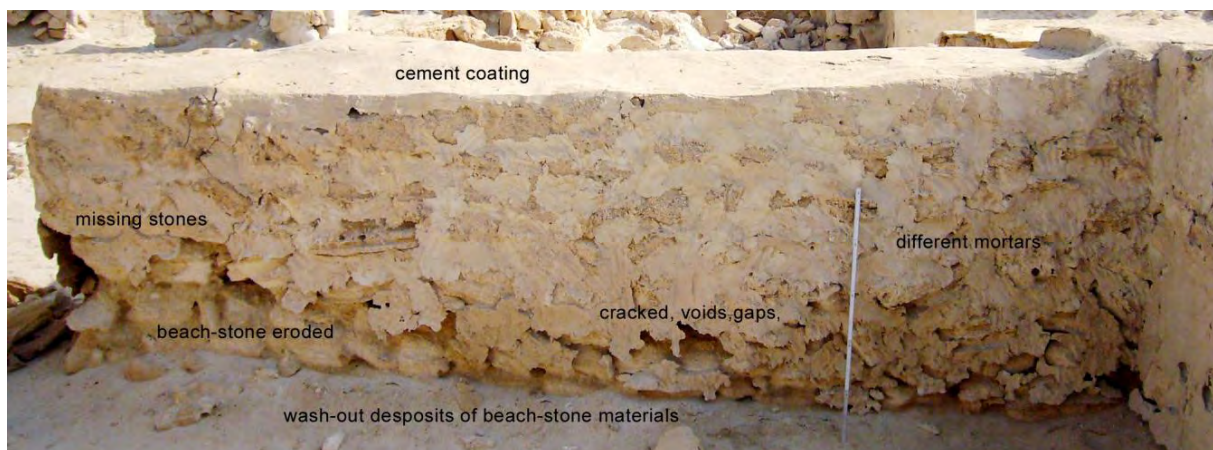
Wall d	
Description	Consolidation/Conservation suggestions
<p>Beach stone-wall with mud/soil-, anhydrite- & cement-mortar. Cement coating, in lower parts also historic plaster fragments are preserved. Substantial plaster remains in door reveal and in front of the wall.</p> <p>Beach stone is in a poor state especially at the wall base. Heavily weathered wall stones. Deposits of disintegrated building material debris and blown-in soil/sand. Wall opening (door) to R.005. Missing stones. Voids in the wall structure.</p>	<p>2012: Remove deposits, Collect fallen plaster remains; Remove cement capping and render; Consolidation of wall structure and plaster remains (mainly at the door); Re-shaping of wall top and re-plastering.</p>

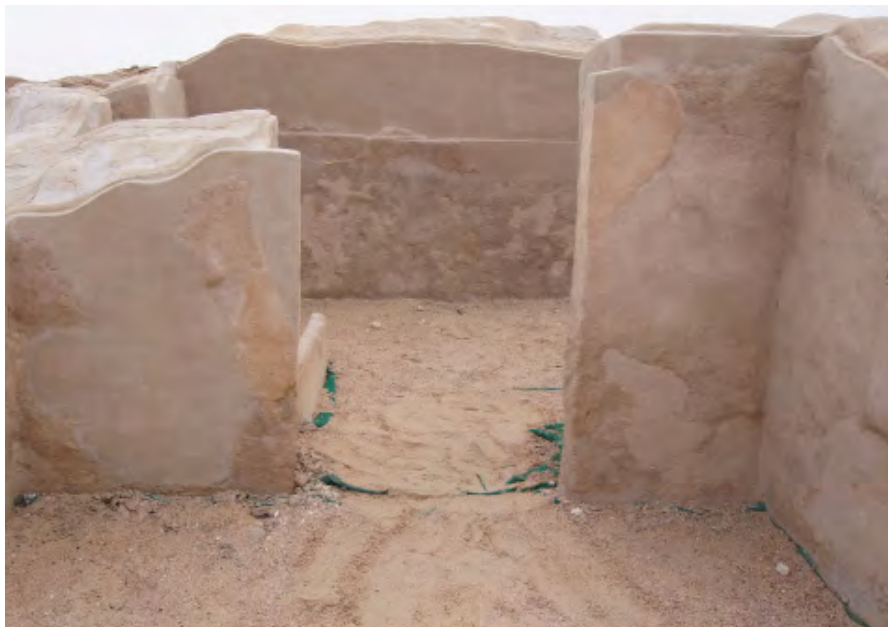
Comparable situation in the Palace (ZUEP04) after consolidation and re-plastering. Historic plaster remains were consolidated and integrated in the plaster surface.

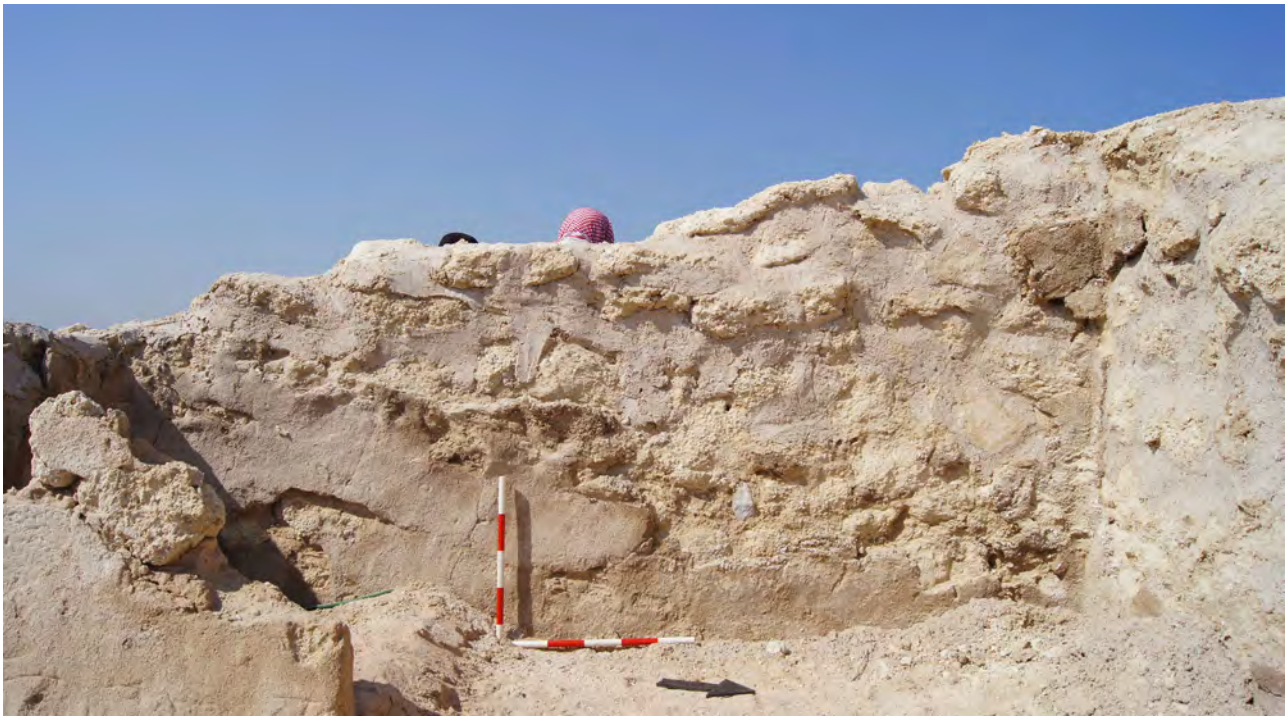
Wall 4476, state of conservation, February 27th, 2012

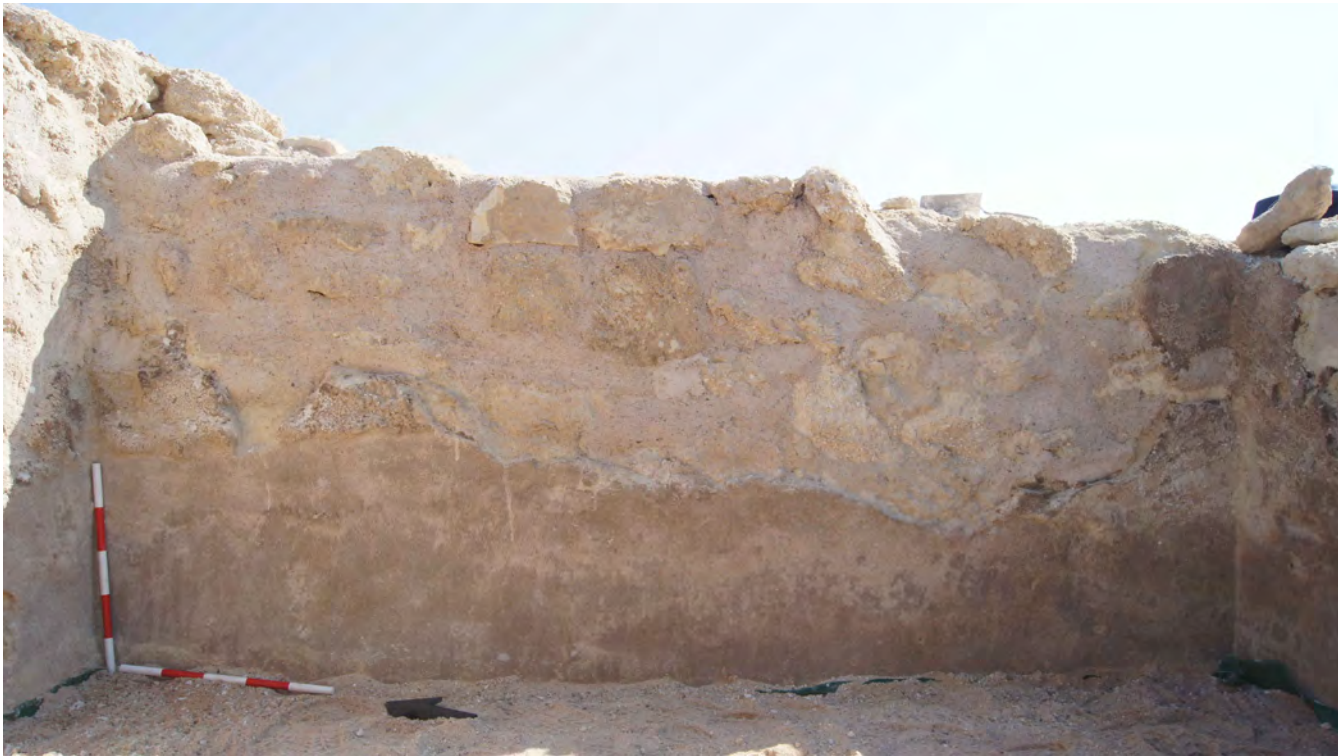
Wall 4481, state of conservation, February 27th, 2012
